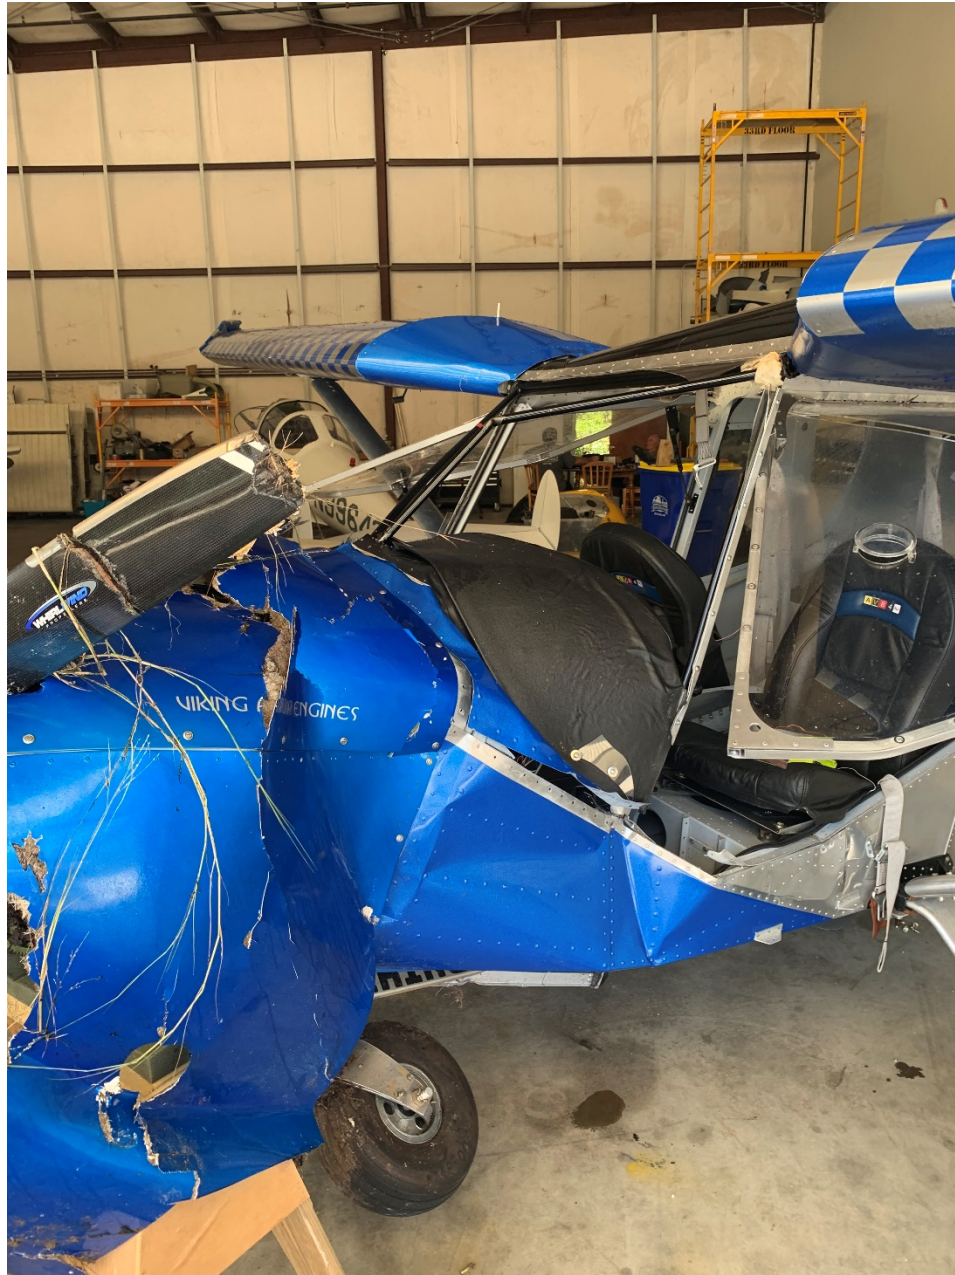
**Photo 1– front left view of main wreckage**

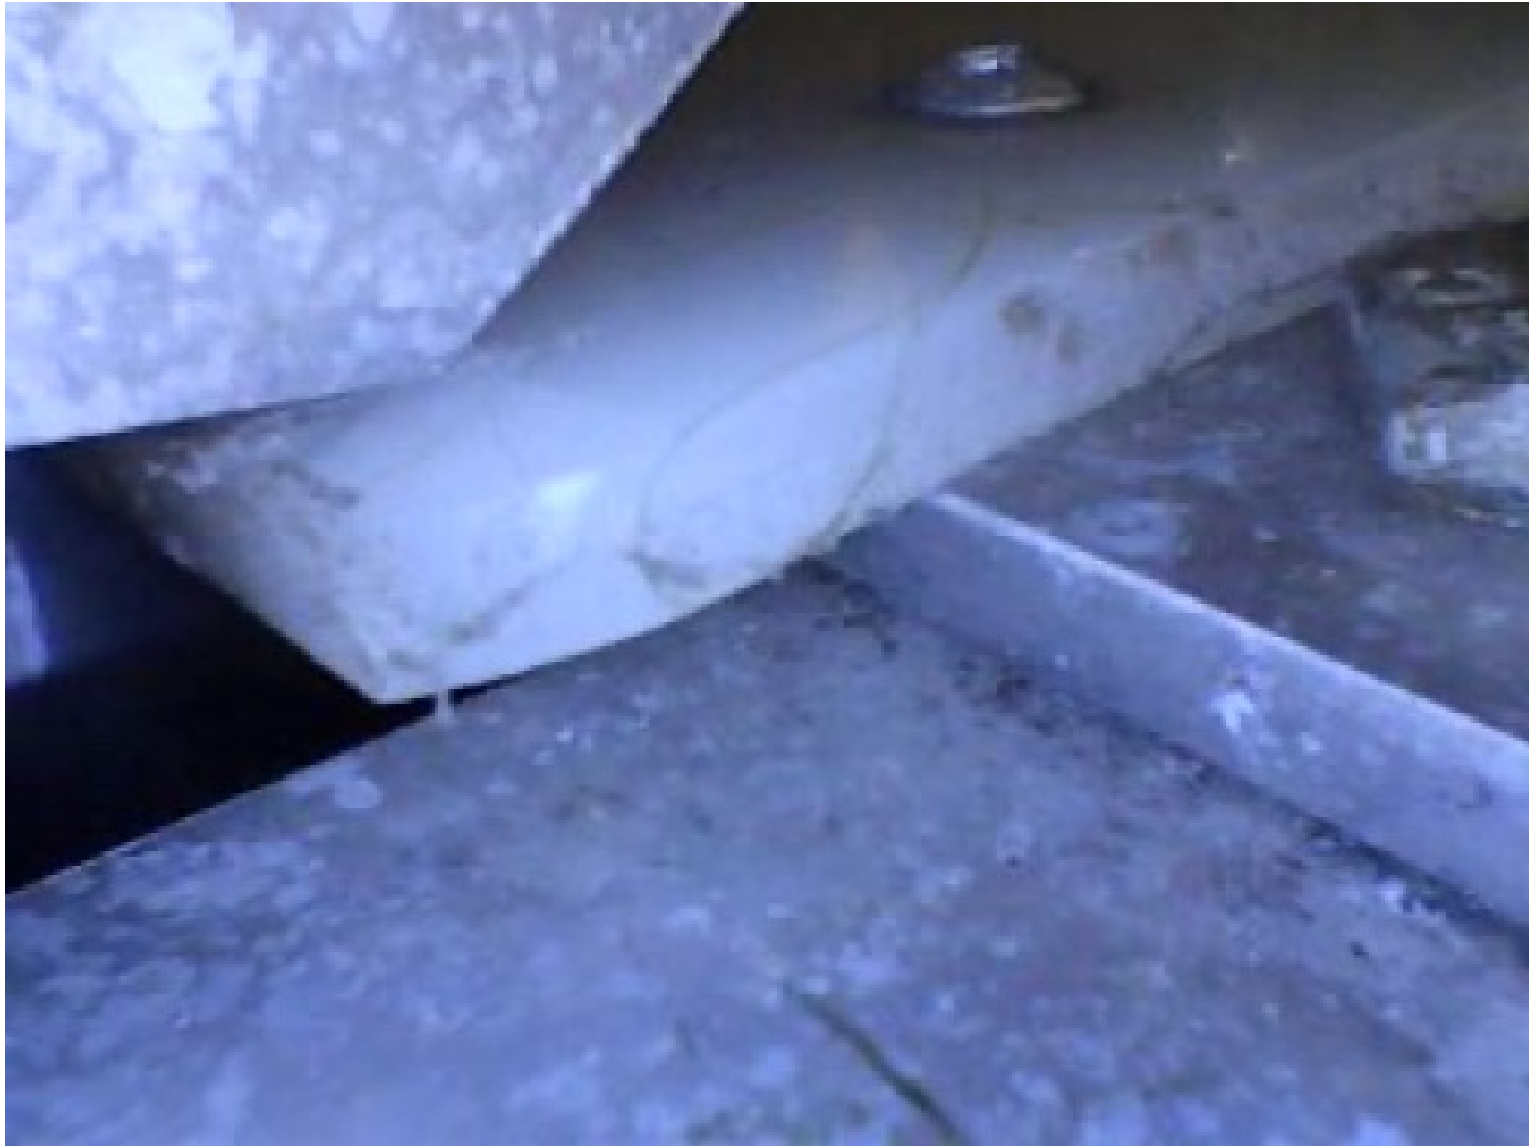
**Photo 2 – elevator bracket jammed on nylon stop.**

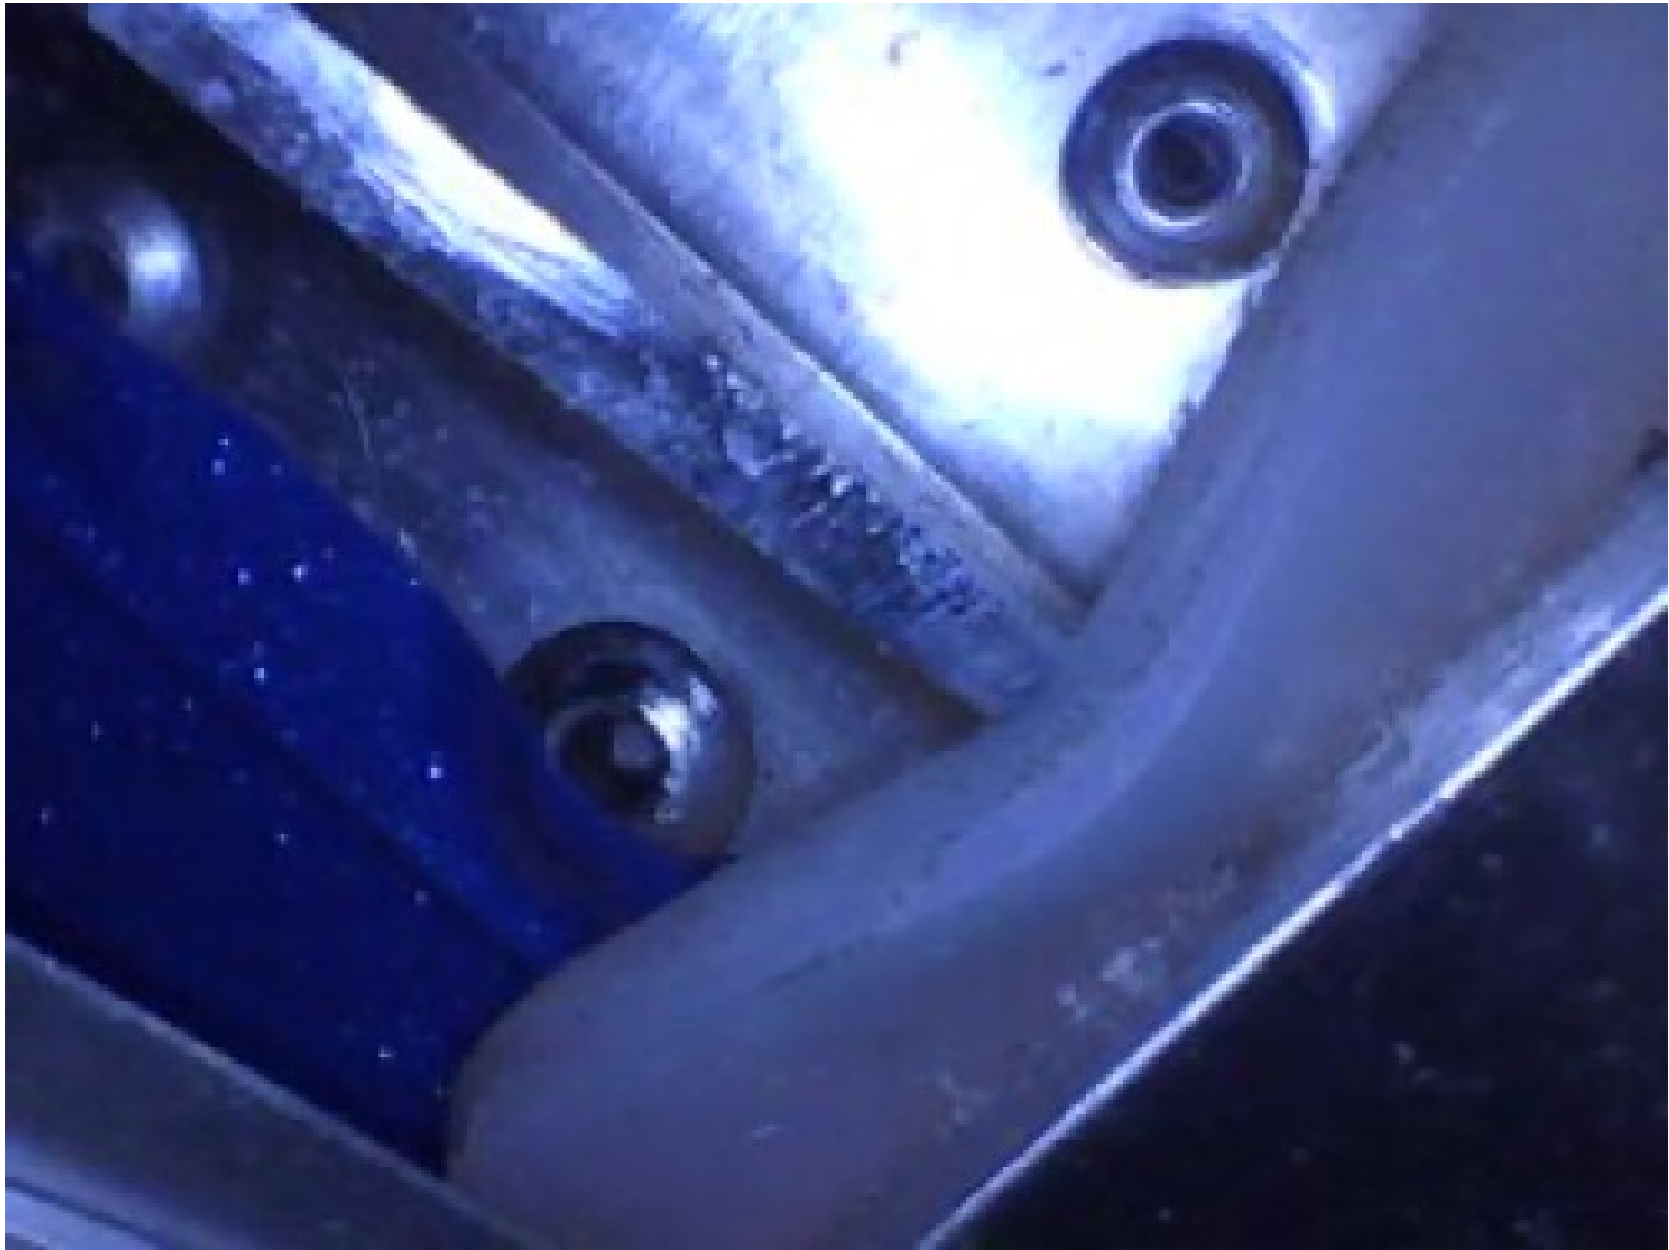
**Photo 3 – bottom view of elevator bracket jammed on nylon stop**

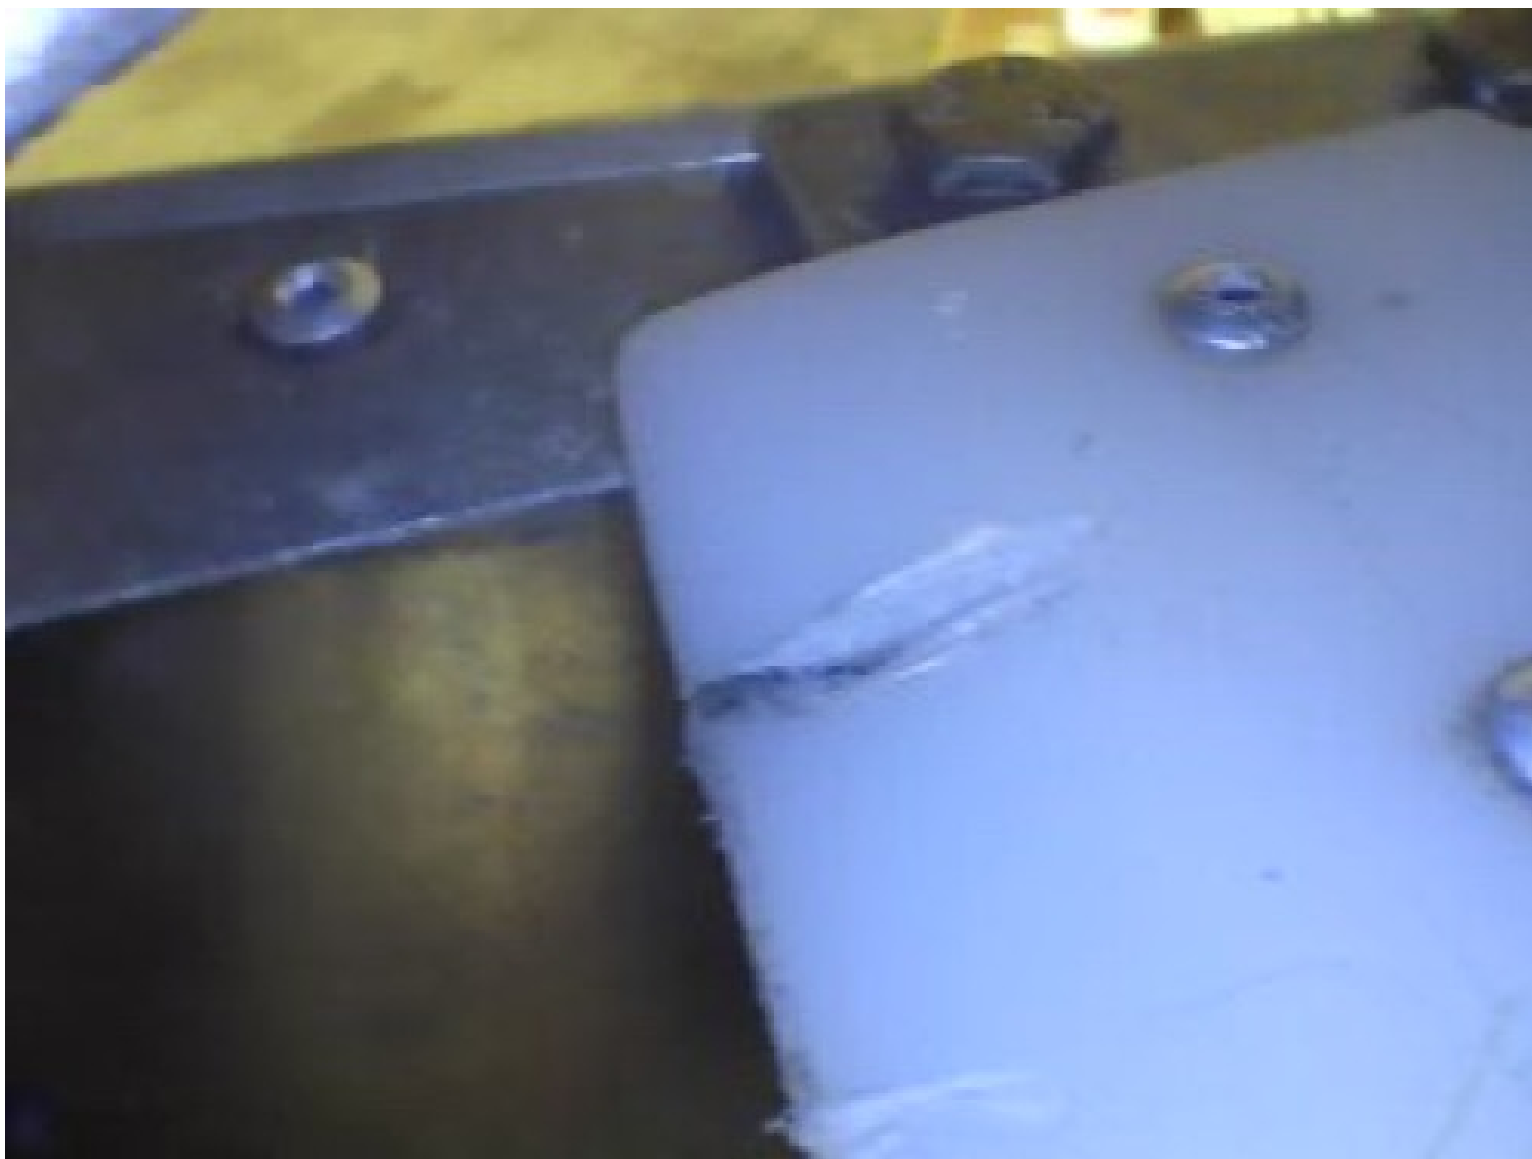
**Photo 4– nylon stop with elevator bracket impression marks**

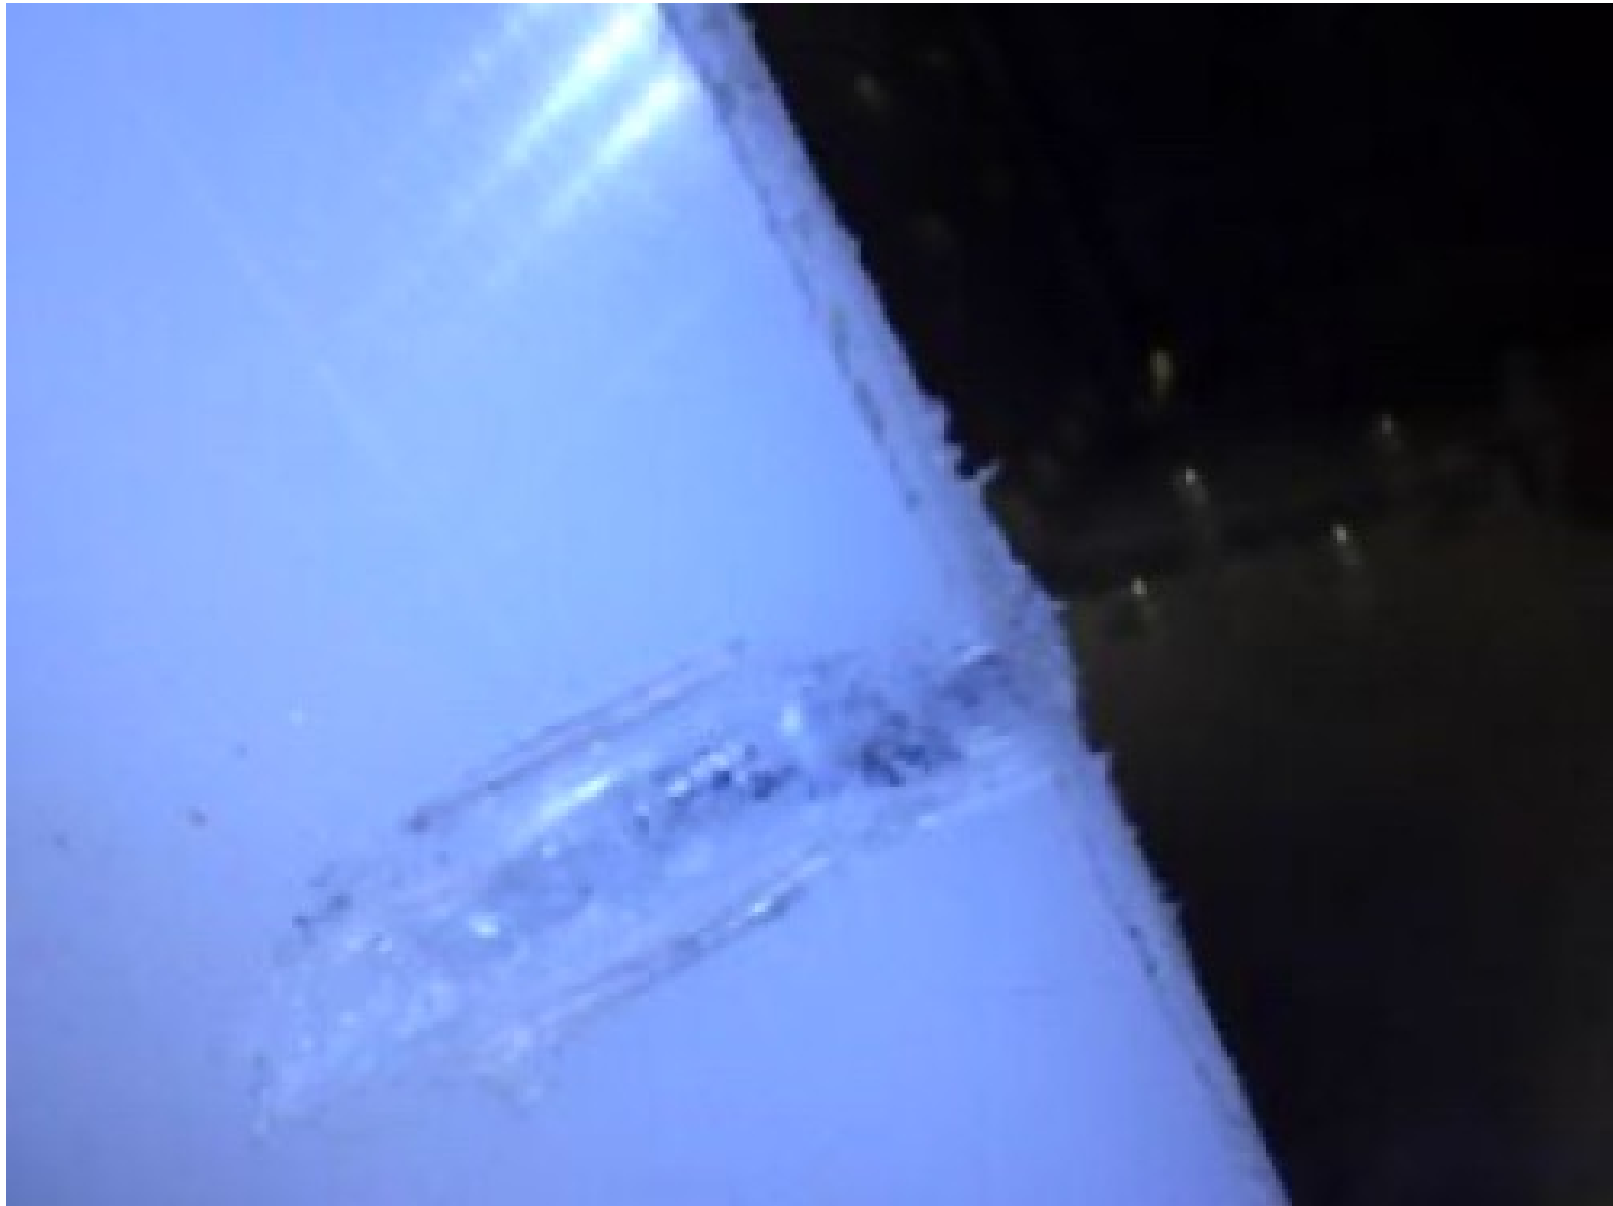
**Photo 5– top view of nylon stop with elevator bracket impressions**

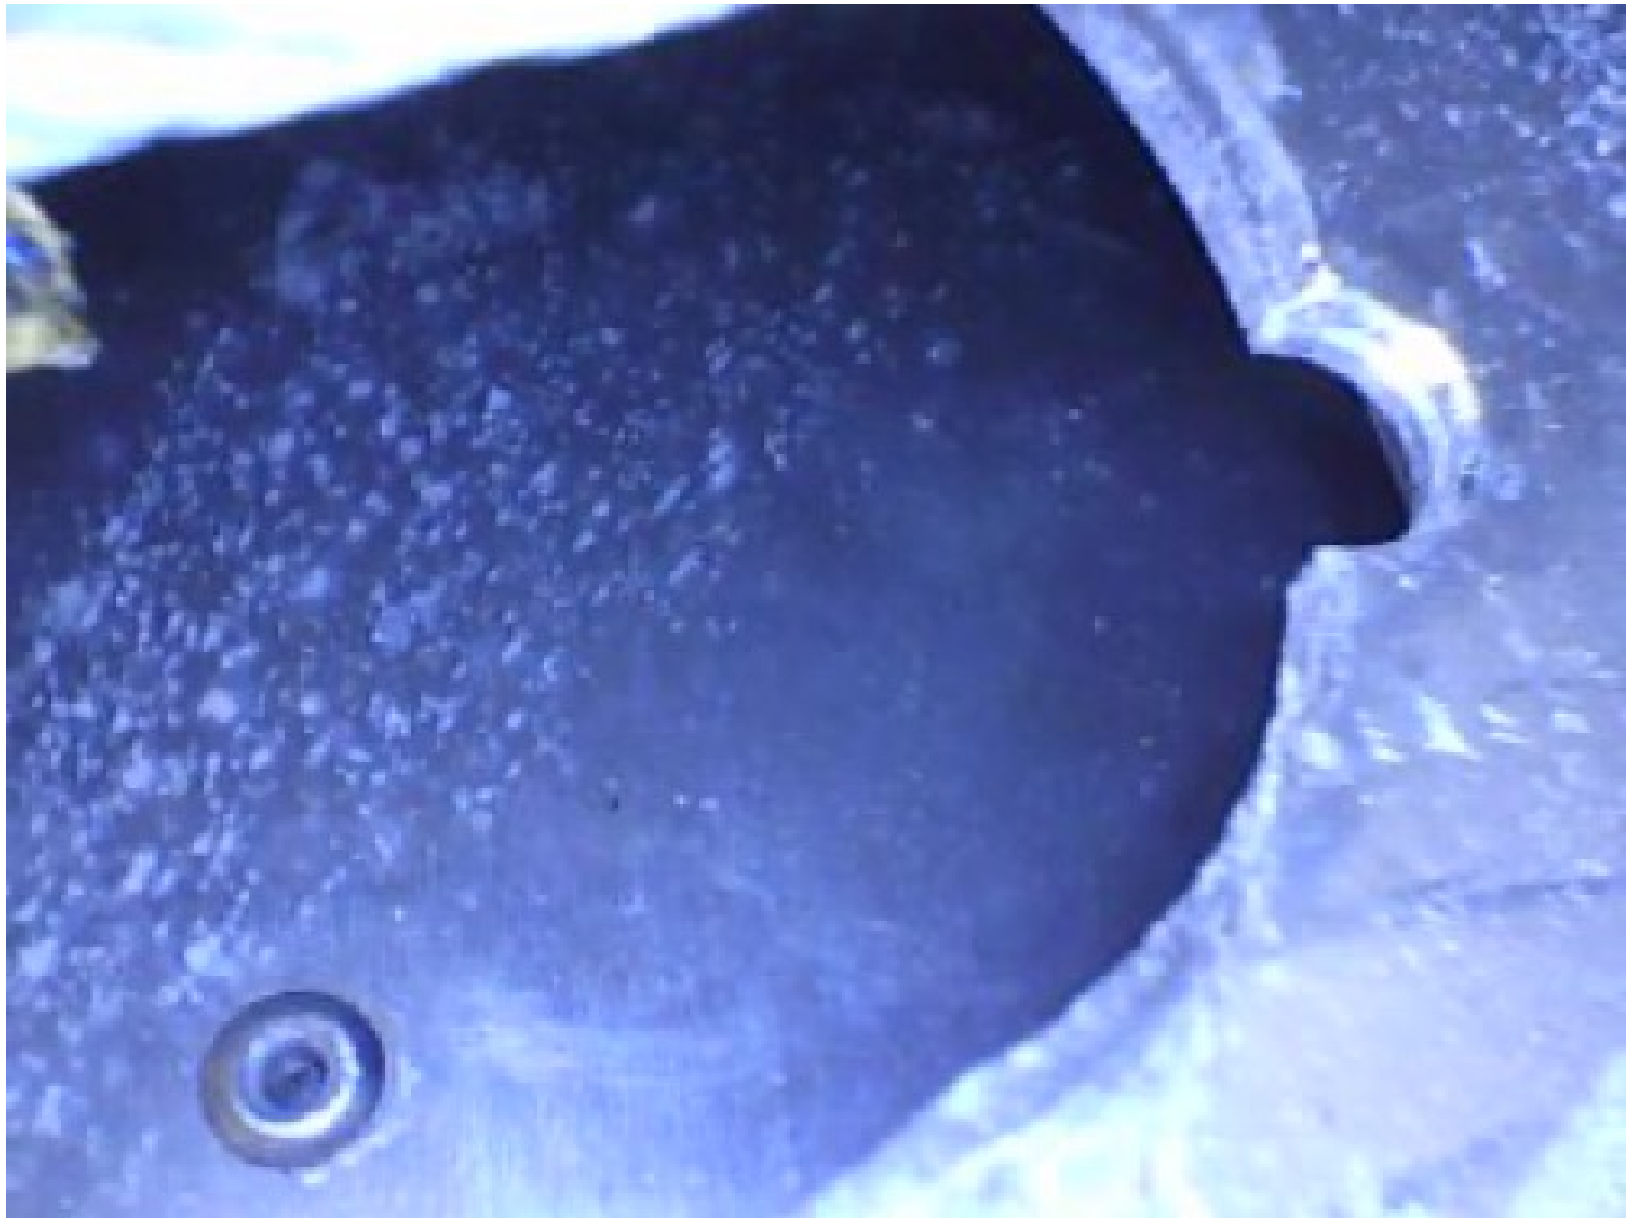
**Photo 6 – cables cutting into structure**

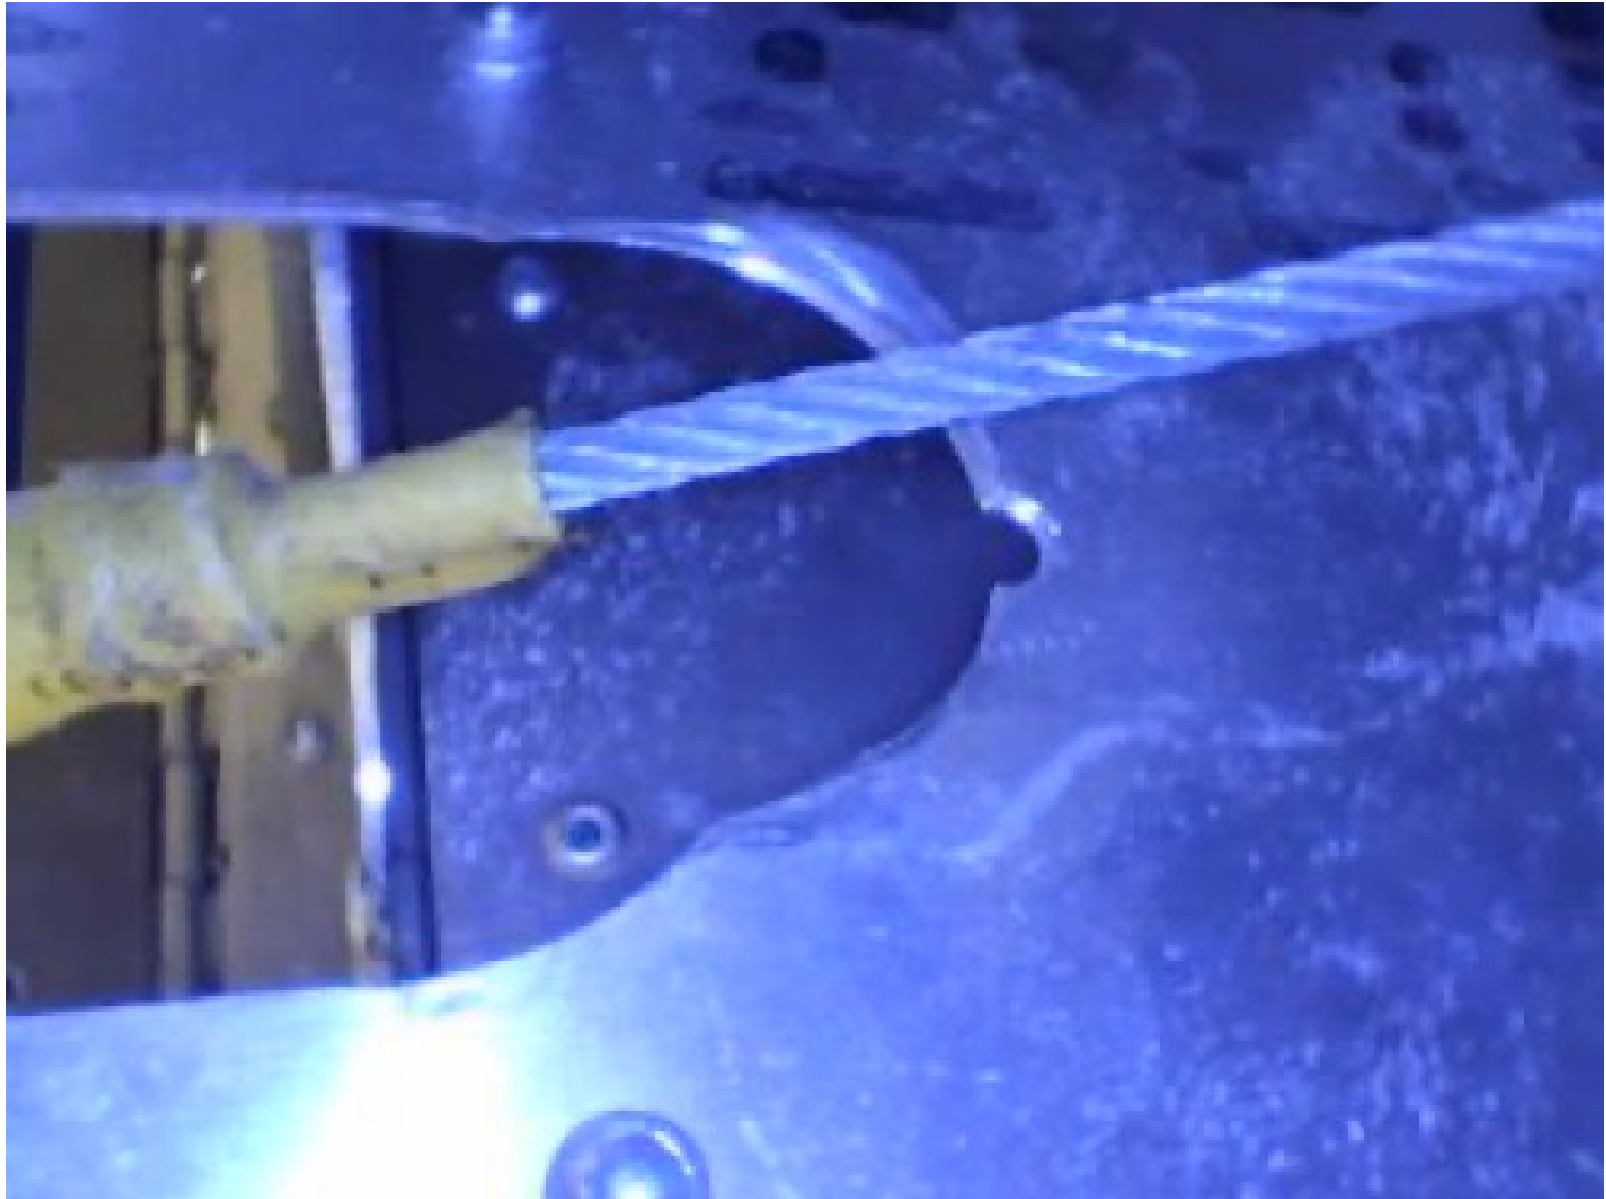
**Photo 7– elevator cable cutting into tail section**

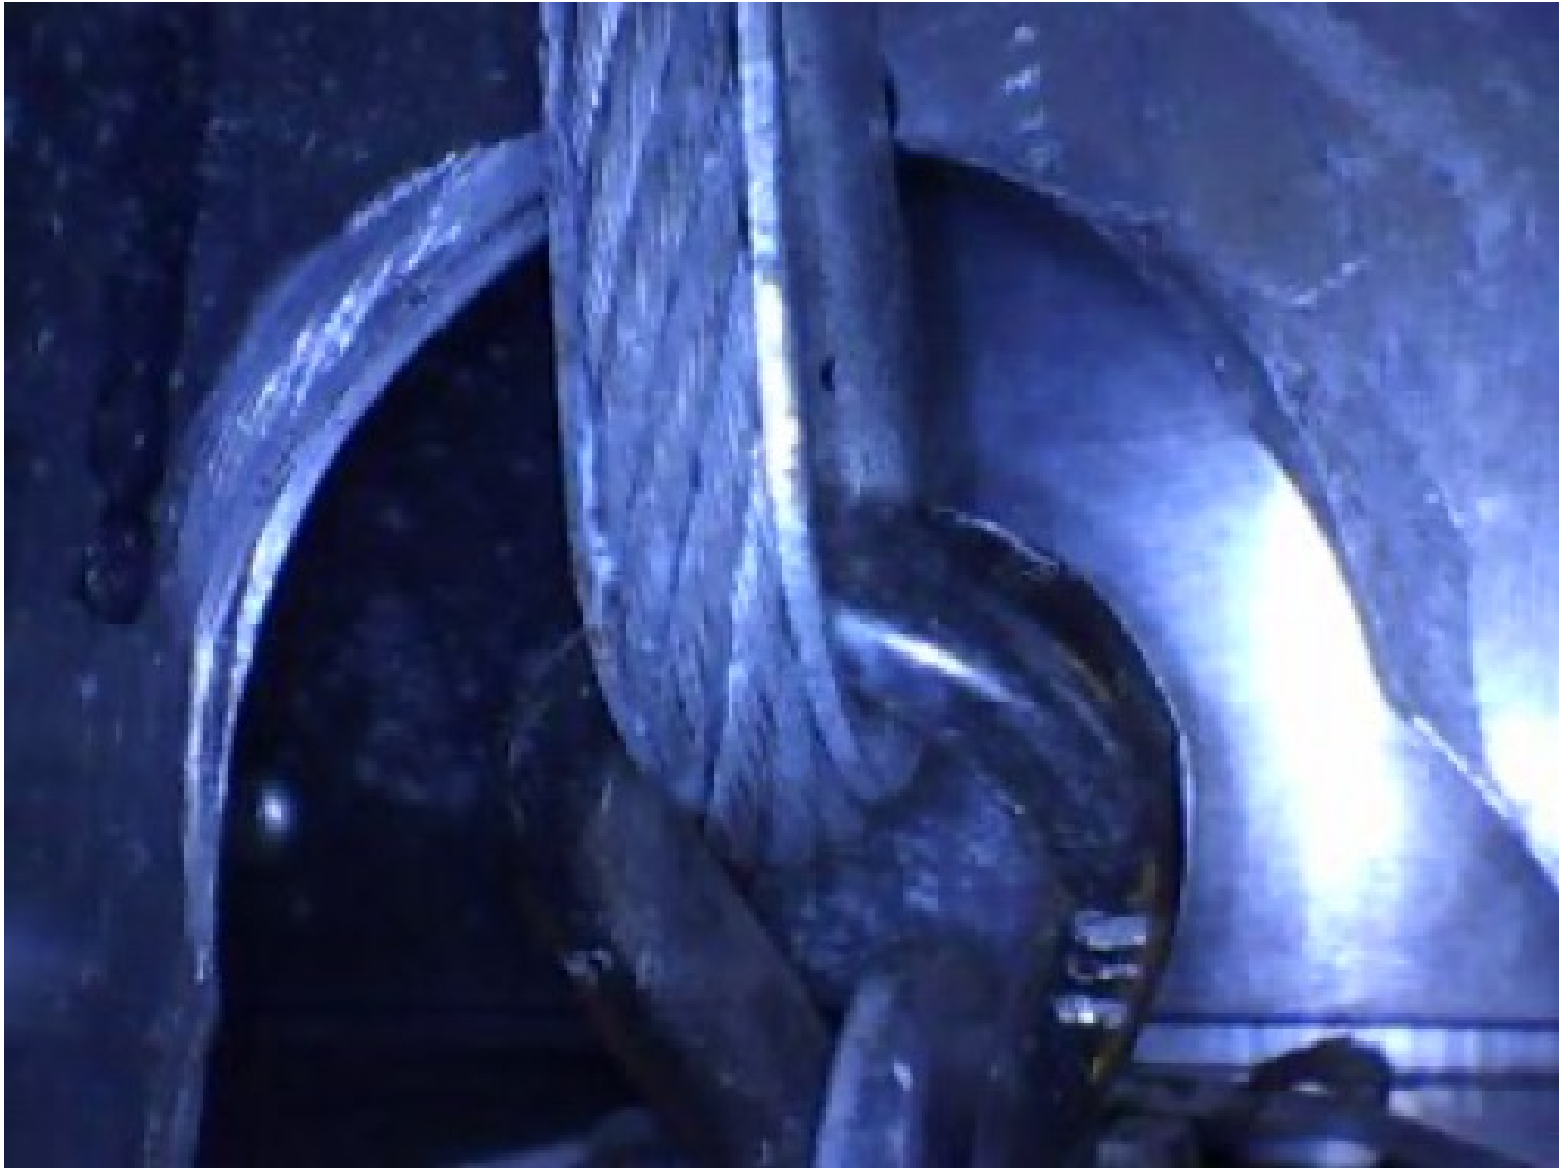
**Photo 8 – tail section damage by loose cables**

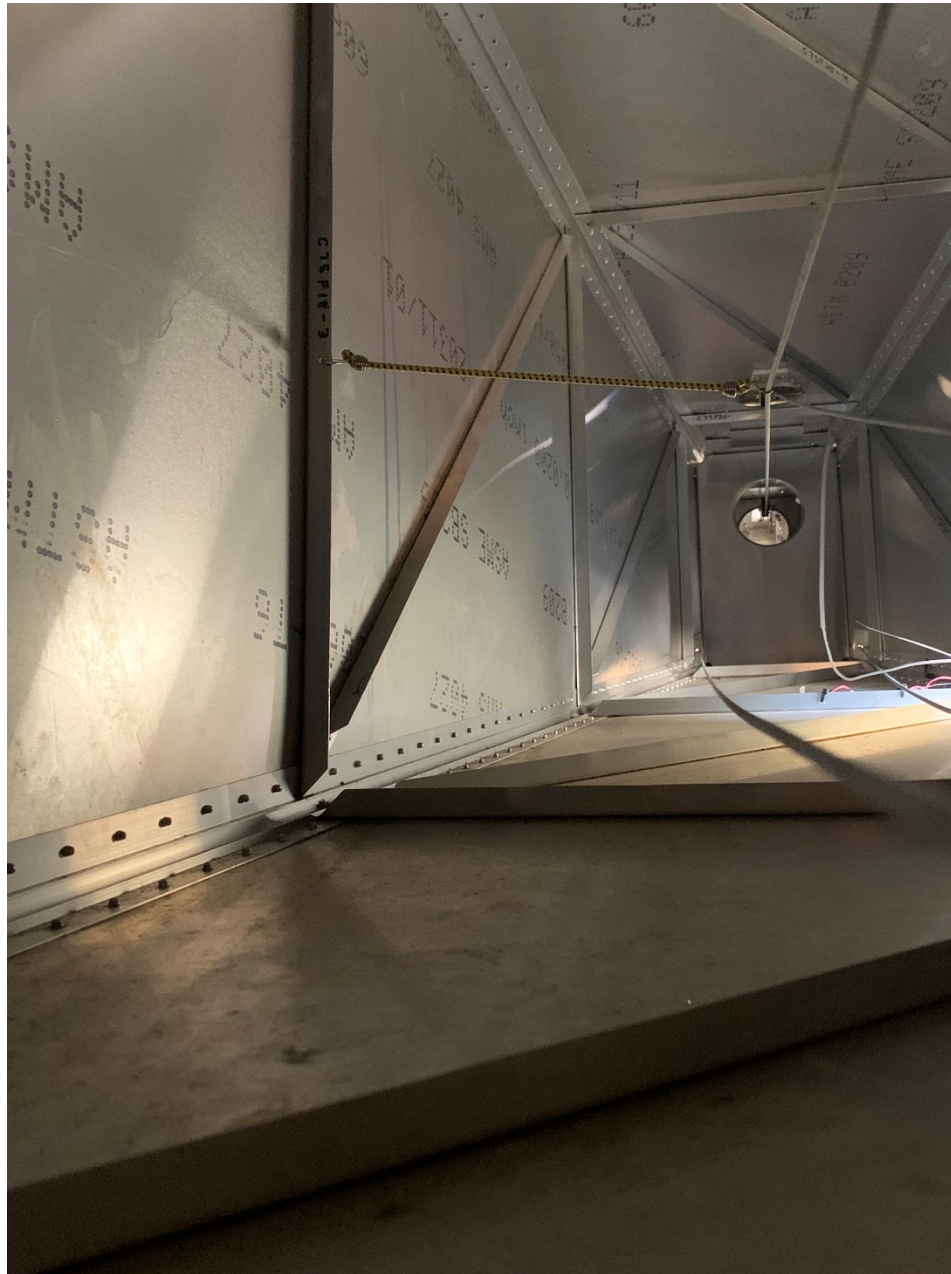
**Photo 9 – Elevator and rudder cables loose and held with bungy cord**
