## **Engine Investigation Report**

**Rolls-Royce Corporation  
Model 250-C20  
Engine CAE-800953BA**

**DAT Aircraft LLC – MD-369HS  
Ash, North Carolina**

**Accident date: 17 September 2021  
Wreckage exam date: 16 November 2021  
Engine exam date: 19 April 2022  
Report date: 17 January 2023  
NTSB Case: ERA21LA368**

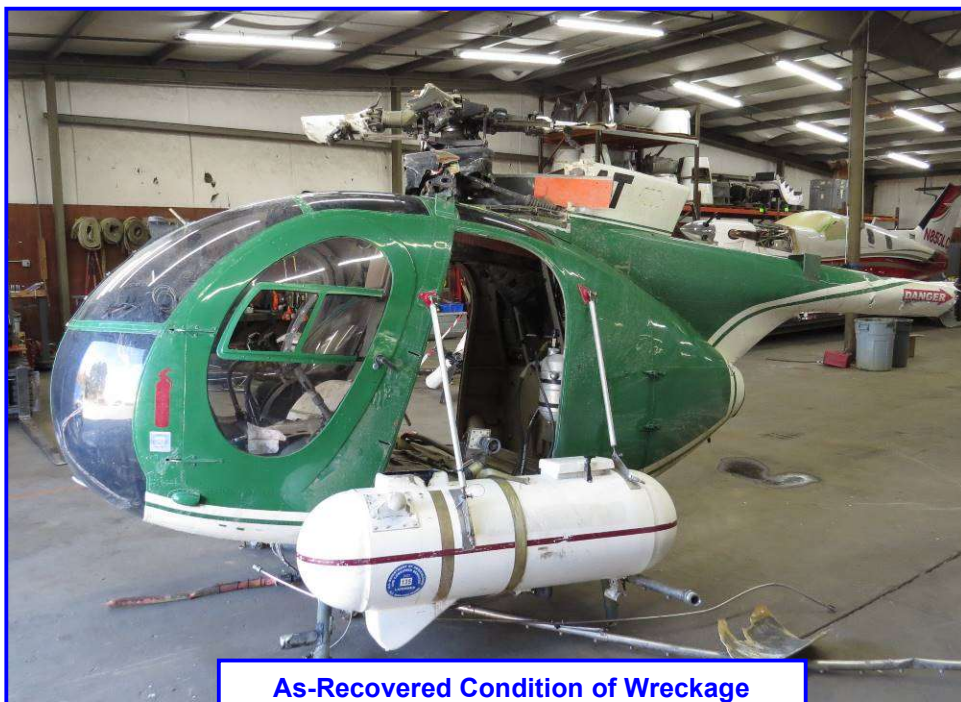
The aircraft sustained substantial damage upon impact fracturing the entire right hand skid and strut assembly. The left-hand landing gear struts were mechanical cut on site to facilitate recovery transportation & to allow the fuselage to sit level for the purposes of the wreckage examination.

The tail-boom and tail rotor driveshaft were severed approximately 18"-24" forward of the tail-rotor gearbox & aft stabilizer. The tail rotor drive shaft exhibited signs of rotational scoring & torsional fracture at the severed location. All 4 main rotor blades were fractured outside of the doublers adjacent to the main rotor attachments. One of the blades was wrapped around the base of the main rotor mast.

**As-Recovered Condition of Wreckage**

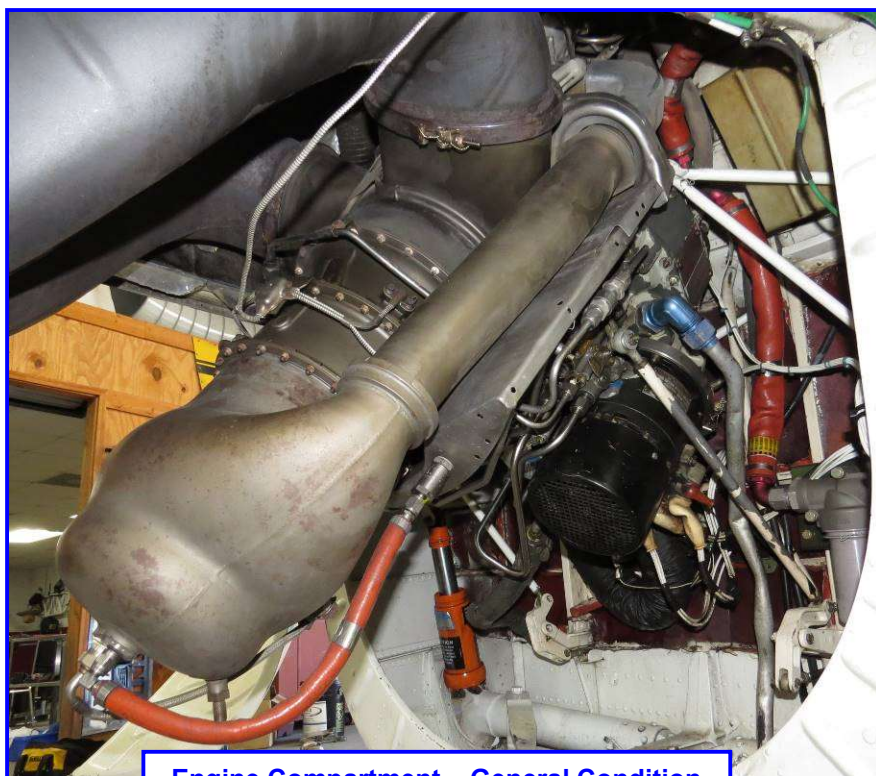
The engine remained within the engine compartment. All three mount struts were secure with no sign of bending, fracture, or lateral displacement. The engine exterior did not reveal any obvious signs of damage from impact forces, internal engine failure, or evidence of fire.

The output drive shaft coupling forward of the freewheeling unit was securely attached at the 4-bolt mount flange. The engine to main rotor transmission interconnect shaft was intact at its respective connection points and exhibited no visually noticeable damage.

Engine Compartment – General Condition

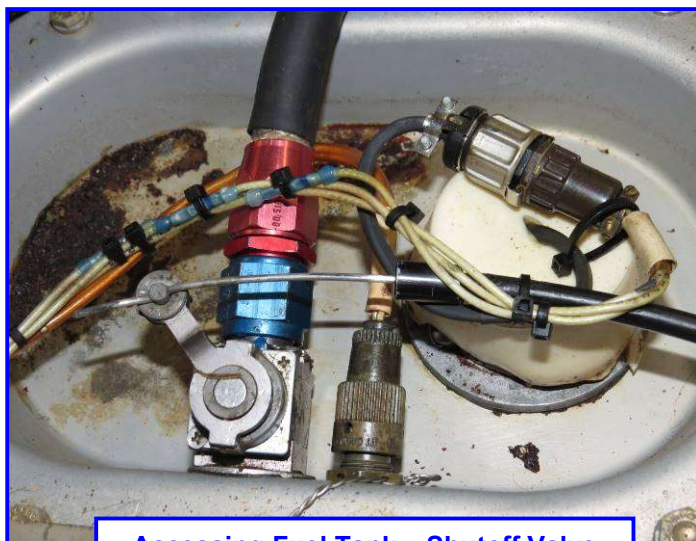
In conjunction with the airframe fuel system vacuum check, the airframe fuel tank was accessed to verify functionality of the fuel cut-off valve, condition of the fuel start boost pump, & presence/condition of fuel in the tank. The shut-off valve was reaching its full open/close travel positions via the cockpit push/pull knob control on the instrument panel. The start boost pump was removed & visually examined. No obvious anomalies were noted. The pump was not electrically tested. The tank was approximately  $\frac{1}{2}$  full of clean, clear fuel with no obvious signs of debris. A fuel sample was not collected for further examination.

Accessing Fuel Tank – Shutoff Valve

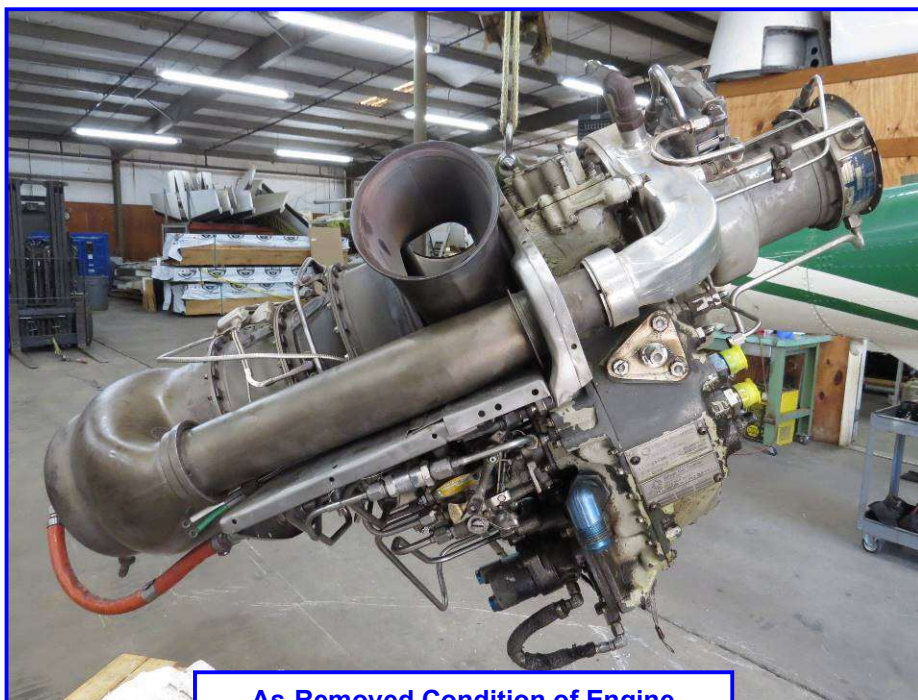
As-Removed Condition of Engine

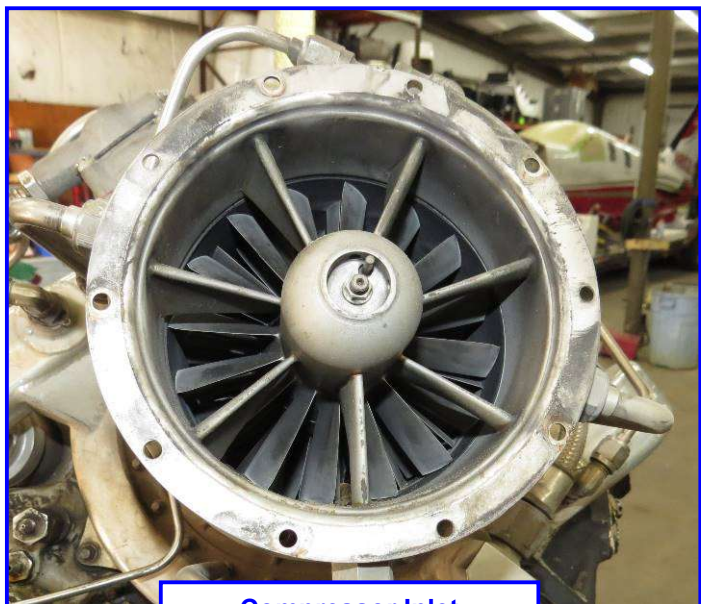
The 4<sup>th</sup>-stage turbine blades appeared undamaged when inspected as did the surrounding turbine sections and exhaust plenum. The compressor inlet was also undamaged and exhibited no indication of FOD ingestion.

Compressor Inlet

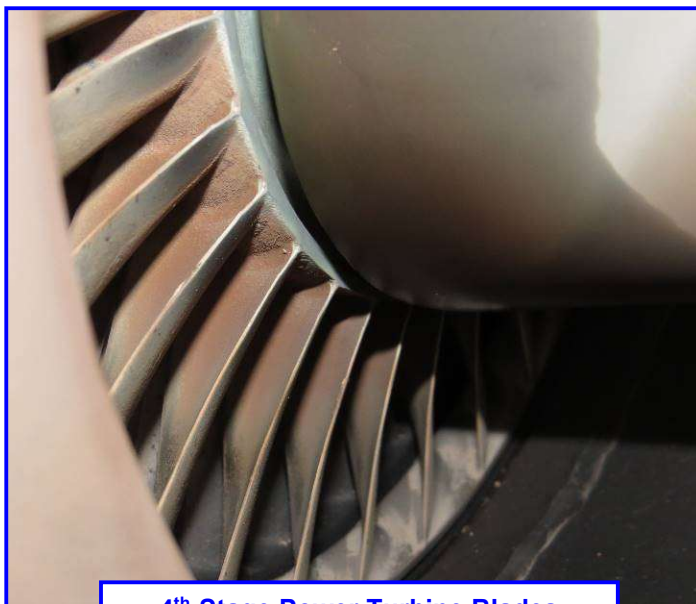
4<sup>th</sup>-Stage Power Turbine Blades

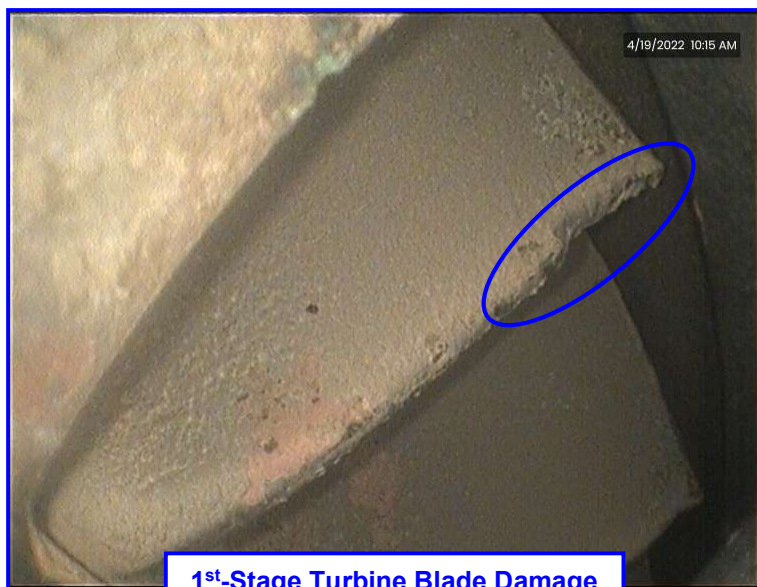
Borescope inspection of the gas producer turbine showed the 1<sup>st</sup>-stage nozzle in good condition with no apparent thermal or impact damage. Several 1<sup>st</sup>-stage blades exhibited impact damage on the outer 1/3 of their leading edges.

The general condition of the gas producer turbine was not sufficient to produce the lack of power observed on test; therefore, it was decided to remove a compressor case half for further evaluation.

1<sup>st</sup>-Stage Turbine Blade Damage

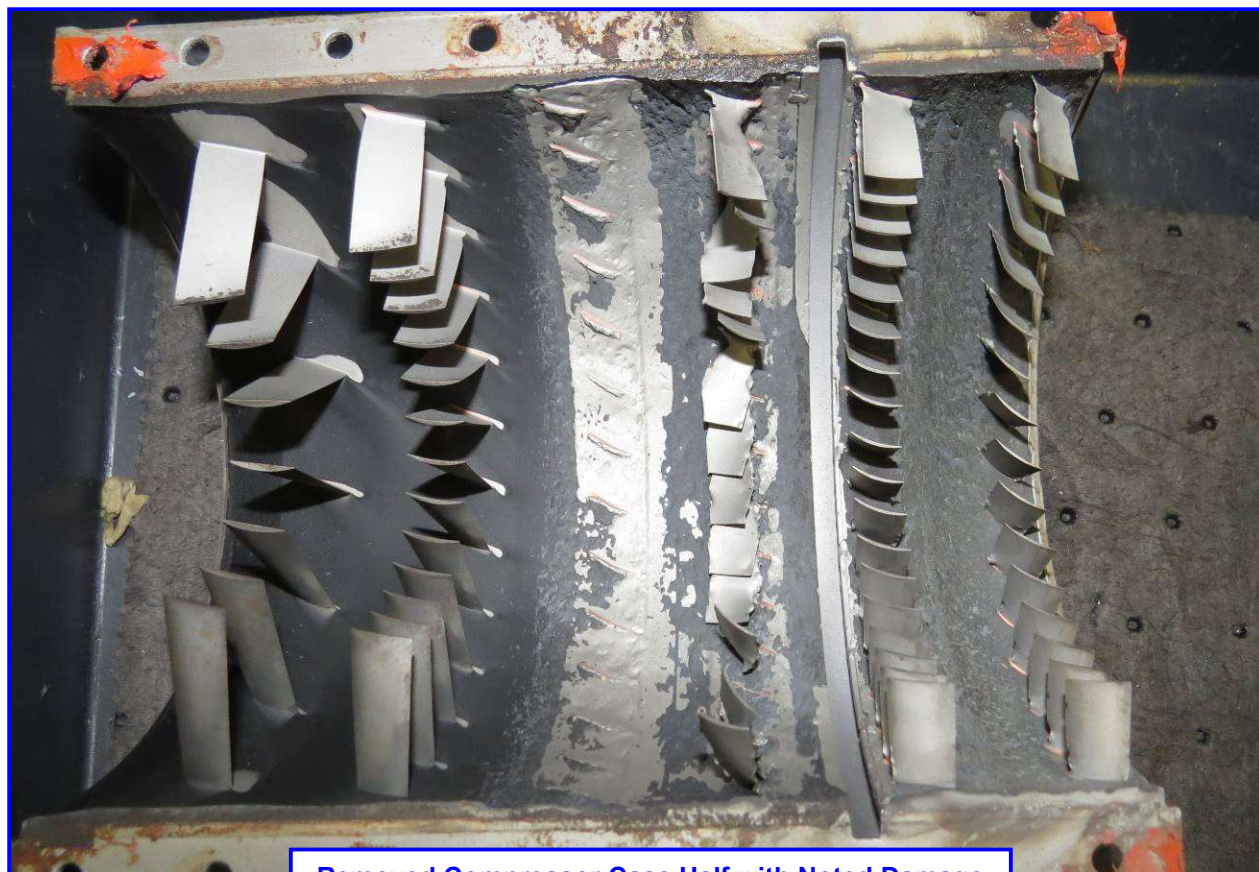
Upon exposure of the internal of the compressor, the removed case half exhibited substantial damage specifically in the 3<sup>rd</sup> & 4<sup>th</sup> stages. All of the 3<sup>rd</sup>-stage stator vanes were completely missing at the base of the airfoils. Numerous 4<sup>th</sup>-stage vanes were heavily damaged from fully rolled over to severely distorted or twisted. Considerable erosion of the black plastic case lining was noted at the base of the 1<sup>st</sup> & 2<sup>nd</sup> stage stator vanes.

Removed Compressor Case Half with Noted Damage

1. All but four of the stage 3 compressor vanes were fractured and separated near the root. The fracture surfaces were too damaged to resolve fracture features.

2. Four stage 4 compressor vanes were fractured and separated near the root. The fracture surfaces were too damaged to resolve fracture features. The remaining vanes were dented and distorted due to secondary impact damage.

3. The compressor case exhibited erosion throughout. The polymer coating was eroded, exposing areas of the stage 1 and 2 compressor vane bands. Stage 1, 2, and 3 compressor vanes exhibited erosion of the leading edge, braze joint fillet, and mid-chord thickness of the airfoils.

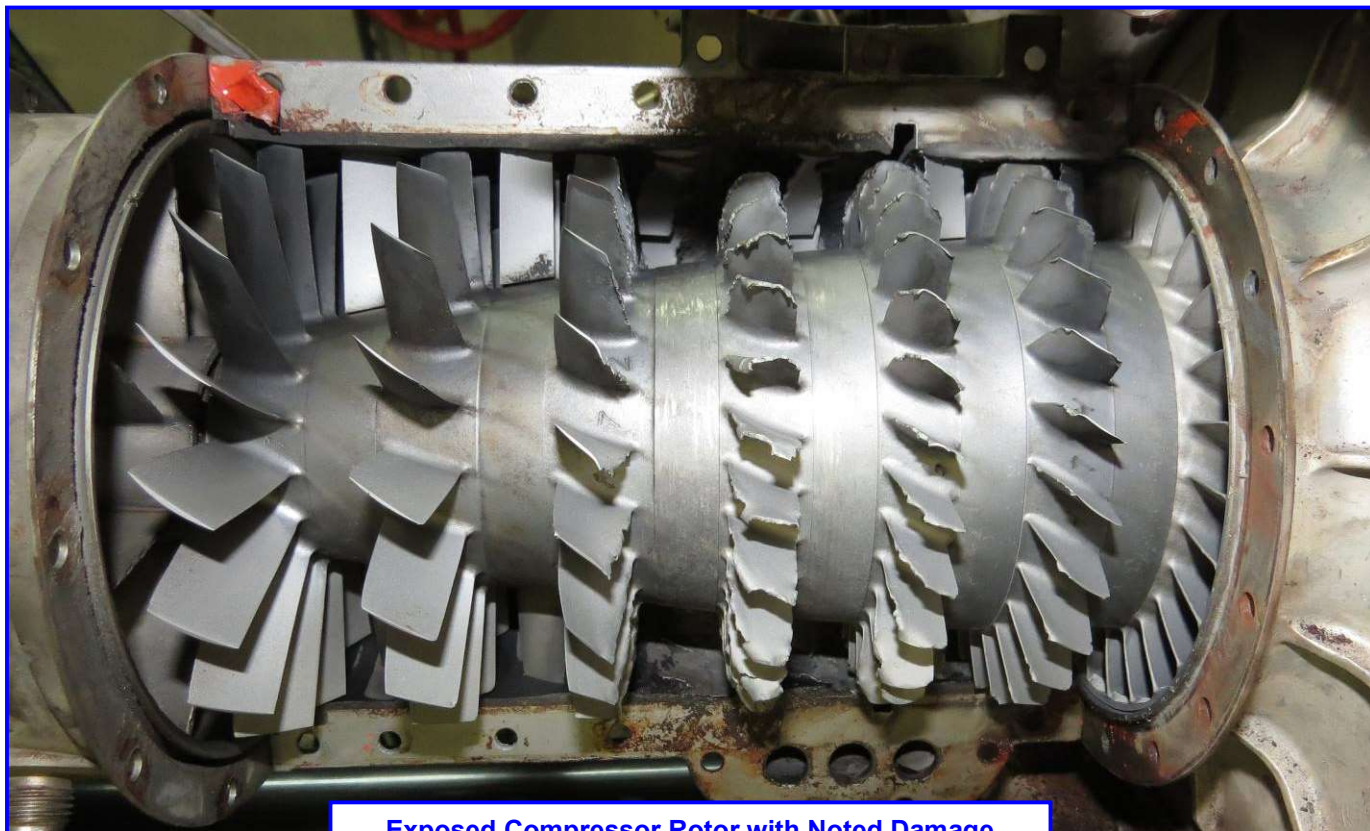
Heavy impact damage was noted on the compressor rotor from the trailing of stage 3 back to the outer 1/3 of the 6<sup>th</sup>-stage. Full rotational examination of the rotor showed all of the blades were intact and accounted for. The compressor's condition accounts for the engine's power loss during the accident sequence. The engine was removed from the test stand and placed in a turnover/transportation stand for further evaluation.

Exposed Compressor Rotor with Noted Damage

4. Corrosion damage was present on the vanes. The leading-edge root of the stage 3 compressor blades exhibited corrosion pitting.
5. The EPS 10702 aluminum coating had been eroded from leading edge root and adjacent surfaces of the stage 3 compressor blades.

- The compressor's condition as documented following test attempts accounts for the engine's power loss during the accident sequence. Fracture liberation of the compressor vanes and subsequent rotor damage significantly compromised the compressor's aerodynamic efficiency. This scenario likely occurred shortly after lifting off from the support truck resulting in the power loss event.

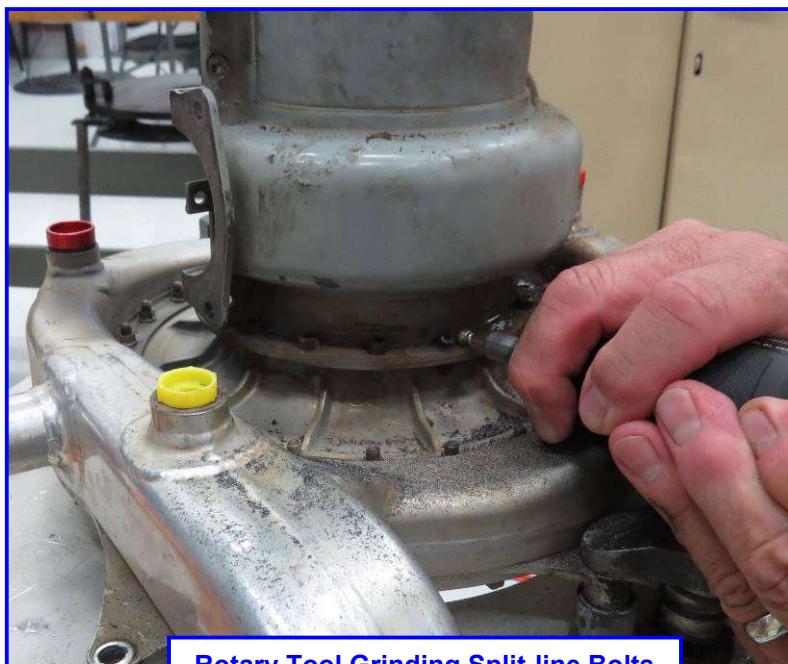
It was noted during the removal of the opposite case half, from that removed on the test stand at Keystone, that several of the split-line bolts adjoining the aft flange to the compressor front diffuser were significantly rusted and required rotary tool grinding for removal.

Rotary Tool Grinding Split-line Bolts

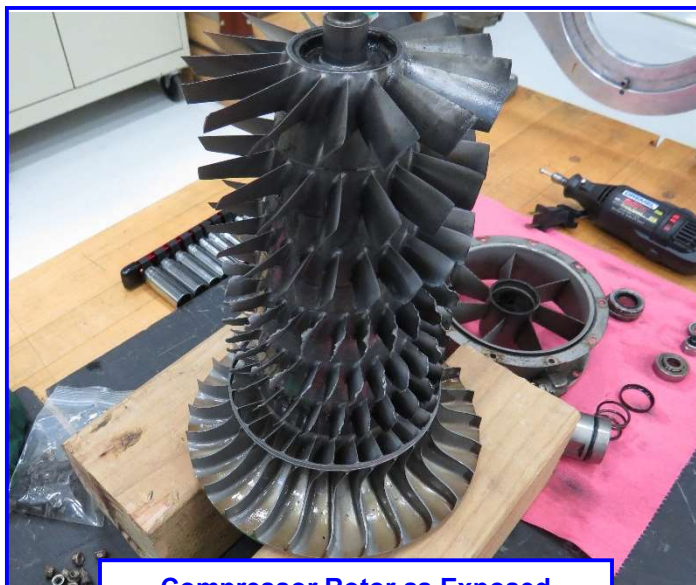
Compressor Rotor as Exposed

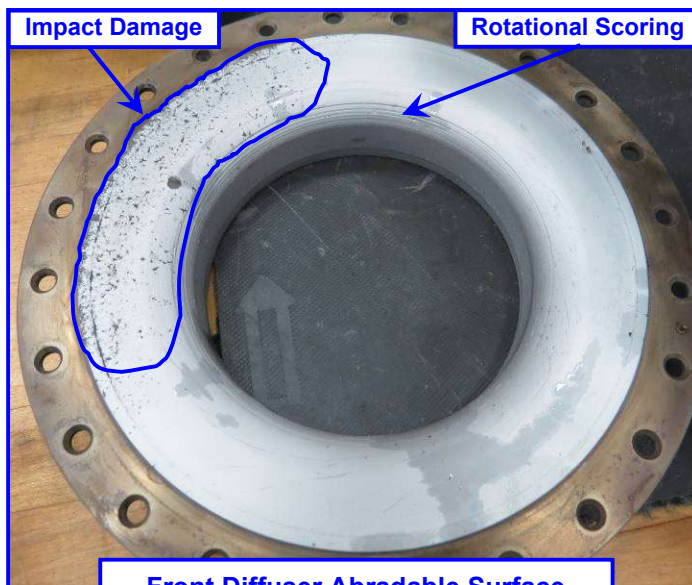
The contoured interior surface of the front diffuser is covered with abradable sprayed aluminum. This surface displayed significant rotational scoring and impact damage. This is likely due to liberated compressor blade & vane airfoil material into the flow-path during engine operation.

Front Diffuser Abradable Surface
