## RECORD OF CONVERSATION

**Date: October 27, 2021**  
**Person Contacted: Alexander Munoz**  
**NTSB Accident Number: ERA21LA383**

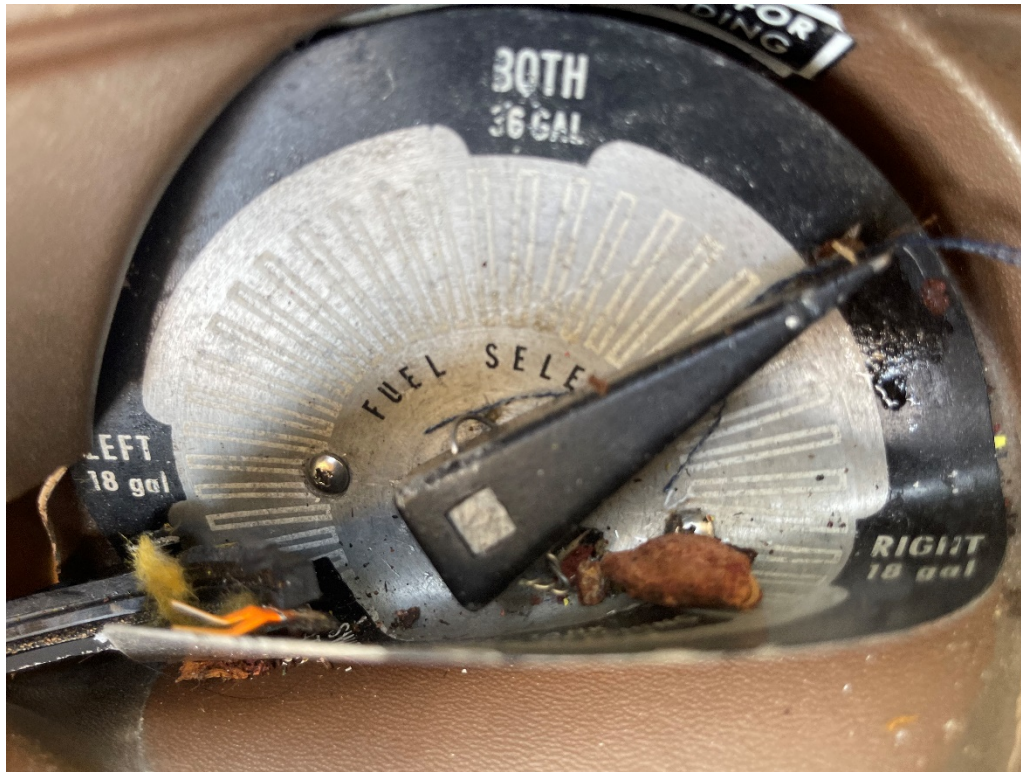
He called from the accident site and indicated that it was not safe to apply aircraft power to electrically check the fuel quantity indicating system. The fuel selector was found between the right tank and both position (figure1).

Figure 1: FAA Digital photograph. View depicting the fuel selector valve.

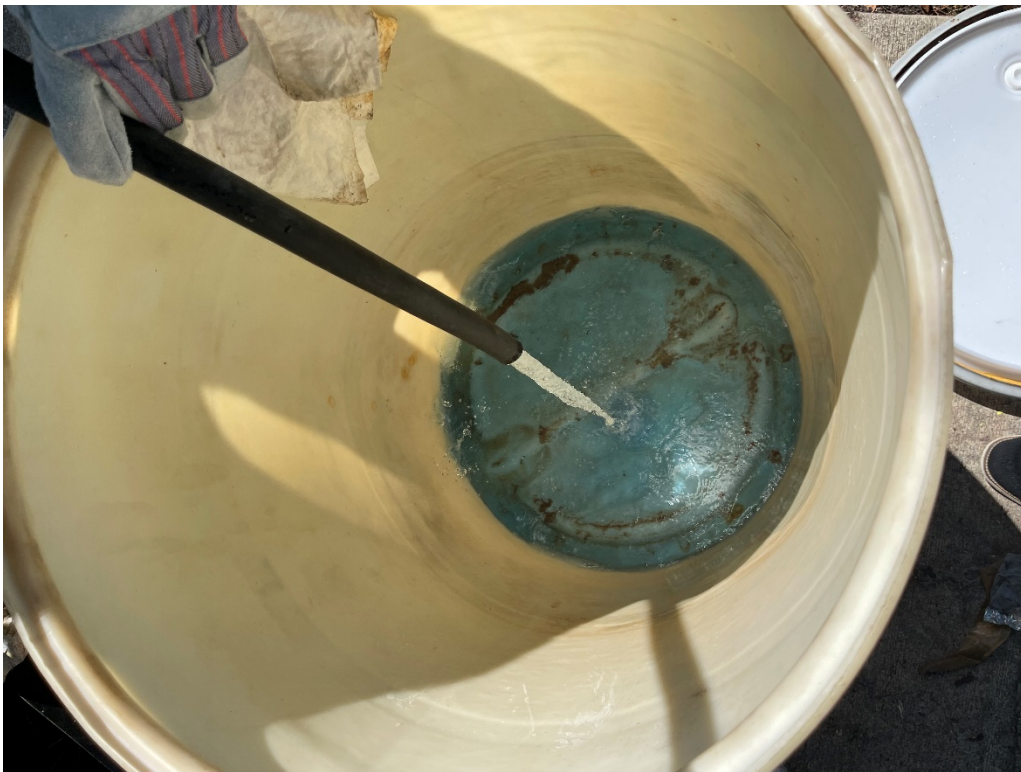
He indicated that 2.5 gallons of fuel were drained from the left fuel tank (Figures 1 and 2) which was not breached. The right fuel tank which also was not breached was empty of fuel. The fuel selector was found between the both and right tank positions. The gascolator or fuel strainer was empty, and he could not access the carburetor bowl.

Figure 1: FAA Digital Photograph. View During Draining of the Fuel From the Left Fuel Tank.

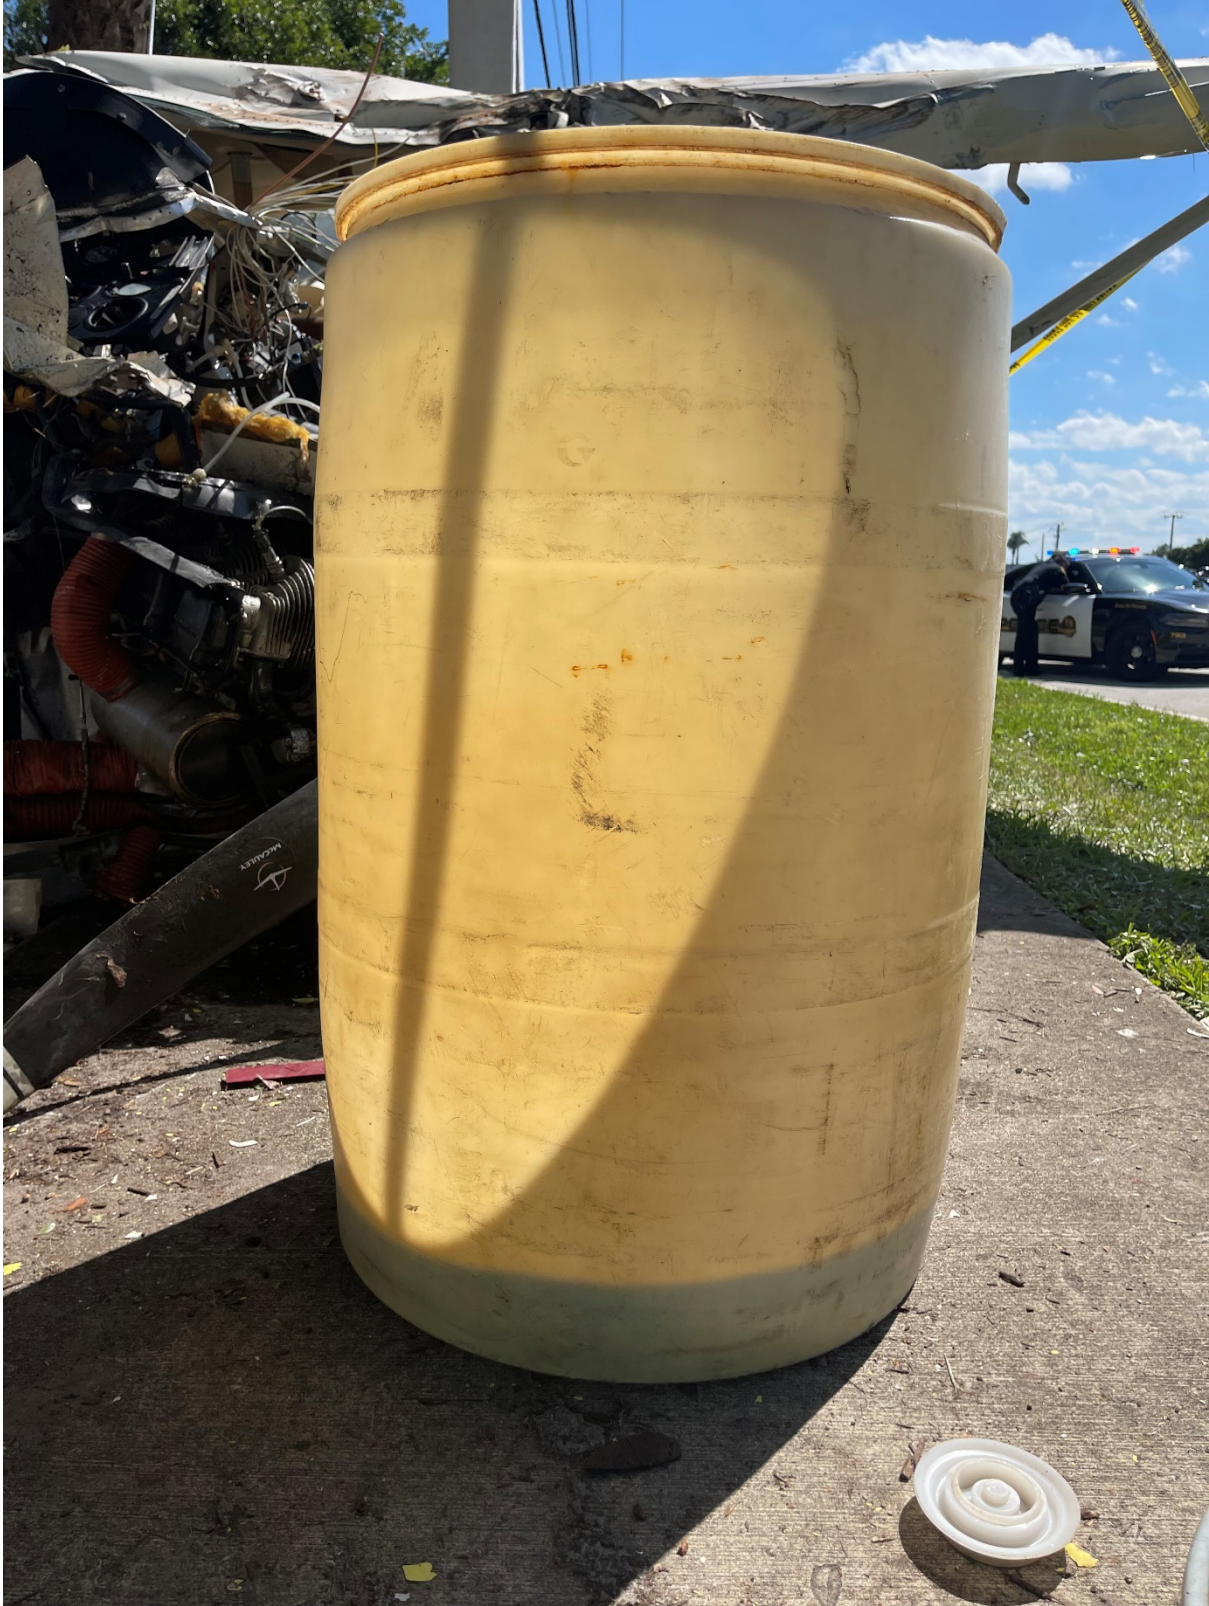
Figure 2: FAA Digital Photograph. View of the Fuel Drained from the Non-Breached Left Fuel Tank.

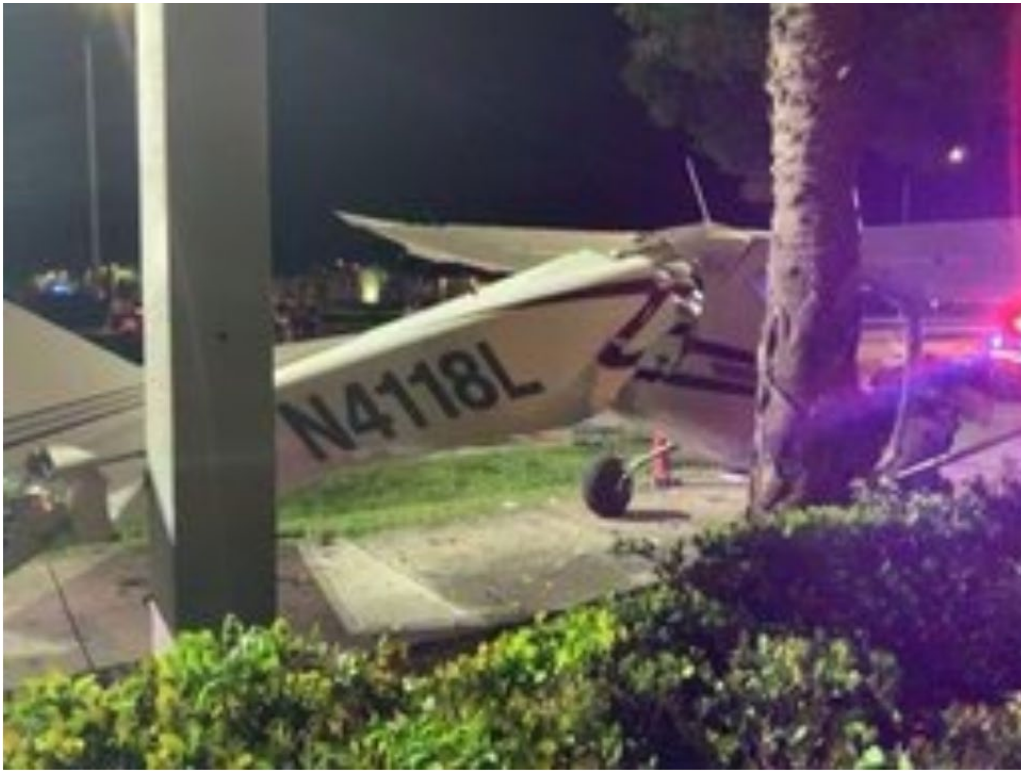
light pole (Figure 3). The resting position of the wreckage was located at 25.982483° north latitude and -080.278637° West longitude. The airplane came to rest heading in a northerly direction adjacent to the northbound lanes of Palm Avenue. He measured a distance of 20'6" from the impacted oak tree to the resting position of the airplane.

Figure 3: FAA Digital Photograph. Right side view of the Wreckage at the Accident Site. Note the Displaced Empennage.
