# National Transportation Safety Board

ERA21LA384

## WRECKAGE EXAMINATION

Airplane: Cessna 150M, Registration N4100V

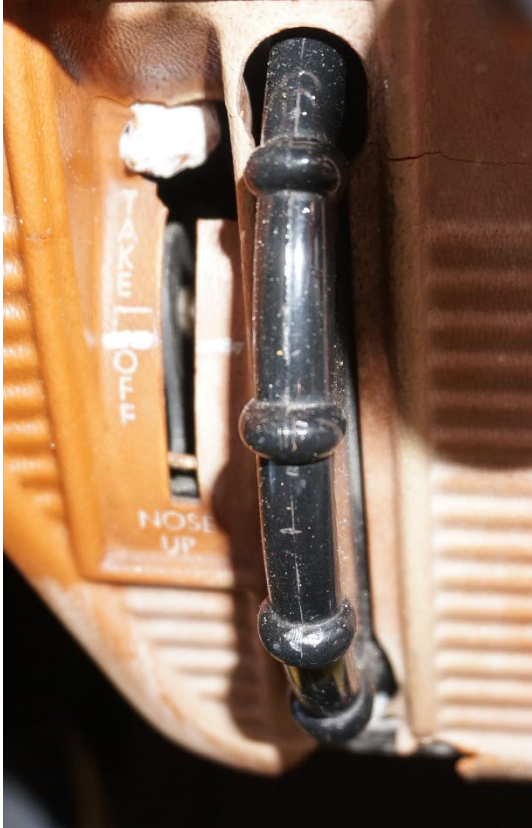
**Figure 1 Elevator Trim Indicator**

Flight control continuity was established from the cockpit to all flight controls, through recovery cuts. The elevator trim indicator showed nearly full nose up. The trim tab actuator extension was measured as 1.0 inches, which equates to 10° tab trailing edge down (airplane nose up).

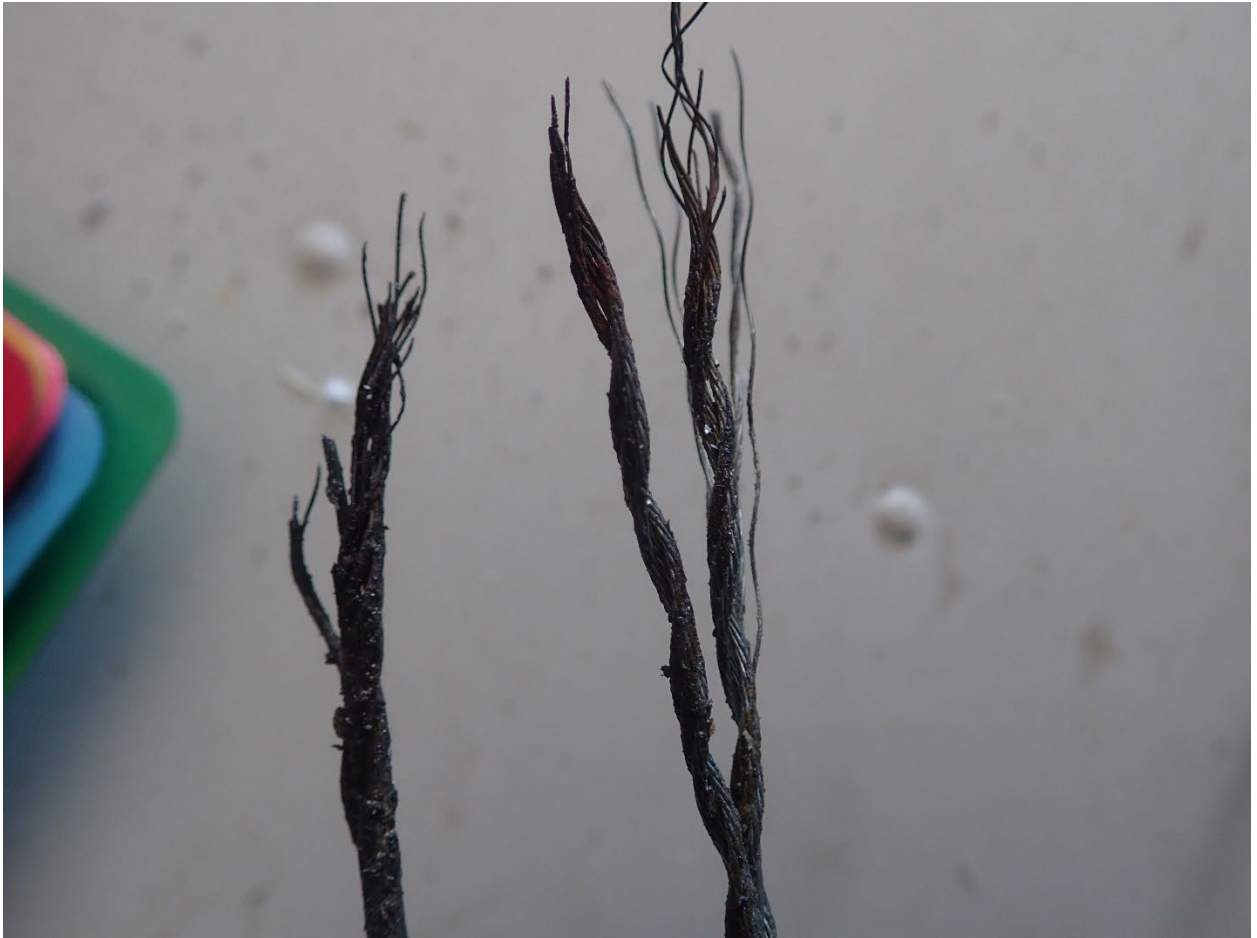
**Figure 3 - Left Flap Cable Fracture**

The left flap cable was fracture separated between the wing root and the bell crank. Some corrosion was found on the cable near the fracture.

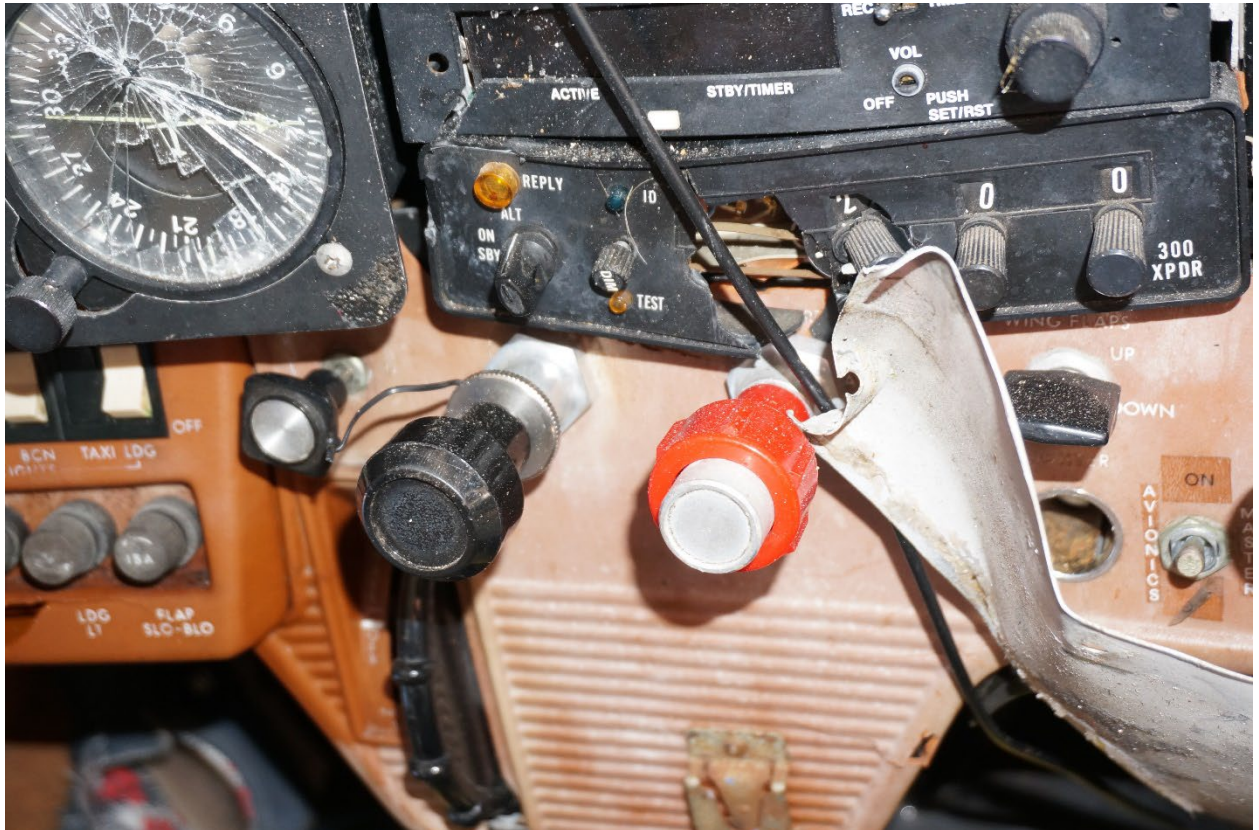
**Figure 4 - Engine Controls**

The carburetor heat control was off (in) , the throttle control was full (in), the mixture control was full rich (in) and each operated normally.

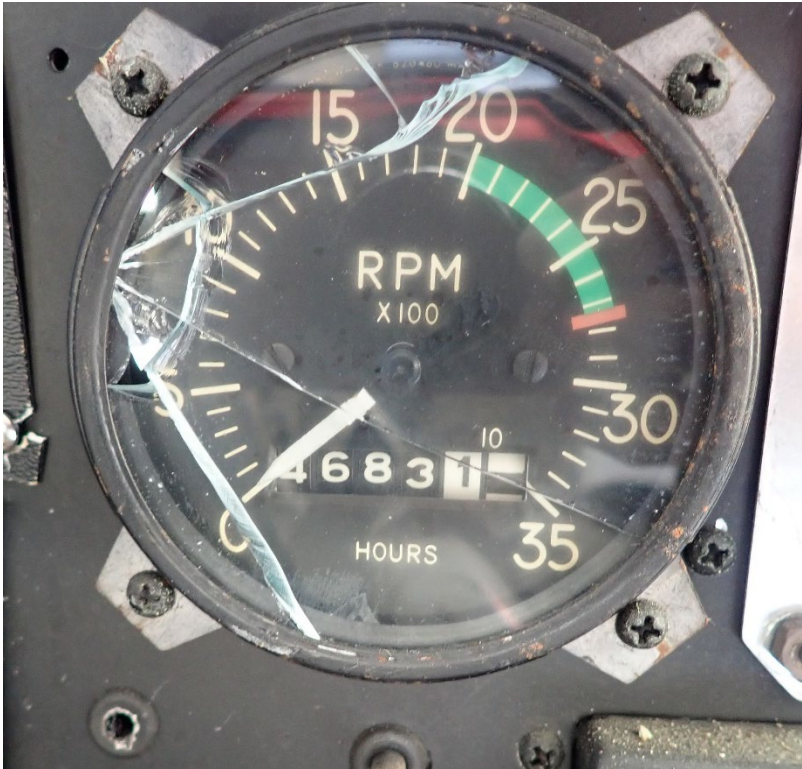
**Figure 5 - Tachometer**

The primer control was in and locked. The magneto switch was in the "both" position. The recording tachometer read 4,683.1 hours, the hour meter read 770.7 hours.

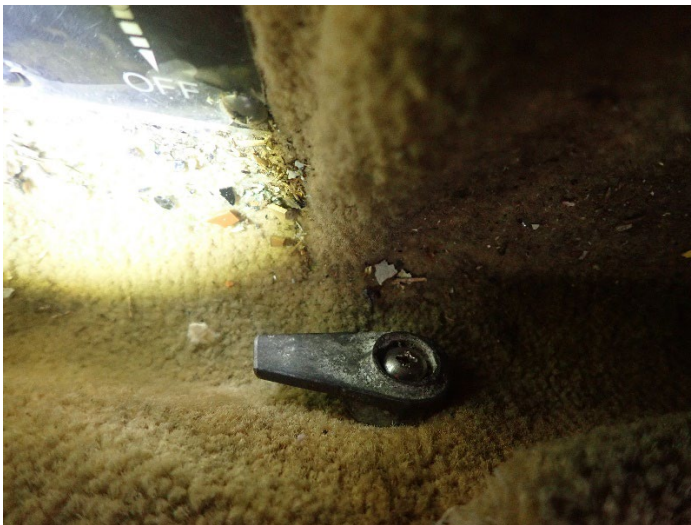
**Figure 7 - Fuel Selector Handle**

The fuel selector was in the ON position. The fuel strainer was absent of debris. Fuel sampled from the strainer was blue in color and tested negative for water using water finding paste.

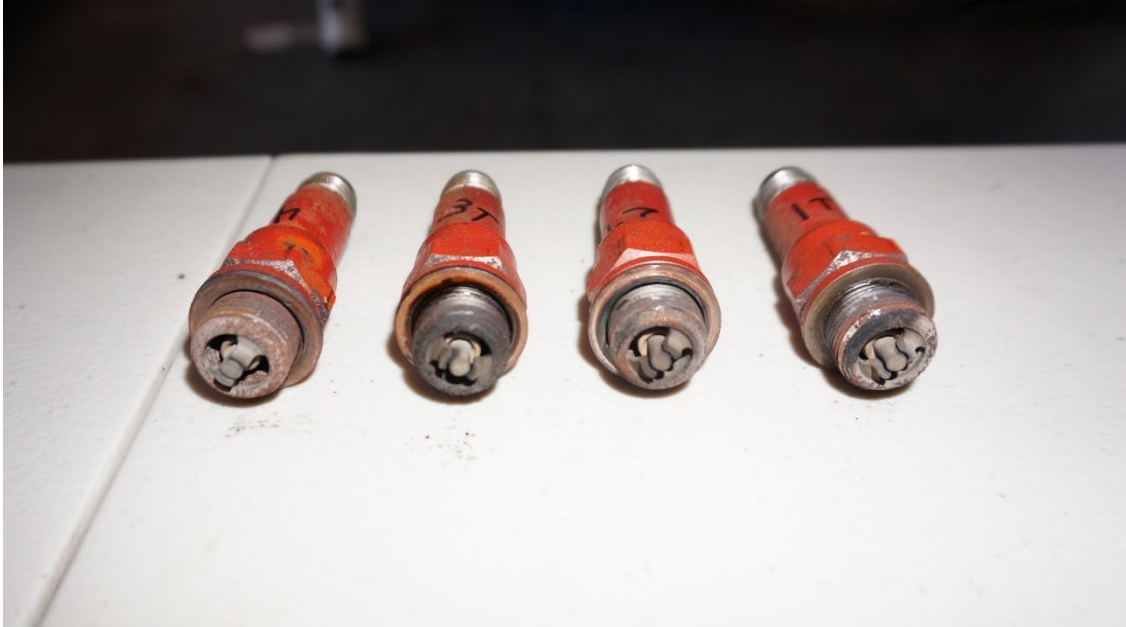
**Figure 13 - Top Spark Plugs**

Both magnetos produced spark on all 4 towers when rotated. The top spark plugs were removed. The electrodes were light grey in color and appeared "worn-normal" when compared to a Champion check-a-plug chart.

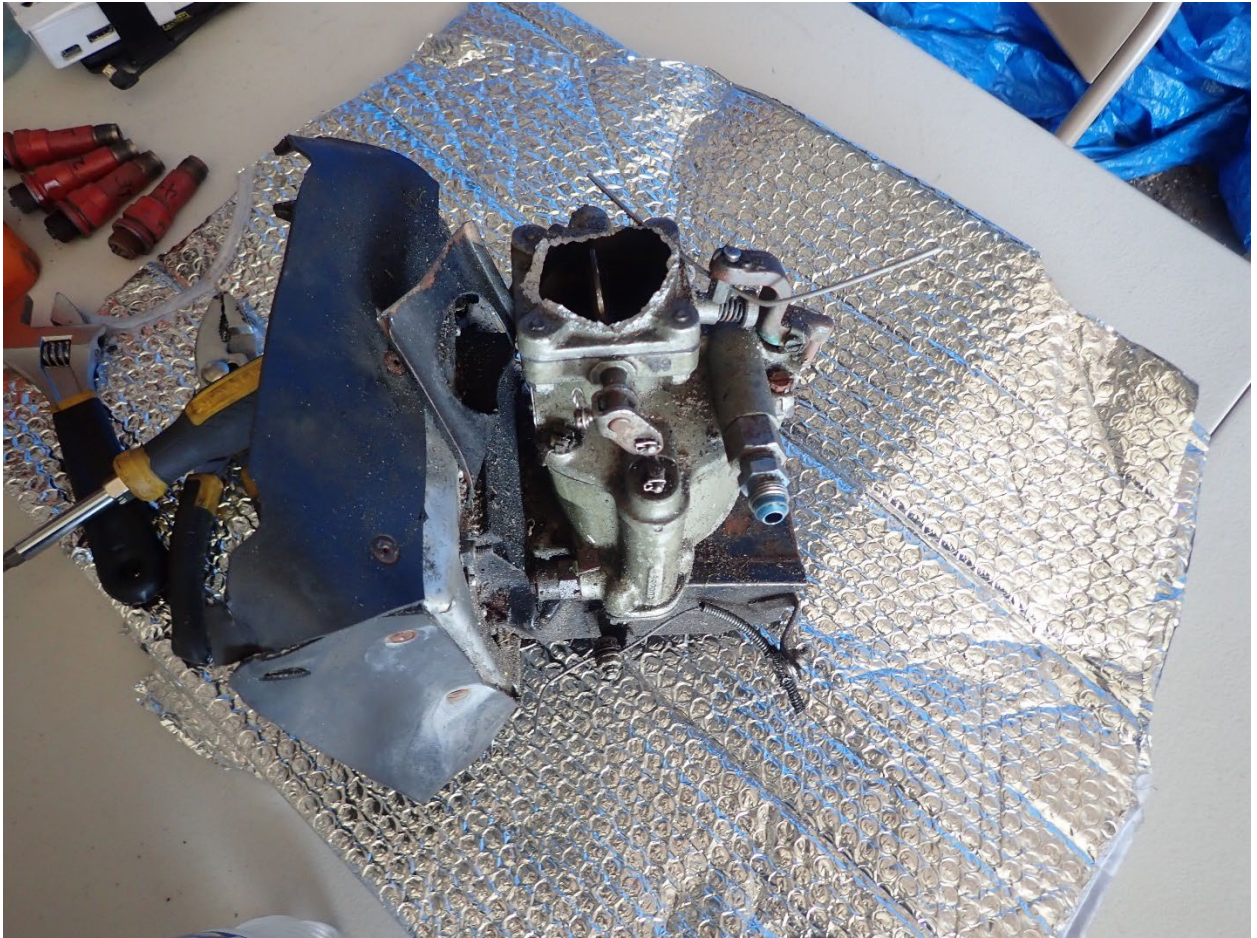
**Figure 14 - Carburetor Assembly**

The carburetor was fracture separated from the intake manifold. The throttle, mixture and carburetor heat control cables remained attached to their respective control arms. The fuel inlet screen was unobstructed. The bowl was dry and contained a trace amount of debris. The metal float assembly and needle valve/seat were intact.

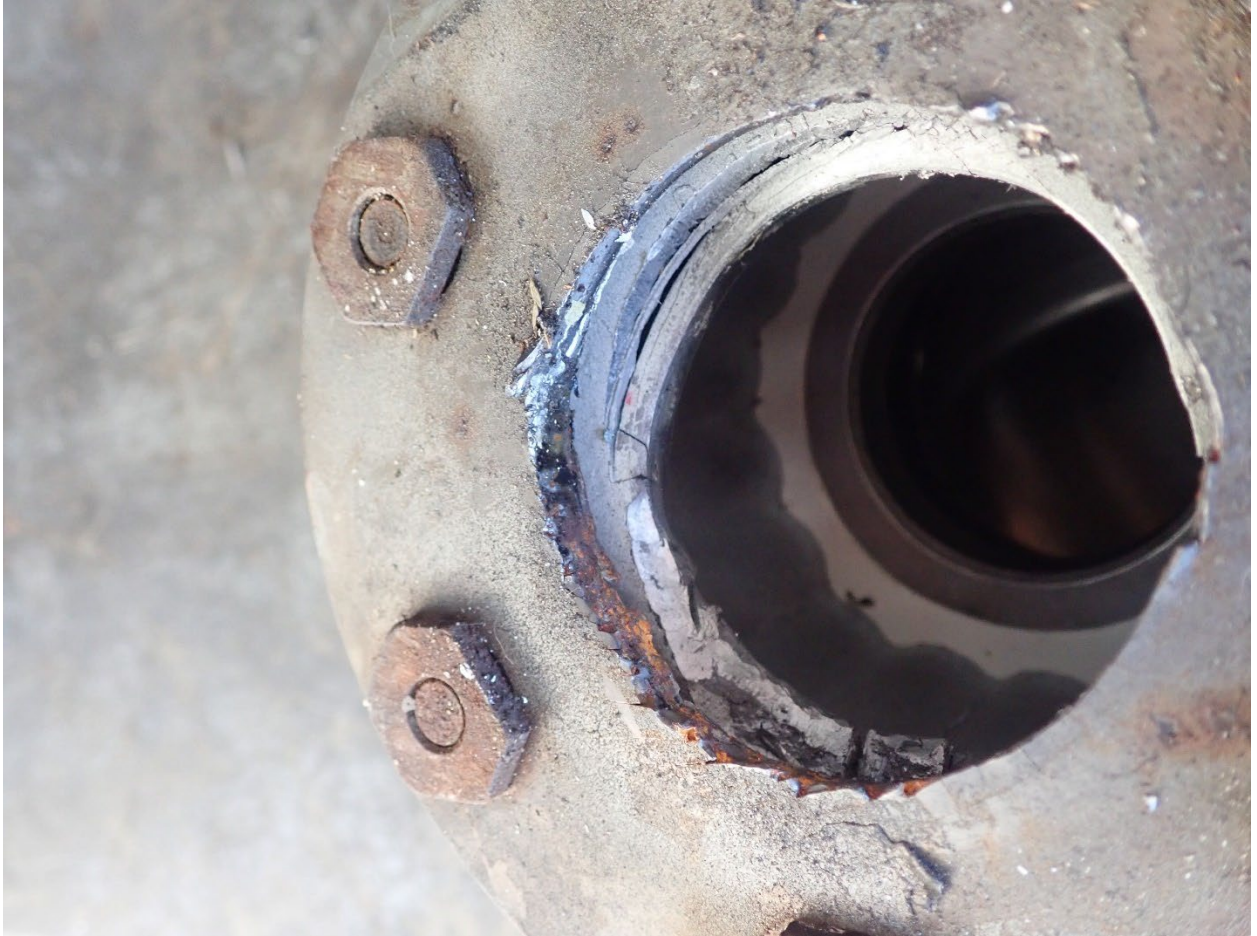
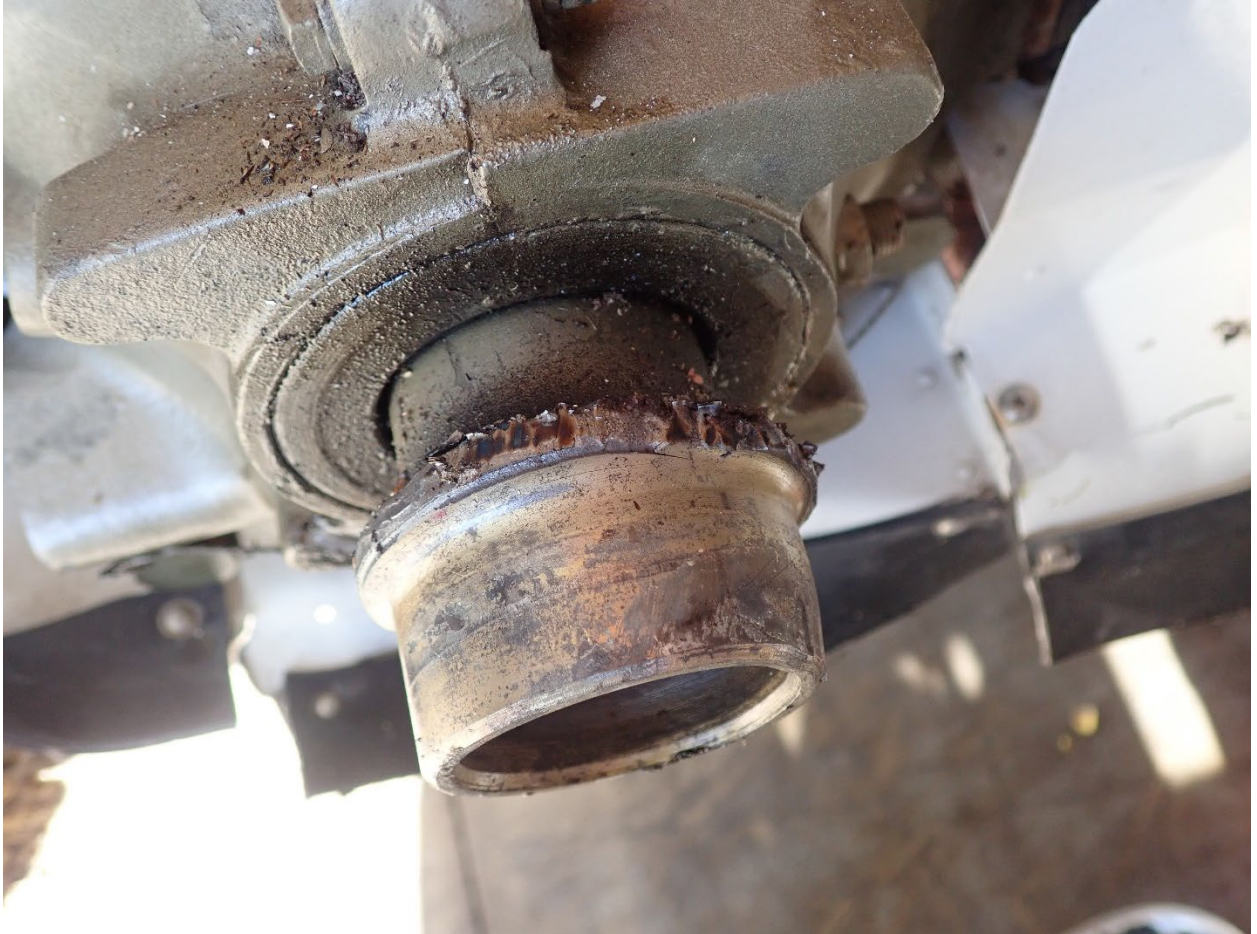
The propeller was separated from the engine. The flange was fractured circumferentially, at its base. A portion of the fracture surfaces exhibited corrosion/rust.

**Figure 18 - Propeller Flange Fracture**

**Figure 19 - Propeller Flange Fracture - Crankshaft Side**

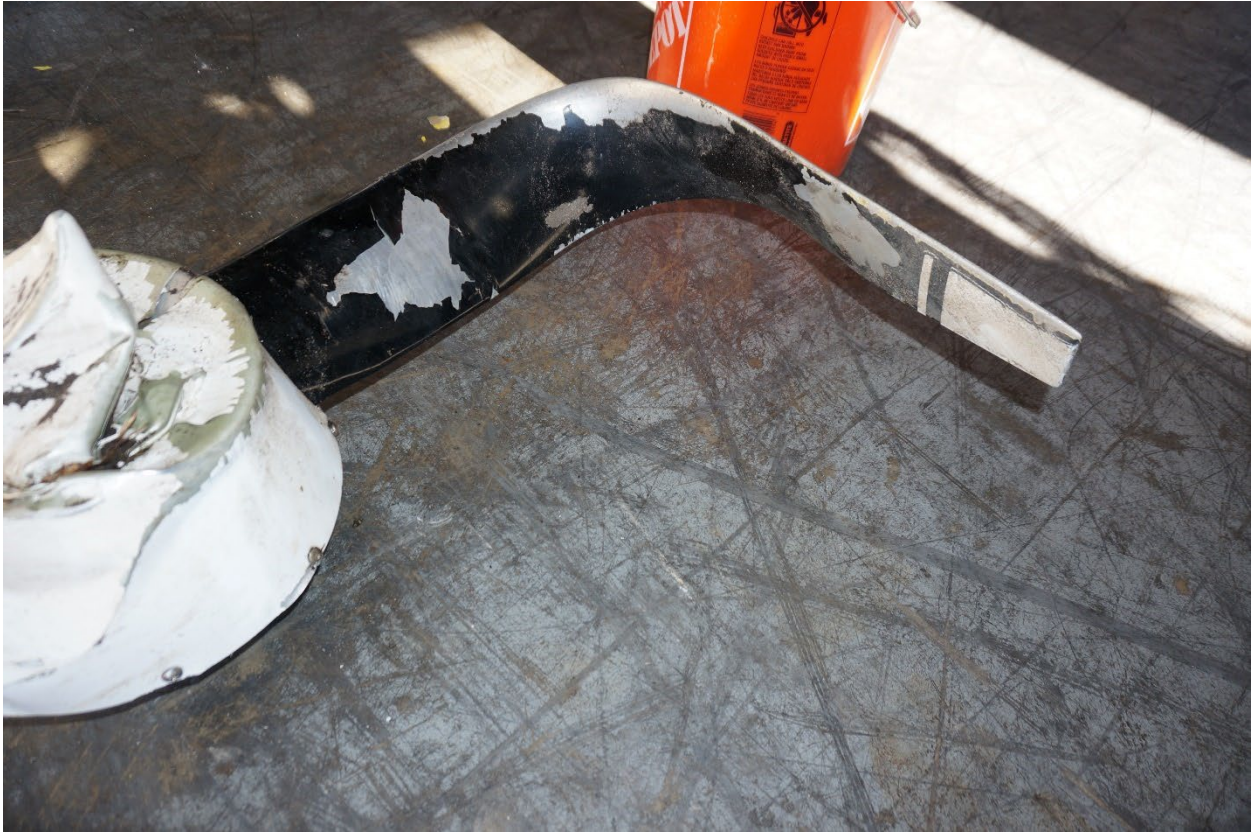
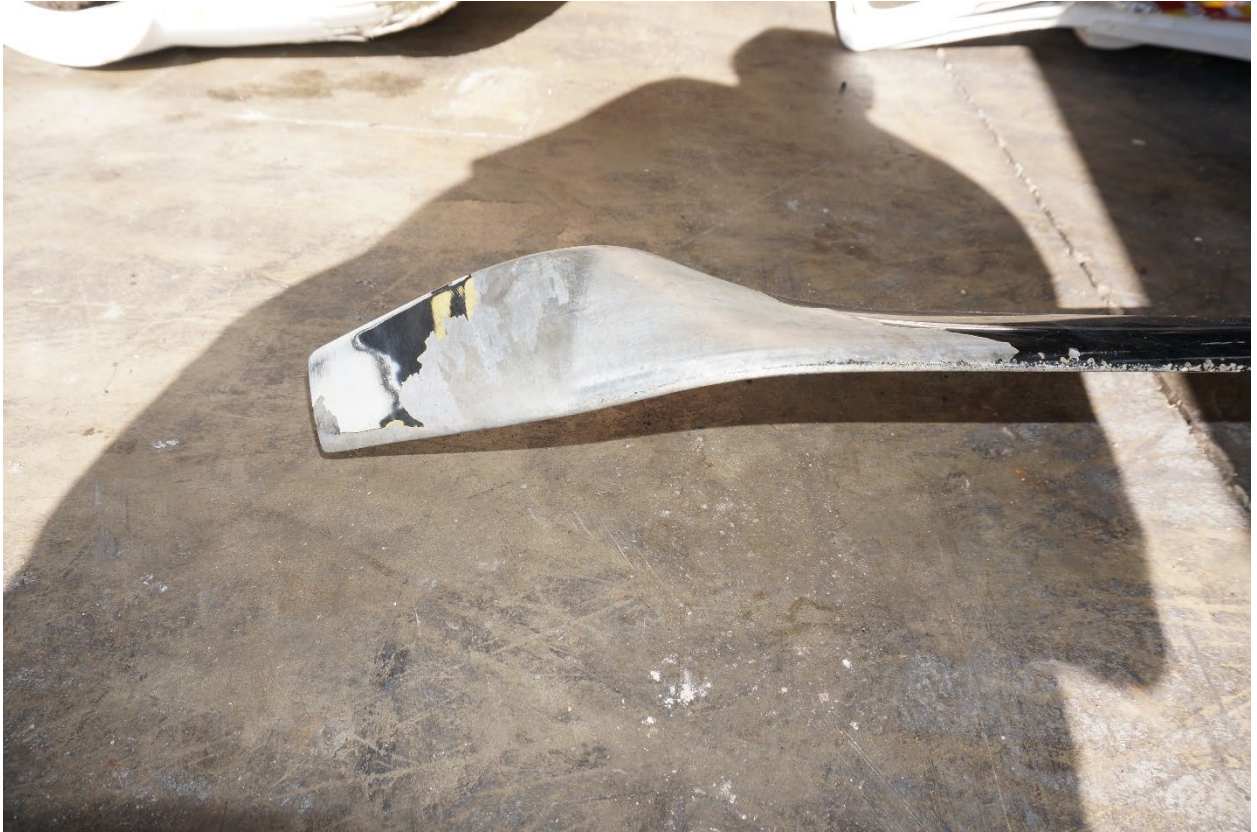
One propeller blade was bent 90° about mid span, the other blade as bent aft with a slight twist, about 10 inches from the tip. No leading edge gouges or chordwise scratch marks were noted on either blade.
