**NATIONAL TRANSPORTATION SAFETY BOARD**

**Photo Array**

**ERA21LA387**

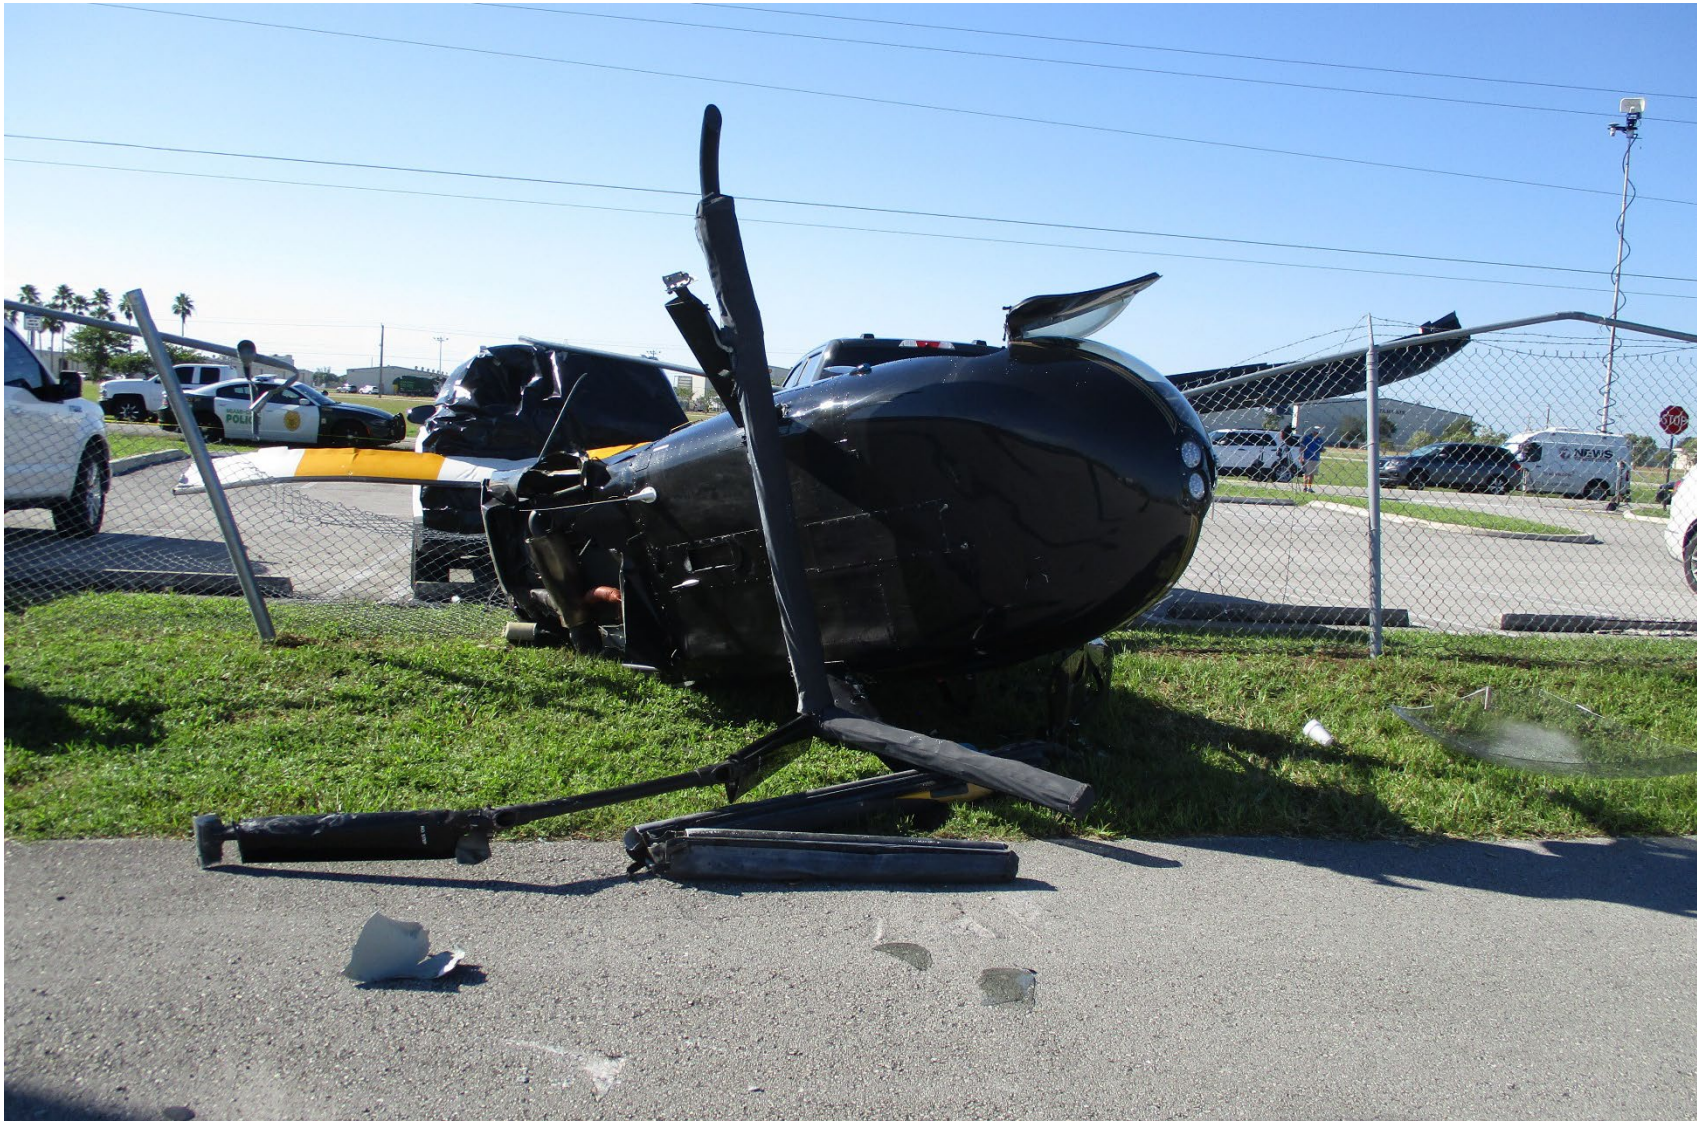
**Photo 1 – View of Main Wreckage (Courtesy of FAA)**

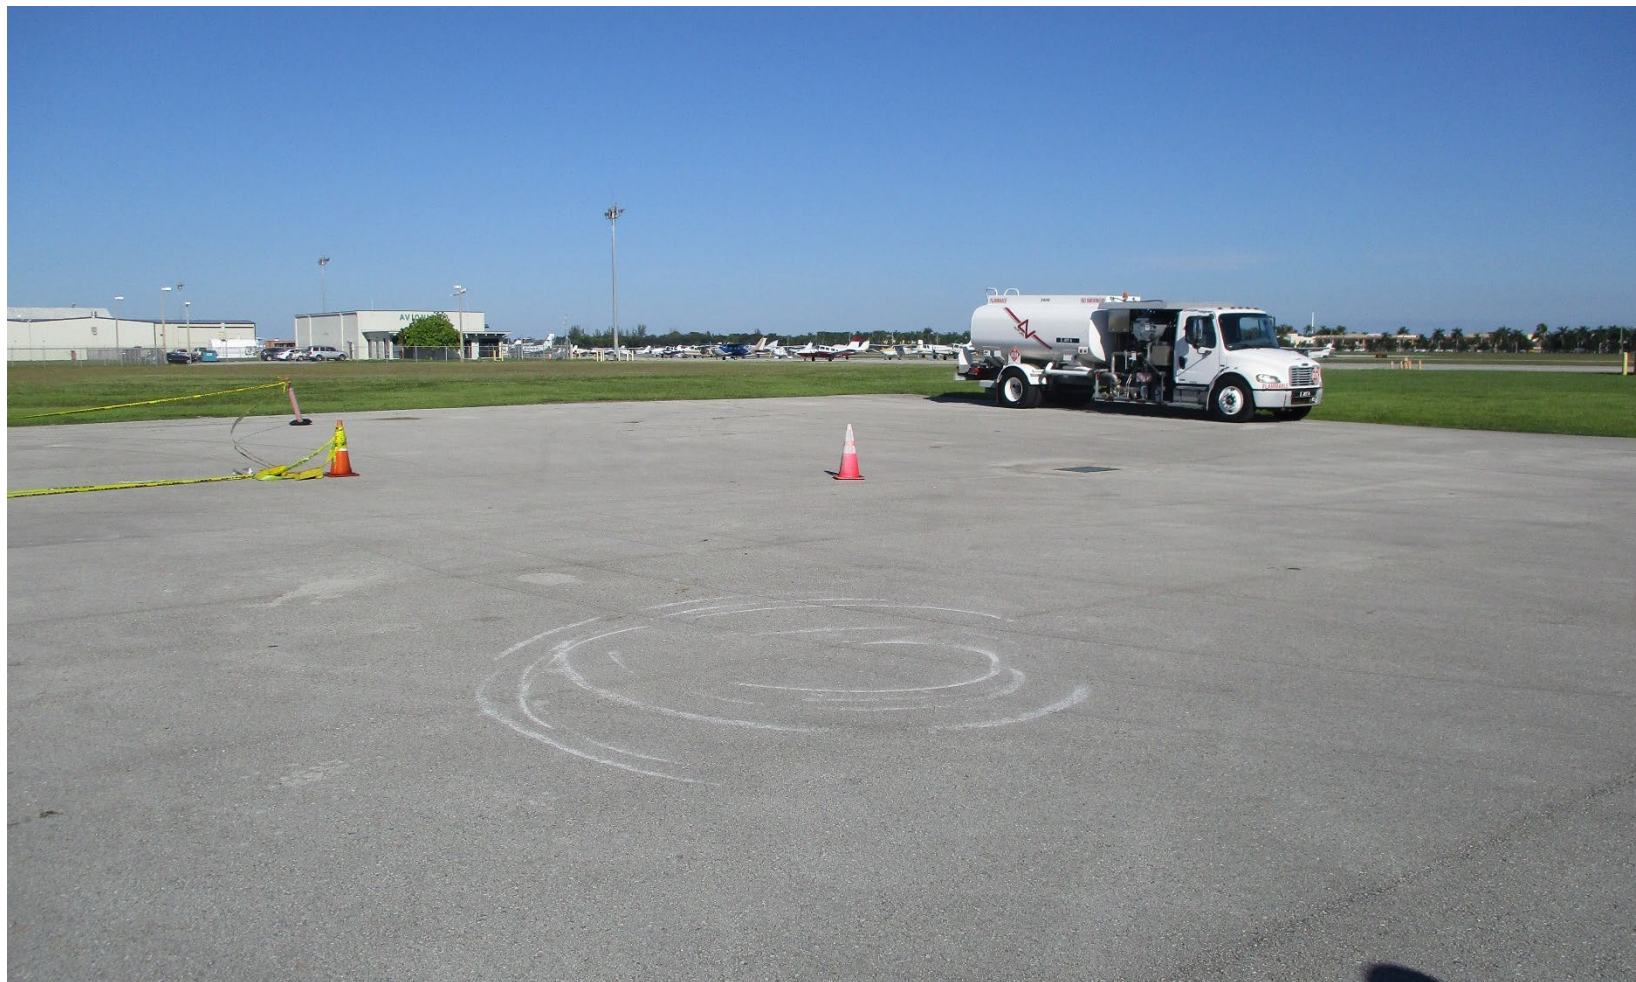
**Photo 2 – View of Rotational Skid Marks at Point of Takeoff (Courtesy of FAA)**

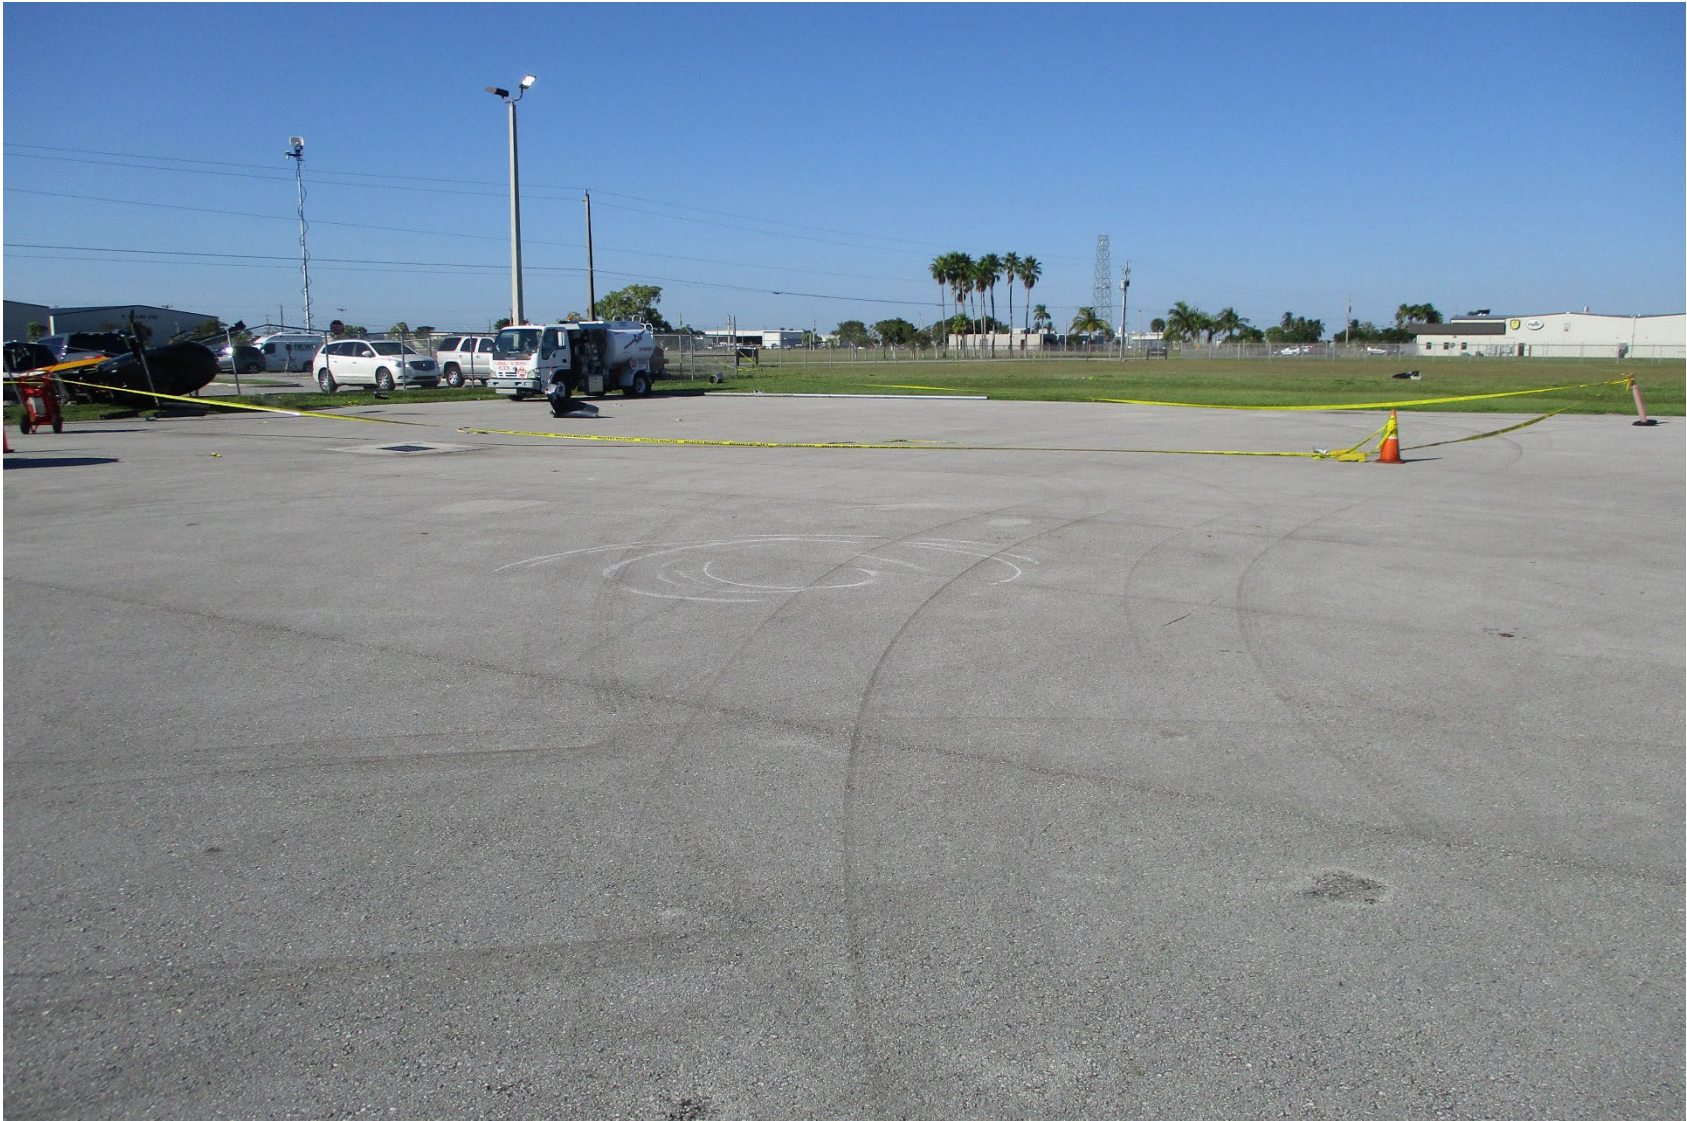
**Photo 3 – View of Rotational Skid Marks (Courtesy of FAA)**

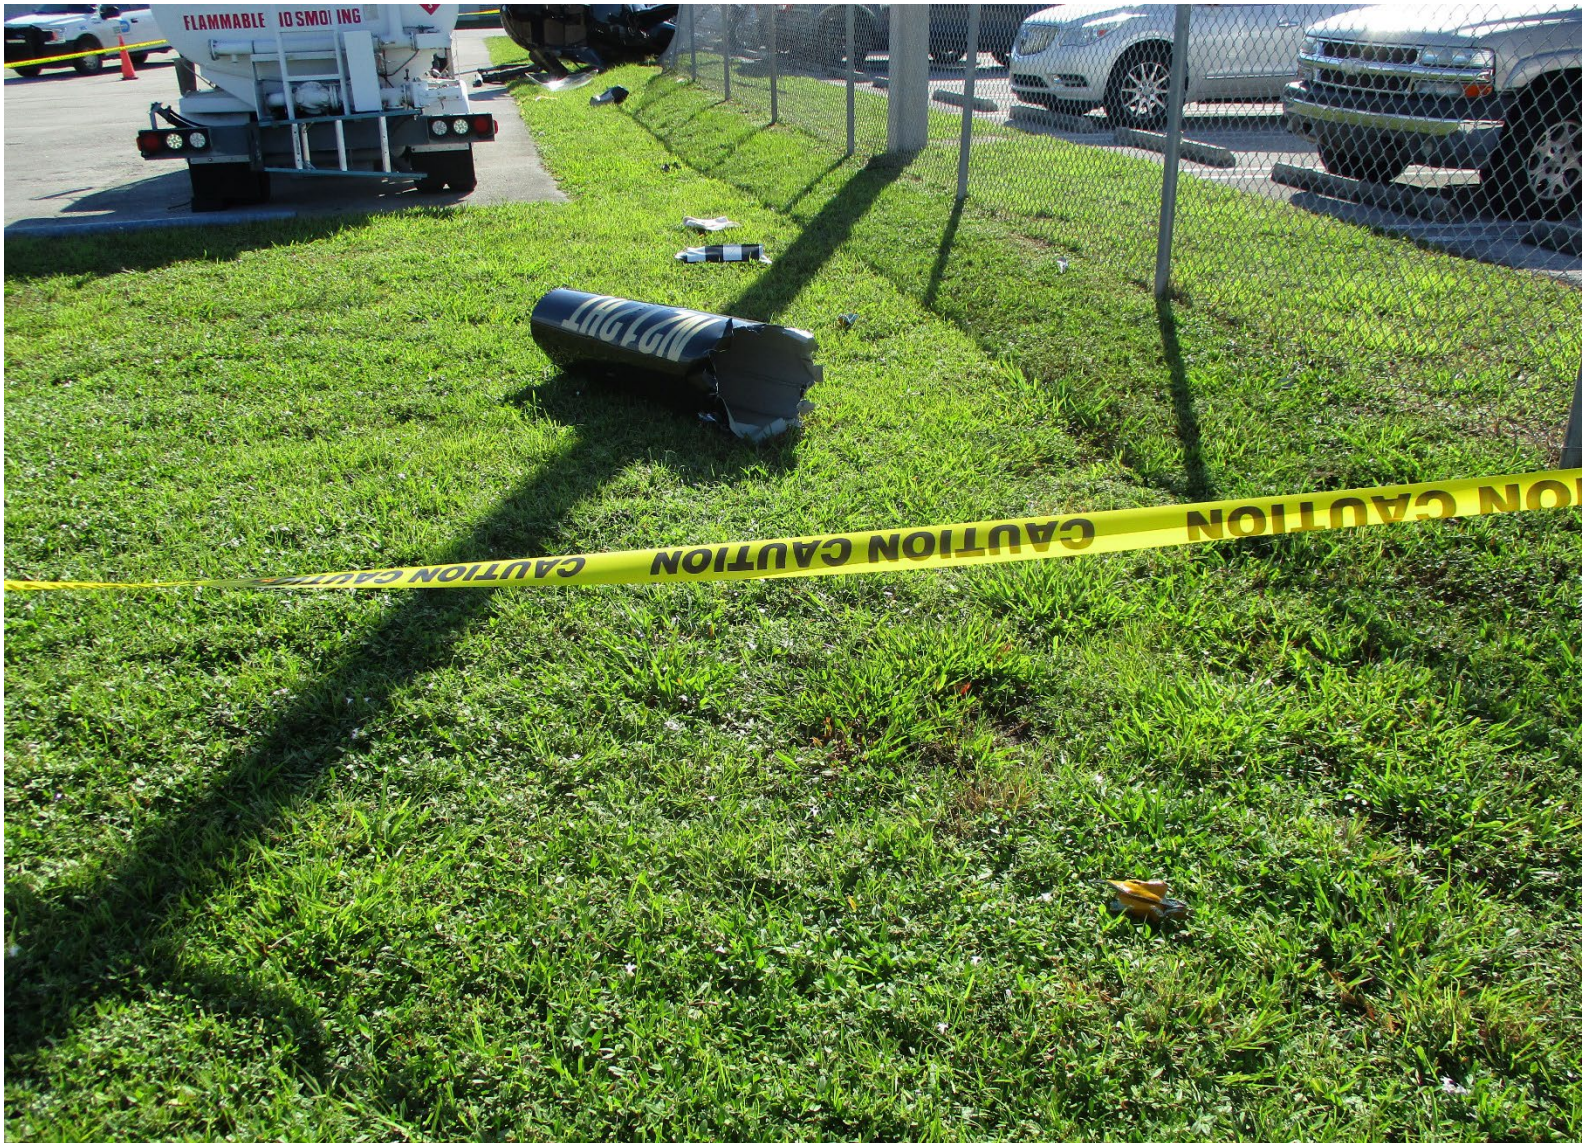
**Photo 4 – View of Separated Tailboom Section (Courtesy of FAA)**
