**NATIONAL TRANSPORTATION SAFETY BOARD**

**Video Study**

**NTSB Case Number:  
ERA21LA387**

Location: Miami Executive Airport (KTMB), Miami, Florida  
Date: September 28, 2021  
Time: 1906 eastern standard time (EST)  
Aircraft: Robinson R44 helicopter

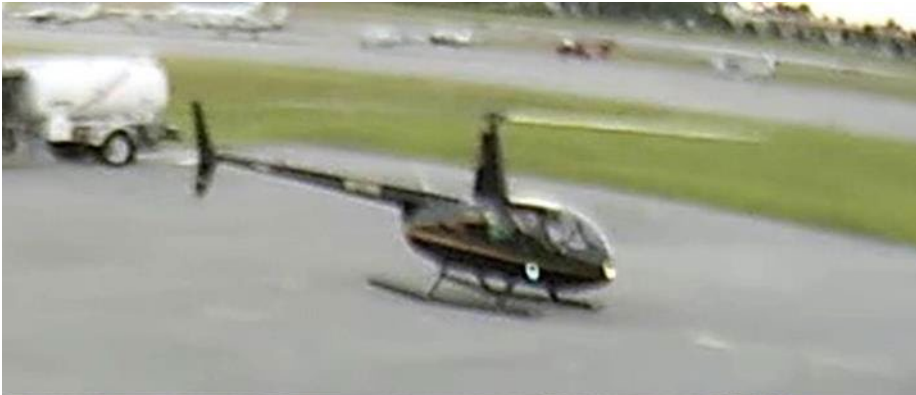
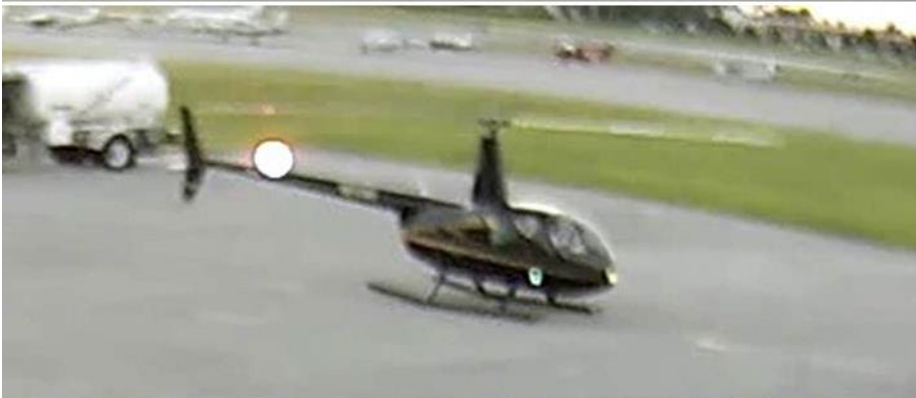
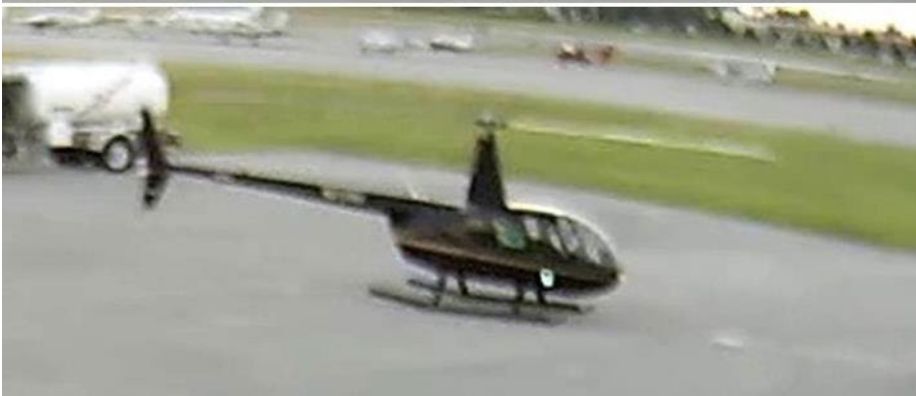
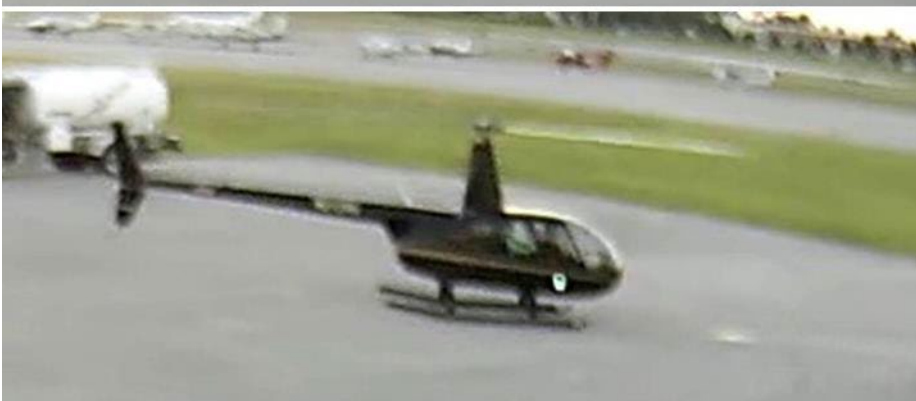
**Figure 1. Four Video Frames Just before Takeoff**

Figure 1 shows segments from four video frames that were recorded when the helicopter started yawing counterclockwise while still on the ground at about time 22.7 seconds. These four video frames are all spaced by four frames between them. The rotor is seen at about the same angular position with respect to the helicopter fuselage in all four frames, supporting the assumption that the rotor speed was close to the assumed 408 RPM.

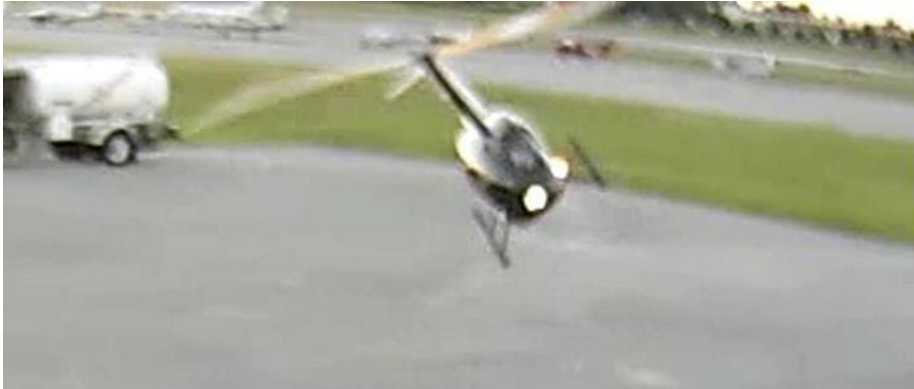
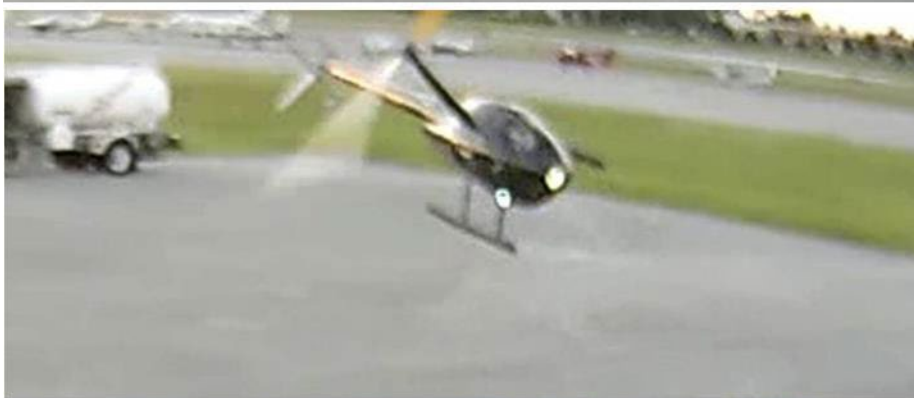
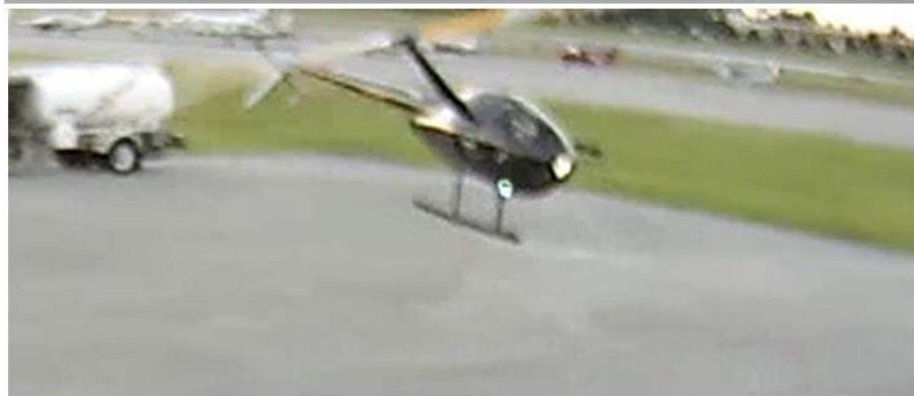
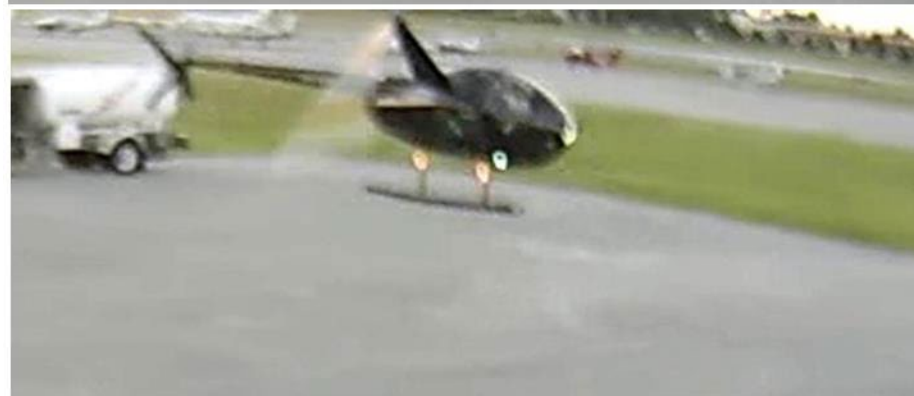
**Figure 2. Four Video Frames Just after Takeoff**

Figures 2A and 2B show segments from two adjacent video frames recorded when the helicopter was already airborne and rotating counterclockwise viewed from above. The blade seen in Figure 2B is at an angular position that is close to the predicted  $41.4^\circ$  more counterclockwise than the blade seen in Figure 2A. Figures 2C and 2D also show segments from two adjacent video frames recorded when the helicopter was airborne and rotating counterclockwise. The blade seen in Figure 2D is at an angular position that is close to the predicted  $41.4^\circ$  more counterclockwise than the blade seen in Figure 2C. Therefore, Figure 2 also supports the assumption that the rotor speed was close to the assumed 408 RPM.

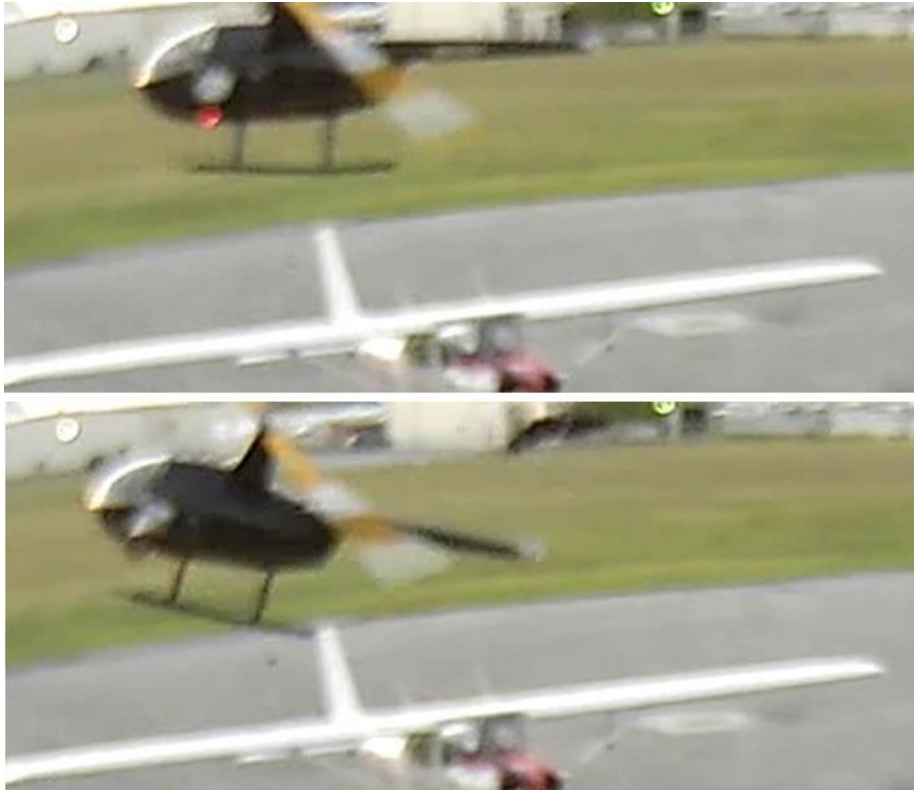
**Figure 3. Two Video Frames Just before Ground Impact**

Figure 3 shows segments from two adjacent video frames recorded just before the helicopter impacted the ground. In video frame No. 330, the one before the frame shown in Figure 3A, rotor blades are not visible. In video frame No. 333, the one after the frame shown in Figure 3B, the helicopter already impacted the ground. Therefore, only the two video frames shown in Figure 3 are available for analysis.

The blade seen in Figure 3B is at an angular position with respect to the fuselage that is larger counterclockwise than the angle seen in Figure 3A. Since it is difficult to estimate the blade angles accurately because of the helicopter roll and pitch angles, and accounting for the possibility that the rotor speed was reduced due to the impact with the tail rotor section, Figure 3 also supports the assumption that the rotor speed was close to the assumed 408 RPM up to ground impact or, at least, up to the impact of the rotor with the tail rotor section.

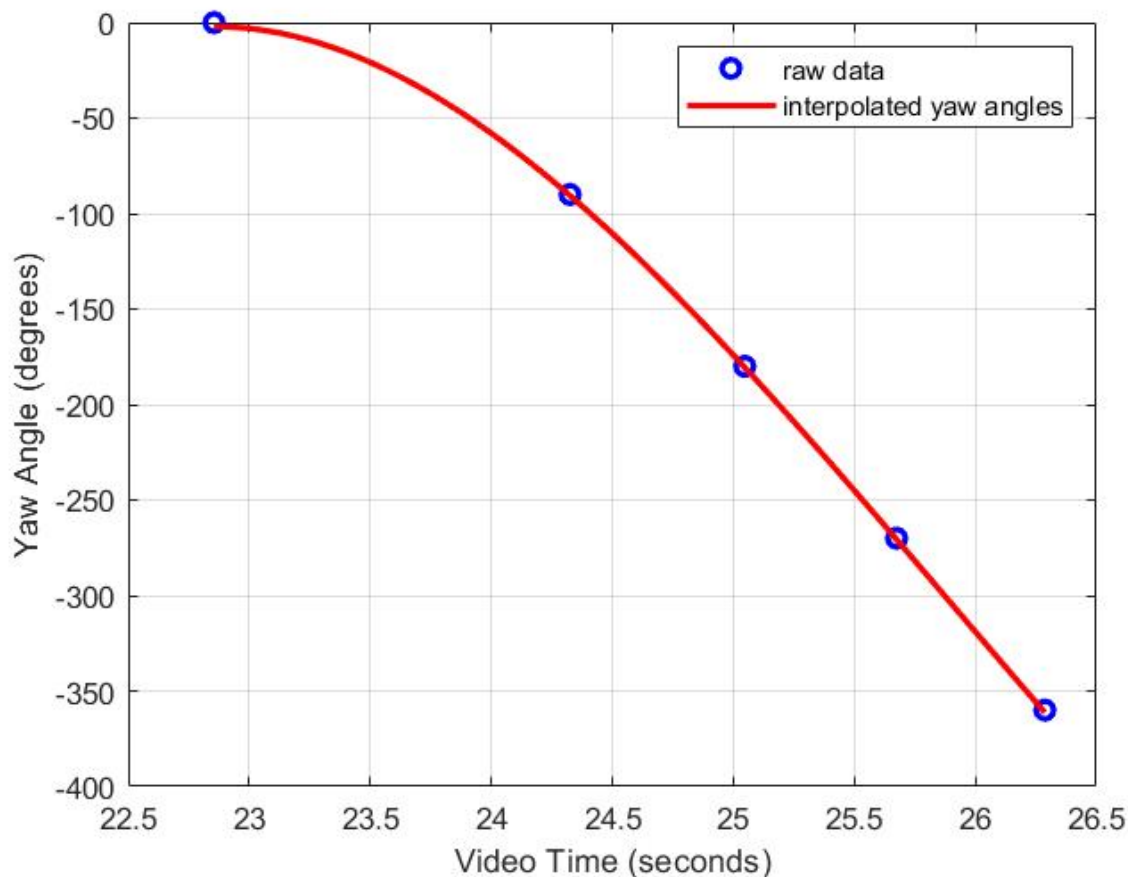
**Figure 4. Estimated Helicopter Yaw Angle**

It was possible to estimate the helicopter yaw orientation with respect to its orientation before it started spinning counterclockwise. The angle was defined as zero when the helicopter started spinning at time 22.7 seconds. It became airborne at about time 25.3 seconds. The angle was estimated as  $-360^\circ$  at time 26.2 seconds, when the helicopter was already airborne. Negative yaw angle corresponds to counterclockwise rotation. At time 27.0 seconds, the helicopter exited the field of view of the camera until time 29.3 seconds. Figure 4 shows the plot of the yaw angle vs. time. The yaw rate past time 25 seconds was  $-142$  degrees/second.
