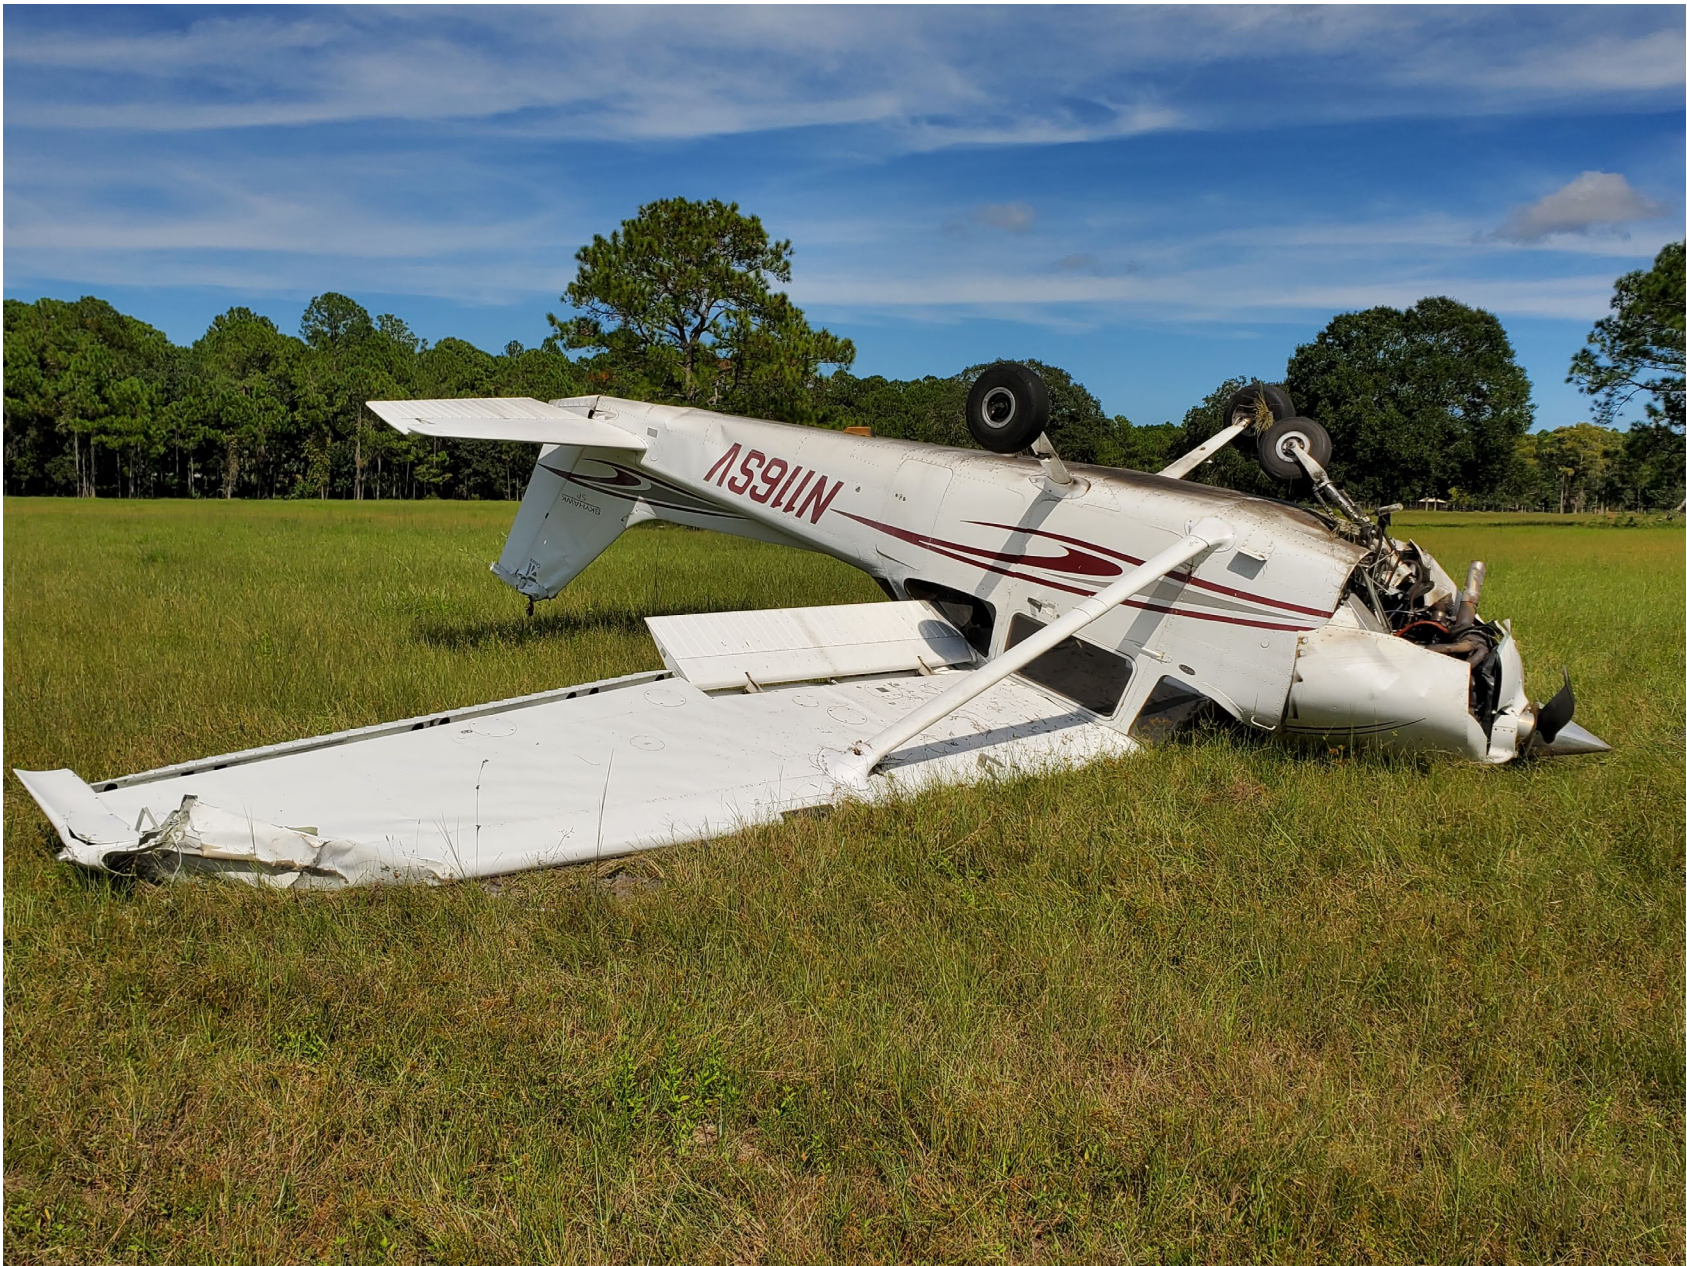
**Photo 1 – FAA Digital Photograph. Left Forward View of the Inverted Airplane at the Accident Site. Note the damage to the Left Wing, and Bottom and Side of the Fuselage near the Left Horizontal Stabilizer.**

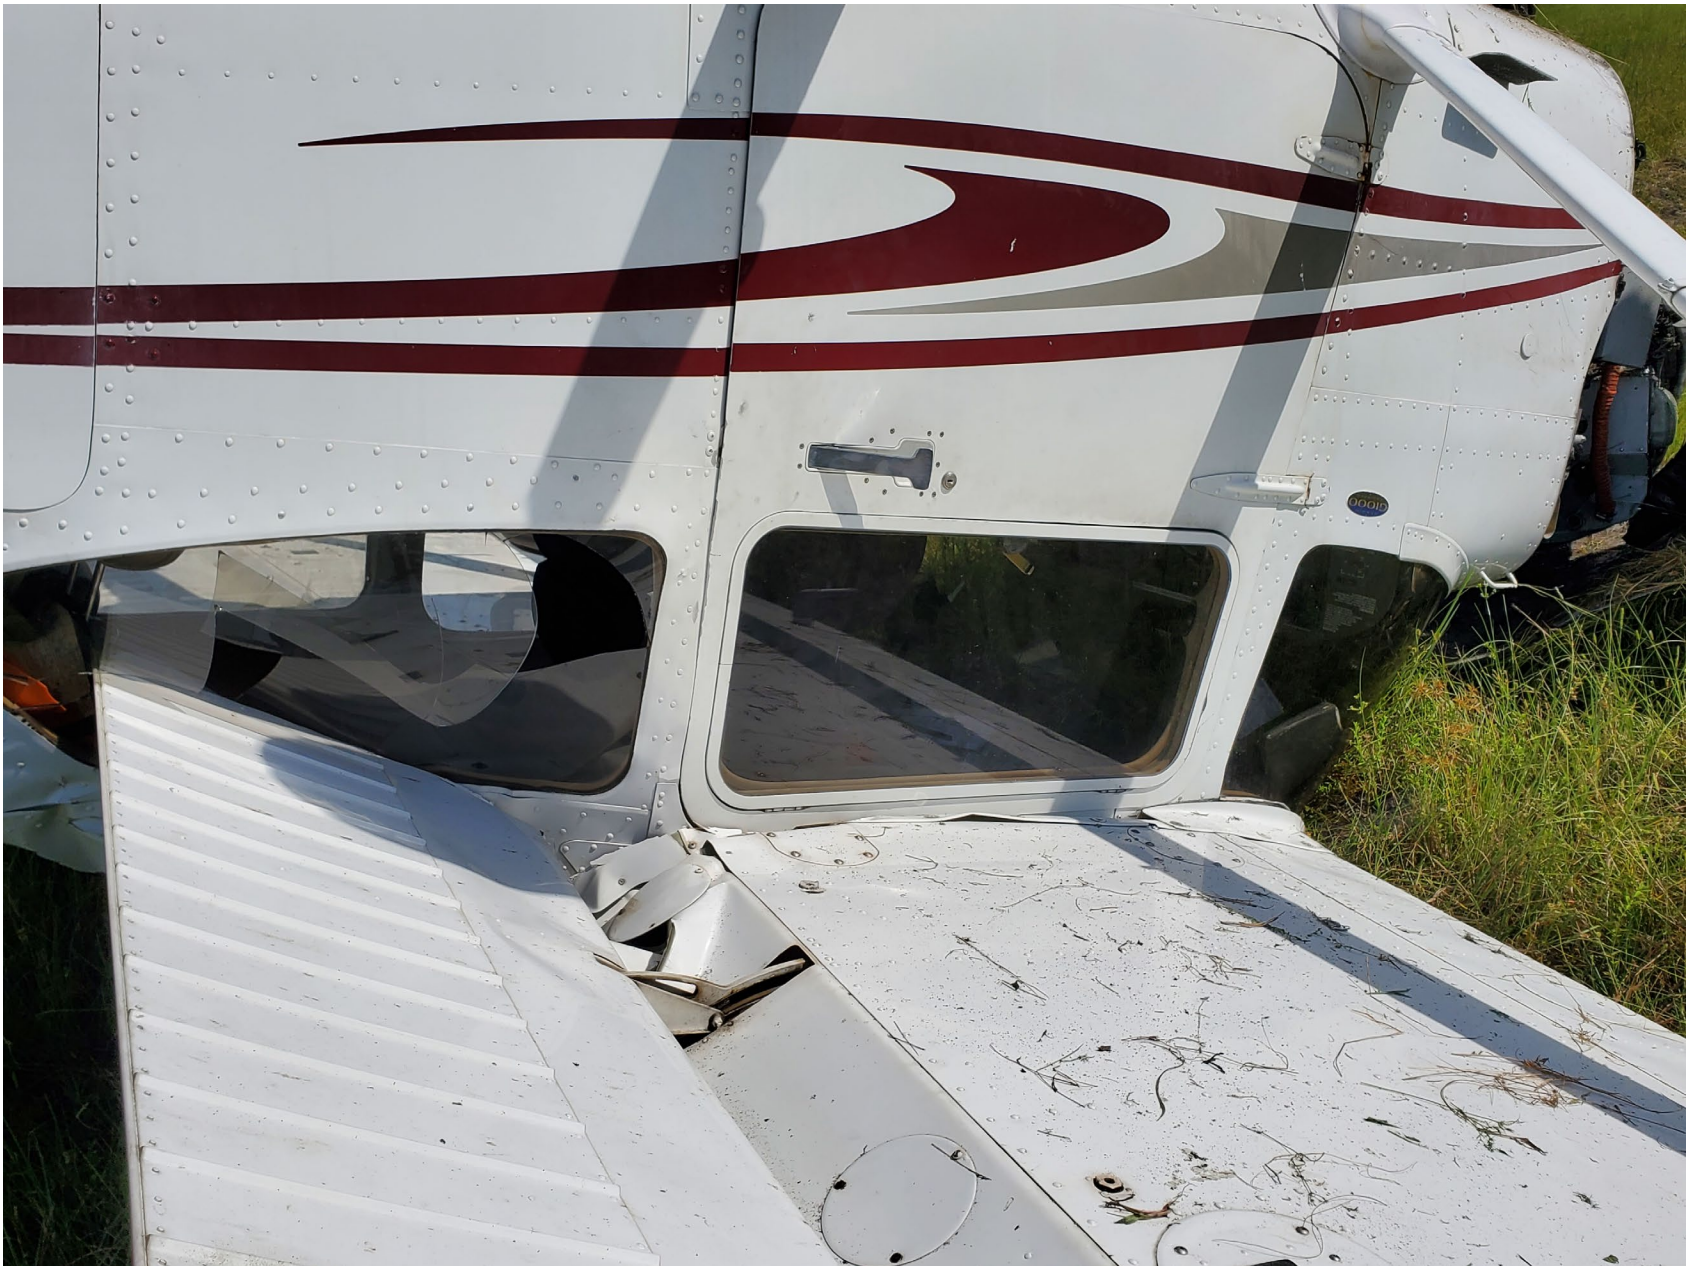
**Photo 2 - FAA Digital Photograph. View of the Bottom Side of the Inboard Section of the Left Wing Noting Structural Damage.**

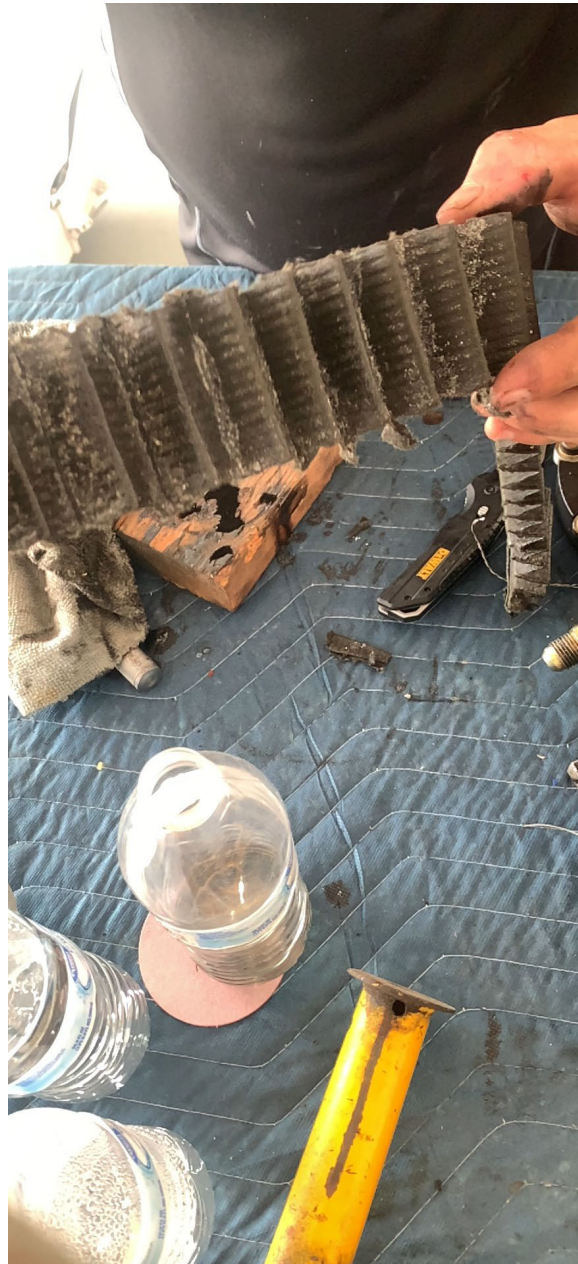
**Photo 3 – Photograph From Owner/Operator. View of the Oil Filter Element. Note the non-ferrous Particles.**
