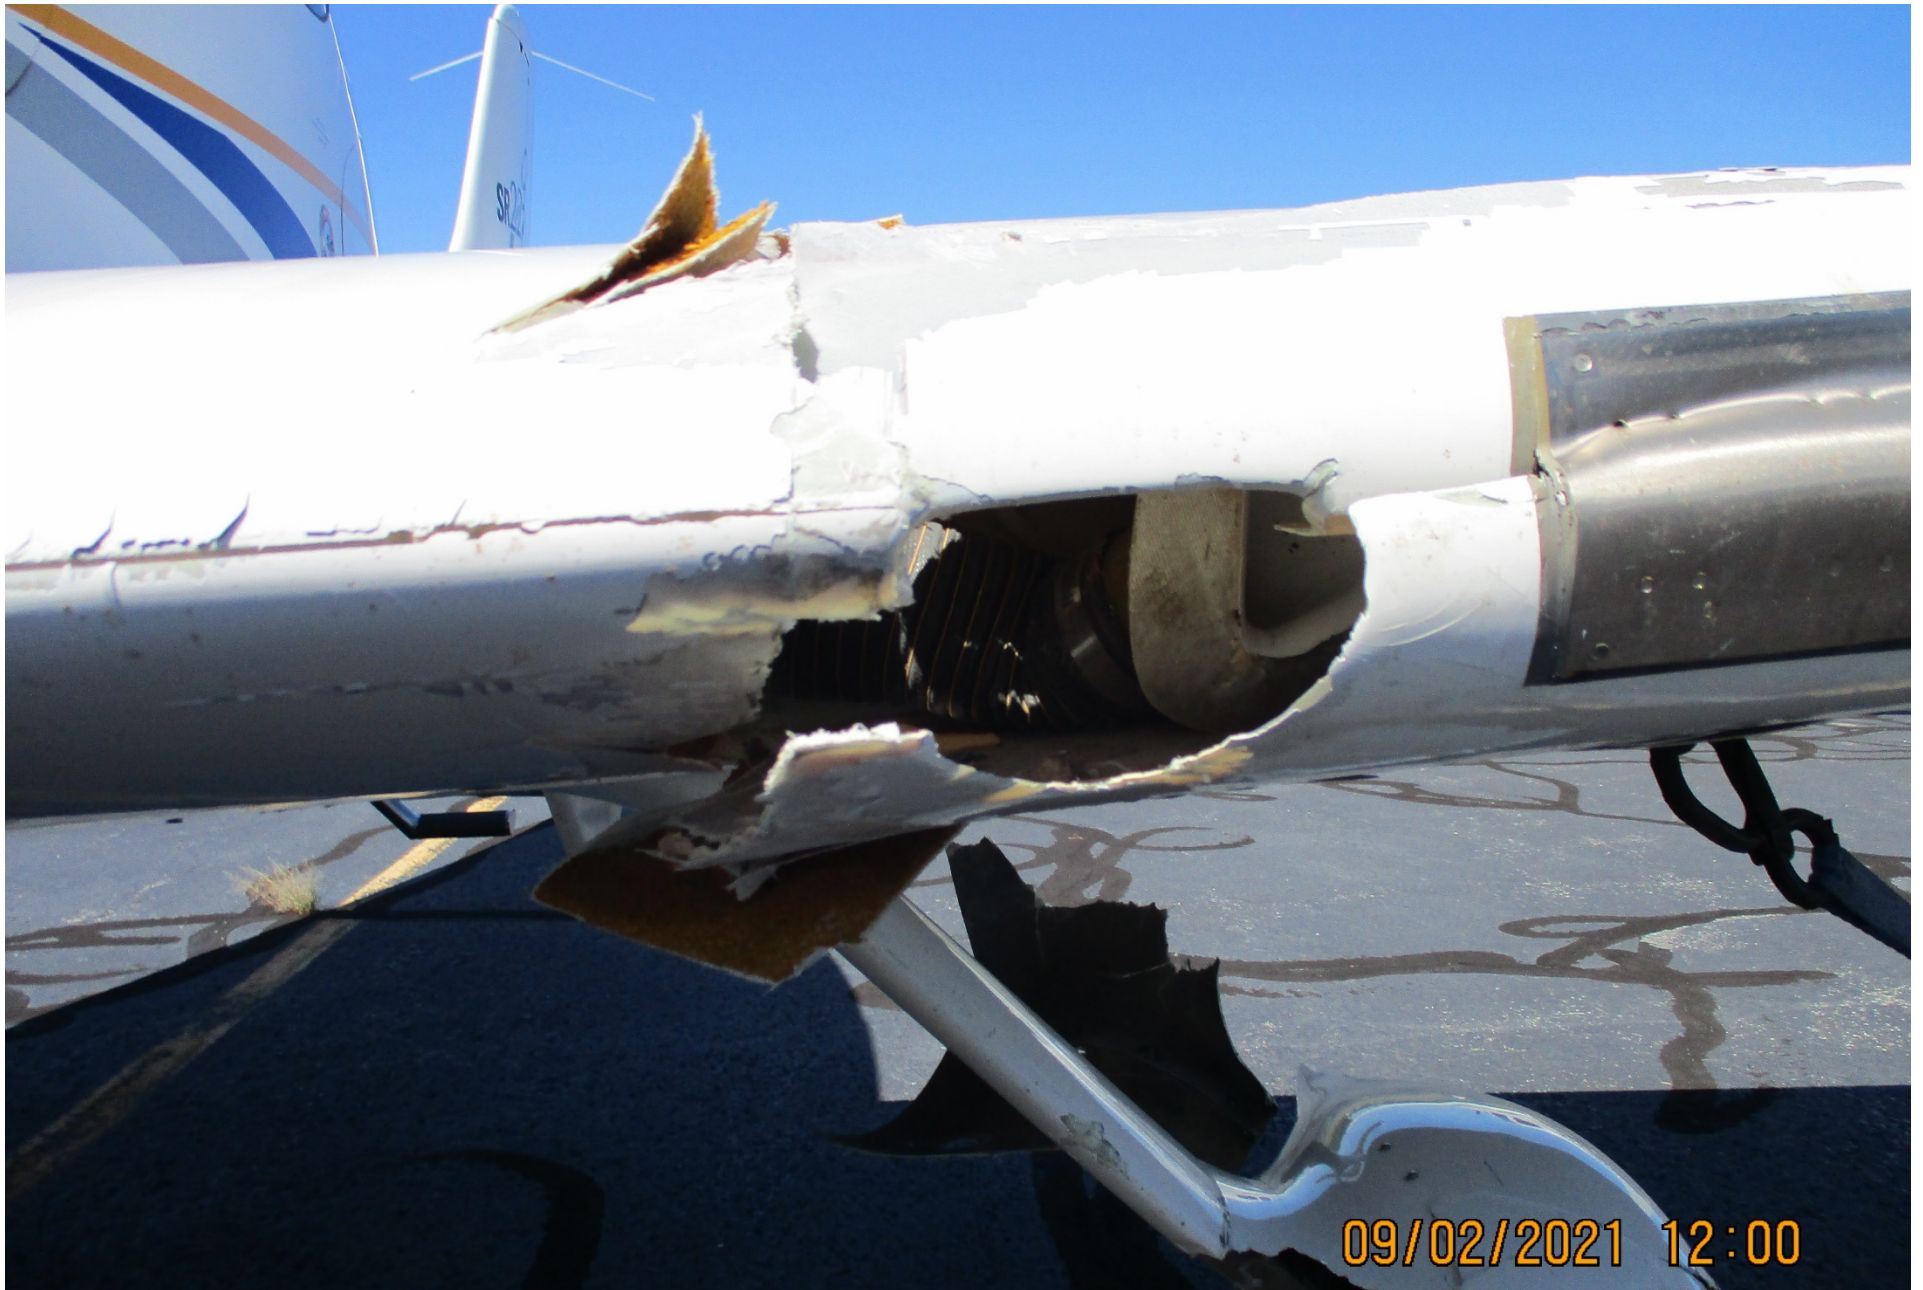
**Photo 2 – view of left wing leading edge damage.**
