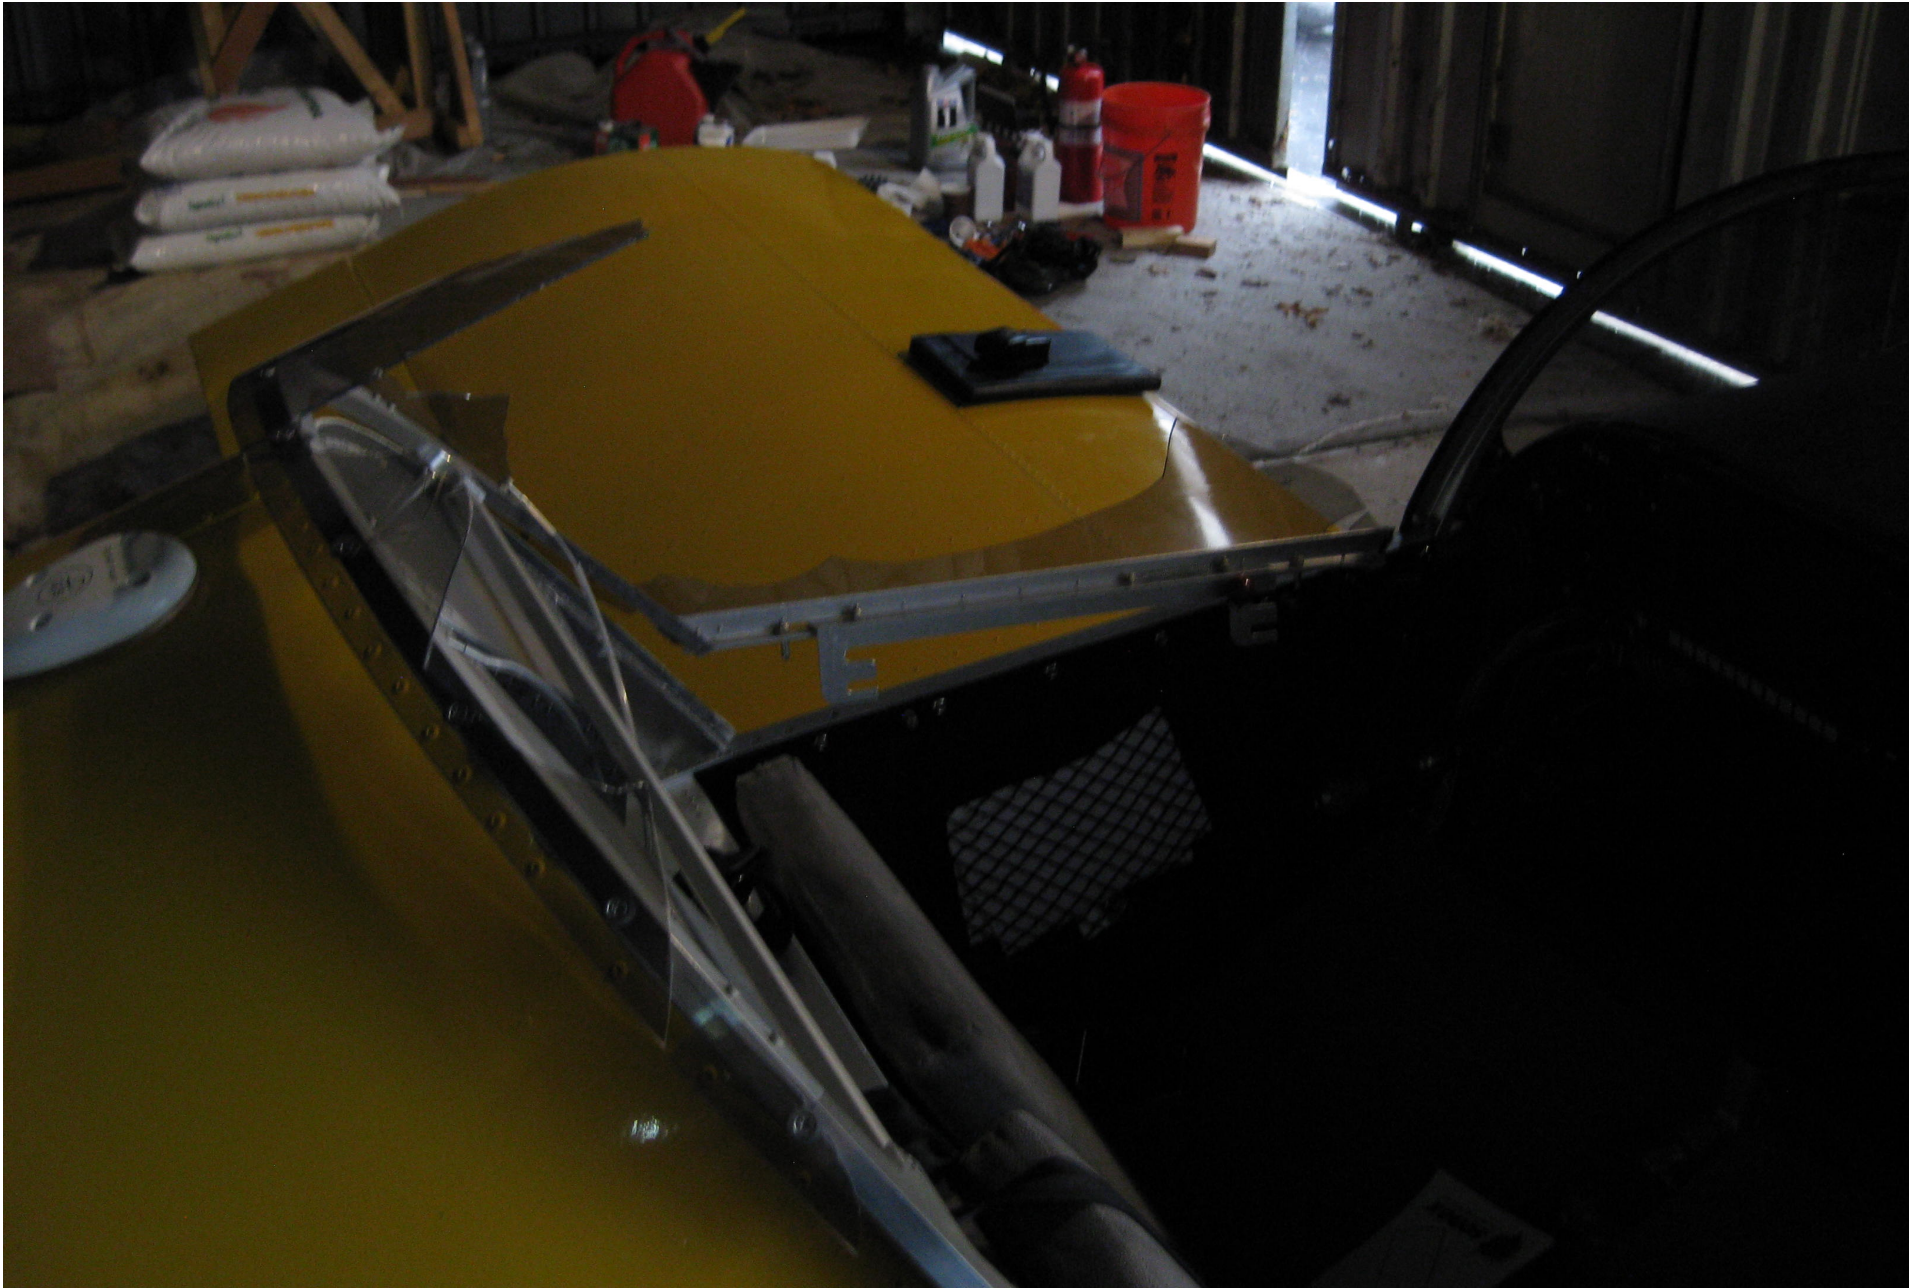
**Photo 1 – canopy structure damaged**

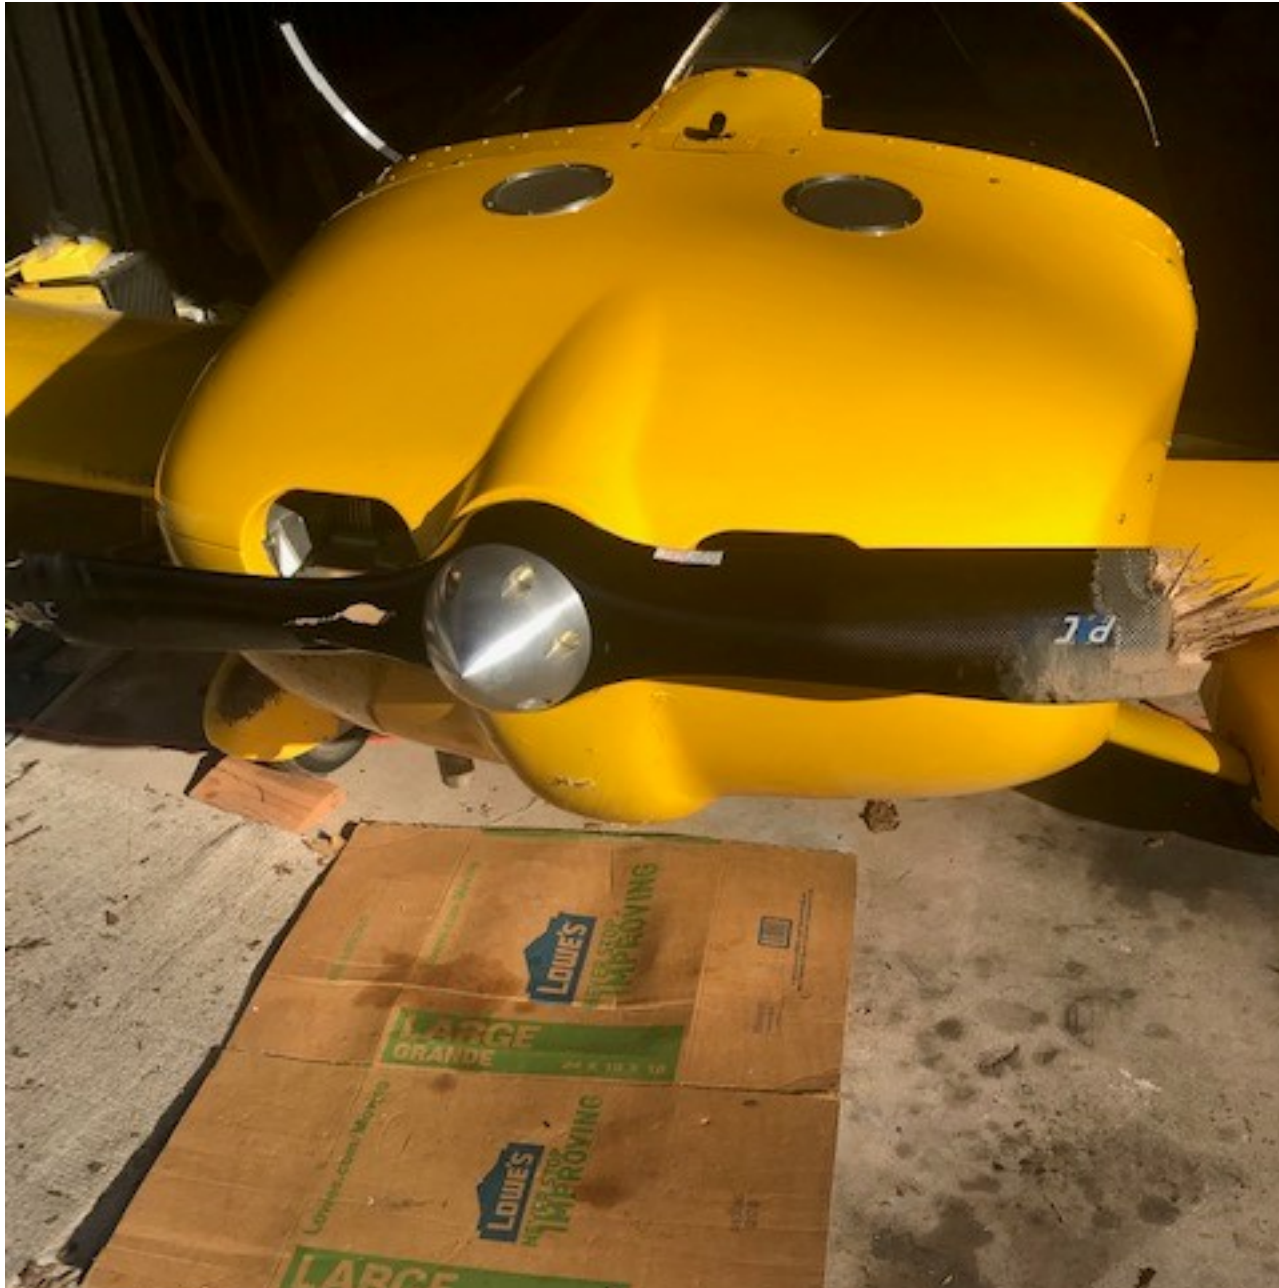
Photo 2 – propeller damaged

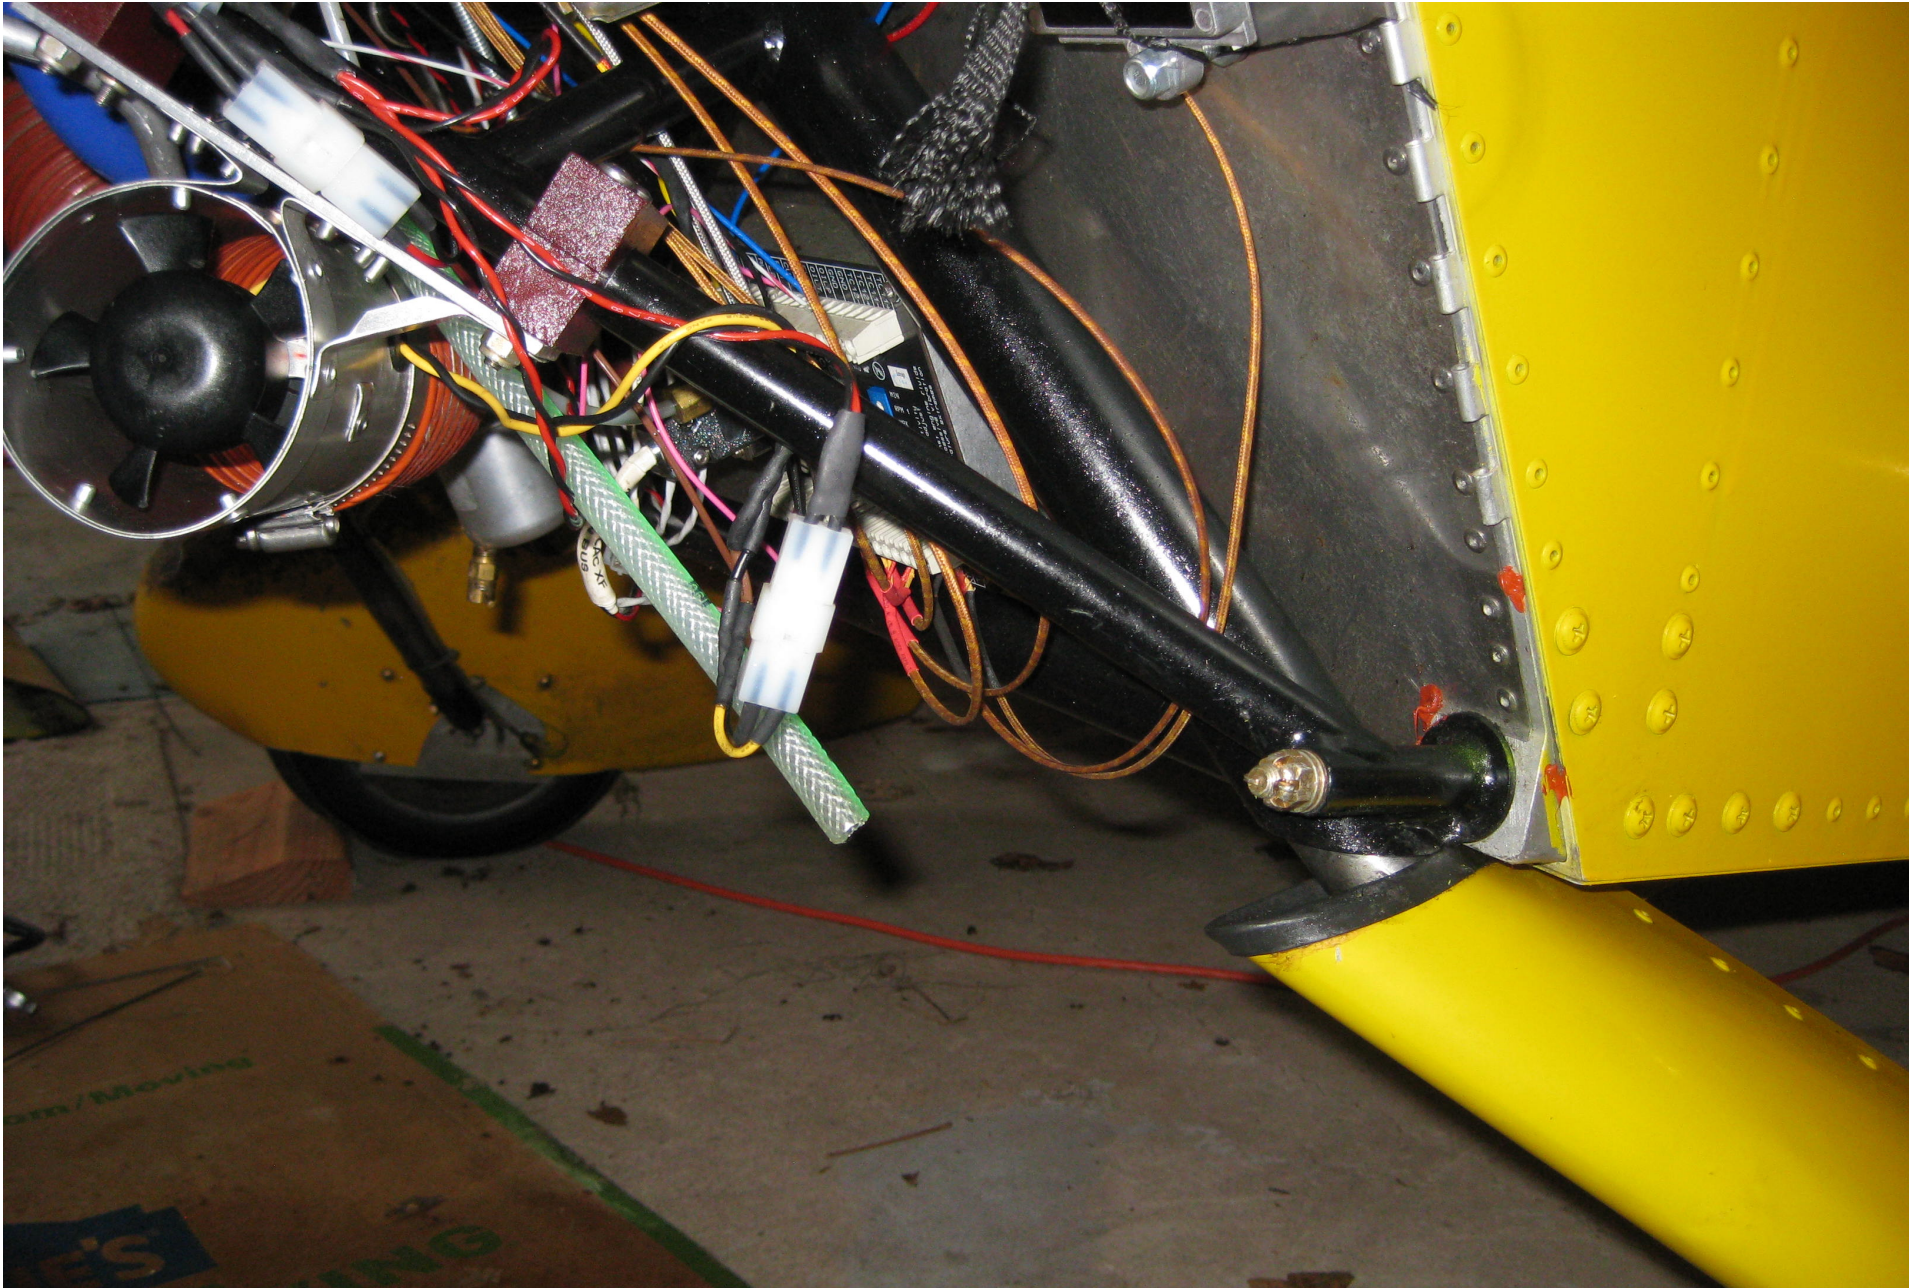
**Photo 3 – Landing gear and firewall damage**
