# National Transportation Safety Board

ERA22FA010

## WRECKAGE EXAMINATION

Location: Cornwall, New York  
Date: October 10, 2021  
Time: 1357 eastern daylight time  
1757 UTC  
Helicopter: N637HP, Robinson R44 II

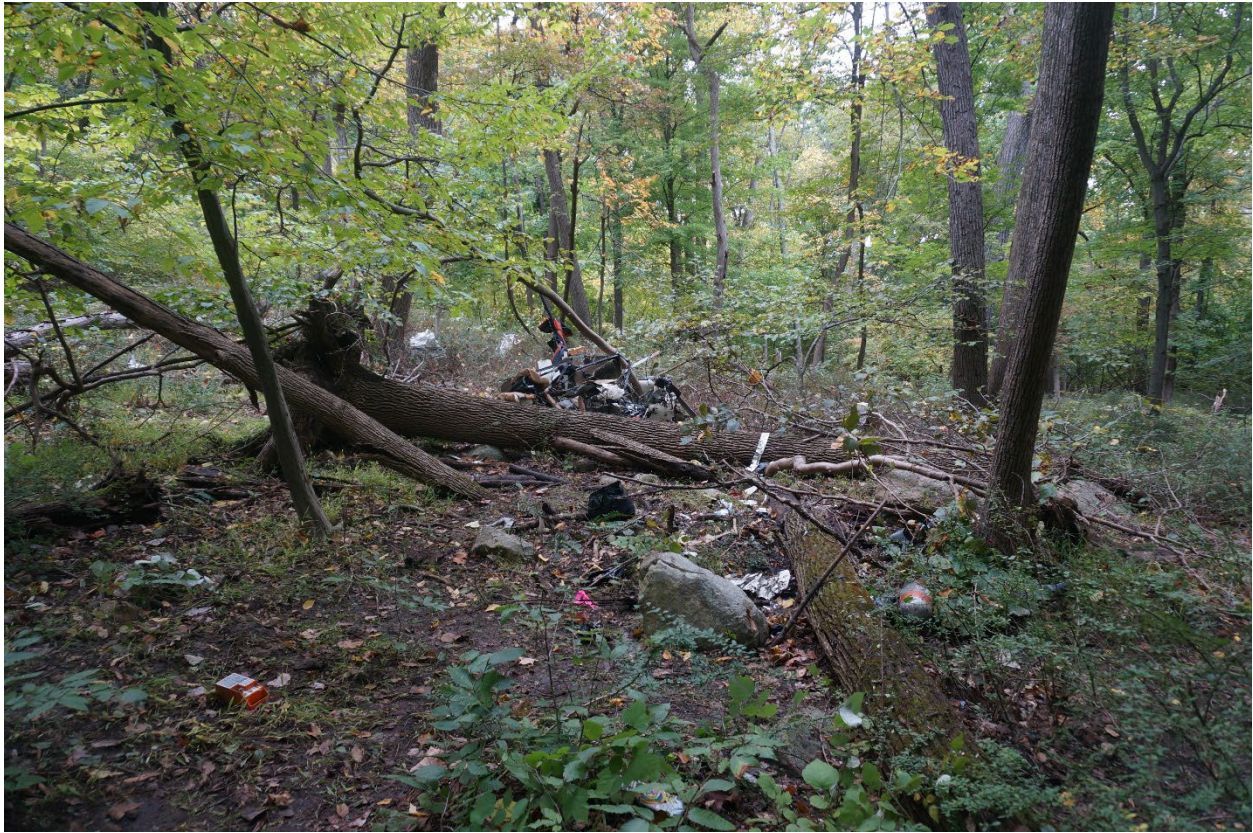
**Figure 1 - Accident Site**

The helicopter came to rest in a hilly wooded area. The primary wreckage path was about 110 ft long, oriented on a heading of about 155° true (168° magnetic). It began with a section of damaged trees at the base of which was the tail rotor gearbox (with blades attached) and ended at the main wreckage. The main wreckage came to rest against a fallen tree about 60 feet south of the first point of ground impact (impact crater) which was a two-foot-deep crater in the soft dirt, approximately 5 feet wide and 9-10 feet long. The crater had portions of several components associated with the belly of the fuselage, landing gear, and lower part of the engine. Located in the immediate area around crater were the empennage, fuselage pieces, tail rotor driveshaft, landing gear components, and engine components. There were no

indications of fire. Another damaged tree with broken branches on the ground was found about 40 ft northeast of the start of the wreckage path.

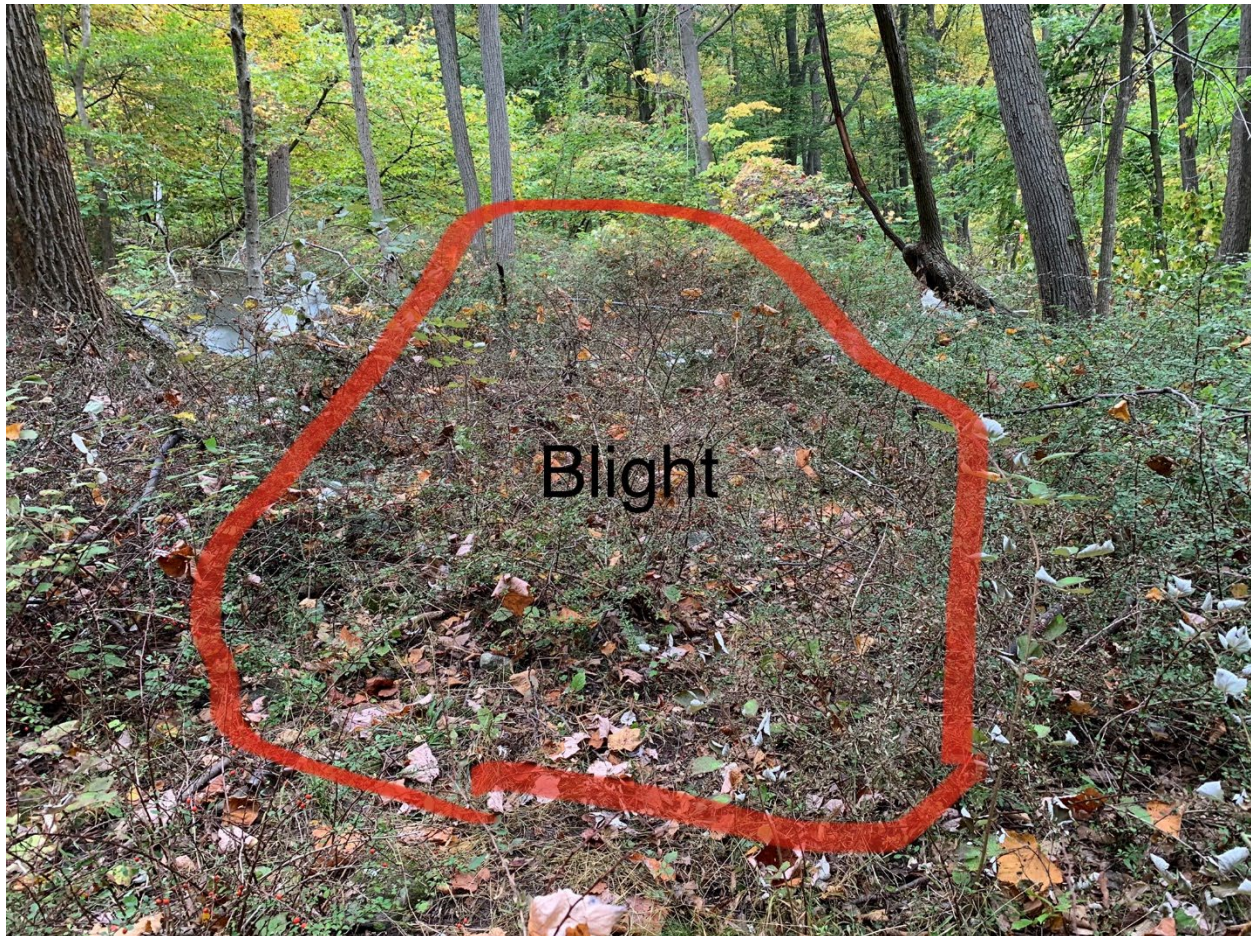
**Figure 3 - Foliage Blight**

An area to the left of the main wreckage exhibited blight of the foliage.

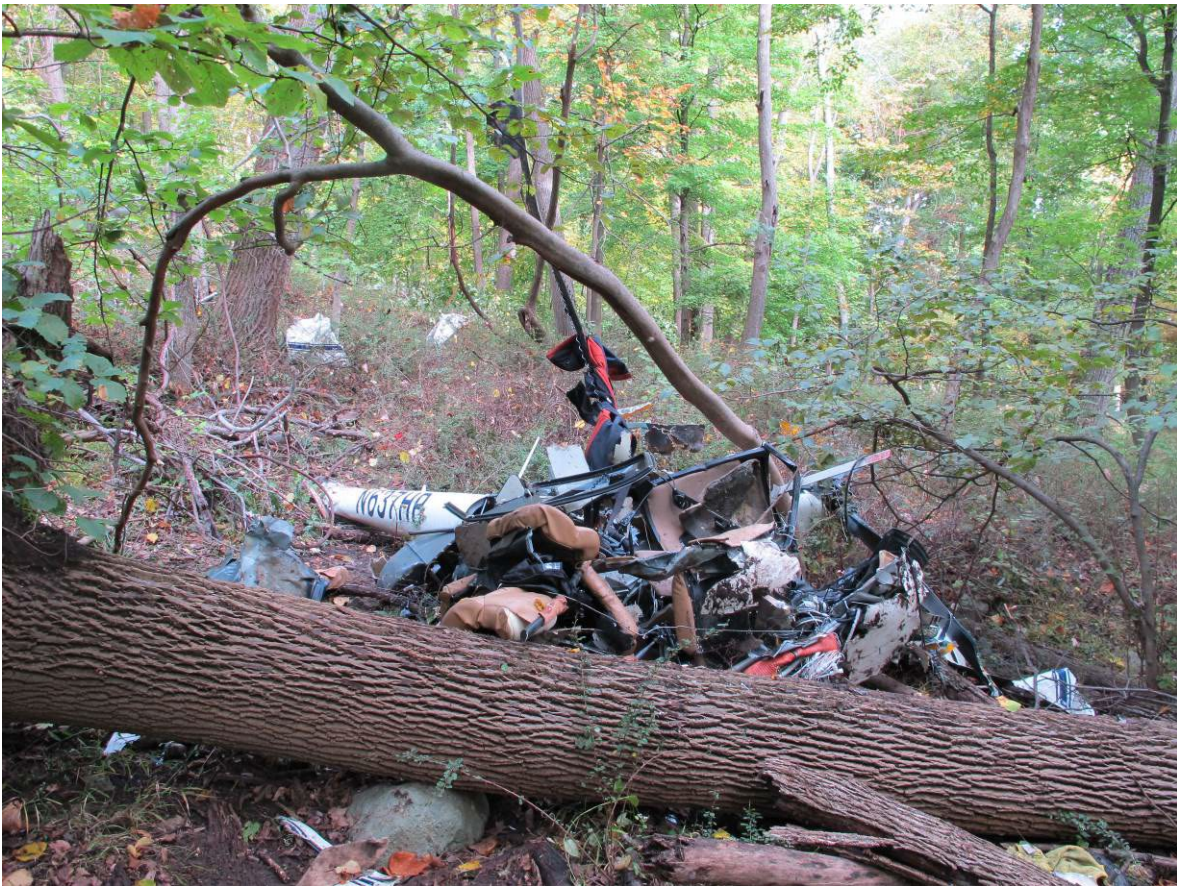
**Figure 4 - Front Right Side of Fuselage**

The airframe sustained severe impact damage. The cabin structure and fuselage cowlings were crushed from the nose to the rear seats. All 4 seats were separated from the structure. The upper and lower frame tubes were bent, deformed, and had several disconnects including a complete separation of the frame tubes around the main rotor gearbox. Remnants of all four doors were found in the debris path or with the main

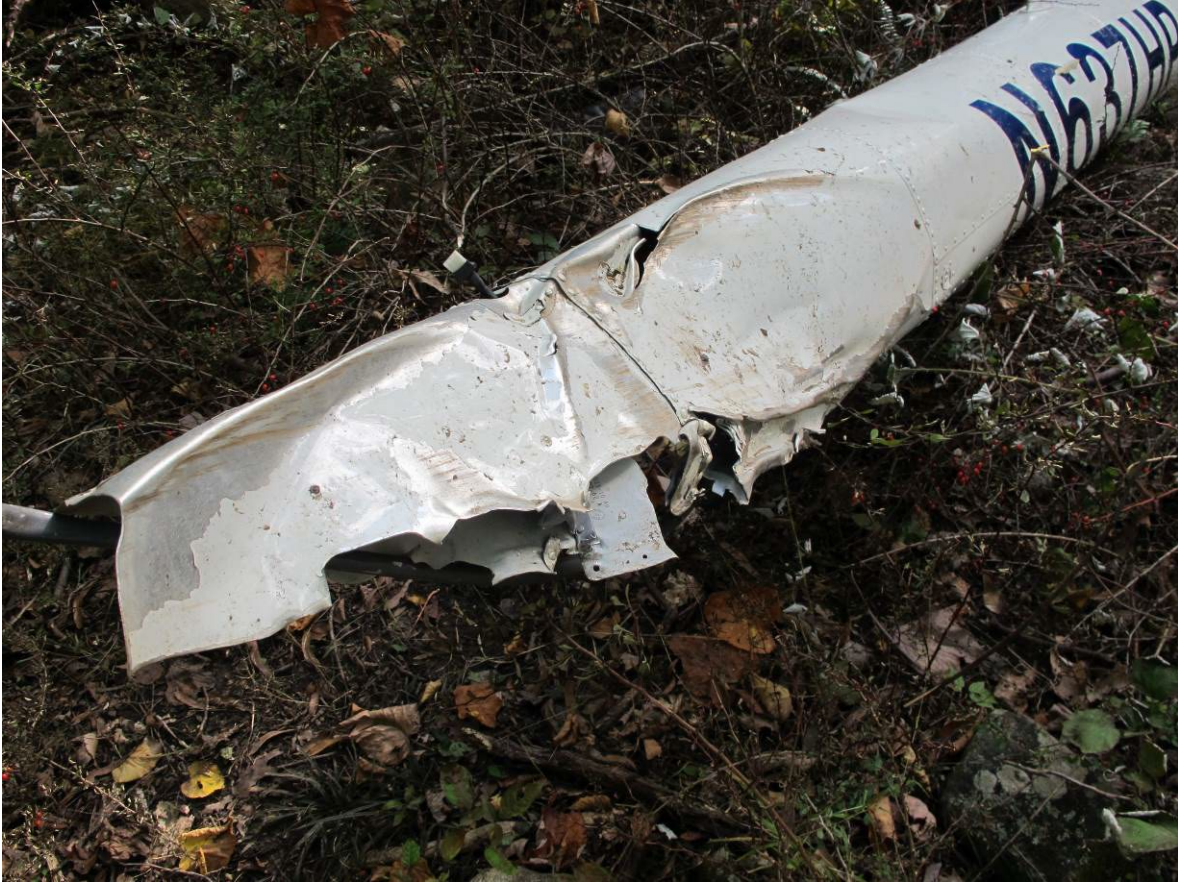
**Figure 6 - Damage to Tailcone Bays 5 and 6**

wreckage. The vertical firewall was crushed upward, and the horizontal firewall was severely deformed with the section around the main rotor gearbox torn away. One of the attachments for the tailcone was pulled away from the upper frame mount, the others remained secure but slightly deformed. Tailcone bays 5 and 6 were crushed on the right side with a large amount of brown transfer marks appearing to be tree residue. The lower portion of tailcone bays 5 and 6 were torn away along with the aft portion of bay 6. Small sections of tailcone bays 5, 6 and 7 were recovered in the debris field. The aft bulkhead remained attached to bay 7 although the empennage mount was disconnected. The empennage sustained impact damage to the leading edge of all three stabilizers.

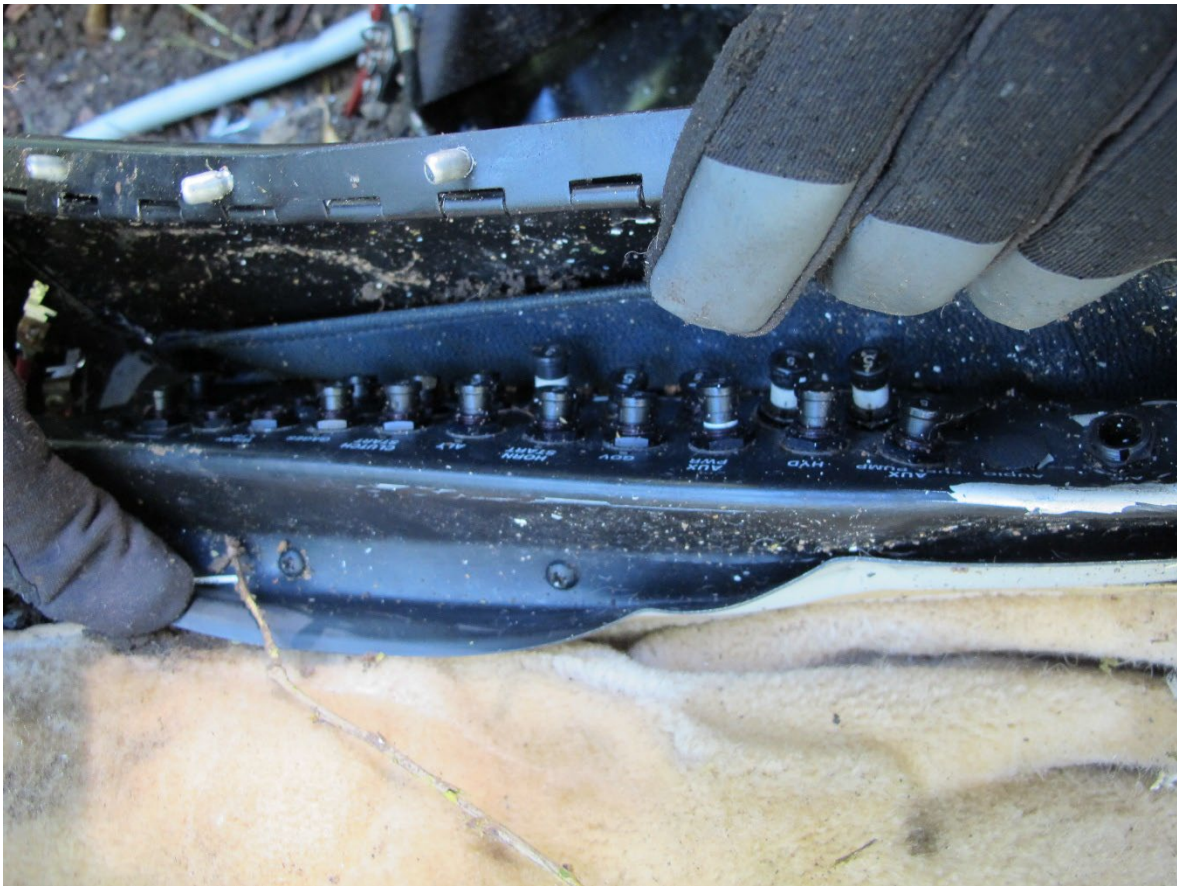
**Figure 10 - Circuit Breaker Panel**

All circuit breakers were found IN/DOWN except:

AUX/PWR and HYD were found partially UP/OUT

D GYRO/HORIZ, EFIS and AVIONICS FAN were found UP/OUT

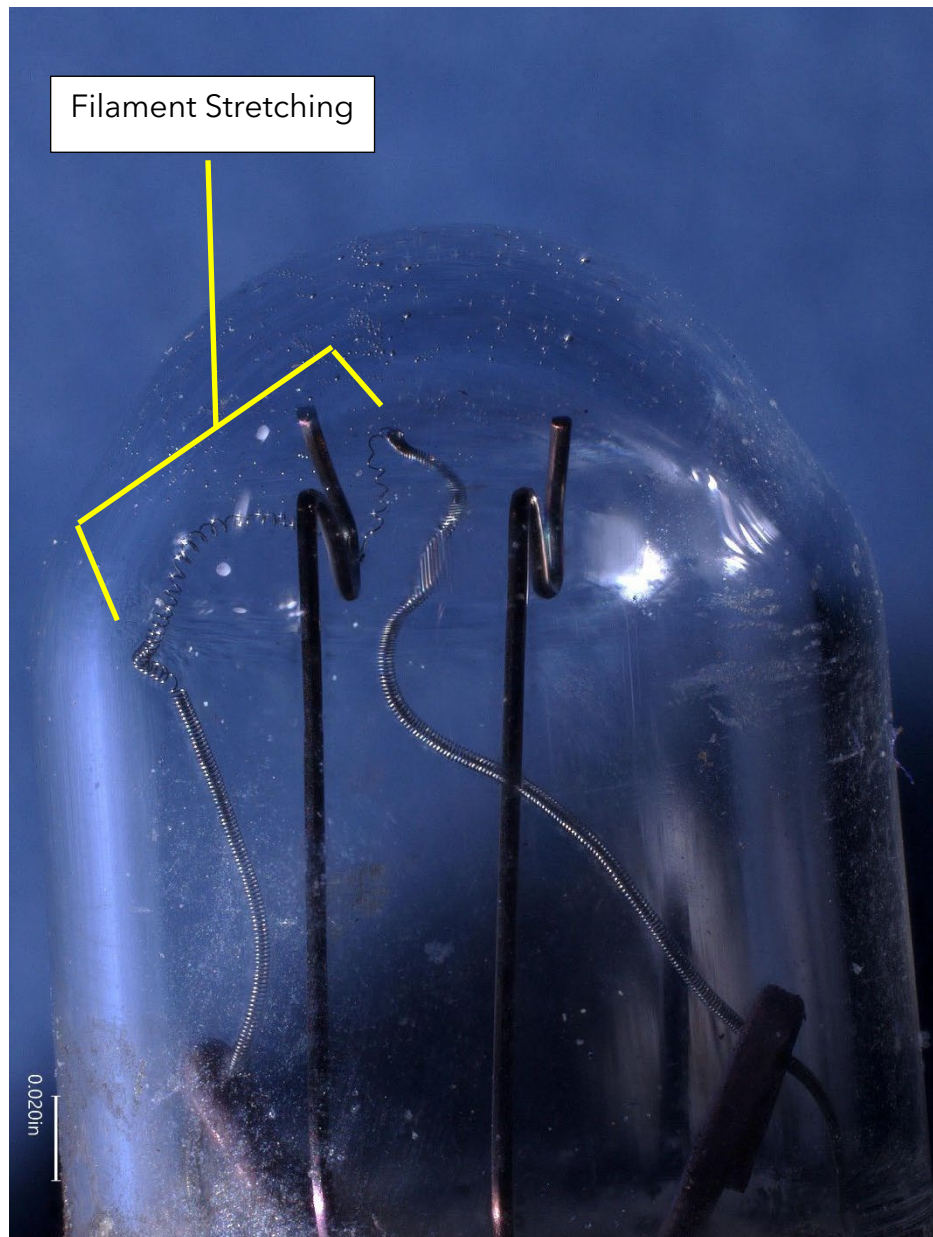
**Figure 11 - Low Rotor RPM Lamp - Filament Stretching - NTSB Laboratory Microscope Photograph**

The low rotor RPM light bulb was sent to the NTSB Materials Laboratory for further examination. The filament was found intact and demonstrated hot filament stretching.

The low rotor RPM lamp illuminates (and a horn sounds) when the main rotor speed is below 97%. The light and horn are disabled when the collective is fully down.

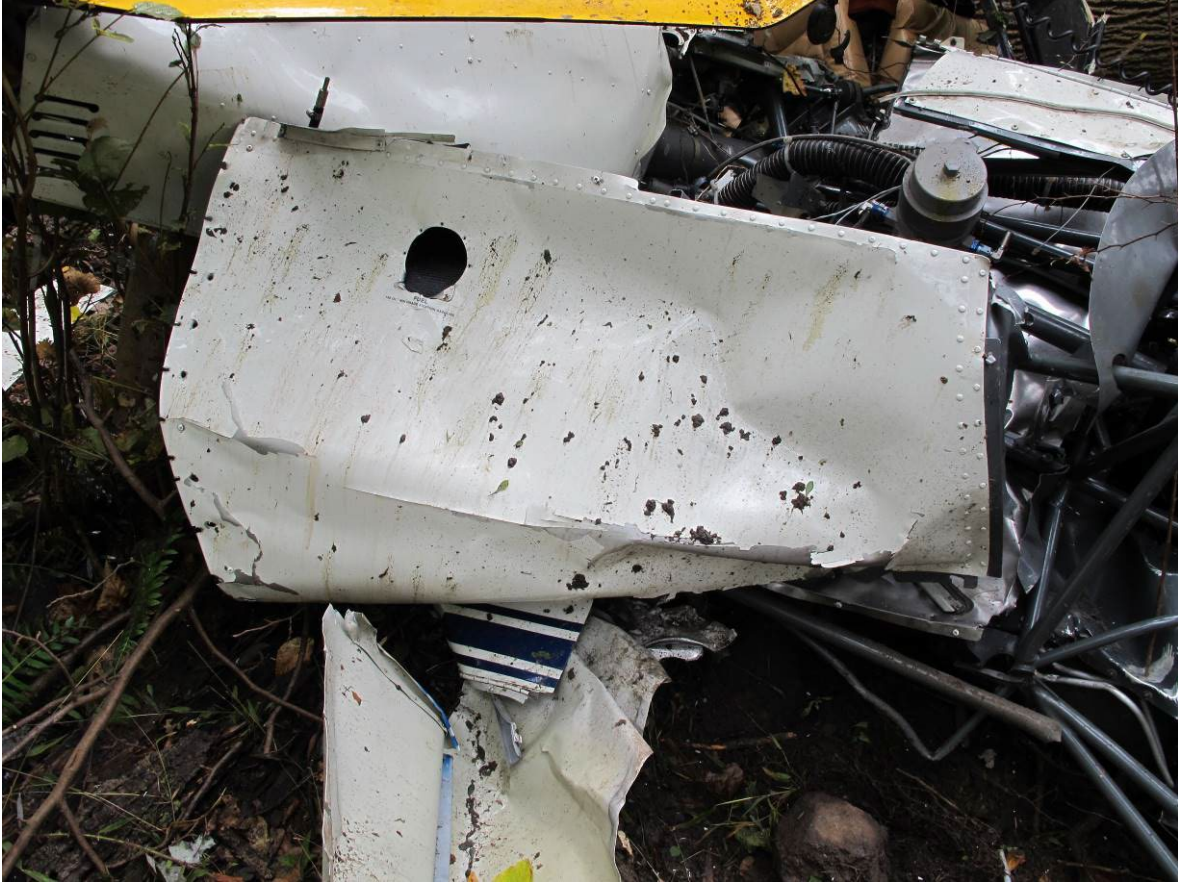
**Figure 12 - Main Fuel Tank Shell**

The main fuel tank remained partially secure to the airframe. The shell was dented and deformed. The bladder was compromised at the forward bulkhead and only a small amount of fuel remained in one corner. The fuel was blue in color and had the aroma of 100LL aviation fuel. The filler neck was pulled off of the shell. The filler cap remained secure on the neck. The finger strainer was clear.

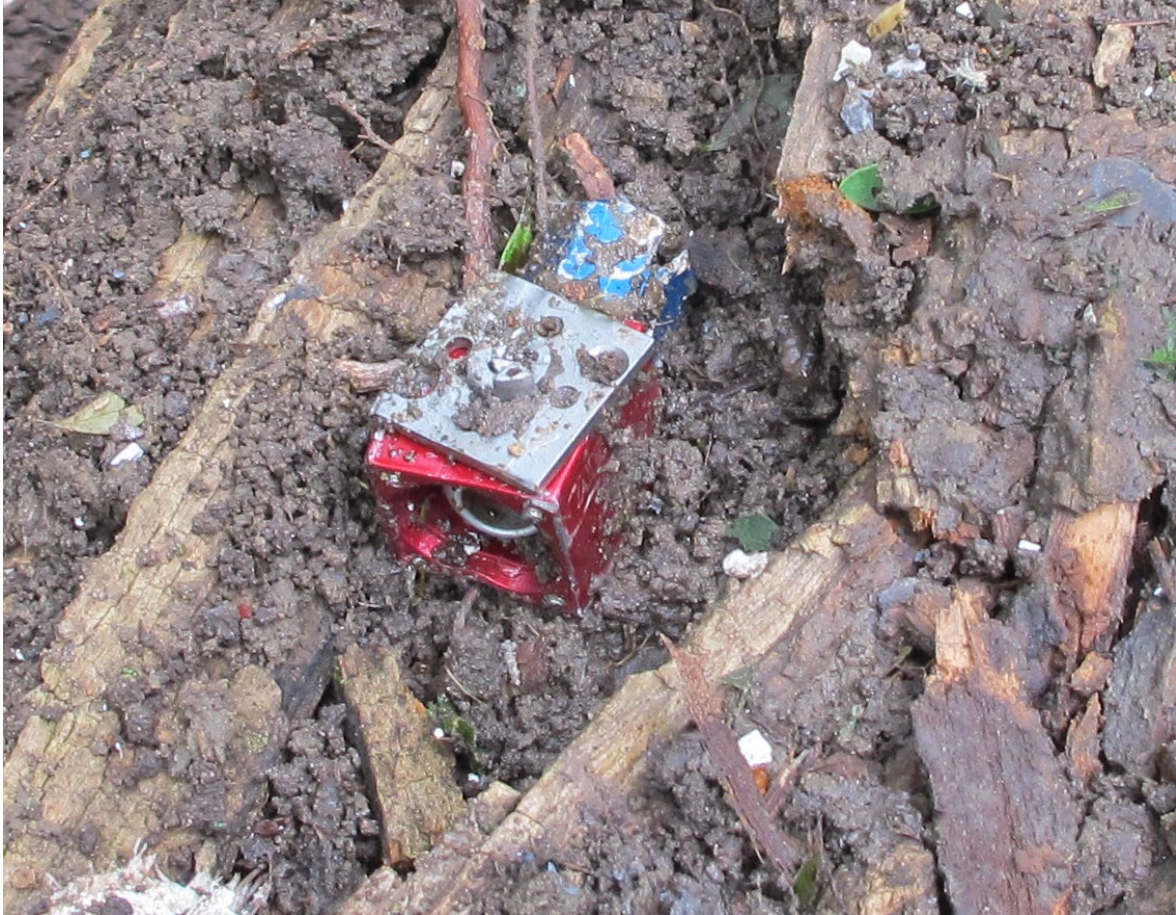
**Figure 16 - Fuel Shut-off Valve**

The fuel shut-off valve was separated from the firewall and the fuel lines. It was in the open position.

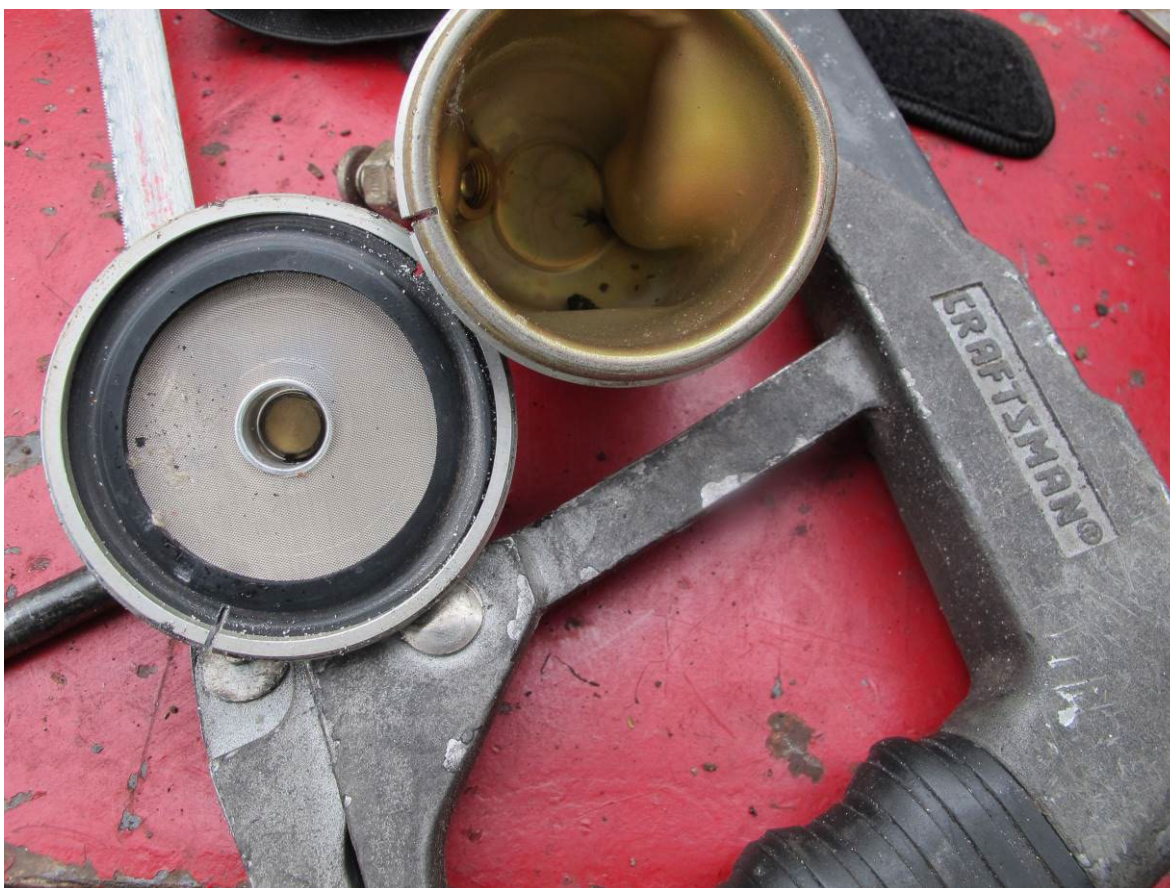
**Figure 18 - Gascolator - Top (and Screen) Removed**

The gascolator was separated from the auxiliary fuel pump and both were separated from the firewall. The gascolator bowl was dented and cracked. The bowl retaining ring had to be cut for removal. The gascolator screen and bowl had a small amount of debris inside, the screen was unobstructed, no fuel was present.

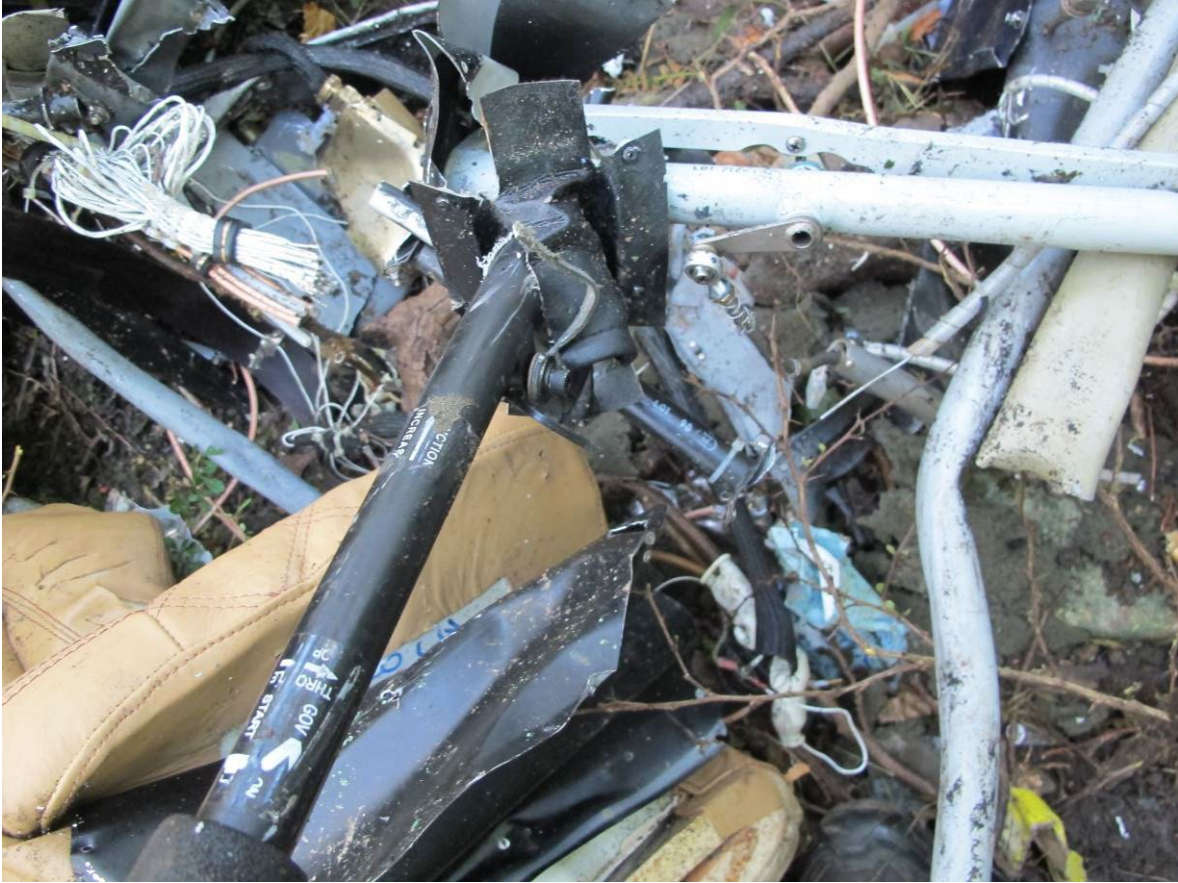
**Figure 22 - Collective Control**

The pilot's cyclic grip was separated from the cyclic crossbar. The collective control was separated from the structure along with the collective friction slider which appeared to be in a collective full up position. The friction knob was positioned beyond its normal travel. The pilot's (right-side) tail rotor pedals were positioned with the left pedal forward. The copilot's (left-side) removeable controls were not installed and were recovered within the debris field.

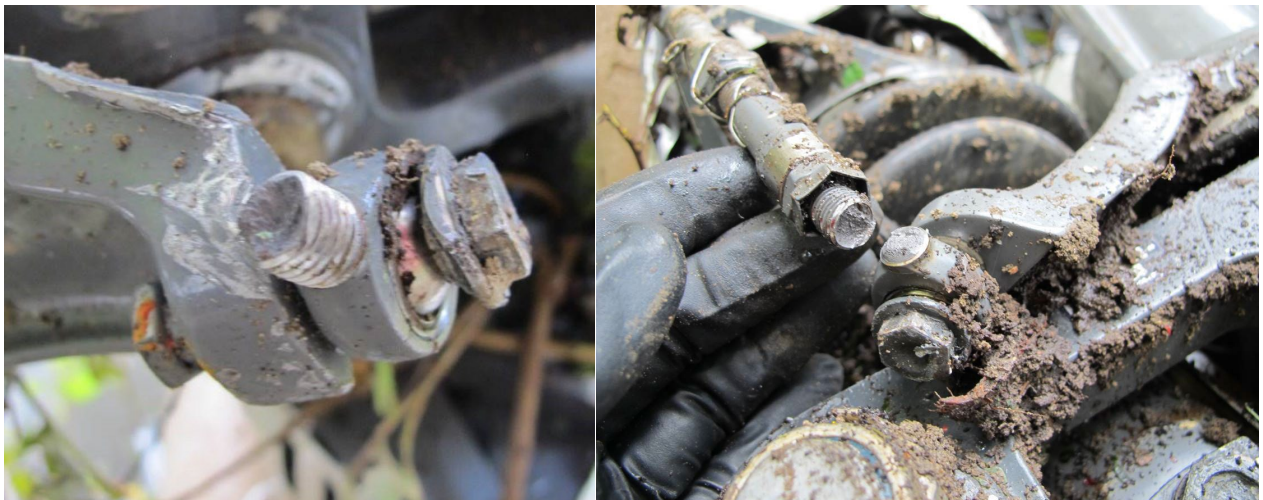
**Figure 24 - Fractures at Upper ends of the Two Main Rotor Pitch Change Links**

Flight control continuity could not be confirmed due to impact damage, and some system portions were not located. All control linkage ends remained attached. Nearly all control tubes were fractured in one or more locations consistent with overload. All three hydraulic servos moved smoothly in both directions when the input control tubes were moved by hand. The tail rotor pitch change slider was free to slide along the tail rotor gearbox output shaft. Both main rotor pitch change links were fracture separated at their upper rod ends. One link was also fracture separated at its lower end, and the link was found in a puncture hole in the cabin ceiling.

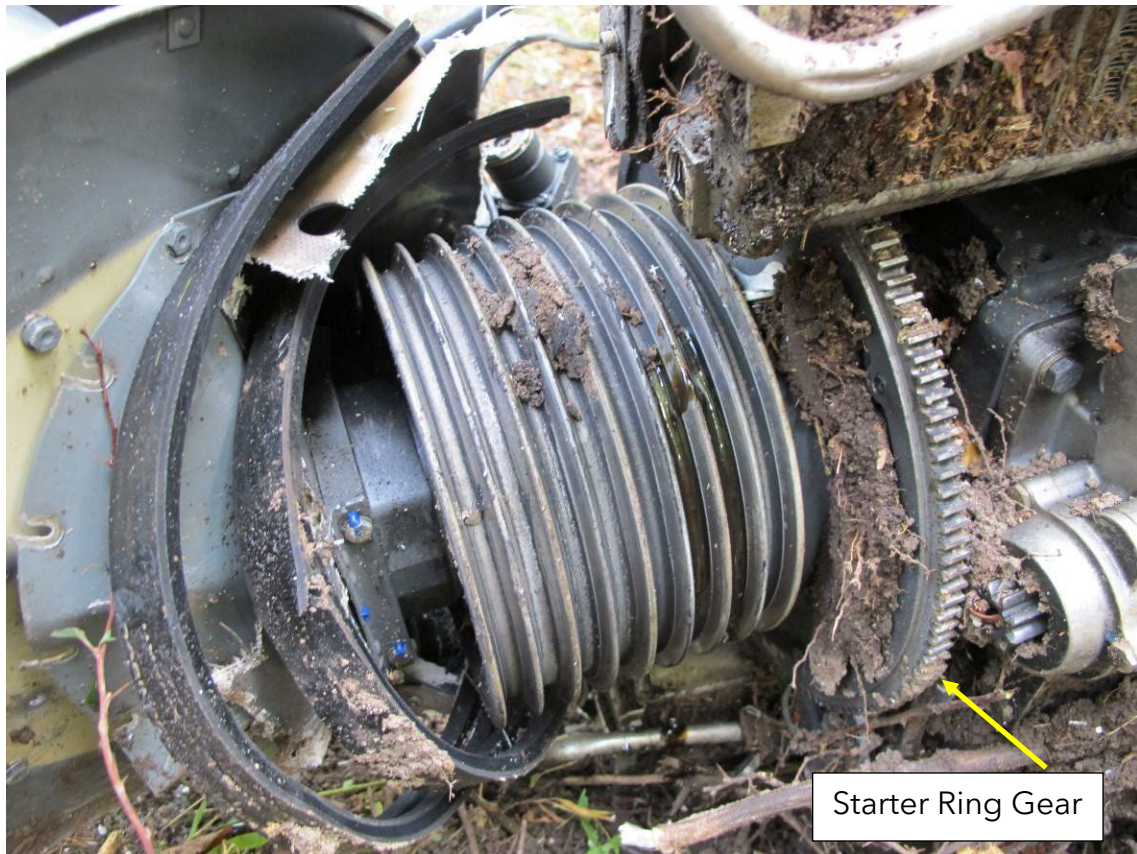
**Figure 29 - Lower Sheave**

The grooves in the lower sheave (mounted to the engine crankshaft) had excessive wear with sharp edges. The wear in the grooves of the upper sheave (which drives the rotor system) was unremarkable although it did sustain impact damage. All four V-belts were out of their grooves and laying across the upper sheave. Each belt had a raised crease down the center of the backing indicating the belts were riding much deeper in the grooves of the lower sheave due to the worn grooves. The friction surface of the belts appeared normal. Two of the belts sustained impact damage to their backing.

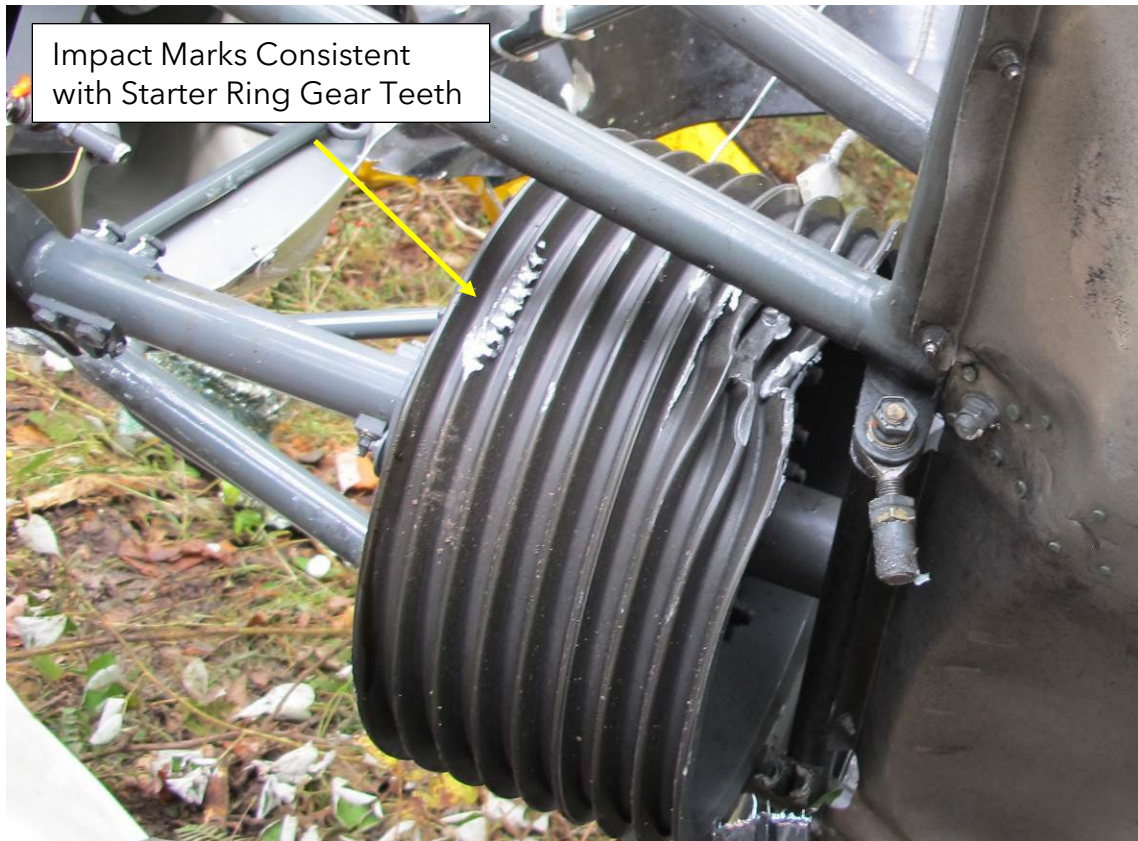
**Figure 30 - Upper Sheave**

The aft face of the upper sheave had a scuff mark adjacent to the clutch centering strut. The strut had no marks on it but the frame tube that the strut was attached to was deformed. The frame tube adjacent to the forward face of the upper sheave was dented with no score marks and no scoring on the sheave face. The aft grooves of the upper sheave had imprint marks matching the size and shape of the starter ring gear teeth and the forward grooves had a large dent matching the size and shape of the top edge of the engine.

The upper sheave (which contains overriding or "Sprague" clutch) rotated smoothly on the shaft when rotated by hand in a clockwise direction (looking forward) and locked on the shaft when rotated in a counterclockwise direction.

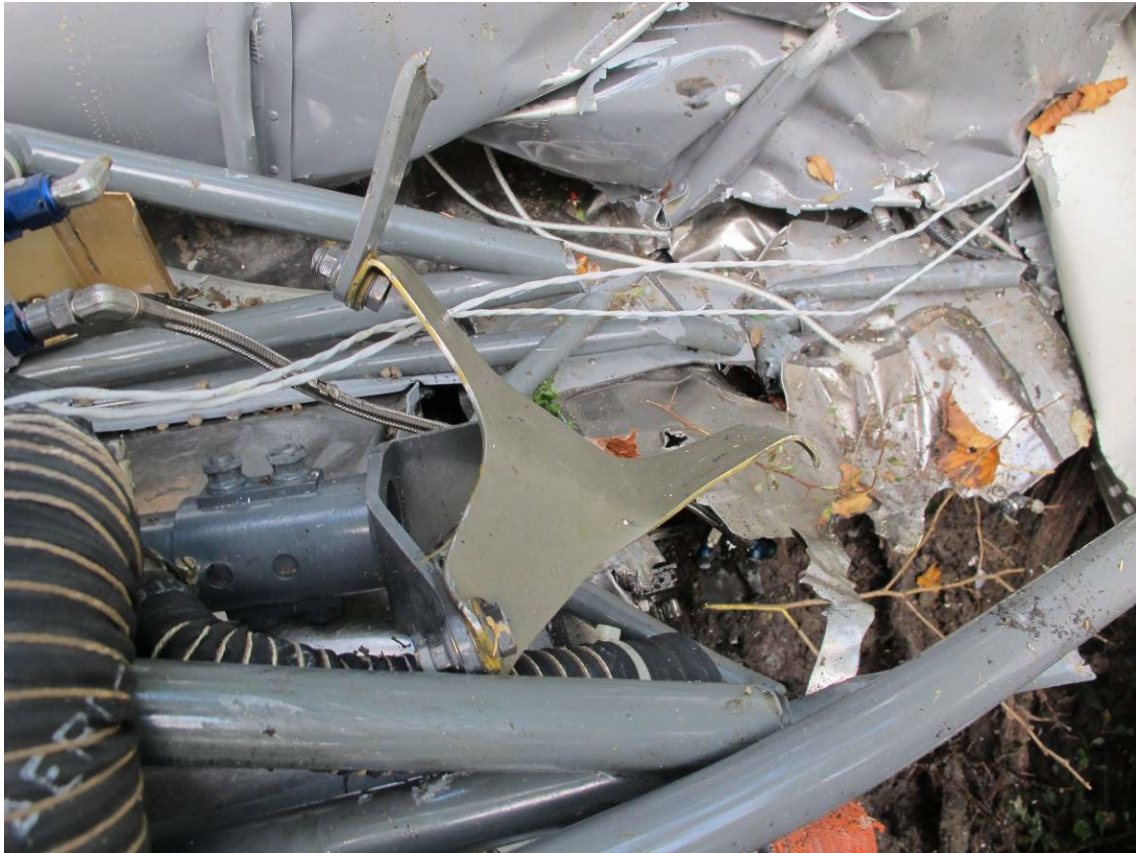
**Figure 31 - Forward Flex Coupling**

The forward flex coupling was bent, and one arm of the main rotor gearbox input yoke was fractured and remained attached to the flex plate. The other ear of the flex plate was fractured from the input yoke. The surface of the fractures were angular and jagged.

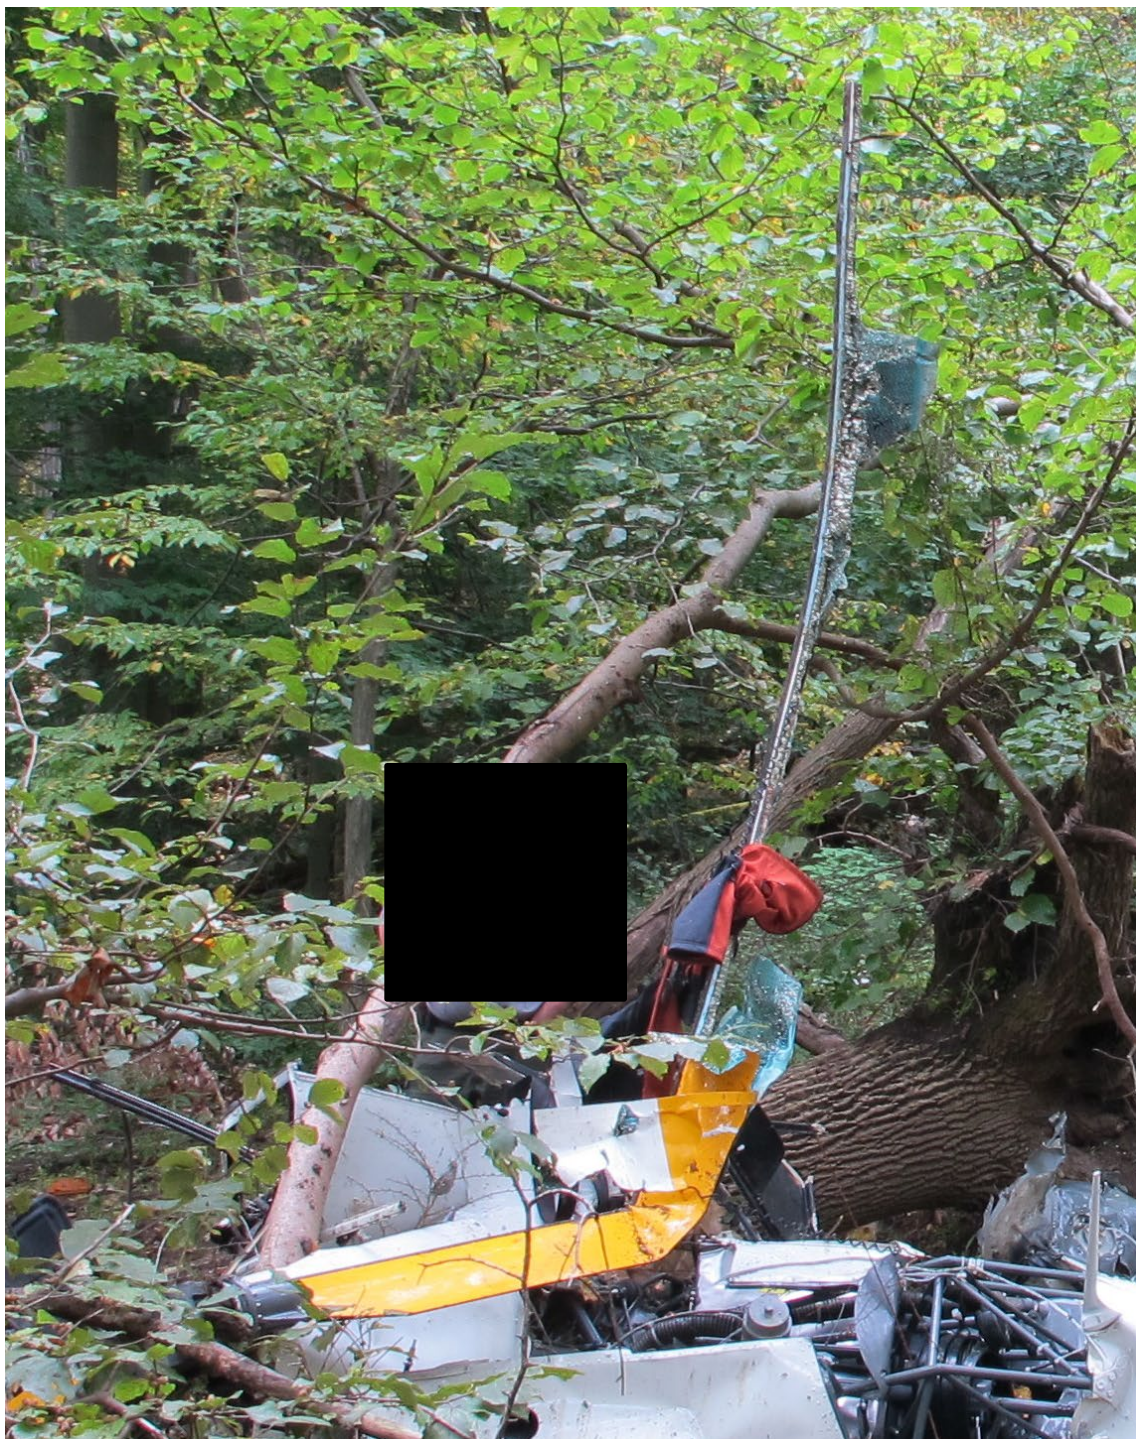
**Figure 34 - Main Rotor Blade S/N 10110**

Main rotor blade serial number 10110 remained attached to the hub and the inboard six feet of afterbody (skin and honeycomb) remained attached to the spar. The remaining afterbody was separated from the spar, portions through tearing of the skin, portions through the joints. The surface of the separated joints of skin and spar had layers of adhesive that remained adhered, the surface of the tearing was angular and jagged. The spar was bent upward about 80°, four feet outboard of the hub, and a slight bow upward at mid-span. The outboard three feet of blade was completely separated and recovered 273 ft from the main wreckage. The surface of the fracture at the spar was angular and jagged. One foot of the afterbody outboard of the fracture was crushed from the trailing edge up to the spar with brown transfer marks consistent with tree residue on the upper surface. This section was bowed back (opposite the direction of rotation) slightly. All of blade 10110 was accounted for except for about 3 inches of spar, from an area about 3 ft inboard of the tip.

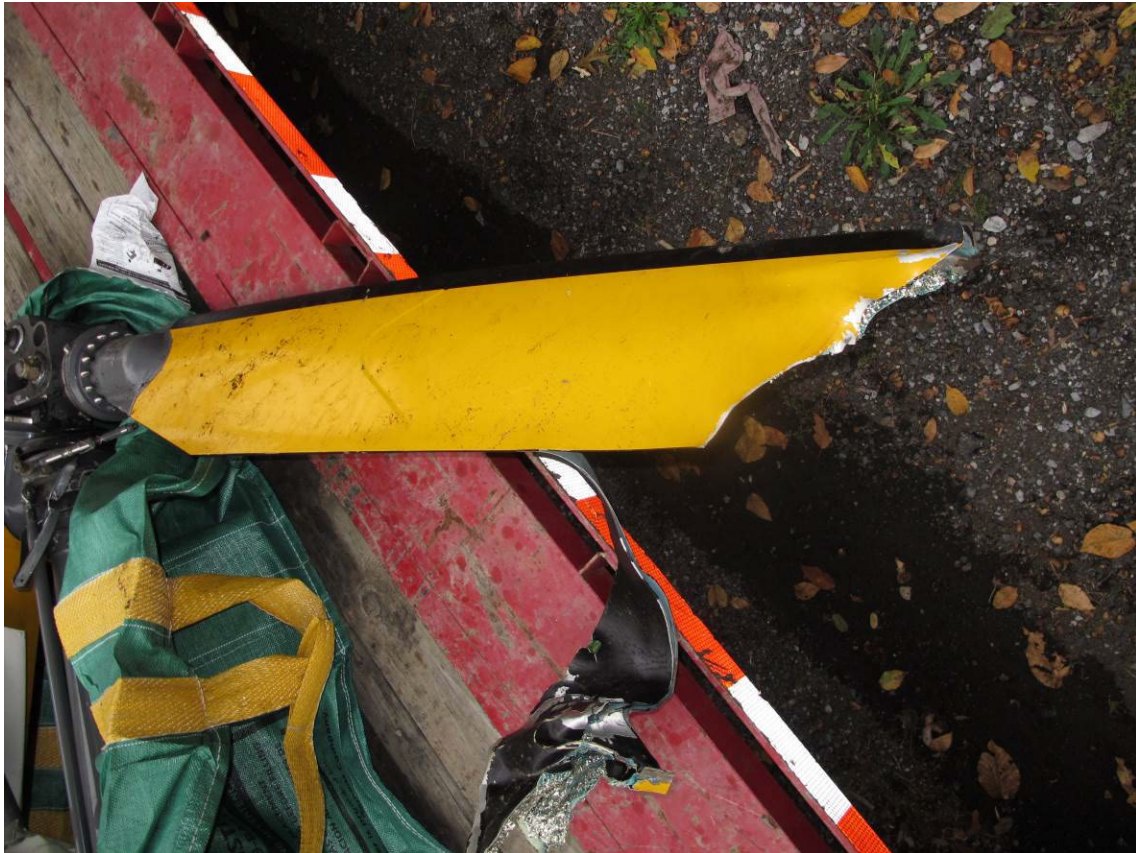
**Figure 38 - Inboard Section of Main Rotor Blade S/N 10122**

The inboard four feet of main rotor blade serial number 10122 remained attached to the hub. The outboard section was fractured in several places. The surface of the fractures in the spar and skin sections were angular and jagged. The surface of the fractures of the skin to spar joints had layers of adhesive that remained adhered. About 2 ft of blade length from an area inboard of the tip, and the outer most 6 inches of the tip, were not recovered.

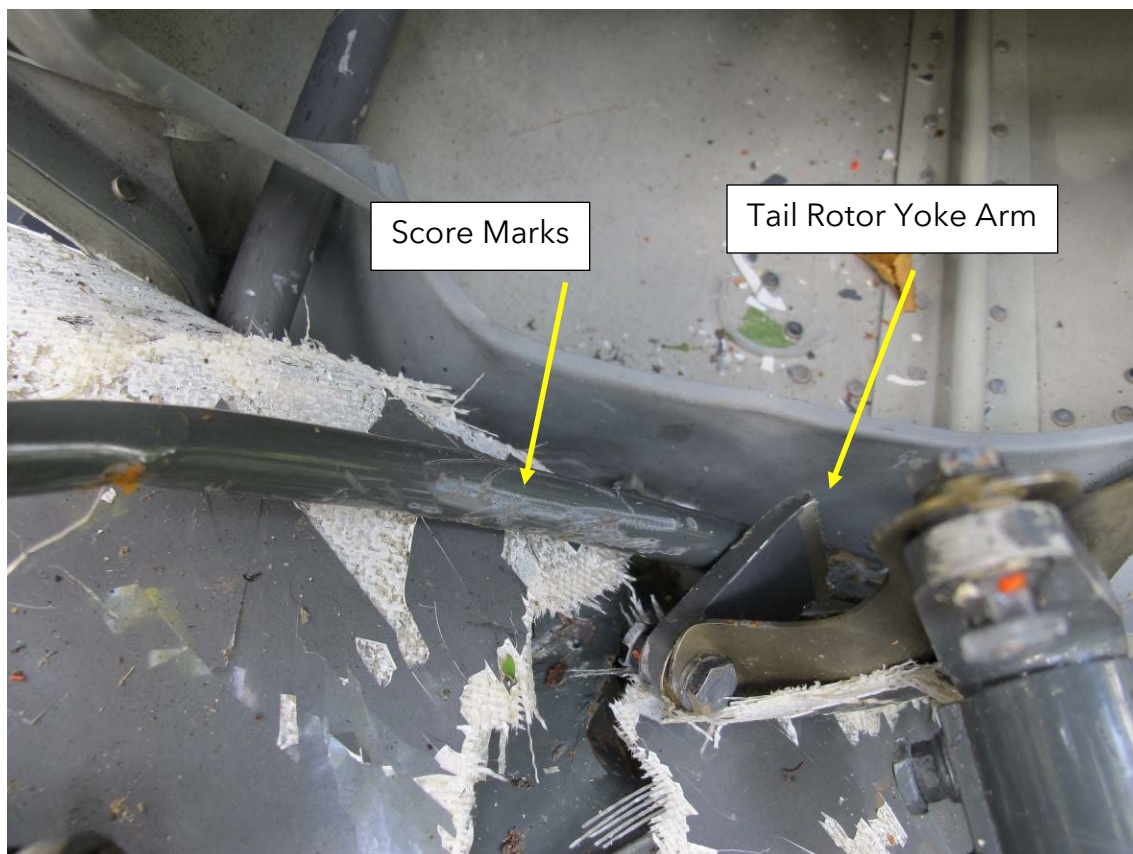
**Figure 40 - Score Marks on Frame Tube Adjacent to the Intermediate Flex Coupling and Fractured Arm of Forward Tail Rotor Yoke**

The intermediate flex coupling was bent slightly, and one arm of the tail rotor forward yoke was fractured and remained attached to the flex plate. The other ear of the flex plate was fractured from the forward yoke. The surface of both fractures were angular and jagged. The frame tube adjacent to the intermediate flex coupling had score marks running in the direction of rotation of the coupling.

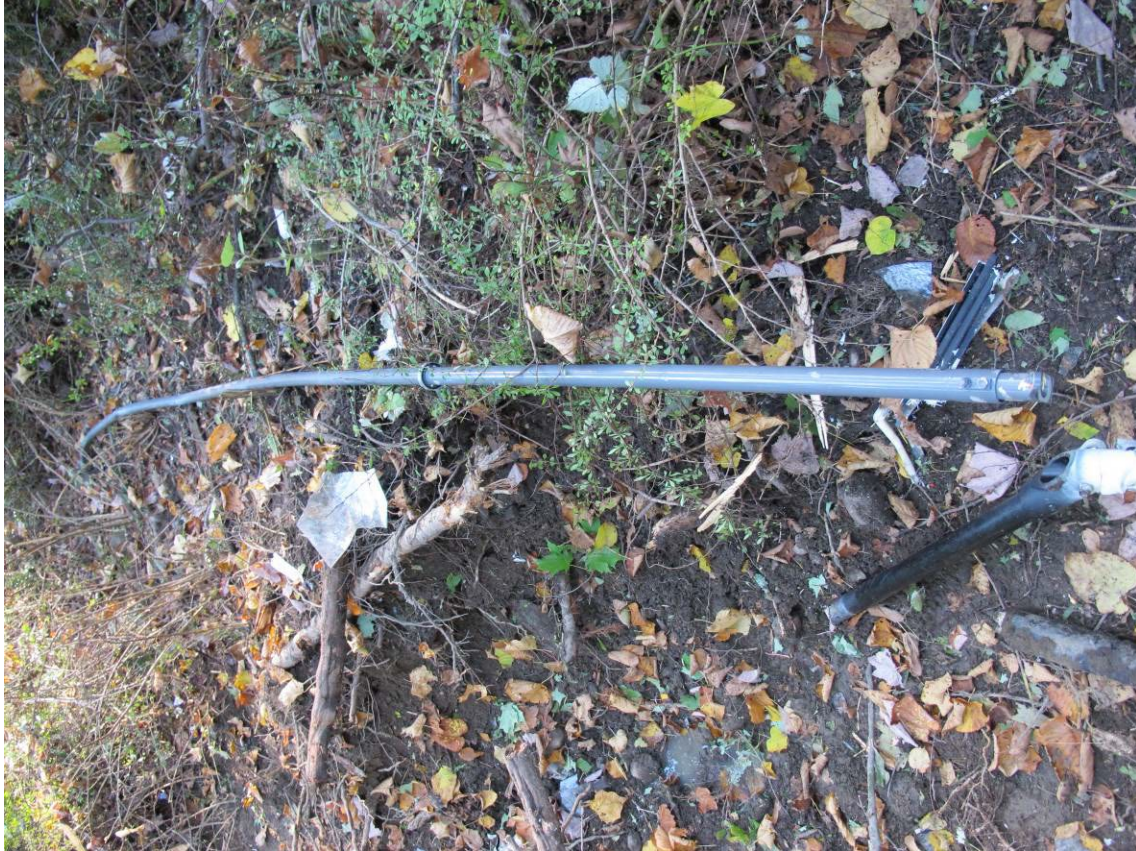
**Figure 41 - Tail Rotor Drive Shaft**

The tail rotor driveshaft was separated from the tailcone leaving the damper bearing housing and hanger inside the tailcone. The hanger was separated from the support bracket and the friction arm was bent. The tail rotor driveshaft was bent slightly in several places. There were scuff marks and scratches along the length of the shaft running mostly lengthwise.

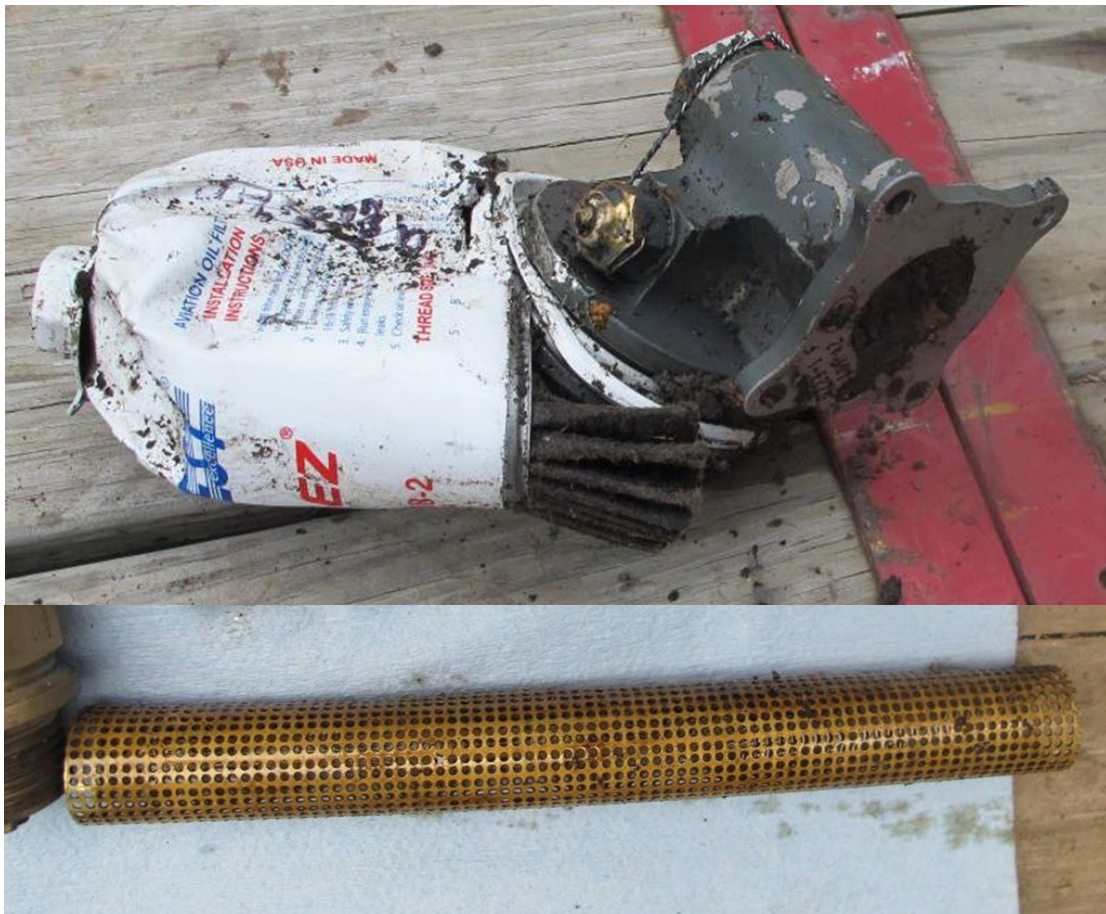
**Figure 49 - Engine Spin-On Oil Filter (top) and Internal Oil Sump Screen (bottom)**

The engine's spin-on oil filter and its adapter were separated from the engine. The filter housing was impact damaged, the top was torn open, and the filter element was partially dislodged with portions covered in dirt. The dirt was the same color and consistency of the soil at the accident site. The damage and subsequent exposure of the filter element (primarily to soil) precluded a definitive examination of the element for pre-impact debris. No metallic material was found in the element. The engine's internal oil sump screen contained a trace amount of debris but was unobstructed.
