# National Transportation Safety Board

ERA22FA010

## WRECKAGE EXAMINATION

Location: Cornwall, New York  
Date: October 10, 2021  
Time: 1357 eastern daylight time  
1757 UTC  
Helicopter: N637HP, Robinson R44 II

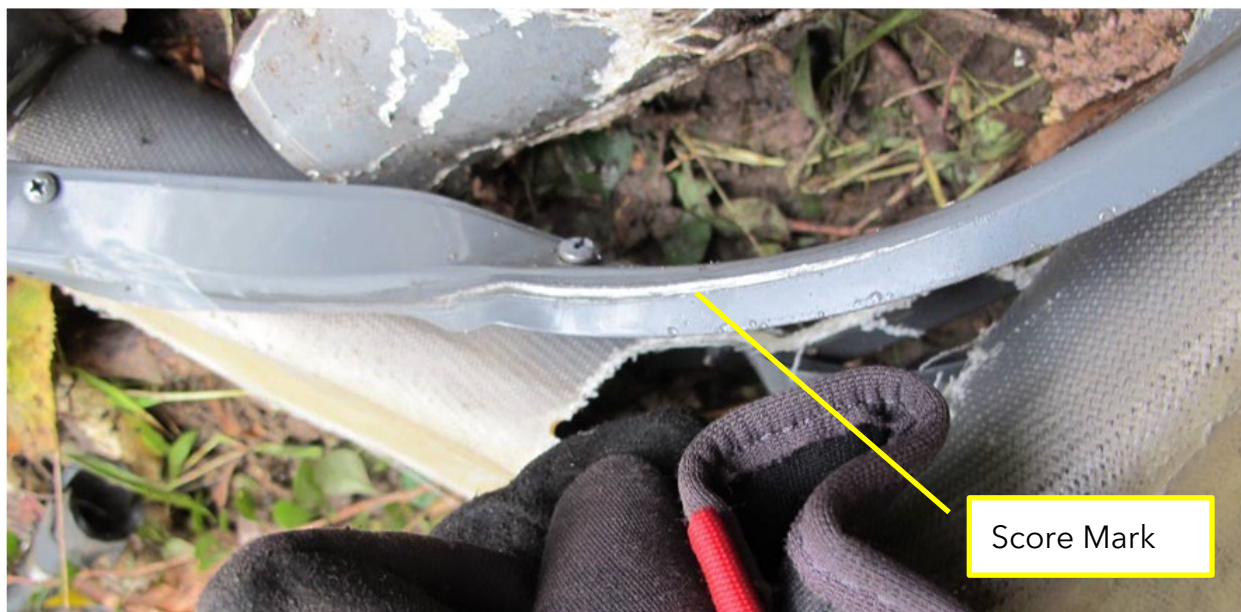
**Figure 52 Fan Lip**

The fiberglass scroll that surrounds the cooling fan as severely impact damaged. No scoring marks were found on the inside of the scroll on the outer edges of the cooling fan. A 3 inch score mark was found on the inside of the metal fan lip, which lines the inside of the hole at the rear of the scroll.

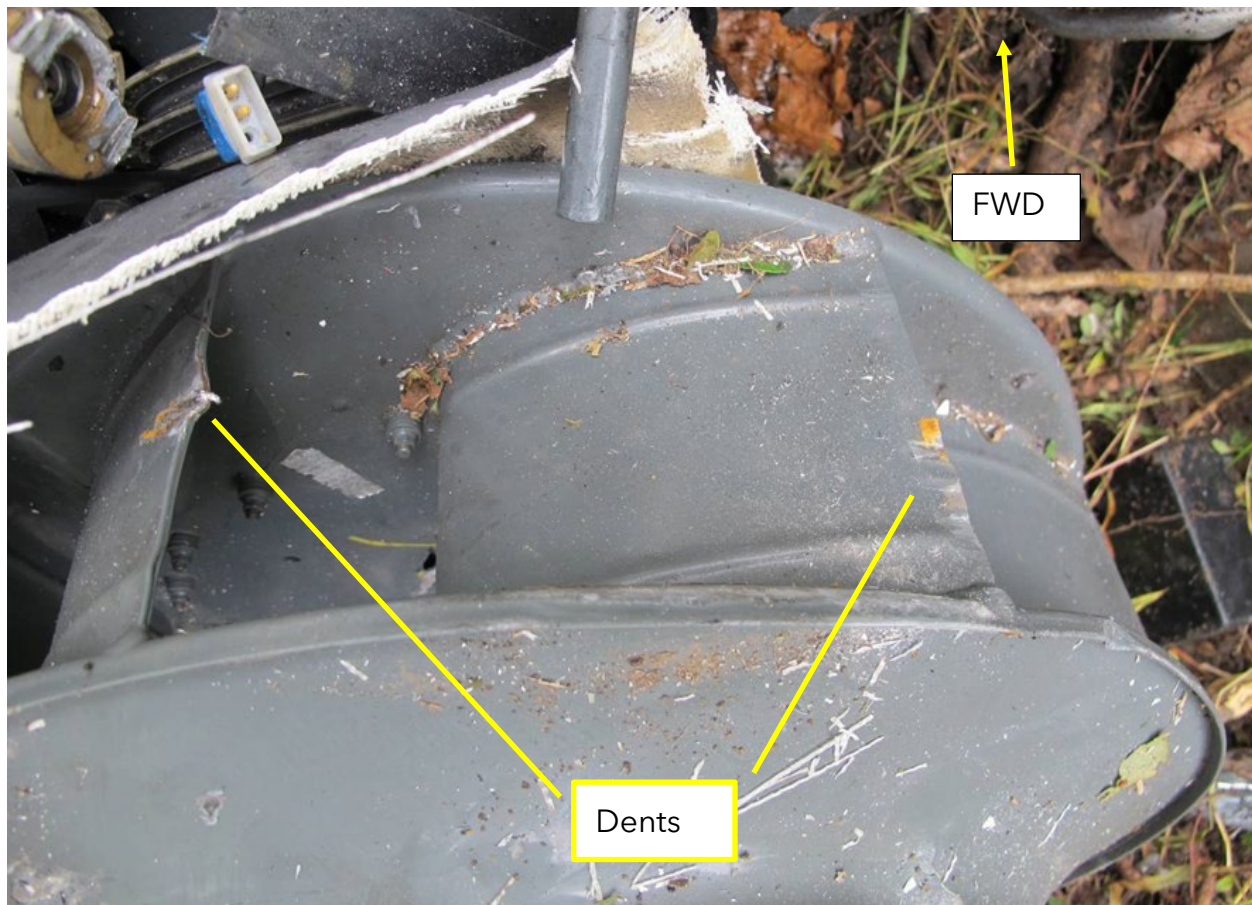
**Figure 53 - Cooling Fan Blade Damage**

The cooling fan was partially separated from the fan hub and bent aft at the 6 o'clock position. The outboard surface of the fan blade at the 12 o'clock position was dented on its trailing edge, just aft of center, in line with the location of the tail rotor intermediate coupling. The next blade in the clockwise direction also had a dent on its trailing edge, in line with the tail rotor control tube attachment hardware, located on the inboard arm of the bell crank.

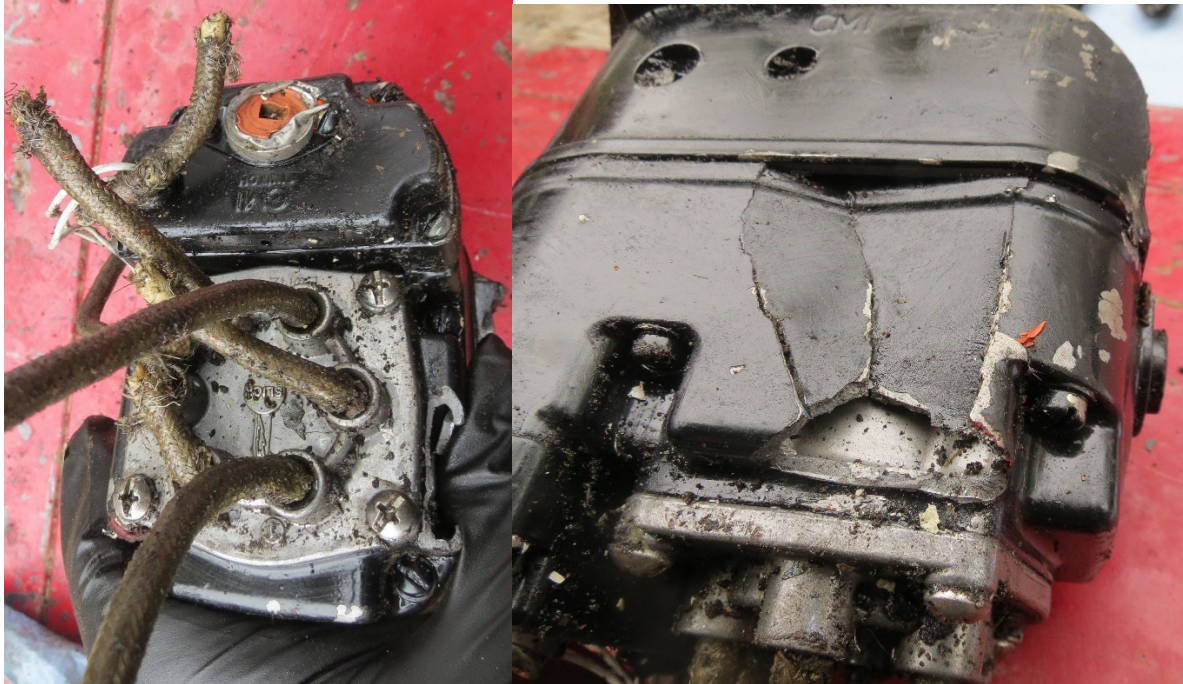
**Figure 54 - Right Magneto**

Both magnetos were separated from the engine, and damaged. All of the ignition leads were broken in multiple locations. Remnants of each of the lead ends remained in the magneto harness assemblies. The right magneto case and its capacitor were impact damaged. It could not be rotated by hand as found. A portion of the case was dented inward and impinged on the distributor gear. After prying the case pieces away from the gear, the magneto rotated freely. However, when rotated with an electric drill, it did not produce spark at any of the ignition leads.

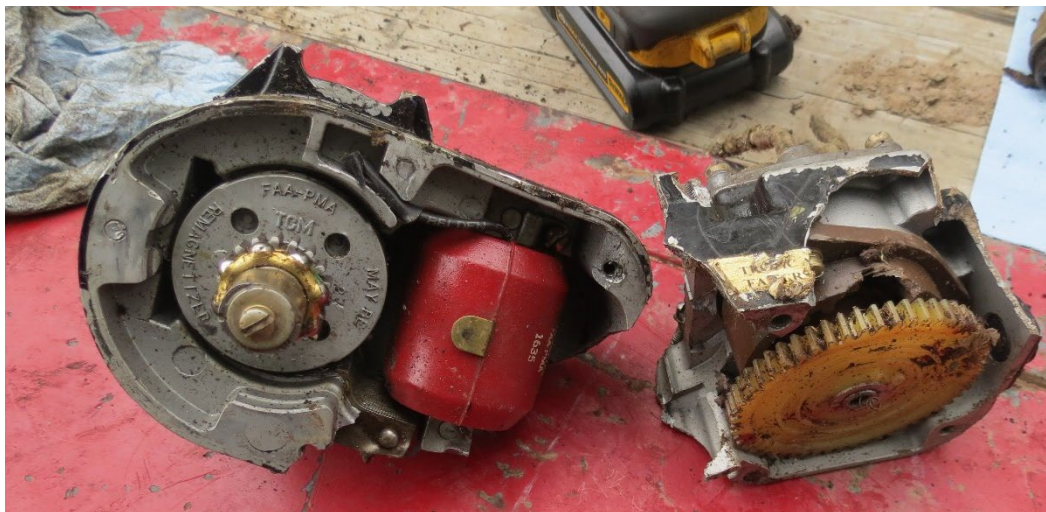
**Figure 55 - Left Magneto**

The left magneto was fractured and separated into two pieces and could not be field tested.

The left magneto's magnet had magnetism, its distributor gear and electrode were intact. The coil wire was separated. The half of the case containing the ignition points was not recovered. The magneto could not be tested on the bench.

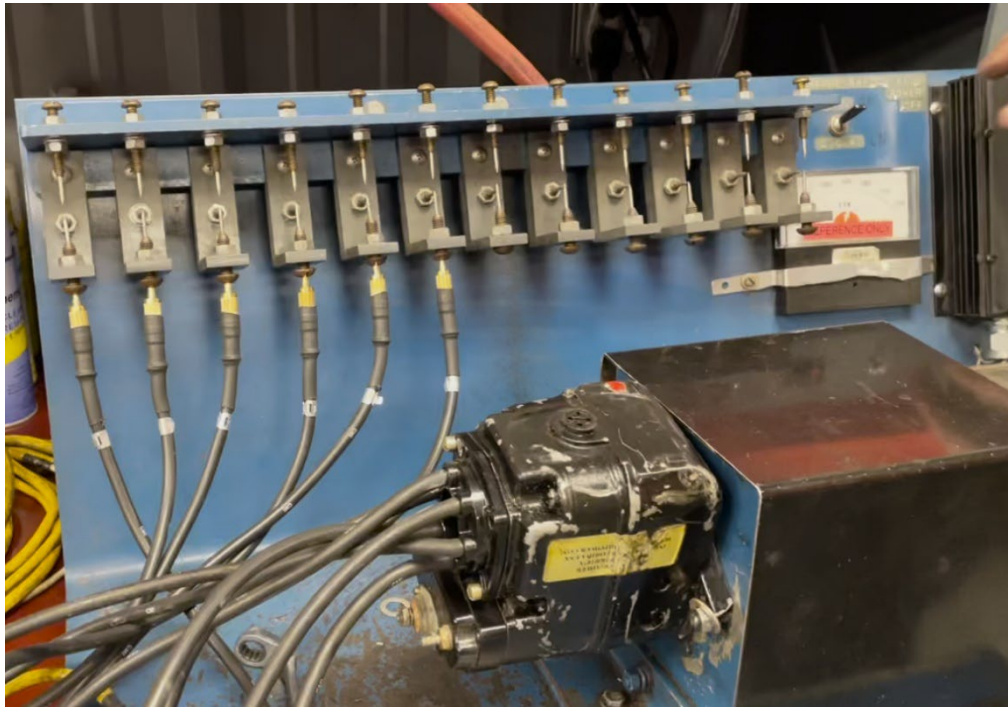
**Figure 56 - Right Magneto on Test Bench**

Both magnetos were sent to the manufacturer for further examination under the oversight of an NTSB investigator. The right magneto was installed in its as received condition on a test bench. It did not produce spark. The damaged capacitor was replaced, and the magneto was retested on the test bench. It operated normally.

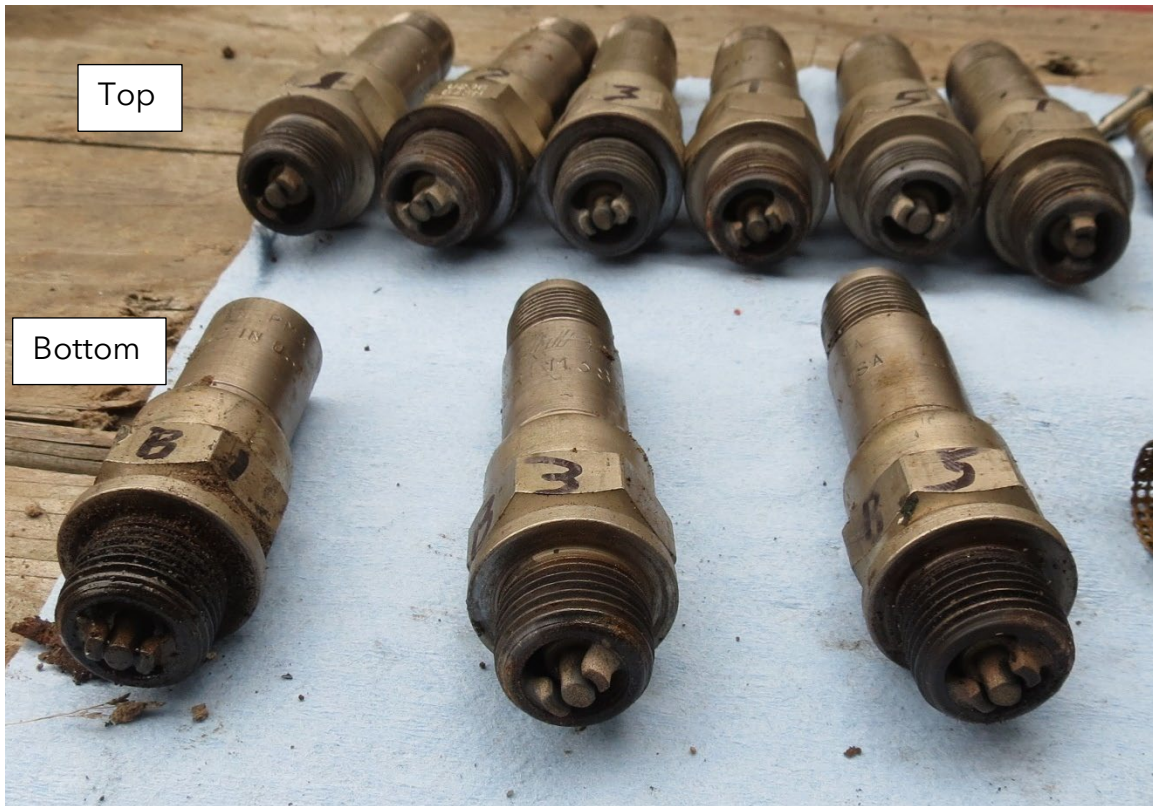
**Figure 57 - Spark Plugs**

The electrodes of all 12 spark plugs were undamaged and "worn normal" when compared to the Champion Check-A-Plug chart. The No. 1 bottom spark plug was oil soaked. All other spark plug electrodes were light brown in color, consistent with normal combustion. The Nos. 2, 4 and 6 spark plugs could not be removed from the engine, their condition and color were observed via borescope.

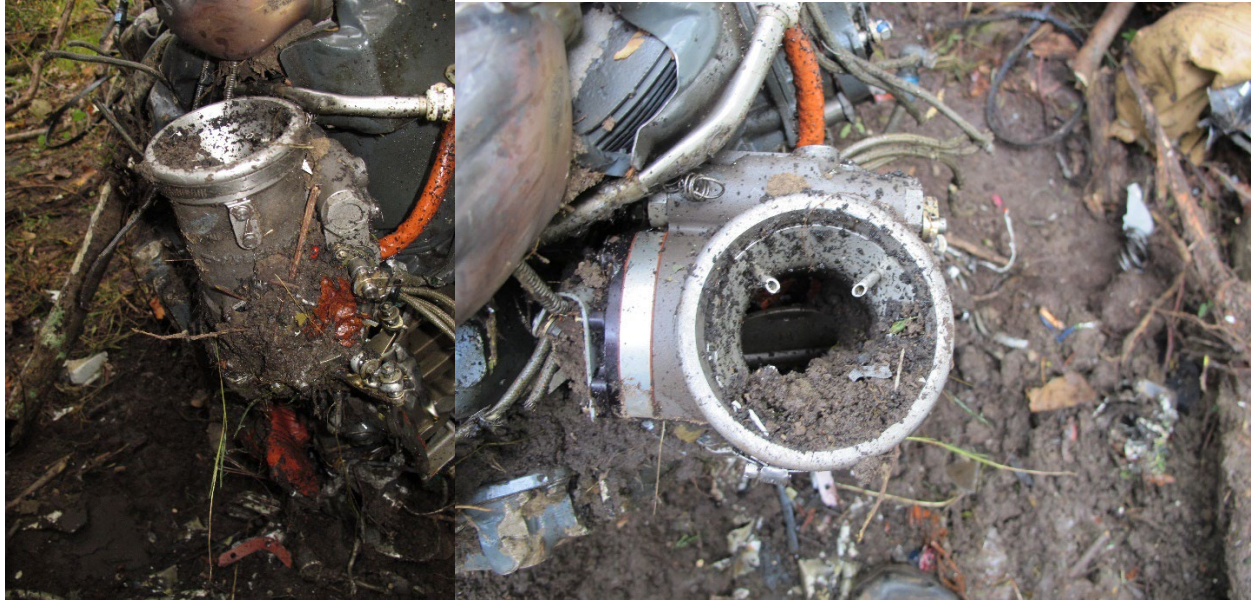
**Figure 58 - Fuel Servo as Found**

The fuel injector servo was impact separated from the engine and partially fragmented. The throttle control rod end was fractured. A portion of the rod end remained attached to the servo throttle control arm. The mixture control cable wire was not attached to the servo mixture control arm. The bolt and attachment hardware which is to secure the cable wire to the servo mixture control arm was not present. The control wire sheath remained attached to its mounting bracket, the bracket was bent outward from the servo body. Lengths of the sheathing were stretched in several locations. The mixture arm was bent inward toward the servo housing and was positioned at the full lean (idle cutoff) position. The servo fuel inlet screen was removed and was absent of debris. Liquid with color and odor consistent with 100LL aviation gasoline drained from the servo when the screen was removed. The servo regulator section was partially disassembled and no damage to the internal rubber diaphragms or other components noted. The regulator cover brass plug was secure.

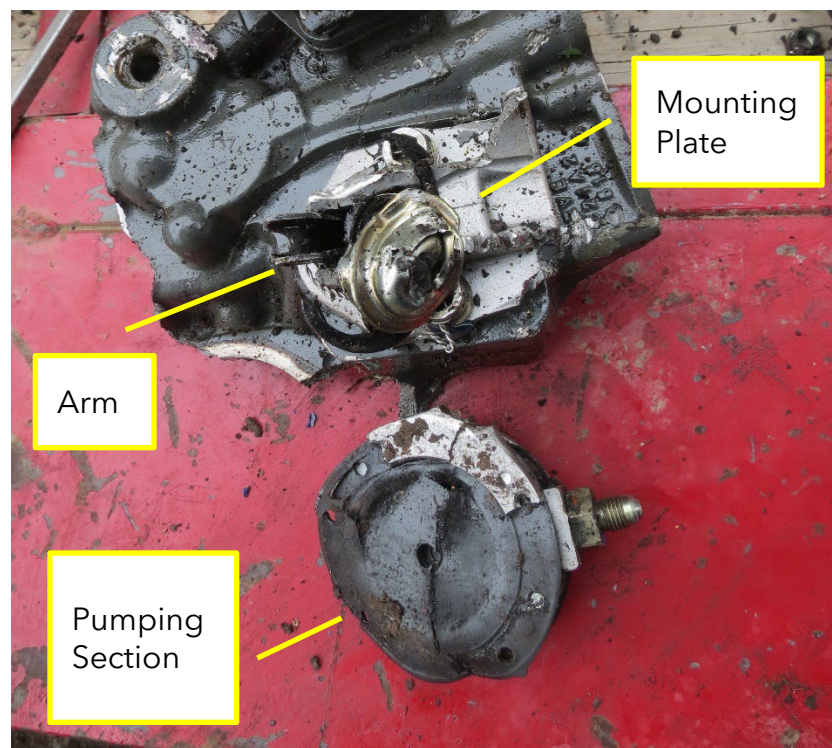
**Figure 65 - Engine Driven Fuel Pump**

The engine driven fuel pump was fractured, and the pumping section separated from the mounting plate. The rubber diaphragms were impact damaged.
