# NATIONAL TRANSPORTATION SAFETY BOARD

## MATERIALS LABORATORY FACTUAL REPORT

Report No. 22-053

Place : Titusville, Florida  
Date : 10/14/2021  
Vehicle : Velocity SE RG (N755V)  
NTSB No. : ERA22FA015  
Investigator : Robert Gretz

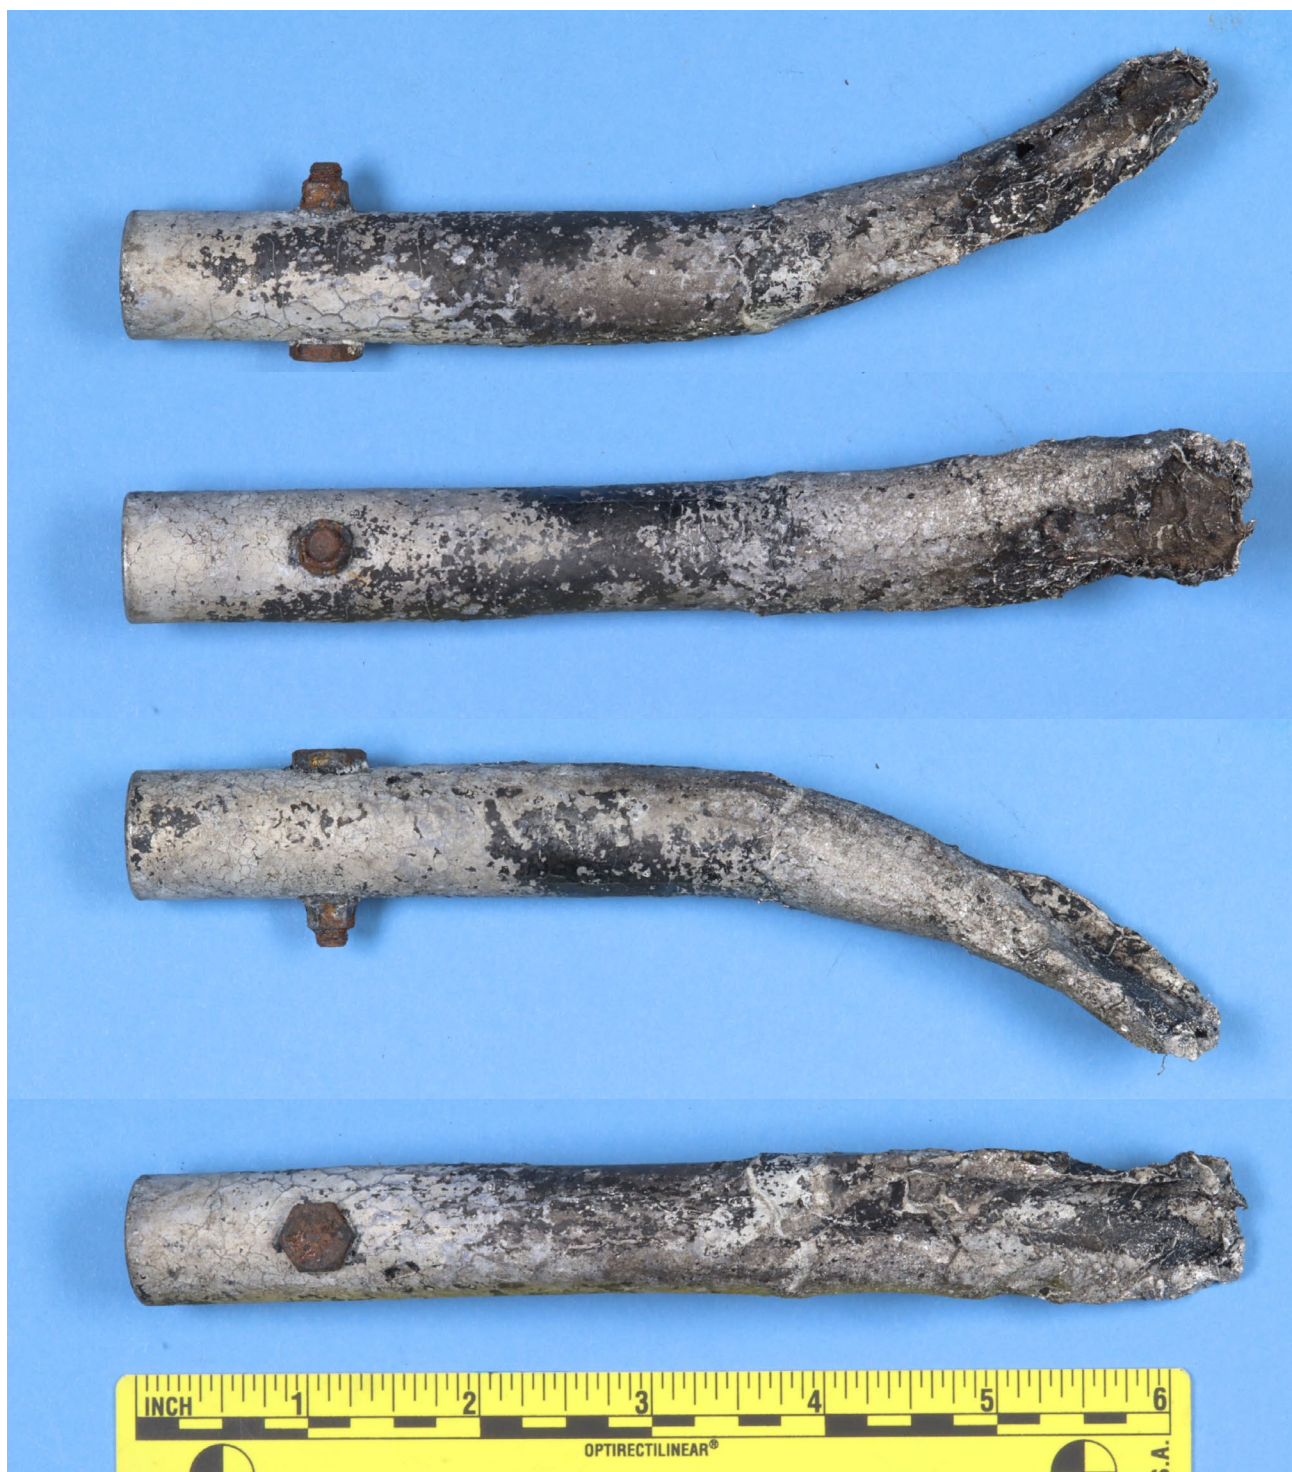
Views of the as-received piece of pitch control pushrod is shown in Figures 1 and 2. The pushrod had been exposed to fire such that a portion of the tube had collapsed and melted.

Figure 1 Four views of the fire-damaged pushrod piece.

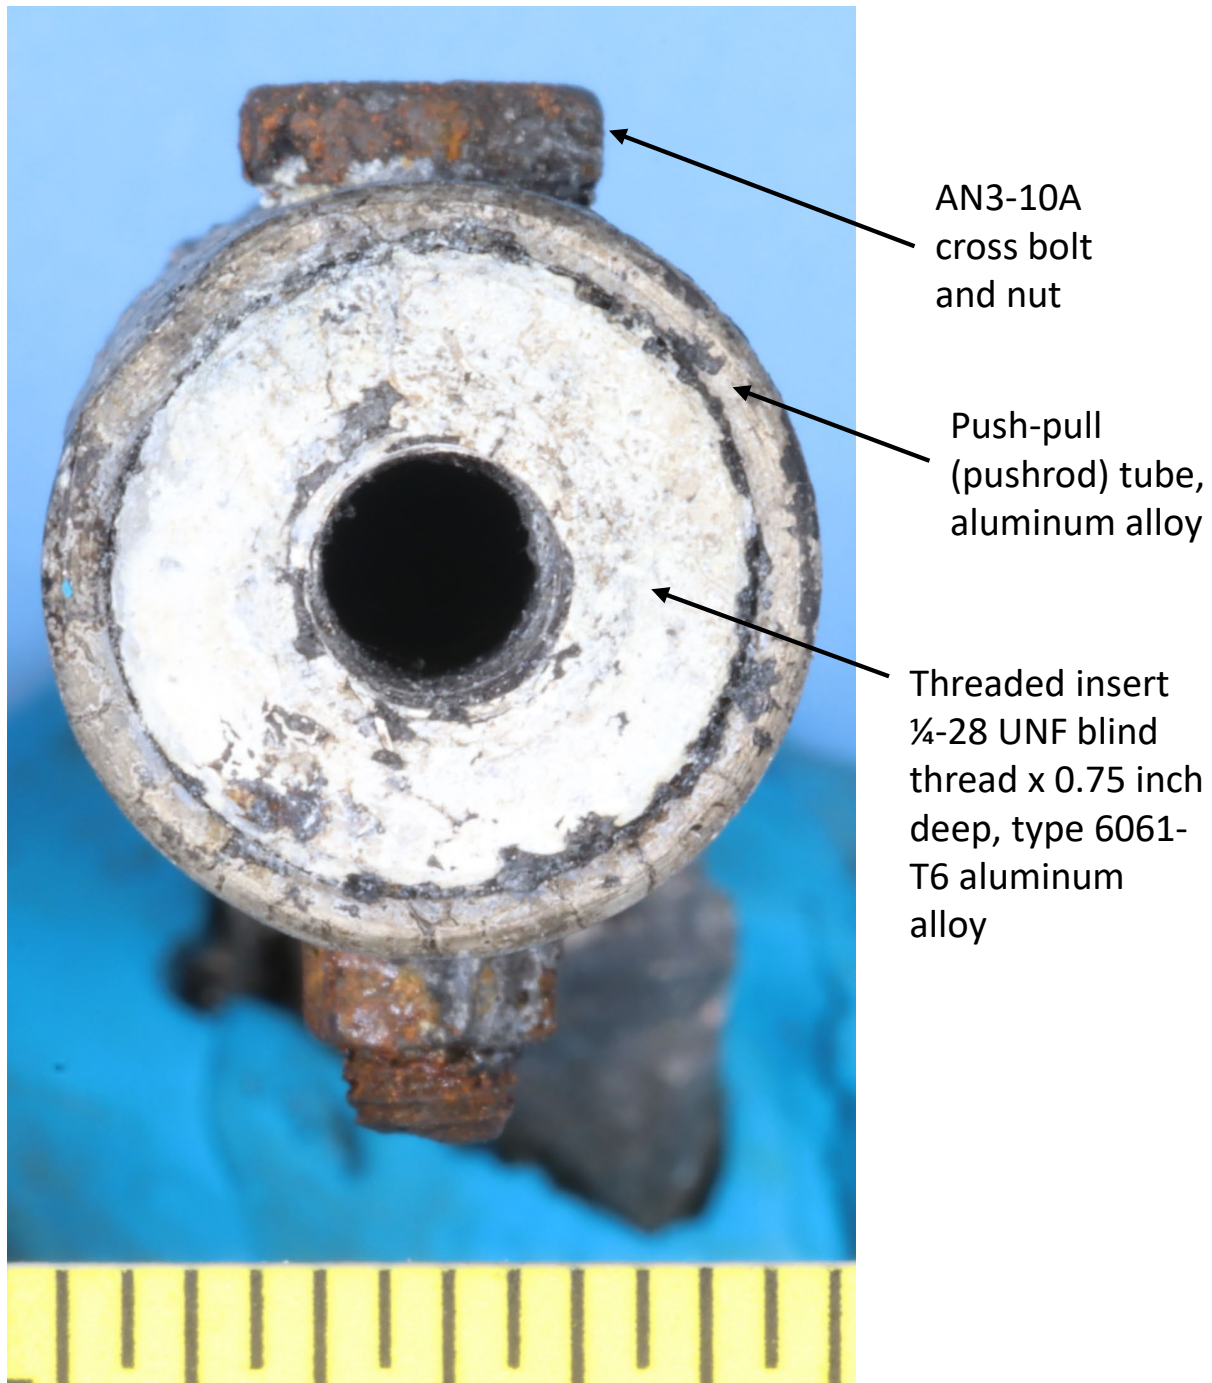
The end of the threaded insert is shown in Figure 2. No contact marks from the jam nut are evident. Oblique images in Figure 3 reveal that the first three threads in the threaded insert are missing.

Figure 2 View of the end of the pushrod showing the threaded insert.

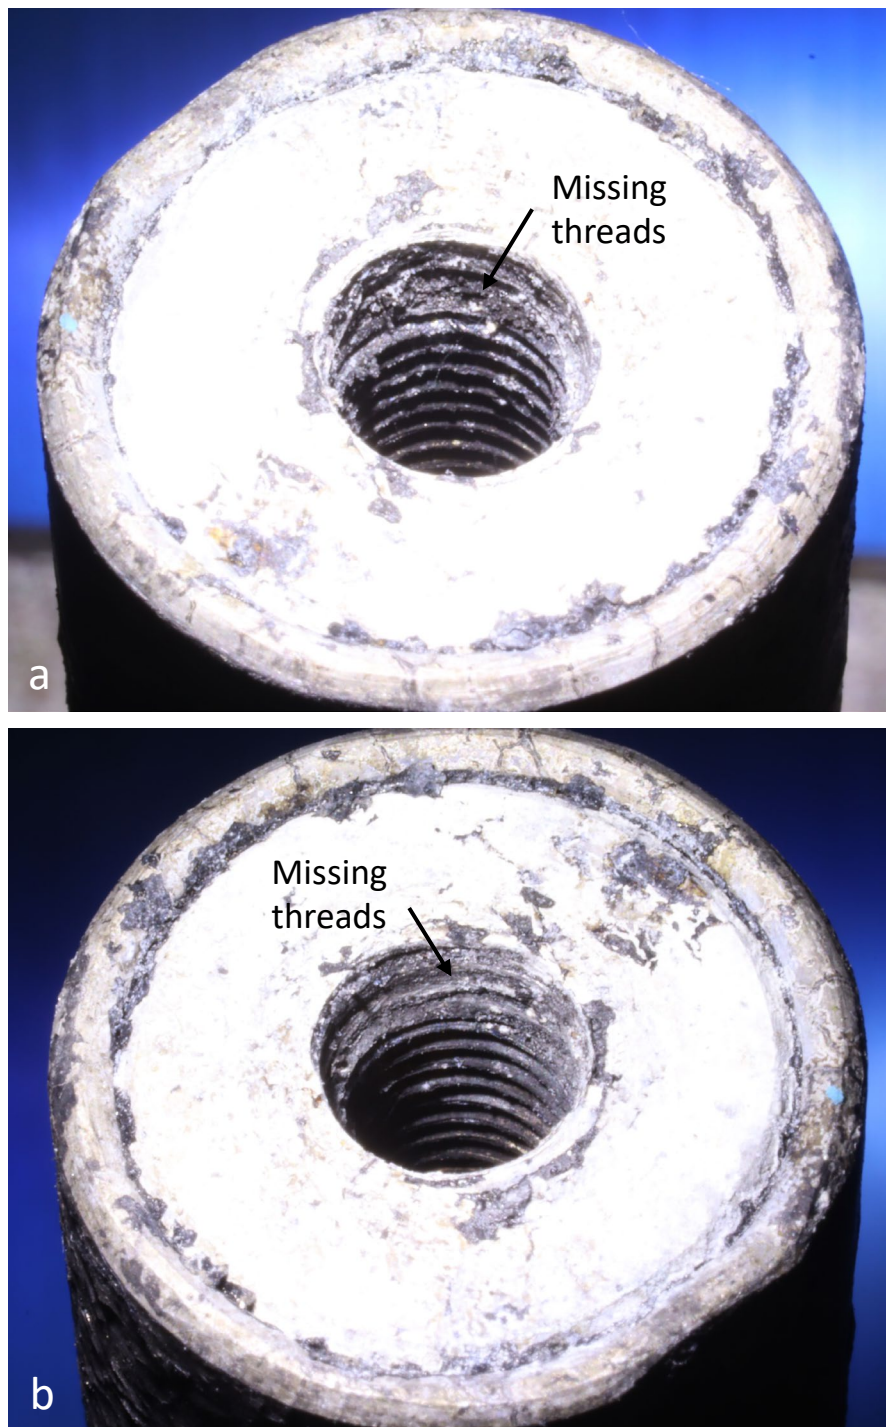
Figure 3 Oblique views of the end of the pushrod with the threaded insert revealing the location of missing threads.

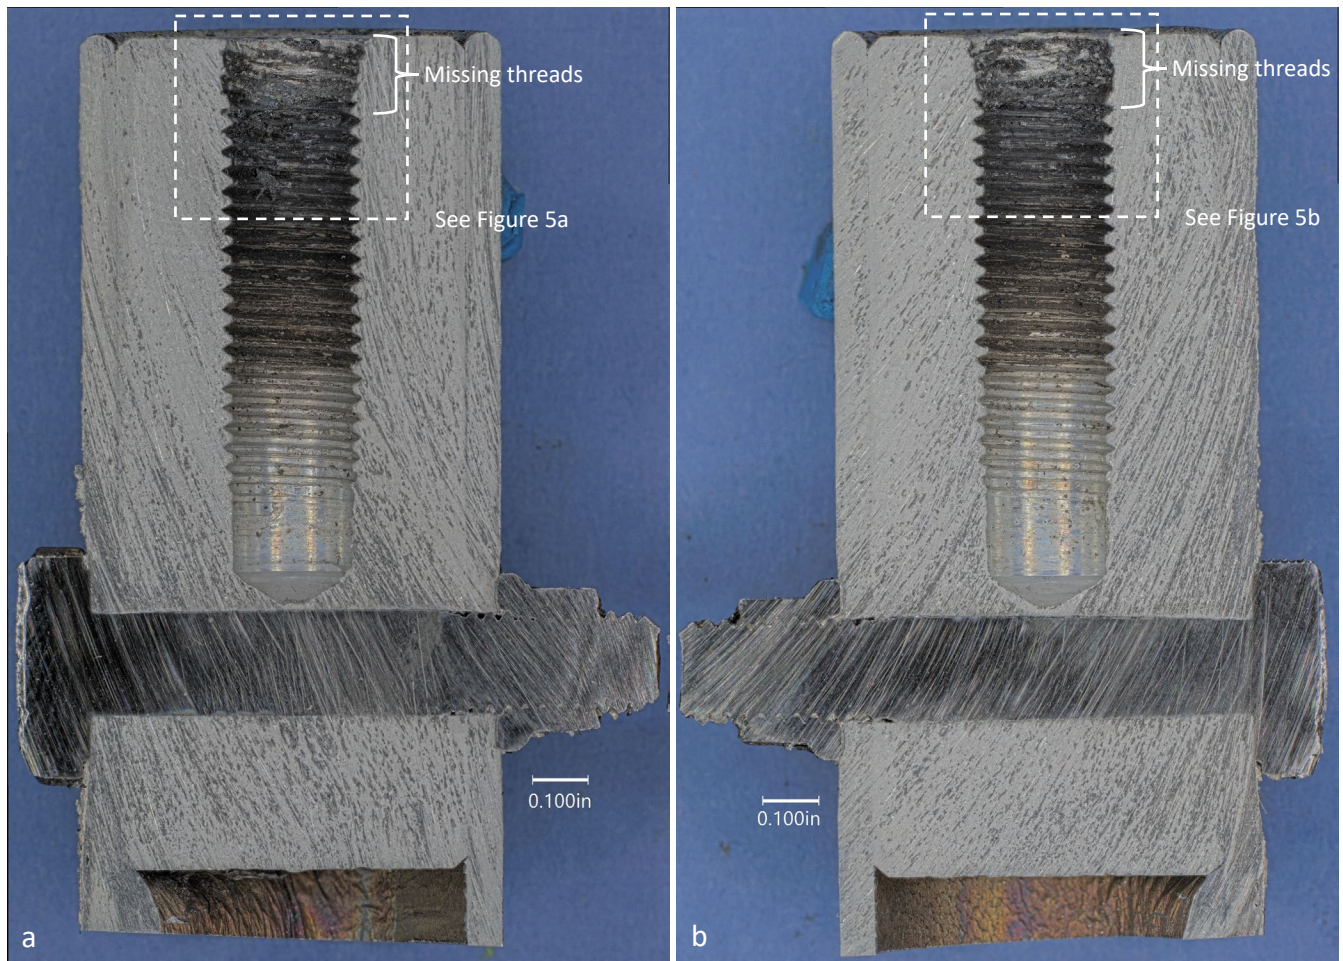
The end of the pushrod with the threaded insert was longitudinally cross section as documented in Figure 4 to reveal the threads within the insert. The threads (including the area with missing threads) were largely covered in a coating of sub-stoichiometric thermally-degraded organic matter and soot. The first three threads are missing as revealed in Figure 4 and in closer images in Figure 5. The cross-section pieces were ultrasonically cleaned in a non-ionic detergent with ultrasonics to remove some of the black deposits. Microscope examination with a 5X to 50X stereo microscope revealed that the first three threads were fractured in shear overstress.

Figure 4 Digital microscope images of longitudinal cross-sections of the threaded insert.

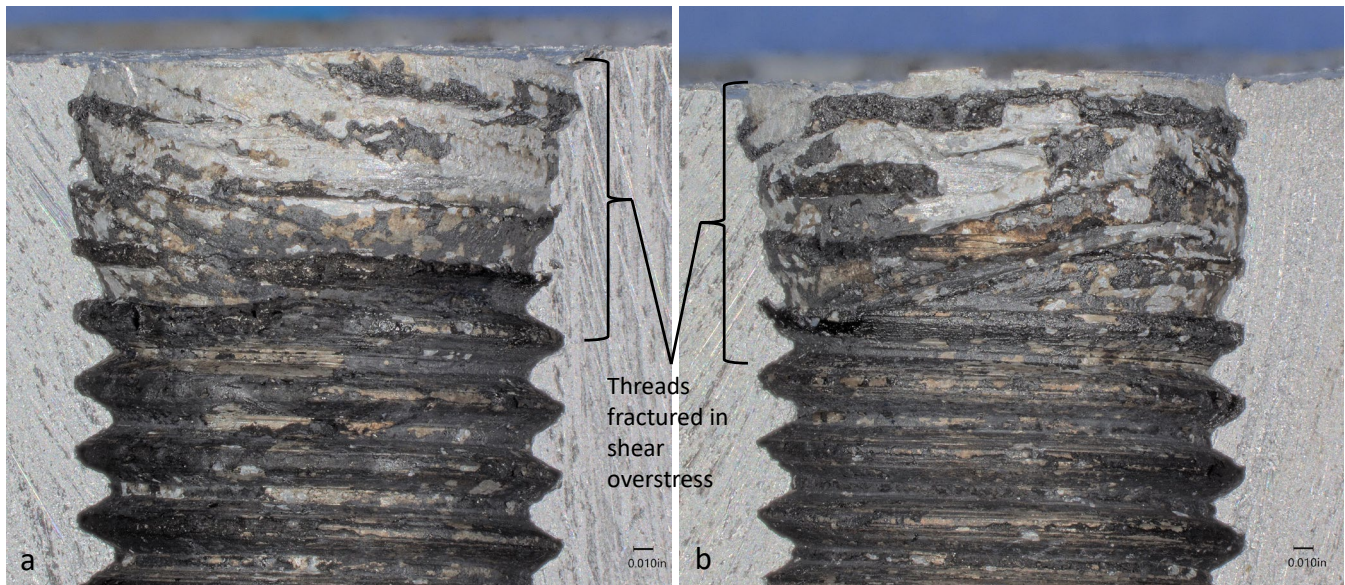
Figure 5 Digital microscope images showing closer views of the missing threads in the threaded insert. The threaded area was cleaned using a non-ionic detergent with ultrasonics.
