**WRECKAGE EXAMINATION**  
**NTSB Accident Number**  
**ERA22FA015**

| Location: | Titusville, Florida |
| Aircraft: | Velocity SE RG |
| Registration | N755V |

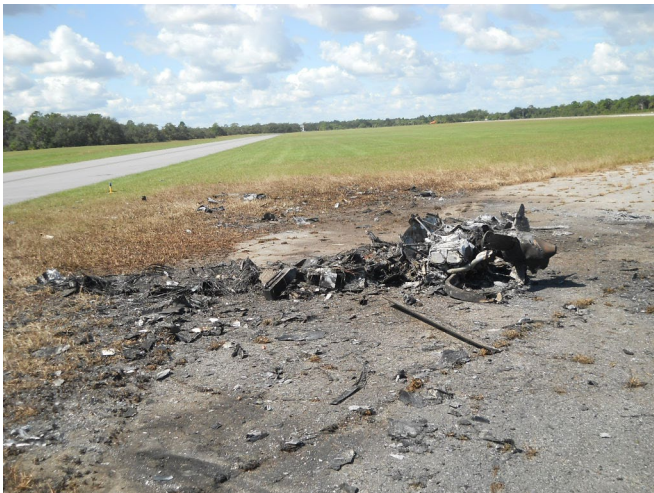
The wreckage came to rest upright, oriented about a 230° magnetic heading, and no debris path was observed. The cockpit and cabin were mostly consumed by fire. The flight control stick was not recovered. The pilot's seat was identified, and the four bolts and their respective hard points remained attached. The pilot's seat pin was also identified, but the seat frame was bent and separated, consistent with impact. A Grand Rapids PFD and MFD were recovered and retained for data download.

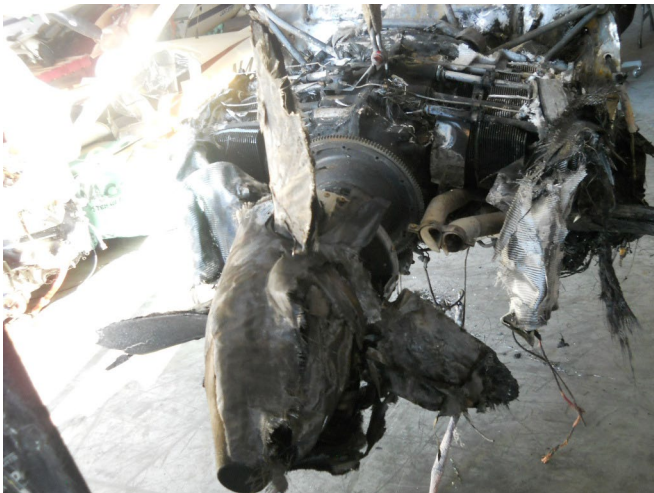
The engine came to rest upright, separated from the airframe. The three composite propeller blades remained attached to the hub and all three blades separated about 12 in from their respective roots. Following recovery to a salvage facility, the top spark plugs were removed; their electrodes were intact and light gray in color. Borescope examination of the cylinders did not reveal any anomalies. The rear accessory section sustained thermal damage. The propeller was rotated about 180° and then seized with no movement in either direction.

The engine was examined again at the recovery facility on 12/2/22, with the assistance of a representative from the engine manufacturer. Once the rear accessory section was removed, the crankshaft rotated 360°. Crankshaft, camshaft, and valve train continuity were confirmed to the rear accessory section of the engine, and thumb compression was attained on all cylinders. Due to thermal damage, the ignition and fuel system could not be tested.
