# National Transportation Safety Board

ERA22FA050

## **WRECKAGE EXAMINATION SUMMARY**

Location: Villa Rica, Georgia  
Date: November 8, 2021  
Time: 1814 Eastern Standard Time (EST)  
Airplane: Mooney M20F

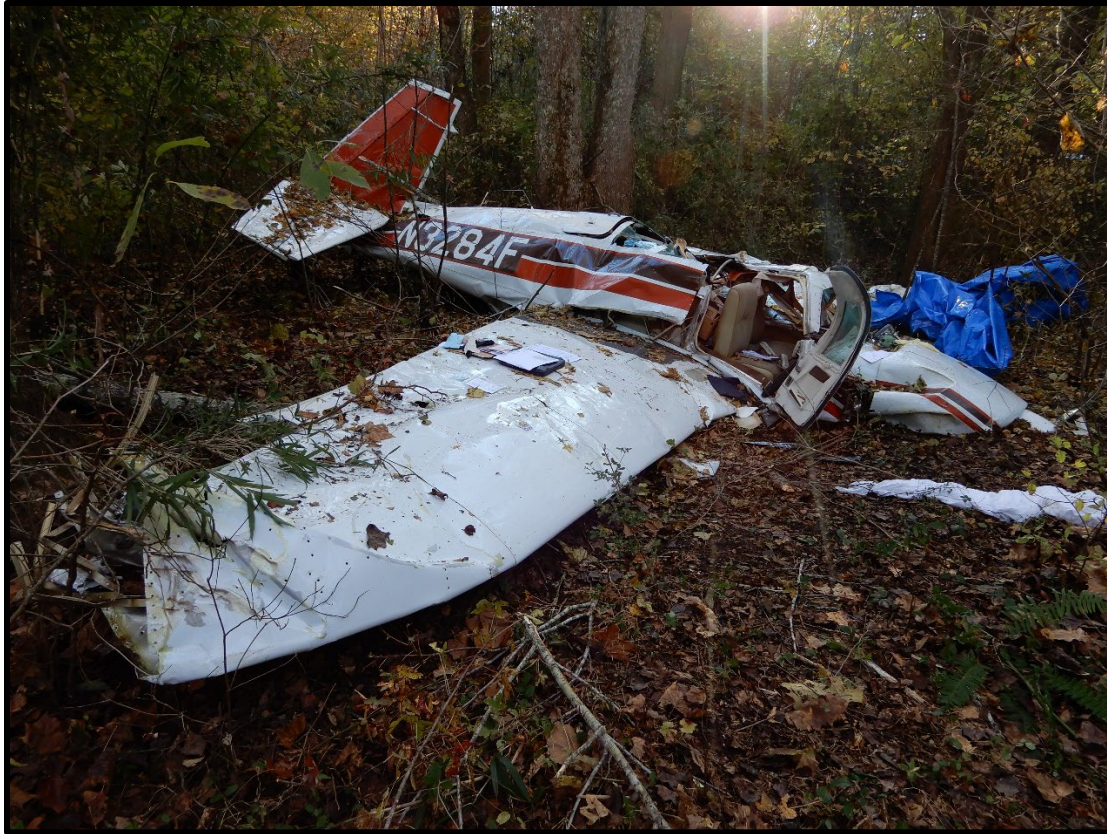
The airplane came to rest in a heavily wooded area, at an elevation of 1020 ft, upright, and in a level attitude on a 240° heading. All major components of the airplane were located in the vicinity of the main wreckage. There were multiple trees near the main wreckage that did not exhibit any impact damage. There was no odor of fuel at the accident site.

**Figure 1 - Main Accident Site**

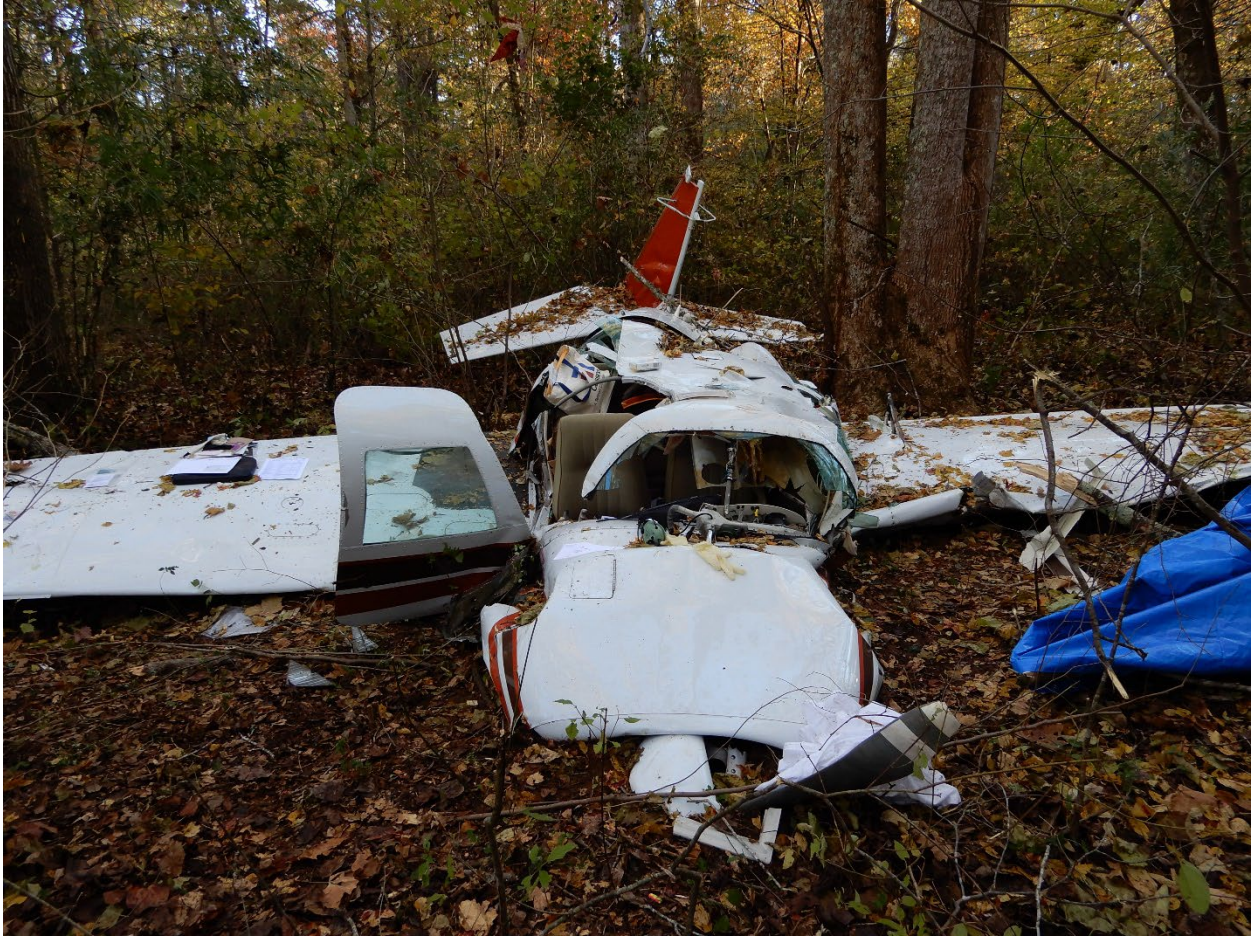
The fuselage remained intact and was impact crushed. Flight control continuity was established from all flight control surfaces to the flight controls in the cockpit.

**Figure 2. Front view of fuselage.**

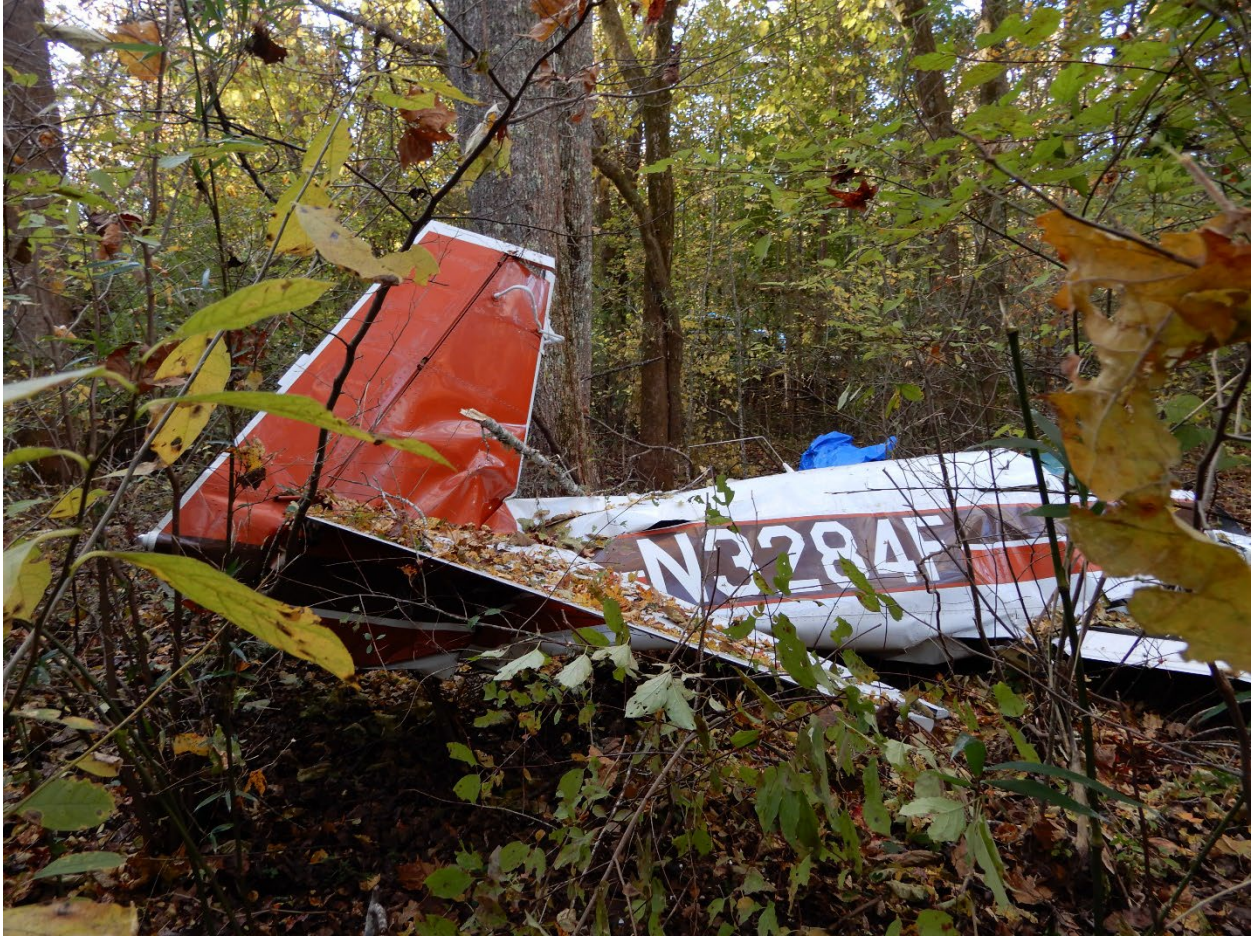
The empennage remained attached to the fuselage and was twisted to the left. The left horizontal stabilizer and elevator remained attached to the empennage and no damage was noted. The right horizontal stabilizer and elevator remained attached to the empennage and were wrinkled. The rudder and vertical stabilizer remained attached to the empennage. The vertical stabilizer was wrinkled.

**Figure 3. View of right side of empennage.**

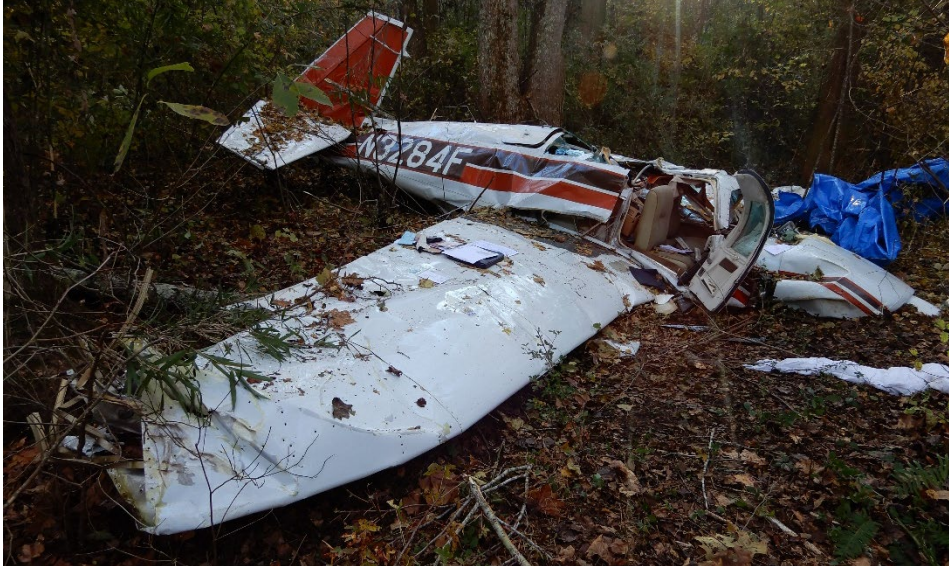
The right wing remained attached to the fuselage at all attach points. The flap remained attached to the wing and was in the extended position. The right aileron was impact separated and located about 25 ft forward of the main wreckage. The right wing tip was also impact separated and located forward of the wreckage. The aileron balance weight was impact separated and located in the vicinity of the wing. The right wing fuel tank was breached. The right fuel tank vent was free of debris. The right fuel cap remained seated and locked into place. The fuel tank was examined and no fuel was noted in the tanks.

**Figure 4. View of right wing.**

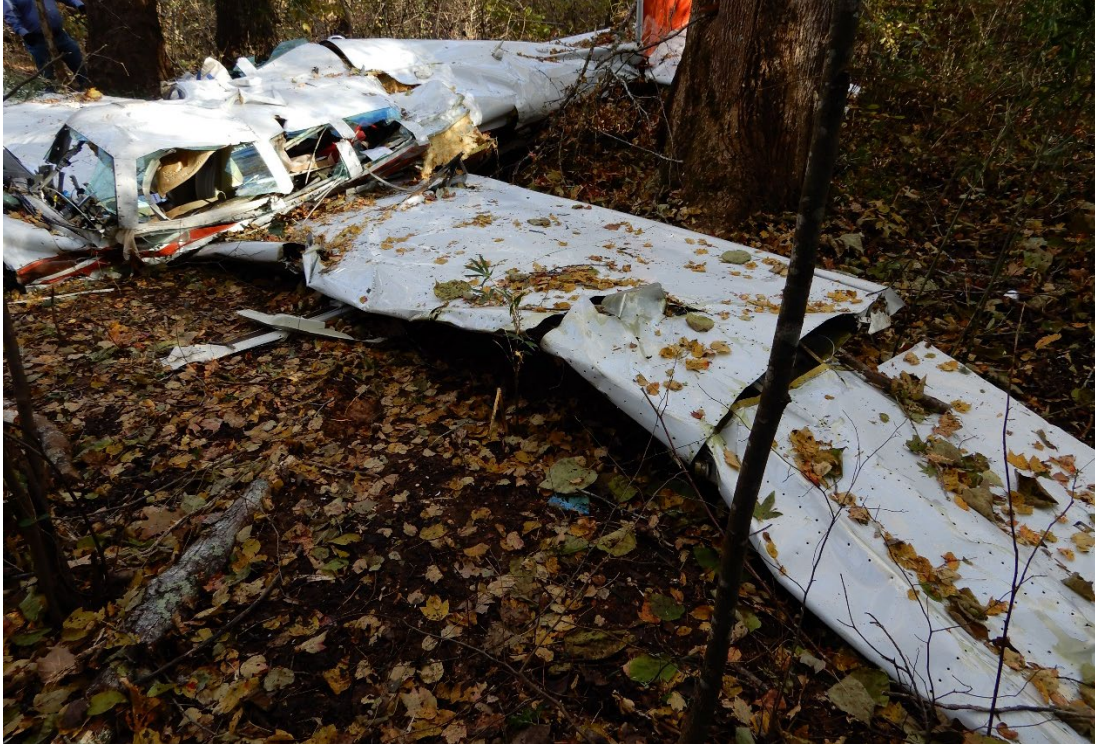
The left wing remained attached to the fuselage. The flap remained attached to the wing and was in the extended position. The left aileron remained attached to the left wing. The left aileron balance weight was impact separated and located next to the wing. The left fuel tank was breached and no fuel was noted in the tank. The left fuel cap remained seated and locked into place. The left wing fuel vent was clogged with debris similar to the dirt at the accident location. The stall warning horn was not located, but there was a place on the left wing where it should have been installed.

**Figure 5. View of left wing.**

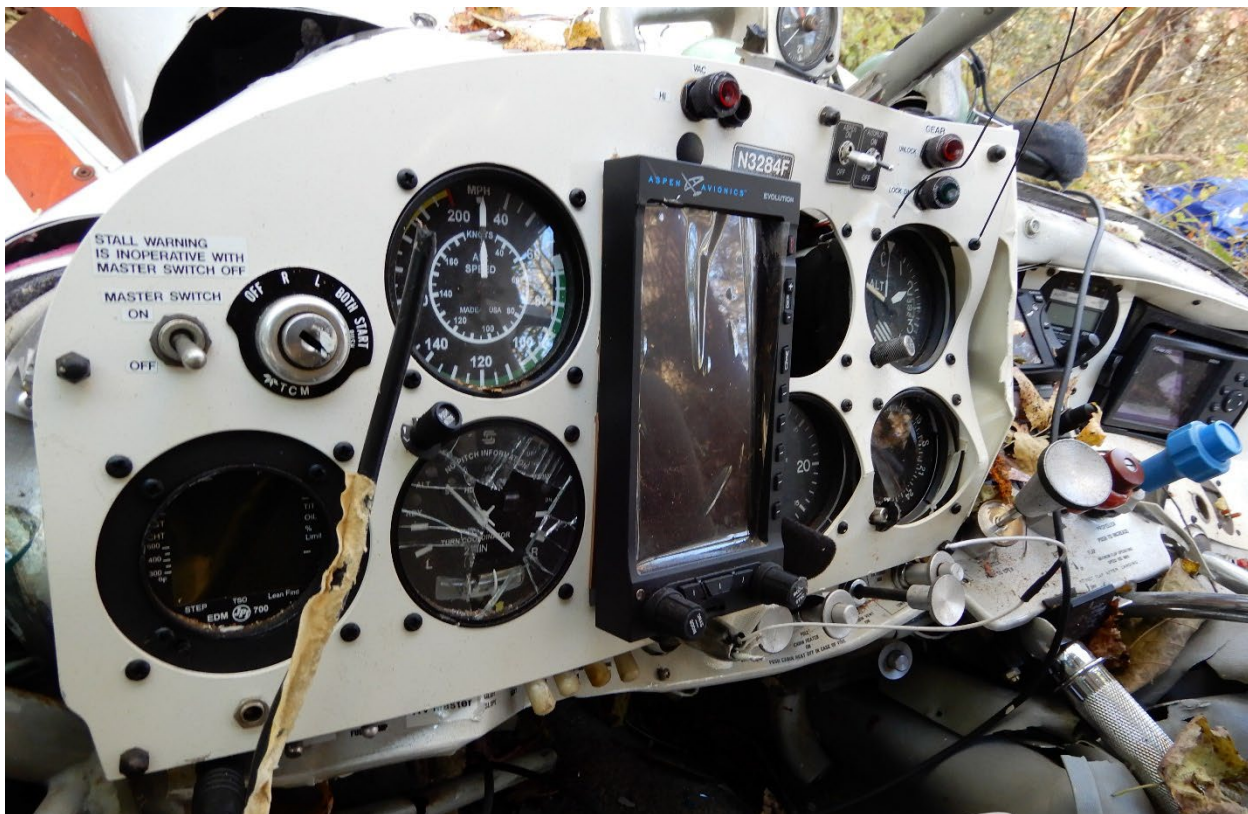
The left seat control yoke was impact separated. The right seat control yoke remained attached to the mount. All switches were turned in the OFF position and the instrument panel was crushed in a downward direction.

**Figure 6. View of instrument panel.**

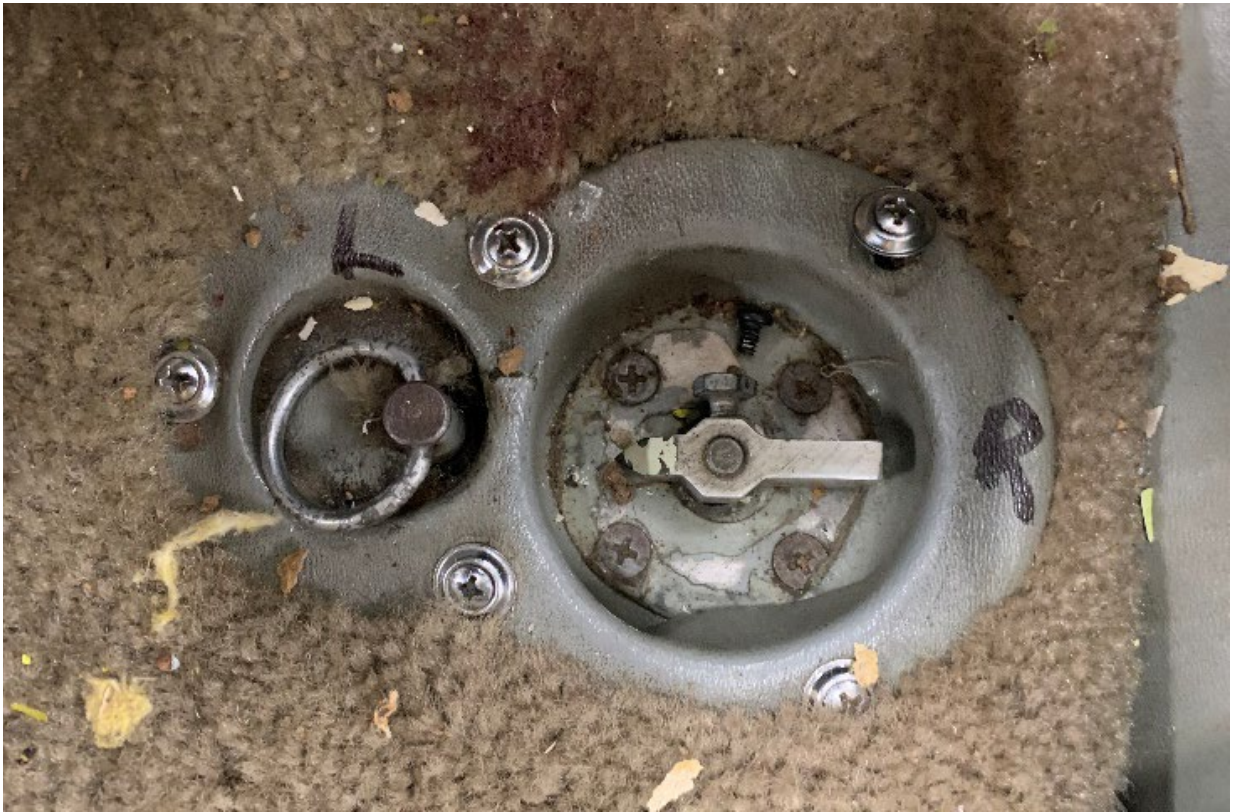
The fuel selector was in the left tank position. When pressurized air was applied to the fuel line going from the firewall back to the tanks, fuel and air came out of the line going into the left fuel tank. There was no debris noted on the fuel screens inside the fuel tanks. The gascolator was disassembled and the fuel screen did not contain debris.

**Figure 7. View of fuel selector as found.**

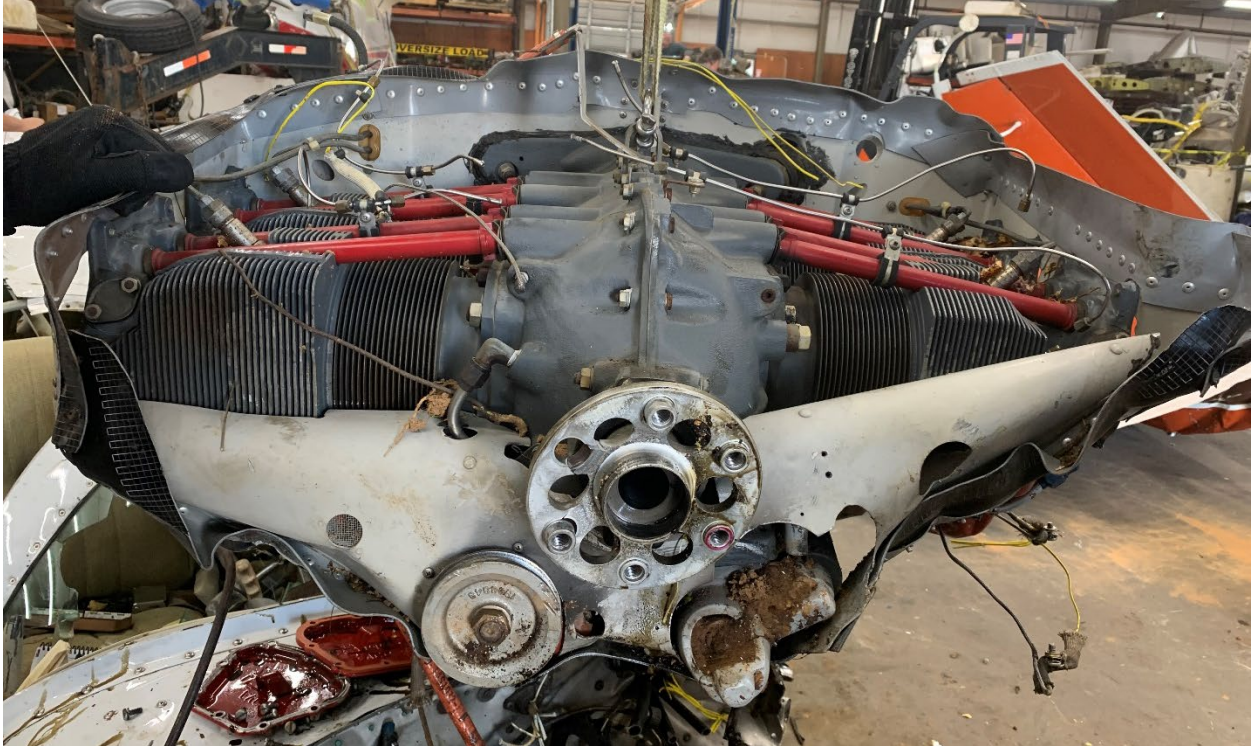
**Figure 8. Front view of engine.**

The engine remained attached to the airframe and was removed to facilitate further examination. Crankshaft and valvetrain continuity were confirmed when the crankshaft was rotated through 360° of motion. Thumb compression and suction was observed on all cylinders.

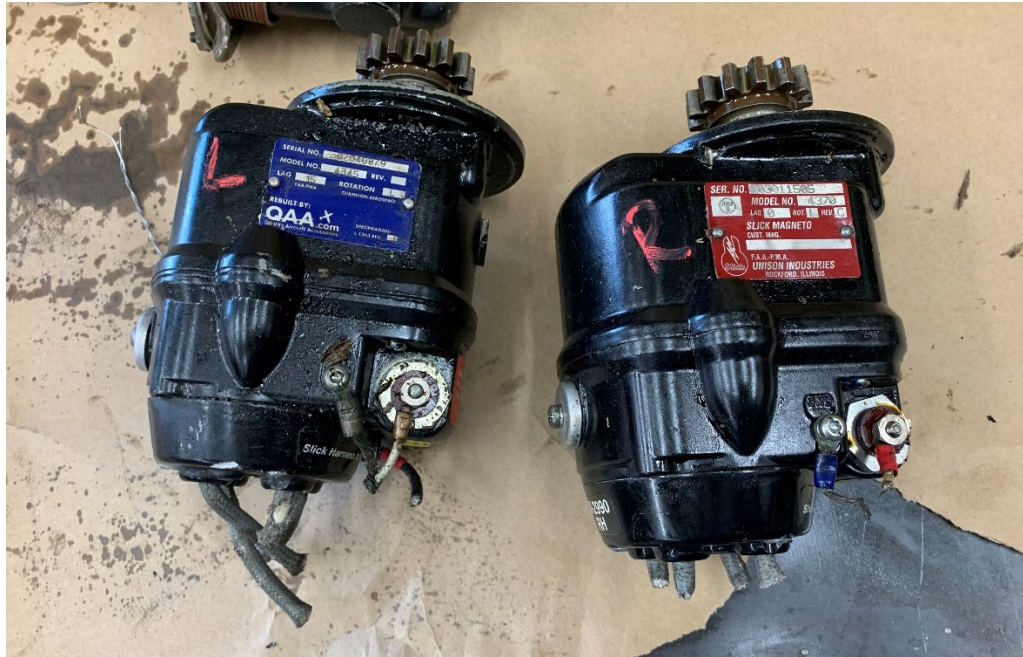
The left and right magnetos remained attached to the engine. The bolts holding the right magneto to the engine were not tight. The magnetos were turned by hand and sparked on all towers.

**Figure 9. View of magnetos**

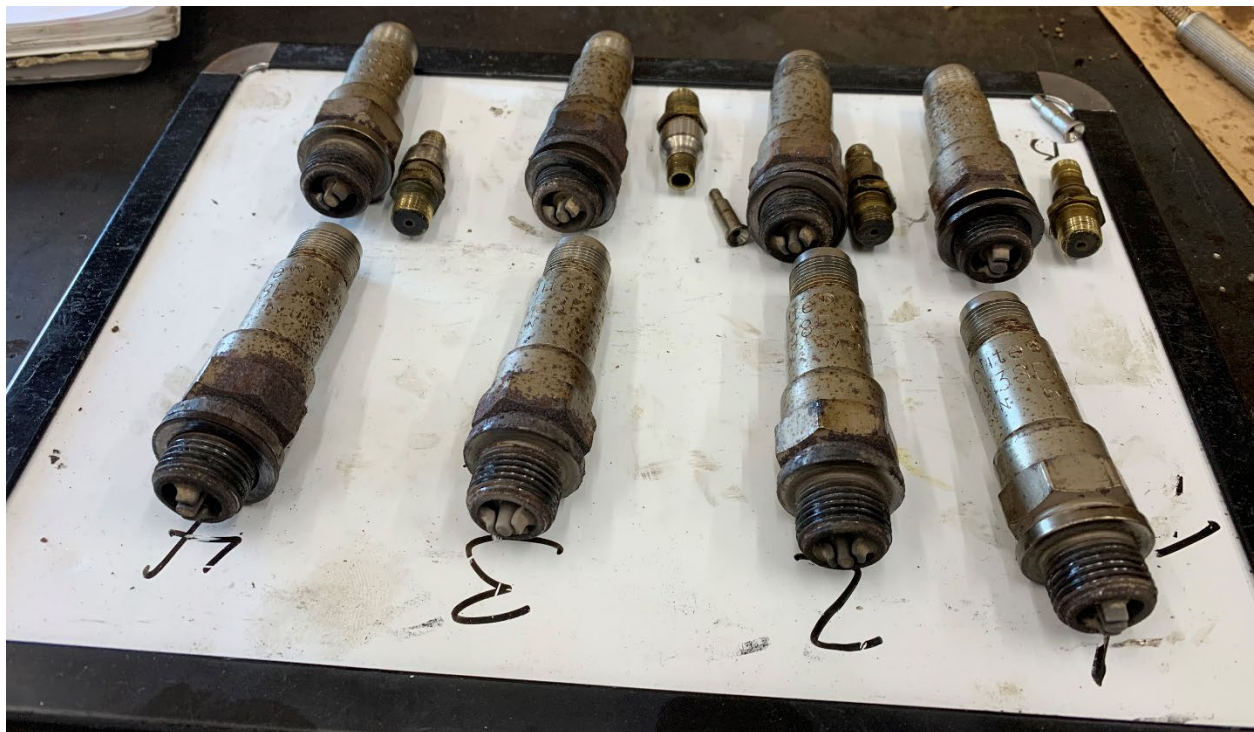
All spark plugs were removed from the cylinders and examined. All spark plugs exhibited worn out/severe condition and were light grey in color.

**Figure 10. Spark plugs and fuel injector nozzles.**

The fuel injector nozzles were removed from the cylinders and were not obstructed.

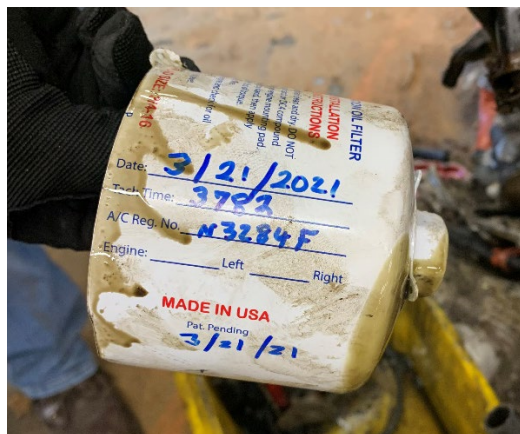
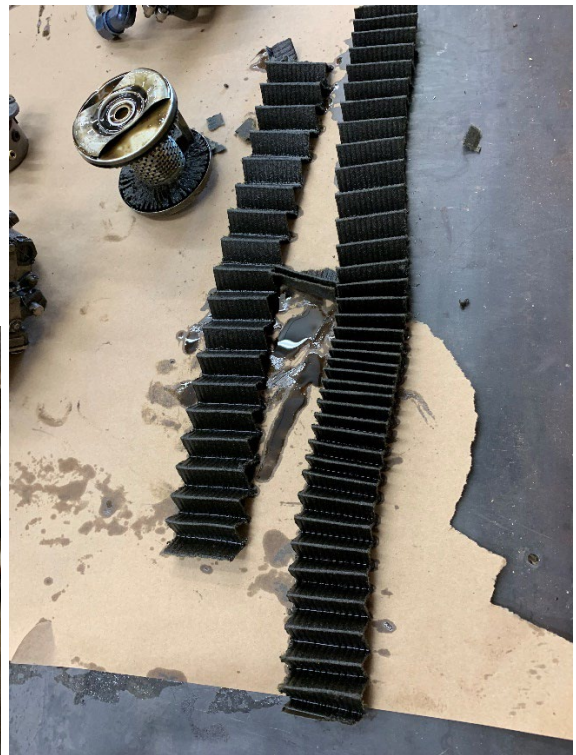
The oil filler neck was impact separated. There was oil present in the engine. The oil suction screen was removed from the sump and no debris was noted. The oil filter was removed from the engine and had March 21, 2021 written on it with a tach time of 3783 hours.

**Figure 11. View of oil filter housing and filter.**

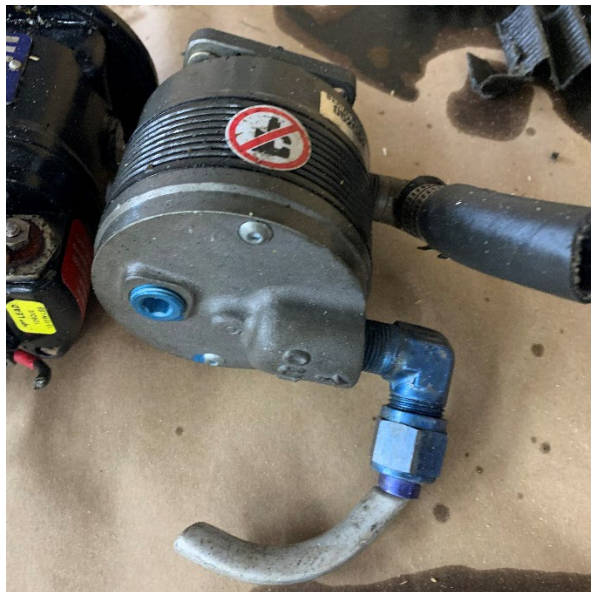
The vacuum pump was removed from the engine and pumped air when turned by hand.

**Figure 12. Vacuum Pump**

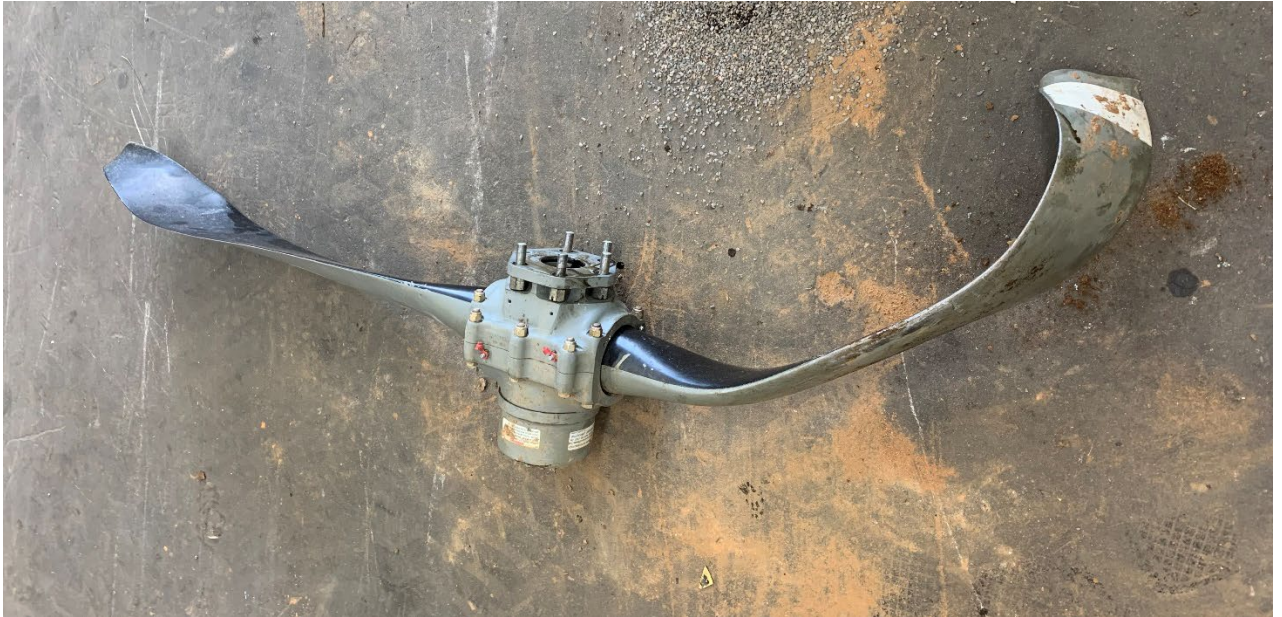
The propeller remained attached to the engine and was removed to facilitate examination. Both propeller blades remained attached to the hub. Blade A exhibited bending at the tip. Blade B was curled, the tip was torn off, and the blade exhibited chordwise scratching. In addition, a root in the ground was cut at a 45° angle near Blade B.

**Figure 13. Propeller.**

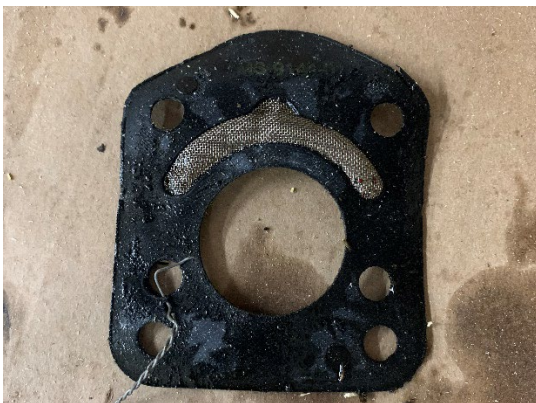
The propeller governor was removed from the engine and pumped oil when the drive was turned by hand. In addition, there was no debris in the governor screen.

**Figure 14. View of propeller governor screen.**
