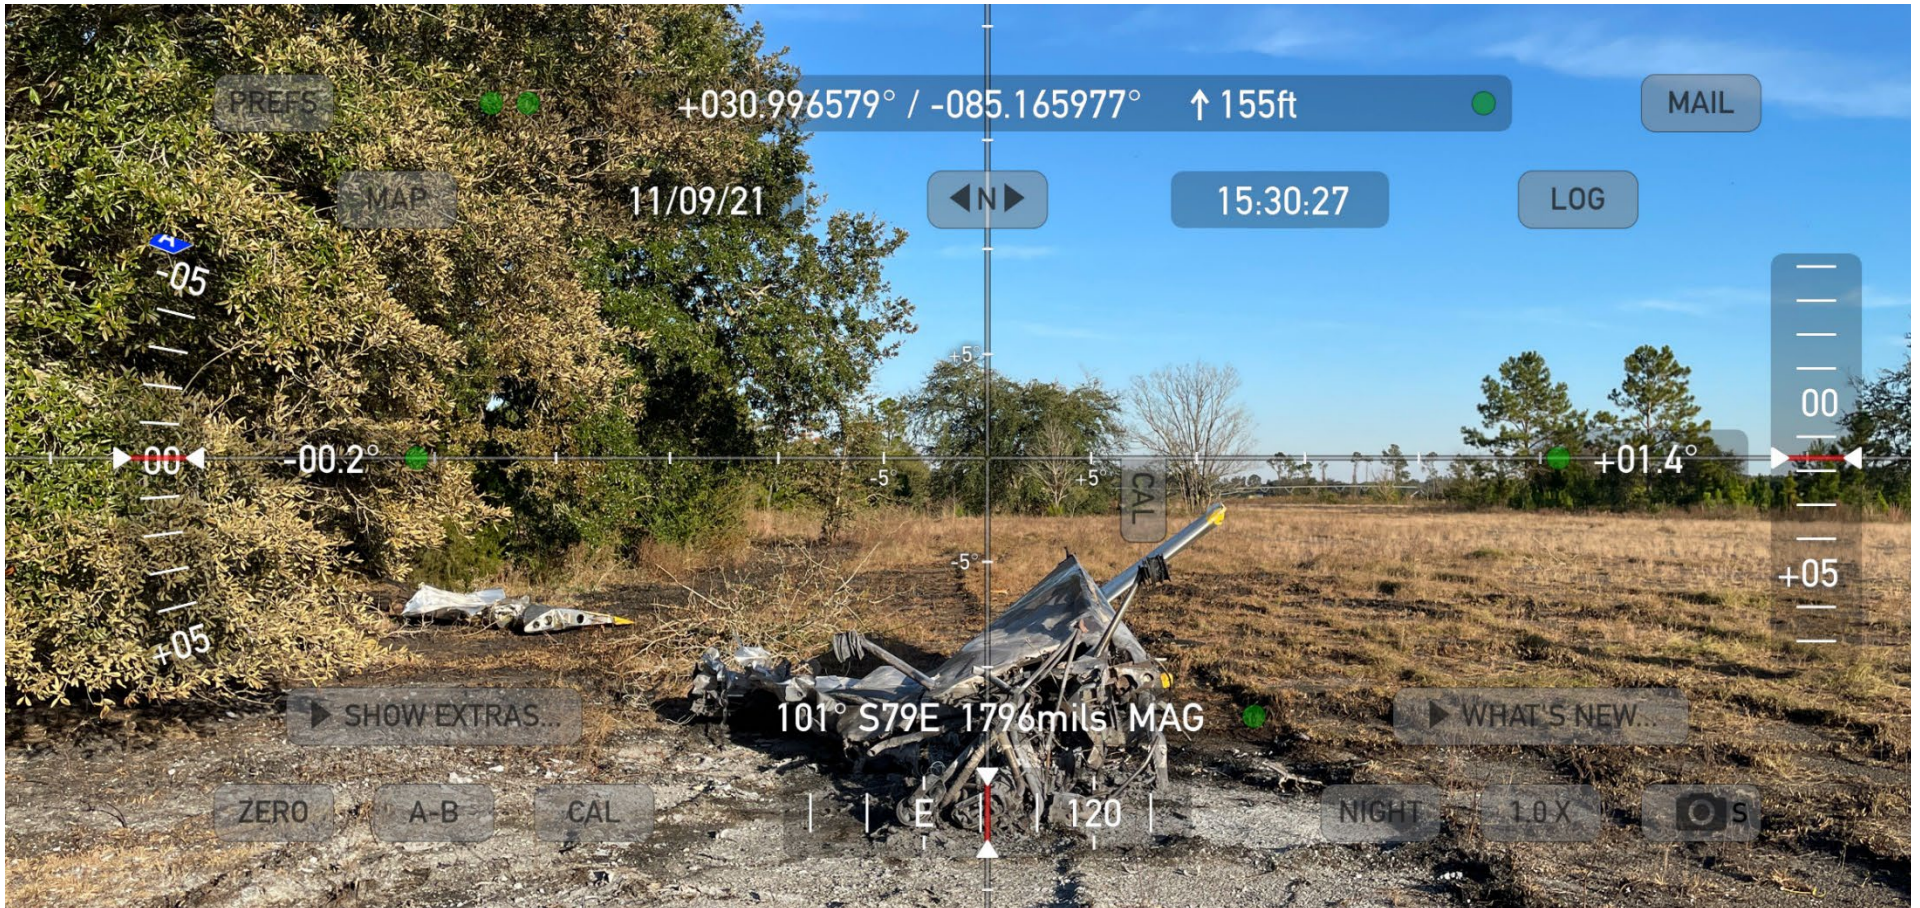
**Photo 1 – NTSB Digital Photograph. View Looking from Main Wreckage Location to Impacted Tree (CrossHairs Depict the Impacted Tree).**

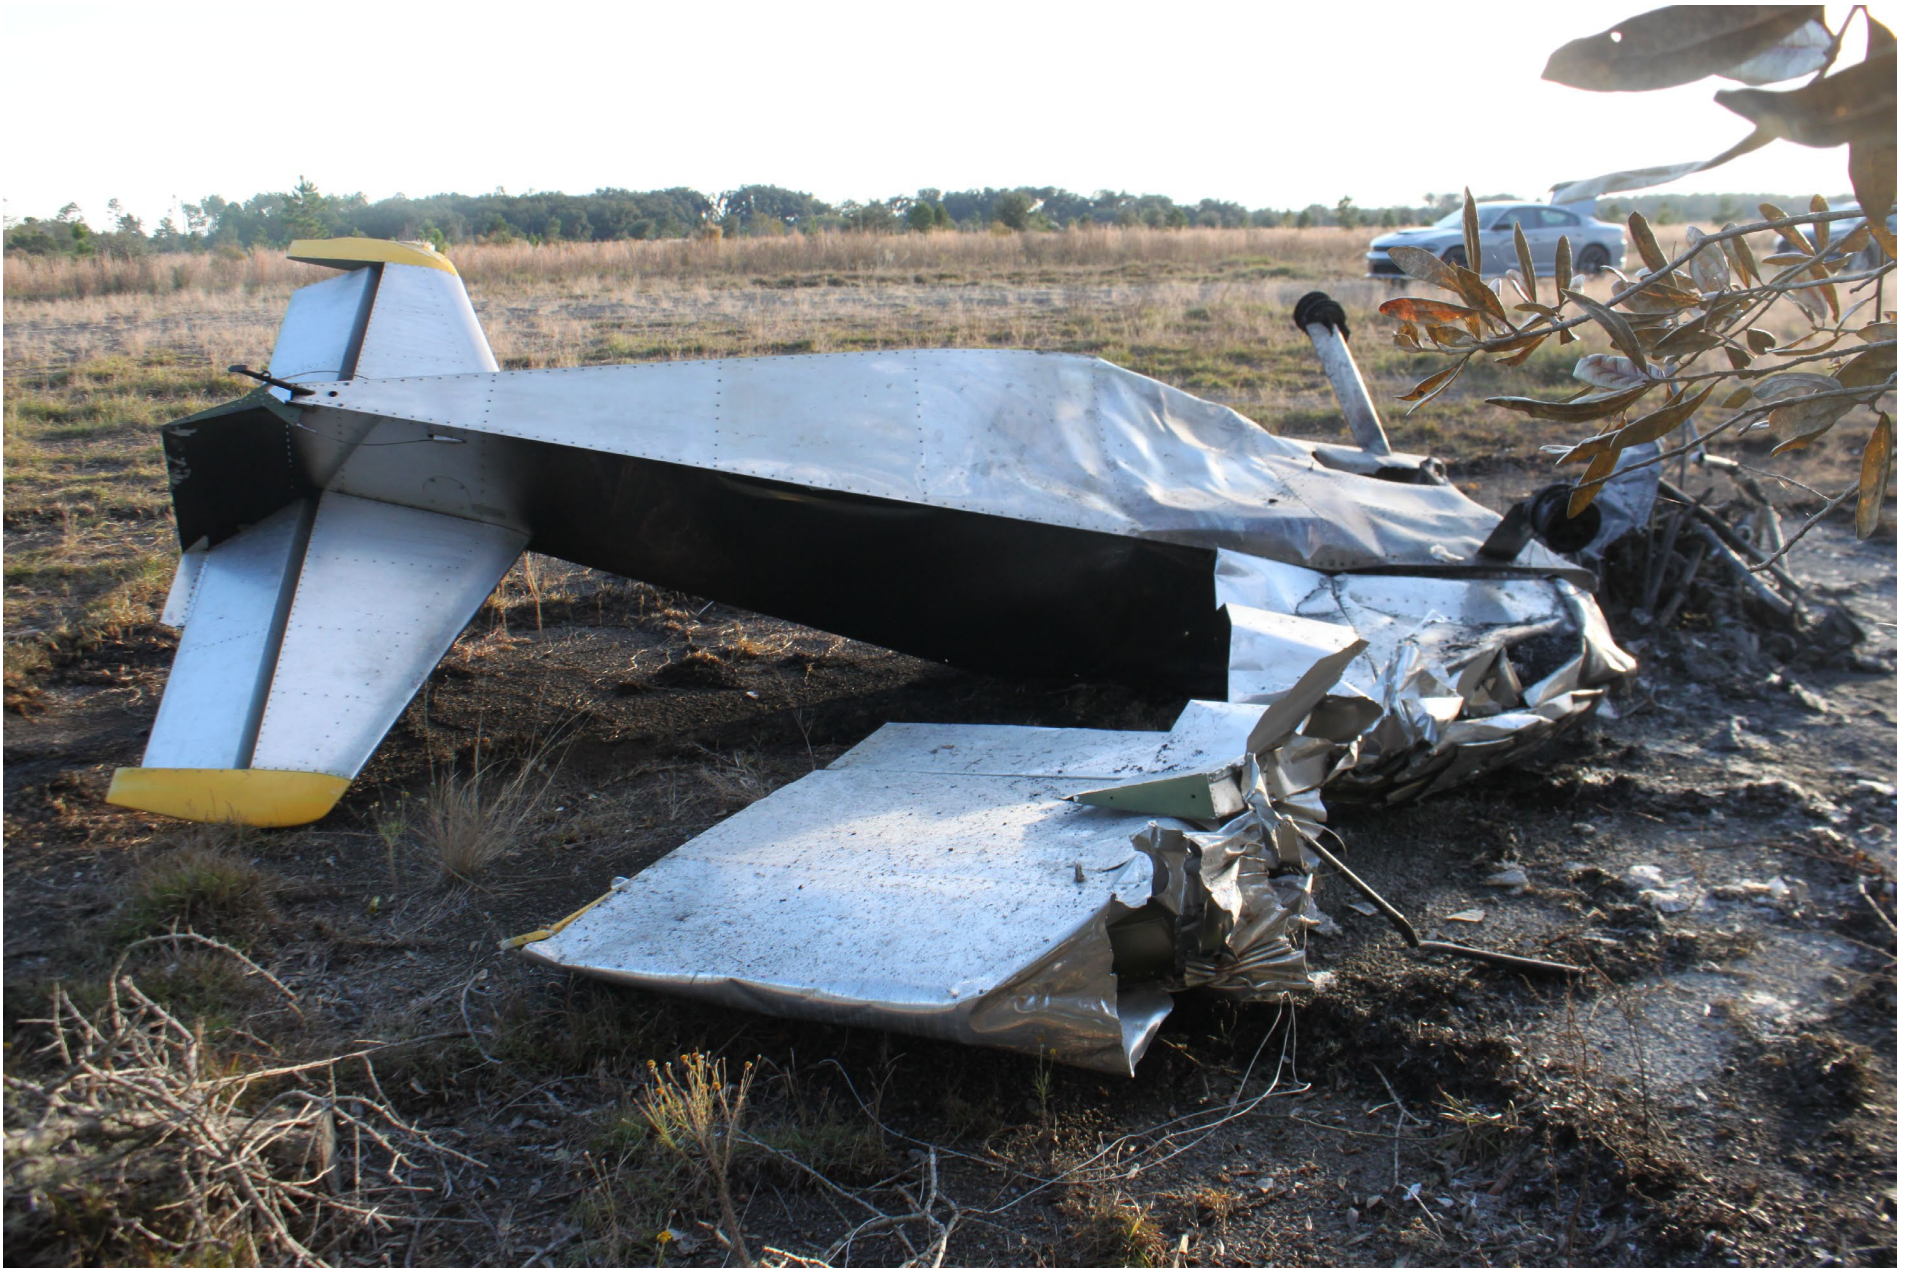
**Photo 2 - NTSB Digital Photograph. Left Side View of the Inverted Airplane at the Accident Site.**

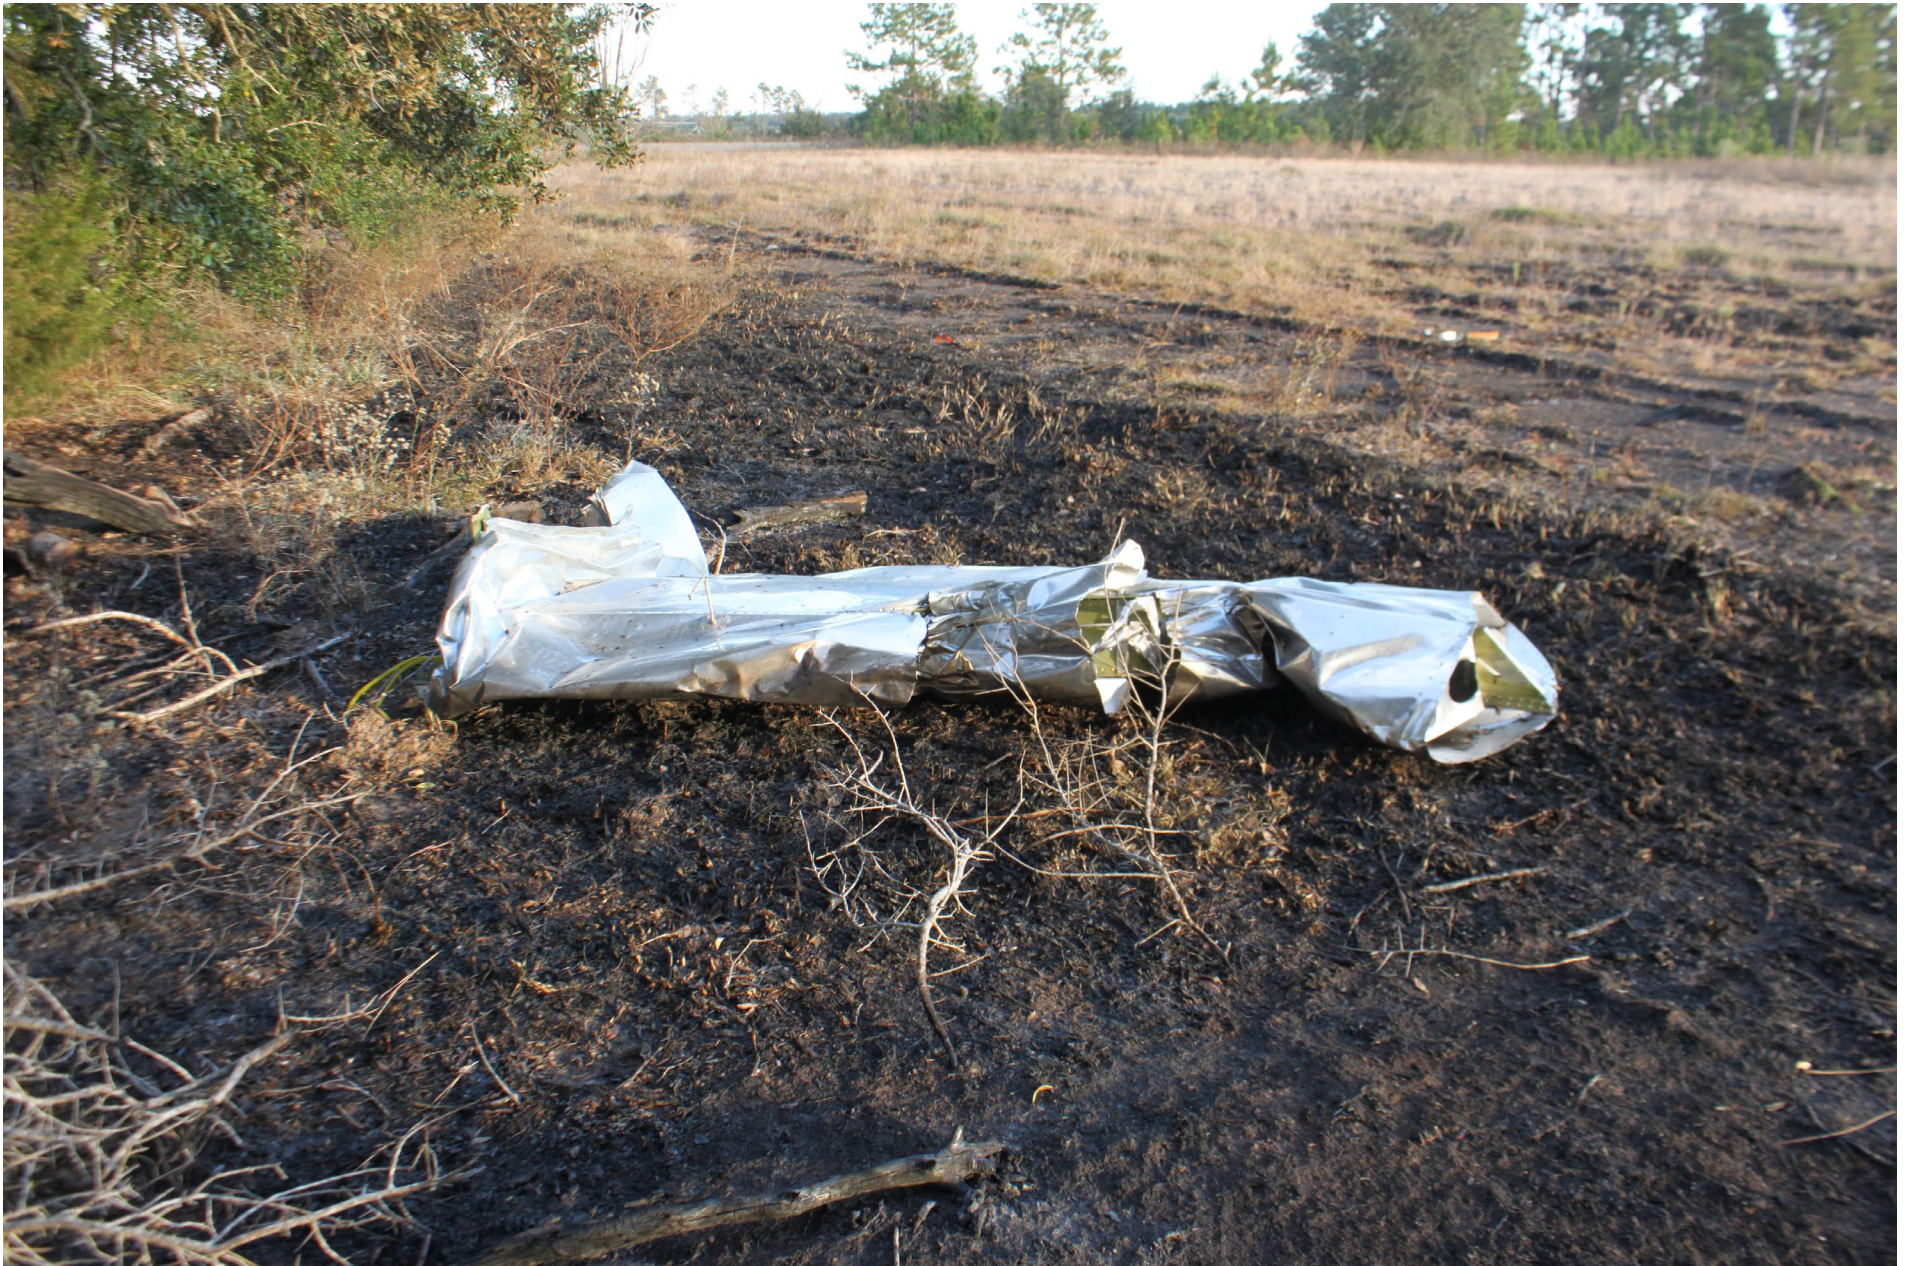
**Photo 3 - NTSB Digital Photograph. View of the Separated Right Wing.**

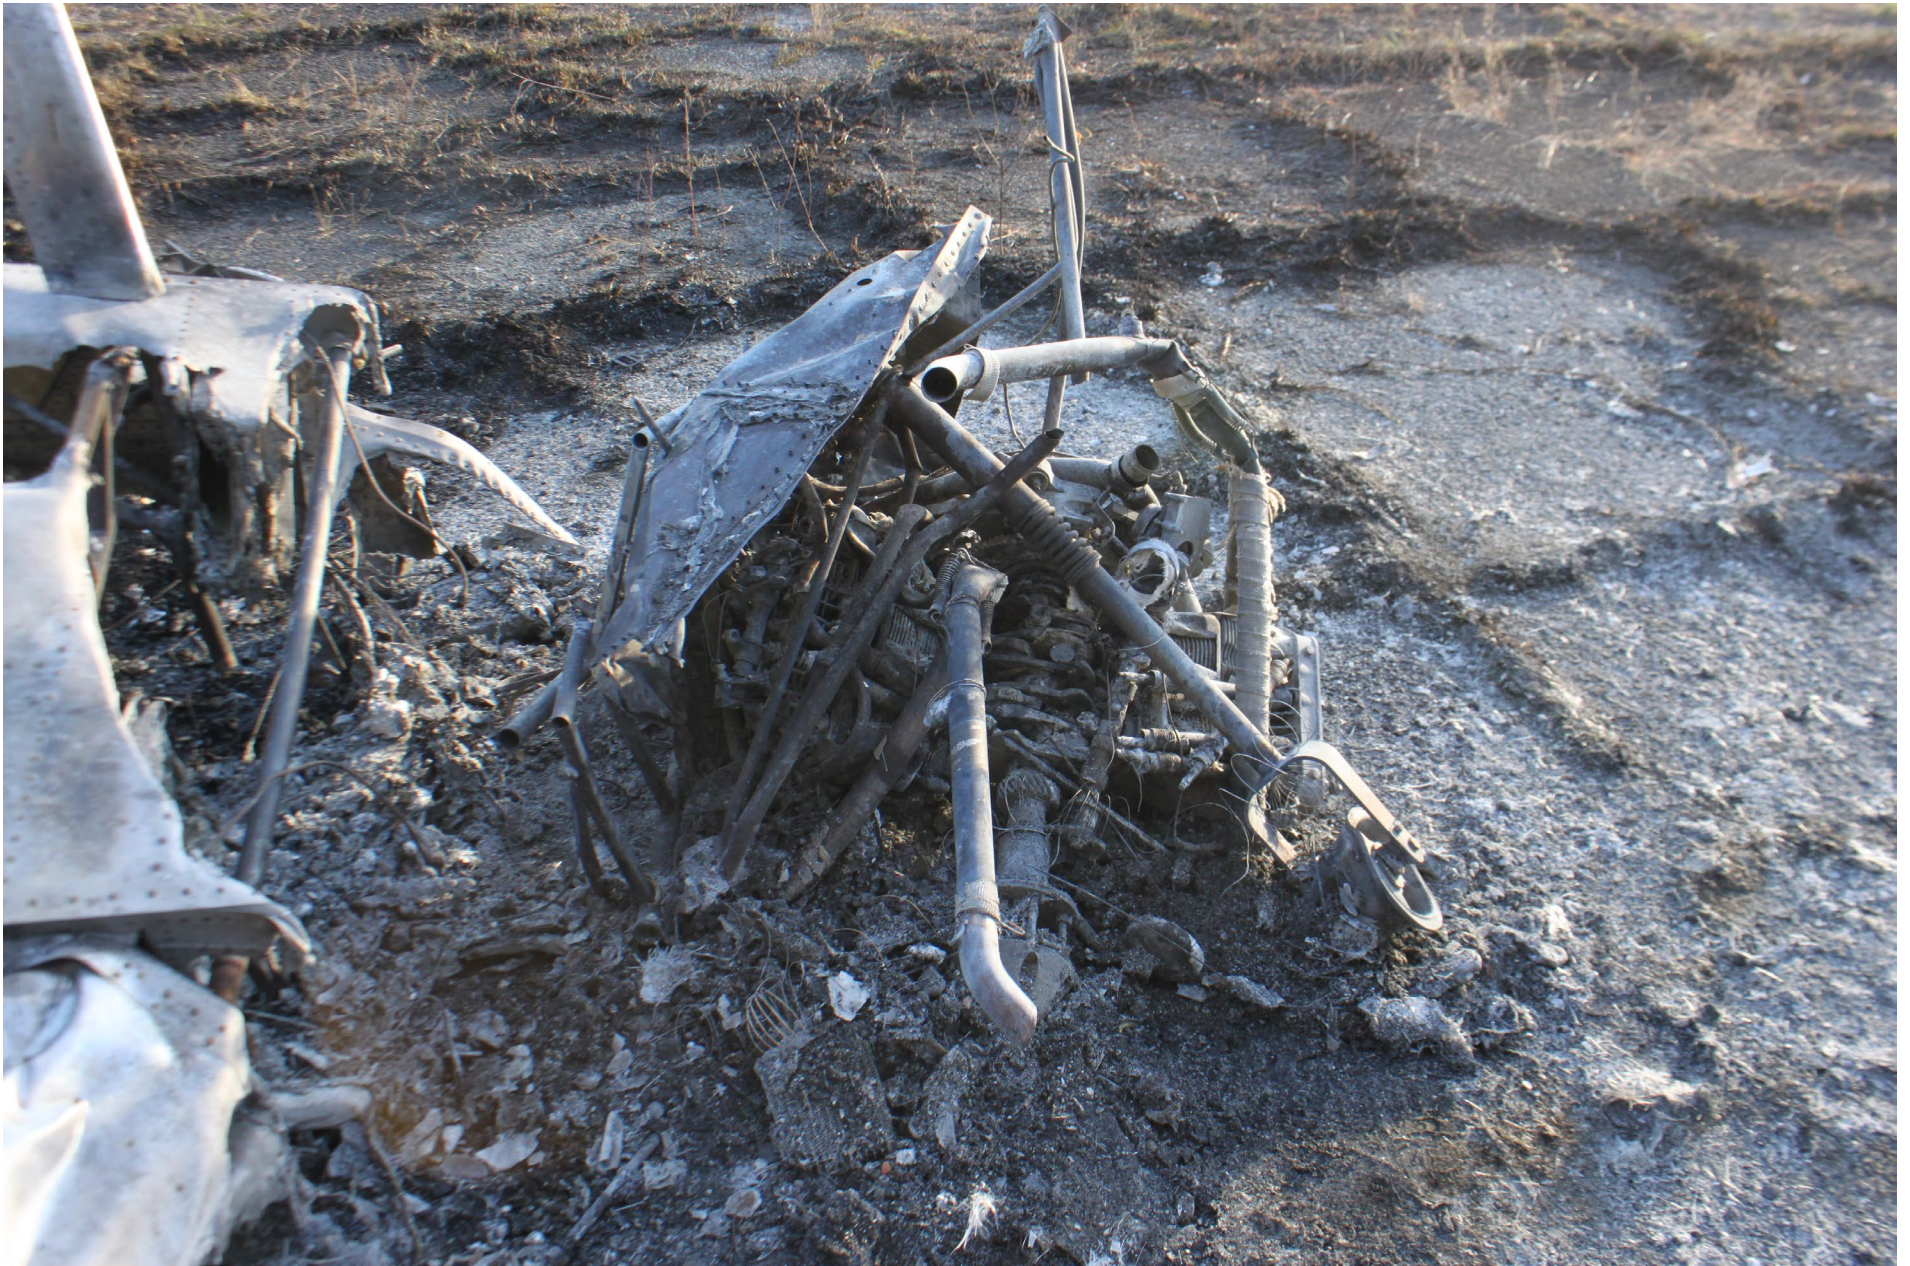
**Photo 4 - NTSB Digital Photograph. View of the Firewall and Remains of the Engine Assembly. Note the Extensive Fire Damage.**

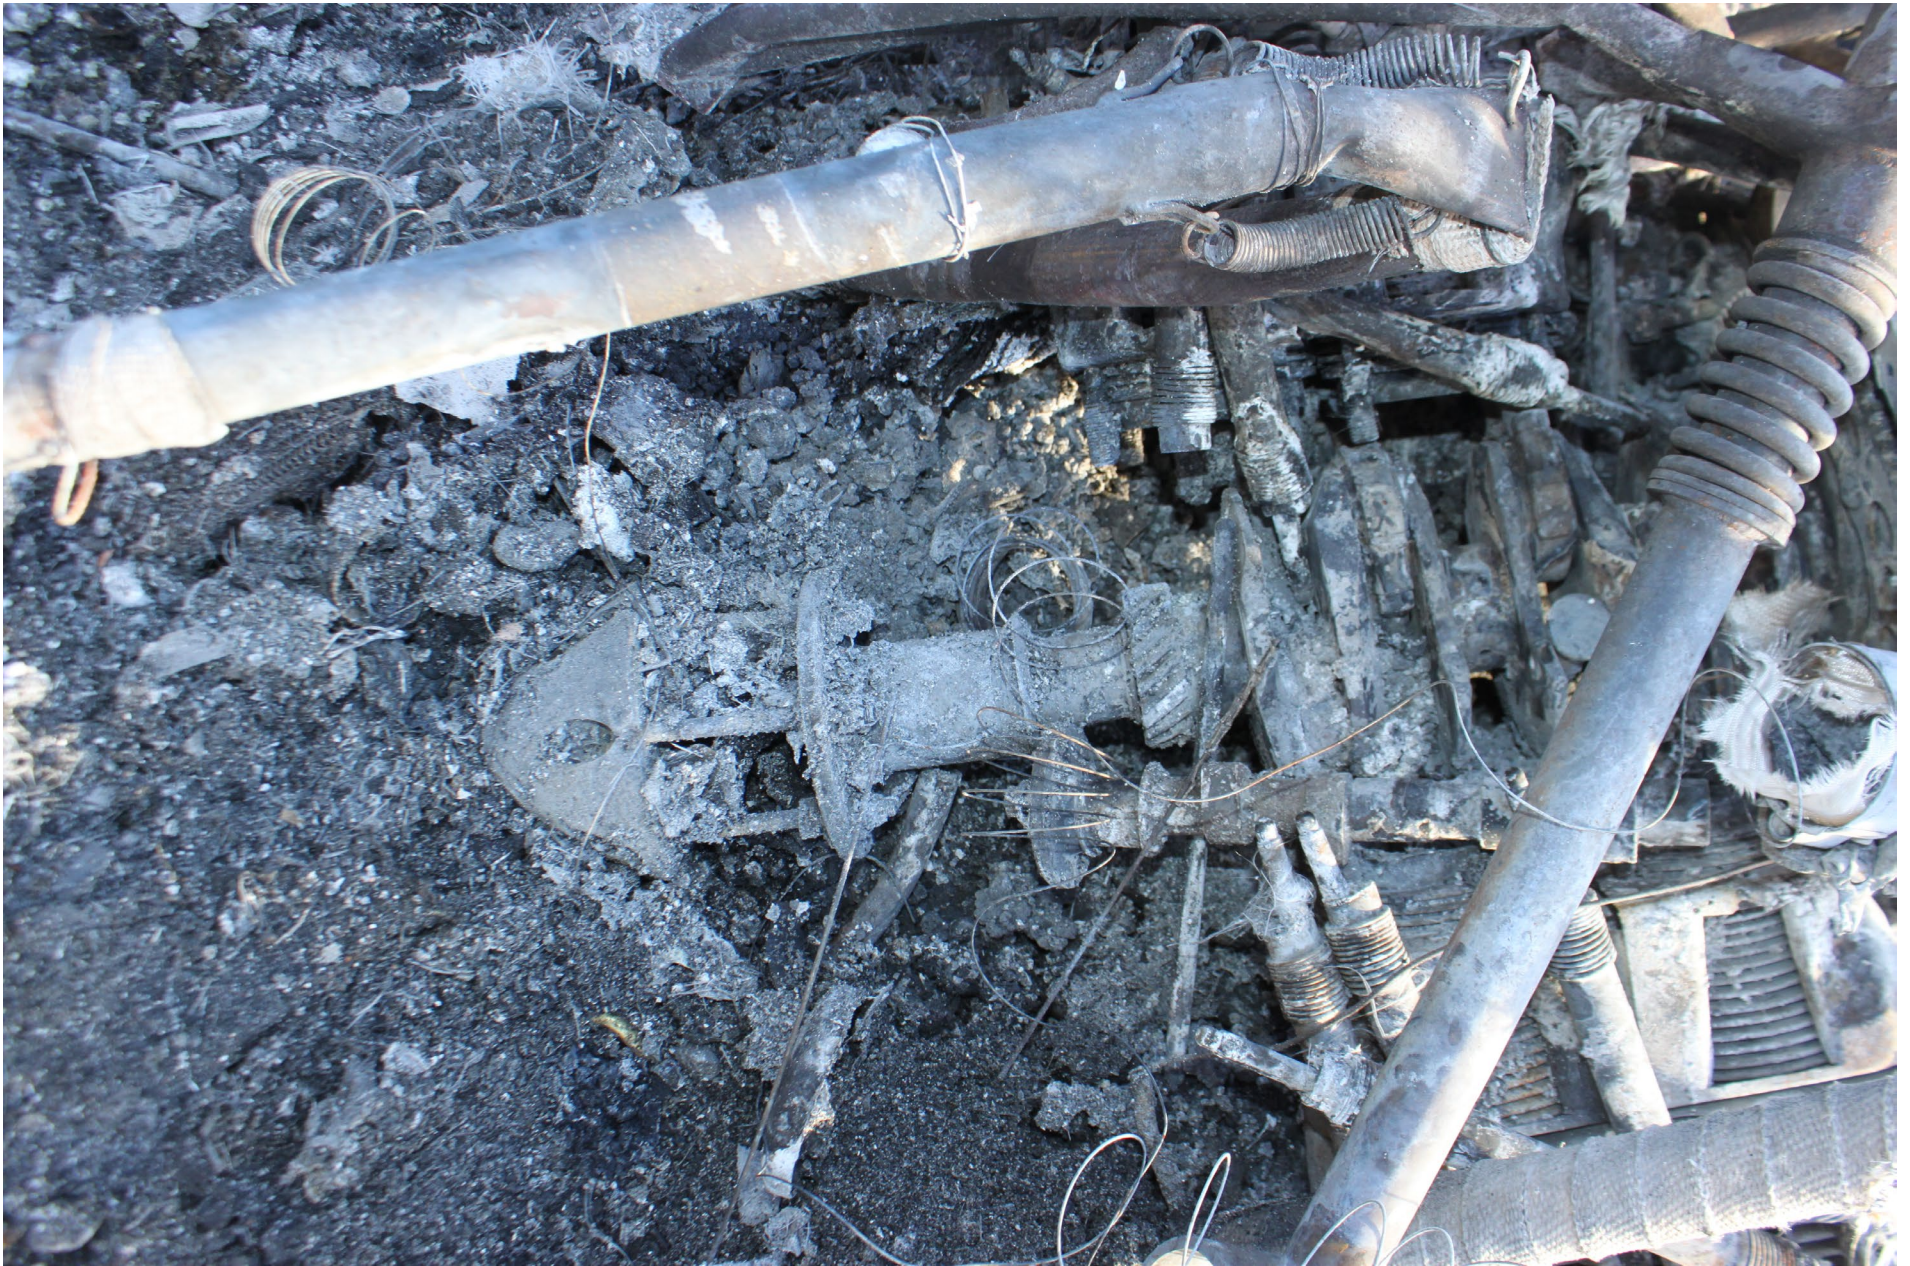
**Photo 5 - NTSB Digital Photograph. View of the Extensively Heat Damage Crankcase Halves. Note the visible Crankshaft, camshaft, and Valve Train Components.**

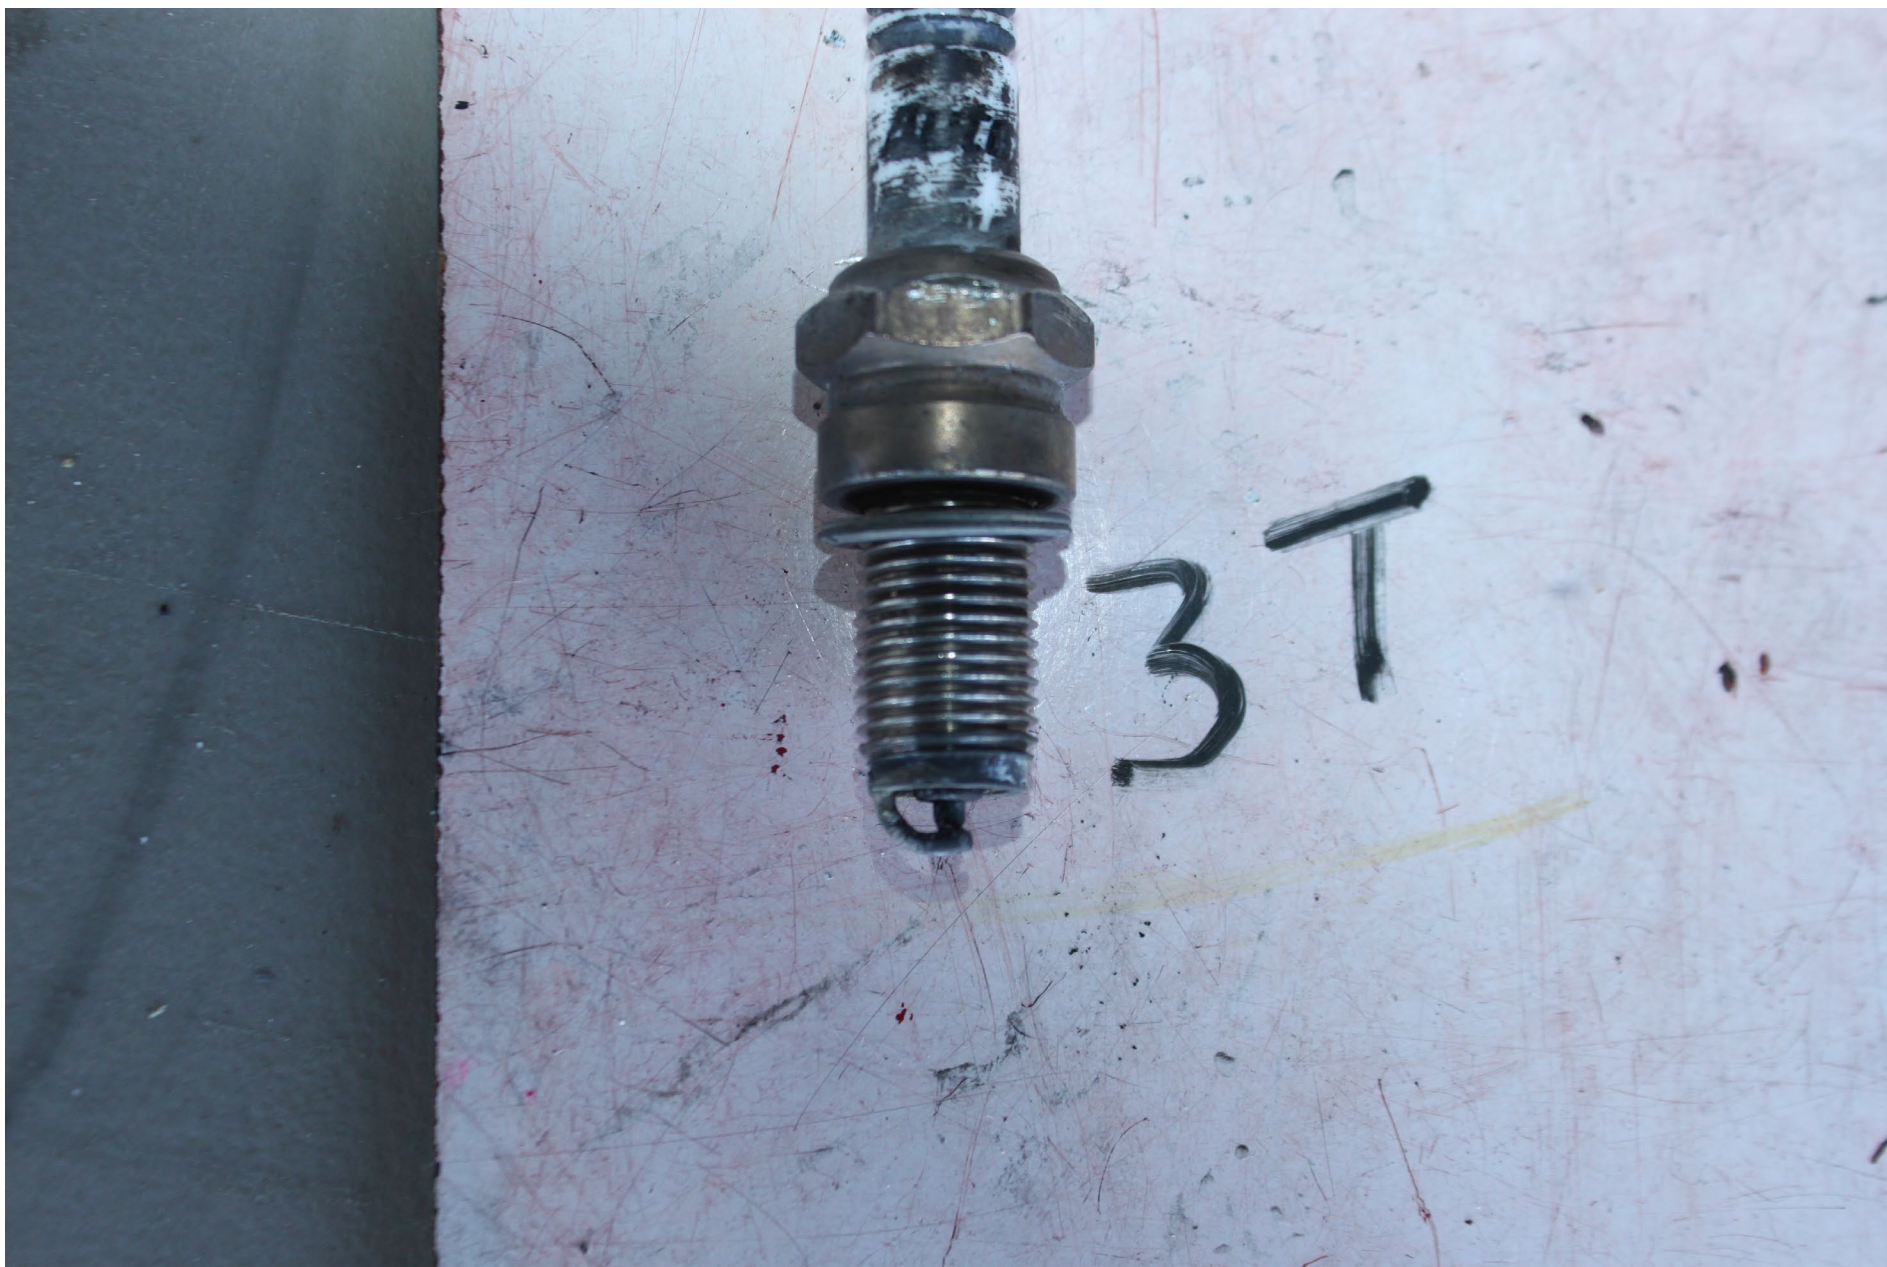
**Photo 6 - NTSB Digital Photograph. View of the No. 3 Top Spark Plug. Note the Ground Electrode Touching the Center Electrode.**

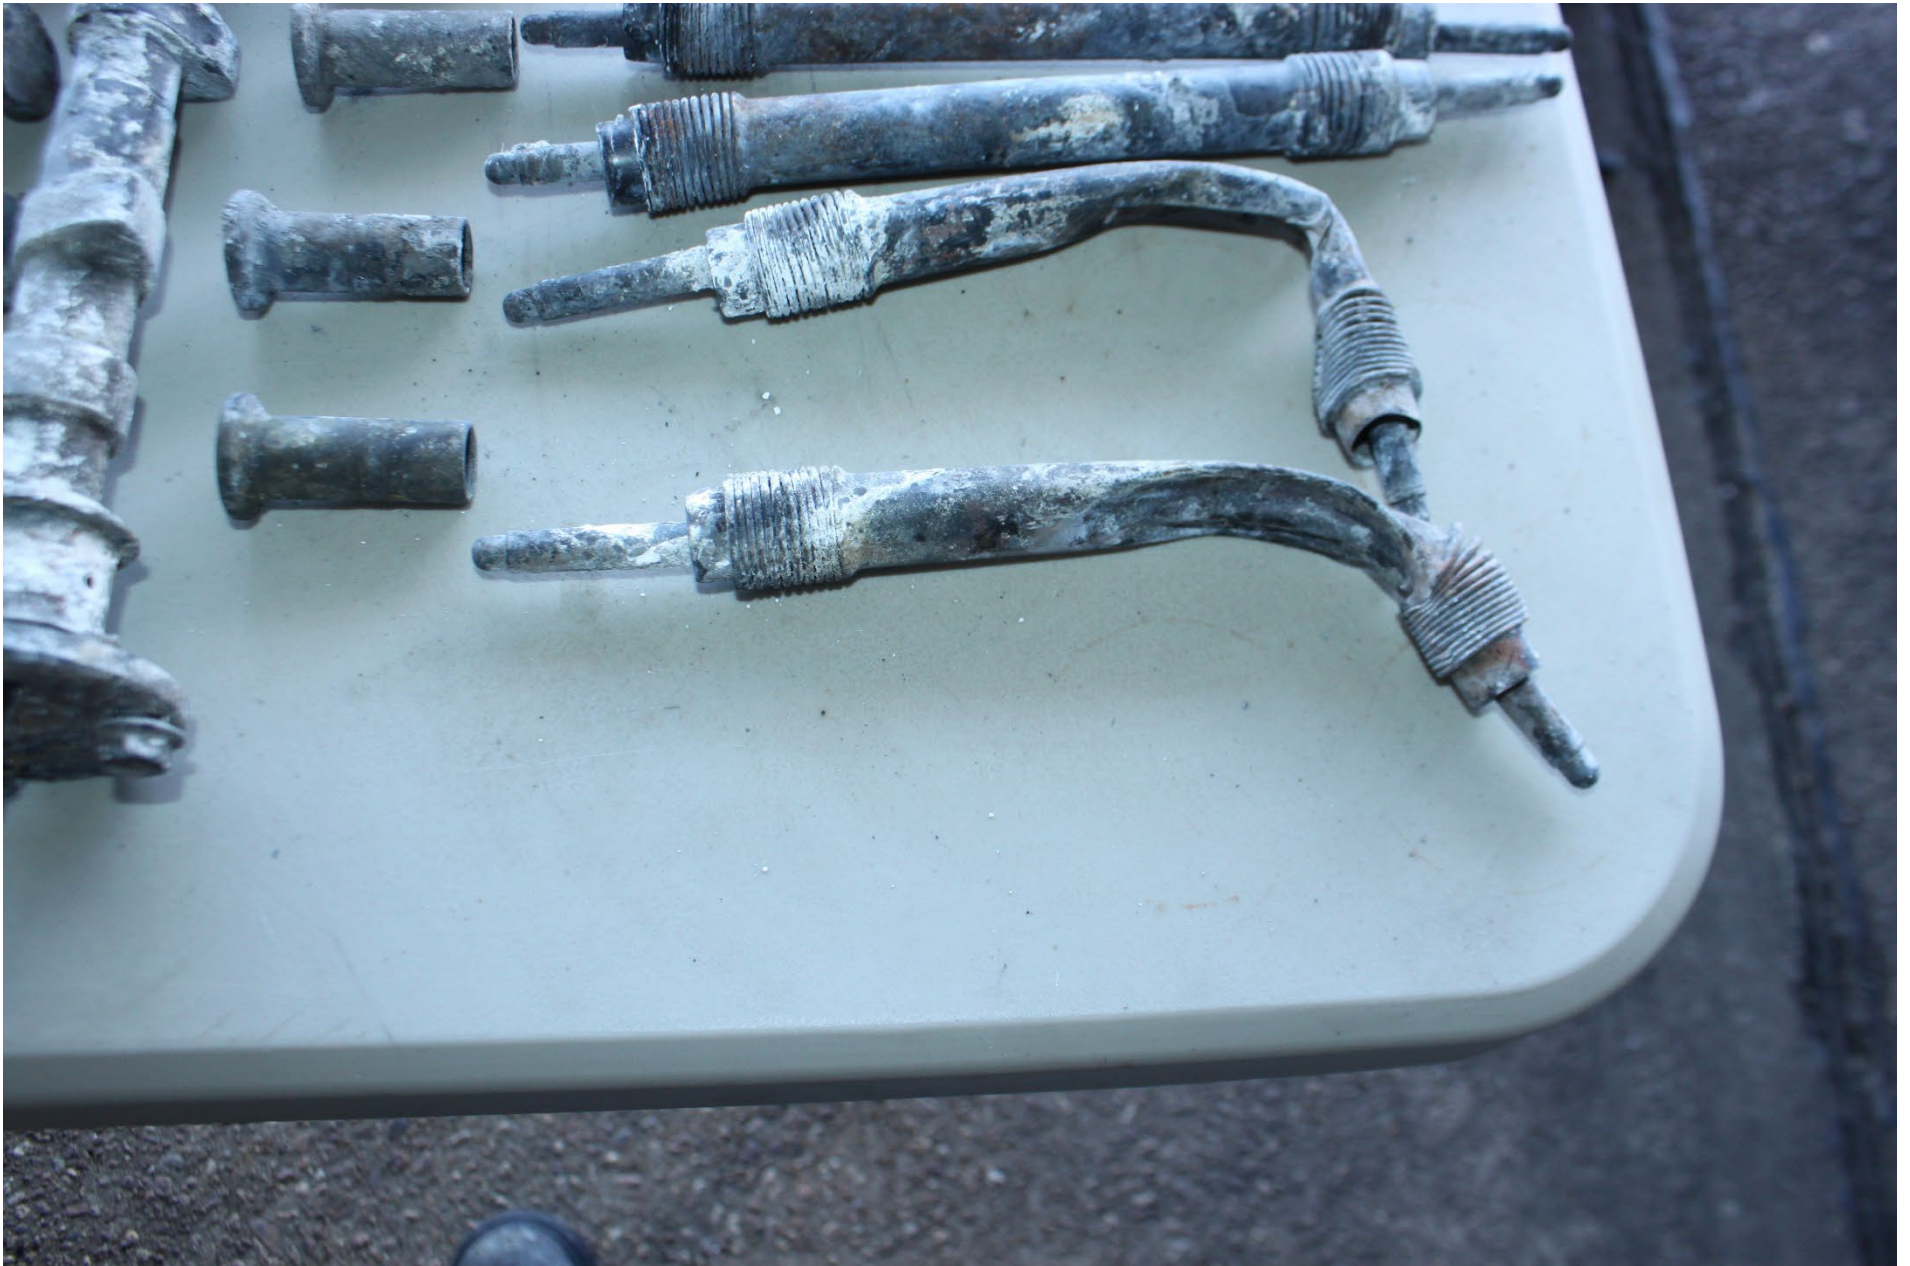
**Photo 7 - NTSB Digital Photograph. View Depicting the Pushrods and Pushrod Housings from the Nos. 1 and 2 Cylinders. Note the Near 90 degree Bending of Two of them.**
