## Air Safety Investigations Aircraft Incident/Accident Technical Report

| Aircraft Incident/<br>Accident Information | Year: 1985 | Make: Cessna | Model: T210R |
| | Serial number: 21064922 | | Registration: N6209U |
| Chief Air Safety Investigator: Henry J. Soderlund | | Report #: ASI-21-DL-T | Report date: 04-26-22 |

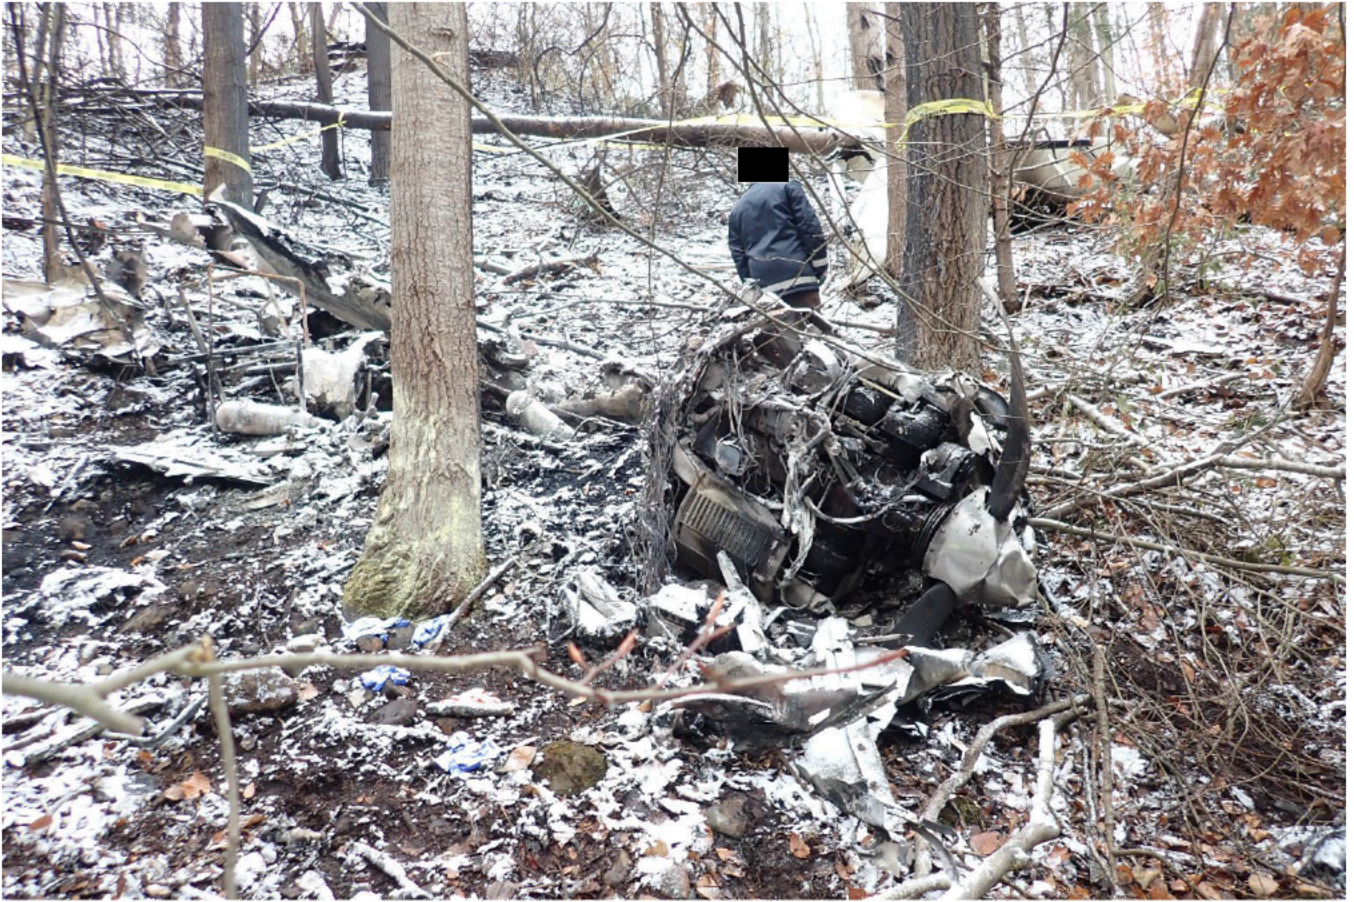
TAI On Site ASI-21-DL-005.jpg

During the descent, the left wing impacted trees and partially separated. The left wing tip was found approximately 180' before the main wreckage. The remainder of the aircraft was found at the impact site. The post-impact fire consumed the majority of the fuselage and a portion of the left wing. Oil was observed on the belly of the aircraft and the bottom of the left horizontal stabilizer.

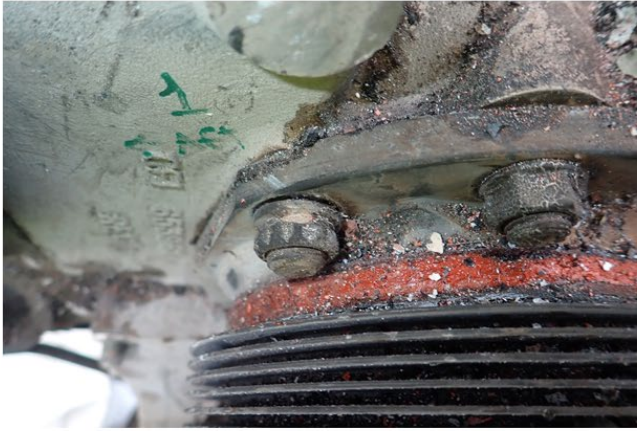
The four thru bolts connecting cylinders 5 and 4 and cylinders 3 and 2 were each missing a nut. The thru bolts on the aft side of cylinder 1 were loose.

Cylinder 1 - top, aft, rear

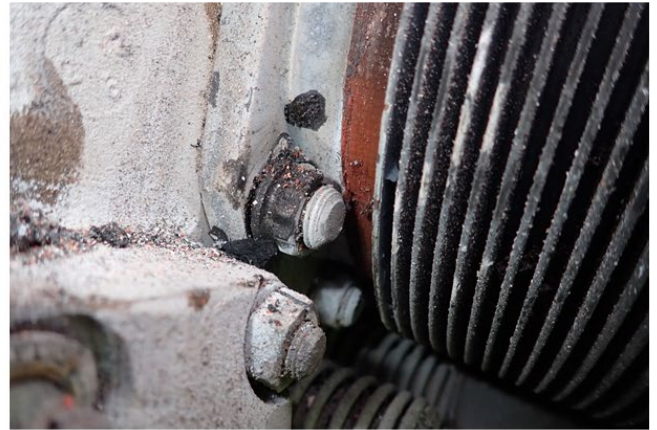
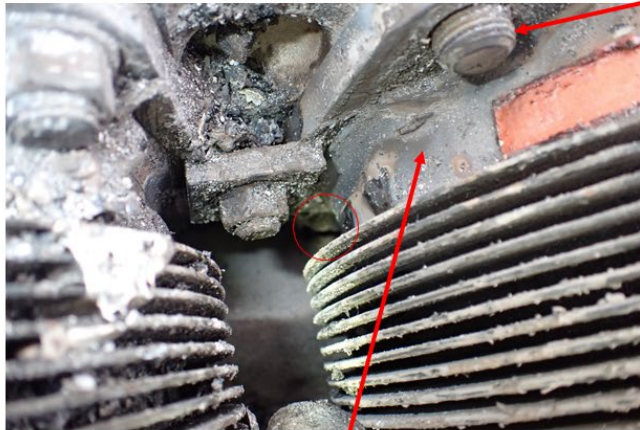
Cylinder 1 - bottom, aft, rear

Cylinder 2

Same thru bolt

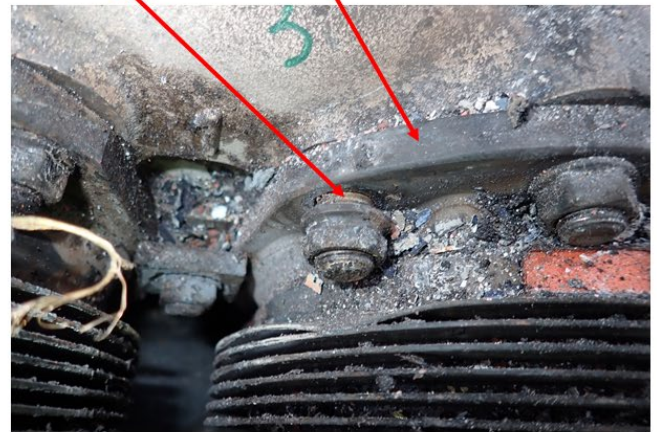
Cylinder 3 – Connecting rod intact

Cylinder 3

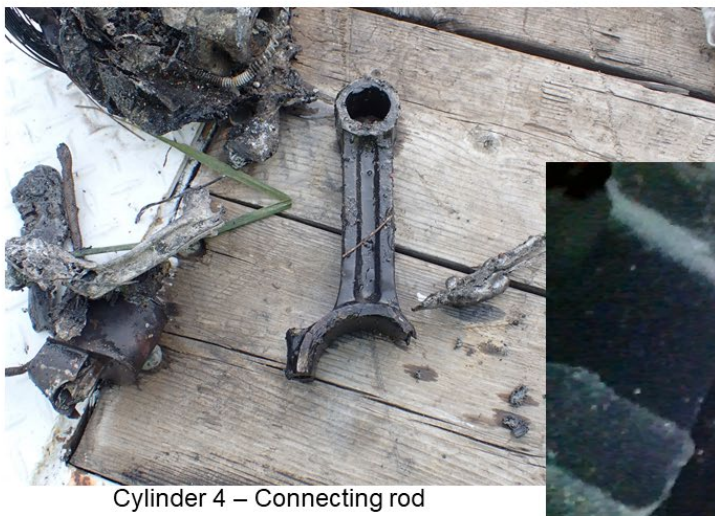
Cylinder 4 – Connecting rod separated at crankshaft, piston end intact, broken at crankshaft, piston top clean

Cylinder 4 – Borescope  
Piston

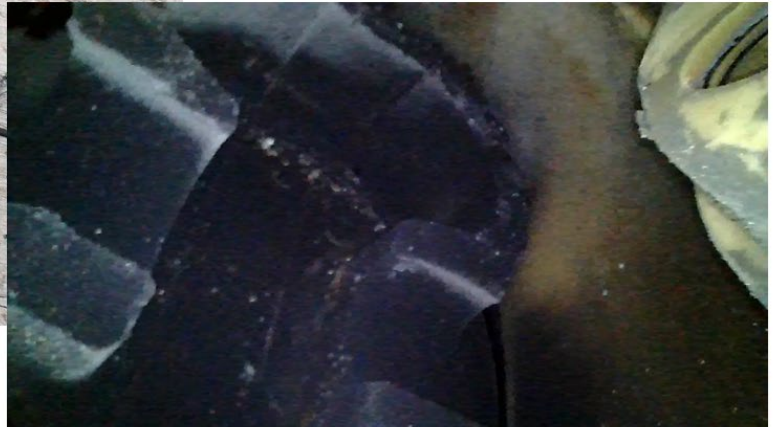
Cylinder 5 top spark plug

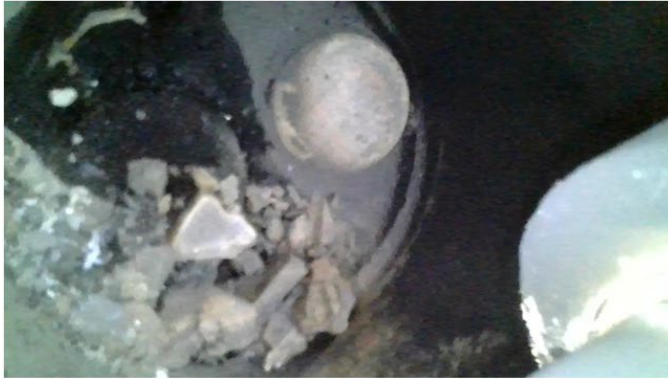
Cylinder 5 – Piston fractured into multiple small pieces, piston pin still in connecting rod

Cylinder 5 borescope -  
Looking from base of cylinder towards head

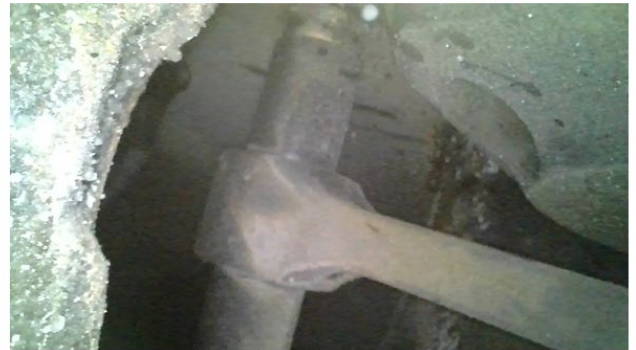
Cylinder 5 borescope -  
Piston pin and connecting rod

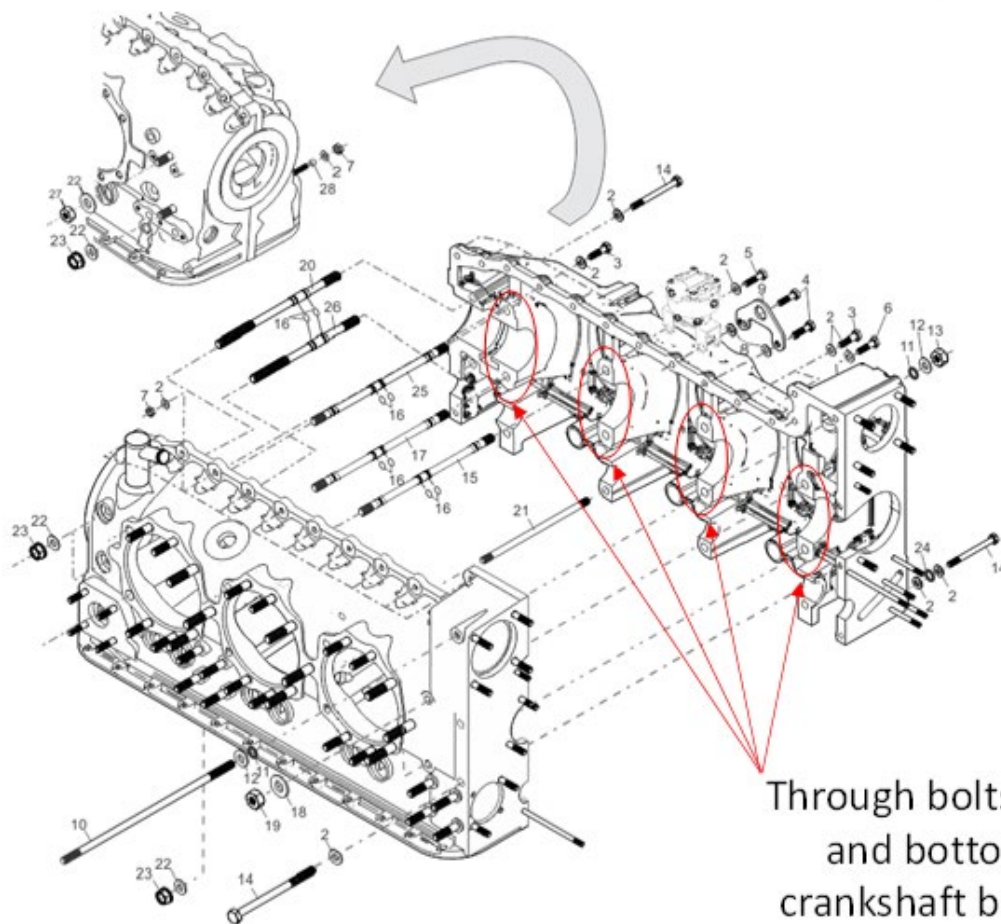
Through bolts on top  
and bottom of  
crankshaft bearings
