# National Transportation Safety Board

ERA22FA076

## ACCIDENT INVESTIGATION EXAMINATION REPORT

Location: Grove City, Pennsylvania  
Date: November 24, 2021  
Time: 1746 EST  
2244 UTC  
Airplane: 1985 Cessna T210R; N6209U

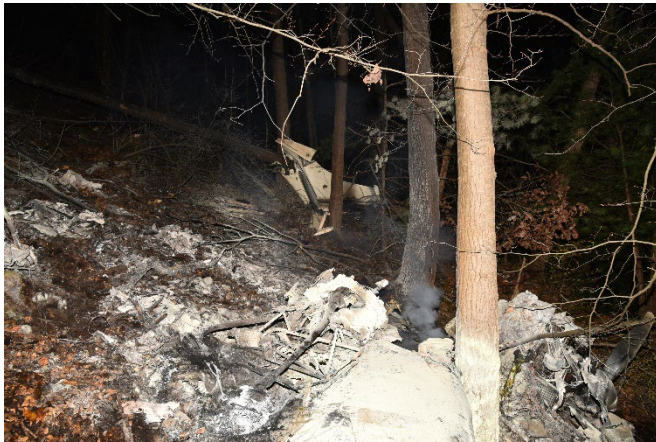
The airplane impacted trees and steep terrain at an elevation of about 1,200 ft, about 1.5 miles from the approach end of runway 28 at 29D. (Figure 1&2) The initial tree impact was about 200 ft and on a heading of about 230° to the main wreckage which came to rest on a 35° incline against several trees, about 40 feet up from level terrain that bordered a stream. The post-impact fire consumed most of the fuselage. Oil was observed on the belly of the aircraft and the bottom of the left horizontal stabilizer.

Figure 1 Main wreckage smoldering in foreground and empennage up hill about 30 ft away.

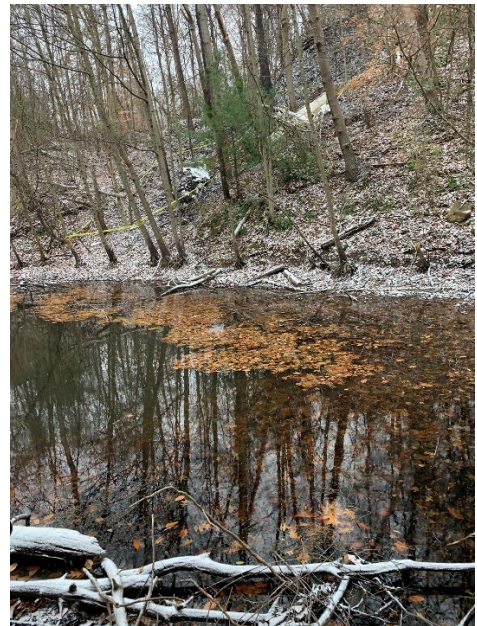
Figure 2 Wide view of wreckage on hill.

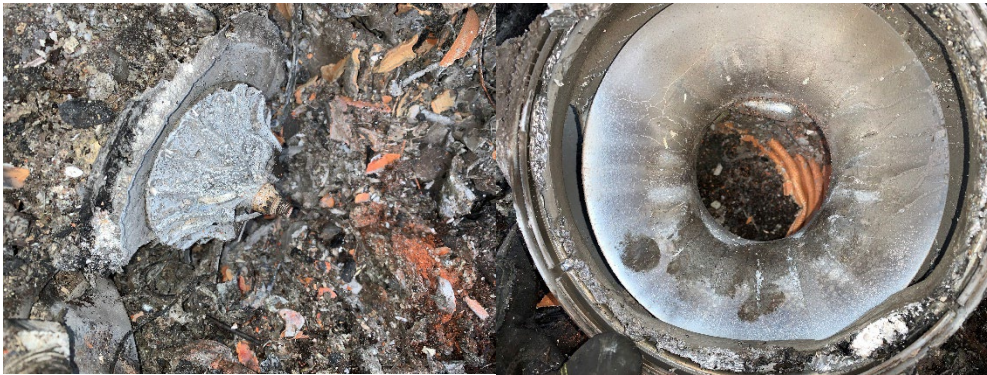
The turbocharger was examined and static impact impressions consistent with contact from the compressor wheel. There was no rotational damage to the blades or housing. (Figure 3)

Figure 3 Turbo and compressor wheel showing static impact marks.

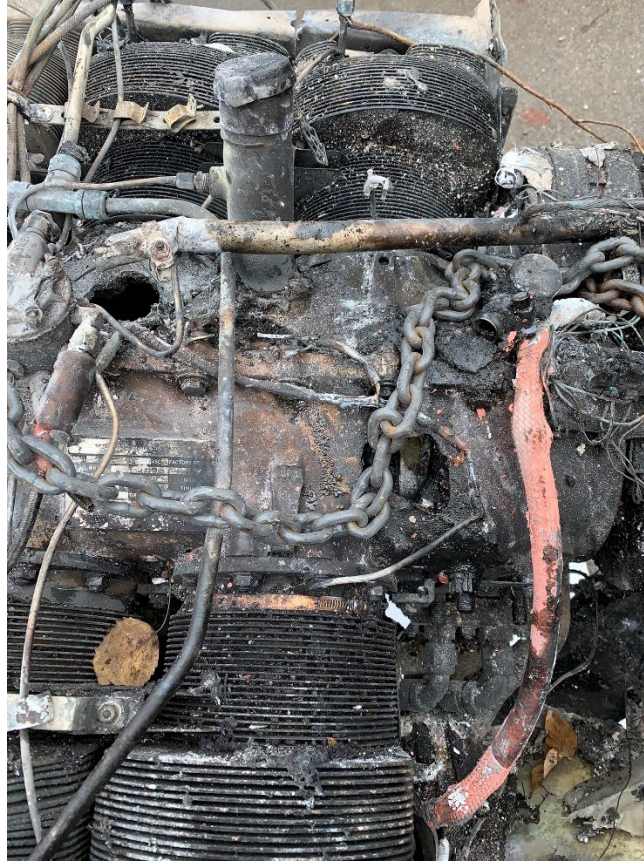
Two holes were observed in the top of the engine crankcase. (Figure 4) One hole was located forward of the No. 5 cylinder and was about 2 inches in diameter. The second hole was located adjacent to the No. 4 cylinder and was about 3 inches in diameter. The No. 4 cylinder connecting rod was separated from the crankshaft. The No. 5 cylinder piston was fragmented with the piston pin still installed in the connecting rod.

Figure 4 Holes on top of engine case.

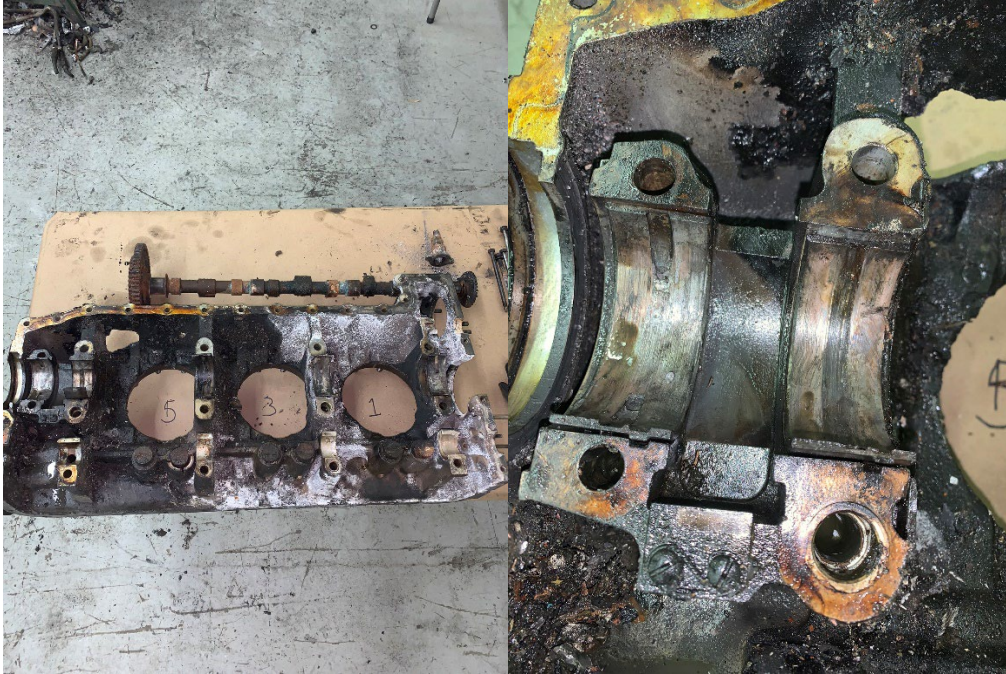
Engine crankshaft removal/disassembly revealed the crankshaft main journal bearings showed evidence of polishing and metal to metal contact. The crankshaft and camshaft were intact, although exposed to significant heat.

Figure 5: No. 5, 3, 1 Engine case half interior and forward bearings.

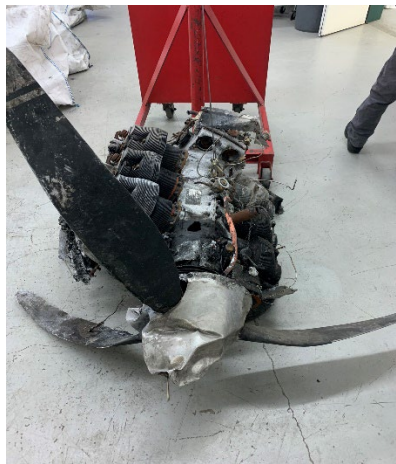
The three-bladed propeller and spinner remained attached to the crankshaft flange. Two of the three propeller blades were bent aft in a uniform manor. The third blade was bent aft and exhibited severe gouges and scrapes on the upper surface and leading edge of the blade tip, but little chordwise scraping was observed on all three blades. The propeller spinner was crushed uniformly from the front to aft and exhibited no evidence of rotational damage.

Figure 6 Propeller condition
