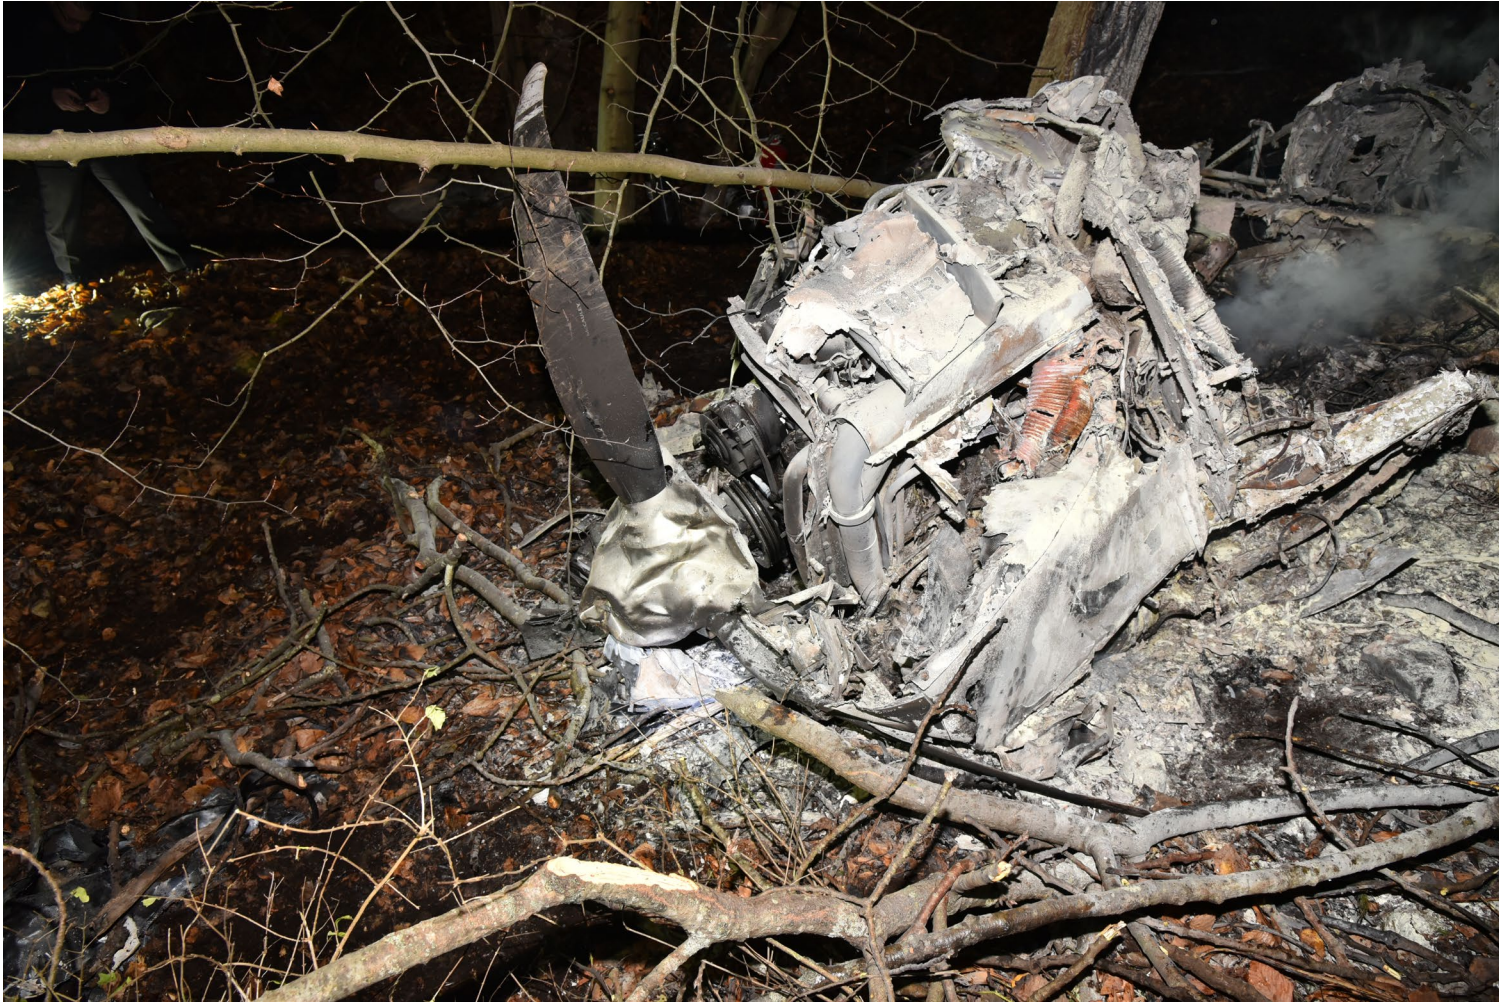
**Photo 1 – View of engine shortly after arrival of fire personnel. (Courtesy of Pine Township)**

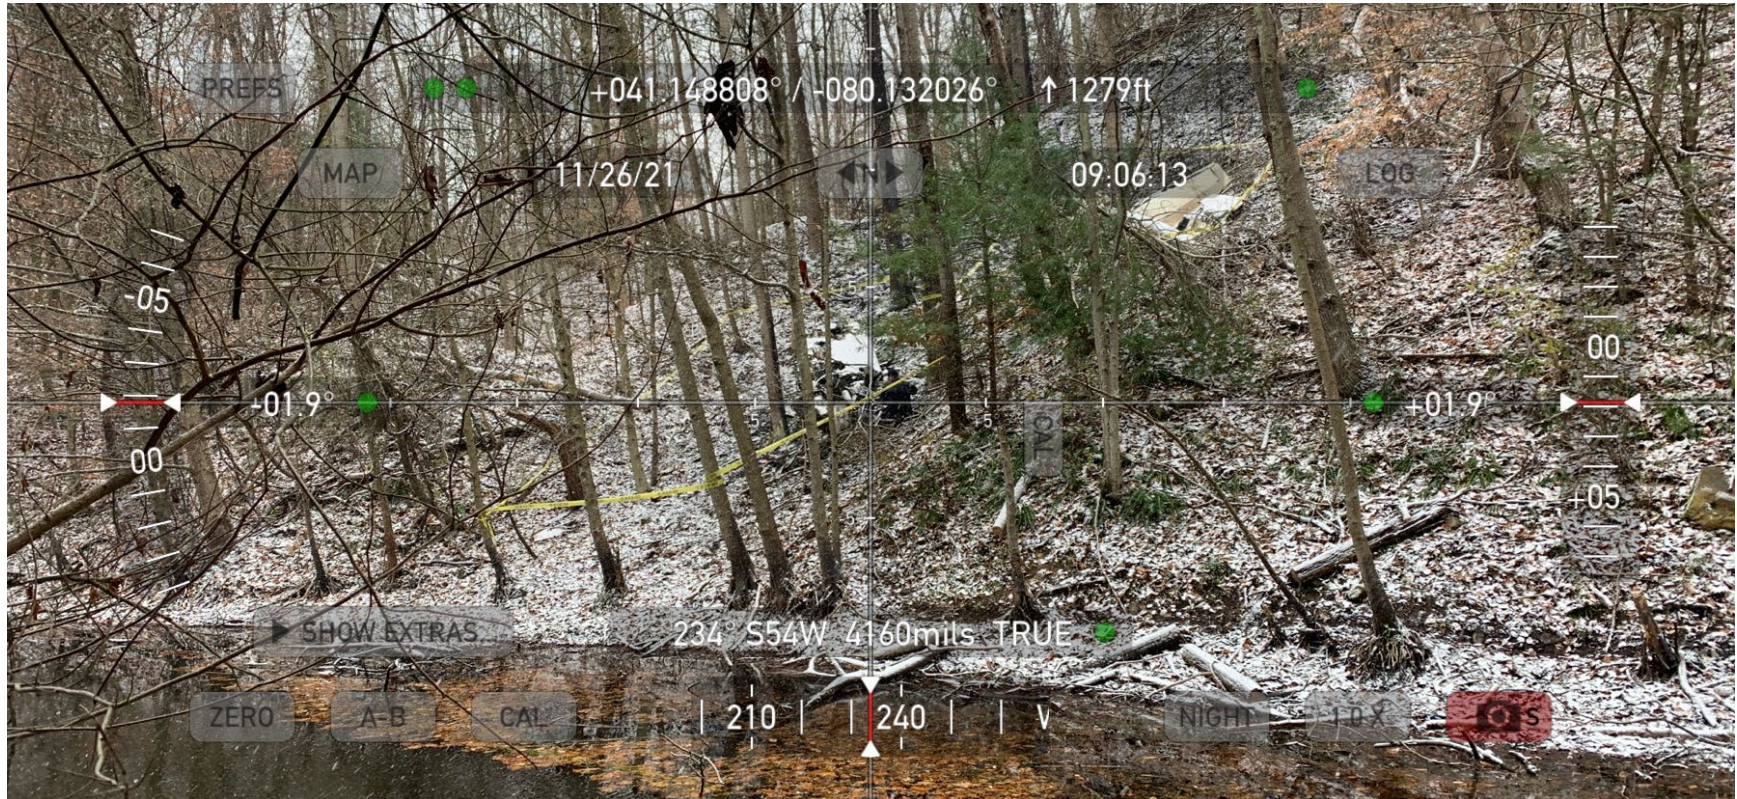
**Photo 2 – Overall view of the wreckage location showing geographic details.**

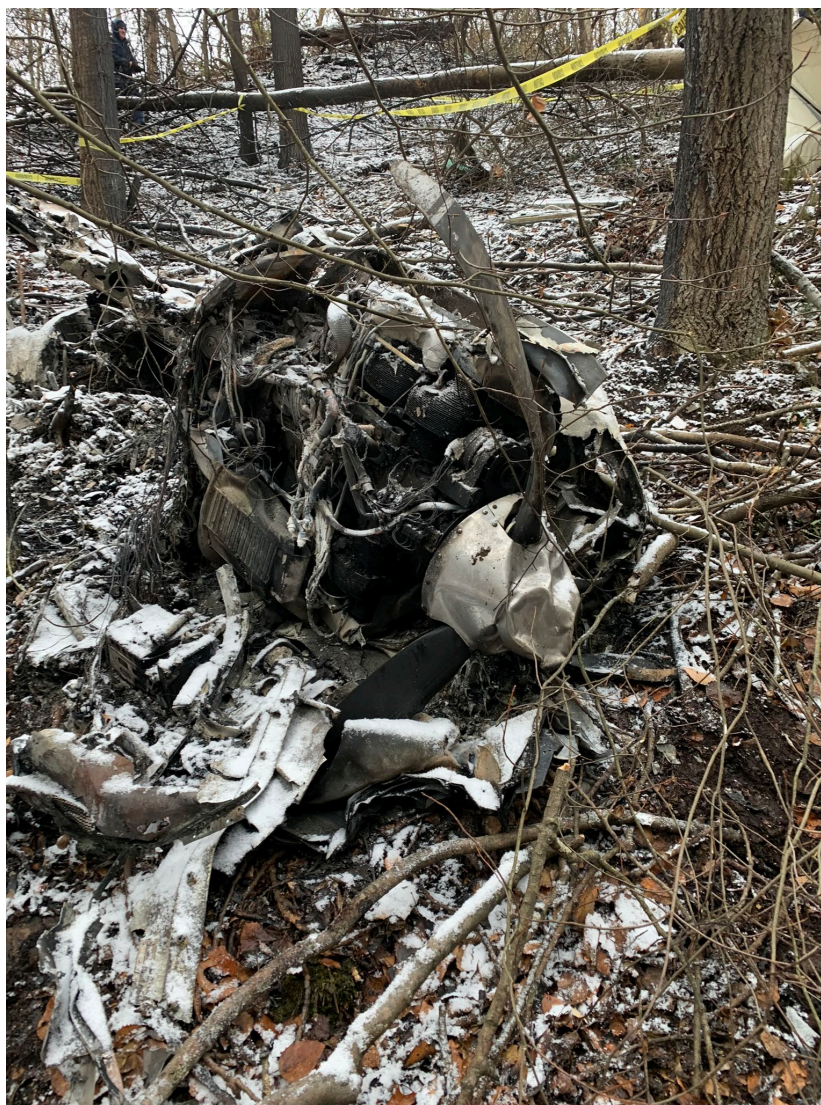
**Photo 3 – View of engine and propeller the following day. Note the snow was morning after the accident. (Courtesy of Textron)**

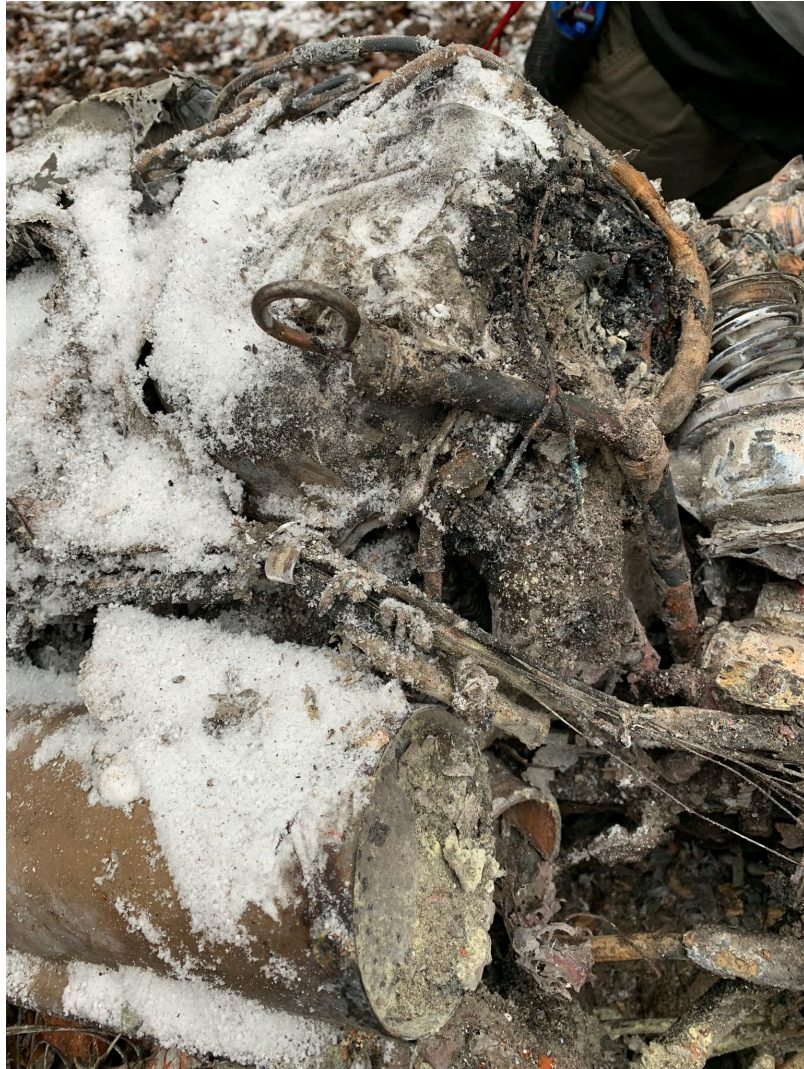
**Photo 4 – View of oil dip stick as discovered.**

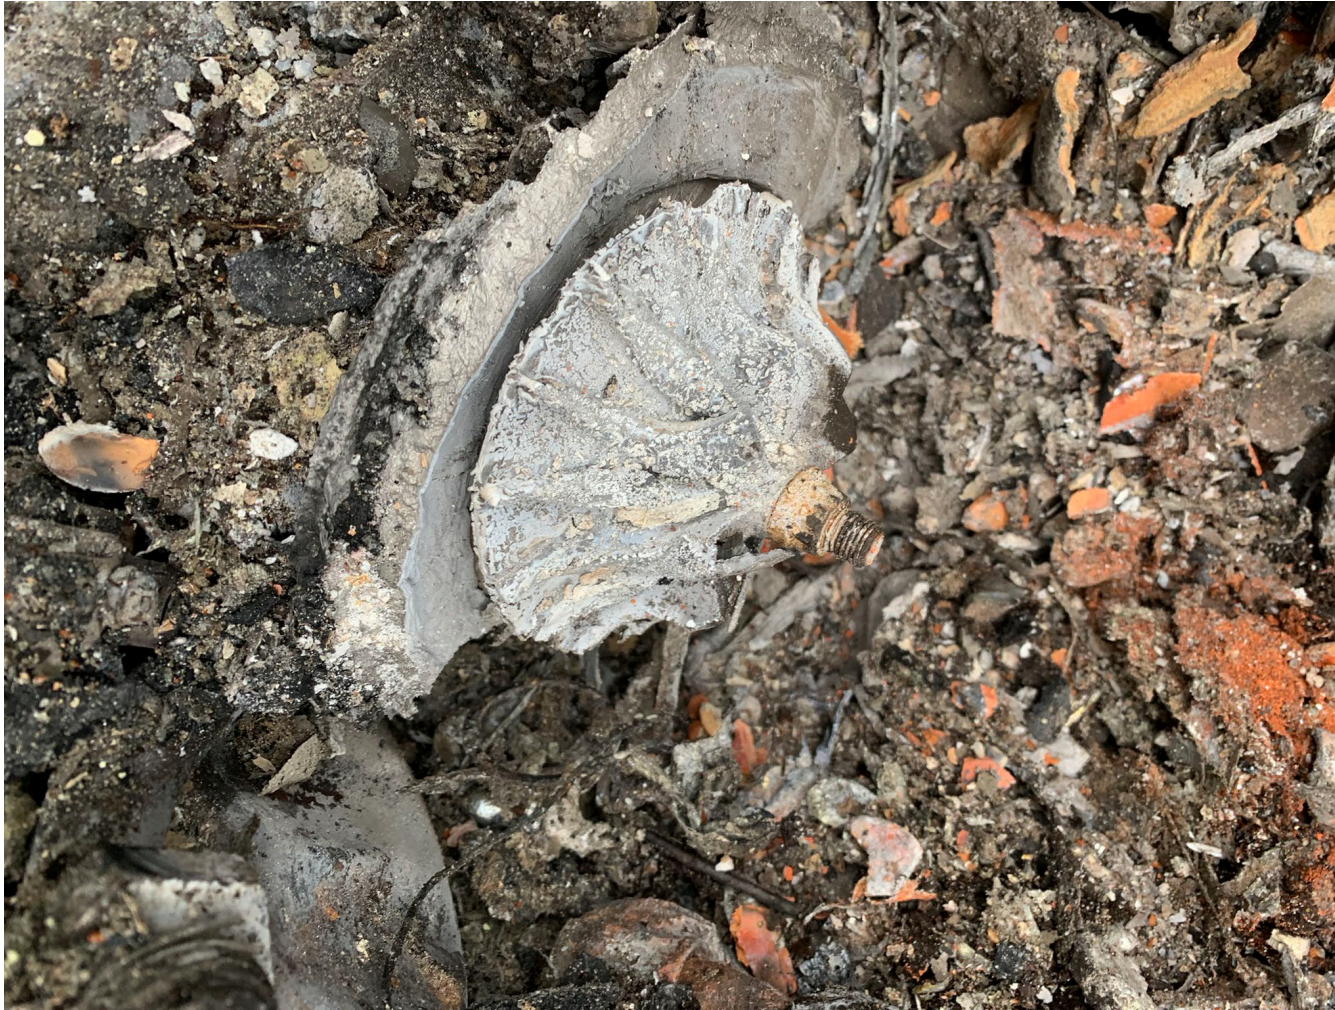
**Photo 5 – View of turbo compressor.**

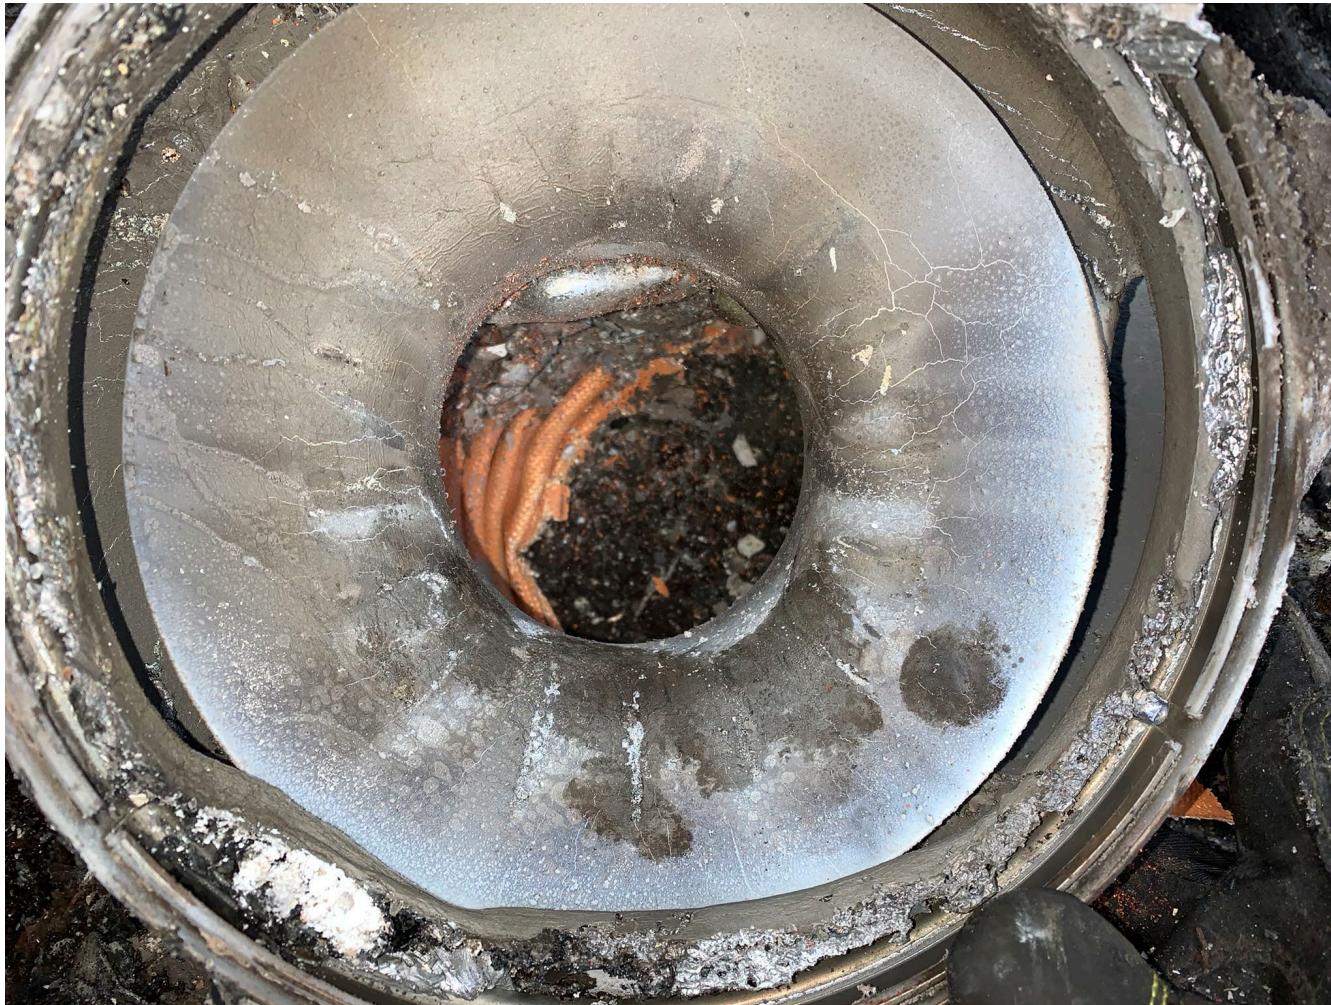
**Photo 6 – View of turbo compressor housing. Note static impact marks.**

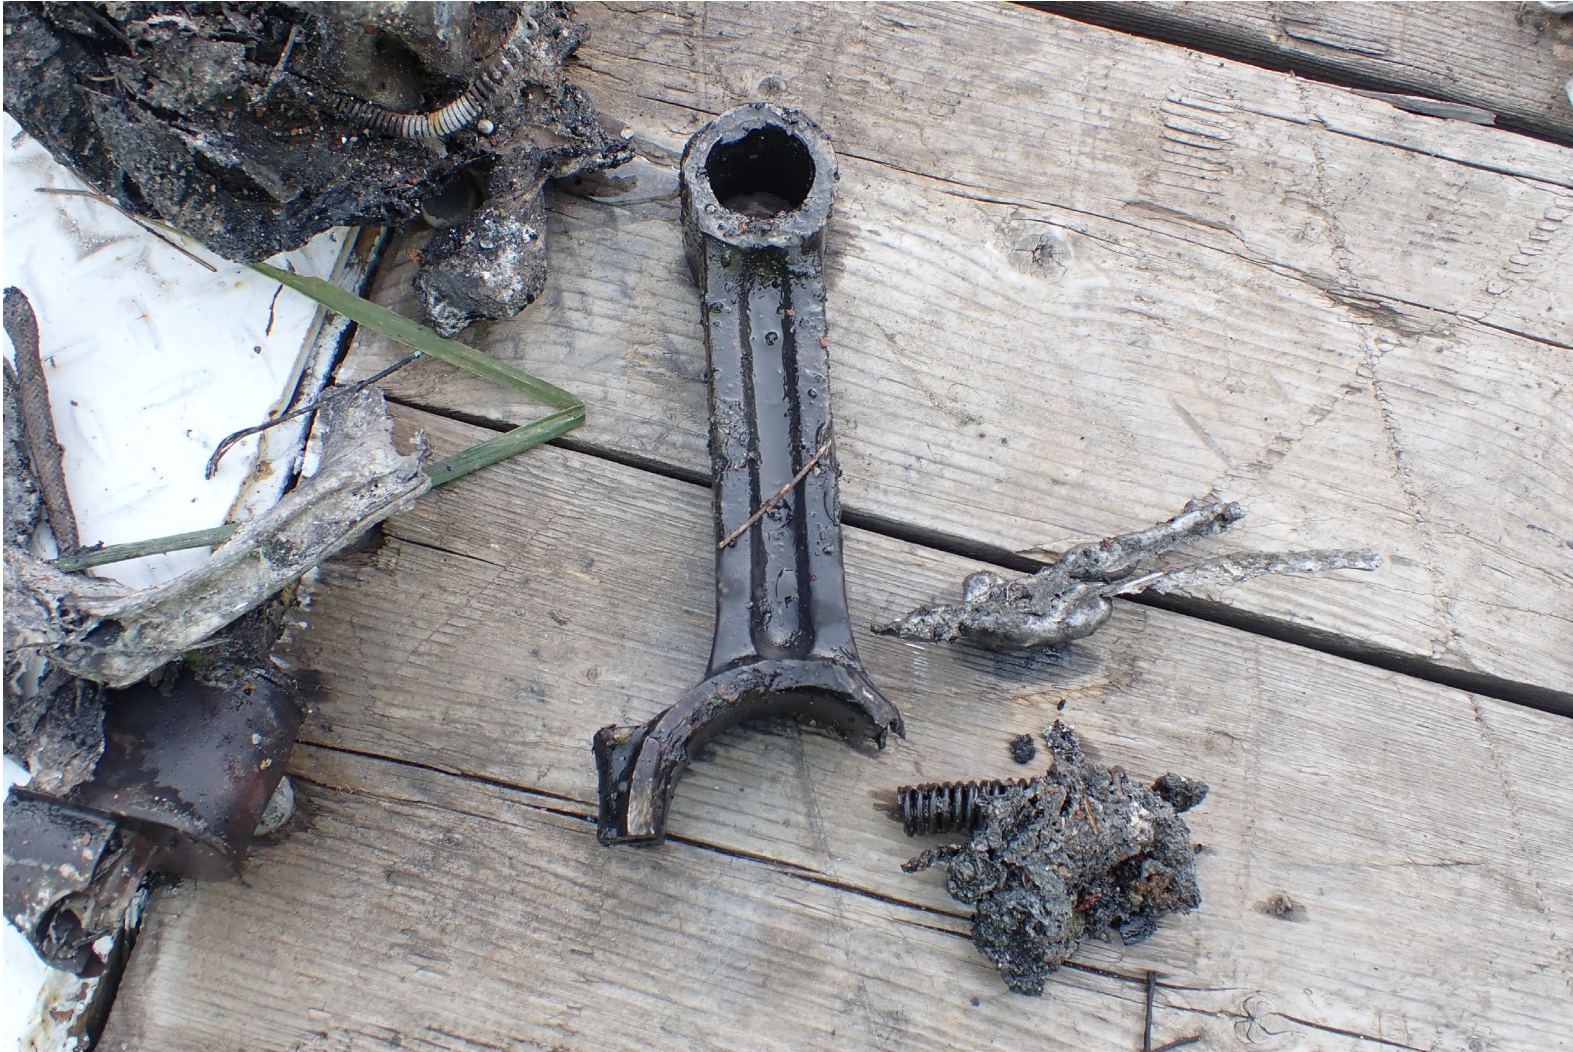
**Photo 7 – View of number 4 connecting rod discovered outside of engine. (Courtesy of Textron)**

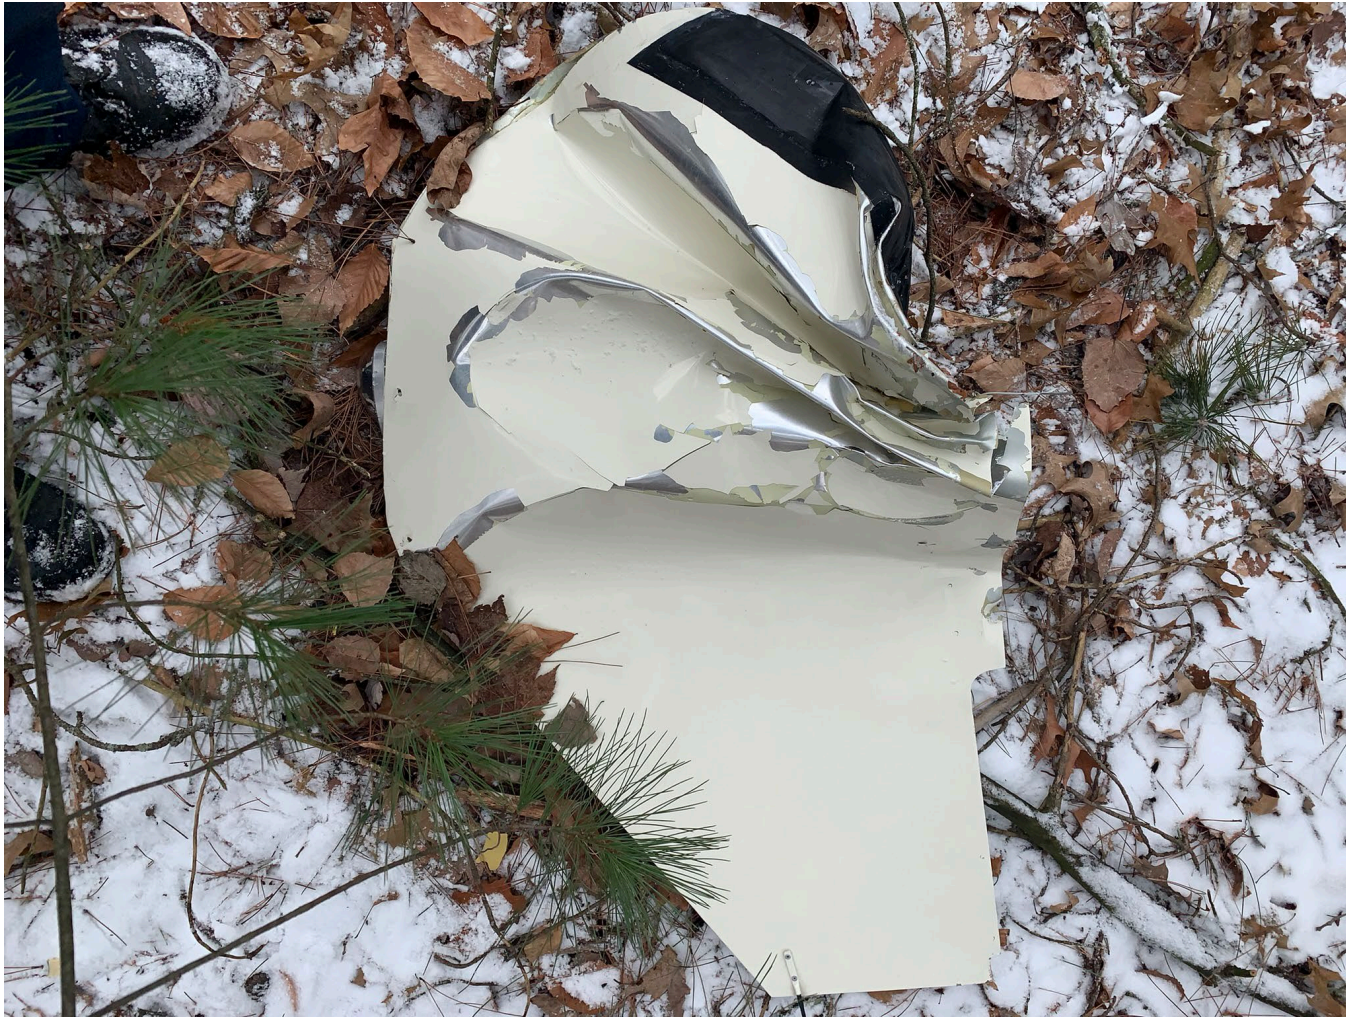
**Photo 8 – View of left wingtip that separated after striking trees about 200 feet from main wreckage.**

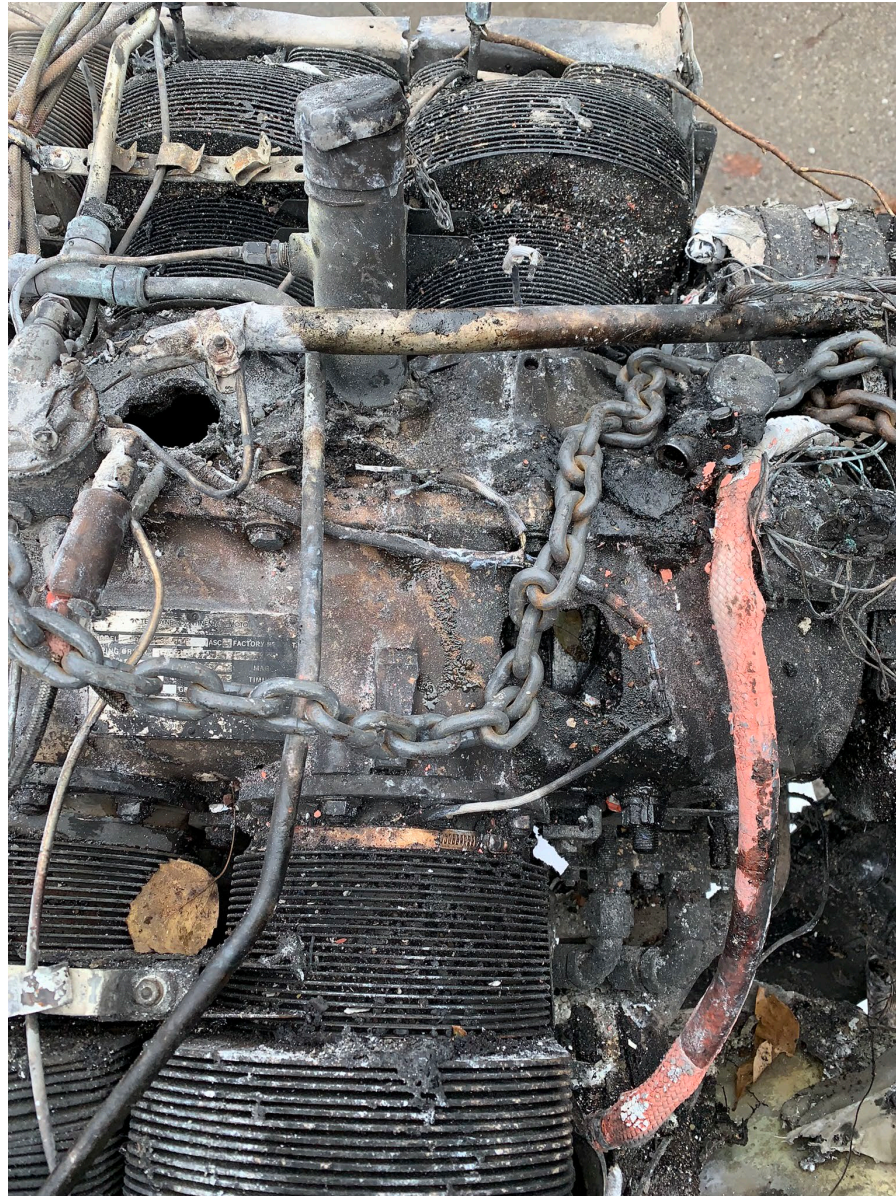
**Photo 9 – View of top side of engine showing 2 holes.**

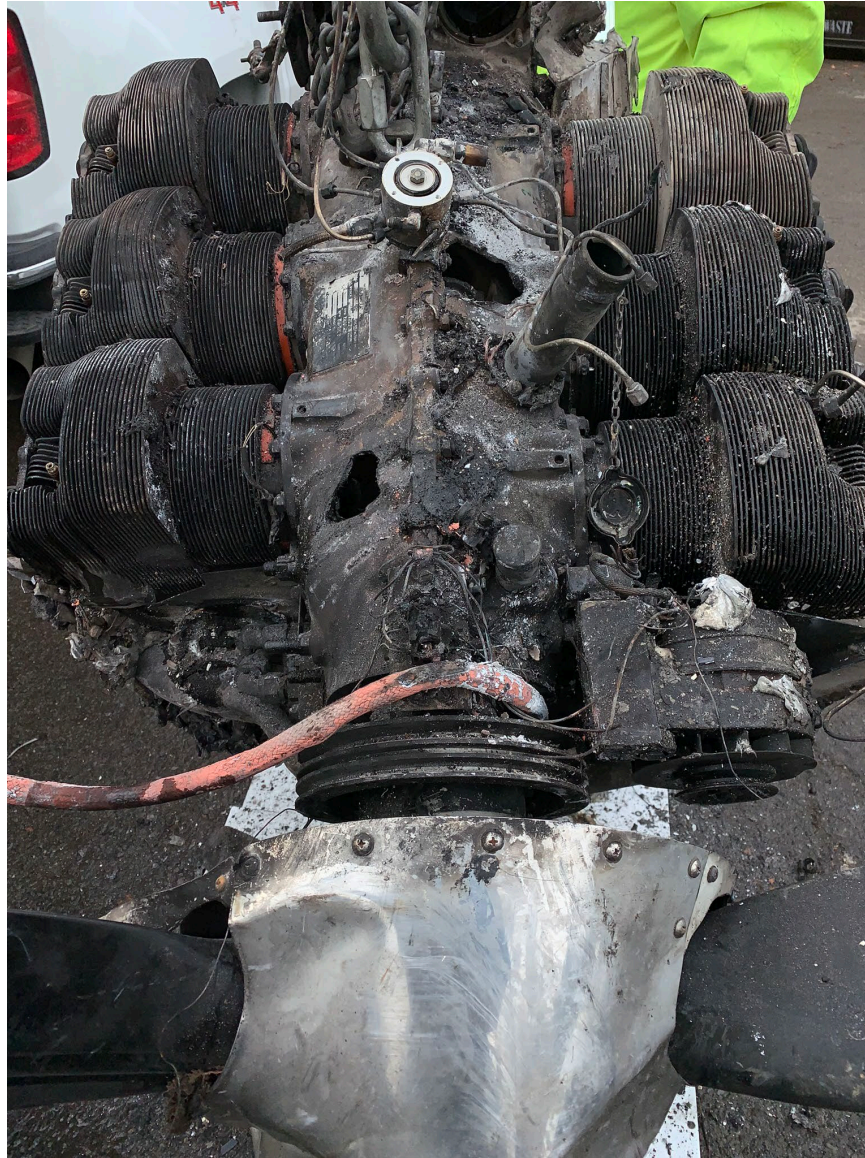
**Photo 10 – Entire top view of engine showing holes in case and propeller spinner.**

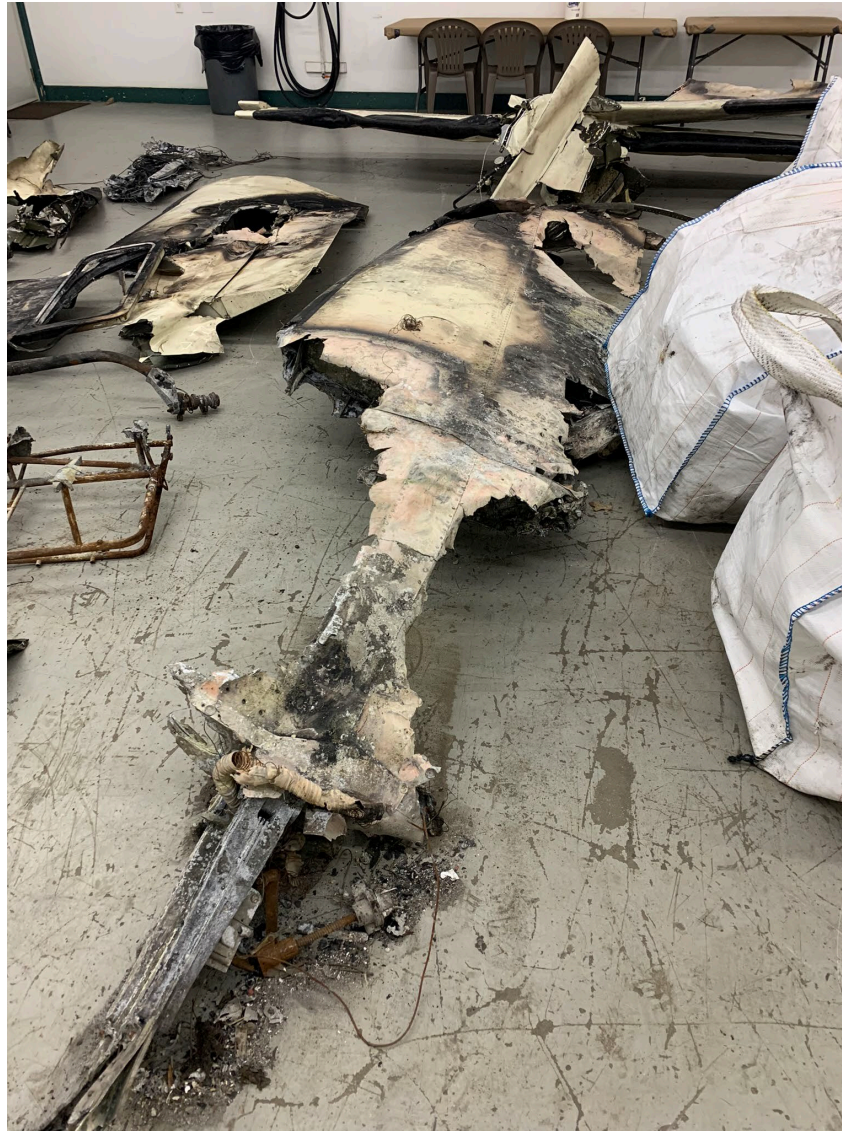
**Photo 11 – View of left wing and spar during wreckage layout.**

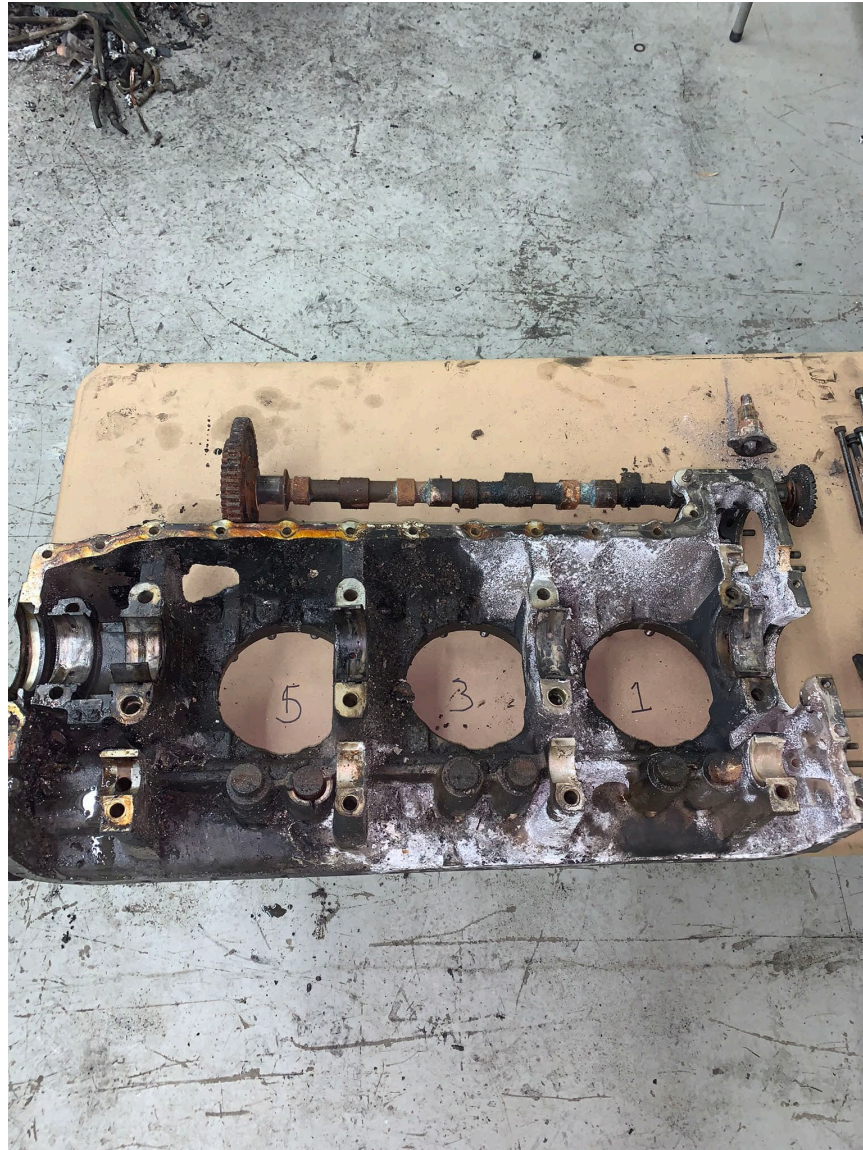
**Photo 12 – View of opened engine case half and camshaft showing bearings.**

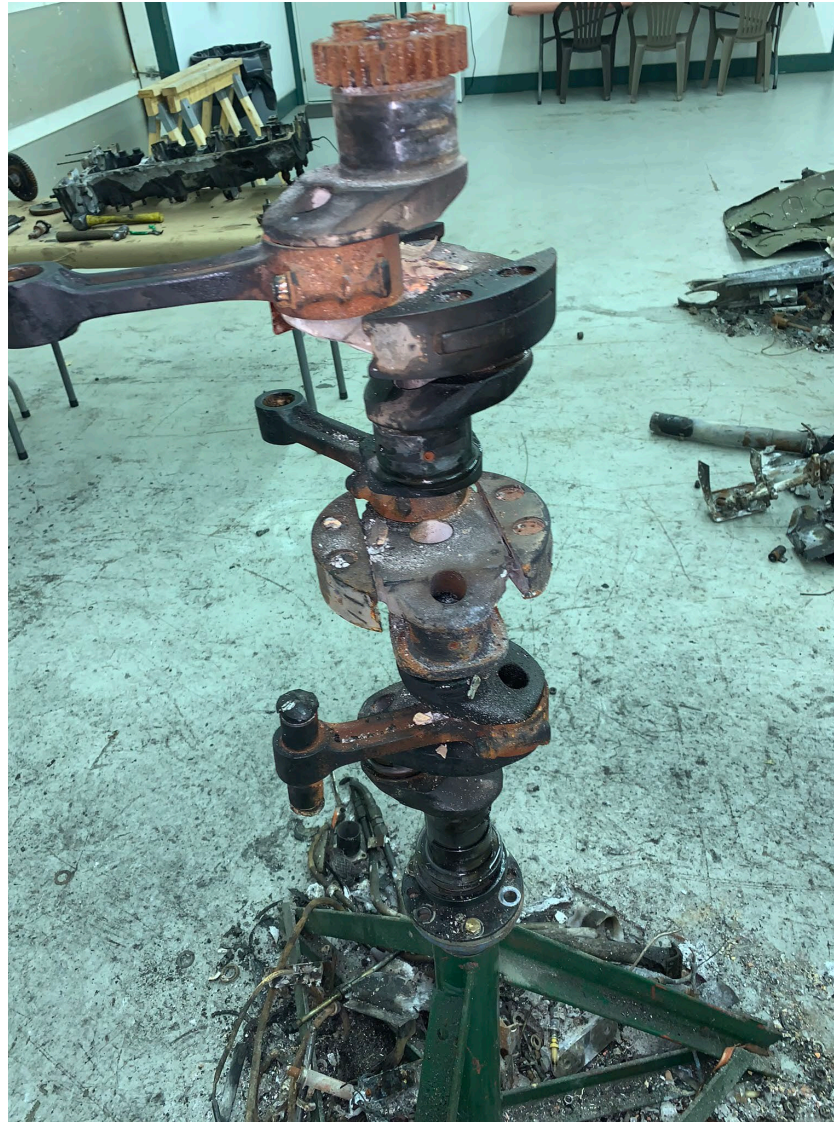
**Photo 13 – Overall view of condition of crankshaft after removal.**
