# National Transportation Safety Board

ERA22FA083

## **AIRWORTHINESS FACTUAL REPORT**

Location: Statesboro, Georgia  
Date: December 7, 2021  
Time: 2124 Local EST  
0224 UTC  
Airplane: Cessna 182, N5776B

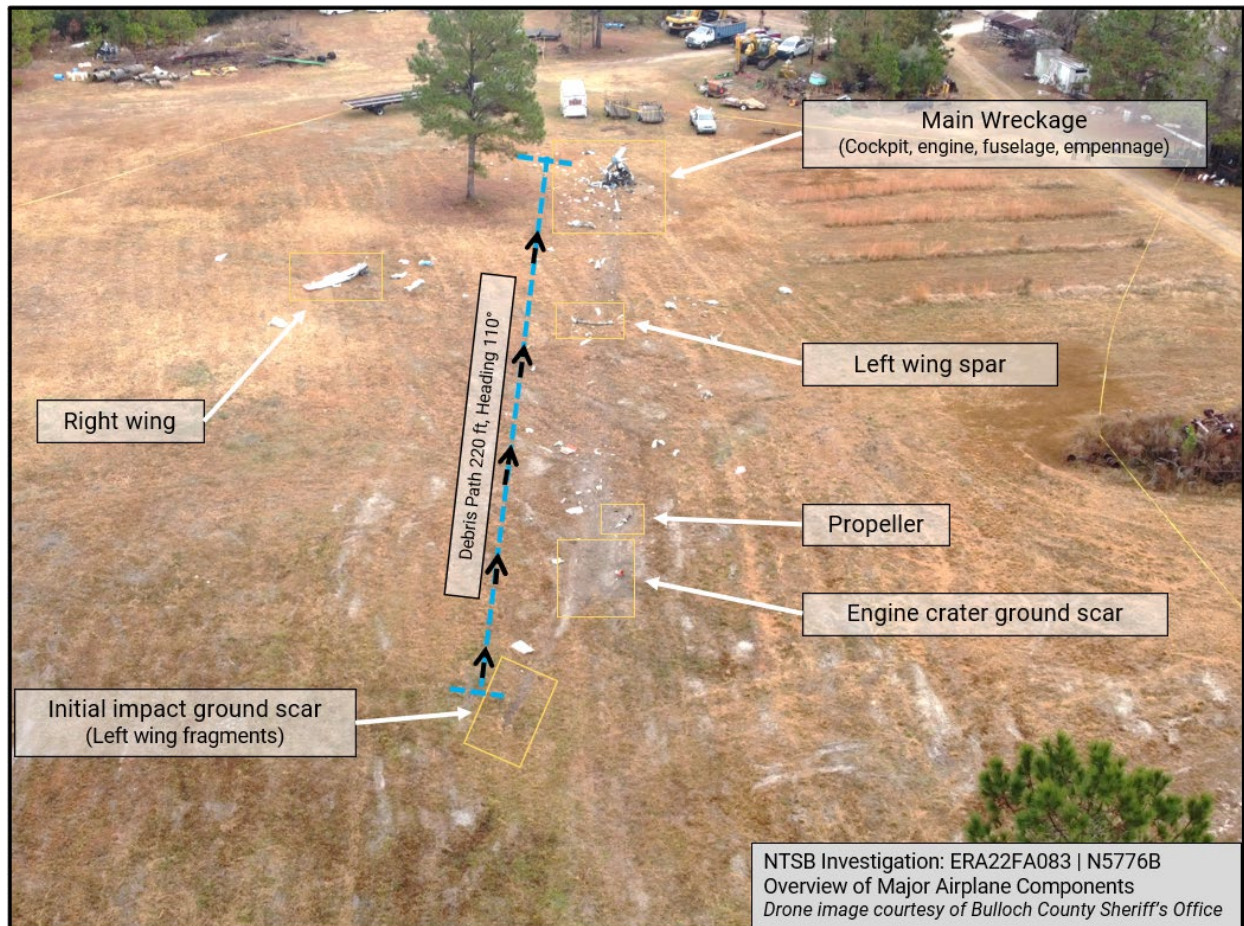
The wreckage was highly fragmented and was oriented on a debris path of about 110° magnetic heading. The initial impact ground scar was located about 220 ft from the main wreckage.

All major components of the airframe and engine were located in the debris path. Debris located in the initial impact scar and a subsequent large engine impact crater indicated that the airplane impacted terrain in a descending left bank. This was evident due to the co-location of the left-wing tip, a left-wing fragment, and the ADS-B antennae observed at the initial impact crater. The propeller separated from the engine and was located near the engine impact crater. Evidence of a post-crash was observed at the main wreckage. Figure 1 provides an overview of the wreckage debris path.

**Figure 1: Overview of the wreckage debris path**

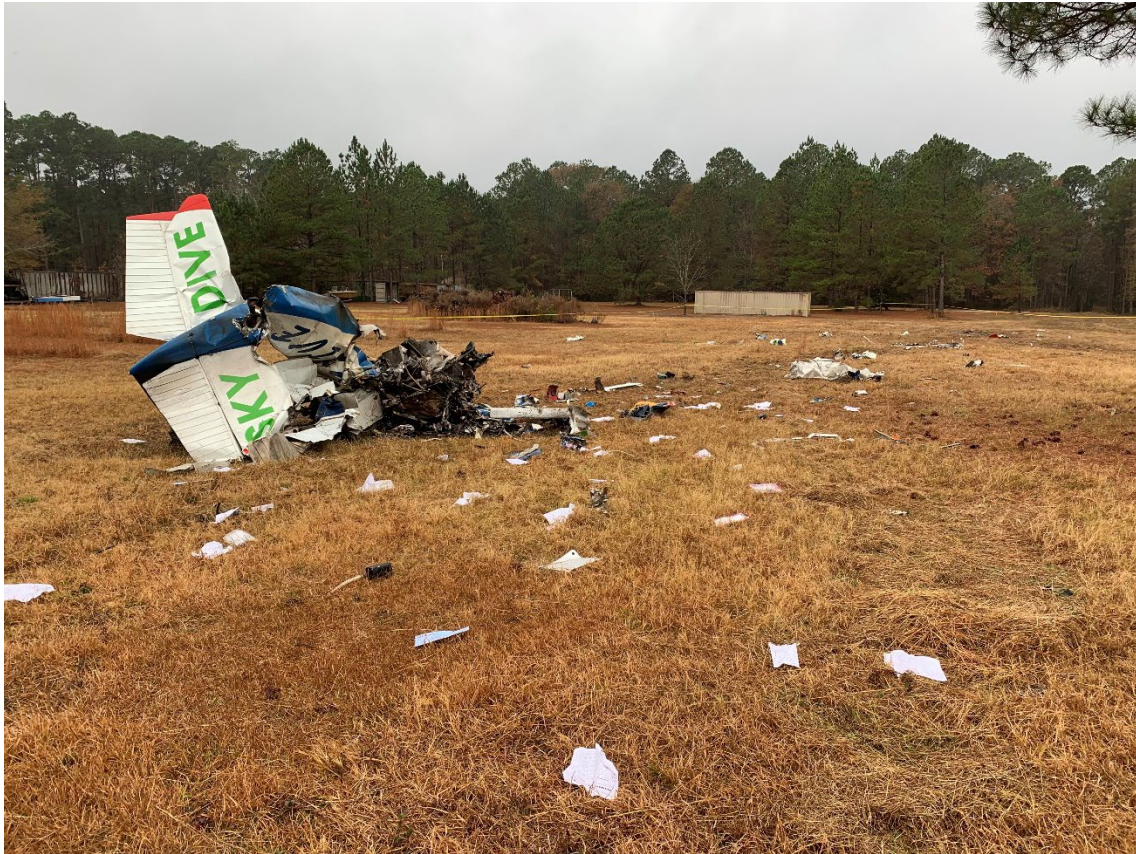
**Photo 1: Overview of the debris path and main wreckage**

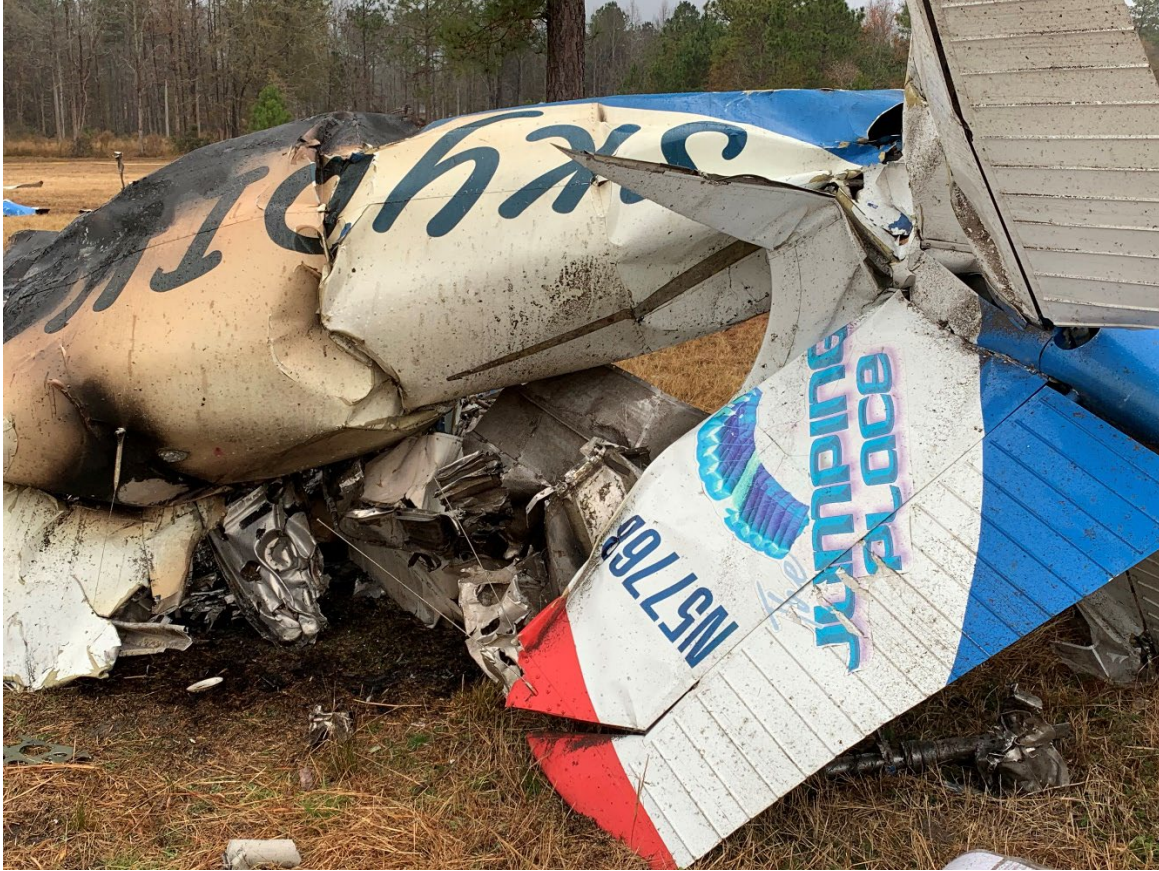
**Photo 2: View of the empennage and fuselage**

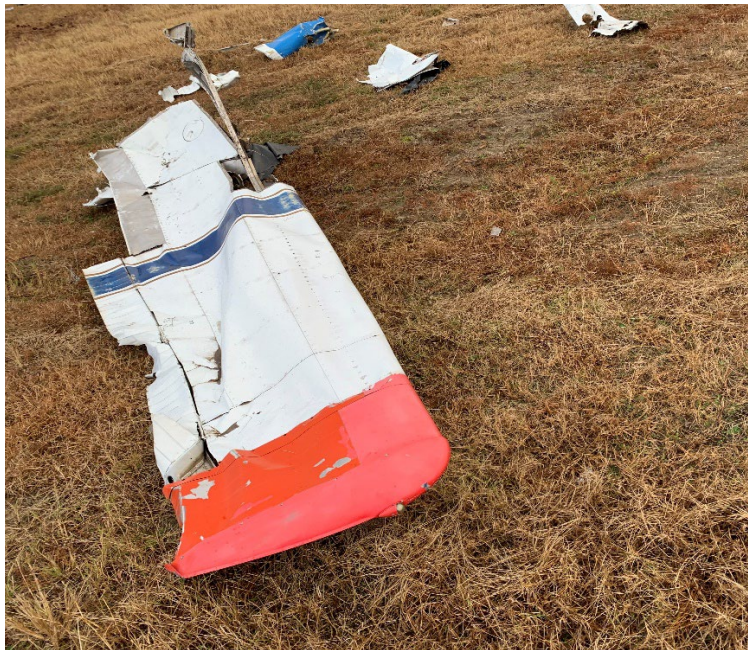
The right wing was observed relatively intact. The aileron remained attached. When the tension overload separated cables were manipulated from the inboard section of the wing the aileron moved in both directions. The right wing lift strut was observed separated from the wing and had fractured about its mid-span. The right wing flap had fragmented, and its majority was located near the right wing.

**Photo 3: View of the right wing separated from the fuselage**

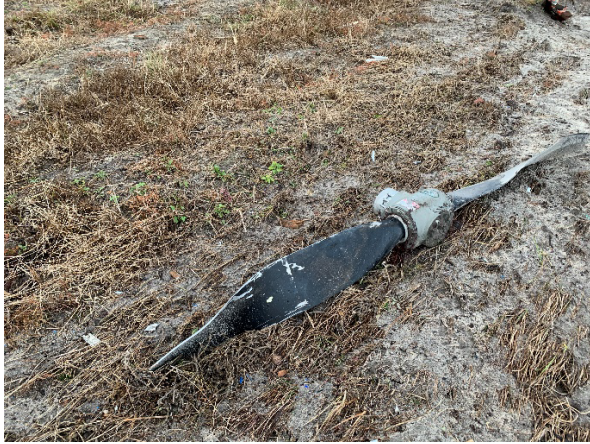
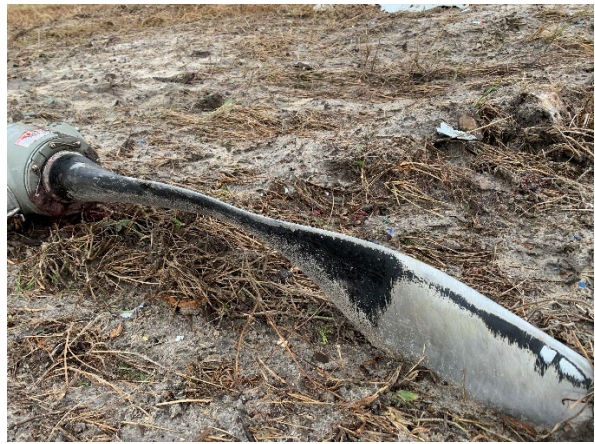
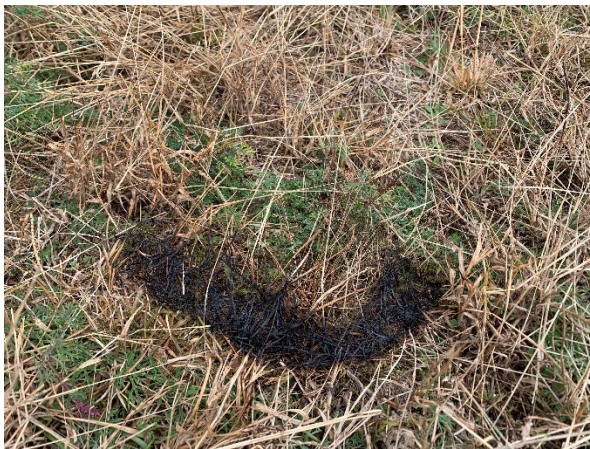
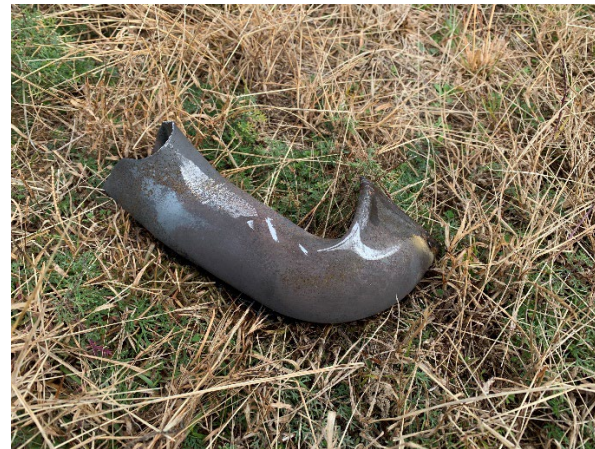
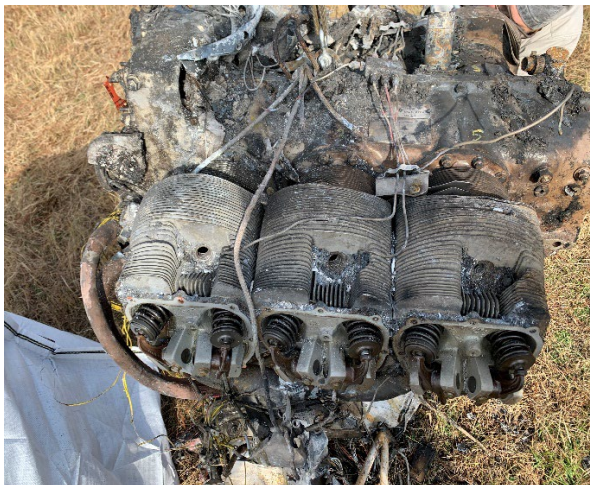
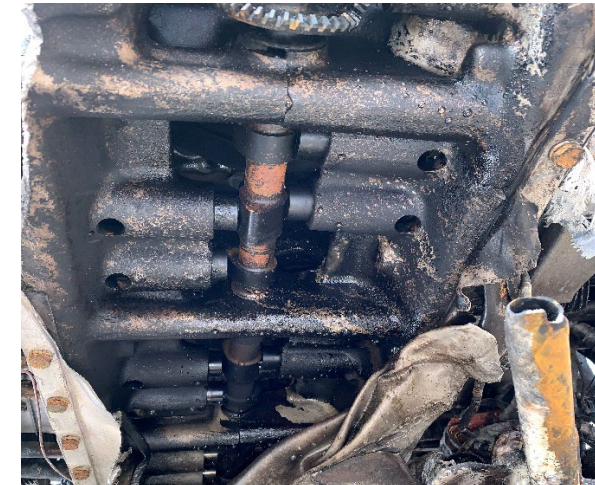
The engine sustained heavy impact damage. Its underside displayed significant damage that allowed the core of the engine, to include the camshaft, to be visible. The camshaft was continuous from the forward and rear section of the engine without any fracture observed. Each cylinder displayed varying degrees of impact damage, but each remained attached to the crankcase.

A fragment of an exhaust pipe was located in a grassy area separated from the engine. The grass below its resting location displayed burning and discoloration. The fuel manifold remained intact and the respective fuel lines were continuous to the cylinders.

The propeller exhibited varying degrees of blade polishing, leading edge gouging, chordwise scratches, and torsional twisting.

**Photos 4-9: View of the propeller, engine exhaust and grass burn, and engine**

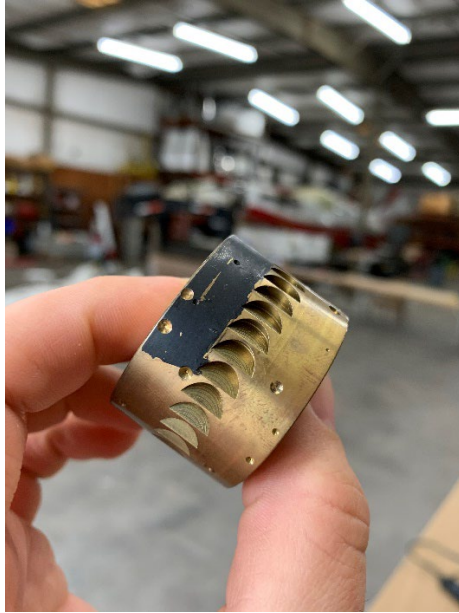
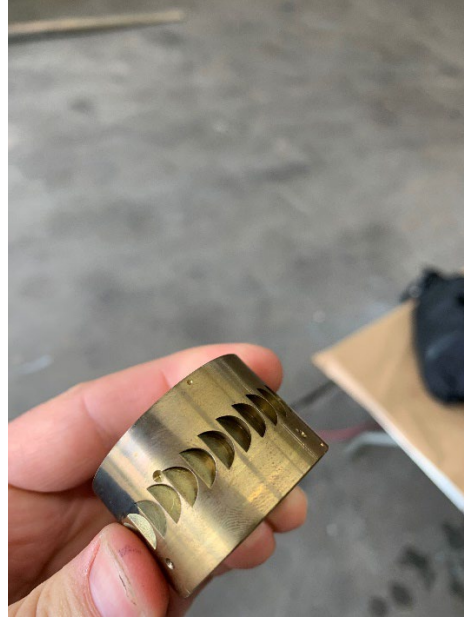
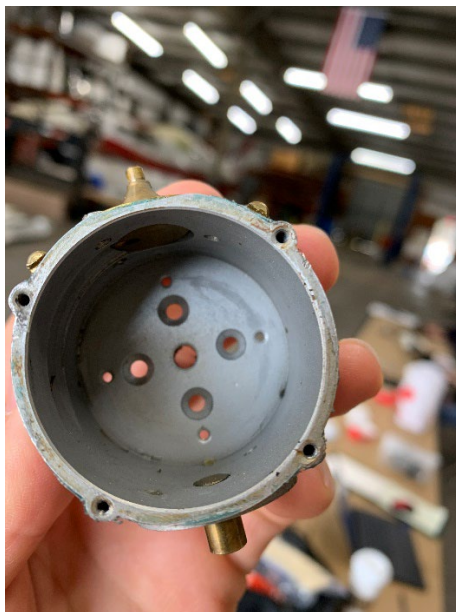
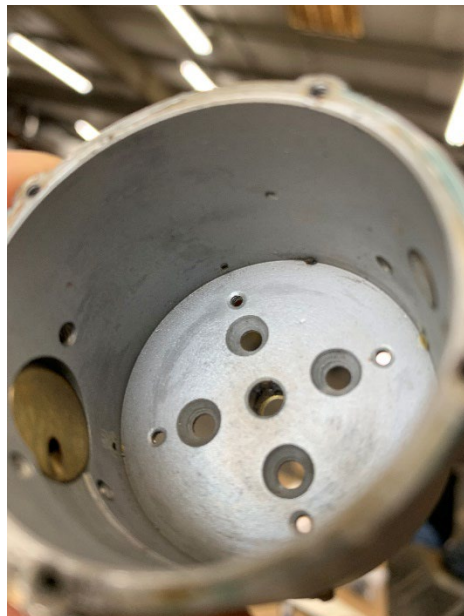
The attitude indicator was found in the debris path and displayed a 50° left bank and a 30° pitch up attitude. The attitude indicator was later disassembled at the recovery facility. The rotational gyro and its casing displayed minimal evidence of rotational scoring.

**Photos 10-13: View of the attitude indicator gyro and its casing disassembled postaccident**
