# NATIONAL TRANSPORTATION SAFETY BOARD

MATERIALS LABORATORY FACTUAL REPORT

Report No. 22-020

Place : Crab Orchard, Kentucky  
Date : December 10, 2021  
Vehicle : Beech V35, N5704V  
NTSB No. : ERA22FA085  
Investigator : Ralph Hicks, ASI – ERA

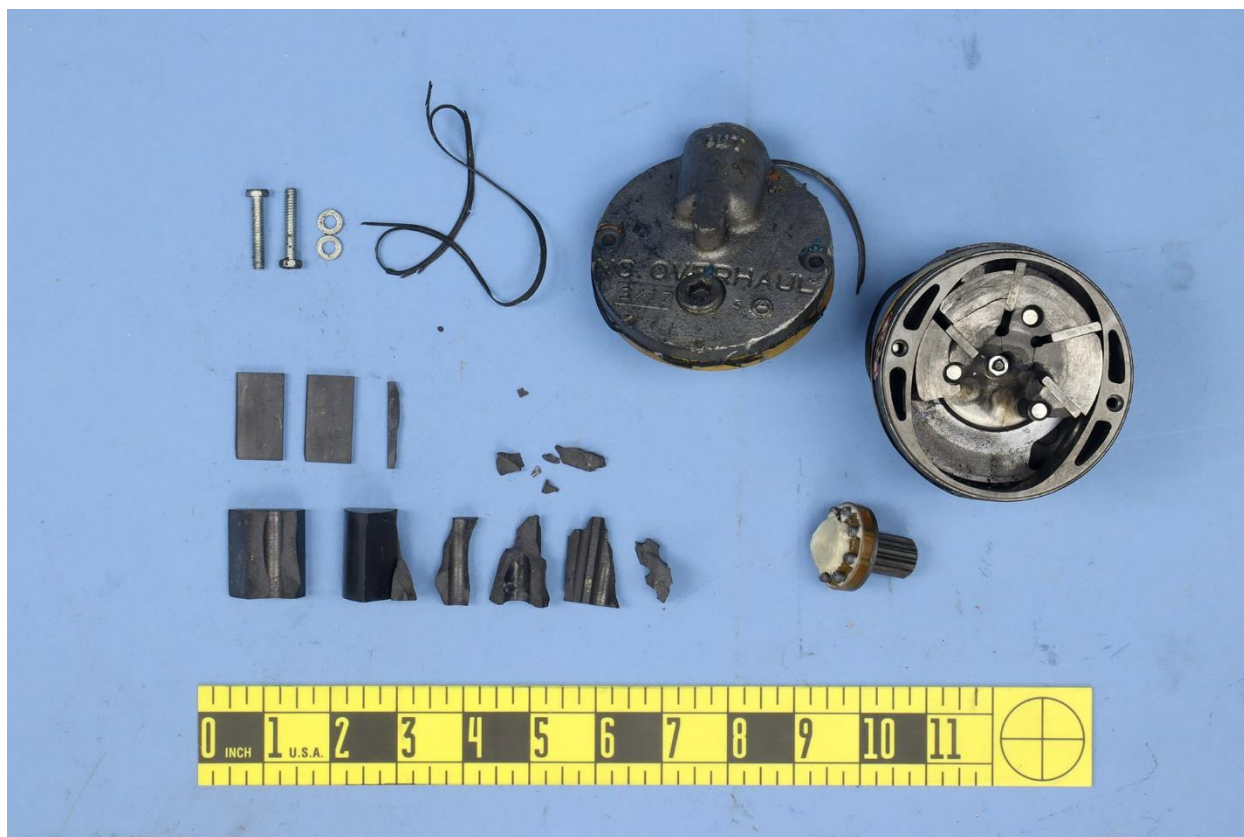
Pieces of an Airborne dry air pump were submitted to the NTSB Materials Laboratory for examination, as shown in figure 1. The pump's outlet cover plate had been previously removed, revealing a rotor that had fractured into multiple pieces and one rotor vane that had fractured spanwise. The other five rotor vanes were still intact. As shown in figures 1 and 2a, the drive coupling had fractured along the shaft's transverse plane in a reduced diameter section. Examination of the fracture surfaces revealed circular marks and a molten/resolidified polymeric appearance that was consistent with a torsion overstress fracture.

**Figure 1:** Image of the as-received vacuum pump pieces.

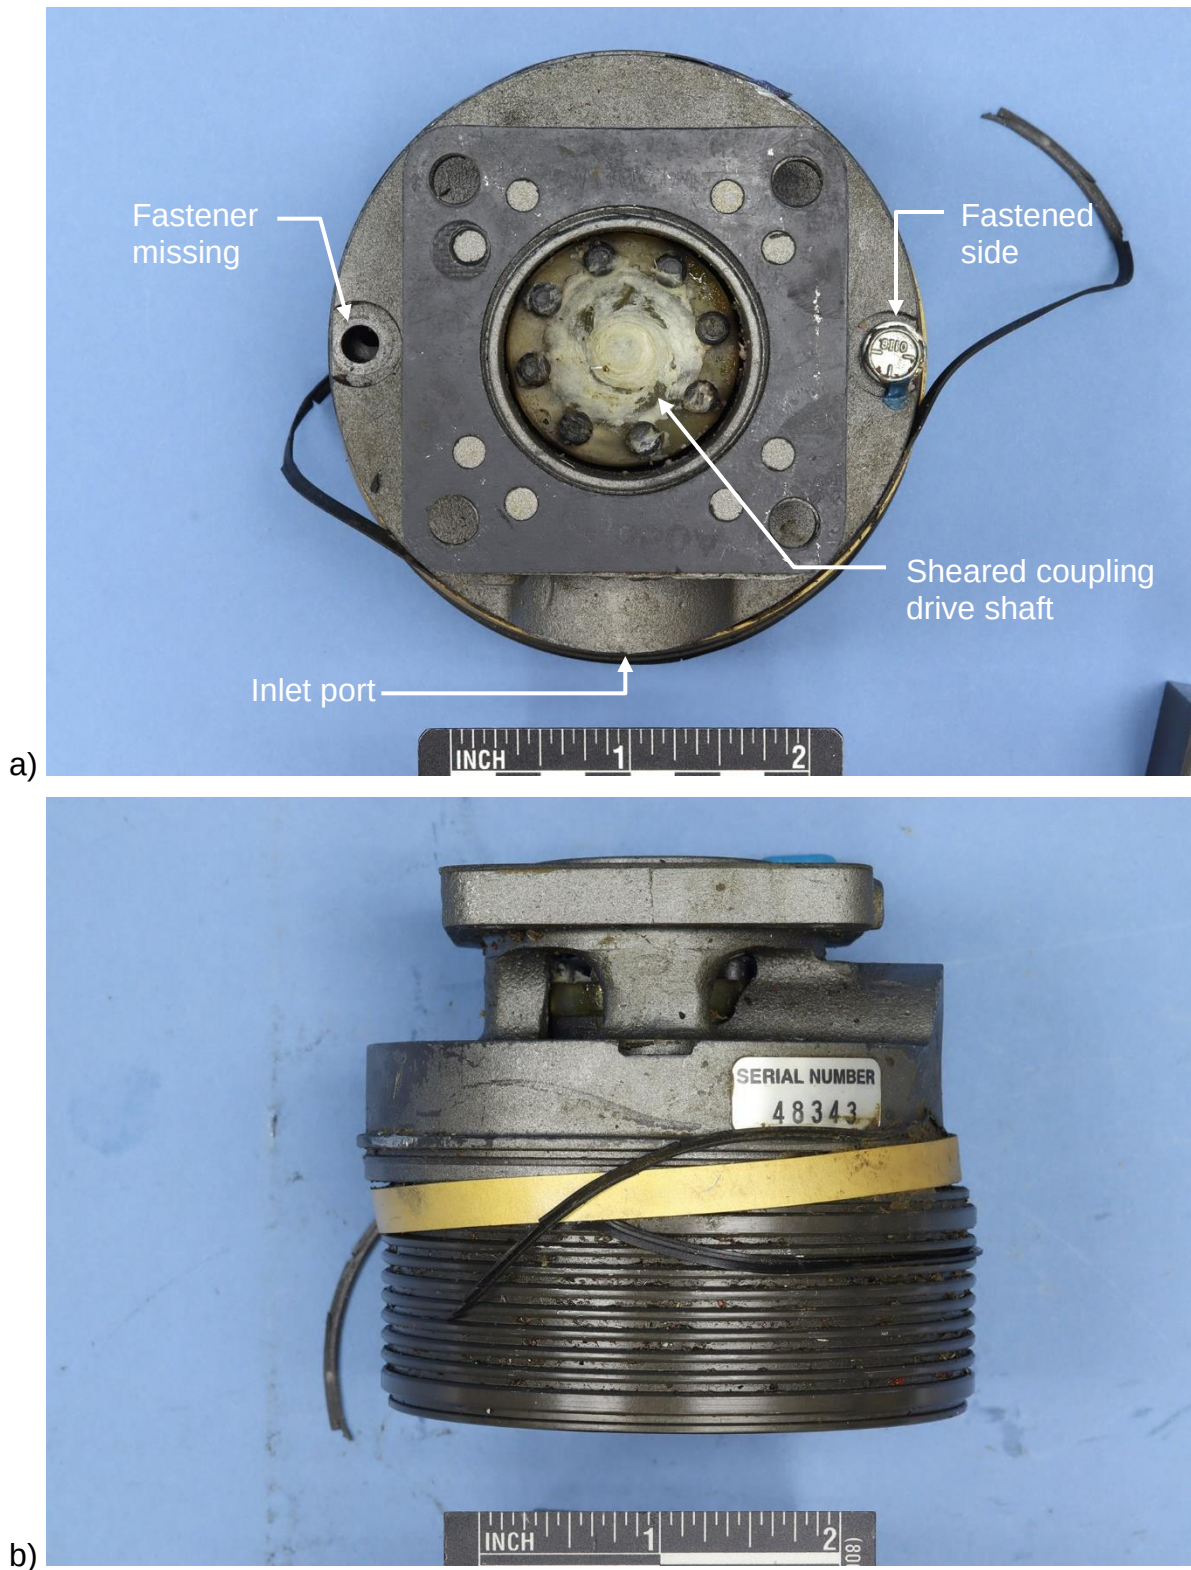
Examination of the inlet cover plate revealed that a fastener was missing, as indicated in figure 2a. The fastener was one of two used to attach the inlet cover plate to the stator housing. When viewed from the side, as seen in figure 2b, the stator housing and inlet cover plate were visibly offset relative to one another in the lateral direction. The screw that was still attached was removed and is shown in figure 3. The stator housing was then separated from the inlet cover plate. The screw was bent along its length approximately one-third of the distance from the threaded end. The screw was examined for indications of thread locking compound. A dab of torque seal compound was observed on the screw cap, but no thread locking compound was found on the screw threads. The stator's threaded holes were examined for indication of sheared screw fragments or damaged threads, but none were found.

**Figure 2:** a) Image of the inlet cover plate showing a missing attachment screw and the sheared drive shaft and b) side view of the pump body showing the displacement of the inlet cover plate relative to the pump stator.

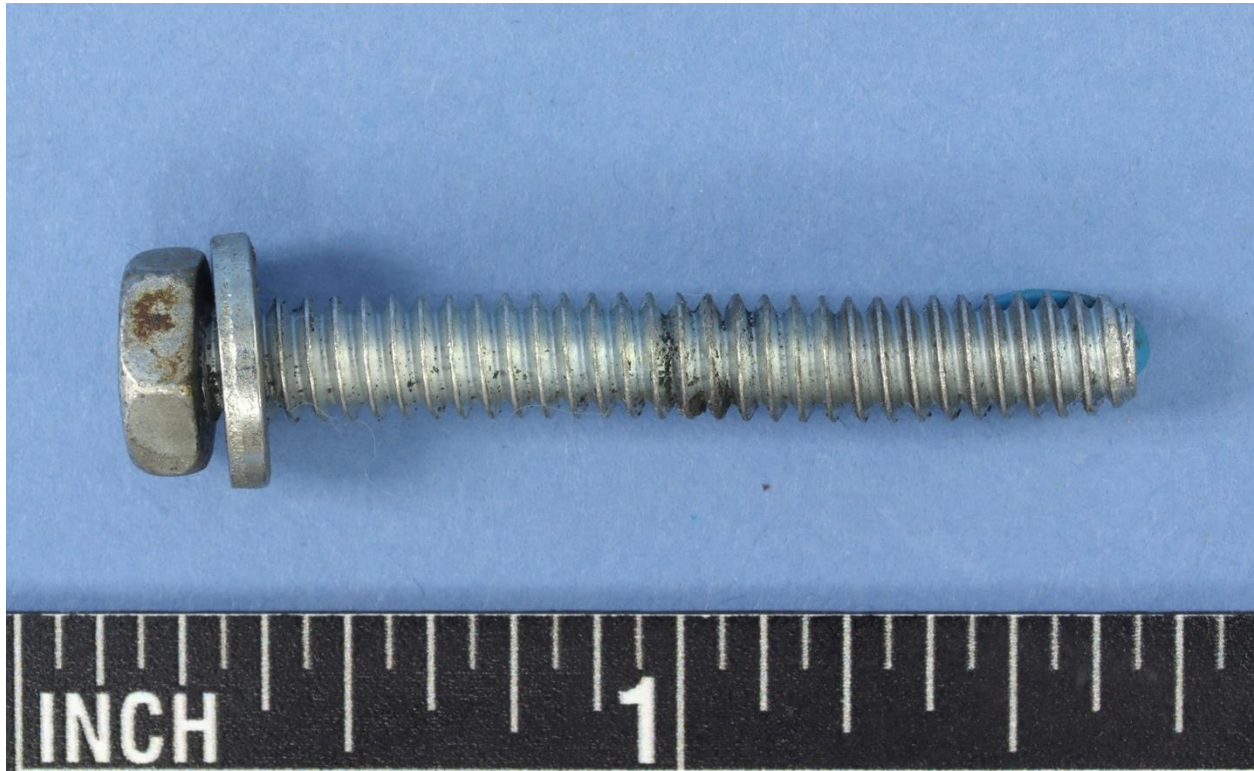
**Figure 3:** Image of the screw after it was removed from the pump. There was no apparent locking compound on the threads and the threaded section was bent.

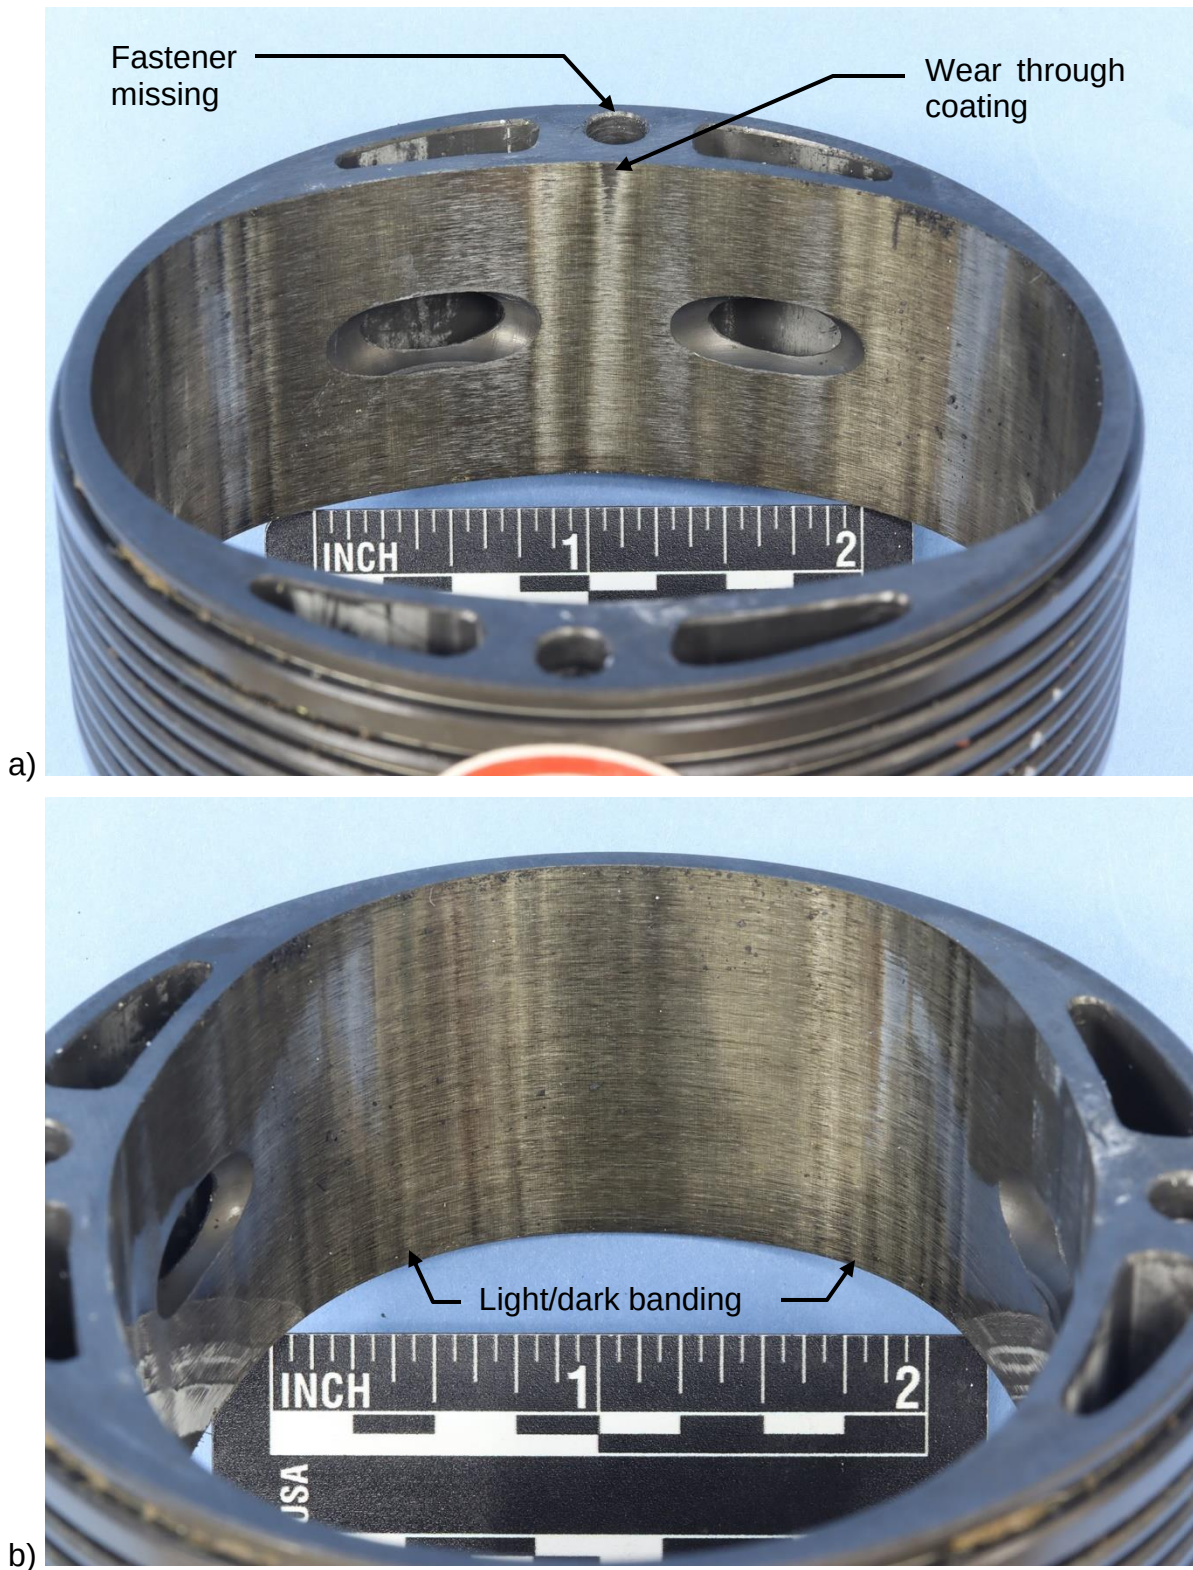
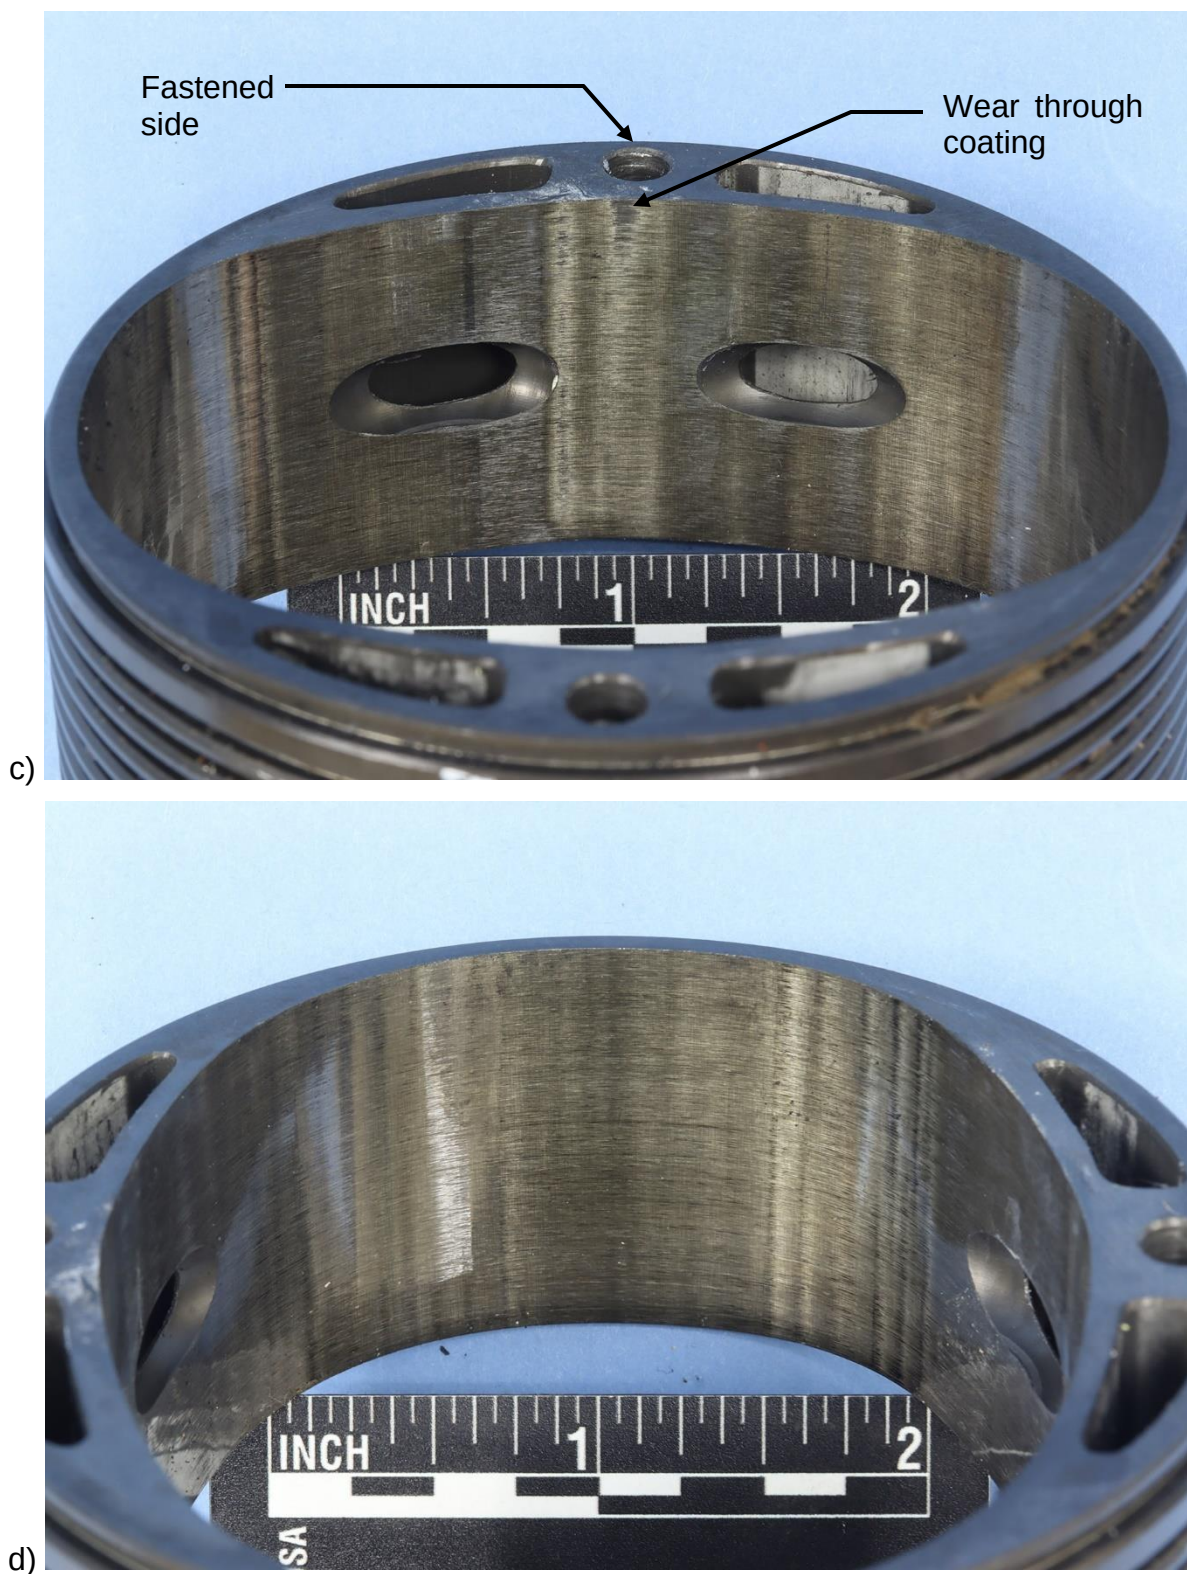
The stator's inner anodized surface exhibited wear patterns as shown in figures 4a – 4d. Near the fastener holes, the surface exhibited comparatively light color banding and spots near one of the end faces where the coating had been worn through, as indicated in figures 4a and 4c. Between the major and minor axes of the oval-shaped cavity, the

inner surface exhibited an alternating light/dark banded appearance, as indicated for two such regions in figure 4b. The stator surface was examined for any gouges or any notable circumferential scratches, but none were found.

**Figure 4:** Image showing the typical condition of the pump stator's inner surface. The end face seen in the images butts against the inlet cover plate; a) side where fastener was missing; b) stator rotated 90° counterclockwise from part a);

**Figure 4 (cont.):** c) side that was fastened; d) rotated by 90° counterclockwise from part c).

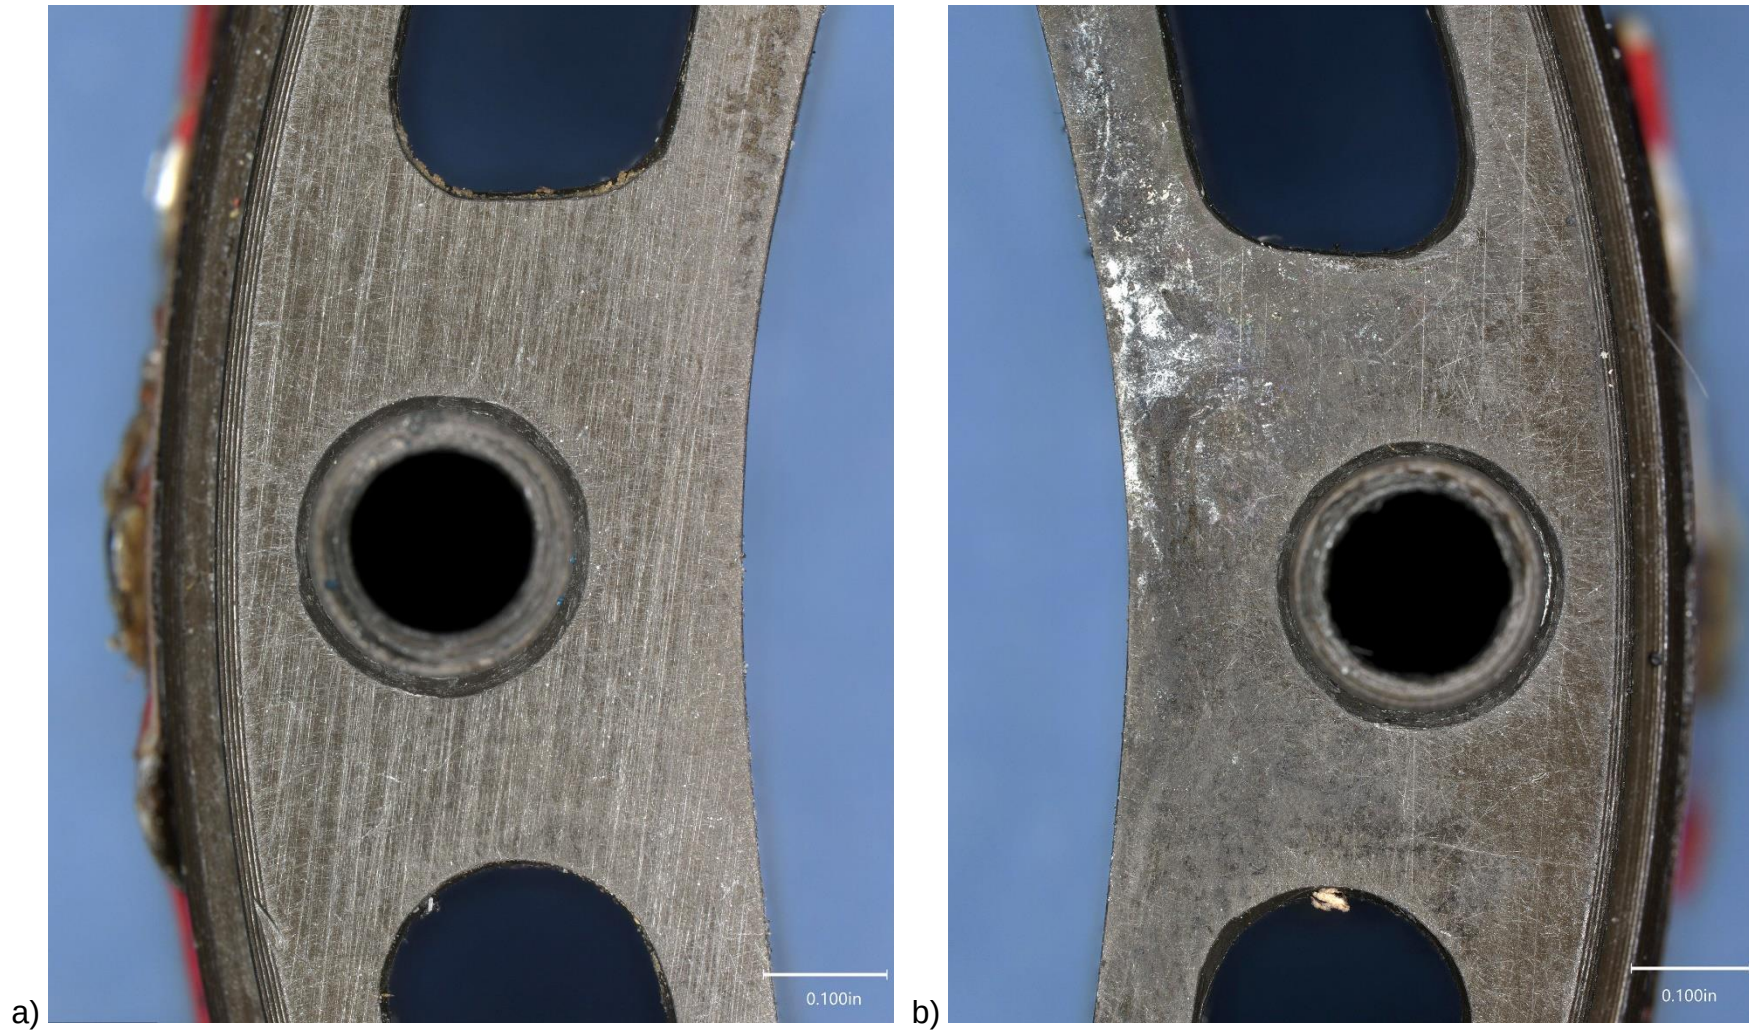
The end faces of the stator housing that butted against the inlet cover plate exhibited an appearance consistent with rubbing. Images of the stator housing's end faces are shown for the threaded hole with the retained fastener (right side in figure 2a) and for the threaded hole with the missing fastener (left side in figure 2a) in figures 5 and 6, respectively. Figure 5a shows the end face that butted against the outlet cover plate (the end plate that was previously removed) and figure 5b shows the end face that butted against the inlet cover plate. Machining marks were observed on the end face that butted against the outlet cover plate, whereas the end face that butted against the inlet cover plate exhibited a comparatively smooth matte appearance. White powdered debris was also observed on the inlet side end face, as seen in figure 5b. Similarly, for the threaded hole with the missing fastener, the end face butting the outlet cover plate exhibited machining marks, as seen in figure 6a, whereas the side that butted against the inlet cover plate exhibited some regions with a matte appearance and some regions where machining marks were still visible, as seen in figure 6b.

**Figure 5:** Images of the stator housing end faces around the threaded hole with the retained inlet cover plate fastener; a) end face that butted against the outlet cover plate and b) end face that butted against the inlet cover plate.

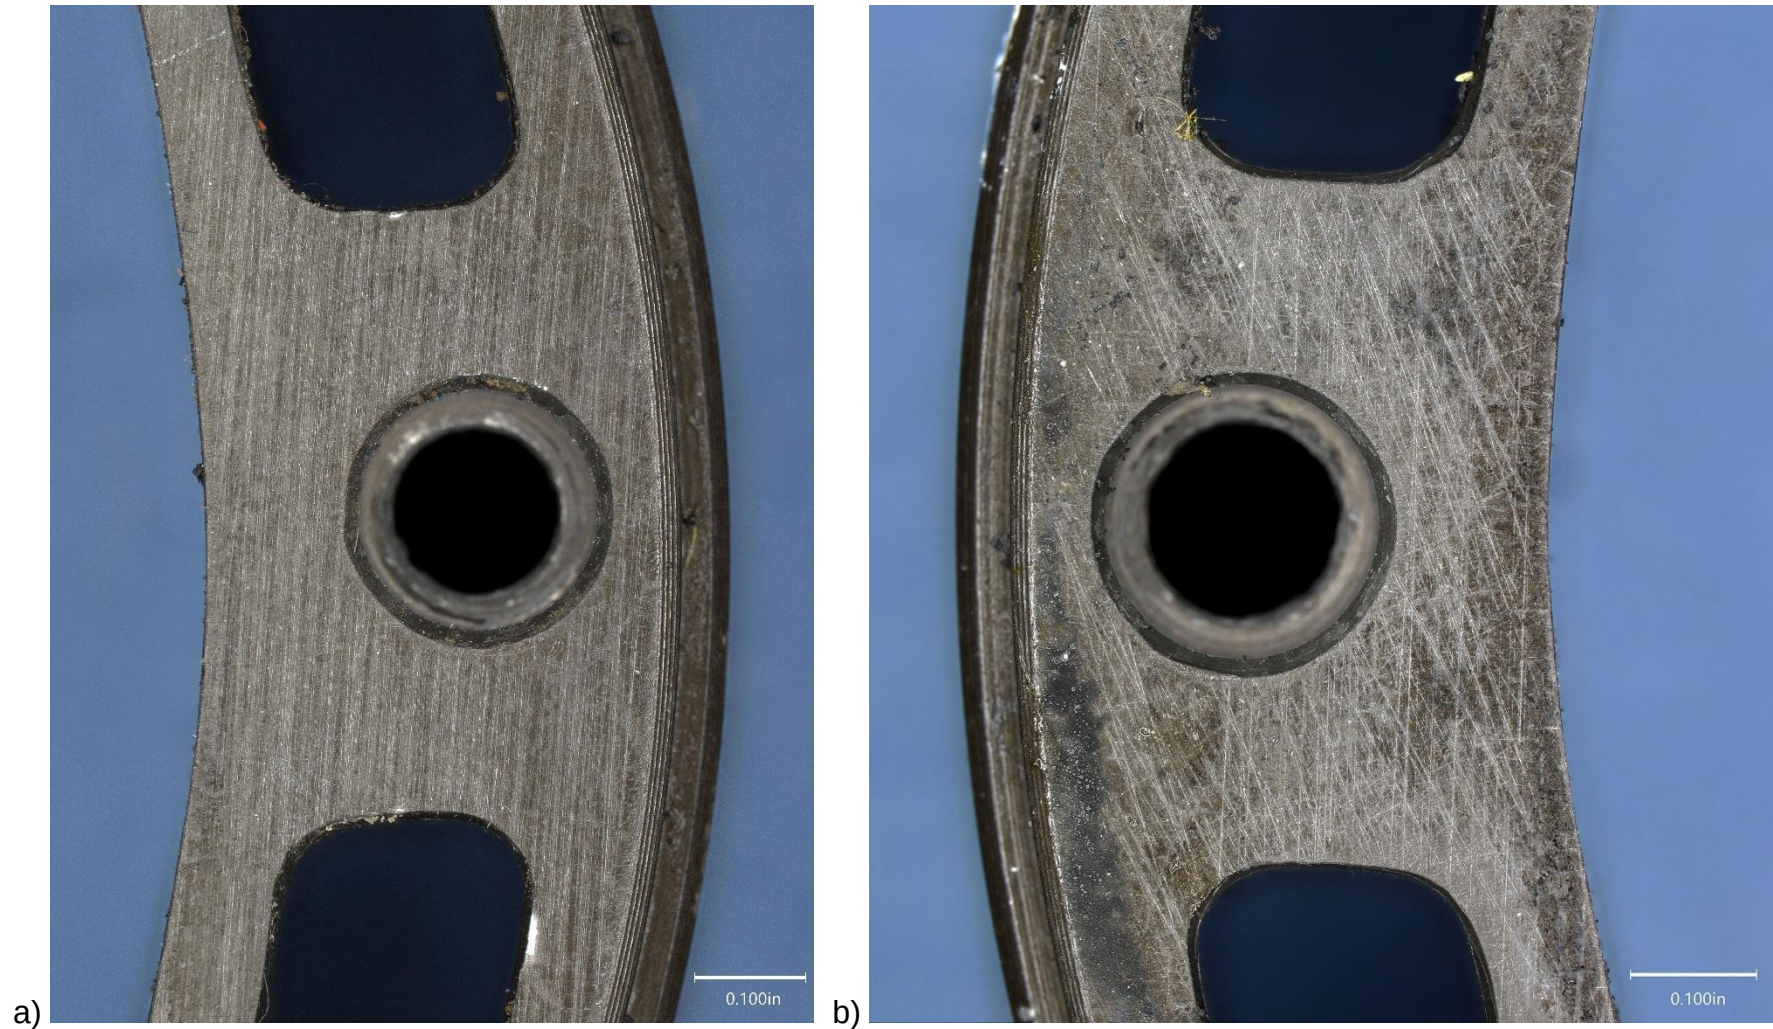
**Figure 6:** Images of the stator housing end faces around the threaded hole with the missing inlet cover plate fastener; a) end face that butted against the outlet cover plate and b) end face that butted against the inlet cover plate.

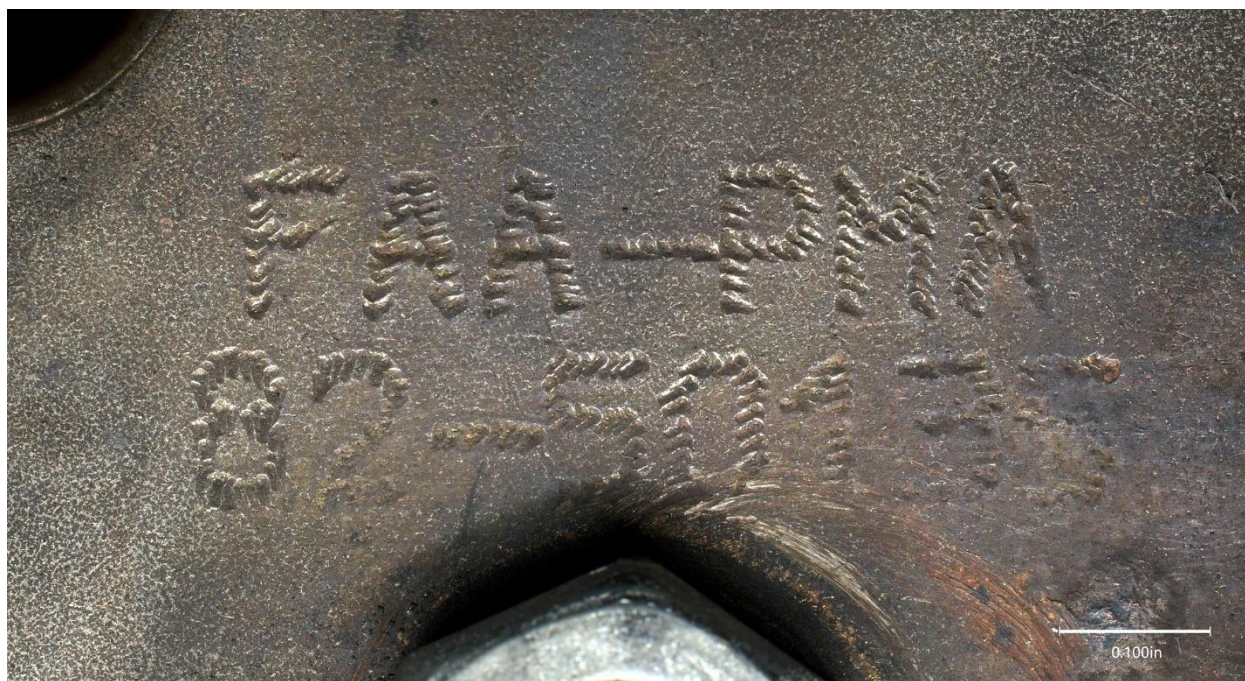
The pump's rotor hub was imprinted with Parts Manufacturer Approval (PMA) identifiers. The remaining pieces of the fractured rotor were removed as was the central screw that joined the hub to the drive coupling. The hub was removed from the inlet cover plate and wiped with alcohol. Information imprinted on the hub's base plate included "FAA-PMA" and "82-50135", as shown in figure 7. According to the FAA's PMA database (located at <https://drs.faa.gov/>), the PMA holder was Aero Accessories Inc.

**Figure 7:** Image of information imprinted on the rotor hub: “FAA-PMA” and “82-50135”.

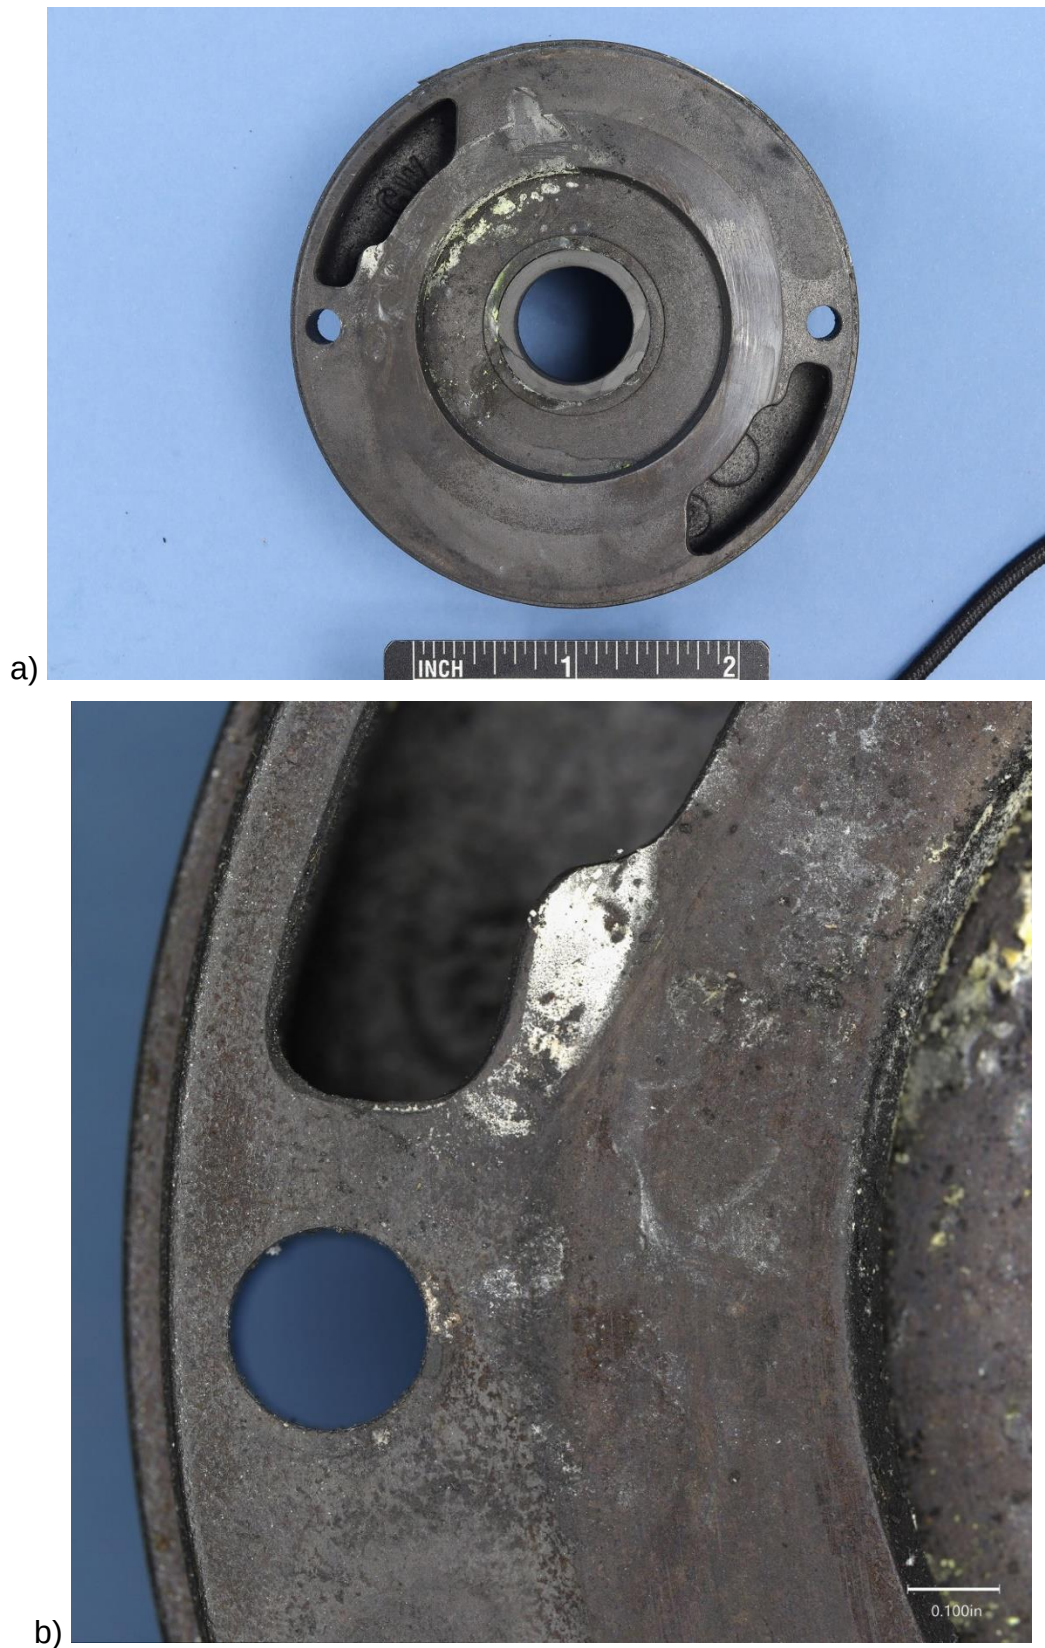
The inlet cover plate was then visually examined, as shown in figures 8a and 8b. Regions of the inlet cover plate were coated with debris. Yellow-colored debris was observed in the space underneath the hub and white-colored debris was observed in a region that butted against the stator housing, as seen in figure 8a. A higher magnification image of the latter is shown in figure 8b. The debris was in a similar location as the debris previously observed on the stator housing, shown in figure 5b.

**Figure 8:** Images of the stator-facing side of the inlet cover plate after rotor hub removal; a) overview image and b) higher magnification image showing debris on the plate.

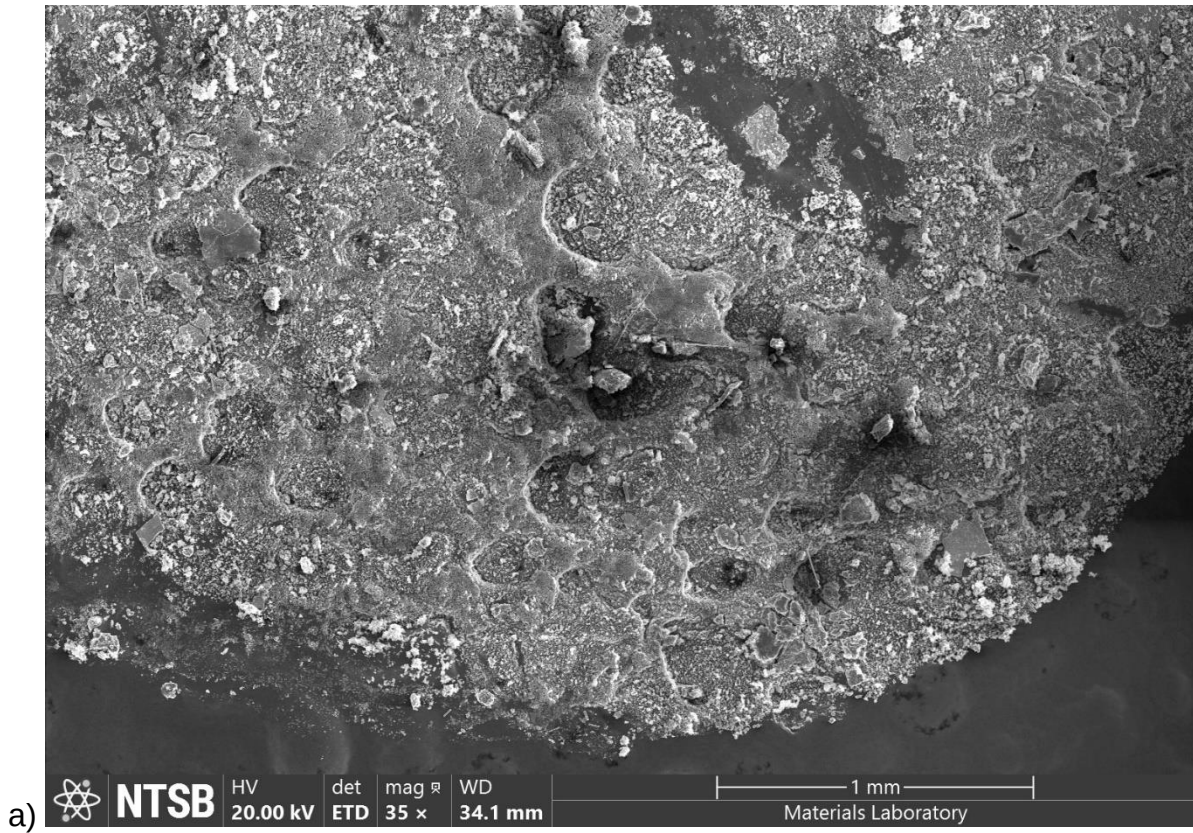
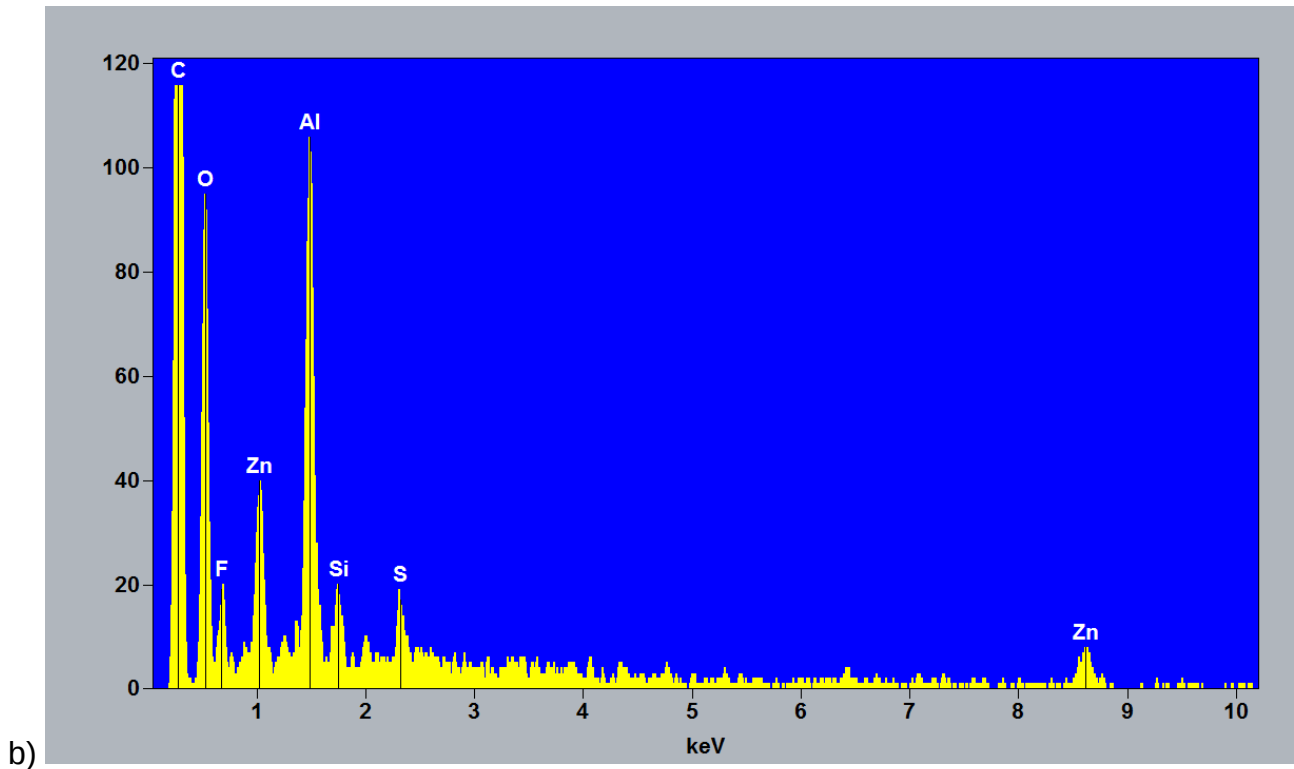
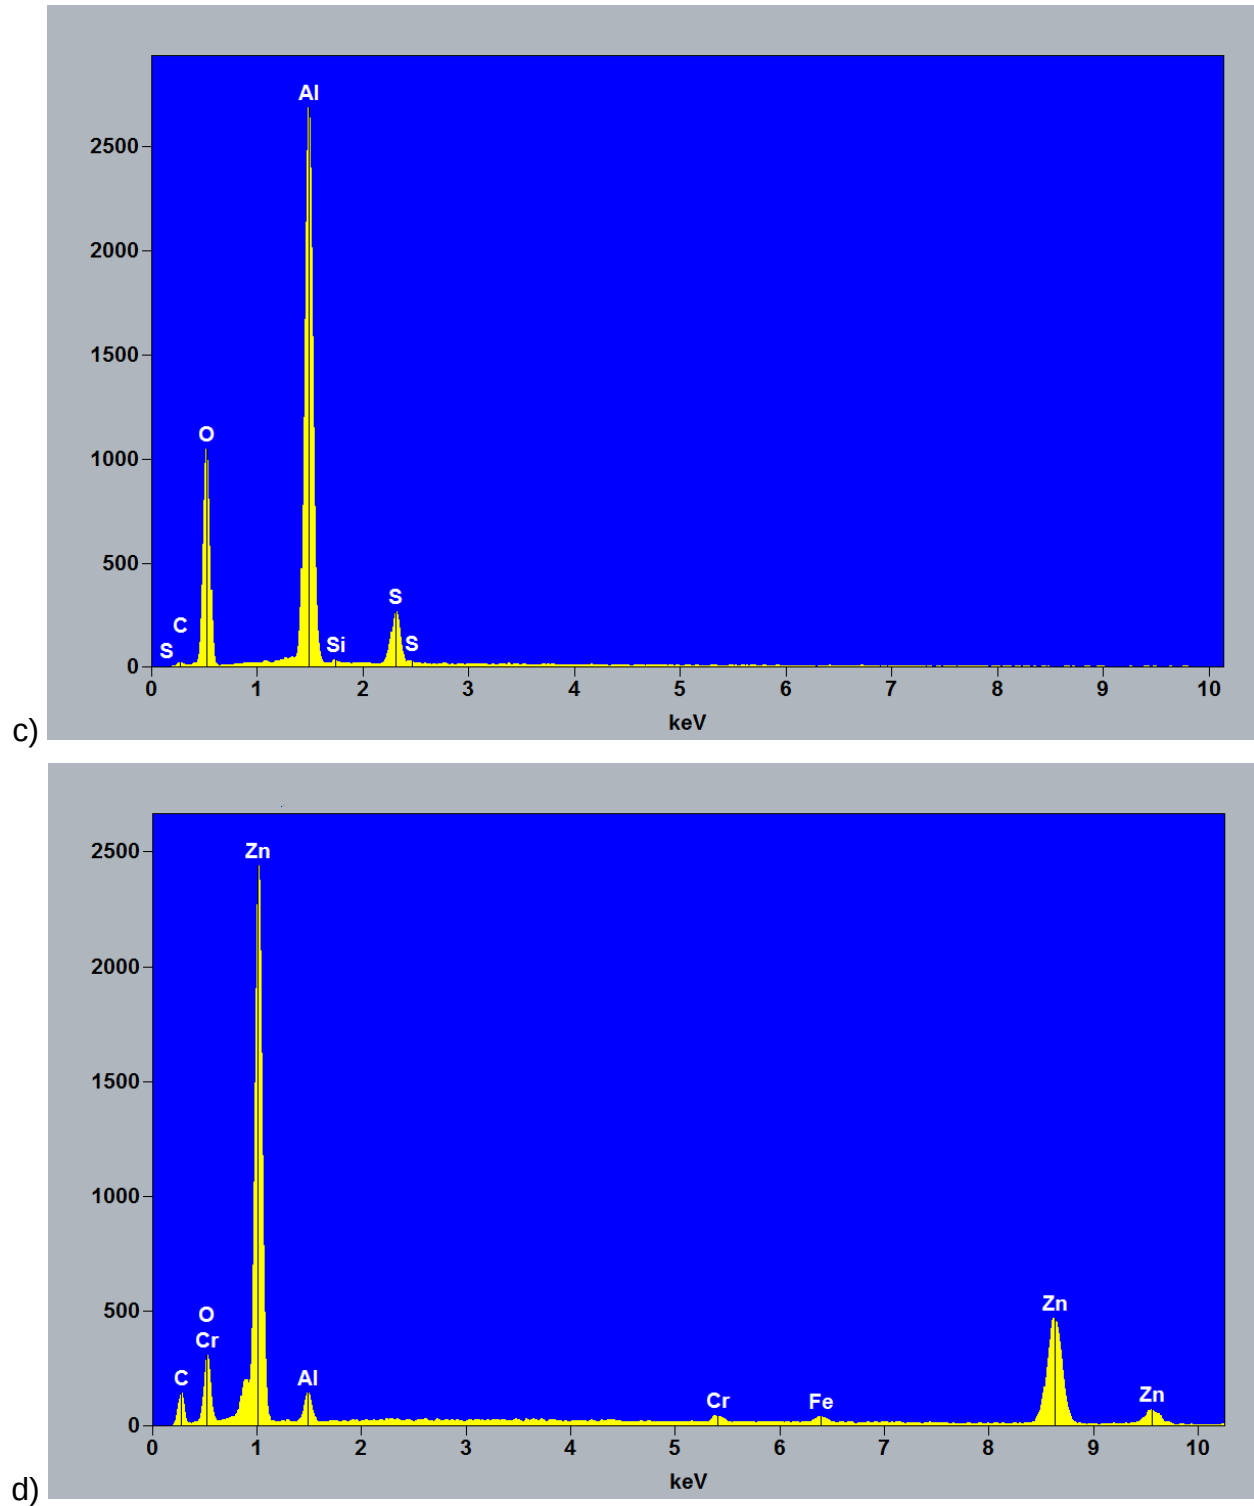
A sample of the white debris was lifted from the plate using a piece of conductive carbon tape and examined using a scanning electron microscope (SEM) equipped with an energy dispersive X-ray spectrometer (EDS), as shown in figure 9a. An EDS spectrum of the debris exhibited primarily aluminum (Al), oxygen (O) zinc (Zn), sulfur (S), silicon (Si), and fluorine (F), as shown in figure 9b. Some the yellow debris was also lifted from the plate and examined similarly. Its spectrum (not shown) consisted of Al and O. EDS spectra were also gathered from the stator's inner anodized surface and the attachment screw (figure 3), as shown in figures 9c and 9d, respectively. The anodization layer's spectrum consisted of Al, O, and S, while the attachments screw's spectrum consisted primarily of Zn with additional peaks for Al, iron (Fe), and chromium (Cr).

**Figure 9:** a) SEM image of the debris taken from the inlet cover plate; b) EDS spectrum of the debris exhibiting aluminum (Al), oxygen (O), zinc (Zn), sulfur (S), silicon (Si), and fluorine (F);

**Figure 9 (cont.):** c) EDS spectrum of the stator's inner surface exhibiting Al and S; and d) EDS spectrum of the inlet plate's attachment screw exhibiting primarily Zn with traces of Al, iron (Fe), and chromium (Cr).

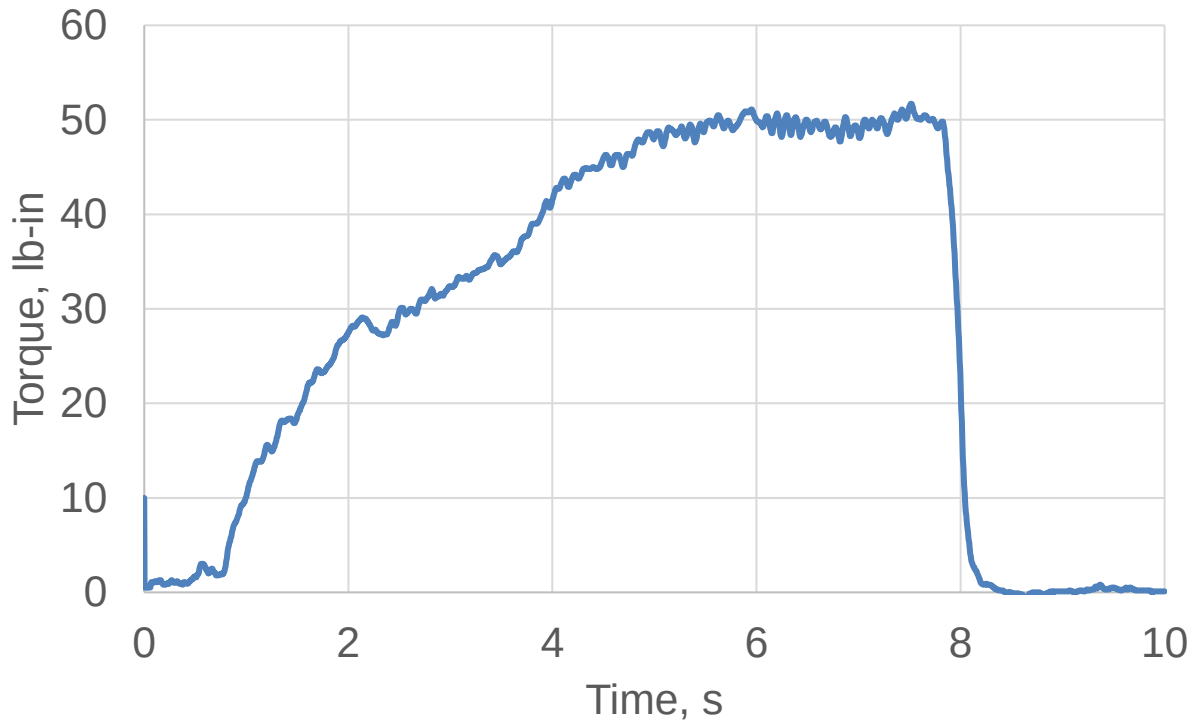
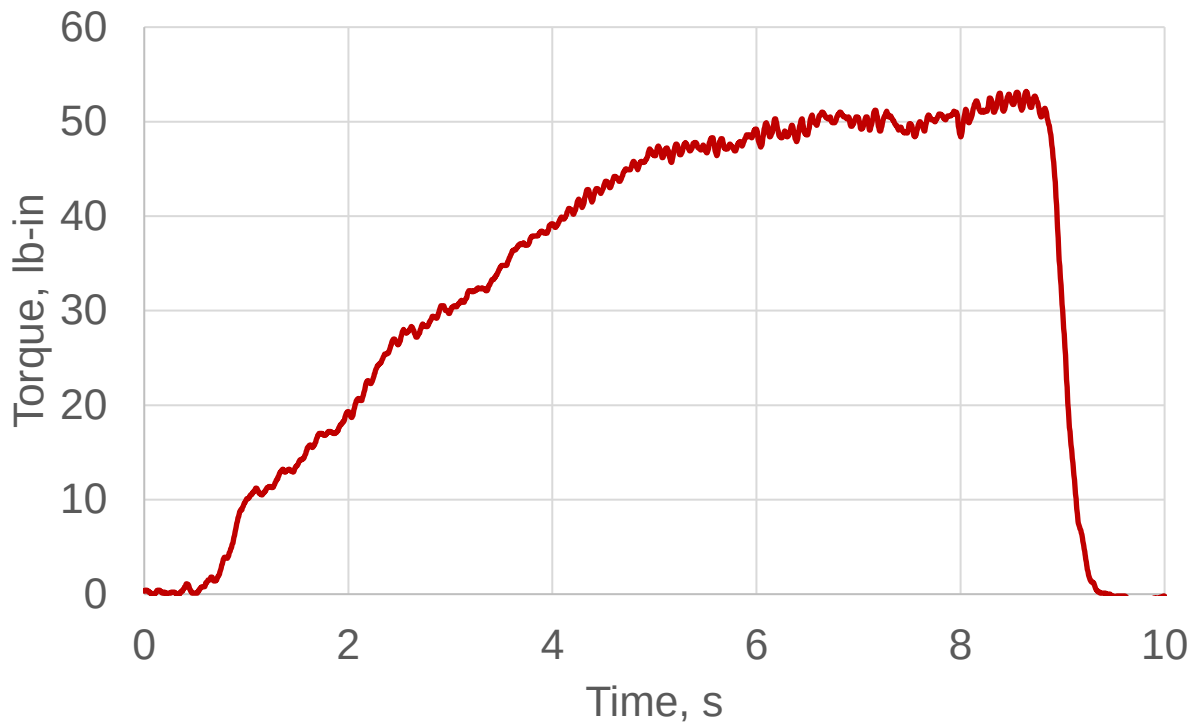
screws were torqued to 50 lb-in, the assembly torque indicated by the manufacturer. The torque as a function of time was measured using a torque gauge. The torque curves for the side that had the retained fastener and the side with the missing fastener are shown in figures 10a and 10b, respectively. Both sides were torqued to the 50 lb-in threshold.

**Figure 10:** Torque vs time data for each cover plate screw hole using exemplar screws; a) the side with the retained fastener and b) the side with the missing fastener.
