# NATIONAL TRANSPORTATION SAFETY BOARD

## Security Video

### Specialist's Factual Report

Location: Bedford, New Hampshire  
Date: December 10, 2021  
Airplane: Swearingen SA-226AT  
Registration: N54GP  
Operator: Castle Aviation Inc  
NTSB Number: ERA22FA086

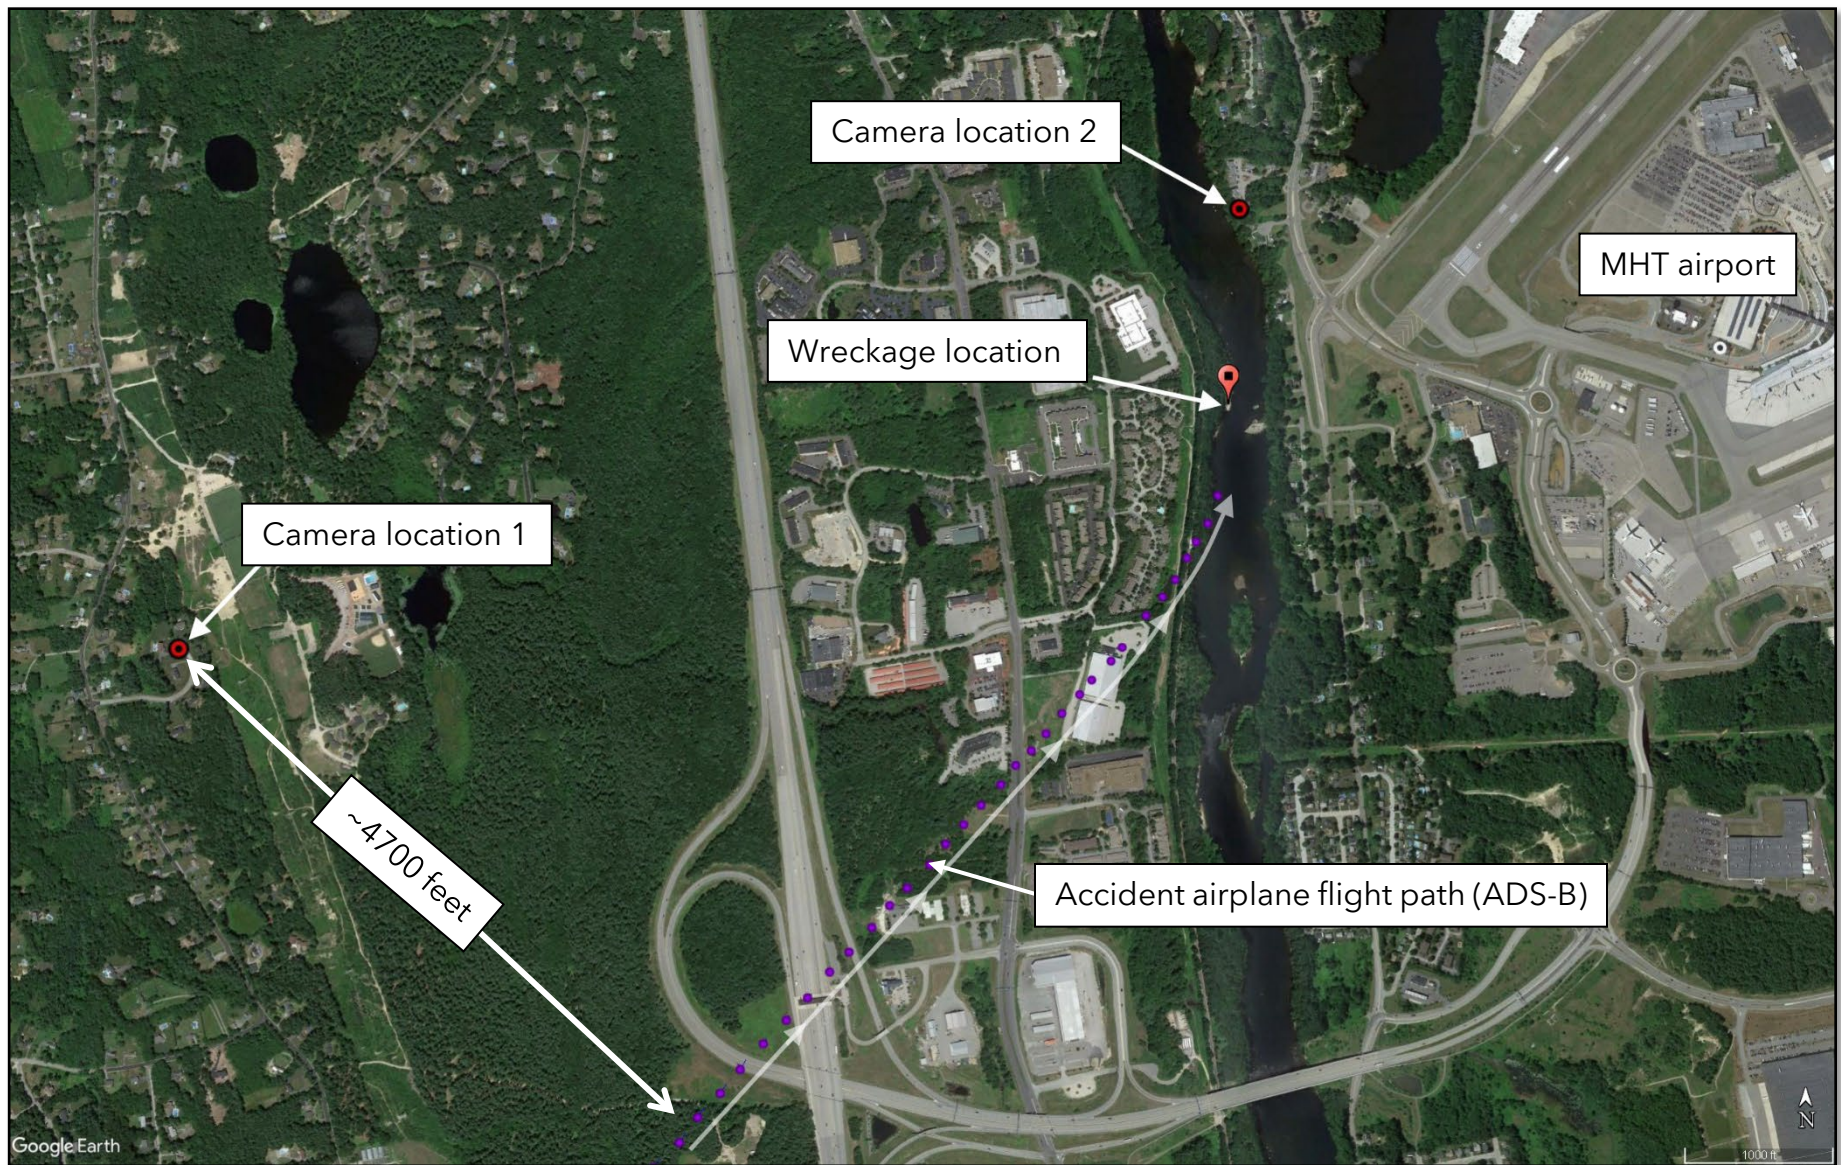
Figure 1 is a Google Earth<sup>1</sup> overview of the location of the security cameras, Manchester-Boston Regional Airport (MHT), the accident airplane's flight path from available ADS-B data, and the approximate location of the wreckage.

**Figure 1.** Google Earth overview of camera locations, accident flight path, and wreckage location.

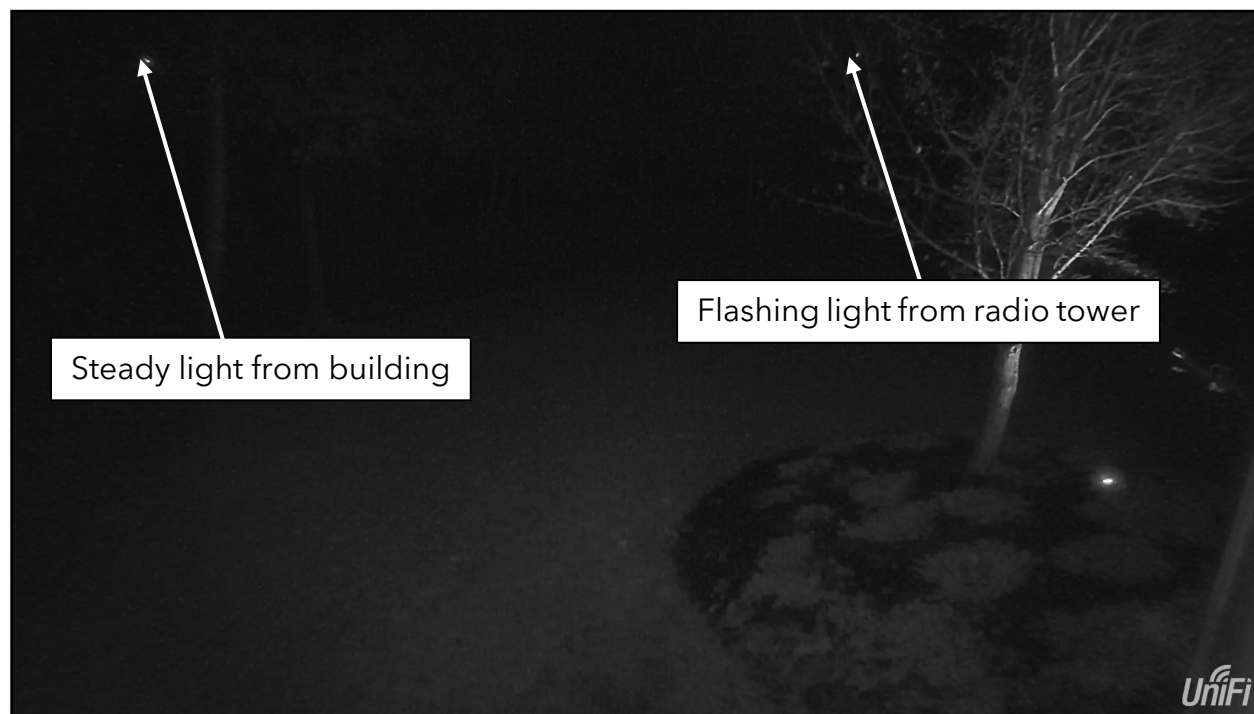
For the duration of the video, the lighting conditions were dark. A flashing light from a nearby radio tower was noted in the upper-right portion of the video. A steady light from an unknown nearby building was noted in the upper-left portion of the video. The first frame of the video is shown in Figure 2.

**Figure 2.** First video frame from camera location 1.
