**Aircraft Accident/Incident Report No.: 211210-2**

**Date of Accident:** December 10, 2021

**Aircraft:** Swearingen SA226-AT

**Written by:** Les Doud  
Air Safety Investigator – Hartzell Propeller Inc.

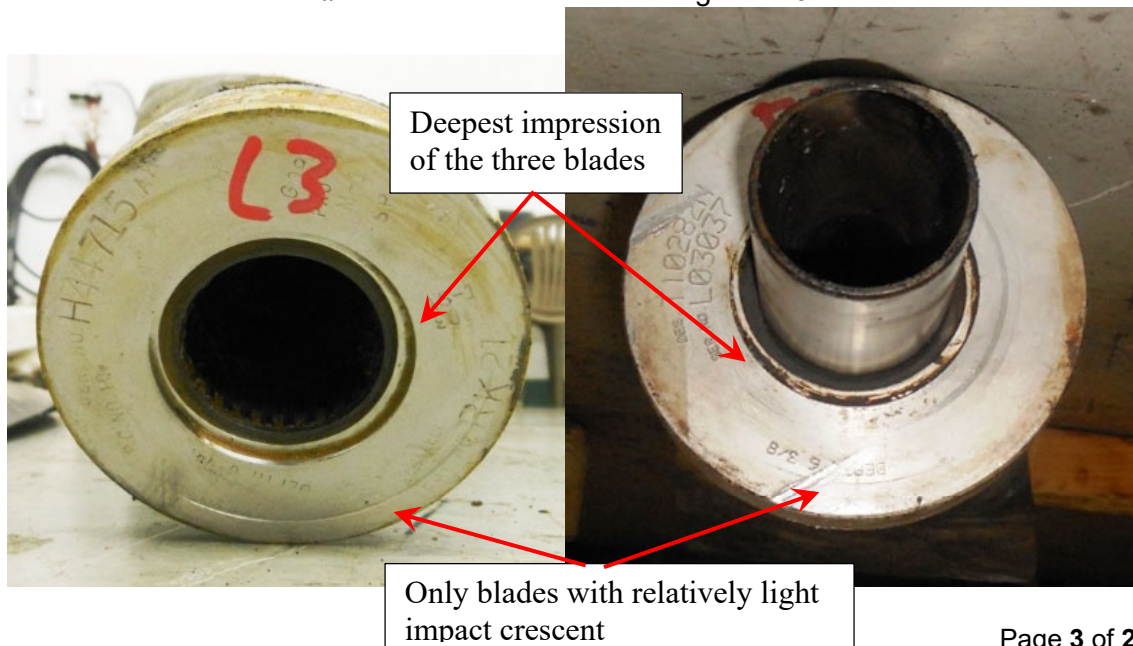
slippage in the blade clamps, no damage or distortion of the blade clamps or bolts, and relatively light link arm damage. The blades on each propeller showing the highest degree of blade butt damage were R1 and L3 as shown in Photo #1, and was relatively light damage compared to previous experience on steel-hub propellers at high power. All three blades of the left propeller appeared to be full-length with no evidence of tip fractures. A fractured tip was found at the crash scene, adjacent to a tree limb with slice marks (Photo #2). It is presumed to be from a right propeller blade, but due to fire damage it could not be determined from which blade it originated. Tip fractures are typically a signature of RPM with some amount of power.

Photo #1 – Similar blade butt damage on L3 and R1

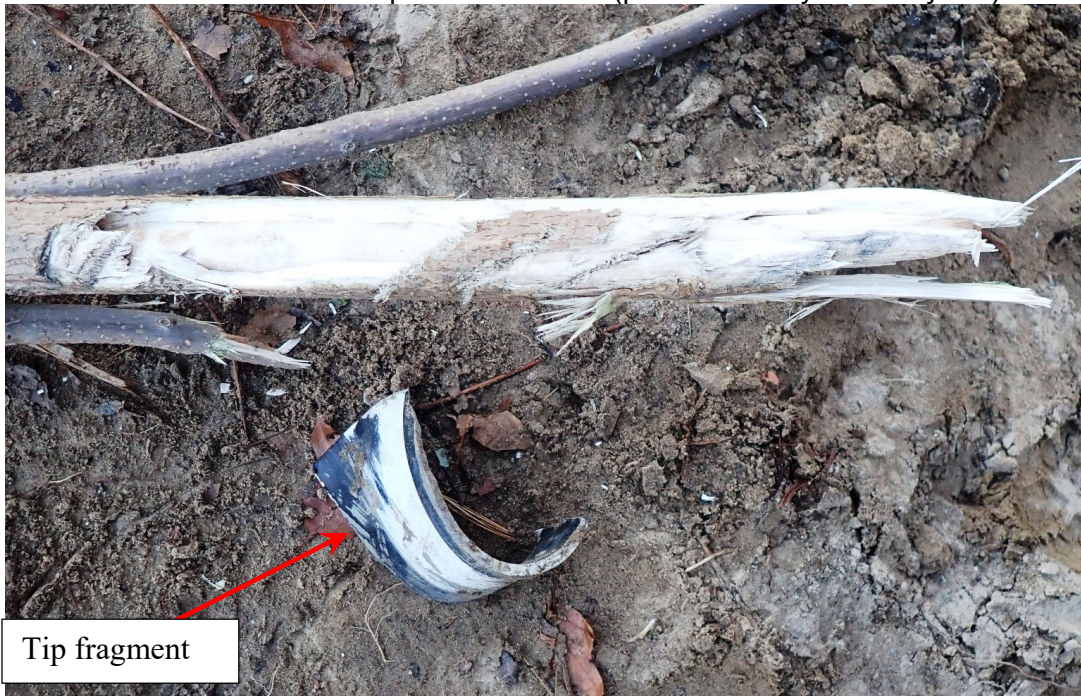
Photo #2 – Fractured tip at crash scene (photo courtesy of Honeywell)

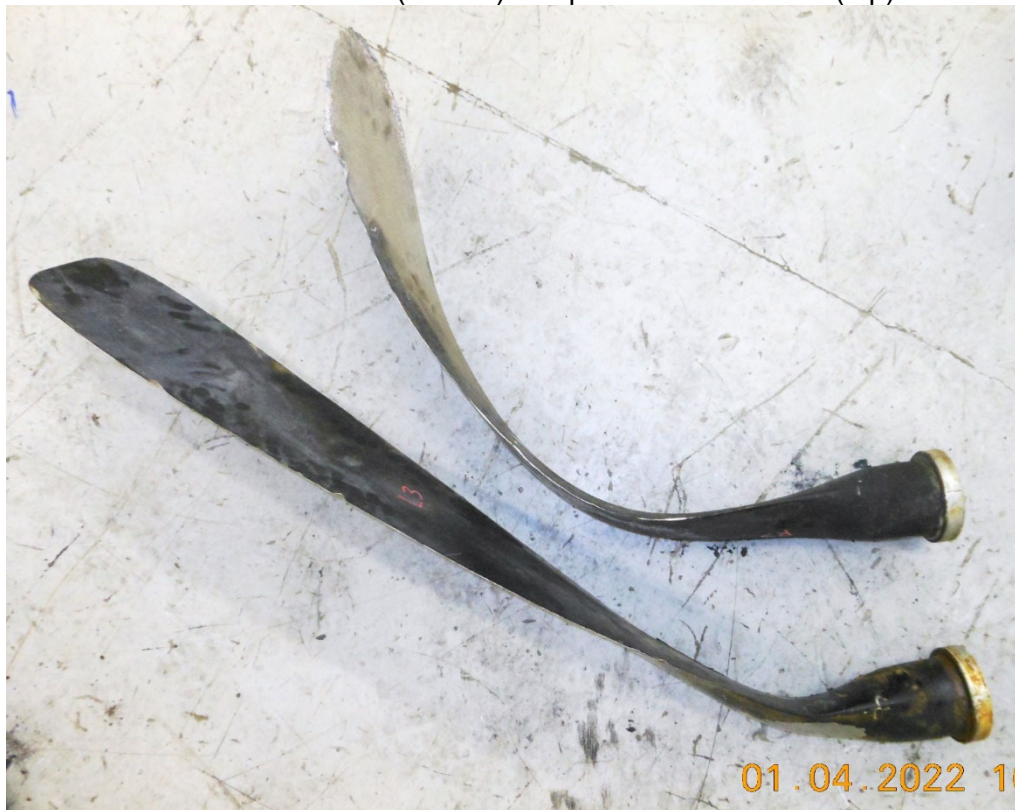
The degree of blade damage (bending and twisting) was similar on blades R3 and L3 as shown in Photo #3.

Photo #3 - Blade L3 (bottom) comparison to Blade R3 (top)

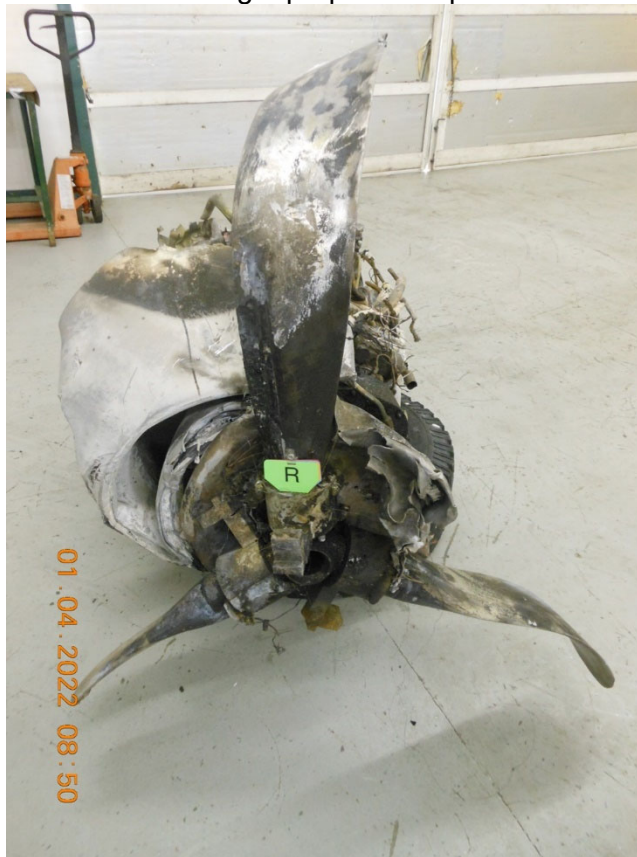
**“As Received” Condition:** The propeller as-presented was securely attached to the propeller shaft flange (Photo #4) with all mounting hardware present, secure and lock-wired. The hydraulic unit (cylinder, piston and feathering spring assembly) had separated during the impact sequence and was recovered at the crash scene. The propeller exhibited remarkable heat damage, charring and sooting. All three blades remained attached to the hub/clamps and the counterweights were intact. All three blades were partially consumed by a post-crash fire and were in a feathered position. The mostly-intact blade was in a low pitch position and could be partially rotated by hand force. The spinner dome was 90+% consumed by a post-crash fire, only a fragment remained attached to the bulkhead. The de-ice slip ring potting compound was consumed and the rings separated from the platter and were loose around the propeller shaft.

Photo #4- Right propeller as-presented

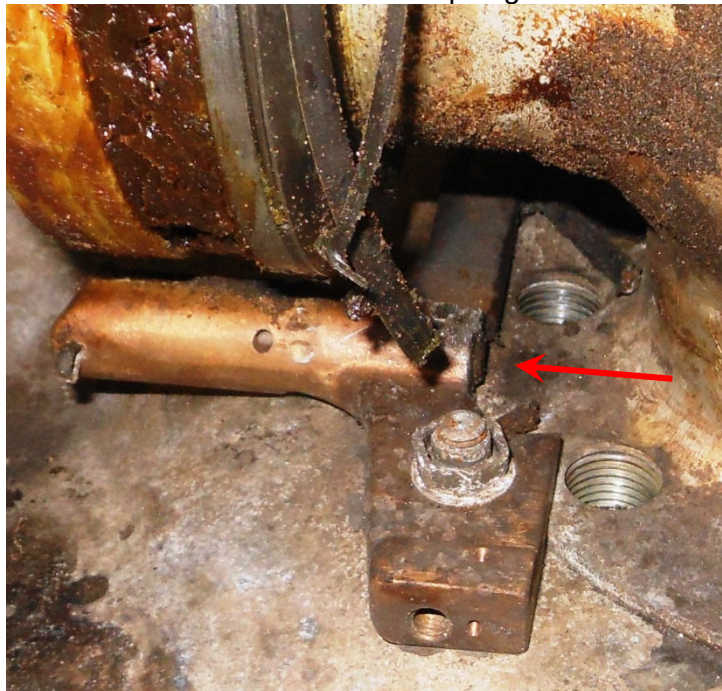
**Start Lock:** All three start lock brackets were intact on the spinner bulkhead and appeared undamaged except for heat exposure. Two start lock plungers (R2 and R3) were in the retracted state and one (R1) was extended. See Photo #5. The start lock plate for R1 was missing and not recovered. The start lock plates for R2 and R3 were intact with screws present and lock-wired.

Photo #5 - R2 start lock bracket and plunger shown retracted

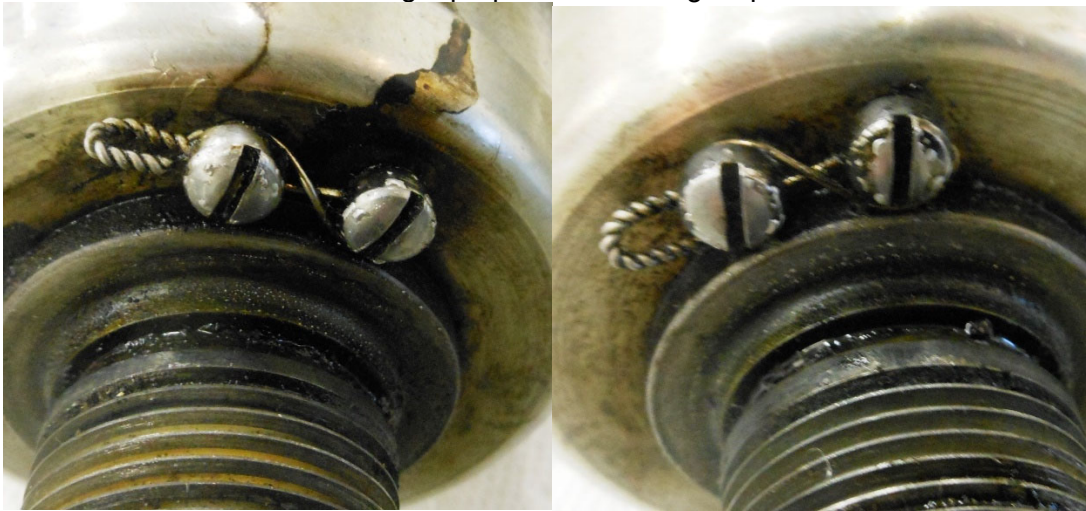
**Feather Stop Screws:** The feather stop screws were intact and appeared undamaged (Photo #6). Undamaged feather stop screws suggest the piston was not in the feathered position at impact.

Photo #6 - Right propeller feathering stop screws

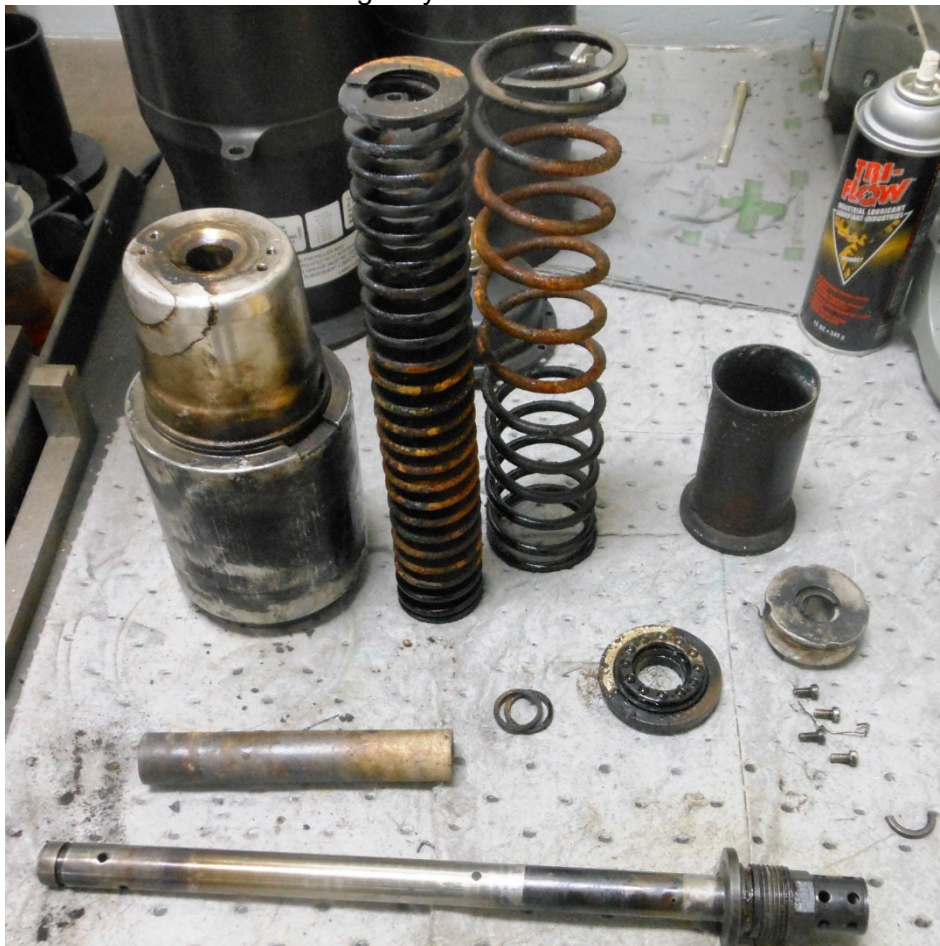
**Hydraulic Unit:** Disassembly of the feathering spring required special tooling so the hydraulic unit inspection was conducted on January 11, 2022 at Hartzell Propeller via a virtual exam with the NTSB Investigator in Charge. Unloading and removal of the feathering spring allowed observation of pitch change rod signatures, spring and low pitch stop sleeve. Components observed at this inspection are shown in Photo #7.

**Feathering Spring Assembly:** The feathering springs were intact and loaded with the spring keepers in-place. It was removed without difficulty using a spring compressor. The springs exhibited heat exposure and surface corrosion (Photo #7). The spring support sleeve was torn at the aft edge where it engages the aft spring retainer.

Photo #7 - Right hydraulic unit disassembled

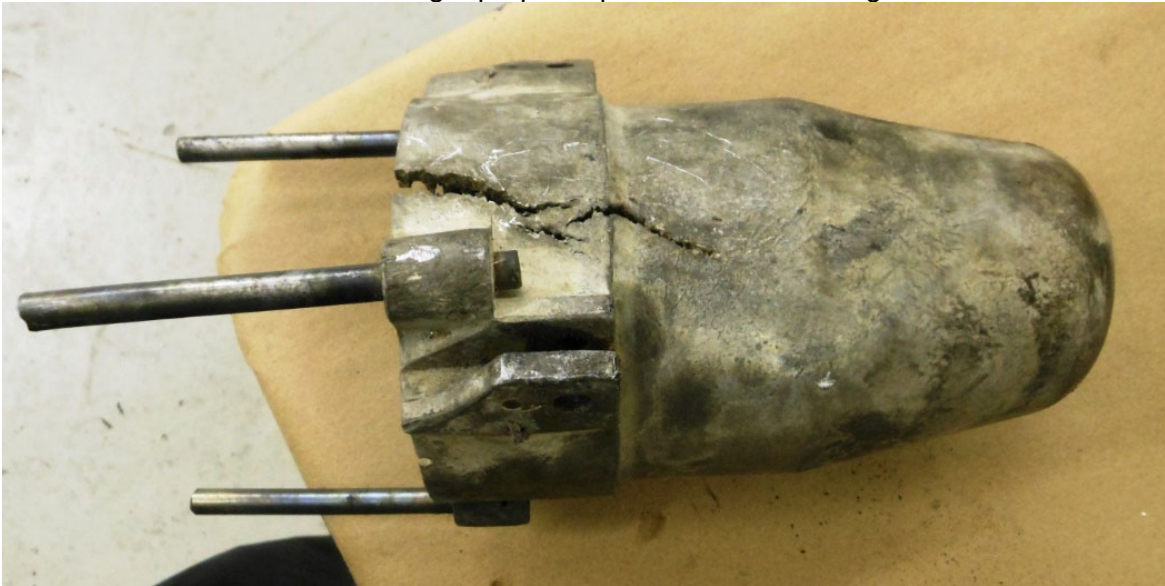
**Piston:** The piston was thermally damaged and removed from the cylinder/spring assembly without difficulty. One side of the piston had partially melted and appeared to have a thermal crack (Photo #8). Another side of the piston had a hole/puncture (Photo #9). Material deformation on the internal surface of the piston suggested this hole was made with the piston in a forward (low pitch) position and then either retracted or was forced aft (high pitch), see Photo #10. There were no discernable marks on the internal surface of the piston that would provide blade angle information.

Photo #8 - Right propeller piston thermal damage

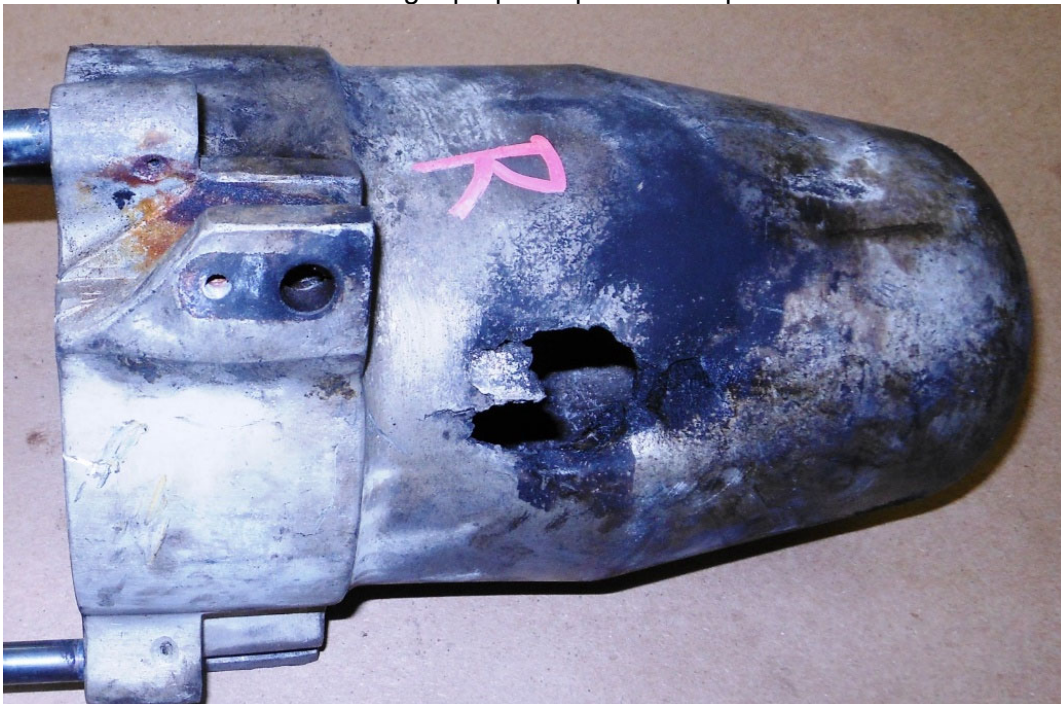
Photo #9 - Right propeller piston hole/puncture

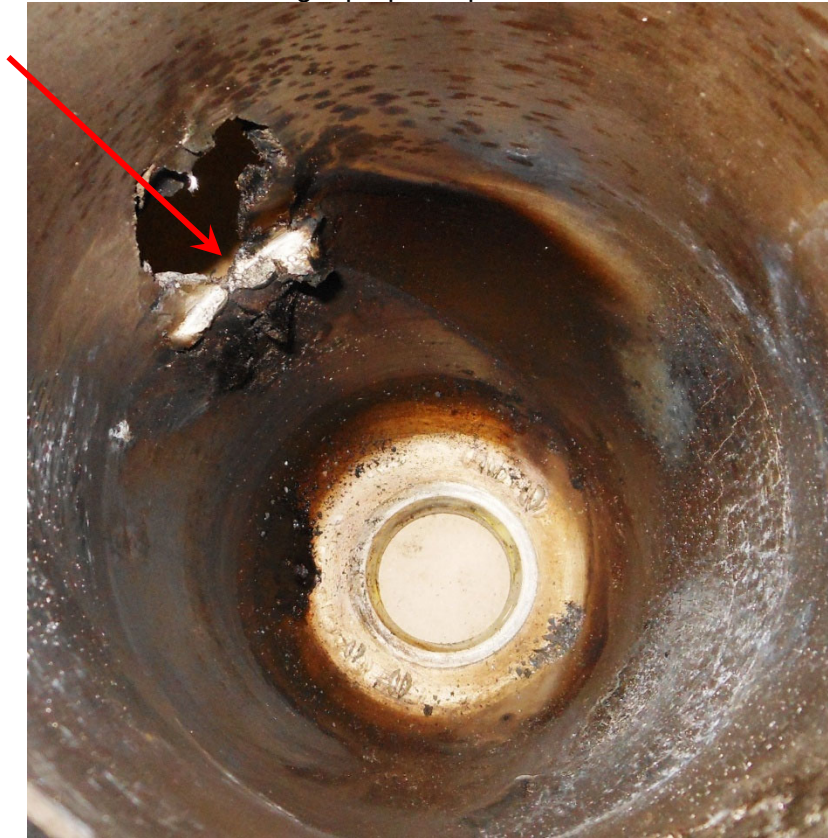
Photo #10 - Right propeller piston internal surface

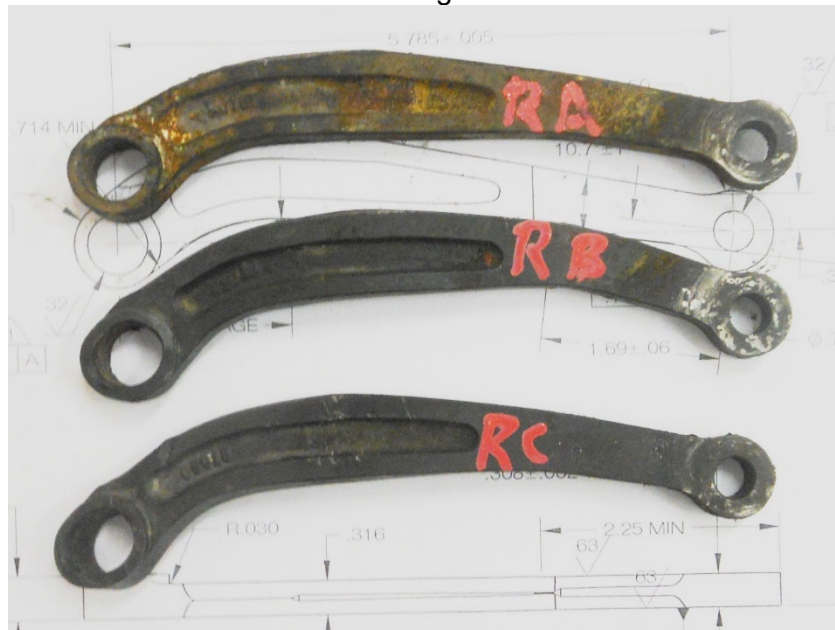
**Link Arms:** All three link arms were bent in compression, there was no remarkable twisting. The link screw holes on two arms was elongated (Photo #11). Note: In Photo #11, the link arms were mistakenly labeled RA, RB and RC which is equivalent to R1, R2 and R3 respectively.

Photo #11 - Right link arms

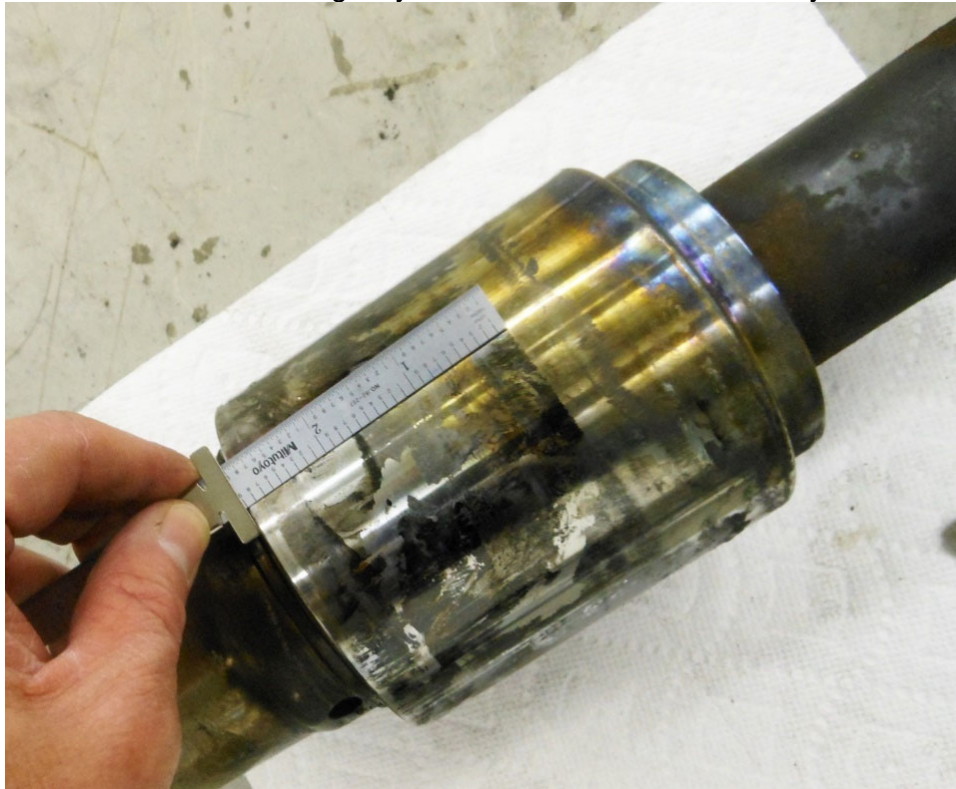
**Cylinder:** The cylinder was intact with the forward spring cup, pitch change rod, feathering spring assembly and rear spring retainer attached. The cylinder had some localized dents and exhibited charring and sooting. There was a discoloration discontinuity on the cylinder wall measured approximately 2.9" from the forward/top corner (Photo #12). This distance represents a blade angle of 36.7°.

Photo #12 - Right cylinder discoloration discontinuity

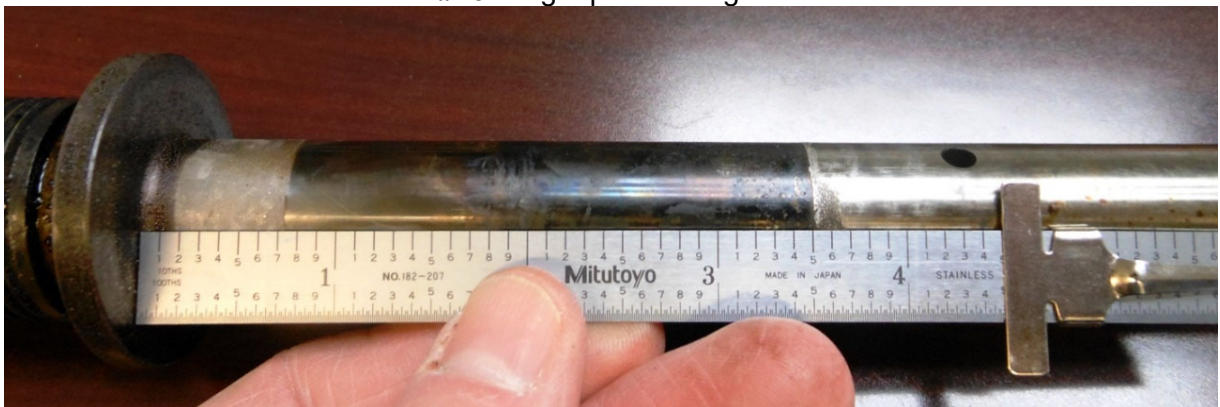
**Pitch Change Rod:** The pitch change rod was intact and did not appear to be bent and slid smoothly out of the forward spring cup. Segments of the rod exhibited heat exposure while another segment appeared to be protected/covered by the low pitch stop sleeve (Photo #13). The forward section of the rod appeared to have some molten aluminum splatter on the surface and measured approximately 0.73" in length. This section represents the resting position of the rod after impact and during the post-crash fire. The section aft of that measured approximately 2.77" in length and exhibited heat exposure discoloration. The section protected by the low pitch stop sleeve started approximately 3.5" from the forward rod flange. The distance from the forward end of the low pitch stop sleeve to the aft end of the forward spring cup sleeve would be approximately 1.6" (3.5" charred region - 0.2" feather stop screw height - 1.7" forward spring cup sleeve length = 1.6"). This pitch change rod displacement from feather represents a blade angle of approximately 34°, and from the reverse stop a blade angle of approximately 50°.

Photo #13 - Right pitch change rod

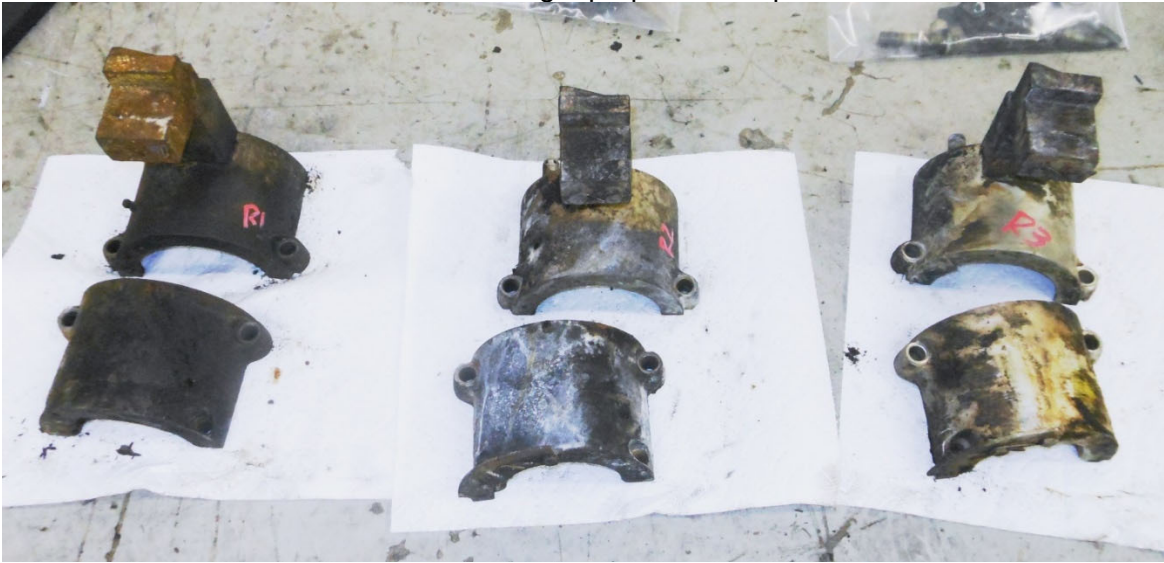
**Clamps and Counterweights:** The clamps and counterweights were thermally damaged with surface charring, sooting and corrosion. There were no discernable cracks and no discernable deformation in the clamps with all clamp bolts present on all three clamps. See Photo #14.

| Clamp Pos. | Clamp S/N | Clamp Condition | Counterweight Condition |
|---|---|---|---|
| R1 | EF5729 | Link screw missing, hole deformation opposite low pitch. Start lock plate missing and not recovered. | Intact |
| R2 | EF6460 | Link screw intact with localized dent on end in cotter pin hole zone indicating over-rotation toward low pitch and contact with hub arm. Start lock plate intact with screws present and lock-wired. | Intact |
| R3 | EF6436 | Link screw intact with localized dent on end in cotter pin hole zone indicating over-rotation toward low pitch and contact with hub arm. Start lock plate intact with screws present and lock-wired. | Intact |

Photo #14 - Right propeller clamps

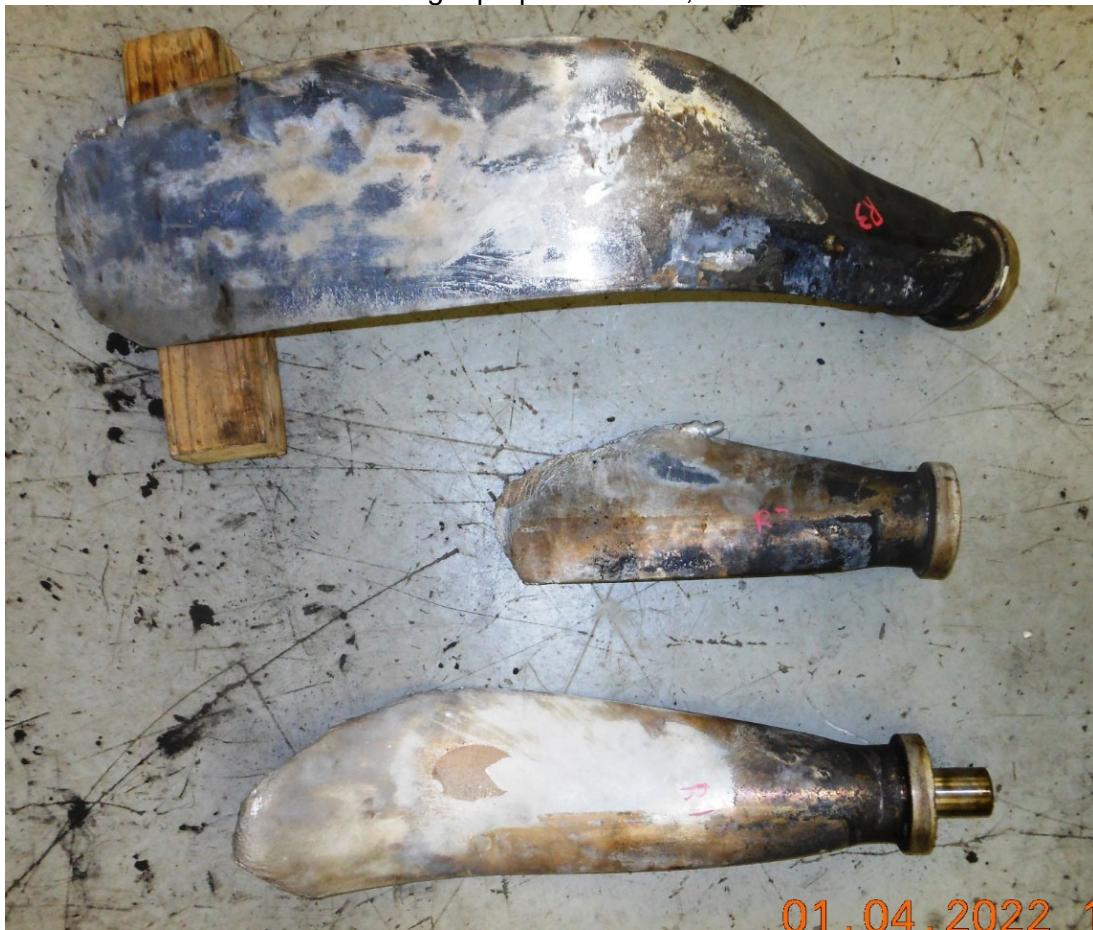
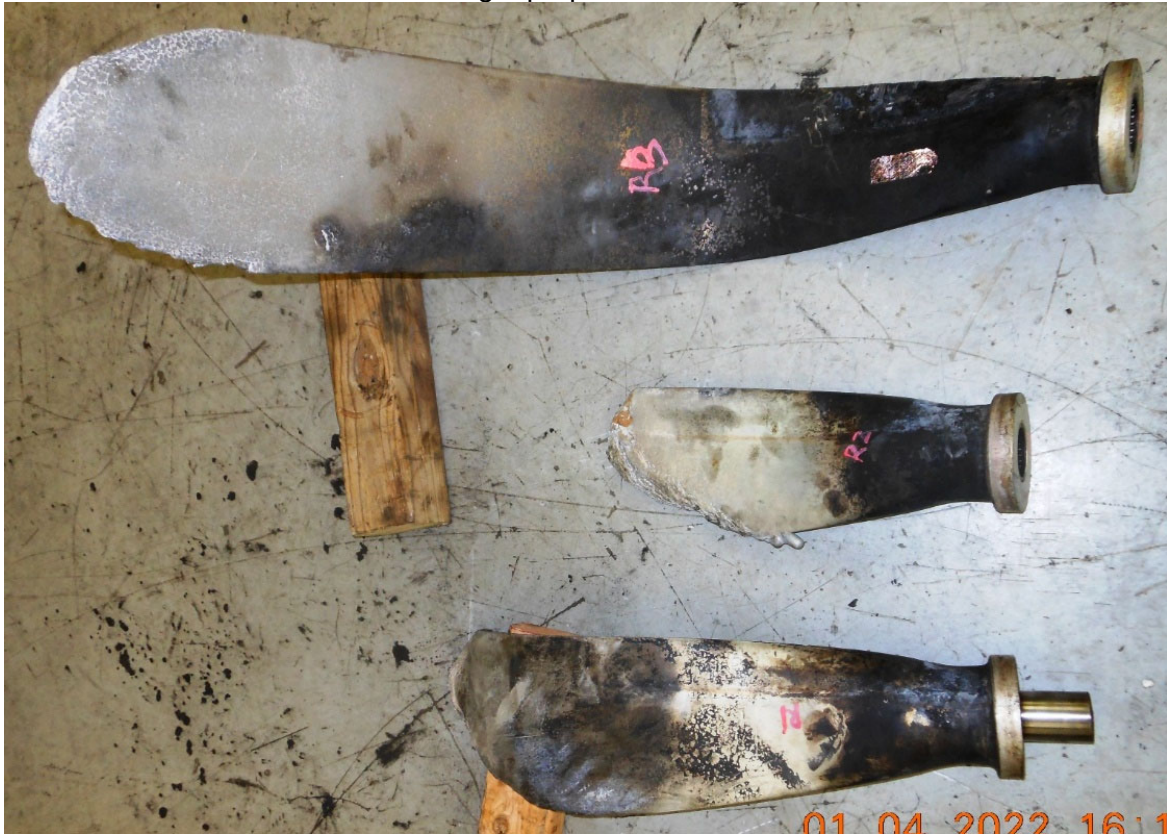
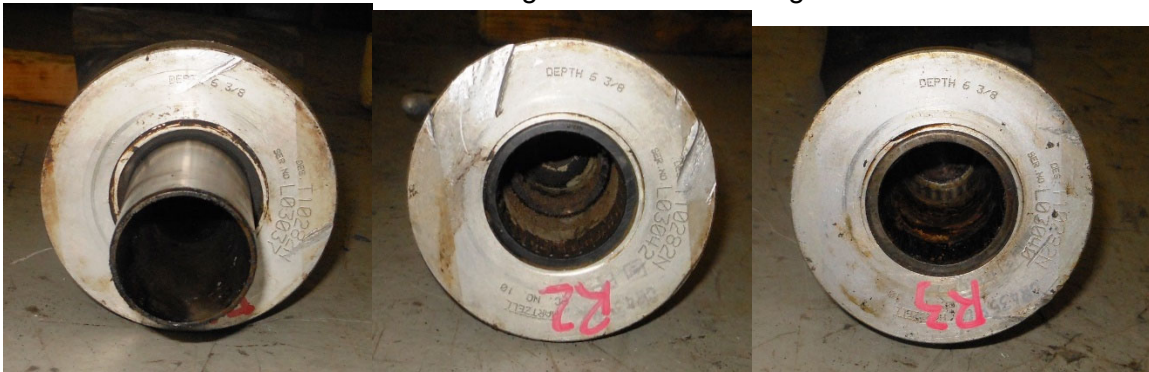
**Blade Properties:** All three blades exhibited thermal damage and were partially consumed in varying degrees. See Photos #15 through #17.

Photo #15 - Right propeller blades, camber side

Photo #16 - Right propeller blades, face side

Photo #17 - Right blade butt montage

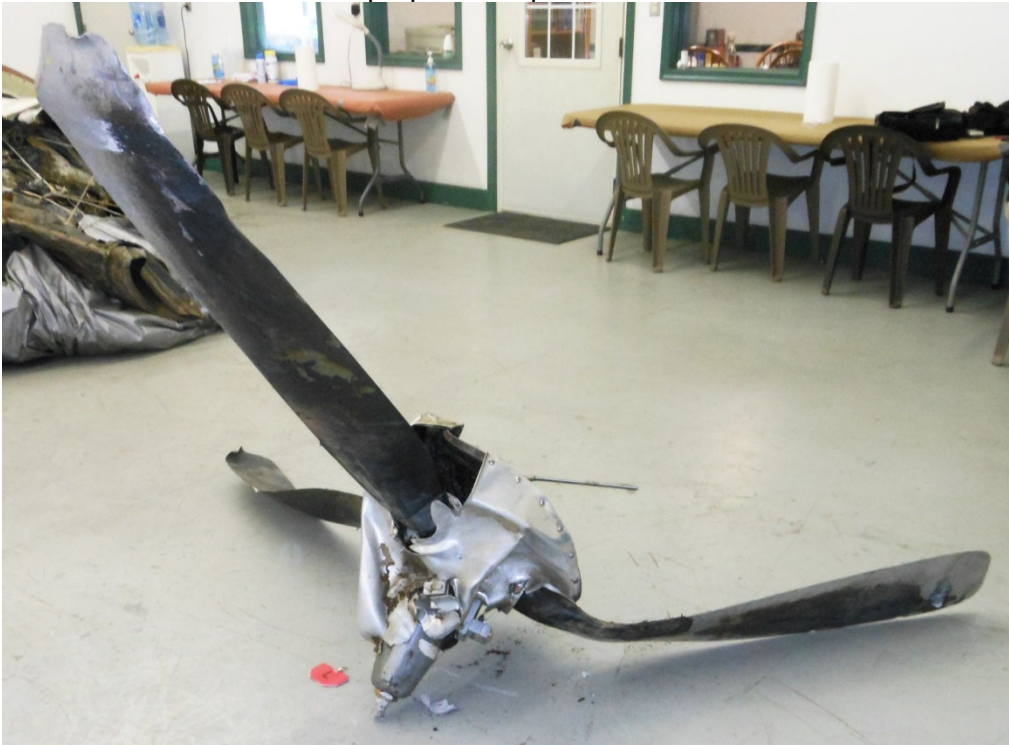
**“As Received” Condition:** The left propeller fractured from the propeller shaft flange during the impact sequence and was presented for examination as shown in Photo #18. A small segment of the propeller shaft flange remained attached to the propeller mounting flange with one of the eight mounting bolts. Six bolts remained with the engine flange (Photo #19). The engine beta rod remained intact and attached to the propeller but was bent. The aft feathering spring retainer was missing one of the two keepers. Two blades were bent aft and one had some apparent twisting toward low pitch. The propeller blades appeared to be at low pitch or on the start locks (Photo #28). All three blades exhibited heat exposure damage; charring and sooting but there was no remarkable evidence of material melting or being consumed. The spinner dome was crushed, torn and partially formed around the hydraulic unit with a counterweight puncture near the low pitch position. After the spinner dome was removed it was noted the cylinder/hydraulic unit separated from the hub. All three link arms remained attached at both the piston and clamp link screws.

Photo #18 - Left propeller as-presented for examination

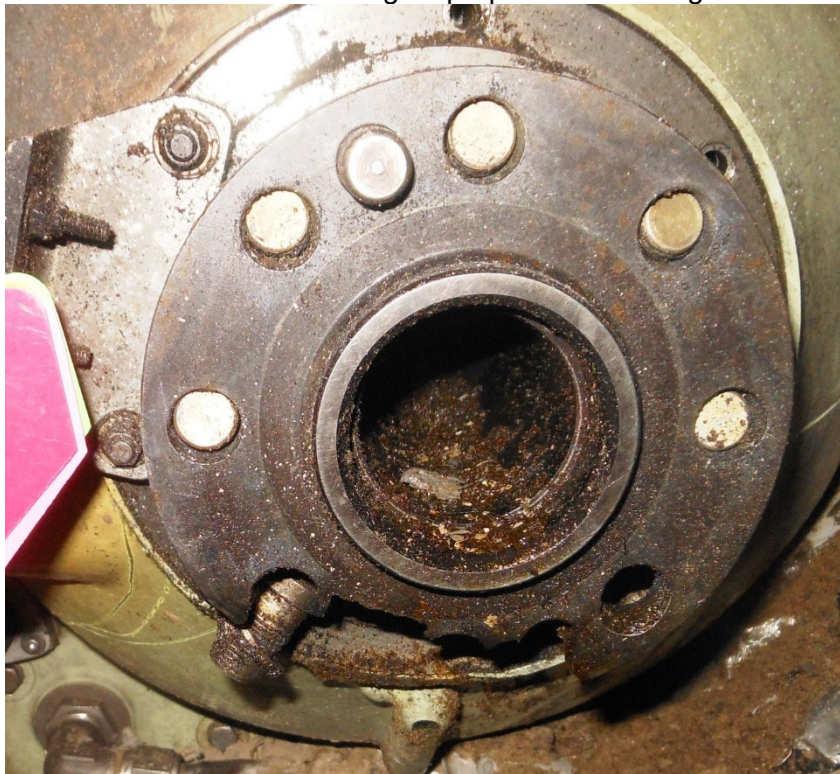
**Engine/Propeller Mounting:** The propeller mounting flange fractured/pulled from the engine propeller shaft flange. One fragment of the shaft flange remained attached to the hub flange. The mounting bolt holes were contaminated with dirt/sand.

Photo #19 - Left engine propeller shaft flange

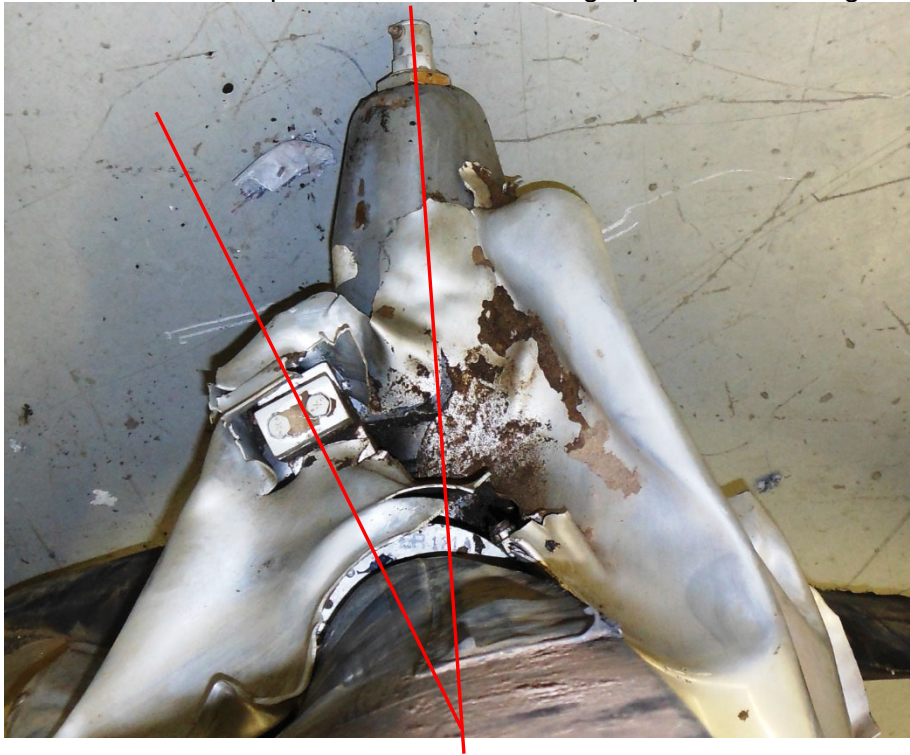
**Spinner Dome:** The spinner dome was crushed and torn. One counterweight punctured through the dome and the angle was measured with the Theodolite App at 21° which equates to a blade angle of approximately 10.5° (Photo #20).

Photo #20 - Left spinner dome counterweight puncture and angle

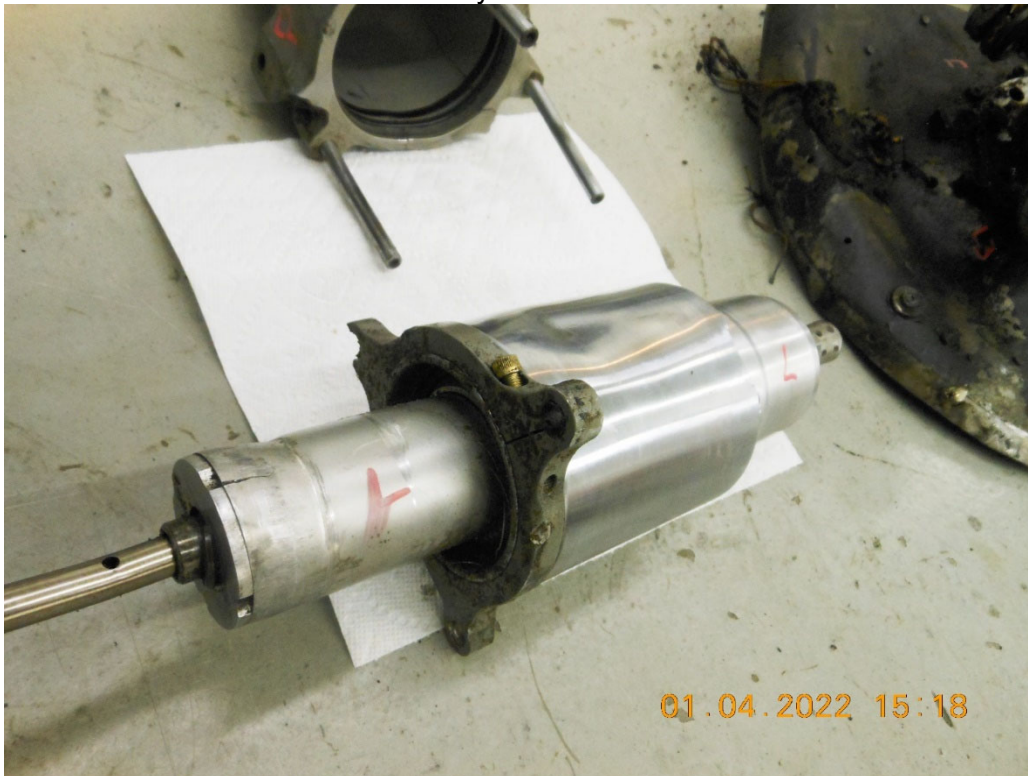
**Hydraulic Unit:** The hydraulic unit (cylinder, piston and feathering spring assembly) and guide ring separated from the hub mounting threads during the impact sequence. It was removed from the propeller as an assembly. The piston was removed from the unit but no further disassembly was conducted. Its final state is shown in Photo #21.

**Beta Tube:** The beta tube was intact but bent. It is shown exiting the pitch change rod in Photo #21.

Photo #21 - Left hydraulic unit in final state

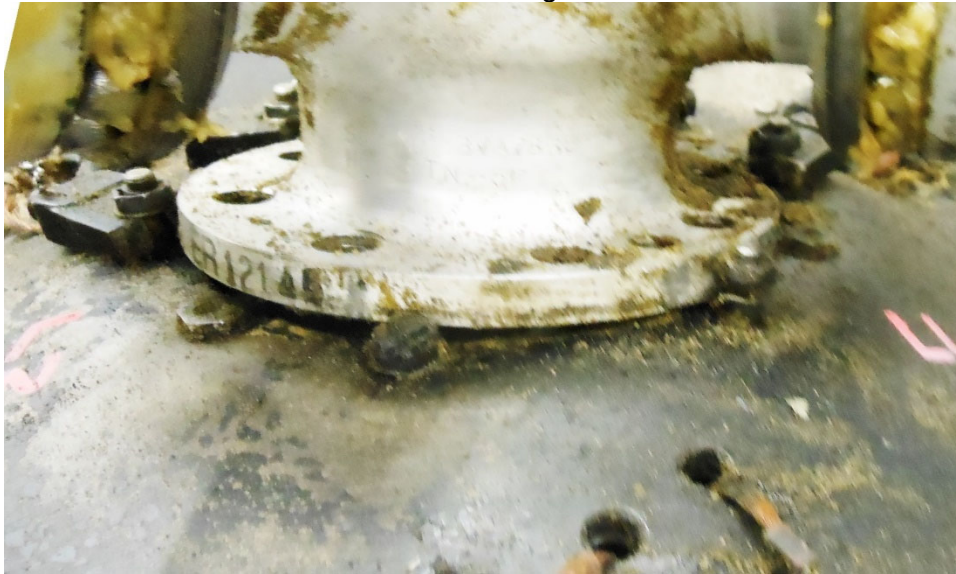
**Start Lock:** The L1 and L2 start lock assembly brackets were fractured from the bulkhead assembly (Photo #22). Some of the bracket fragments were not recovered. The L3 start lock bracket was intact but bent and the plunger would not move by finger force. All three start lock plates were attached to their clamps with fasteners secure and lockwired. The L1 lock plate had a "wiping gouge" along the edge in the low pitch end. The L3 lock plate had a dent in the same approximate location as the L1 plate (Photo #23).

Photo #22 - Fractured/missing start lock brackets

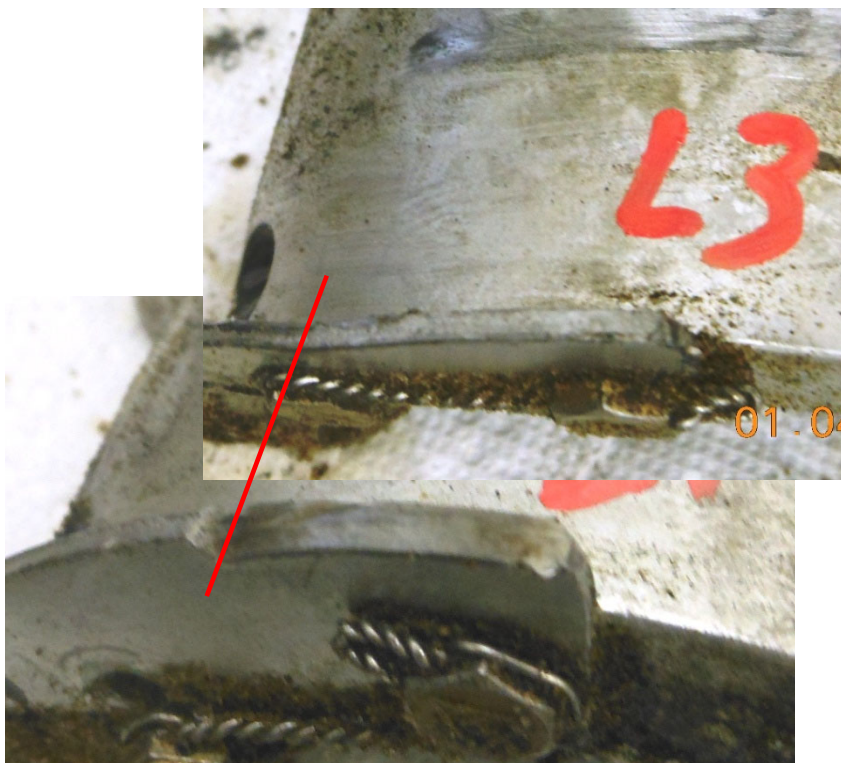
Photo #23 - L1 and L3 start lock plate damage

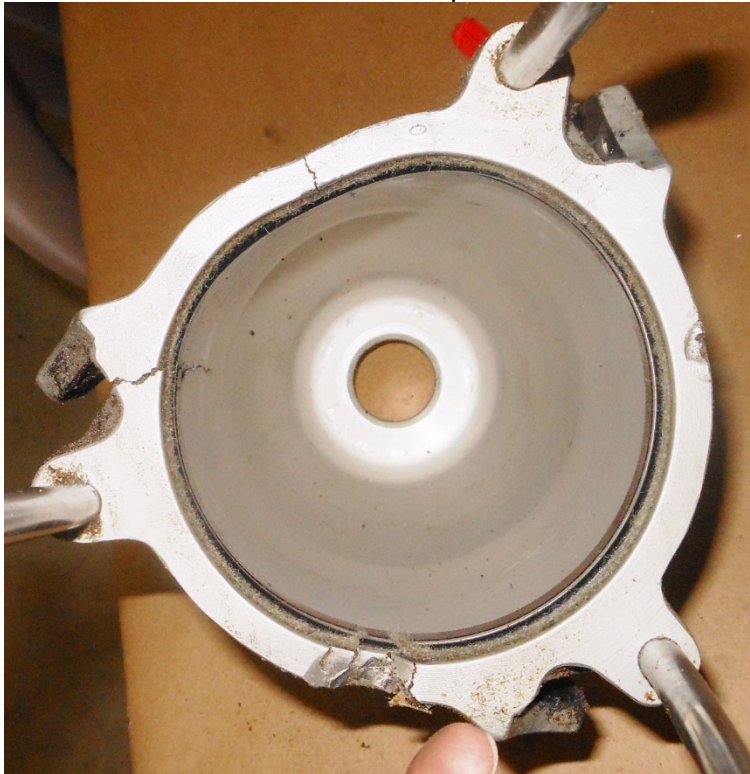
**Piston:** The piston was secure on the pitch change rod and whole, but one side was dented/smashed with two visible cracks emanating from the base, with one adjacent to the link arm connection point for blade L3 (Photo #24). There were also two impact marks made by contact with counterweight arm on the bottom edge of the piston indicating the piston was in a forward/low pitch position when they were made. There was a cylinder impact marks on the internal surface of the piston ranging from approximately 3.3" to 2.2" from the bottom edge (Photo #25).

Photo #24 - Left piston

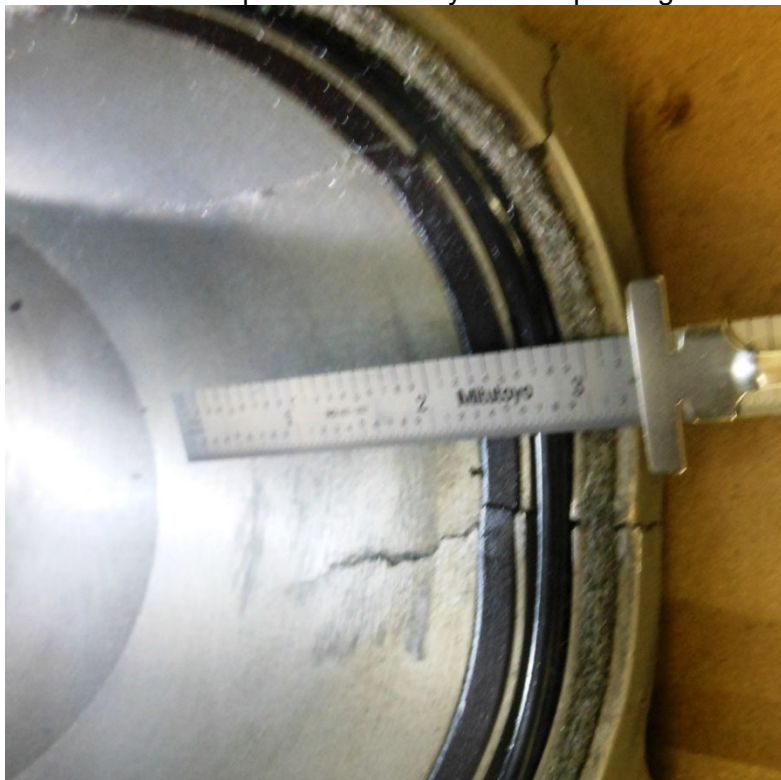
| Internal Marks from Bottom Piston Edge | Approximate Equivalent Blade Angle | Pre-impact Confidence Level / Why? |
|---|---|---|
| 2.2" - 3.3" | 16° - 48.5° | Medium: Impact forces pushed piston when marks were made on side of piston that was smashed. |

Photo #25 - Left piston internal cylinder impact signatures

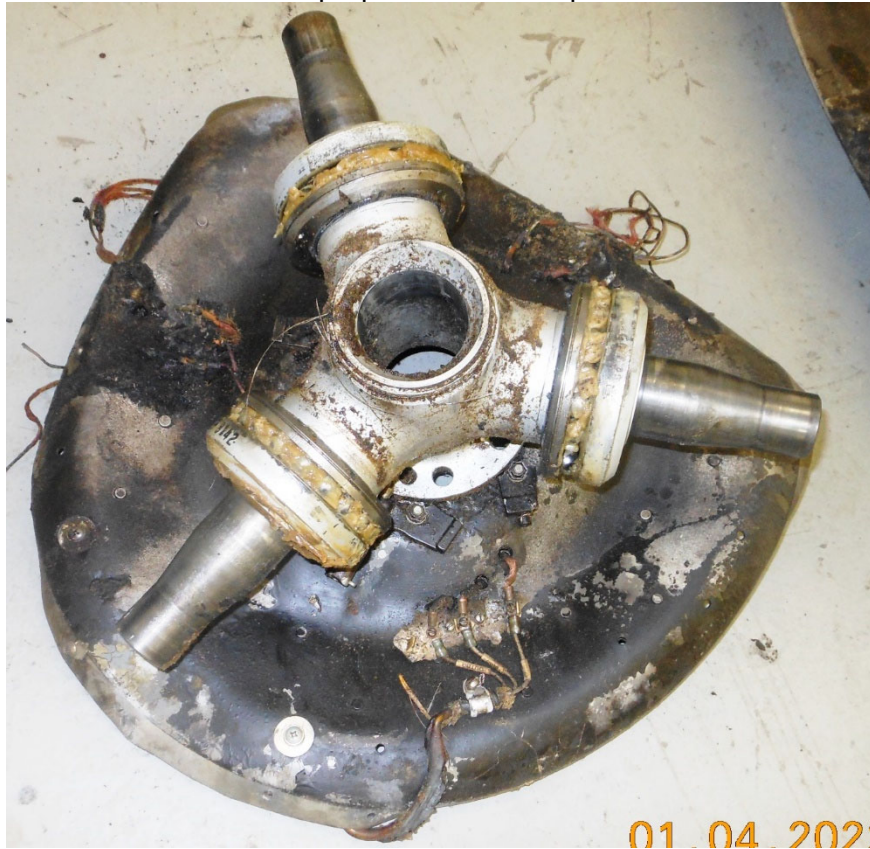
**Hub Unit:** The hub was intact (Photo #26) and the mounting flange appeared undamaged. There was some damage and thread whiskers in the cylinder mounting threads. There were no discernable blade-to-hub contact witness marks on any of the three blade arm flanges.

Photo #26 - Left propeller hub and spinner bulkhead

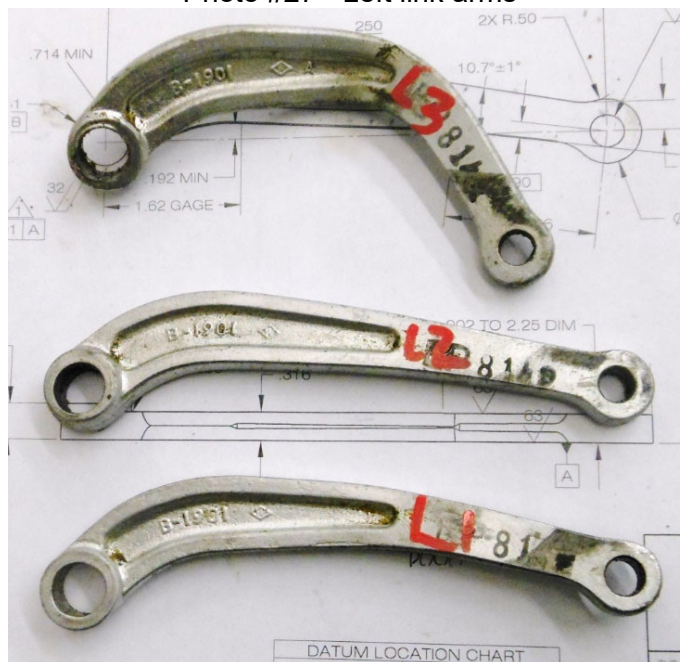
**Link Arms:** Link arms and L1 and L3 were bent in compression (Photo #27). L3 was also remarkably twisted. Link arm L2 appeared undamaged.

Photo #27 - Left link arms
