**Aircraft Accident/Incident Report No.: 211210-2**

**Date of Accident:** December 10, 2021

**Aircraft:** Swearingen SA226-AT

**Written by:** Les Doud  
Air Safety Investigator – Hartzell Propeller Inc.

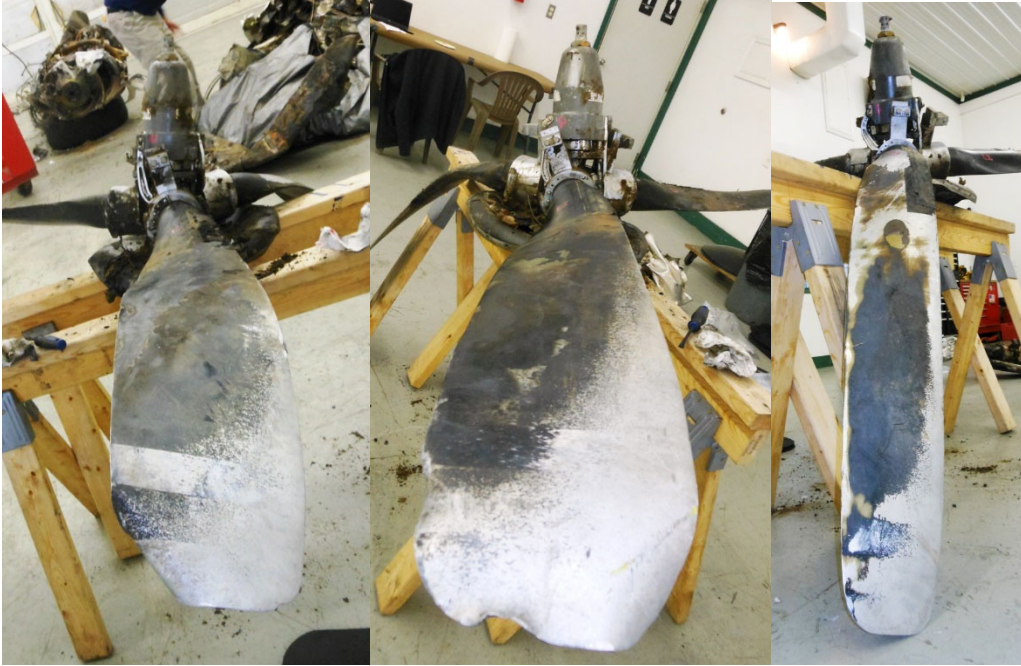
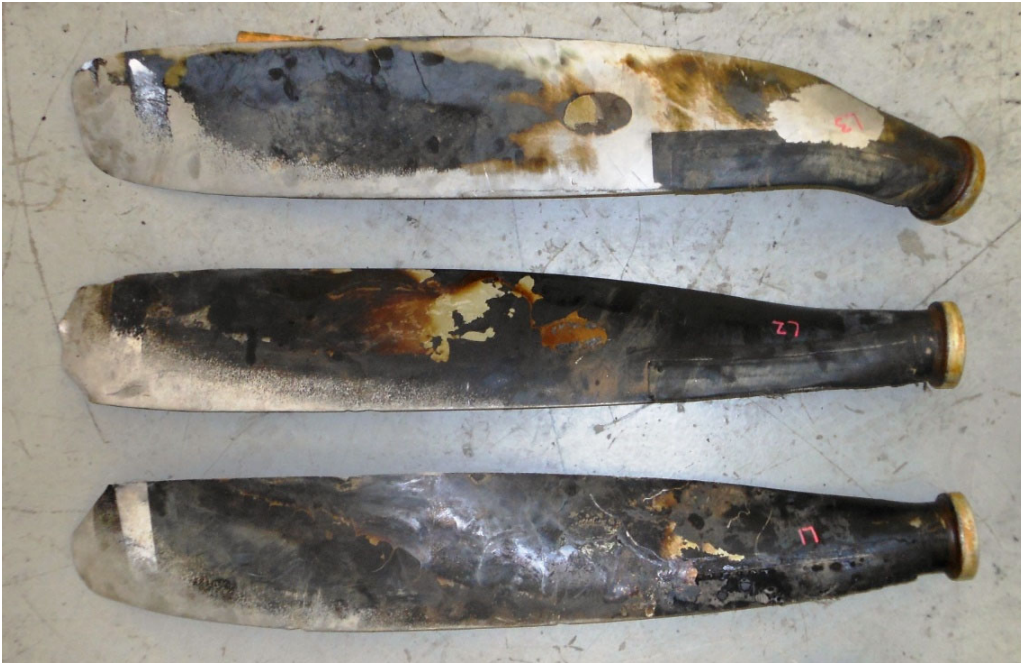
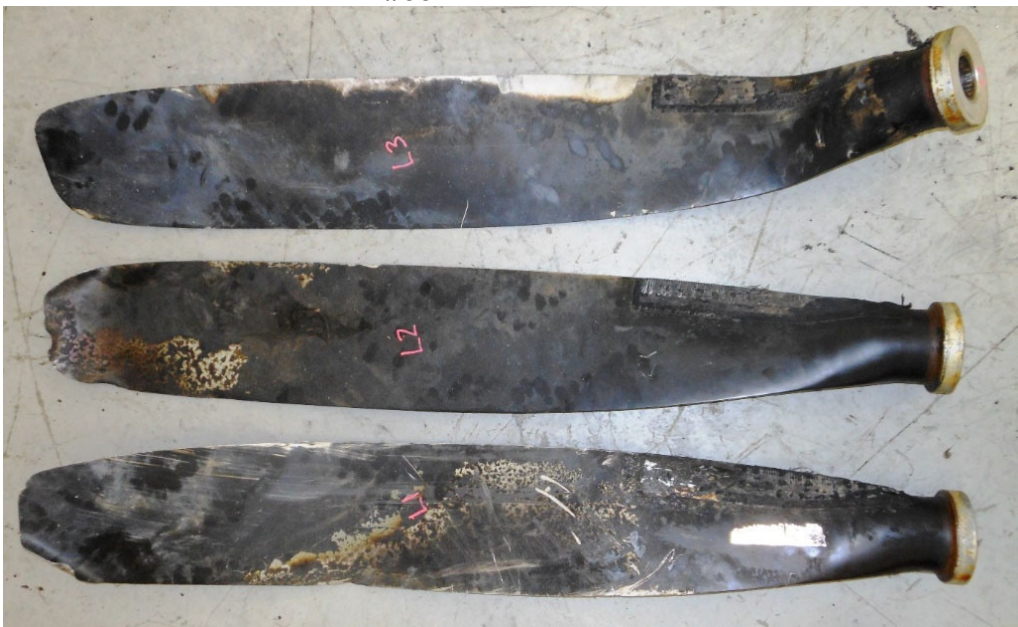
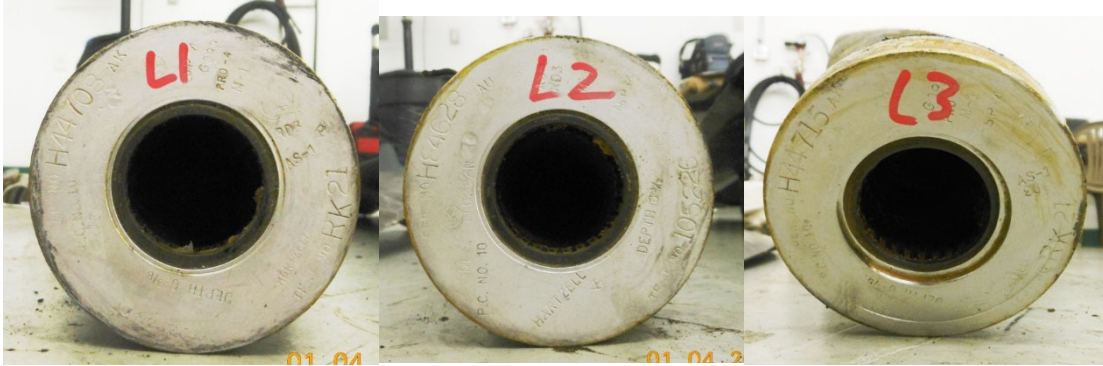
**Blade Properties:** All three blades exhibited varying degrees of heat exposure discoloration (charring, sooting, paint blistering). See Photos #28, and #32 through #34.

Photo #28 - Left propeller blade damage, as-presented

Photo #32 - Left blades camber side

Photo #33 - Left blades face side

Photo #34 - Left propeller blade butts

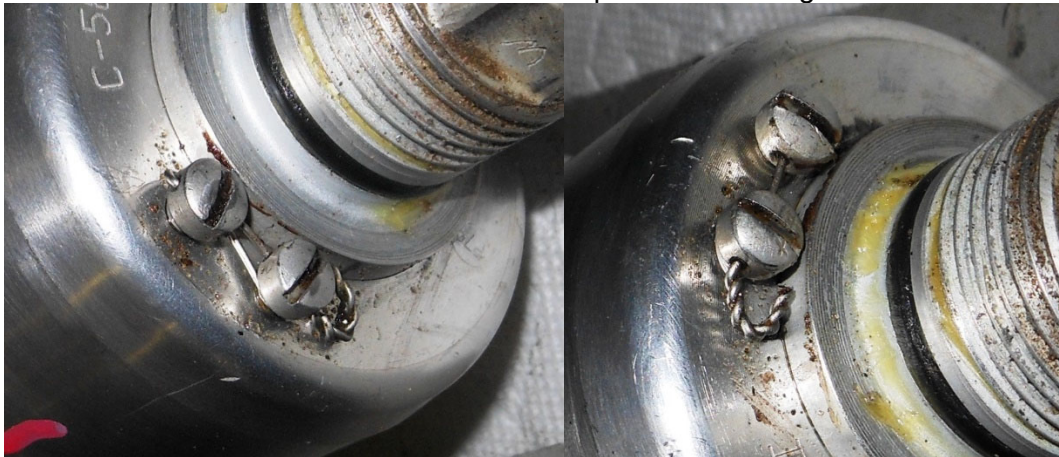
**Feather Stop Screws:** The feather stop screws appeared intact and undamaged (Photo #29).

Photo #29 - Left feather stop screws montage

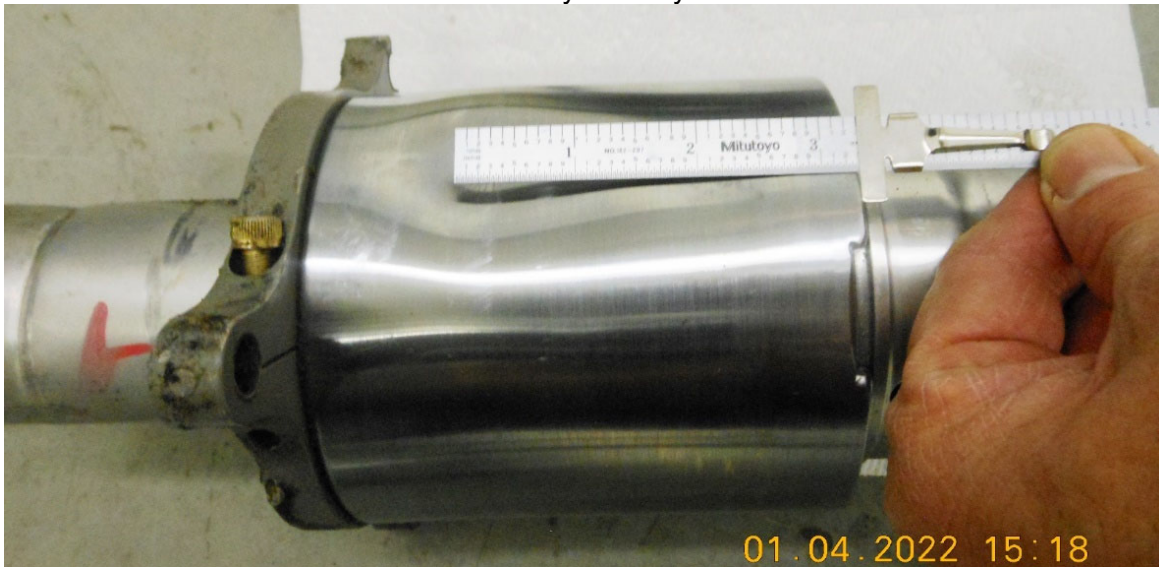
**Cylinder:** The cylinder mounting threads were damaged when it forced from the hub. The cylinder had a dent/crease approximately 3.3" from the top corner that was consistent with the mark in the piston (Photo #30). This is approximately equivalent to 48.5° blade angle.

Photo #30 - Left cylinder/hydraulic unit

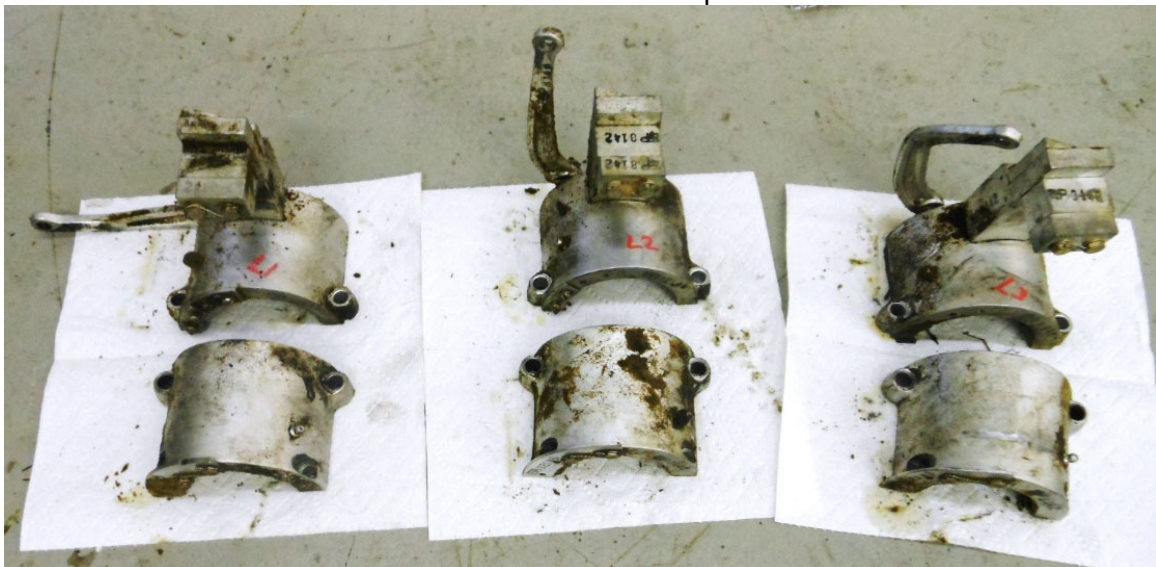
**Clamps and Counterweights:** The L1 and L2 clamps and counterweights were intact. The L3 counterweight was displaced and one bolt appeared fractured. There were no discernable cracks and no discernable deformation with all clamp bolts present on all three clamps. See Photo #31.

| Clamp Pos. | Clamp S/N | Clamp Condition | Counterweight Condition |
|---|---|---|---|
| L3 | EF9047 | Intact with link screw intact | Displaced, one bolt appeared fractured |

Photo #31 - Left clamps
