ERA22FA086

Group Chair's Factual Report - Attachment # 1

Woodward Fuel Control Unit, Serial Number, 2007669, Investigation Report

June 27, 2023

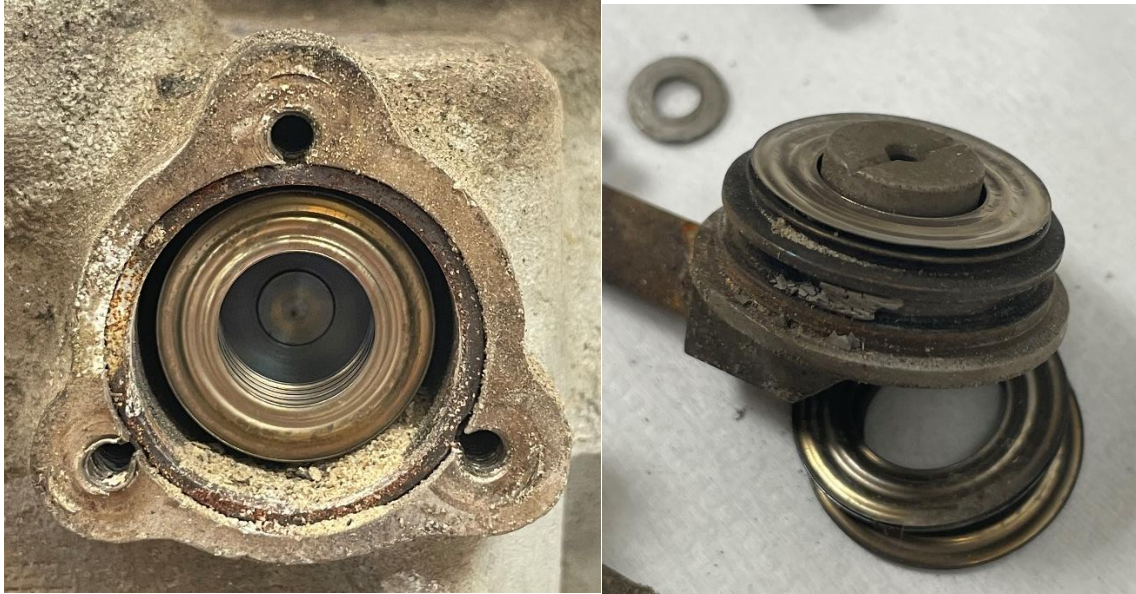
Figure 1. Tt2 Sensor Bellows

The presence of foreign lockwire indicates that the unit was serviced at another facility since it was last shipped from Woodward. The unit was returned with customer fittings, power lever and speed lever linkages, pressurizing valve assembly, and the Tt2 sensor still installed. The Tt2 sensor and customer hardware were removed so that a visual as-received inspection could be performed. A portion of the Tt2 sensor bellows remained stuck in the housing and had to be removed manually (see Figure 1).

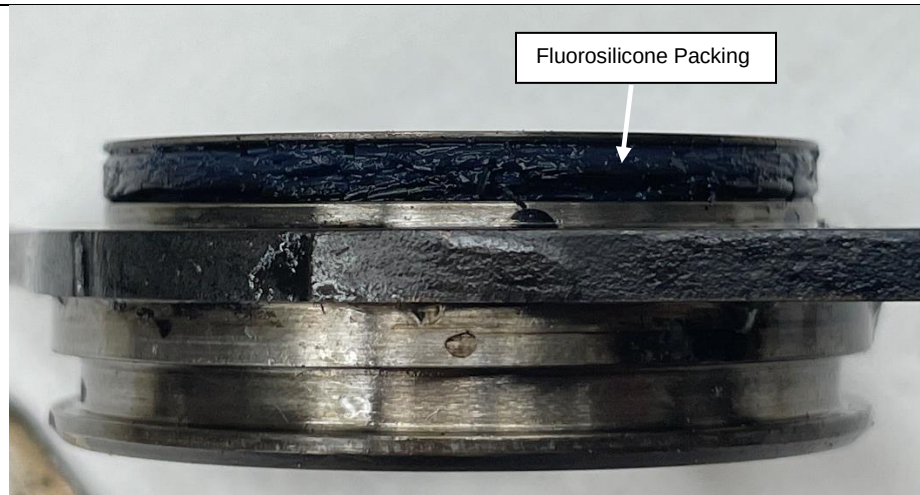
Figure 2. Bypass Valve Cover

A slave inlet filter and transfer tube were installed and the unit was mounted on the test stand for as-received testing. Heavy leakage was observed from the pump interface at low boost pressure (less than 5 psi) during initial startup. Fuel was also observed leaking steadily from the open Pt2 fitting in the cover, indicating that fuel was leaking past the internal packings that seal the fuel section from the air section of the FCU. The unit was removed from the test stand and the bypass valve cover was removed. The fluorosilicone packing installed on the bypass valve cover showed significant thermal damage and was no longer intact (see Figure 2). This packing prevents leakage from the bypass valve to the pump interface. The Max Power adjustment plug was removed from the cover and the fluorosilicone packing on the plug showed similar thermal damage (see Figure 3).

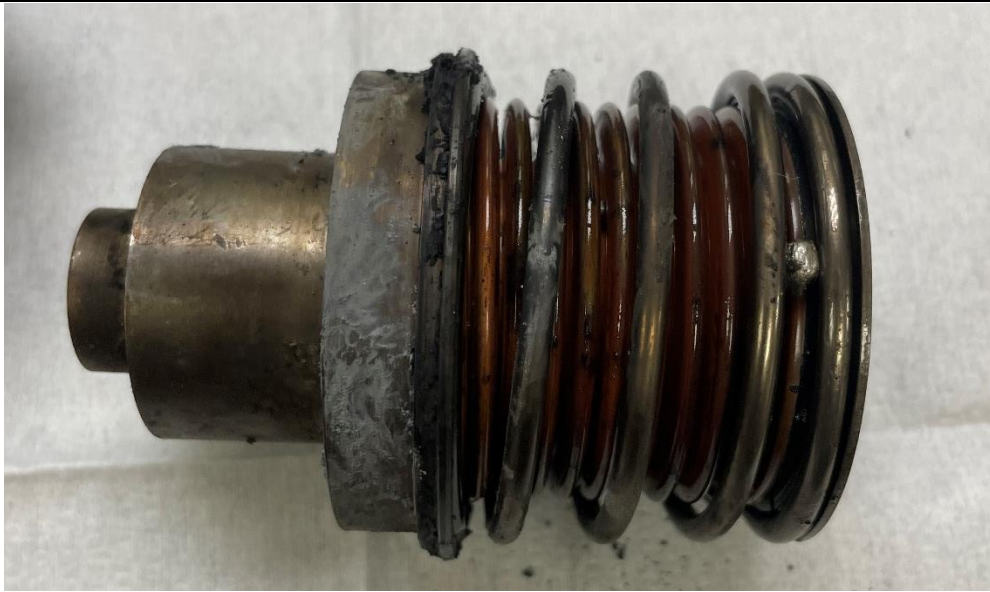
Figure 4. Pt2 Bellows Assembly

The Pt2 bellows assembly was removed and found to be extended (see Figure 4). Extension of the evacuated bellows indicates a leak to ambient pressure. Visual inspection found evidence that the solder joining the bellows and end caps melted and re-solidified. This is consistent with the observed thermal damage.

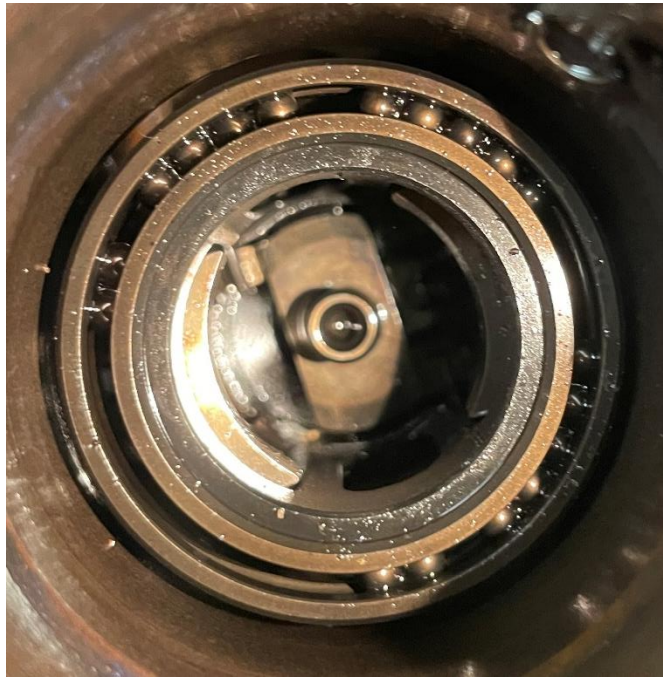
Figure 5. Overspeed Governor Bearing

No other broken parts were observed during disassembly but removal of the internal components was difficult due to thermal damage. Portions of the phenolic retainer were missing from the top bearing of the overspeed governor assembly, but all bearing balls were present (see Figure 5). All springs were intact, but several of the springs showed evidence of heat set in a loaded position.
