ERA22FA086

Group Chair's Factual Report - Attachment # 2

Woodward Propeller Governor, Serial Number, 1440642, Investigation Report and  
Test Run Sheet

June 27, 2023

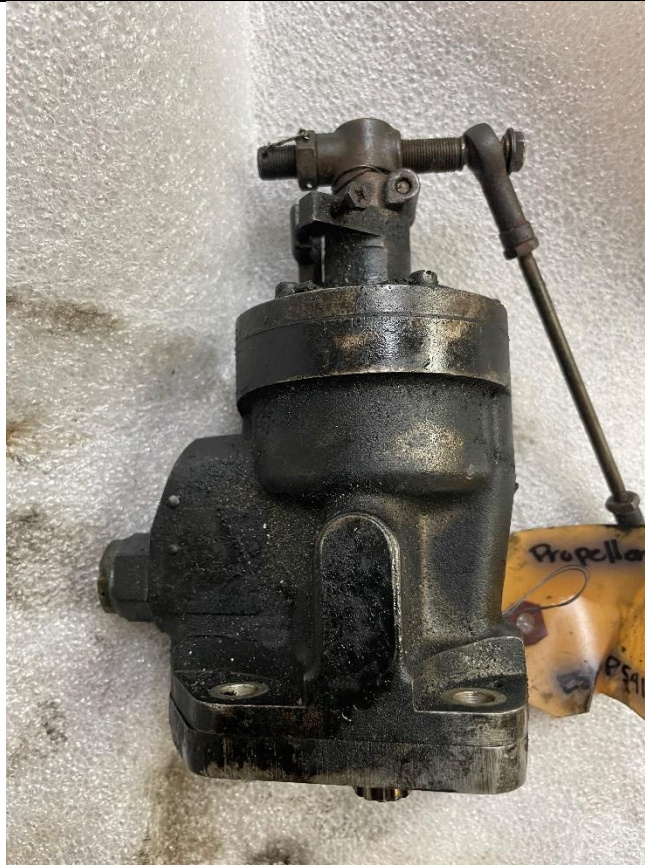
**Figure 1 Prop Governor**

The unit was received and an as received visual inspection was performed on the unit. Immediately present during the inspection was the charred appearance of the unit. The appearance was consistent with a unit involved in a fire see Figure 1. The magnetic pick-up coil wires were severed see Figure 2. The baseplate had evidence of heat damage and a missing baseplate packing see Figure 3. Lastly the lockwire was non-Woodward, indicating the original had been removed after leaving the Woodward Facility. Even with the findings during the visual inspection it was determined that an as received test could be completed on the unit.

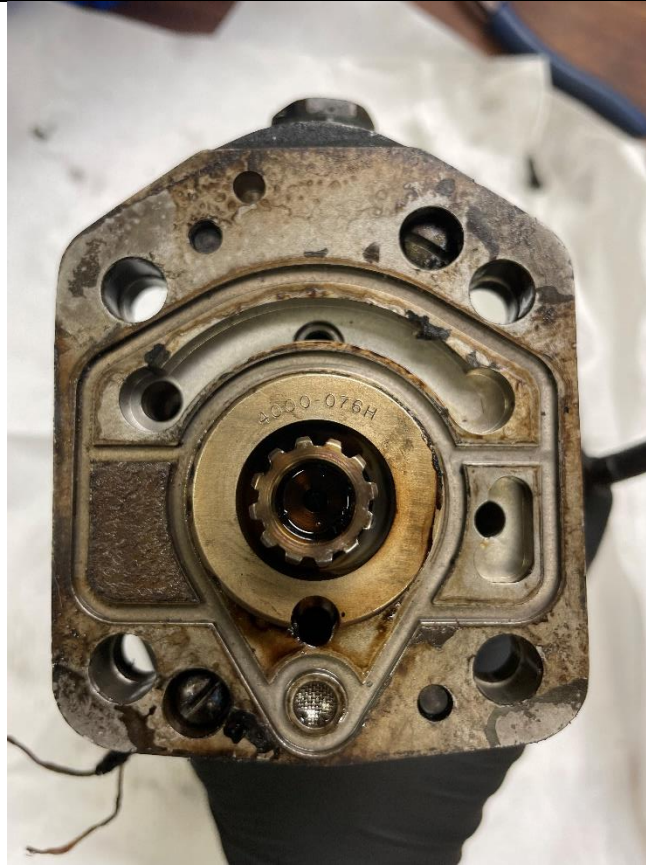
**Figure 3 Missing Baseplate Packing**

Prior to testing a new packing was installed into the baseplate since the original packing was missing. During testing the unit was started up slowly to check for any audible signs of internal damage to the unit. There were no signs of apparent damage to any of the highly rotated components on startup. The relief valve pressure was out of limits low on startup and for the duration of the test. A full test was completed even with the reduced unit pressure the following test points were out of limits.

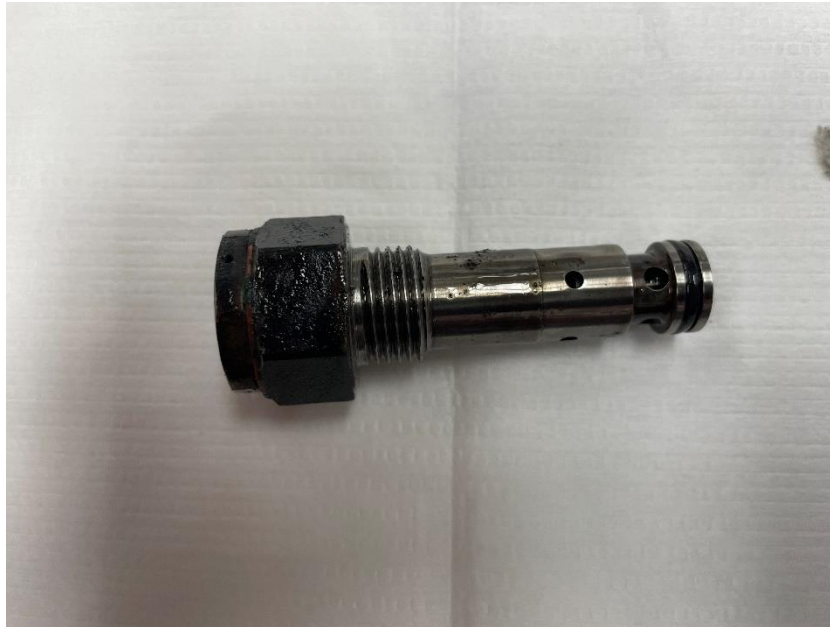
**Figure 4 Assembled Relief Valve**

Test points total leak check, relief valve check, and pump capacity checks are also not typical field adjustments. In order to troubleshoot these three test points the relief valve was swapped with a house relief valve. The swap would not have disturbed anything else on the unit as this is an isolated system. Additionally, the relief valve assembly was not disturbed during the swap. After the swap the unit was retested and found that total leak check and relief valve points were within limits confirming that the relief valve was the cause of those test points checking out of limits on the original run. While the pump capacity test point did not come all the way back into limits after the swap it improved from 3.7 qpm to 7.1 qpm. The adjustments to the max rpm setting can explain the remaining gap between the 7.1 qpm observed and 9 qpm minimum requirement. Since the speed was adjusted lower the pilot valve was slightly open allowing internal leakage while this test was run.

The cause of all the out of tolerance test points was understood. Therefore, no further testing was necessary. The unit was disassembled to investigate the cause of the shift in the relief valve performance. Upon disassembly of the relief valve, it was discovered that the relief valve spring (P/N 192370) was shorter than expected. The free length of the spring on new units is approximately 1.760" while the relief valve spring checked 1.560". After the discovery additional dimensions on the spring were checked to confirm that correct spring was used. Dimensions inspected included the number of coils, wire size, inner diameter, and outer diameter all of which were conforming to the spring drawing specification. The relief valve spring is compressed to approximately 1.500" when installed into the unit, therefore its probable that the spring took a set at the working height due to excessive heat from the post-crash fire. Therefore, when it was tested, the spring had a lower preload on it allowing the relief valve to open easier than usual causing the out-tolerance test points observed during testing. See Figures 4-6 for relief valve photos.
