ERA22FA086

Group Chair's Factual Report - Attachment # 5

Woodward Propeller Governor, Serial Number 746090, Investigation Report and Test  
Run Sheet

June 27, 2023

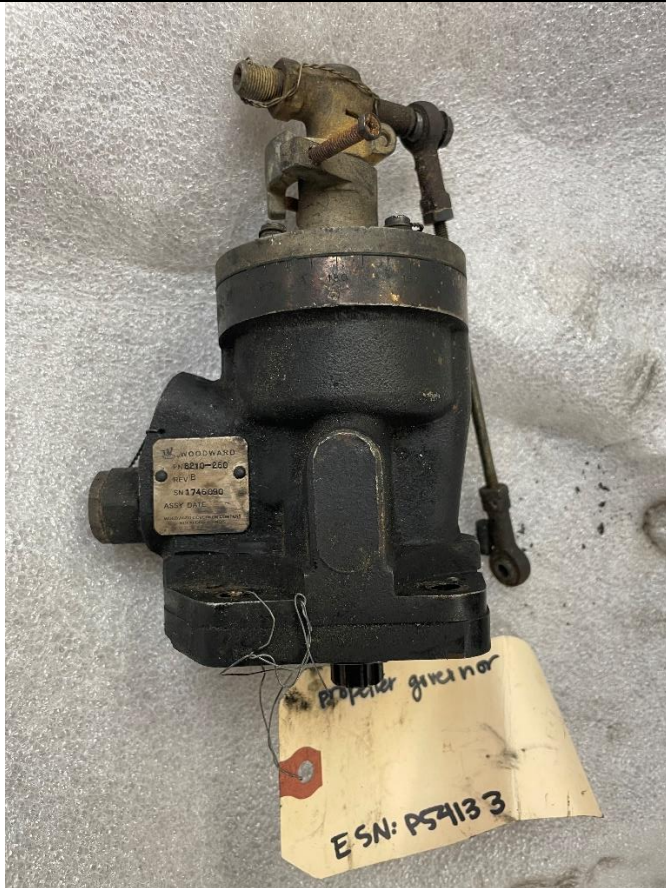
Confirmation Text: DID NOT CONFIRM REASON FOR INVESTIGATION/RETURN  
 Discrepant Item Number: NA  
 Discrepancy: No Discrepancy Found  
 Finding: The unit was received and an as received visual inspection was performed on the unit. Immediately present during the inspection was the charred appearance of the unit. The appearance was consistent with a unit involved in a fire see Figures 1 and 2. The magnetic pick-up coil's wires were not present see Figure 3. When the drive shaft was rotated it had a bit of binding but was capable of rotating. The baseplate packing had evidence of heat damage and had protruded into the inlet and drain ports, however, the packing materials were removed from the ports prior to testing to prevent contaminating the test stand. Lastly, the lockwire was foreign indicating the original had been removed after leaving the Woodward Facility. Even with the findings during the visual inspection it was determined that an as received test could be completed on the unit.

Figure 1 Prop Governor

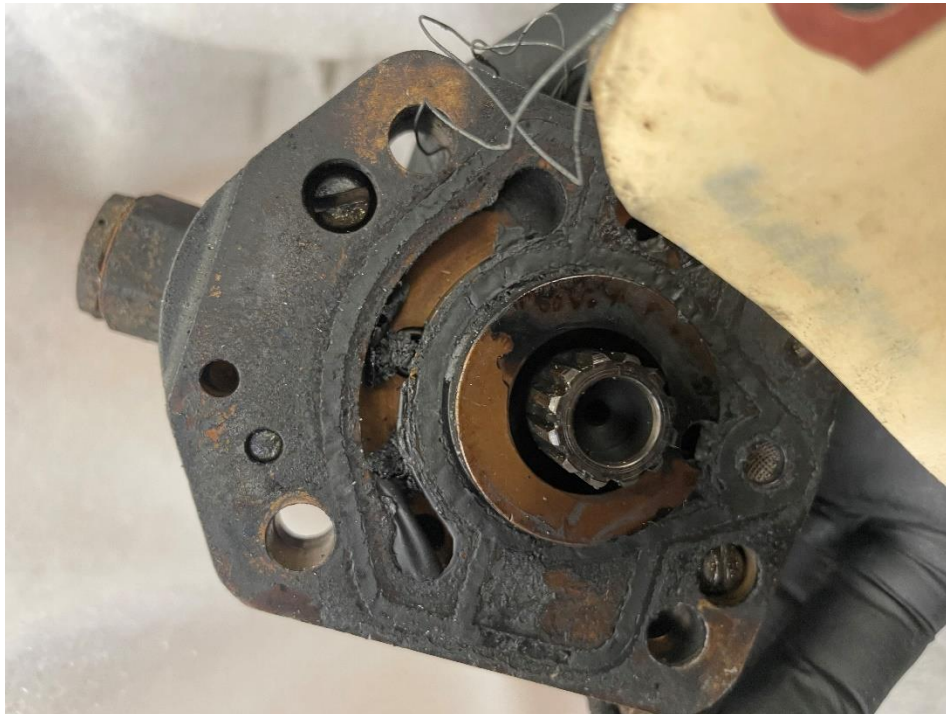
Figure 2 View of Governor Base

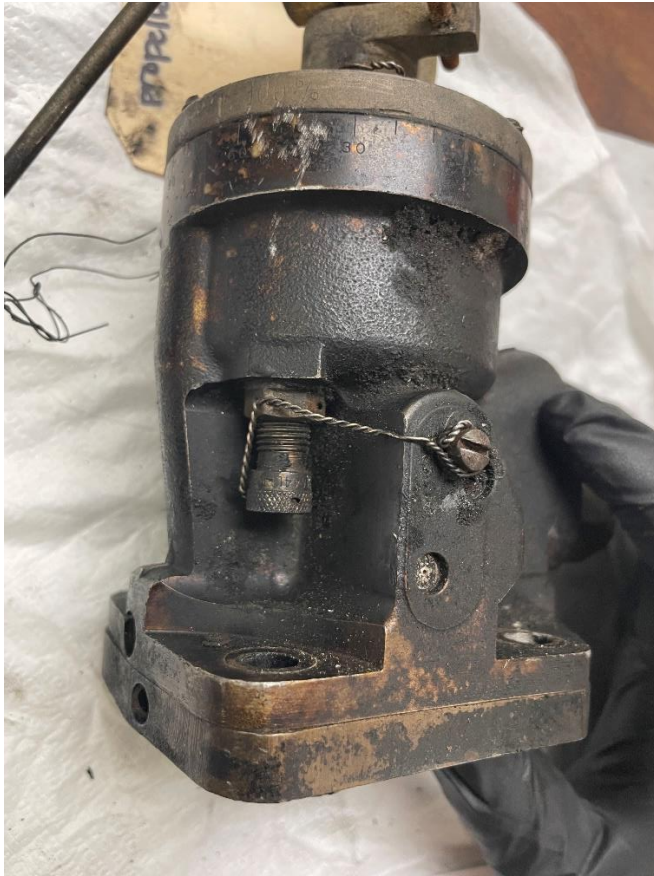
**Figure 3 Missing Magnetic Coil Wires**

- "Total Leak Check" test high at 5.3 qpm (Limits 0.5 qpm max)
- "Relief Valve Check" was low at 230 psig (Limits 465+/-20 psig)
- "Pump Capacity Check" was low at 6.0 qpm (Limits 9.0 qpm minimum)
- "External Leakage" was observed at baseplate, housing base, and cover (Limits none allowed)
- "Maximum RPM" was high at 3786 rpm (Limits 3574+/-10 rpm)
- "Minimum RPM" was high at 3337 rpm (Limits 2815+/-10 rpm)
- "Arm Travel Max to Min" was low at 29 degrees (Limits 60 +/- 5 degrees)
- "Magnetic Pickup Voltage" was skipped since the magnetic pickup coil wires were not present
- "Pickup Indicated RPM" was skipped since the magnetic pickup coil wires were not present.

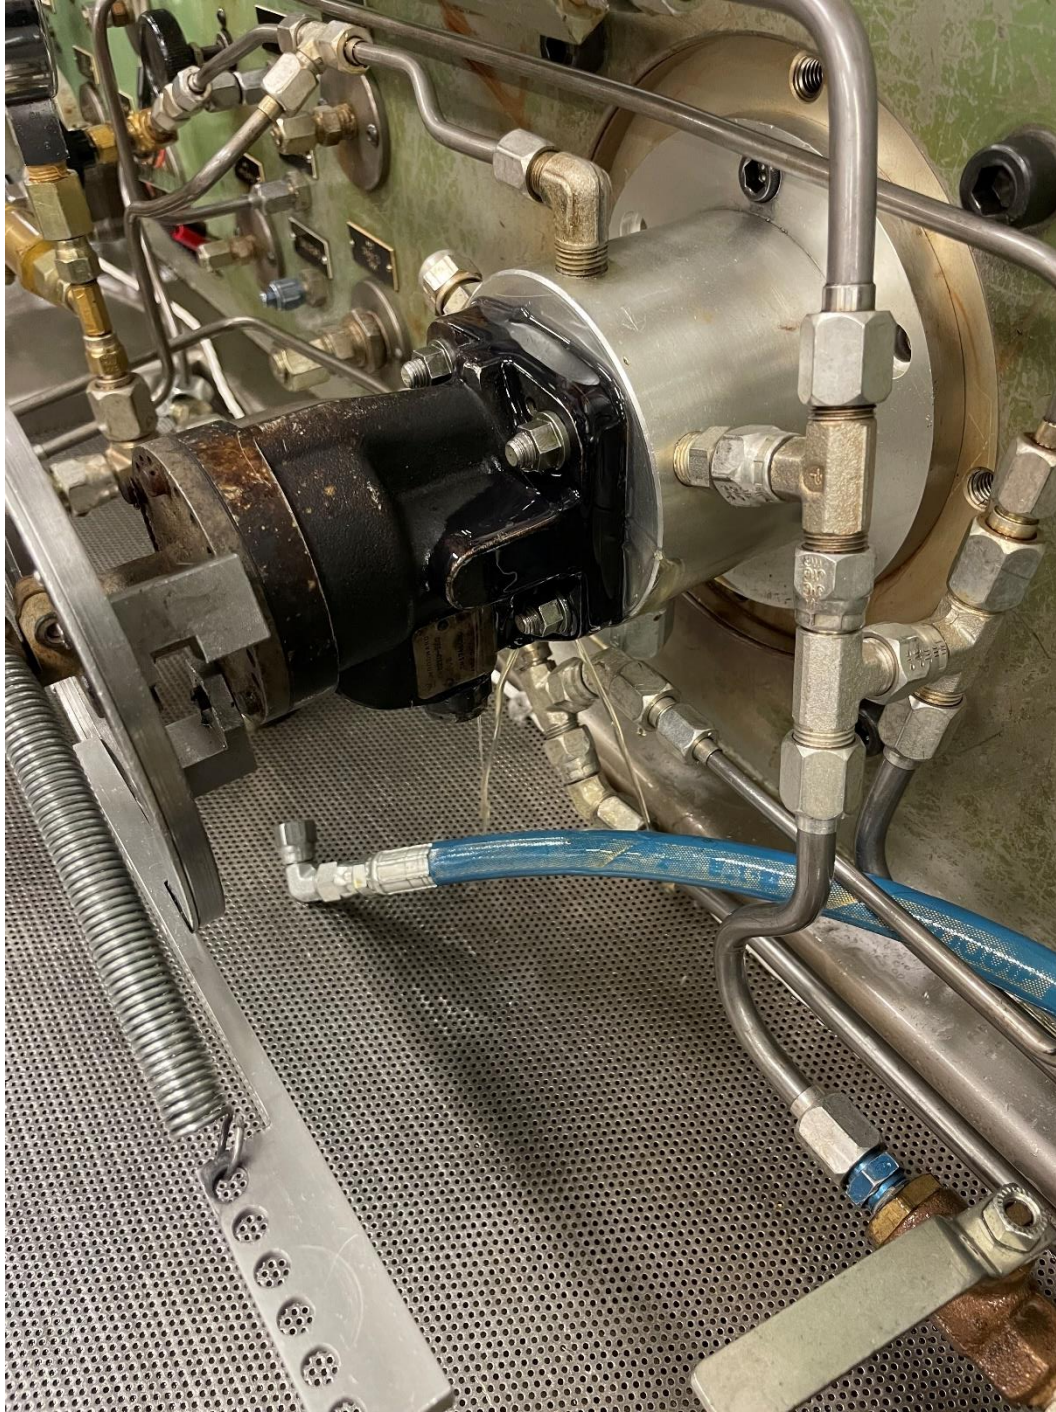
The unit's external leakage test point can be explained by the post-crash fire which damaged the unit's gaskets allowing oil to leak externally. Test points like min rpm, max rpm, and arm travel, are typically adjusted in the field and the presence of non-Woodward lockwire indicate an adjustment was performed in the field to these settings.

**Figure 4 External Leakage from Baseplate**

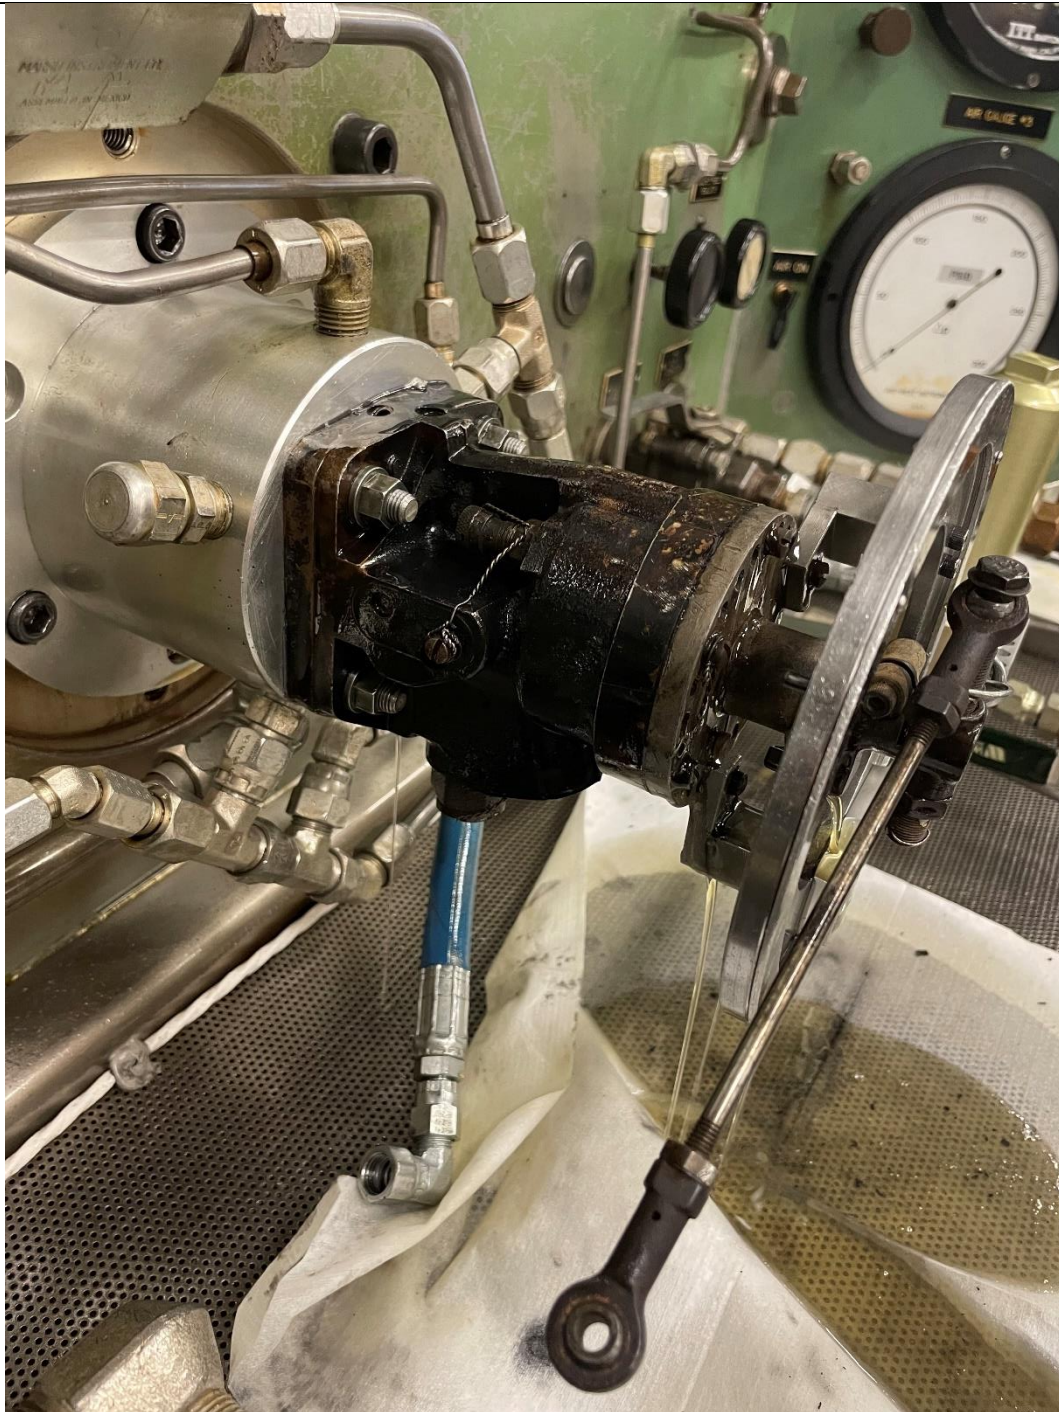
**Figure 5 Additional External Leakage While Testing**

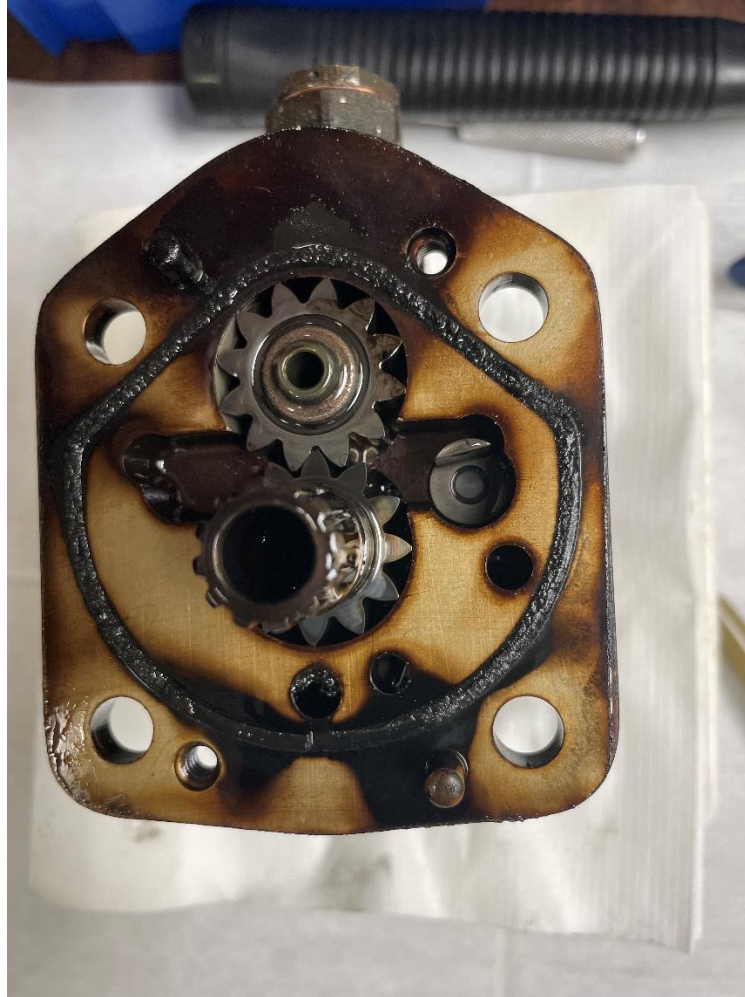
**Figure 6 Baseplate Removed**

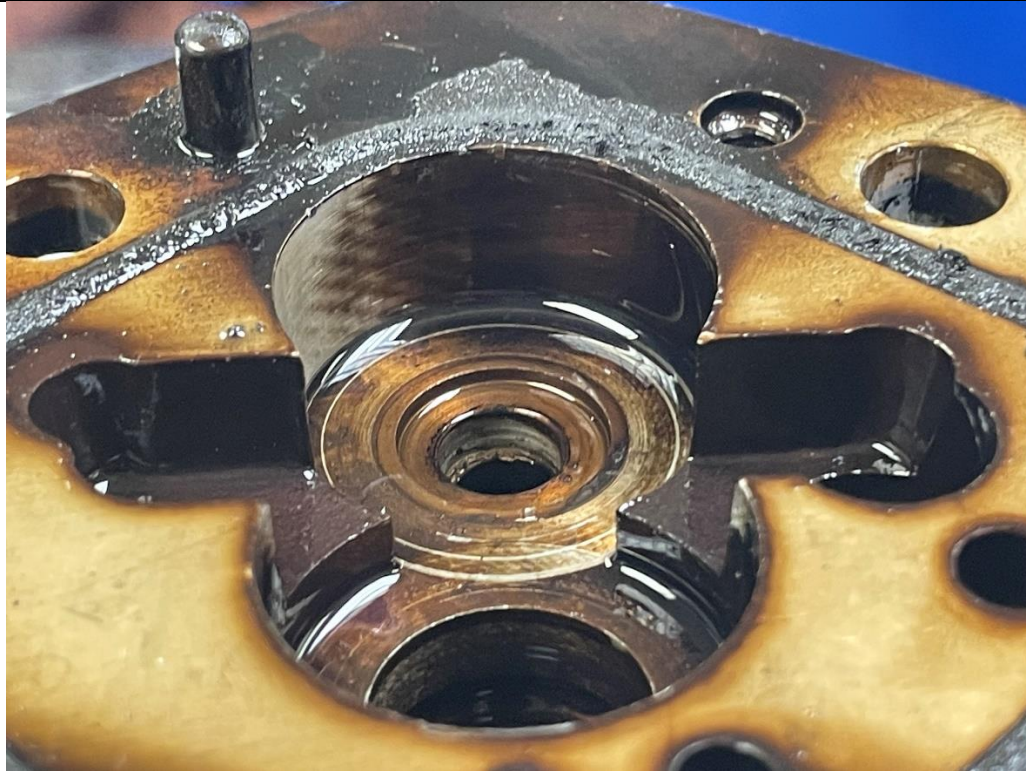
During disassembly, the unit's idler bushing (3276-012), was found to be tight to the idler stud (3274-032) and loose to the idler gear (204864). Typically, the idler bushing would be tight to the idler gear and loose to the idler stud. The idler gear, stud and bushing have tight clearances and materials with different coefficients of thermal expansion, so it is probable that the post-crash fire caused the observed condition. Also, this could not have been related to the event as the idler gear was free to rotate in the housing and the unit operated as intended once the relief valve was swapped. During the remainder of the teardown there was more evidence of fire damage, but there was no evidence of any pre-existing conditions that could have contributed to event. See Figures 6 – 11 for disassembly photos.

**Figure 7 Pump Pocket with Idler Stud Removed**

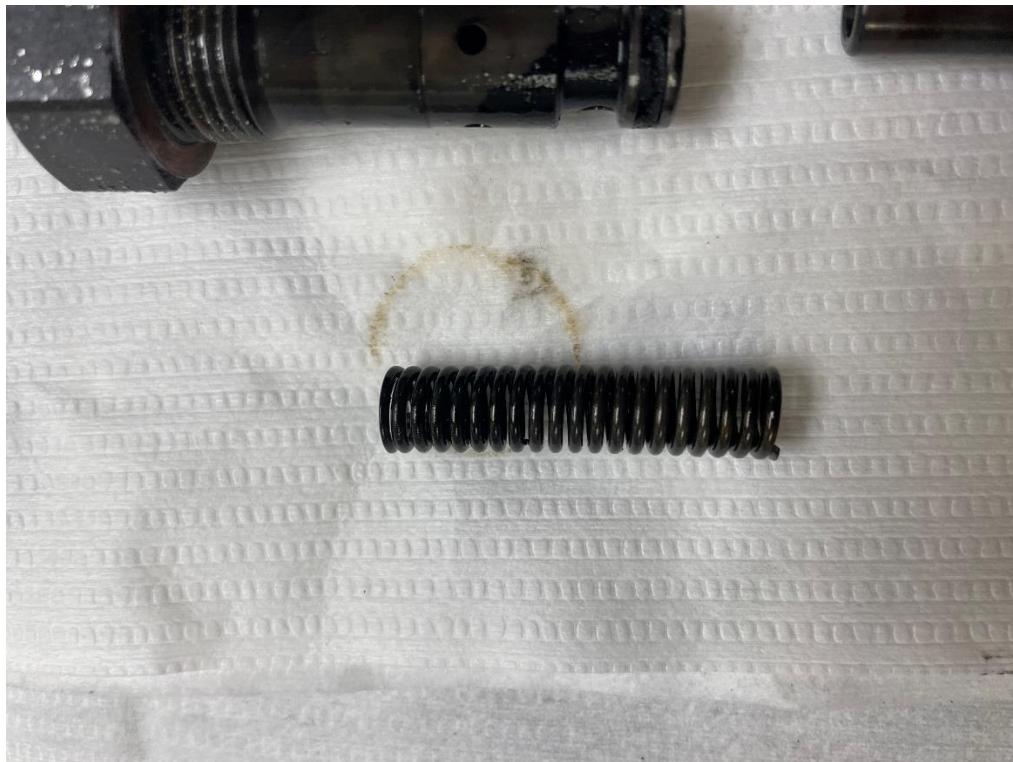
The cause of all the out of tolerance test points was understood. Therefore, no further testing was necessary. The unit was then disassembled to investigate the cause of the shift in the relief valve performance. Upon disassembly of the relief valve, it was discovered that the relief valve spring (P/N 192370) was shorter than expected. The free length of the spring on new units is approximately 1.760" while the relief valve spring checked 1.495". After the discovery additional dimensions on the spring were checked to confirm that correct spring was used. Dimensions inspected included the number of coils, wire size, inner diameter, and outer diameter all of which were conforming to the spring drawing specification. The relief valve spring is compressed to approximately 1.500" when installed into the unit, therefore its probable that the spring took a set at the

working height due to excessive heat from the post-crash fire. Therefore, when it was tested that spring had a lower preload on it allowing the relief valve to open easier than usual causing the out-tolerance test points observed during testing. It was determined that the observed condition occurred after the crash and would not have been a contributor to the reported event.

**Figure 8 Pressurizing Valve Spring**

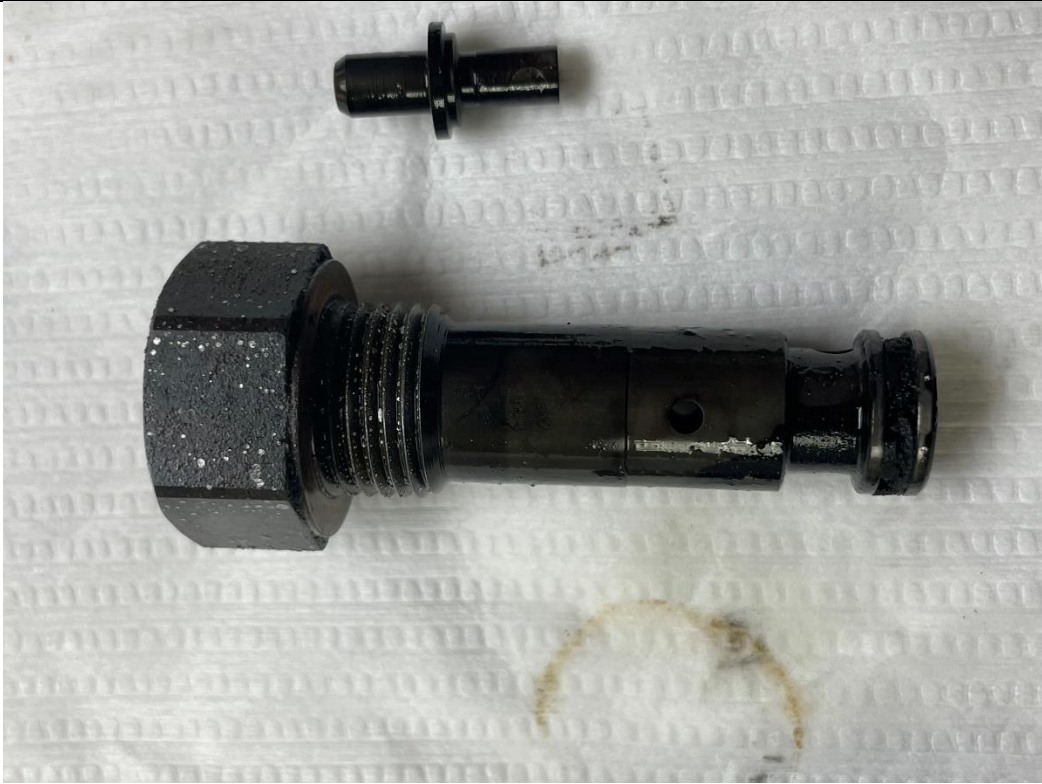
**Figure 9 Pressurizing Valve**

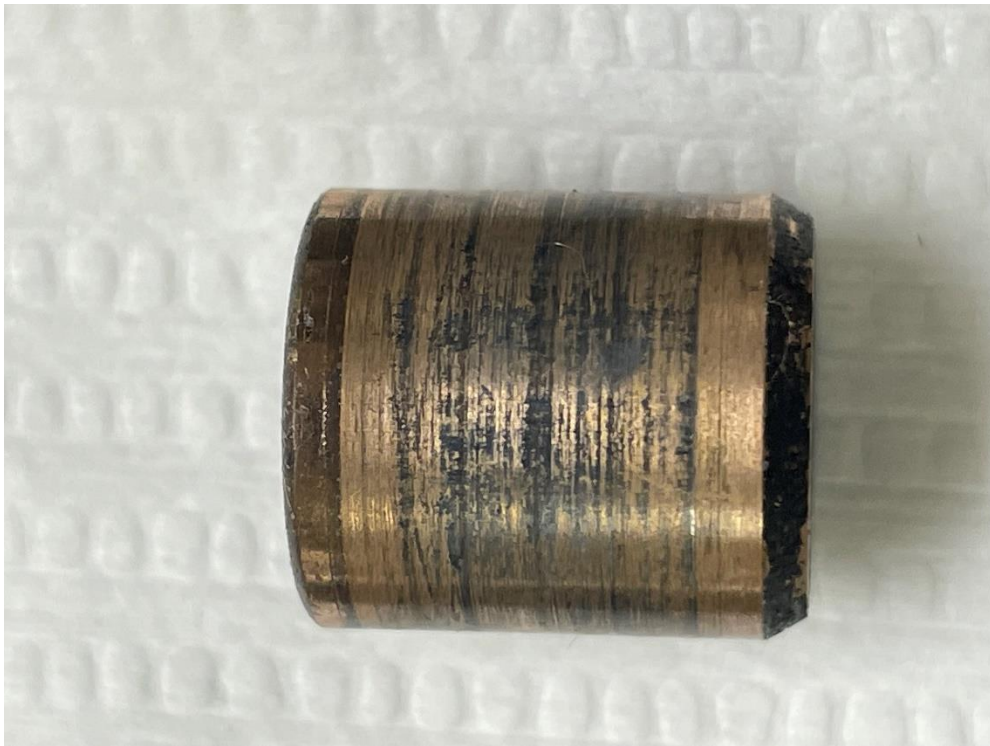
**Figure 10 Idler Bushing**

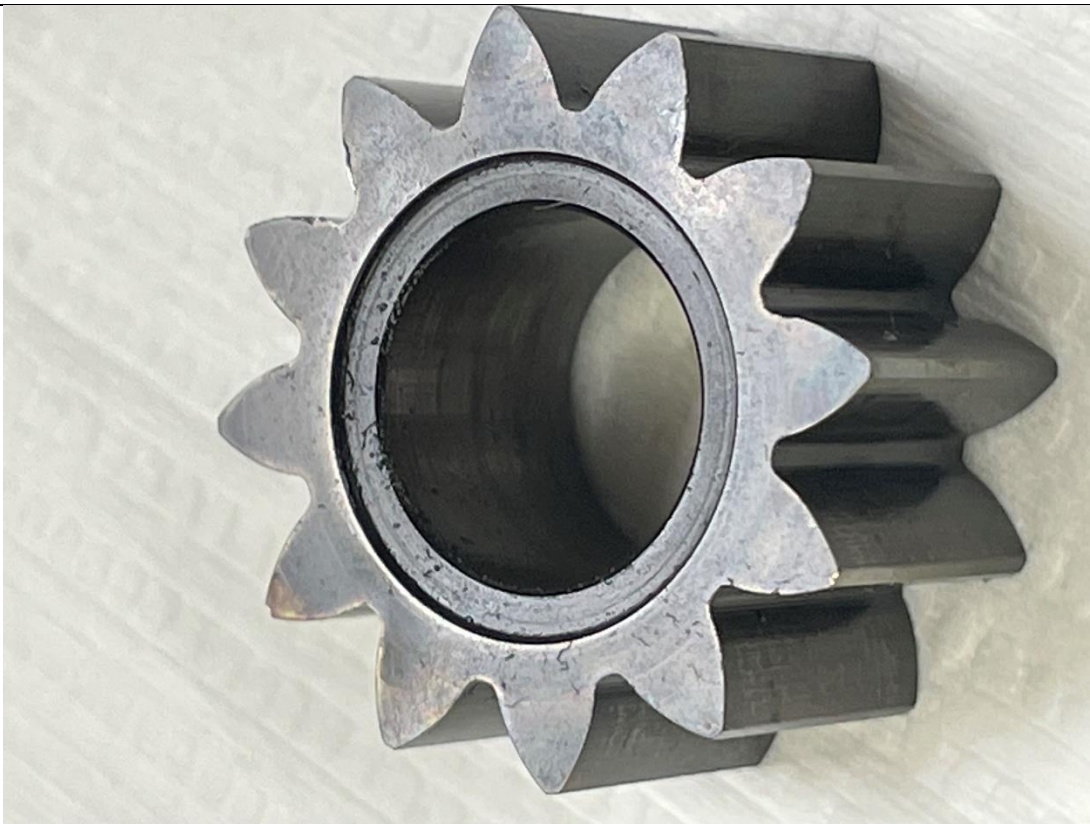
**Figure 11 Idler Gear**
