ERA22FA086

Group Chair's Factual Report - Attachment # 4

Woodward Fuel Control Unit, Serial Number, 905139, Investigation Report

June 27, 2023

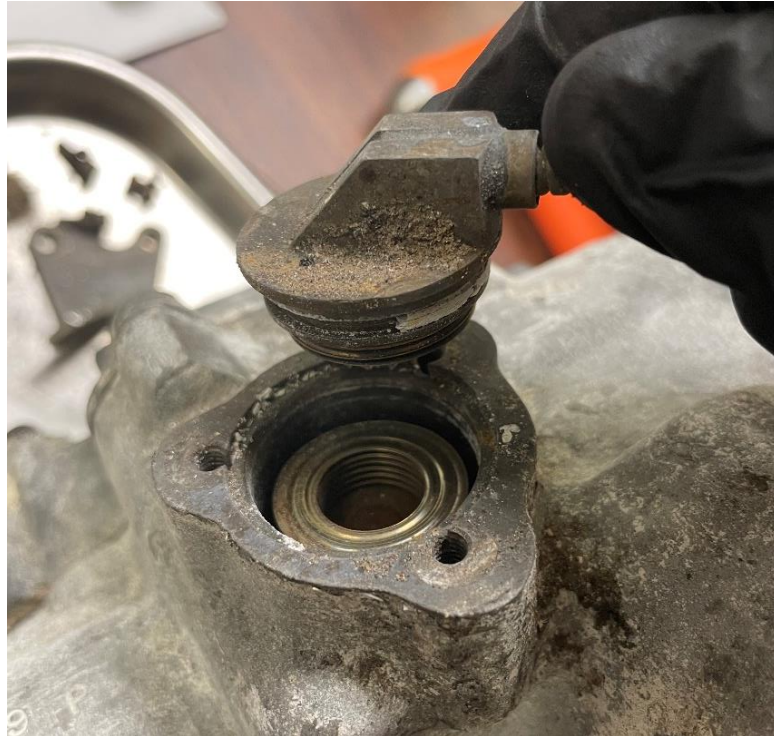
Figure 1. T2 Sensor Bellows Removal

The presence of foreign lockwire indicates that the unit was serviced at another facility since it was last shipped from Woodward. The unit was returned with customer fittings, power lever and speed lever linkages, pressurizing valve assembly, and the Tt2 sensor still installed. The Tt2 sensor and customer hardware were removed so that a visual as-received inspection could be performed. A portion of the Tt2 sensor bellows remained stuck in the housing and had to be removed manually (see Figure 1).

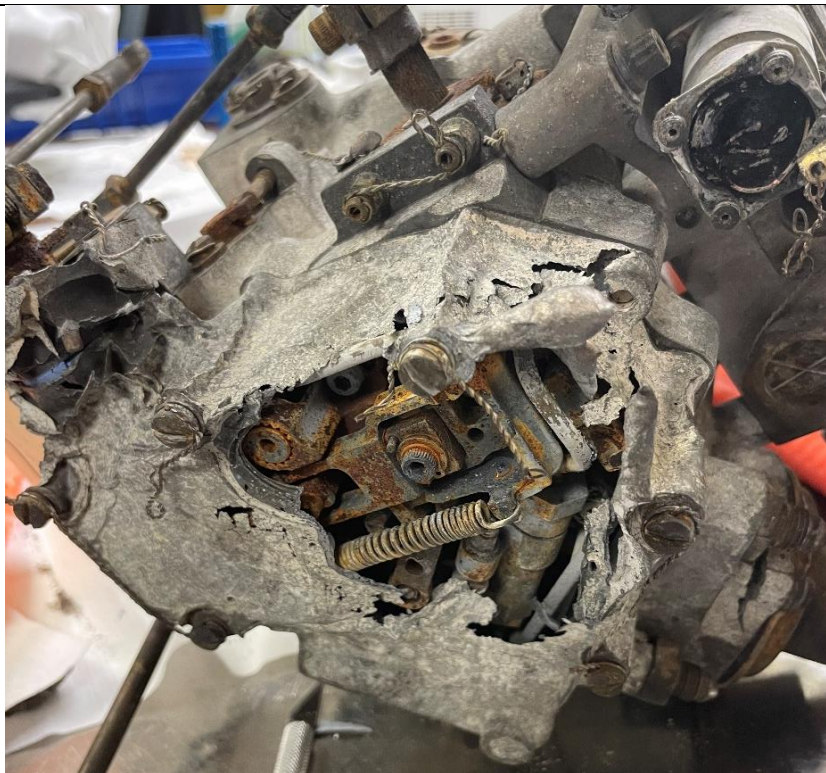
Figure 2. Cover Damage

A portion of the cover was melted and missing such that the internal mechanical linkage was exposed (see Figure 2). The housing was fractured next to the Pt2 bellows assembly and the bellows was pulled out such that there was a gap between the retaining plate and the housing (see Figure 3). The speed setting lever rotated normally. The power lever rotated freely but could not reach its max stop due to damage on the cover. The drive shaft could not be rotated by hand but turned stiffly with a mating drive spline tool.

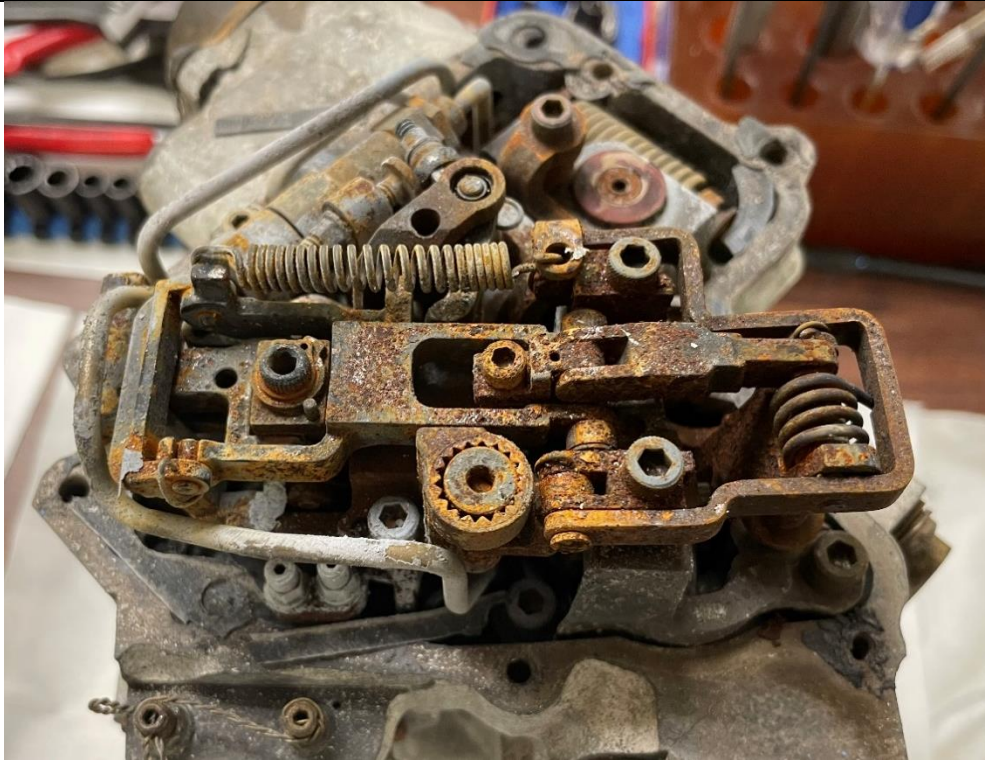
Figure 4. Internal Linkages

As-received testing could not be performed due to the extensive damage. The unit was then disassembled to inspect the internal components. The cover was removed and the internal linkages were found to be seized due to corrosion (see Figure 4).

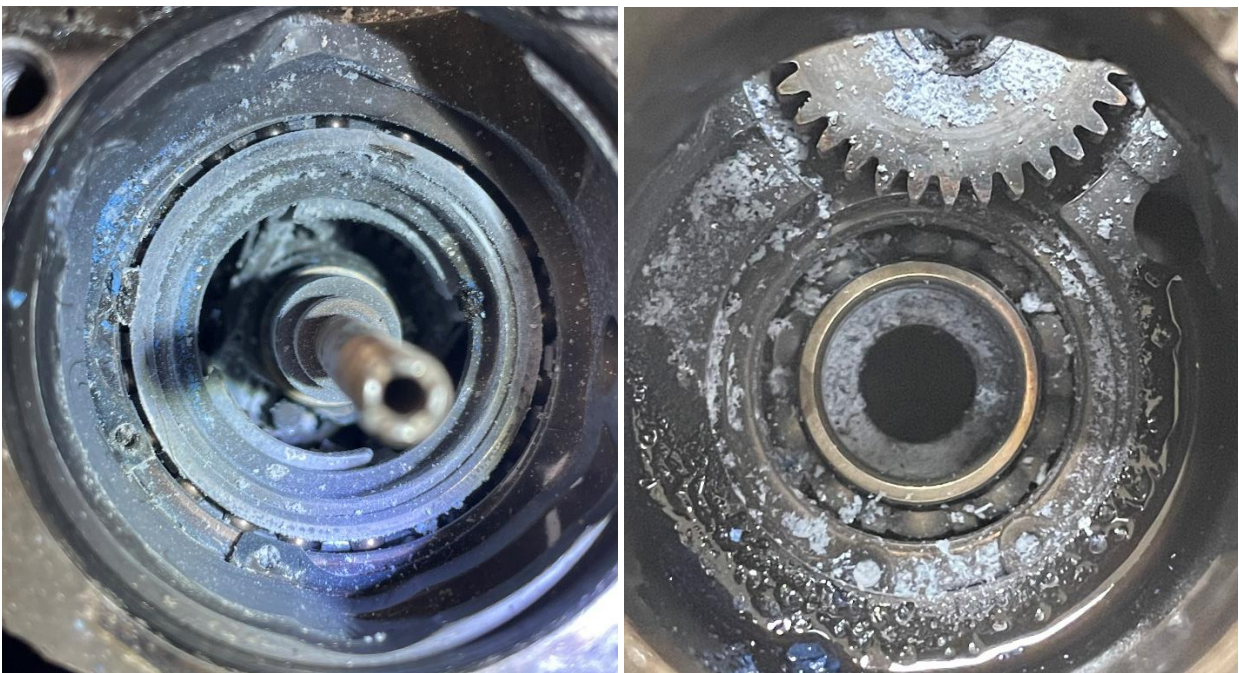
Figure 5. Debris on Underspeed Governor and Housing Bore

No other broken parts were observed during disassembly but removal of the internal components was difficult due to the corrosion and thermal damage. All fluorosilicone packings exhibited thermal damage and crumbled apart during disassembly. Debris consistent with the packings was found on the underspeed governor assembly and in the corresponding housing bore (see Figure 5). Portions of the phenolic retainers were missing from the top bearings of the overspeed governor assembly, but all bearing balls were present. All springs were intact, but several of the springs showed evidence of heat set in a loaded position. Dirt and sand was found underneath the Ps3 cap when it was removed (see Figure 6).
