# National Transportation Safety Board

ERA22FA086

## POWERPLANTS

Group Chair's Factual Report

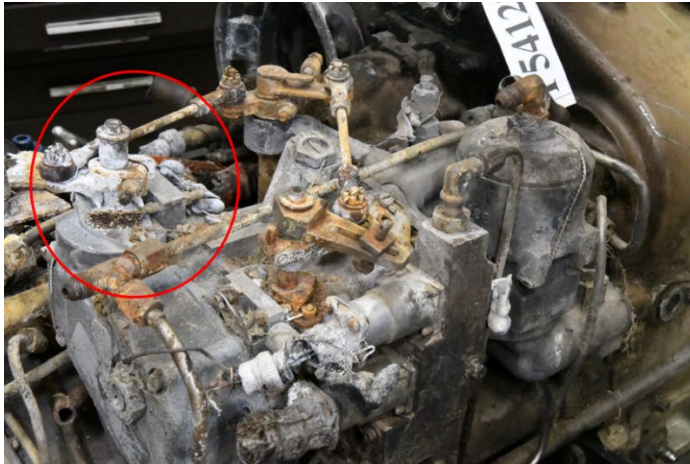
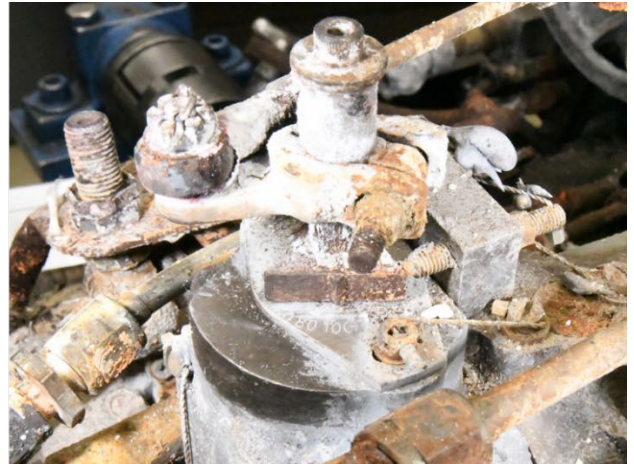
Photo 9- (L) Fuel Pump and Fuel Control, (R) Fuel Control Power Lever Linkage Dial Indicator

The fuel pump and fuel control unit (FCU) remained secured to the accessory gearbox (AGB). Both components appeared ashy with areas of light corrosion. The FCU power lever indicator dial was aligned with the 100 degree mark and was against the hard stop (maximum) (**Photo 9**). All three propeller pitch control (PPC) attachment lugs were broken and the PPC was pushed aft, away from the AGB. The PPC indicator dial was partially melted, but what remained of the dial was aligned

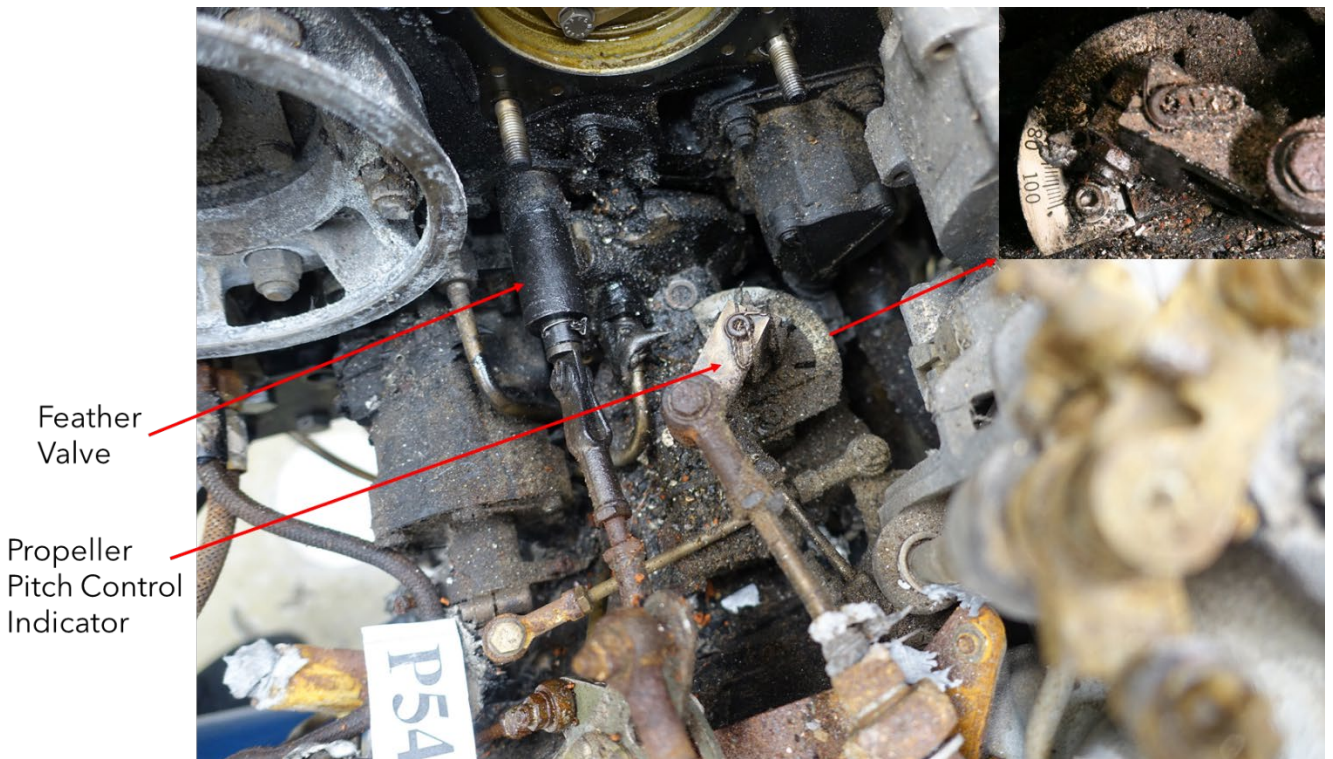
Photo 10- Propeller Pitch Control, Indicator Dial

with the 90 degree mark<sup>2</sup> (**Photo 10**). The aft propeller shaft thrust bearing was pushed out of the aft side of the gearbox. The propeller feather valve was retracted (closed position). The propeller governor<sup>3</sup> was intact with dark discoloration/sooting. The propeller governor check valve orifice on the AGB was free of obstructions. The fuel shutoff valve (FSOV) remained secured to the engine but exhibited thermal damage and case deformation. Following FSOV removal, a microscope was used to examine the scribe mark on the input shaft, and it was aligned with the 12 o'clock position<sup>4</sup> (**Photo 11**). A low pressure air check was performed, and air passed through the valve, indicating it was in the open position.

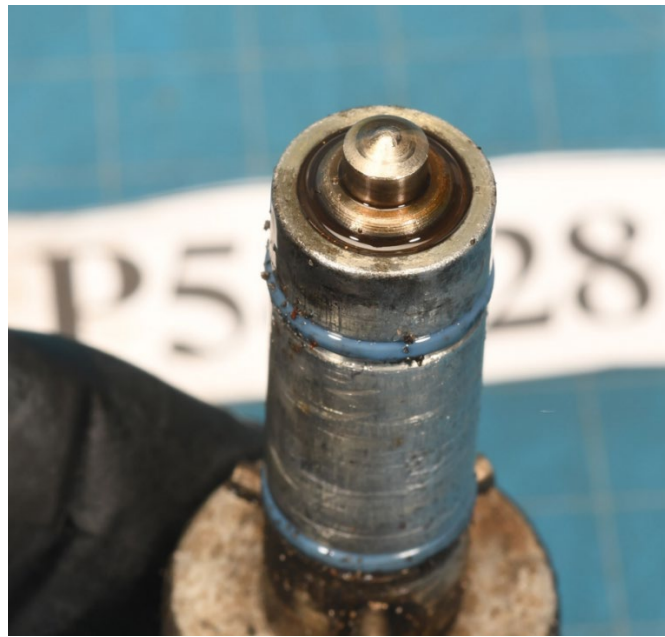
Photo 12- Magnetic Chip Detector Plug

The magnetic chip detector (MCD) was free of debris accumulation or metal “fuzz” (**Photo 12**). The oil filter was oil wetted and no debris was visible in the filter or the filter bowl. The fuel filter was dry with localized areas of dark discoloration. The filter and filter bowl smelled acrid, consistent with exposure to post-crash fire.

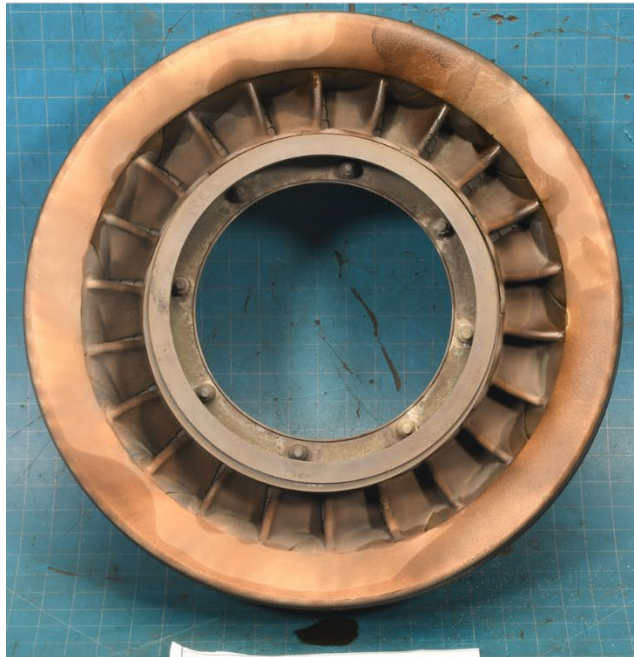
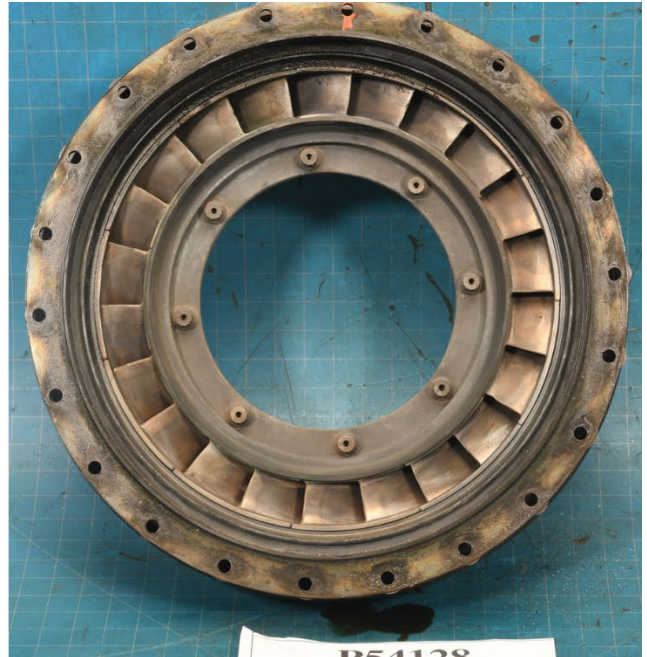
Photo 16- 1<sup>st</sup> Stage Turbine Stator, (L) Pressure Side, (R) Suction Side

The rear (turbine) bearing support was intact. The turbine bearing was oil wetted and rotated smoothly. Scoring was observed on the inner diameter of the turbine bearing retainer at the 3, 6, 9, and 12 o'clock positions. The 1<sup>st</sup> stage turbine stator was intact with light impact marks on the leading edge of all vanes (**Photo 16**). All the 1<sup>st</sup> stage turbine rotor blades were present and one blade had separated at midspan (identified as Blade 1) (**Photo 17**). The blade fracture surface appeared jagged and charred. The adjacent receding blade (blade 36) and two succeeding blades (blades 1 and 2) exhibited leading and trailing edge impact damage and material loss. The leading edge tip of all 1<sup>st</sup> stage turbine blades were missing material and appeared smooth and rolled over (**Photo 18**). The trailing edge of 1<sup>st</sup> stage turbine blades 27, 29-32, 35, and 36 had trailing edge tip material loss.

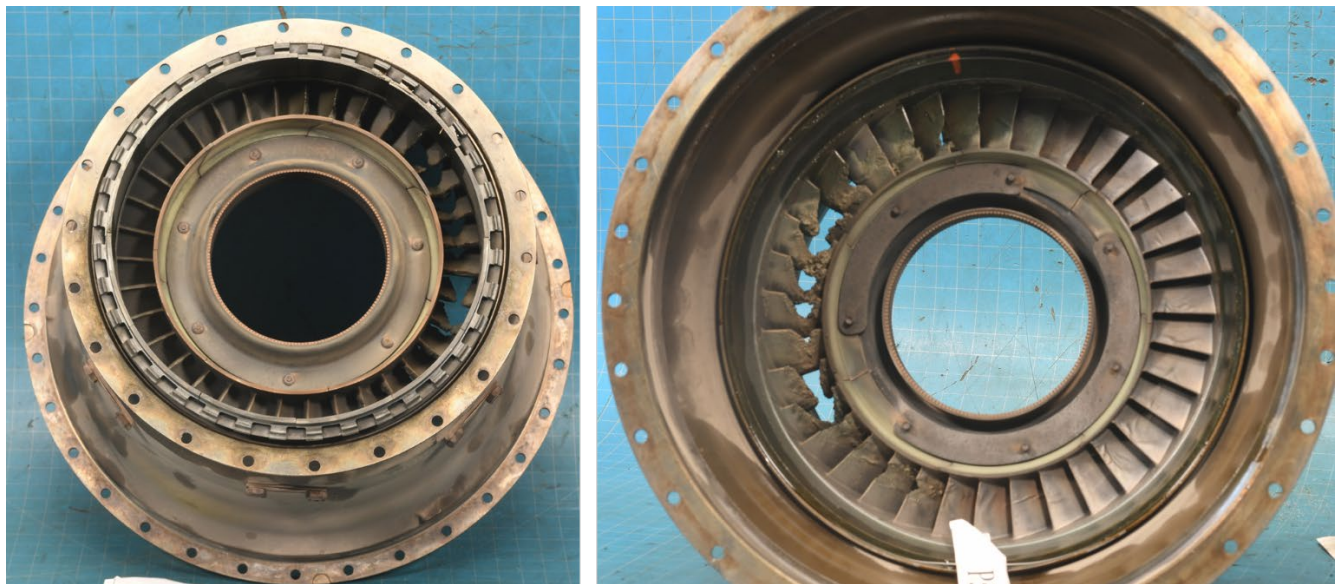
Photo 19- 2<sup>nd</sup> Stage Turbine Stator, (L) Pressure Side, (R) Suction Side

The 2<sup>nd</sup> stage turbine stator exhibited thermal damage and vane material was missing from the 6 to 12 o'clock positions. The thermal damage was most severe from the 8 to 10 o'clock positions (**Photo 19**). All intact vanes had suction side trailing edge thermal damage and the suction side vane surfaces appeared wrinkled. Light 360 degree rotational scoring was visible on the 2<sup>nd</sup> stage turbine shroud. The 2<sup>nd</sup> stage turbine rotor blades were all intact but had light leading edge impact damage (**Photo 20**). The trailing edge along the outer third of the blade span of all 2<sup>nd</sup> stage turbine blades were rolled over opposite the direction of rotation. Tip rub was visible 360 degrees around the rotor.

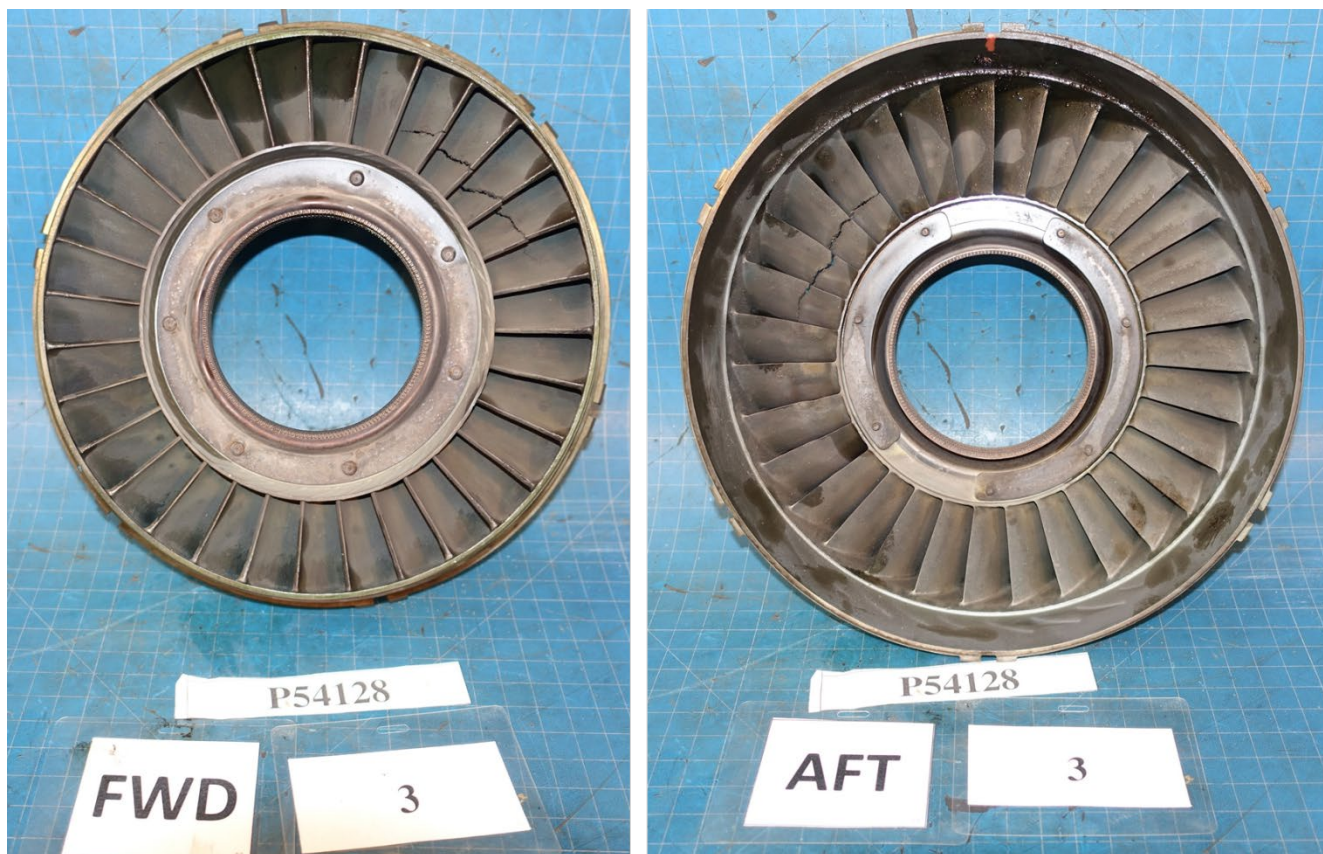
Photo 21- 3<sup>rd</sup> Stage Turbine Stator, (L) Pressure Side, (R) Suction Side

The 3<sup>rd</sup> stage turbine stator had four vanes with chordwise cracks at the midspan from the 9 to 10 o'clock positions (**Photo 21**). One additional vane had a small incipient crack on the leading edge at the 11 o'clock position. Trailing edge deformation was noted on three consecutive vanes at the 11 o'clock position. Light rotational scoring was visible on the 3<sup>rd</sup> stage rotor shroud at the 6 o'clock position. All the 3<sup>rd</sup> stage turbine rotor blades were intact (**Photo 22**) and exhibited tip rub and small leading edge nicks (**Photo 23**). The 3<sup>rd</sup> stage turbine shroud exhibited circumferential scoring consistent with contact from the 3<sup>rd</sup> stage blade tips (**Photo 23**).

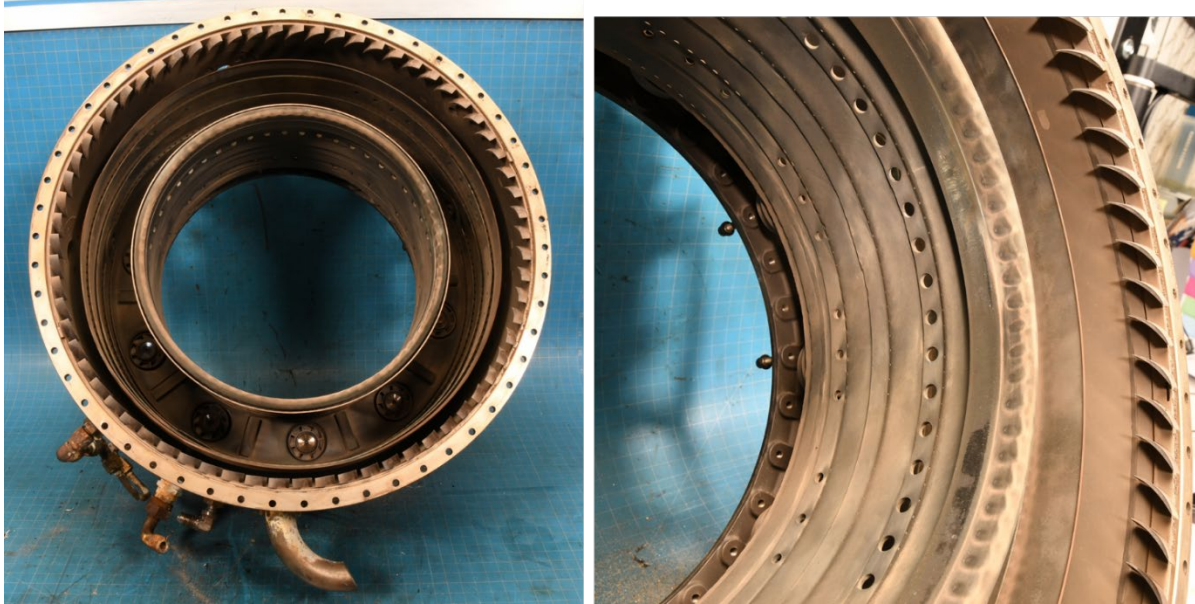
Photo 24- Combustion Liner, Plenum

The combustion liner was intact and had no indications of fuel nozzle streaking (**Photo 24**). All the fuel nozzles were properly seated. There was light coking/discoloration on the dome of two fuel nozzles. The primary and secondary fuel manifold was separated at the nozzle connection at multiple locations around the plenum. Most fuel nozzle manifold thermal insulation was thermally consumed. Sand was collected in the combustor, most notably in the outer transition liner. There was no metal spray visible on the combustion liner walls.

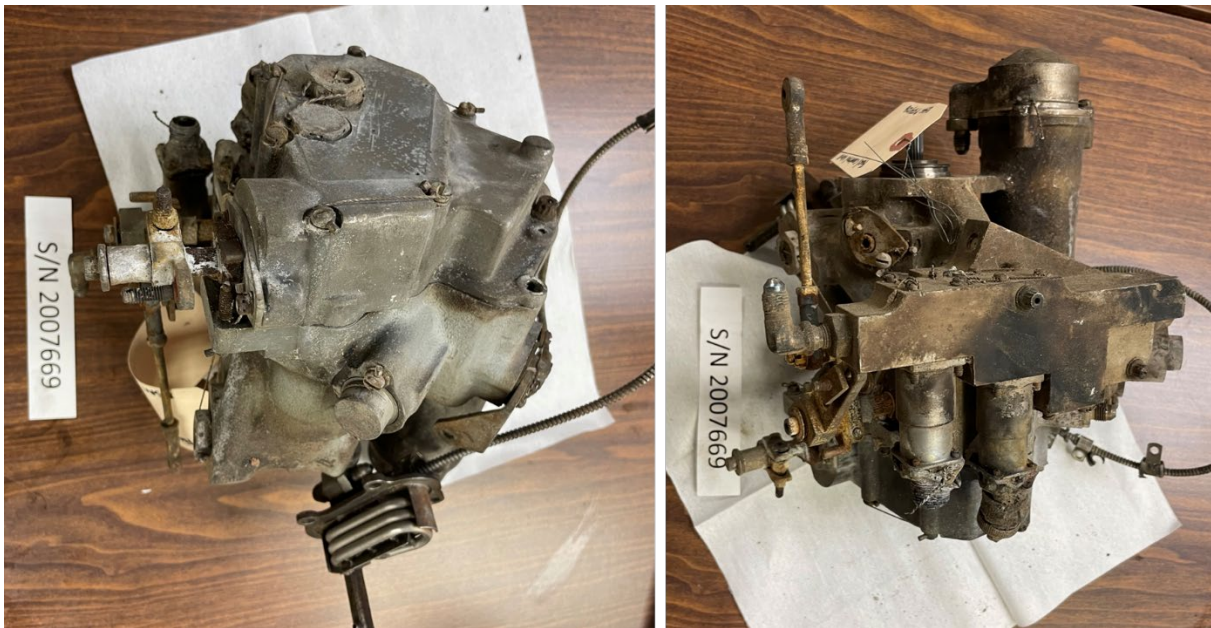
Photo 30- FCU, as Received at Woodward

Due to extensive thermal damage, the FCU could not be bench tested (**Photo 30**). The FCU was fully disassembled, and thermal damage was observed on all internal components but there was no evidence of pre-impact failure or other anomalies. The Woodward report is available in the investigation docket as "Attachment 1- Woodward Fuel Control Unit, Serial Number, 2007669, Investigation Report."

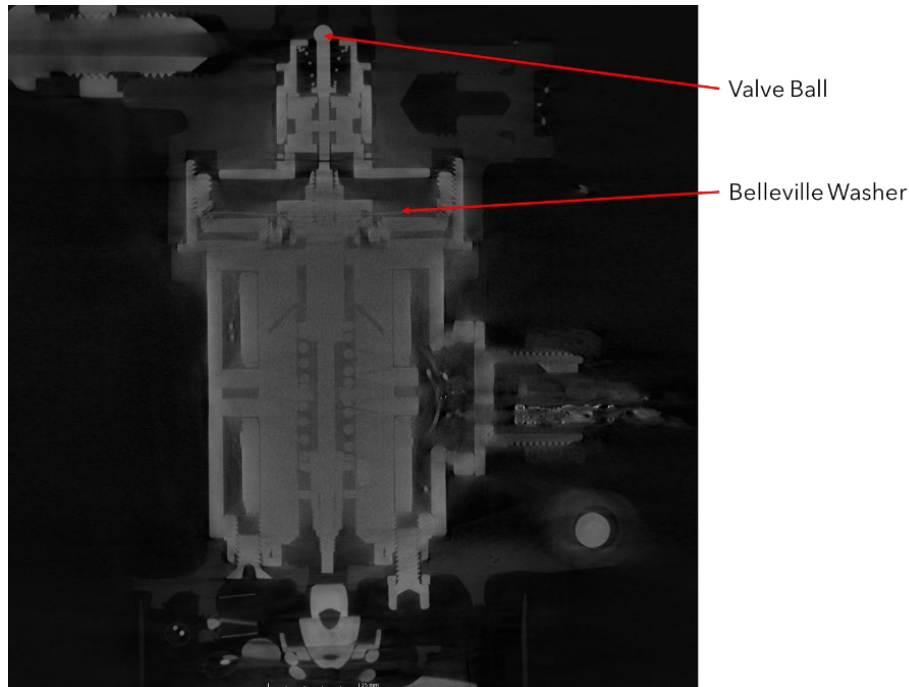
Photo 34- CT scan of the No. 1 Engine FSOV (Photo Courtesy of Honeywell)

The FSOV was computed tomography (CT) scanned at Honeywell in Phoenix, Arizona and video files of the CT scans were provided to the NTSB for review. The CT scan showed the FSOV was in the open position, consistent with the low pressure test findings during the teardown examination. The Belleville washer was intact, and no internal anomalies were identified (**Photo 34**).

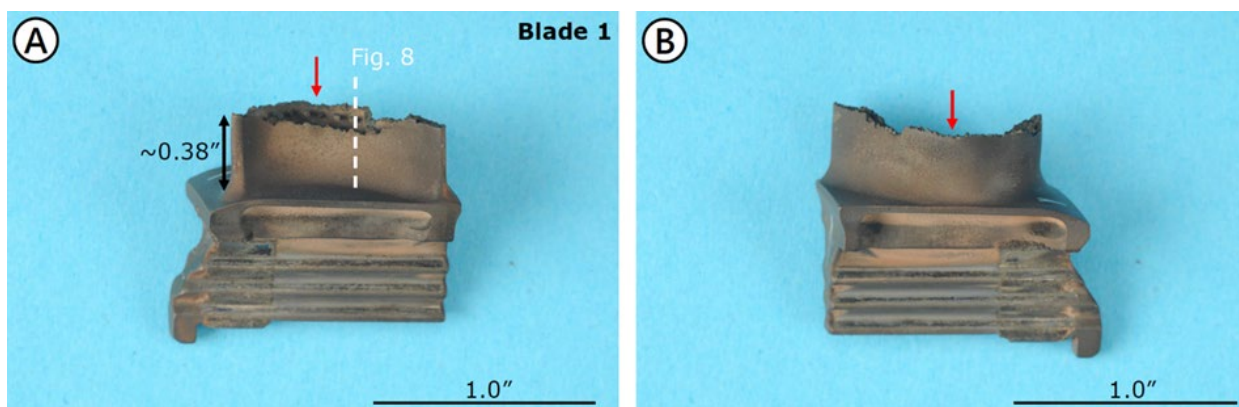
Photo 35- 1<sup>st</sup> Stage Turbine Rotor Blade, Found Separated During Teardown (Photos Courtesy of Honeywell)

The 1<sup>st</sup> stage turbine rotor blade that was found separated during the teardown examination was identified as Blade 1. Blade 1 separated approximately 0.38 inch from the platform as measured from the leading edge (**Photo 35**). The fracture surface had a rough oxidized appearance consistent with a stress rupture mechanism<sup>9</sup>.

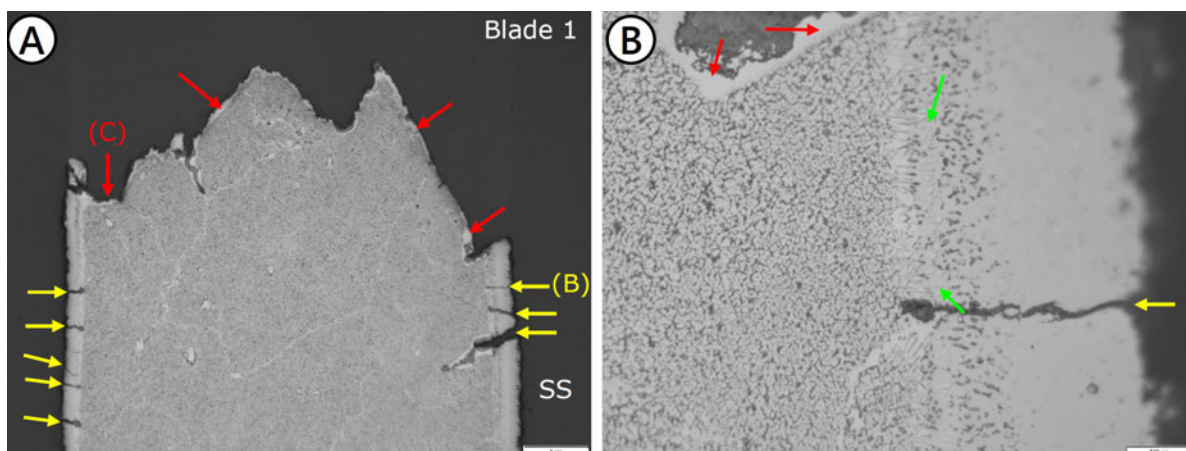
A cross section of Blade 1 revealed oxidation and alloy depletion on the fracture surface. The microstructure near the fracture surface was consistent with exposure to temperatures near 1700°F (927°C) over a period of time between 10 and 100 hours<sup>10</sup>. There was evidence of sigma phase<sup>11</sup> along the coating/blade interface.

There was no evidence of cyclic fatigue, material defects, or other anomalies identified near the fracture surface. Cross sections were also made through Blades 5 and 16. Grain boundary coarsening was observed at multiple locations. The leading edge cross section of Blade 16 exhibited a region of interconnected cracks and voids along the grain boundaries on the suction side of the blade. According to Honeywell, the microstructure observed along the thermal coating/blade interface, the grain boundary voids and cracks, and the coating cracks observed on Blade 1 are all consistent with stress rupture fracture mechanism (**Photo 36**). Energy dispersive X-ray (EDX) analysis confirmed that the blade material was consistent with IN-100 nickel alloy as specified on the part drawing. The IN-100 blade base material and the aluminum/silicon coating indicated that the Blade 1 part number was likely 3101512-10<sup>12</sup>.

Photo 36- 1<sup>st</sup> Stage Turbine Blade Cross Section (L) Red Arrows- Alloy Depletion and Oxidation at Fracture Surface, Yellow Arrows- Blade Coating Cracks, Green Arrows- Sigma Phase Embrittlement Formation (Photos Courtesy of Honeywell)

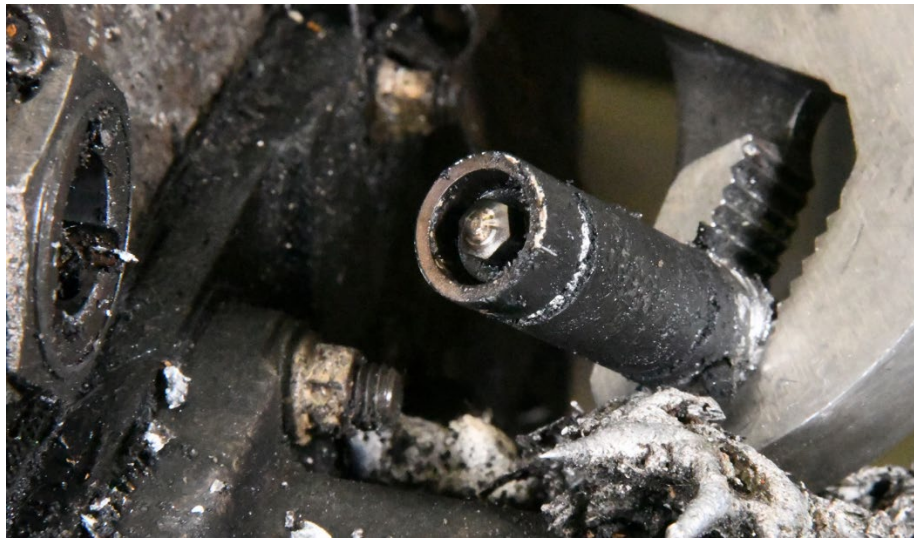
Photo 45- (L) Magnetic Chip Detector Plug

The MCD plug was partially consumed. The MCD was removed from the gearbox and was free of “fuzz” or debris accumulation (**Photo 45**). The oil filter and filter bowl were both dry and discolored and there was no evidence of debris or other obstructions in the filter pleats. The fuel filter and filter bowl were also dry and discolored and free of debris.

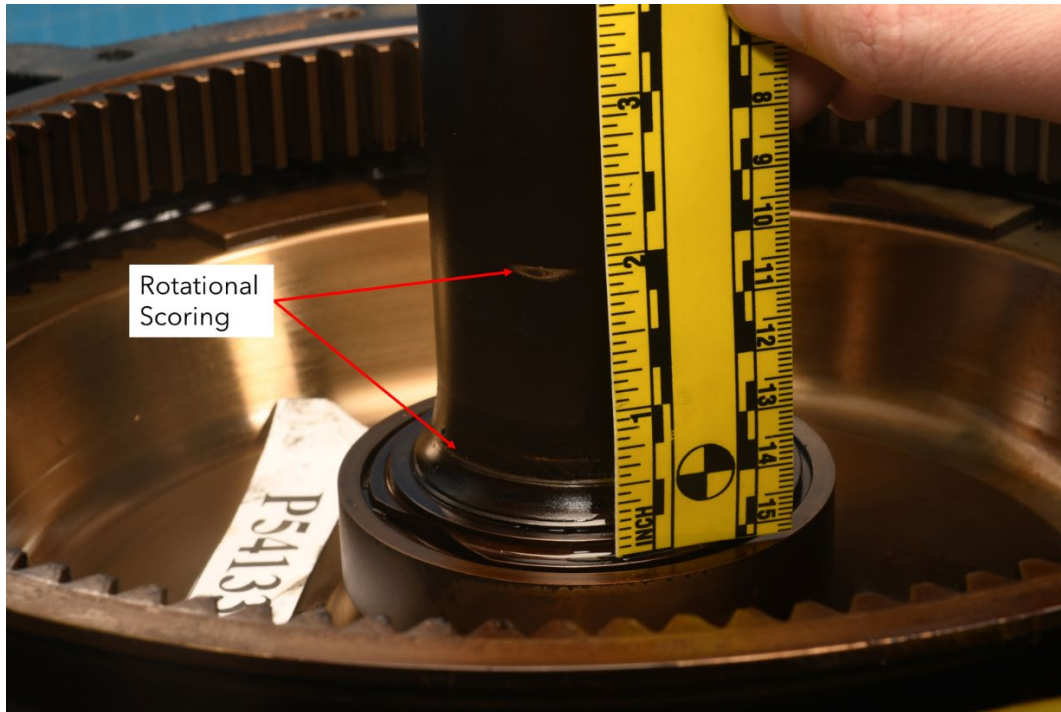
Photo 46- Nose Cone and Propeller Shaft, Rotational Scoring

was no residual oil in the nose cone or AGB case and the internal surfaces appeared discolored, consistent with high temperature due to fire exposure. The propeller shaft had a 360 degree circumferential rub at the forward radius, immediately aft of the forward retaining nut (**Photo 46**). The ring gear was intact and undamaged.

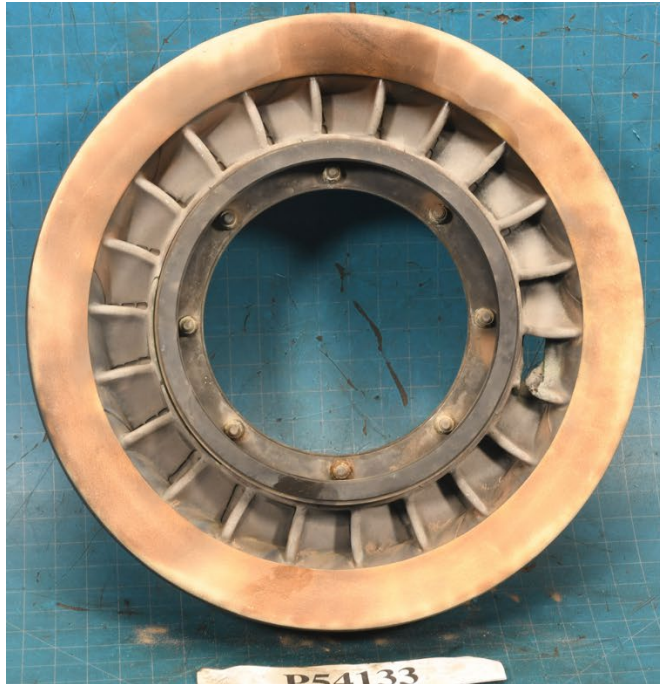
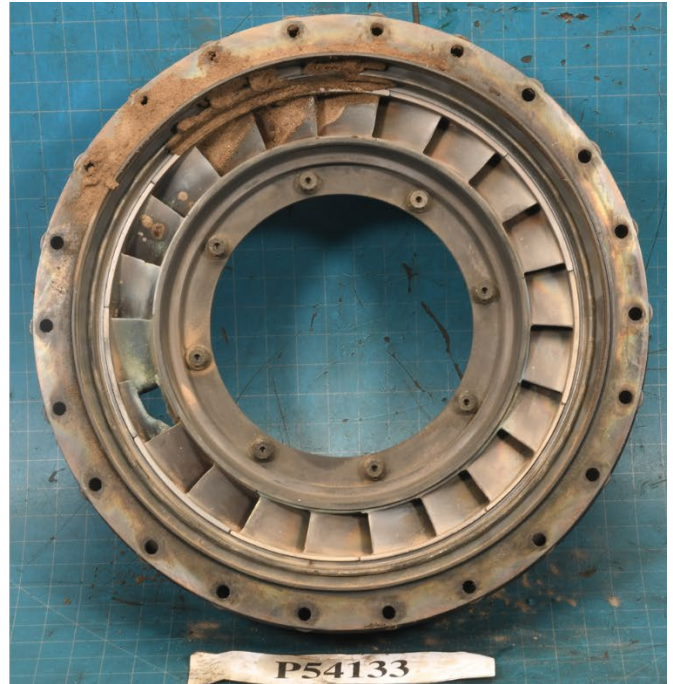
Photo 50- 1<sup>st</sup> Stage Turbine Stator, (L) Pressure Side, (R) Suction Side

The rear (turbine) bearing support was intact. The turbine bearing was oil wetted and rotated smoothly. The 1<sup>st</sup> stage turbine stator was missing part of one vane at the 9 o'clock position from the midspan to the inner diameter platform (**Photo 50**). Several vanes had small cracks midspan on the leading edge. One vane at the 10 o'clock position at trailing edge was deformed. The 1<sup>st</sup> stage turbine shroud had sand debris accumulated at the 12 o'clock position. The shroud had light localized scoring at the 10 o'clock position, coincident with the 1<sup>st</sup> stage turbine blade mid-chord. All the 1<sup>st</sup> stage turbine blades were missing material at the leading edge tip and the surface appeared smooth and rolled over (**Photos 51 and 52**).

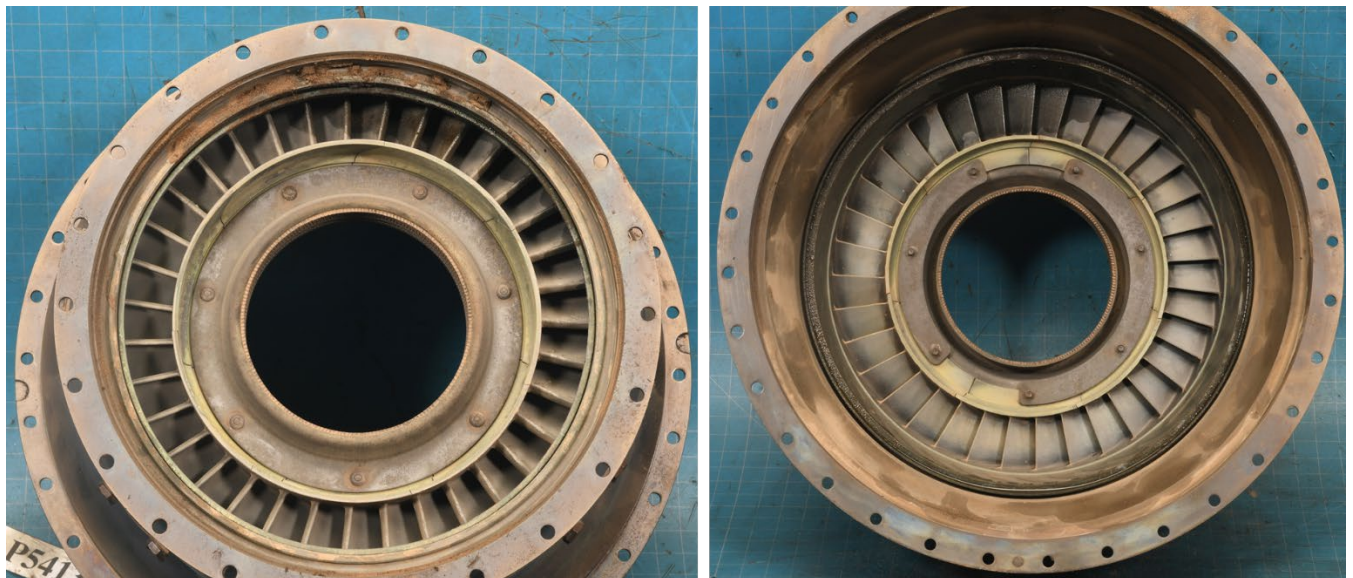
Photo 53- 2<sup>nd</sup> Stage Turbine Stator, (L) Pressure Side, (R) Suction Side

The 2<sup>nd</sup> stage stator vanes were all complete (Photo 53). One vane had small trailing edge cracks at the quarter span and near the inner diameter platform. The 2<sup>nd</sup> stage turbine shroud had light localized scoring at locations coincident with the 2<sup>nd</sup> stage turbine blade mid-chord. The 2<sup>nd</sup> stage turbine rotor blades were all intact and complete (Photo 54). The blades tips exhibited light tip rub from the mid-chord to the trailing edge 360 degrees around the rotor.

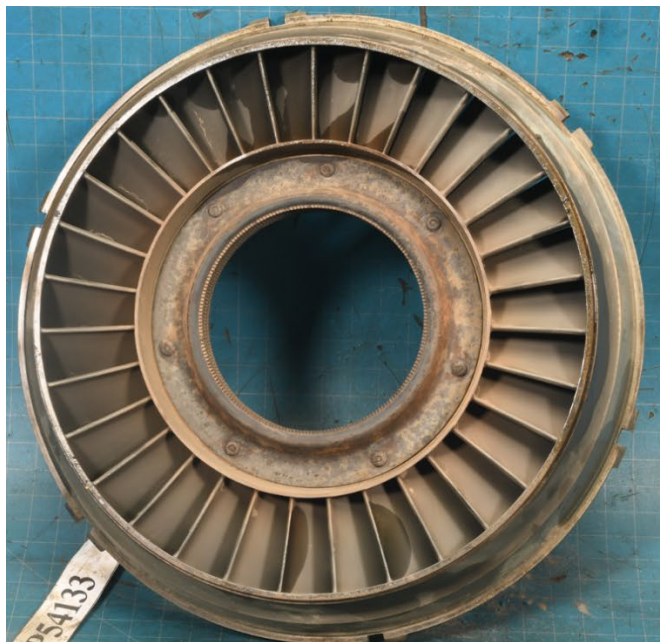
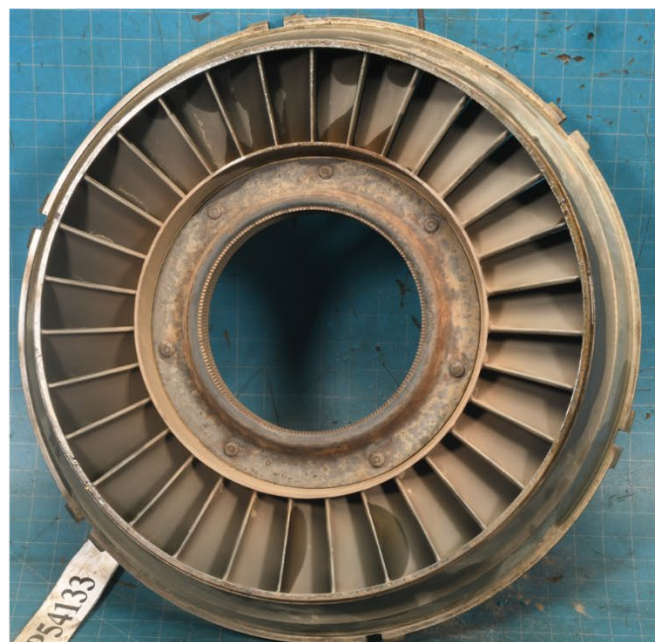
Photo 55- 3<sup>rd</sup> Stage Turbine Stator, (L) Pressure Side, (R) Suction Side

The 3<sup>rd</sup> stage turbine stator was intact and all vanes were undamaged (Photo 55). The 3<sup>rd</sup> stage turbine shroud had light leading edge rub from the 4 to 7 o'clock positions. The 3<sup>rd</sup> stage turbine blades were intact and undamaged (Photo 56).

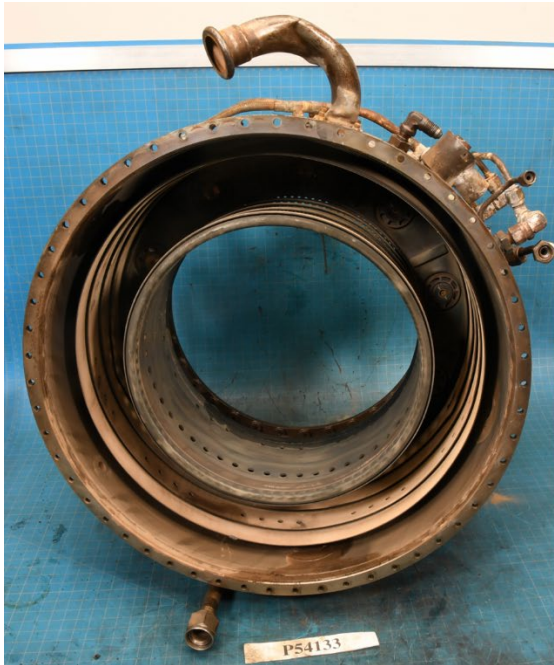
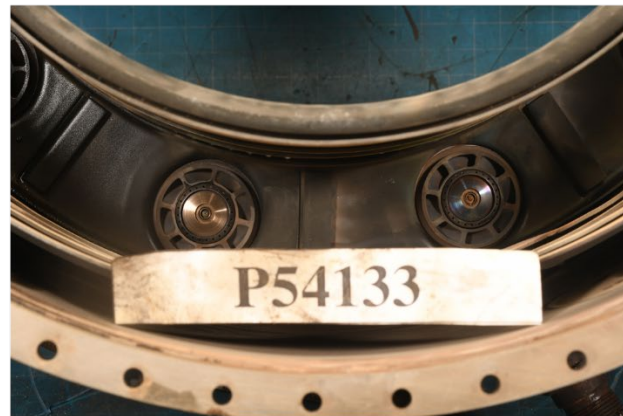
Photo 57- (L) Combustion Liner, (R) Fuel Nozzles

The combustion liner was intact and had no indications of fuel nozzle streaking (**Photo 57**). All the fuel nozzles were properly seated. The thermal barrier coating was eroded on the liner wall skirt adjacent to the fuel nozzle at the 2 o'clock position. The primary and secondary fuel manifold was thermally damaged, but all nozzle connections remained intact. The outer transition liner had localized thermal barrier coating missing at three locations. Sand was collected in the combustor, most notably in the outer transition liner (**Photo 58**). There was no metal spray visible on the combustion liner walls.

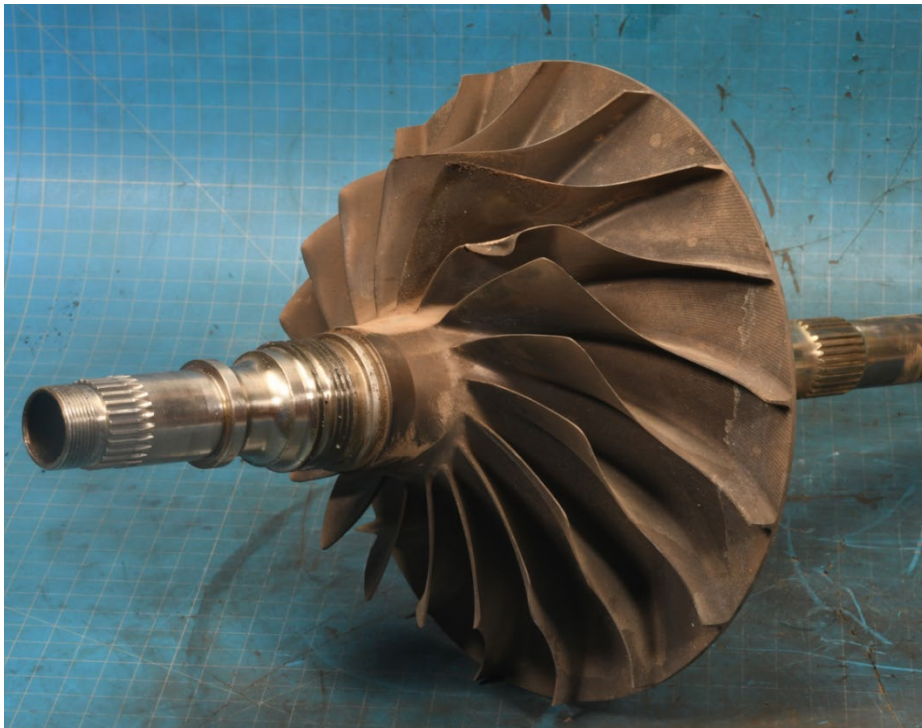
Photo 59- 1<sup>st</sup> Stage Compressor Impeller

The 1<sup>st</sup> stage compressor impeller was intact but exhibited thermal discoloration. One impeller blade tip was bent opposite the direction of rotation (**Photo 59**). There was light 360 degree rotational scoring on the hub forward of the aft curvic coupling. The 1<sup>st</sup> stage impeller shroud had 360-degree rotational scoring at the exducer (**Photo 60**). The 1<sup>st</sup> stage impeller, shroud and the 1<sup>st</sup> stage diffuser vanes were coated in a layer of fine sand.

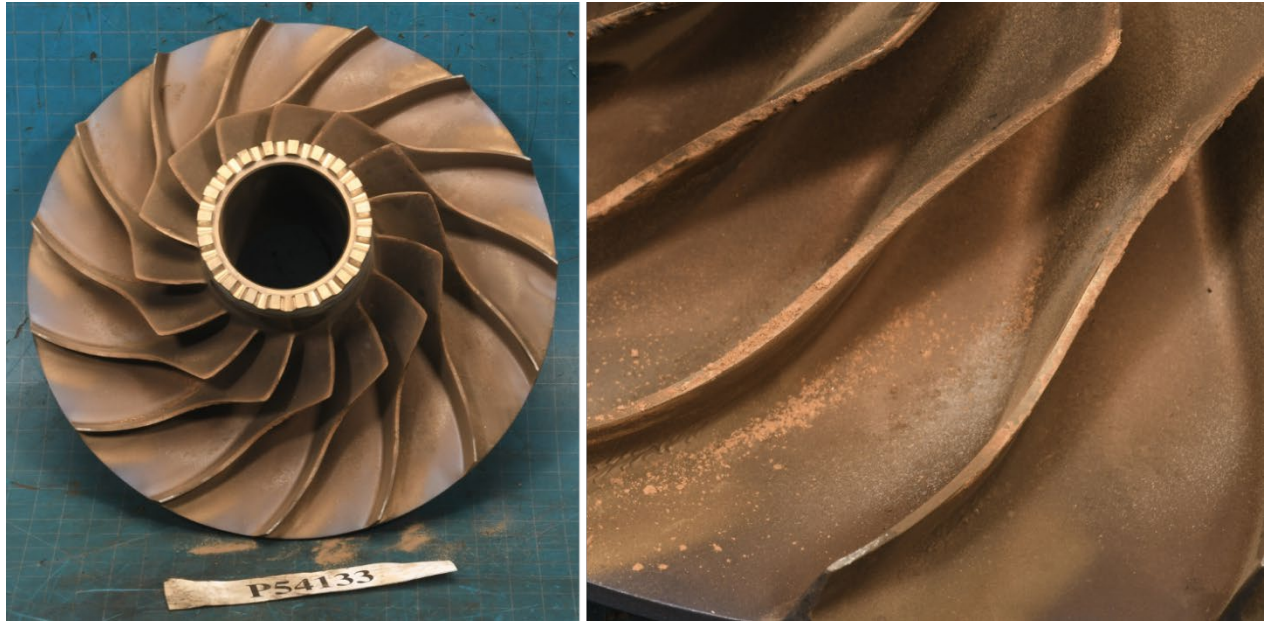
Photo 61- (L) 2<sup>nd</sup> Stage Compressor Impeller, (R) Impeller Blade Tip Rub

The 2<sup>nd</sup> stage compressor impeller blades were all complete (**Photo 61**). The impeller blades tips had tip rub from the inducer to the knee and at the exducer. The impeller had 360 degree rotational scoring on the hub aft of the forward curvic (**Photo 62**). The main shaft was intact and did not appear bent/deformed. The 2<sup>nd</sup> stage impeller shroud had 360 degree rotational scoring at the exducer and light rotational scoring from the inducer to the knee (**Photo 63**).

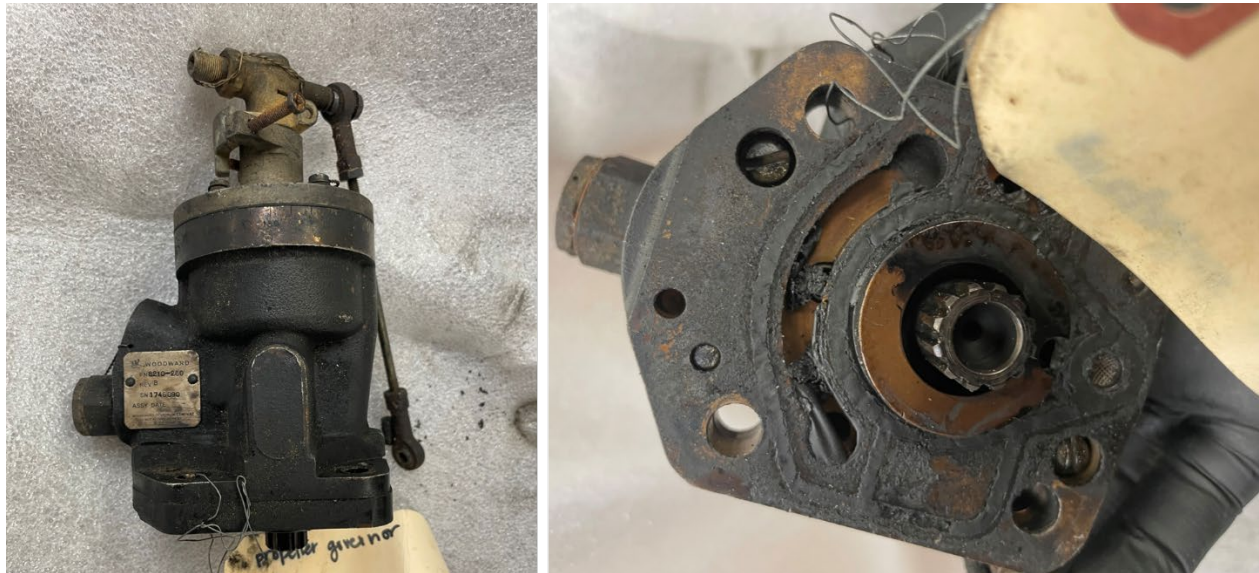
Photo 65- Propeller Governor, as Received at Woodward

The propeller governor external surfaces were all discolored and covered with soot and charred debris (**Photo 65**). The governor was run on the test bench in the as received condition and findings were like what was observed on the No. 1 engine propeller governor. There was significant leakage from the governor baseplate during initial startup. The baseplate packing was replaced but leakage was again observed from the governor housing and baseplate and operating pressure were below normal levels. As received testing was completed with the leak and low pressure readings and multiple test points were out of limits. The bypass valve was replaced with an engineering spare relief valve assembly and the test procedure was run again. After bypass valve replacement, test points were within the expected range of similar service run units according to Woodward. The propeller governor was fully disassembled, and internal components exhibited discoloration and thermal damage consistent with post-crash fire exposure. The relief valve assembly spring had also taken a set similar to what was observed on the No. 1 engine relief valve assembly. The Woodward shop report and test run sheet are available in the

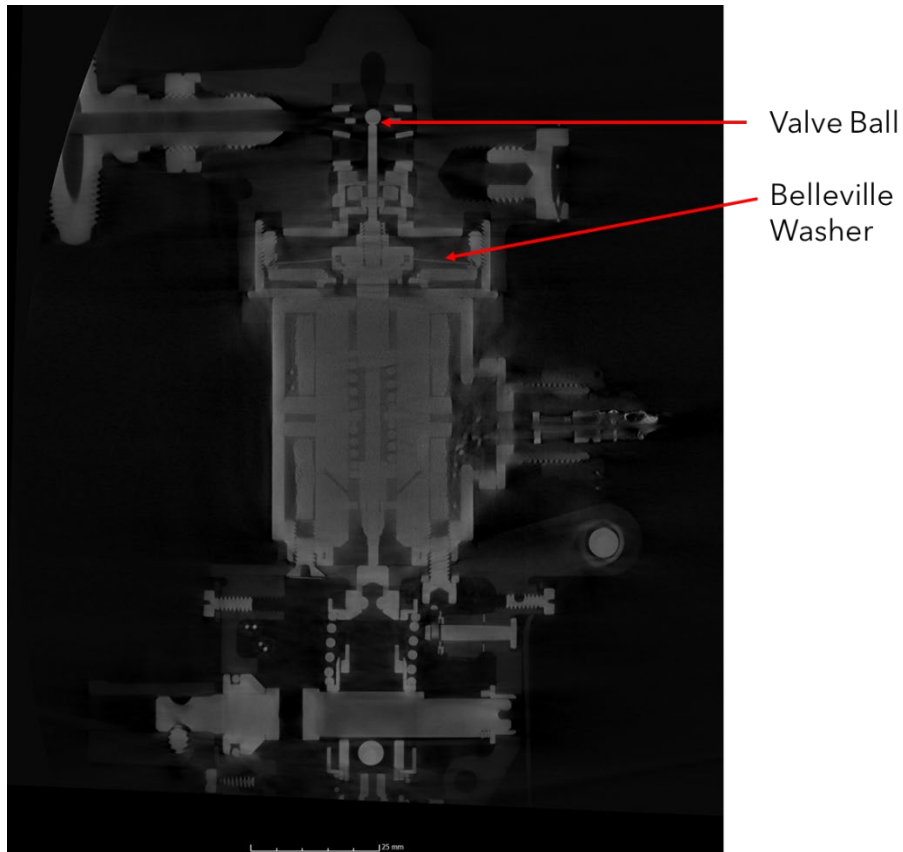
Photo 66- FSOV CT Scan

The No. 2 engine FSOV was CT scanned at Honeywell in Phoenix, Arizona and video files of the CT scans were provided to the NTSB for review. The CT scan showed the FSOV was in the closed position with the Belleville washer deflected towards the valve seat, consistent with the low pressure test findings during the teardown examination. There were no internal anomalies identified during the FSOV CT scan review (**Photo 66**).

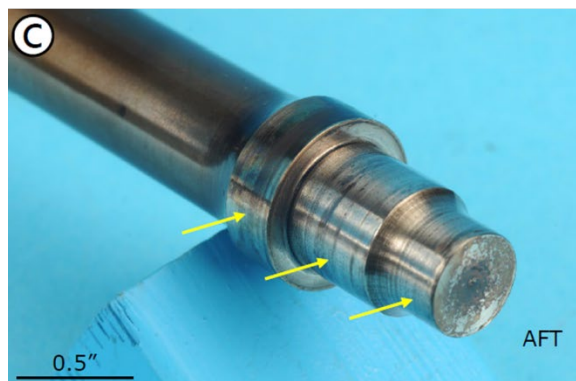
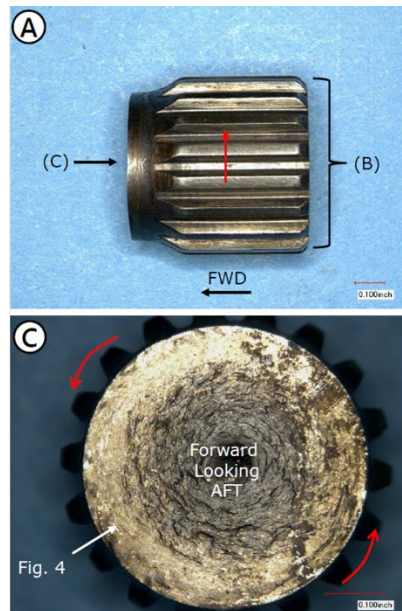
Photo 67- High Speed Coupling Shaft Fracture (Photos Courtesy of Honeywell)

The No. 2 engine high speed coupling shaft was submitted to the Honeywell Materials Laboratory in Phoenix, Arizona for fracture analysis. The lab concluded that the fracture surface was consistent with torsional overload (**Photo 67**). EDX analysis confirmed that the high speed coupling shaft was consistent with H11 tool steel as specified in the part drawing. The materials laboratory report is available in the docket as "Attachment 6- Honeywell Materials Laboratory Report, Engine Serial Number P54133."
