ERA22FA086

Group Chair's Factual Report - Attachment # 3

Honeywell Materials Laboratory Report, Engine Serial Number, P54128

Conduct investigation of the separated turbine blade, Blade 1, from the 1<sup>st</sup> stage rotor assembly P/N 3107080-1, S/N 3-03501-1120.

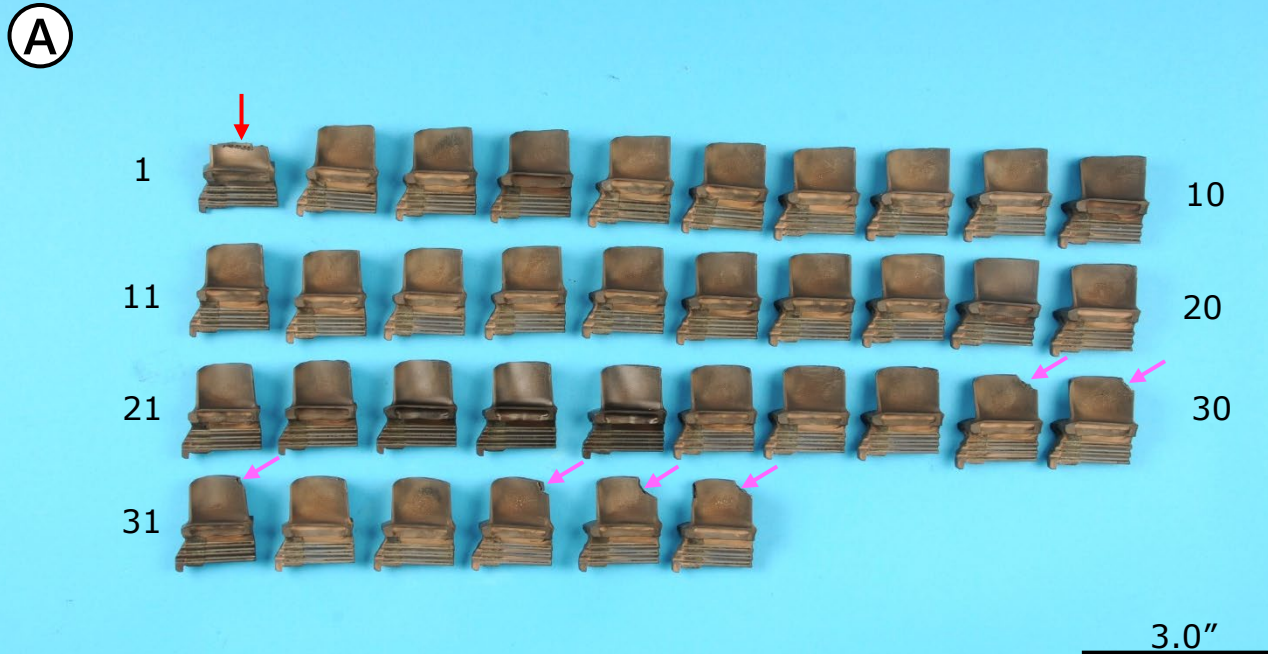
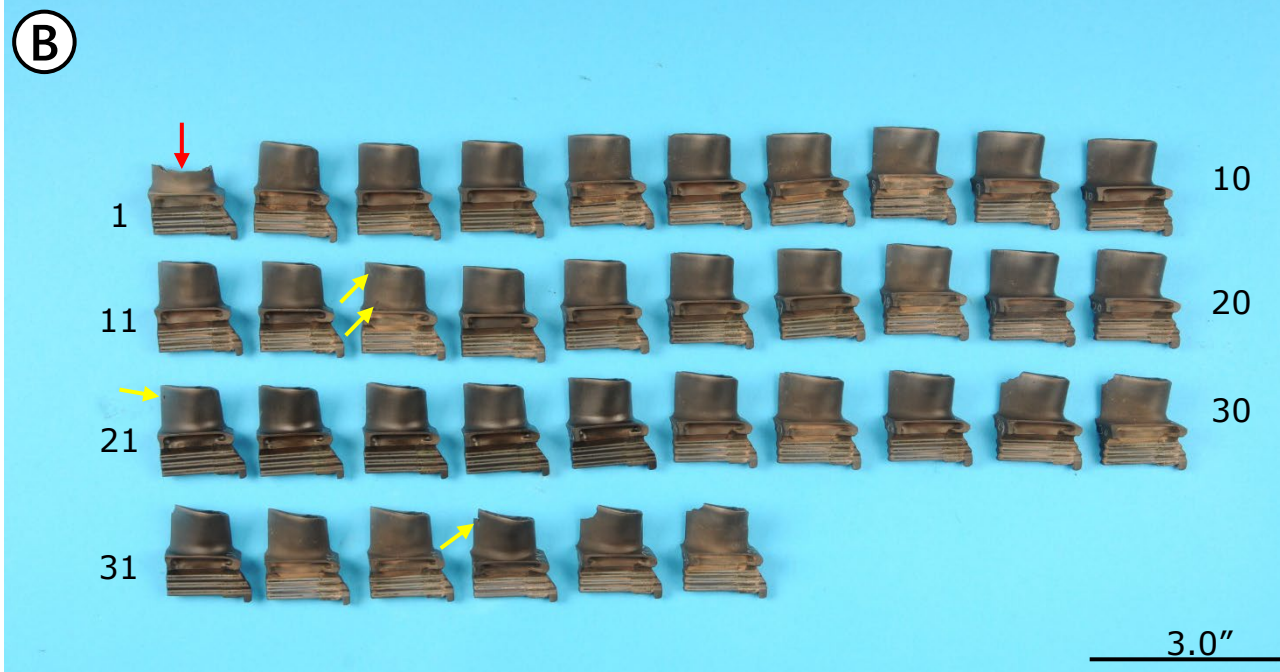
**Figure 1.**

The blades from the 1<sup>st</sup> stage rotor assembly (P/N 3107080-1, S/N 3-03501-1120) were submitted after one of the blades had separated through the airfoil (Figure 1). The blades were identified 1-36, clockwise, aft looking forward. The logbook stated that the 1<sup>st</sup> stage rotor assembly had 9414 hours and 8625 cycles as of 11/30/2021.

Images showing the (A) pressure and (B) suction sides of the 1<sup>st</sup> stage turbine blades from TPE331-10UA-511G engine S/N P54128, in the as-received condition. The blades were numbered 1-36, as indicated. Blade 1 exhibited a separation through the airfoil (red arrows). Separations at the tip near the trailing edge were observed on multiple blades (pink arrows in (A)). Dents were observed on the suction sides of multiple blades (yellow arrows in (B)). Close-up images of Blade 1 are shown in Figures 2-3. Close-up images of Blades 16 and 35 are shown in Figure 4.

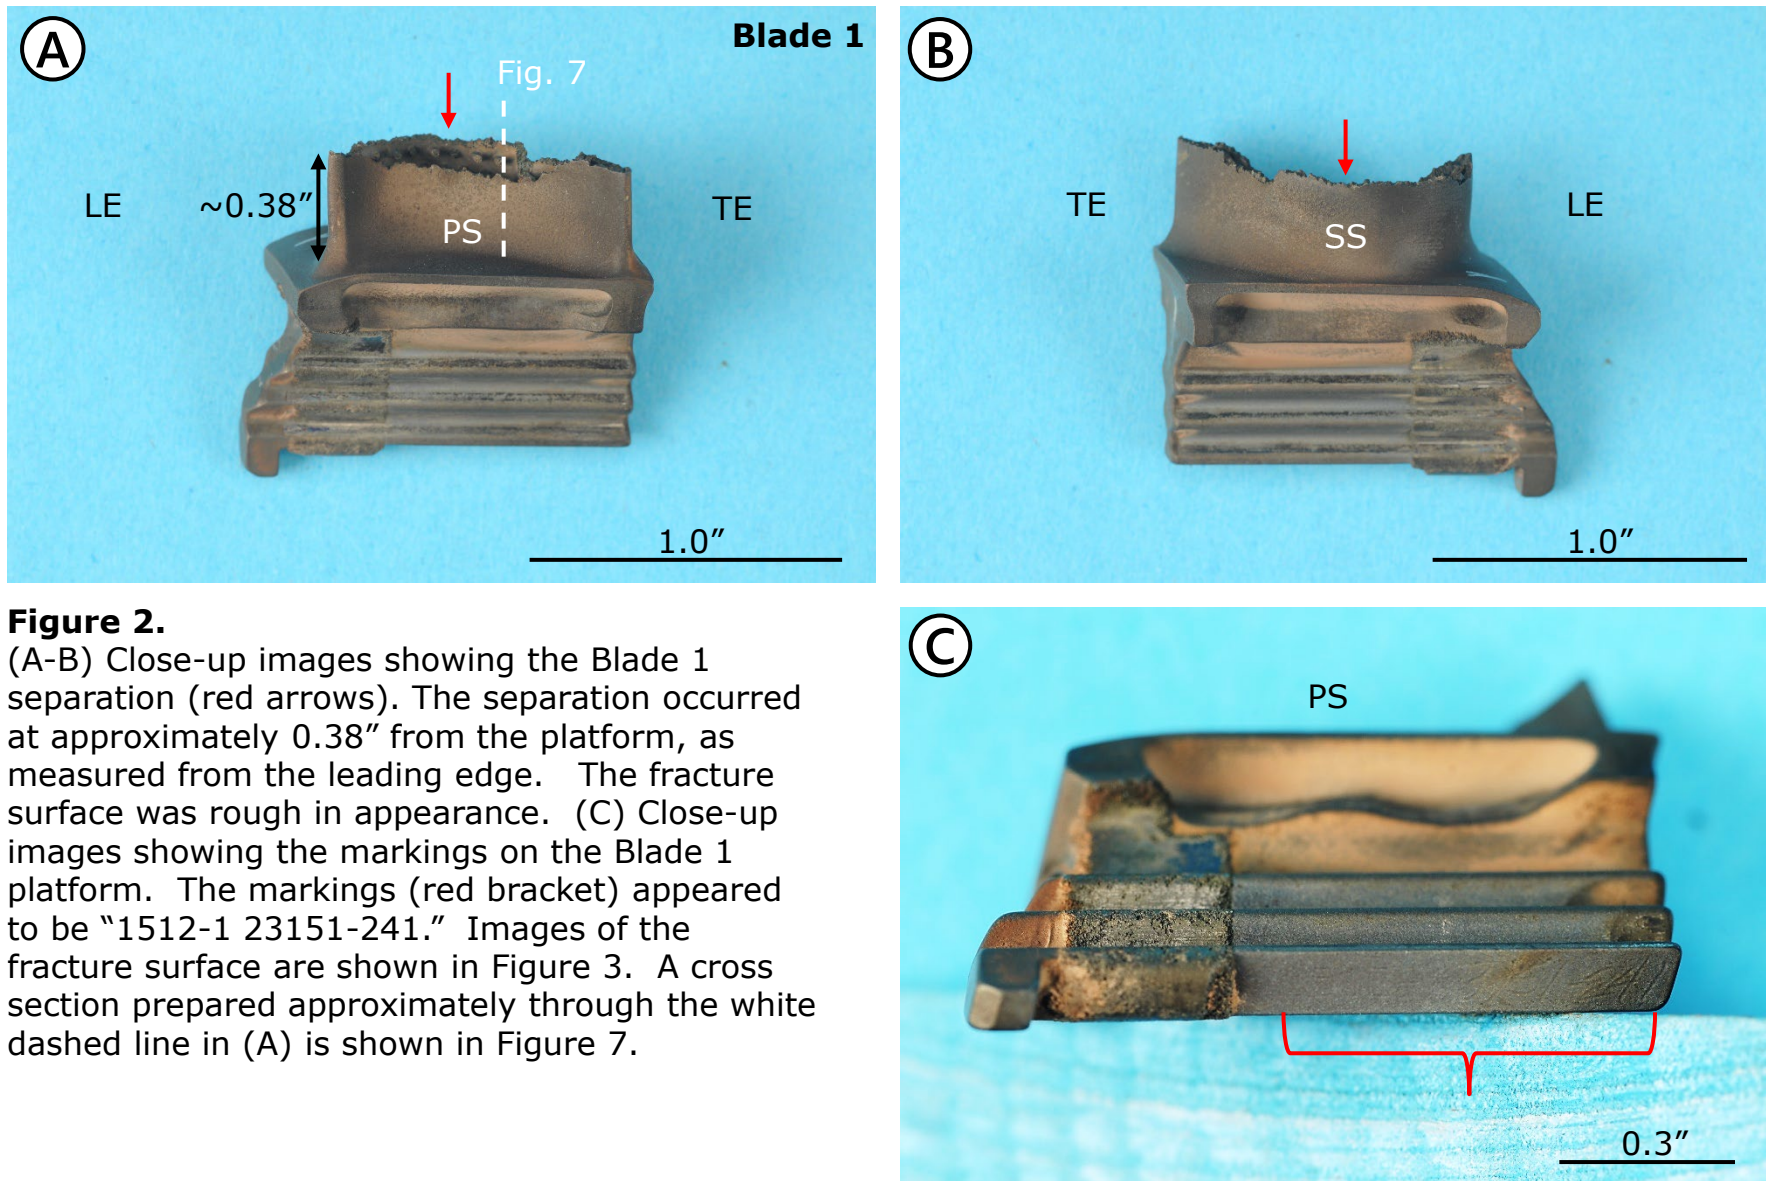
**Figure 2.**

Blade 1 exhibited a separation through the airfoil at approximately 0.38" from the platform as measured from the leading edge. The fracture surface was oxidized and had a rough appearance (Figures 2-3). The markings on the Blade 1 platform appeared to be "1512-1 23151-241." No distinct part number markings were observed on the blade.

(A-B) Close-up images showing the Blade 1 separation (red arrows). The separation occurred at approximately 0.38" from the platform, as measured from the leading edge. The fracture surface was rough in appearance. (C) Close-up images showing the markings on the Blade 1 platform. The markings (red bracket) appeared to be "1512-1 23151-241." Images of the fracture surface are shown in Figure 3. A cross section prepared approximately through the white dashed line in (A) is shown in Figure 7.

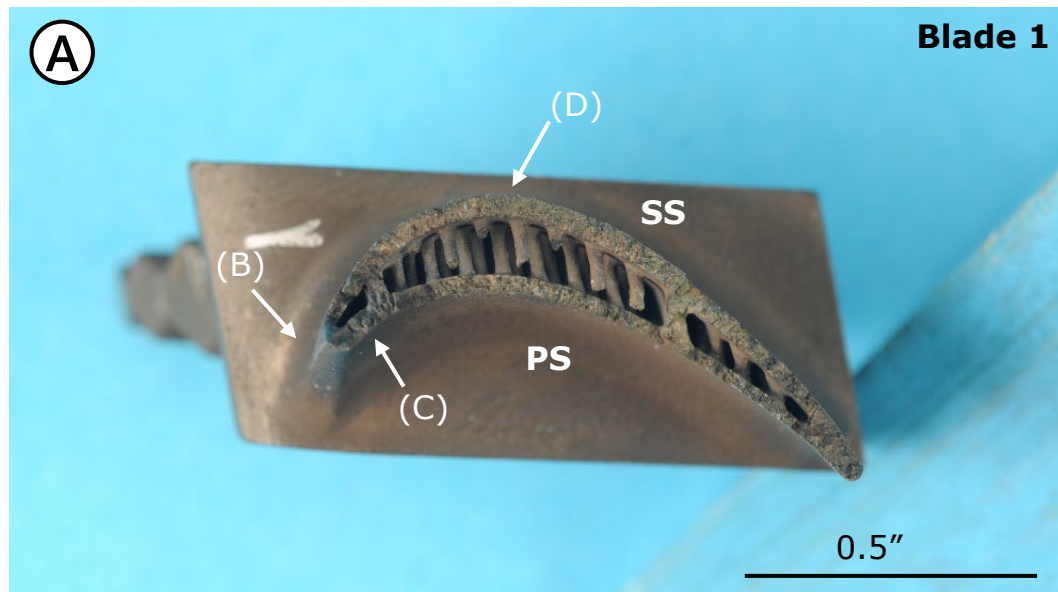
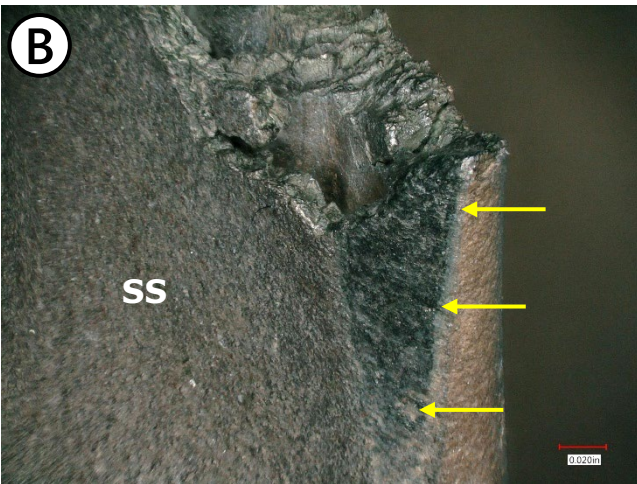
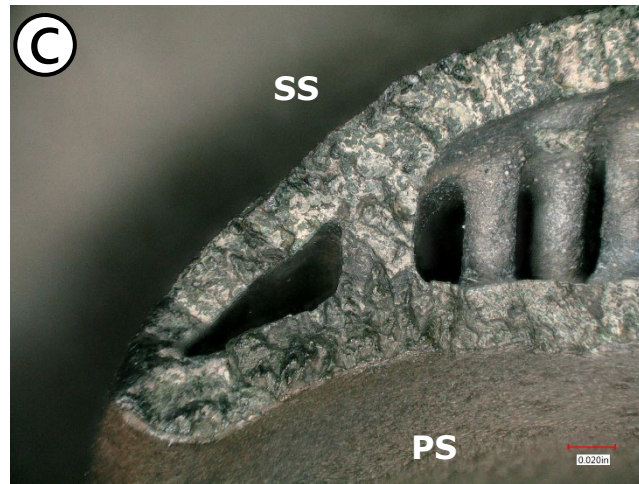
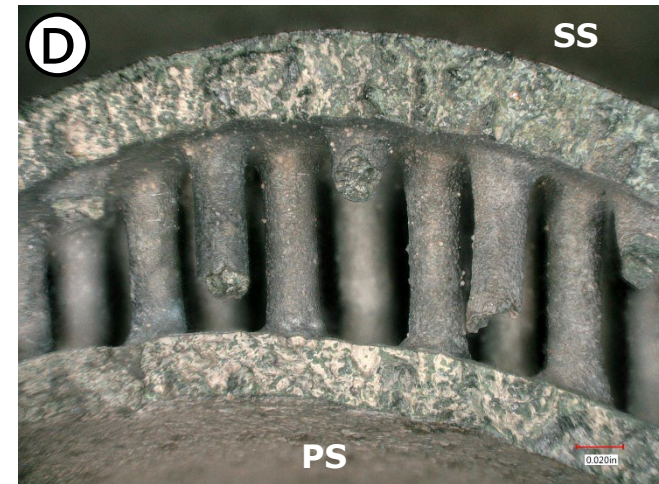
**Figure 3.**  
(A-D) Close-up images showing the fracture features of the Blade 1 separation (reference Figure 2). The fracture surface was rough in appearance. The yellow arrows in (B) identify erosion on the leading edge of the airfoil. Scanning electron microscope (SEM) images of the Blade 1 fracture surface are shown in Figure 5.

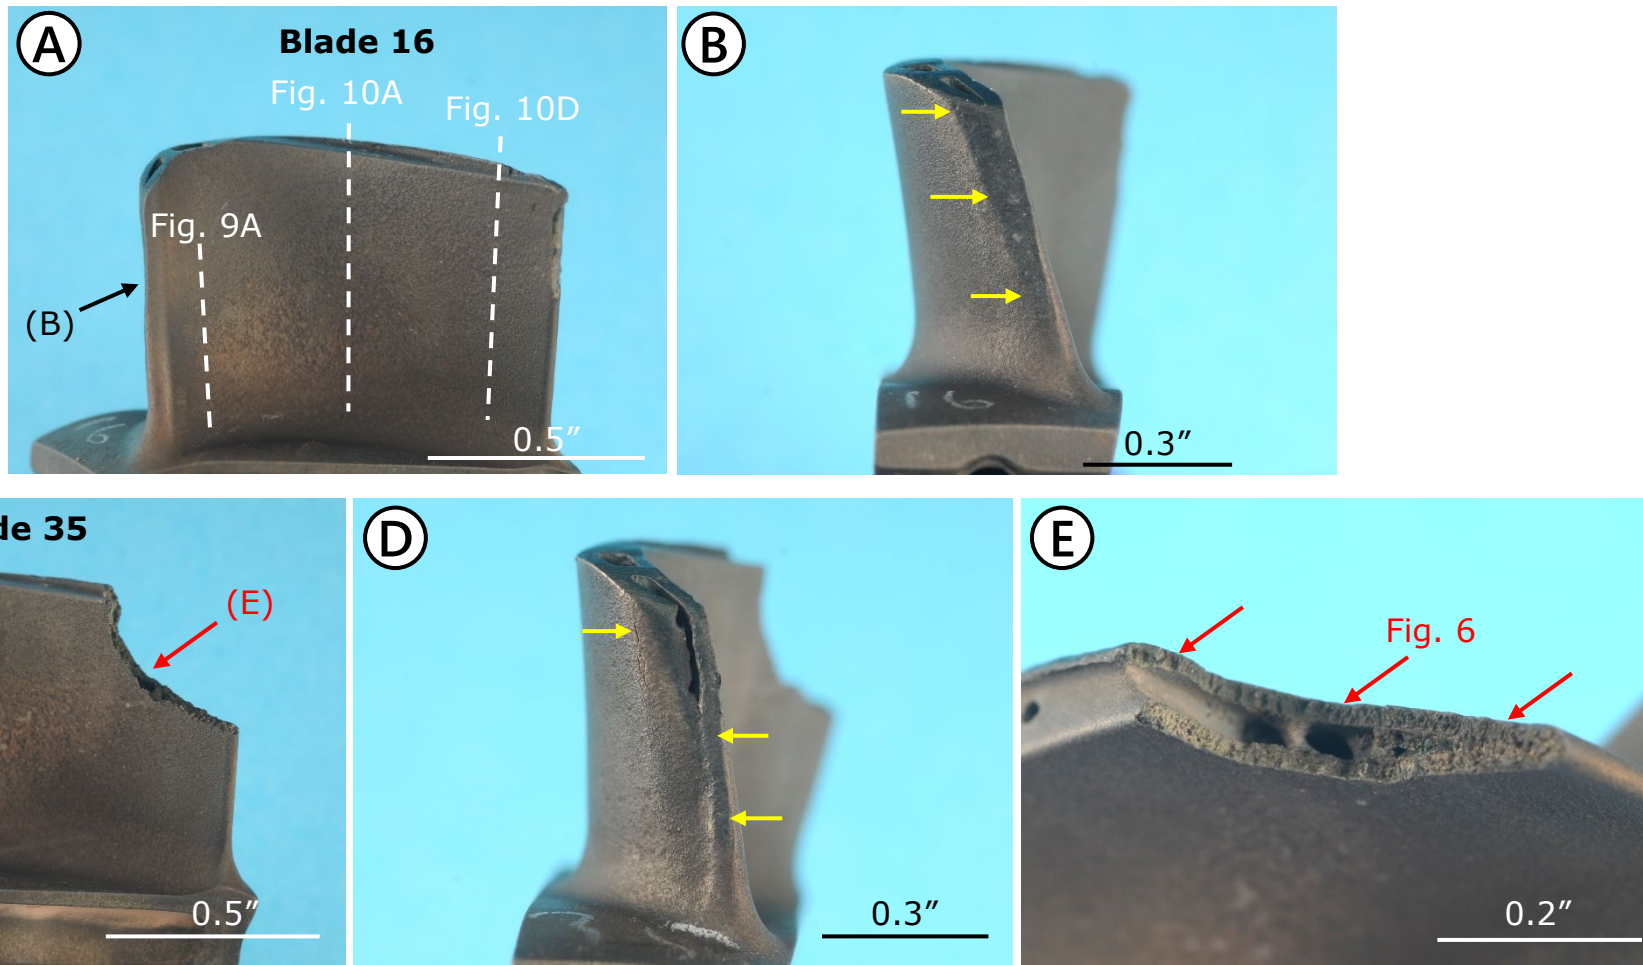
Erosion damage was observed on the leading edge of each of the submitted blades. The erosion on Blades 30, 35, and 36 appeared to have penetrated through the leading edge cooling hole. Blades 29, 30, 31, 34, 35, and 36 exhibited separations at the trailing edges. Dents were observed on the suction side of Blades 13, 21, and 34. Figure 4 shows representative blades exhibiting leading edge erosion and a trailing edge separation.

**Figure 4.** Close-up images showing the condition of (A-B) Blade 16 and (C-E) Blade 35. Erosion was observed on the leading edge of the blades (yellow arrows in (B) and (D)). The erosion on Blade 35 appeared to have penetrated through the leading edge cooling passage. A trailing edge separation was observed in Blade 35 (red arrows in (C) and (E)). SEM documentation of the fracture surface in (E) is shown in Figure 6. Cross sections prepared approximately through the white dashed lines in (A) are shown in Figures 9 and 10, as indicated.

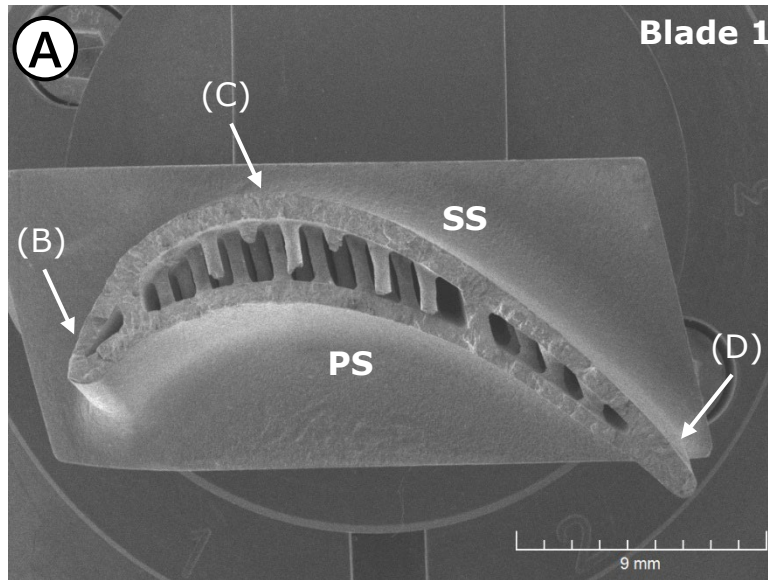
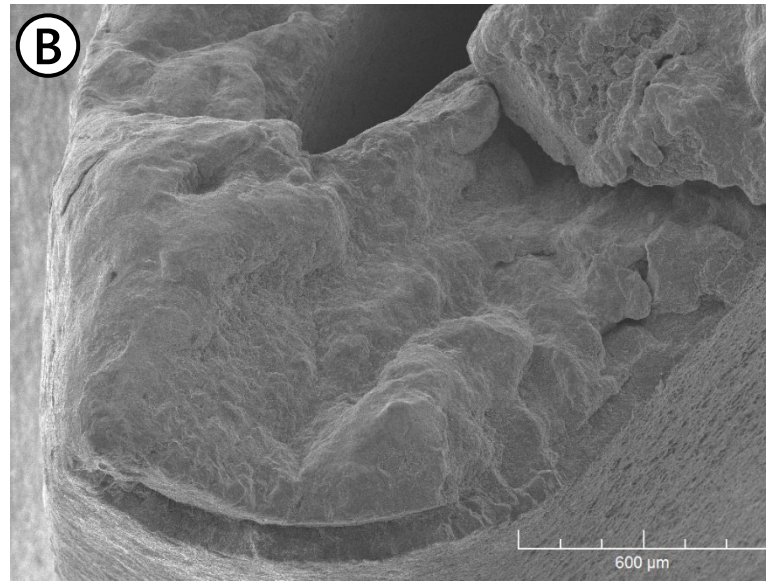
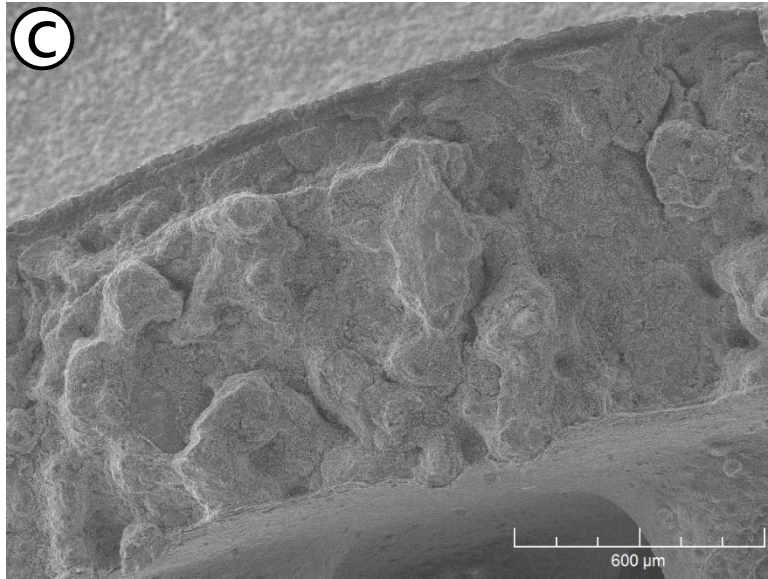
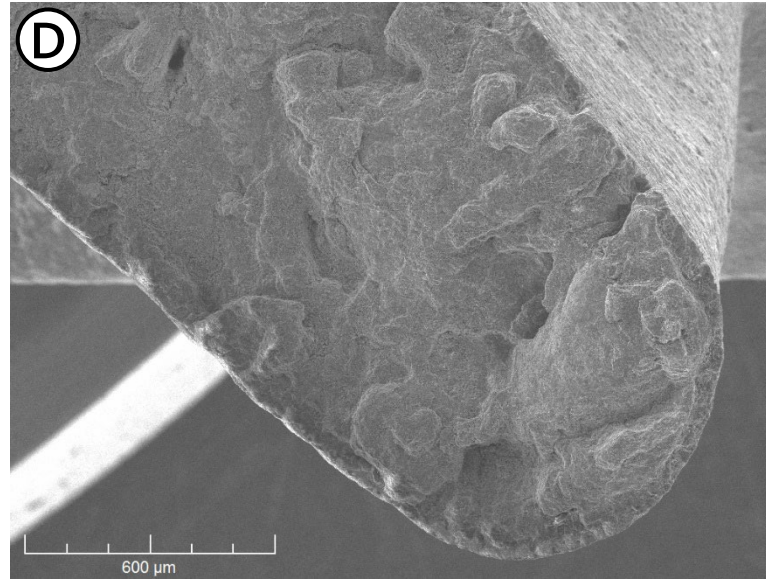
SEM examination was performed on the Blade 1 airfoil separation. The fracture surface was oxidized and had a rough appearance suggestive of a stress rupture-type of separation (Figure 5). No signs of cyclic fatigue propagation or material defects were observed on the fracture surface.

**Figure 5.**  
(A-D) Secondary electron (SE) SEM images showing representative fracture features of the Blade 1 separation. The fracture features were oxidized and rough in appearance, suggestive of a stress rupture-type mechanism. No signs of cyclic fatigue propagation or material defects were observed on the fracture surface.

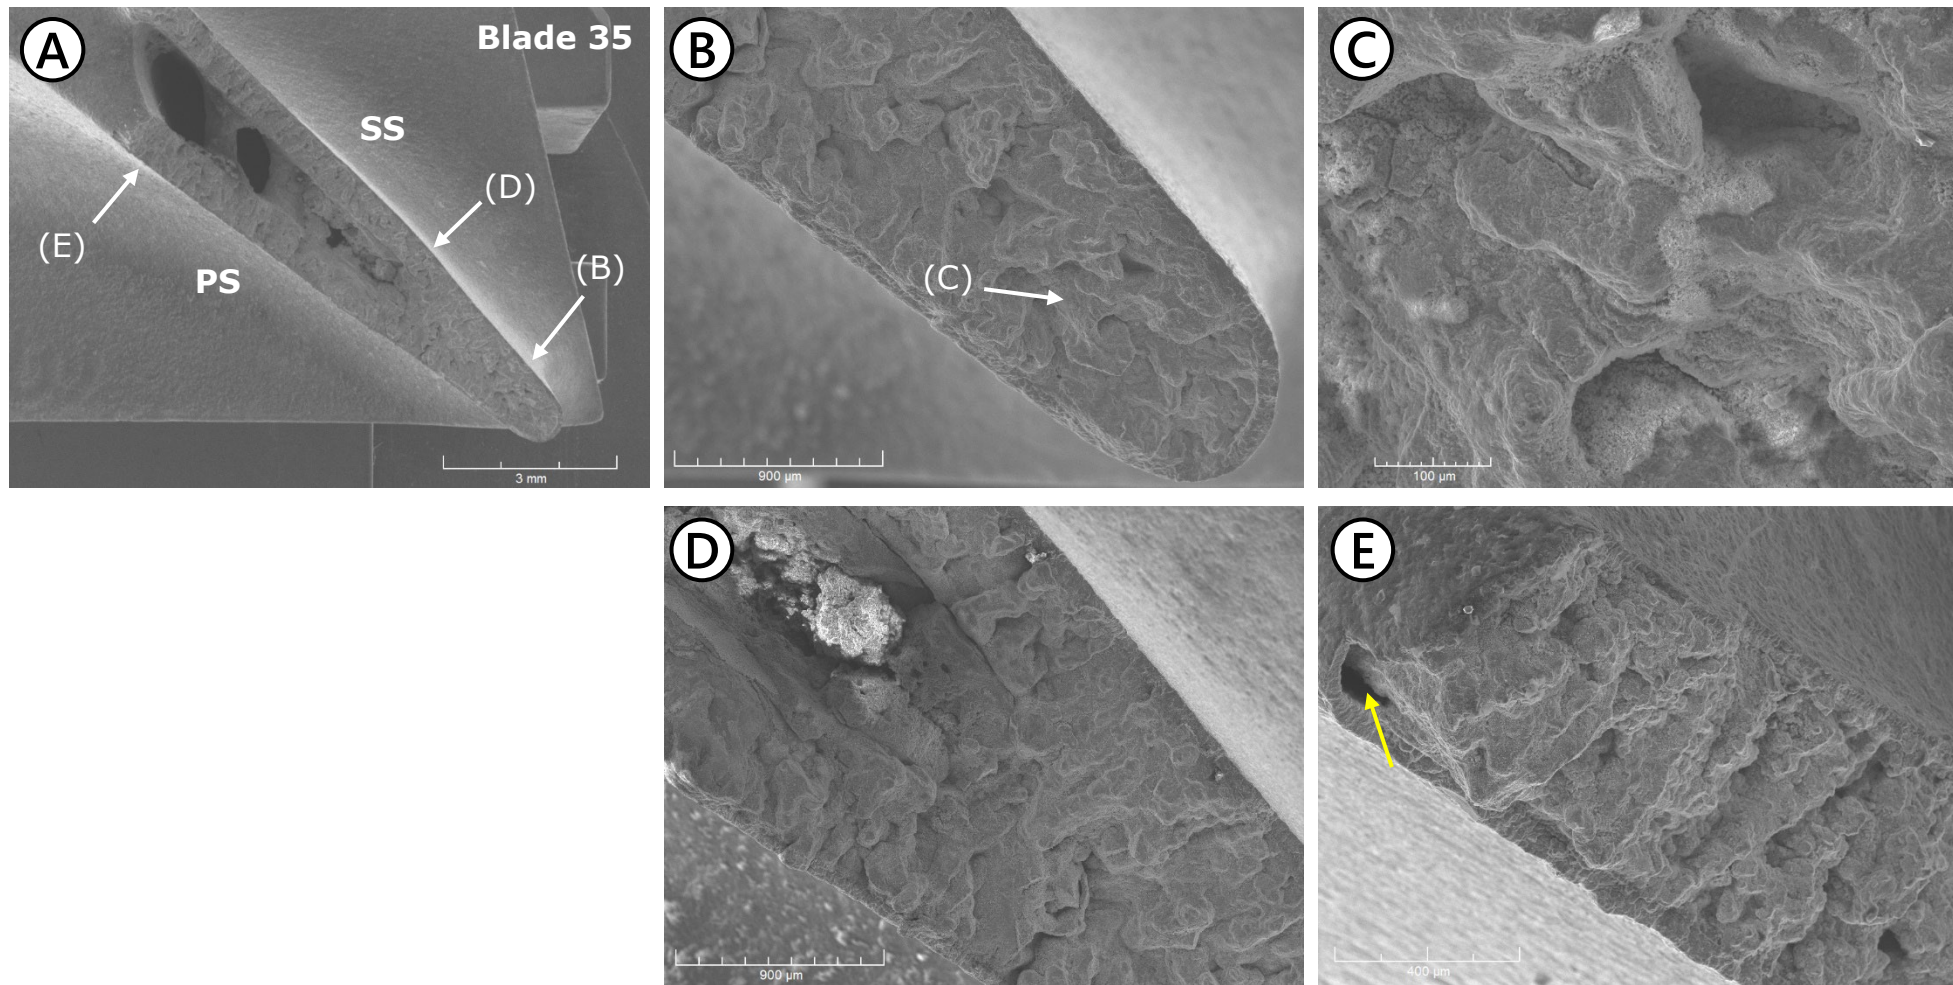
**Figure 6.**

SEM examination was performed on the Blade 35 trailing edge separation. The fracture features were oxidized and rough in appearance suggestive of a high temperature overload or stress rupture-type mechanism (Figure 6). No signs of cyclic fatigue propagation or material defects were observed on the fracture surface.

(A-E) SE SEM images showing the trailing edge separation of Blade 35 (reference Figure 4). The fracture features were oxidized and rough in appearance, suggestive of a high temperature overload or stress rupture-type mechanism. The yellow arrow in (E) identifies a void between the coating and the blade material. No signs of cyclic fatigue propagation or material defects were observed on the fracture surface.

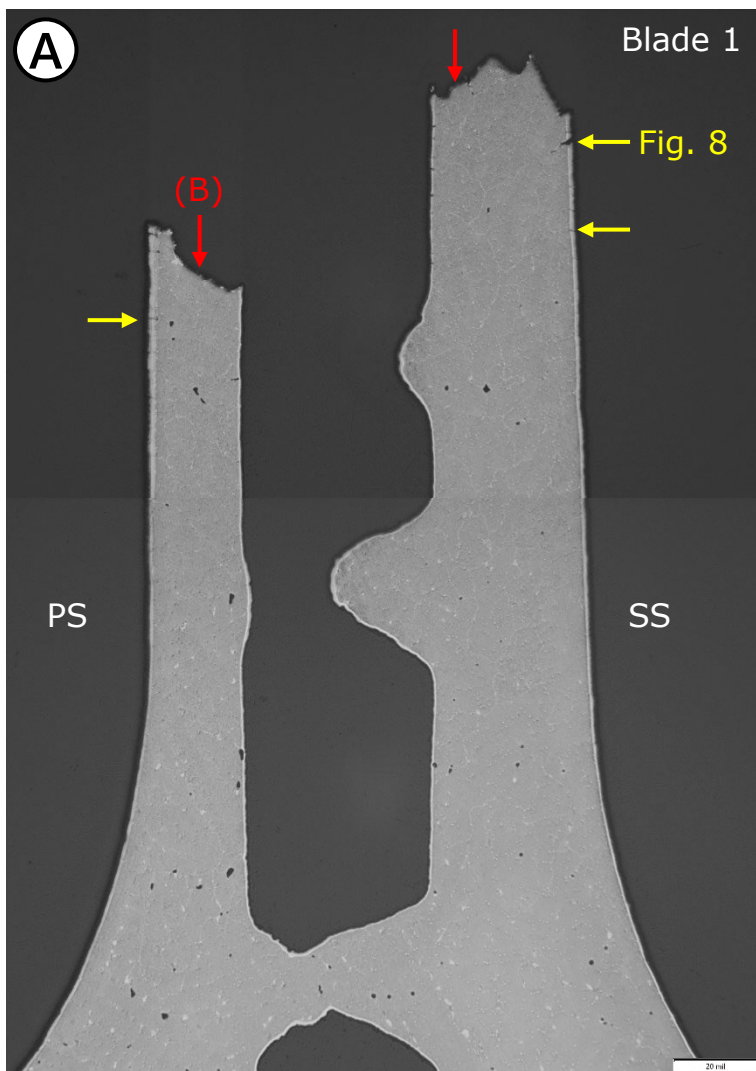
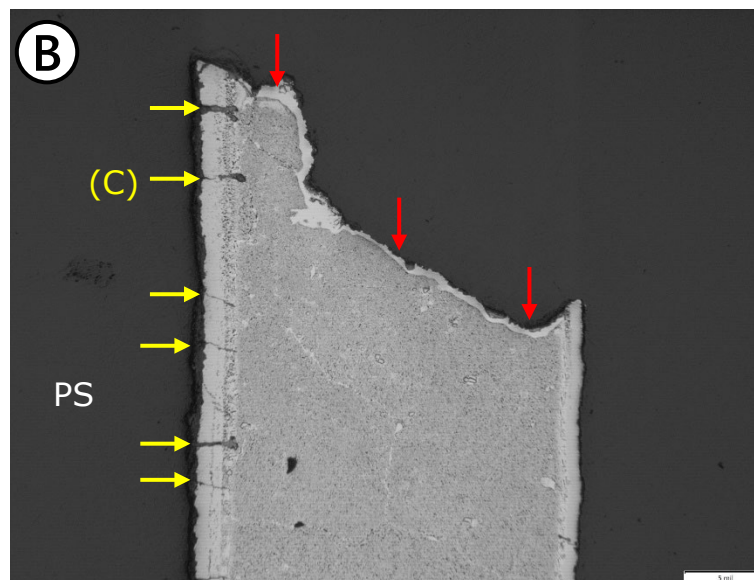
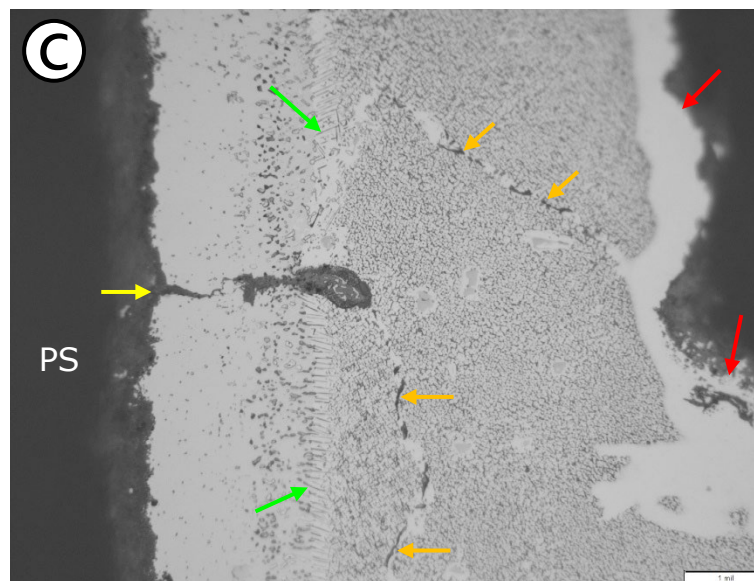
**Figure 7.**

A cross section was prepared through the mid-chord region of the Blade 1 fracture surface (Figures 7-8). Oxidation and alloy depletion were observed along the fracture surface. It was noted that the oxidation/alloy depletion observed on the fracture surface was more predominant on the pressure side wall than the suction side wall of Blade 1 (Figures 7B and 8A). Cracks and voids were observed along the grain boundaries adjacent to the fracture surface. Several coating cracks were observed in the pressure and suction sides of the

blade and in the cooling passage. Evidence of sigma phase along the coating/blade interface was observed. In comparison to heat treat standards for coated IN100 at 1, 10, 100, and 1000 hours of exposure, the microstructural features of Blade 1 suggested exposure to metal temperatures near 1700°F over a period of time between 10 and 100 hours.

(A-C) Cross section prepared through the Blade 1 fracture surface near the mid-chord (reference Figure 2A). Oxidation and alloy depletion was observed on the fracture surface (red arrows). The yellow arrows identify cracks in the coating. The orange arrows identify cracking and voids along the grain boundaries. The green arrows in (C) identify sigma phase (acicular structure) noted along the coating/blade interface. The presence of sigma phase and gamma prime microstructure were indicative of exposures to metal temperatures near 1700°F over a period between 10 and 100 hours. Images of the area identified in (A) are shown in Figure 8. Etchant: 10% Oxalic acid, electrolytic.

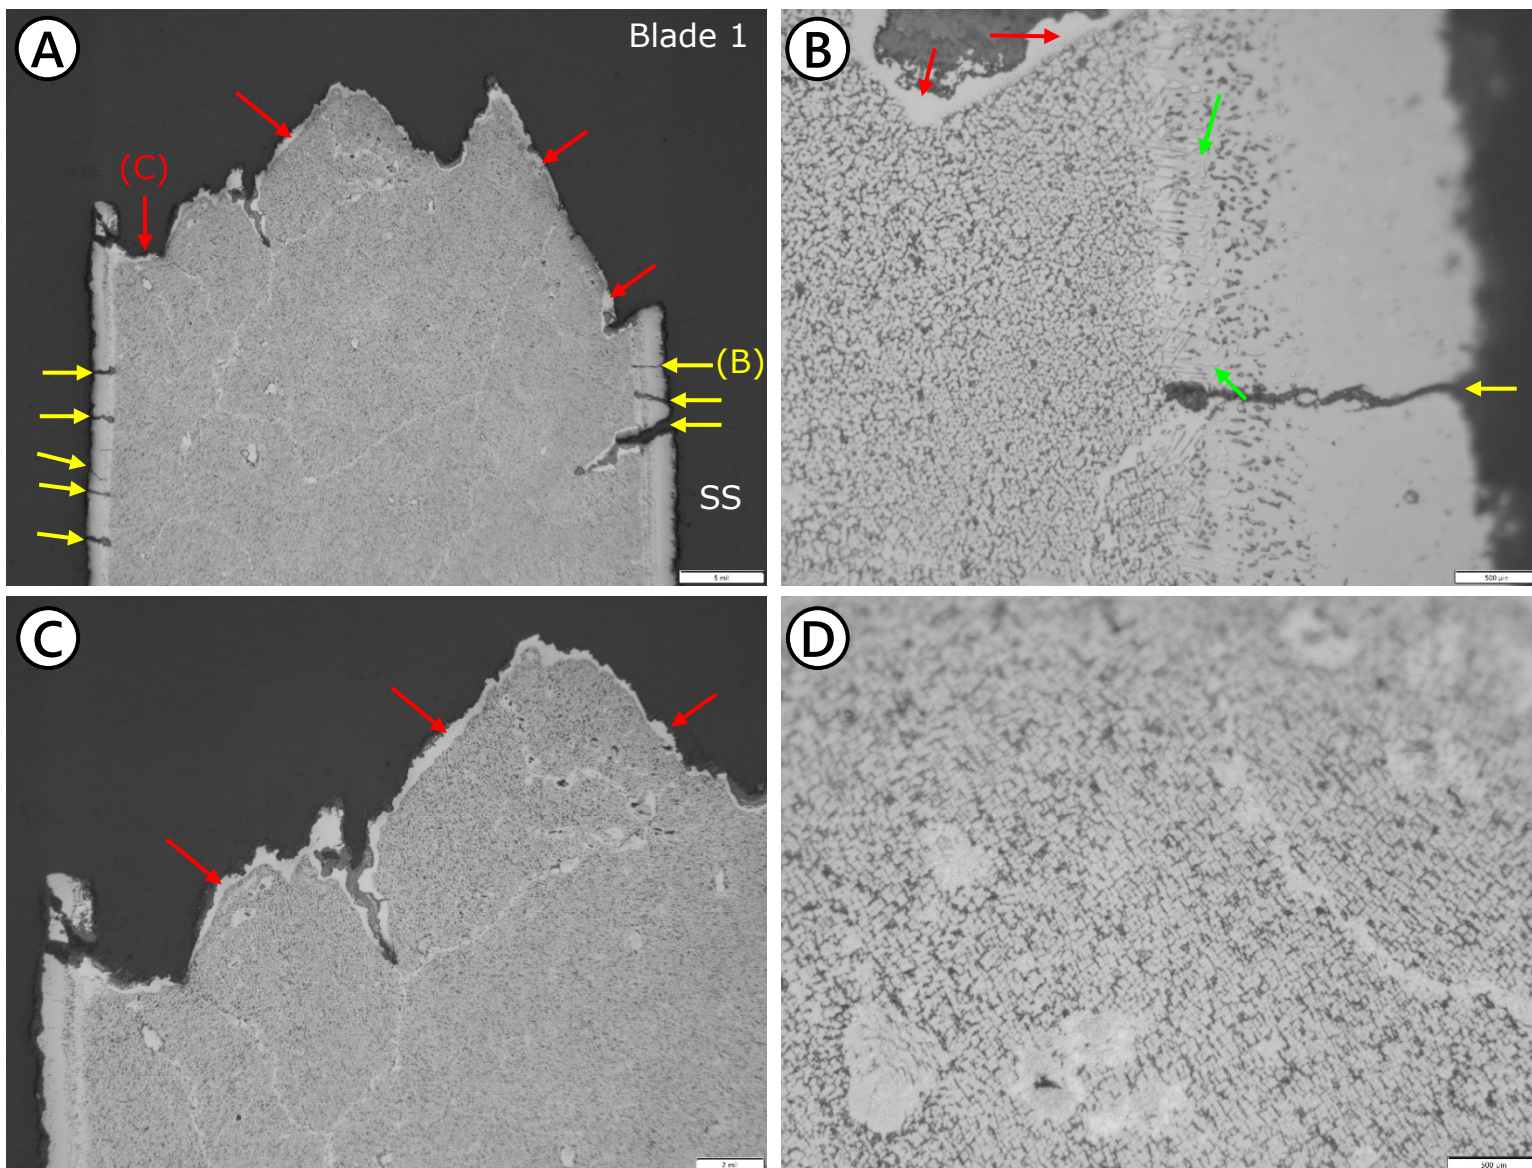
**Figure 8.**

The presence of sigma phase along the coating/blade interface, the grain boundary voids and cracks, and the coating cracks in Blade 1 were indicative of a stress-rupture fracture mechanism.

(A-C) Cross section showing the suction side wall of the Blade 1 fracture surface identified in Figure 7A. Oxidation and alloy depletion was observed on the fracture surface (red arrows). It was noted that the oxidation/alloy depletion on the fracture surface was more predominant on the pressure side wall than the suction side wall (reference Figure 7B). The yellow arrows identify cracks in the coating. The green arrows in (B) identify sigma phase (acicular structure) noted along the coating/blade interface.

(D) Representative image showing the microstructure near the fracture surface. The presence of sigma phase and gamma prime microstructure were indicative of exposures to metal temperatures near 1700°F over a period between 10 and 100 hours. Etchant: 10% Oxalic acid, electrolytic.

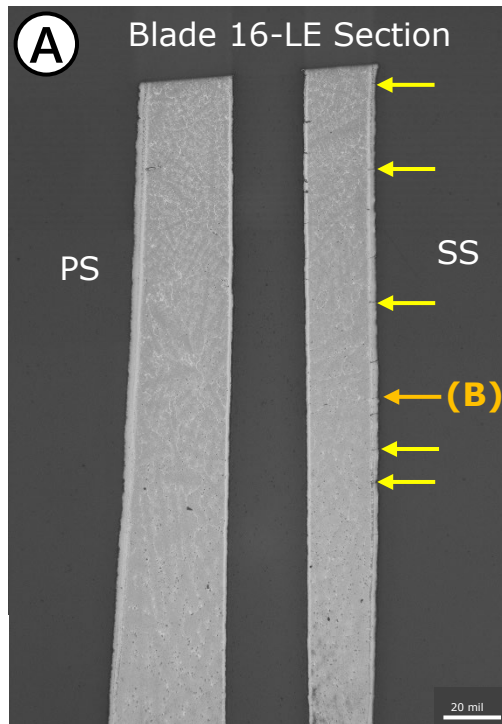
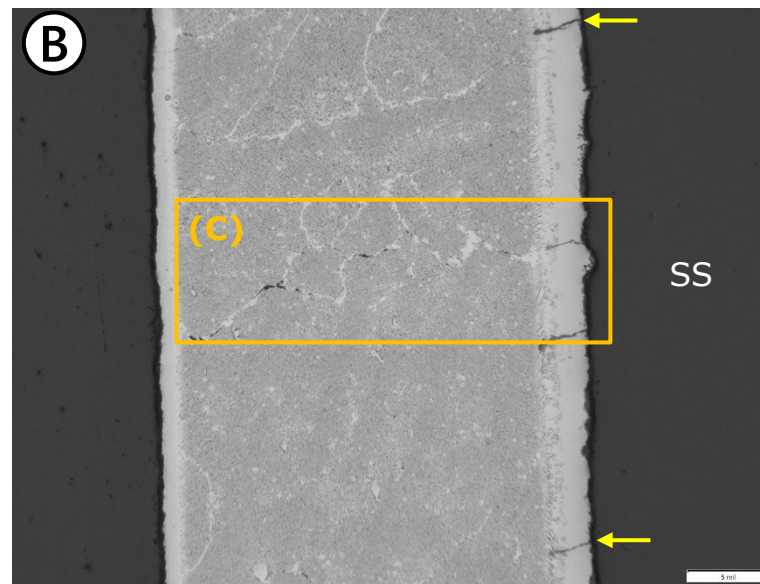
**Figure 9.**

Cross sections were prepared through Blade 5 (not shown) and Blade 16 (Figures 9-10) at the leading edge, mid-chord region, and trailing edge for comparison purposes. Grain boundary coarsening was observed in multiple locations. The cross section prepared through the Blade 16 leading edge exhibited a region with interconnected cracks and voids along the grain boundaries in the suction side of the blade (Figure 9C). Multiple coating cracks were observed predominantly on the leading edge cross sections prepared through the blades. Evidence of sigma phase along the coating/blade interface was observed in Blades 5 and 16. The microstructure features of Blades 5 and 16 suggested exposures to metal temperatures near 1900°F over a period of time between 10 and 100 hours.

(A-C) Cross section prepared through the leading edge of Blade 16 (reference Figure 4A). The yellow arrows identify cracks in the coating. The orange arrows and box identify cracking and voids along the grain boundaries. The green arrows in (C) identify sigma phase (acicular structure) noted along the coating/blade interface. Coarsening of the grain boundaries and presence of sigma phase were indicative of exposures to metal temperatures near 1900°F over a period between 10 and 100 hours.

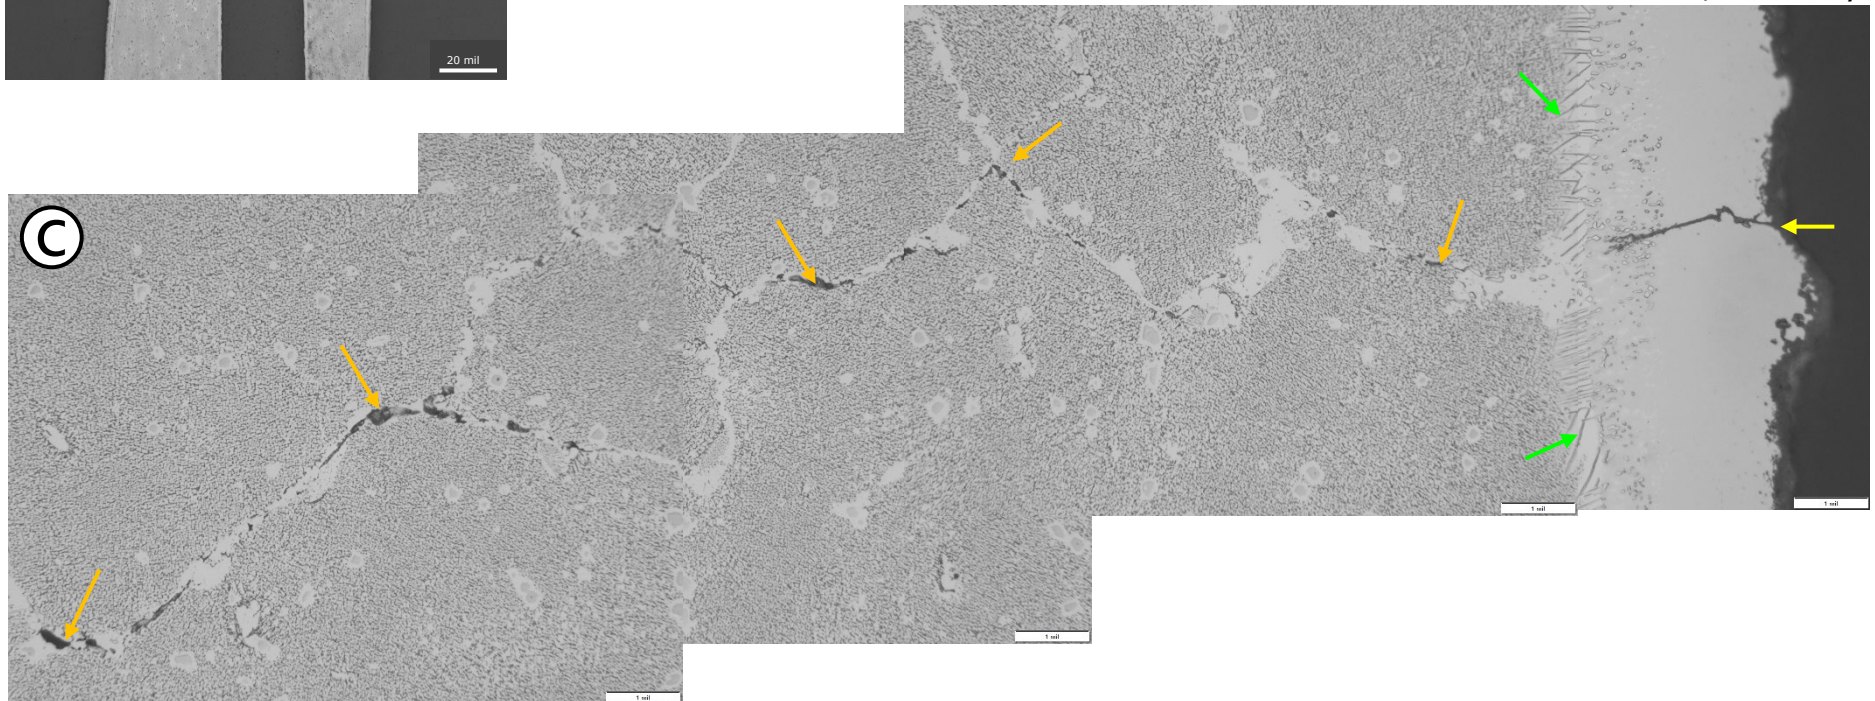
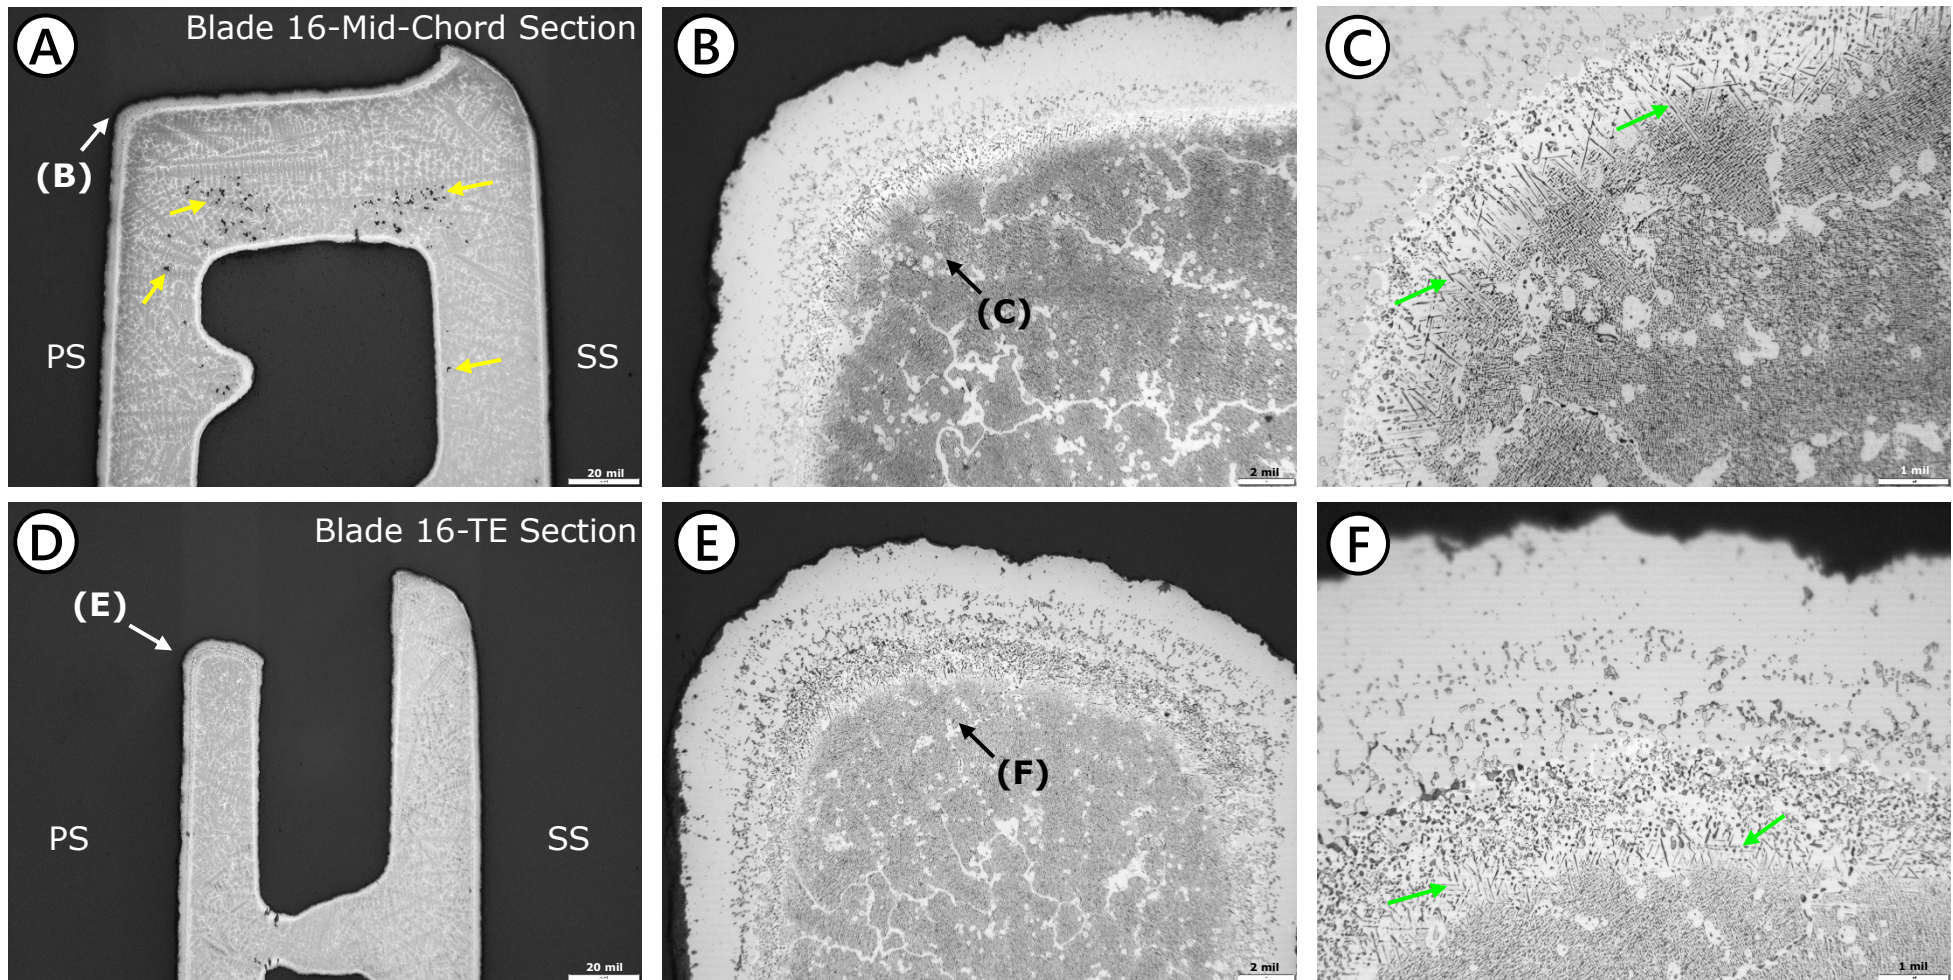
**Figure 10.**

Cross sections prepared through the (A-C) mid-chord and (D-E) trailing edge of Blade 16 (reference Figure 4A). The yellow arrows in (A) identify porosity. The green arrows in (C) and (F) identify sigma phase (acicular structure) noted along the coating/blade interface. Coarsening of the grain boundaries and presence of sigma phase were indicative of exposures to metal temperatures near 1900°F over a period between 10 and 100 hours.
