ERA22FA086

Group Chair's Factual Report - Attachment # 3

Honeywell Materials Laboratory Report, Engine Serial Number, P54128

Conduct investigation of the separated turbine blade, Blade 1, from the 1<sup>st</sup> stage rotor assembly P/N 3107080-1, S/N 3-03501-1120.

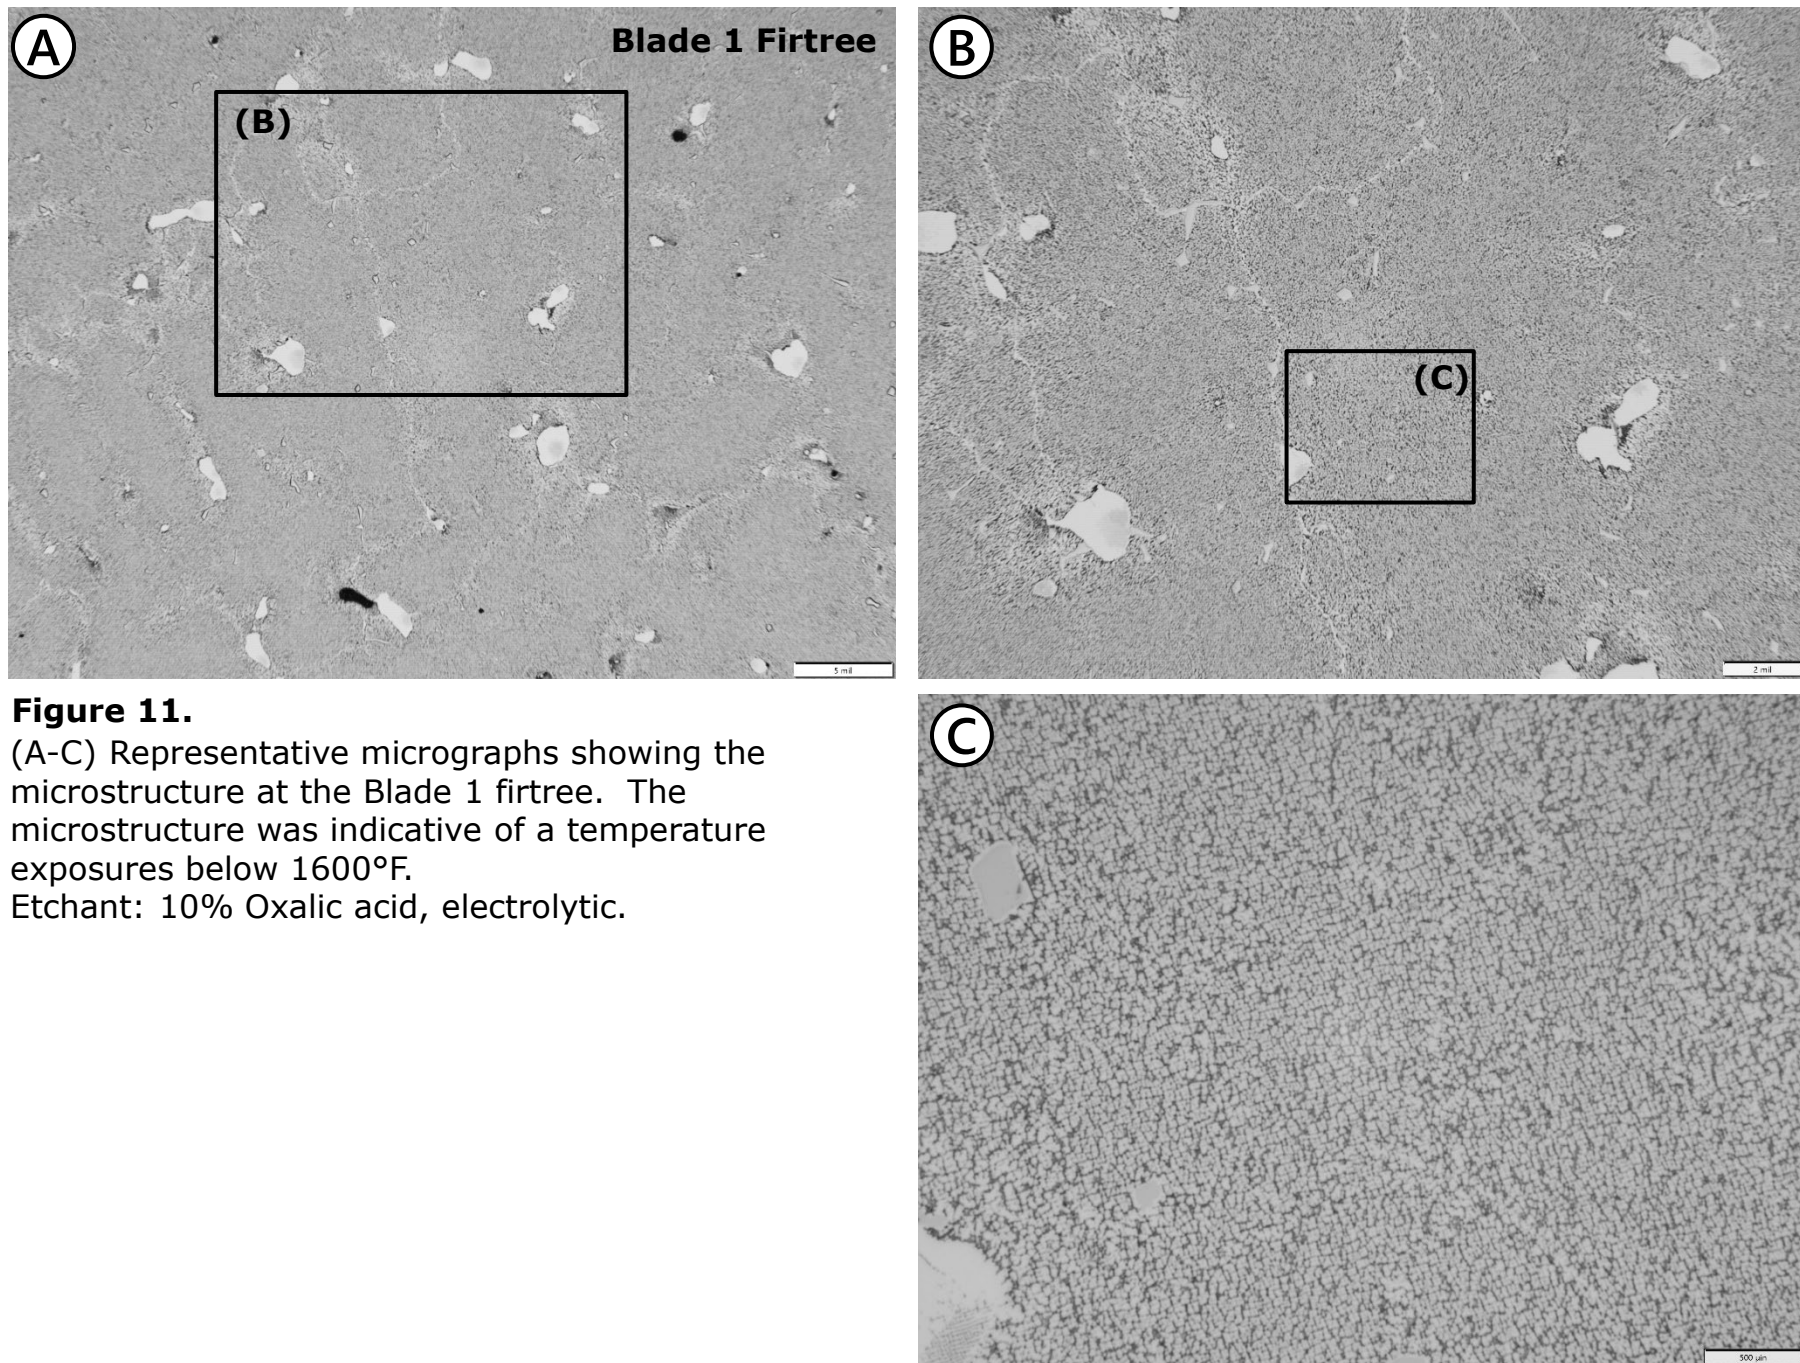
**Figure 11.**

Evaluation of the Blade 1 microstructure near the firtree was indicative of a temperature exposure below 1600°F (Figure 11).

(A-C) Representative micrographs showing the microstructure at the Blade 1 firtree. The microstructure was indicative of a temperature exposures below 1600°F.

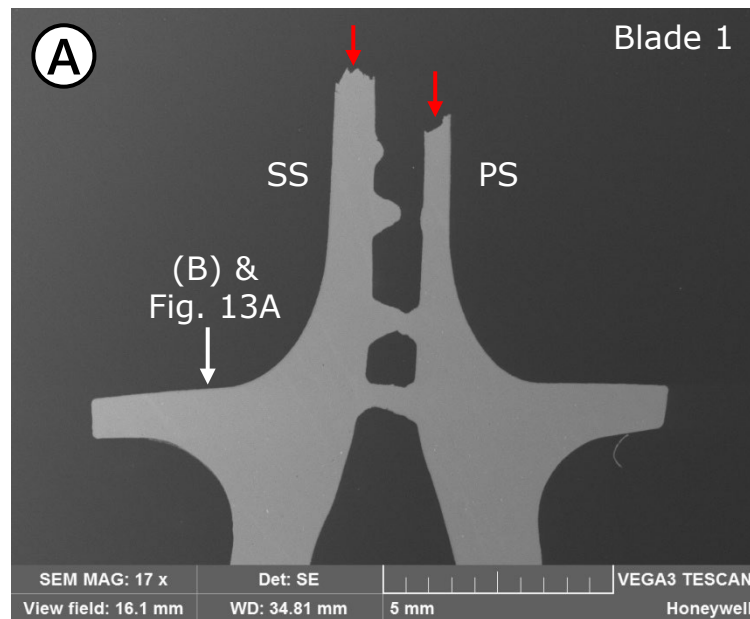
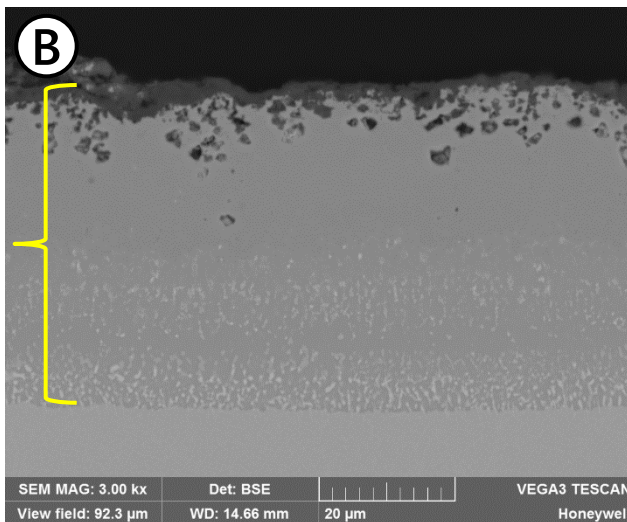
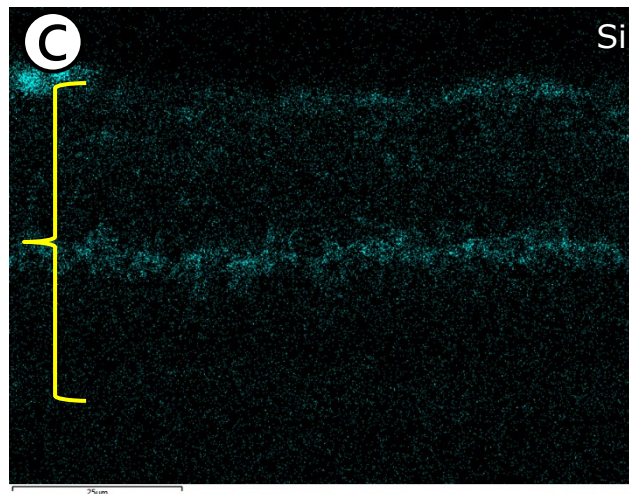
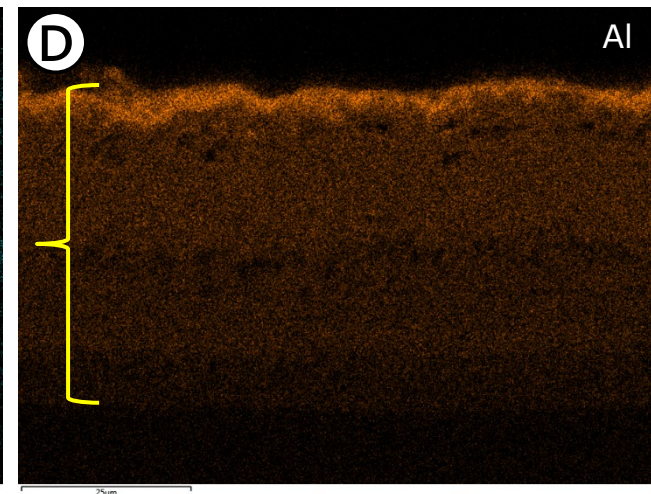
**Figure 12.**

Scanning electron microscope and energy dispersive X-ray (EDX) analyses were performed on the Blade 1 cross section to determine the coating composition (Figures 12-13). The coating was evaluated near the blade platform, away from the separation. Elemental dot maps and EDX spectra showed concentrations of aluminum and silicon in the coating suggestive of a diffused aluminum/silicon coating.

(A-B) BSE SEM images showing the coating at the platform of Blade 1. The blade fracture surface is identified by the red arrows in (A). (C-D) Element dot maps for silicon and aluminum, respectively, of the area shown in (B). The yellow brackets in (B-D) outline the coating thickness. The silicon concentration suggested that the coating applied was a diffused aluminum/silicon coating. Reference Figure 13 for energy dispersive X-ray (EDX) analysis of the coating.

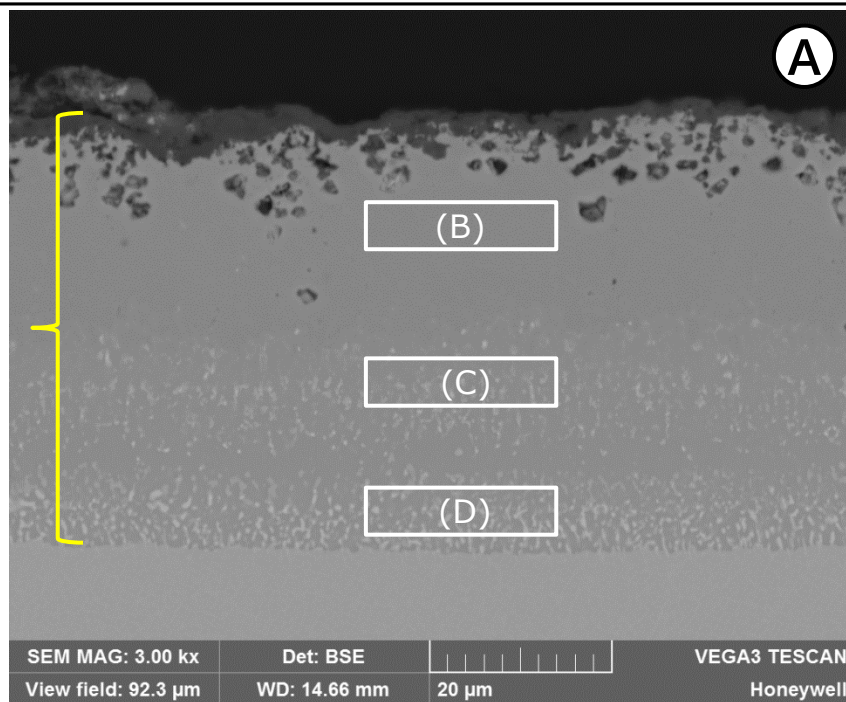
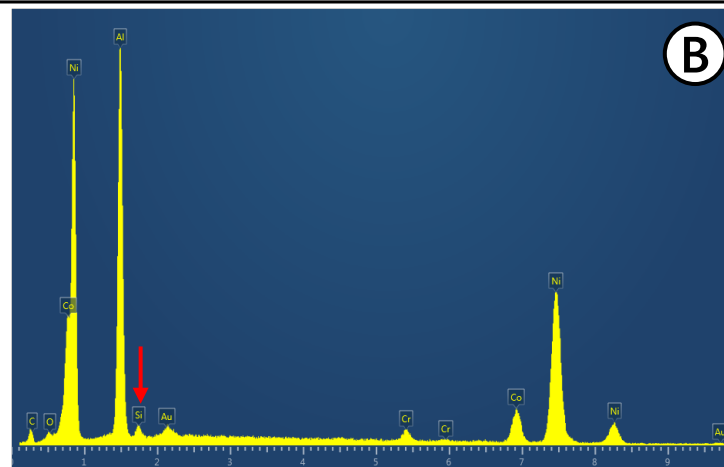
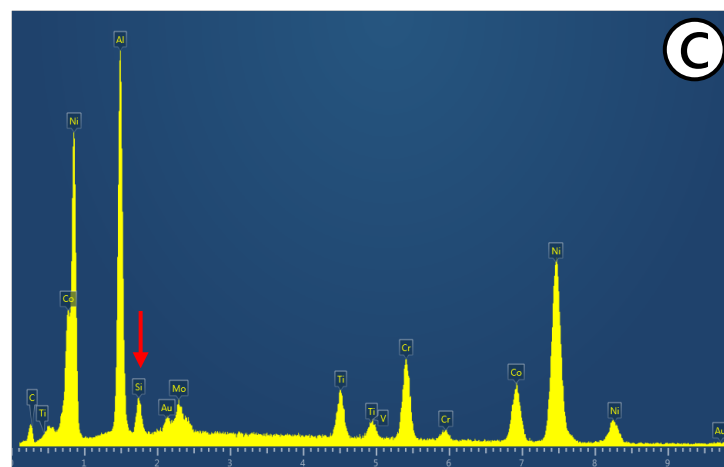
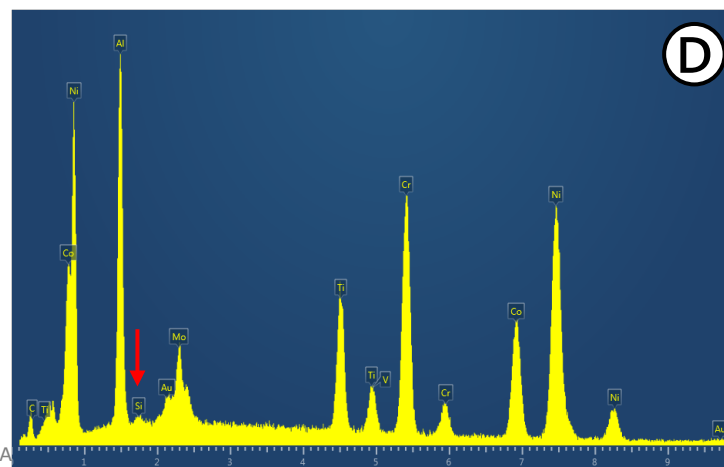
**Figure 13.**

(A) BSE SEM image showing the coating (yellow bracket) in Blade 1 at the platform (reference Figure 12). (B-D) EDX spectra produced from analysis of the areas outlined in (A). The silicon content in the spectra (red arrows) suggested that the coating applied was a diffused aluminum/silicon coating. Note that the gold (Au) peaks in the spectra resulted from the sputter coating applied for SEM conductivity purposes.

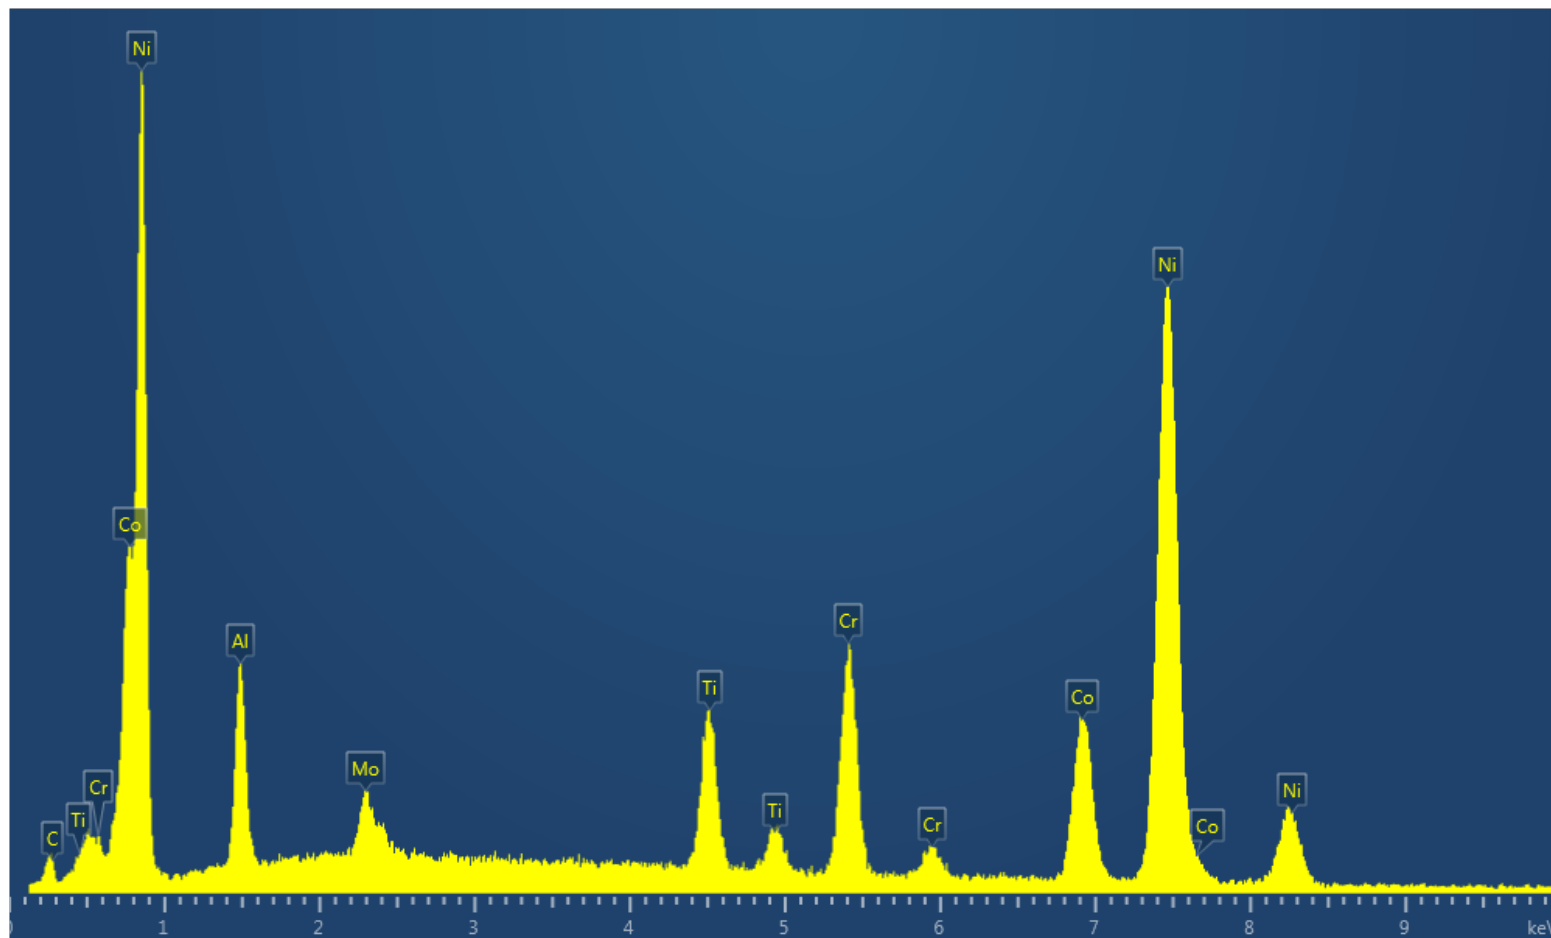
**Figure 14.**

The base material of Blade 1 was indicative of the specified IN100 material, as determined by EDX analysis (Figure 14).

The IN100 blade base material and the aluminum/silicon coating would indicate that the Blade 1 part number was likely 3101512-10.

Representative EDX spectrum produced from analysis of the Blade 1 base material. The spectrum was indicative of a nickel base alloy similar to the specified IN100 base material.

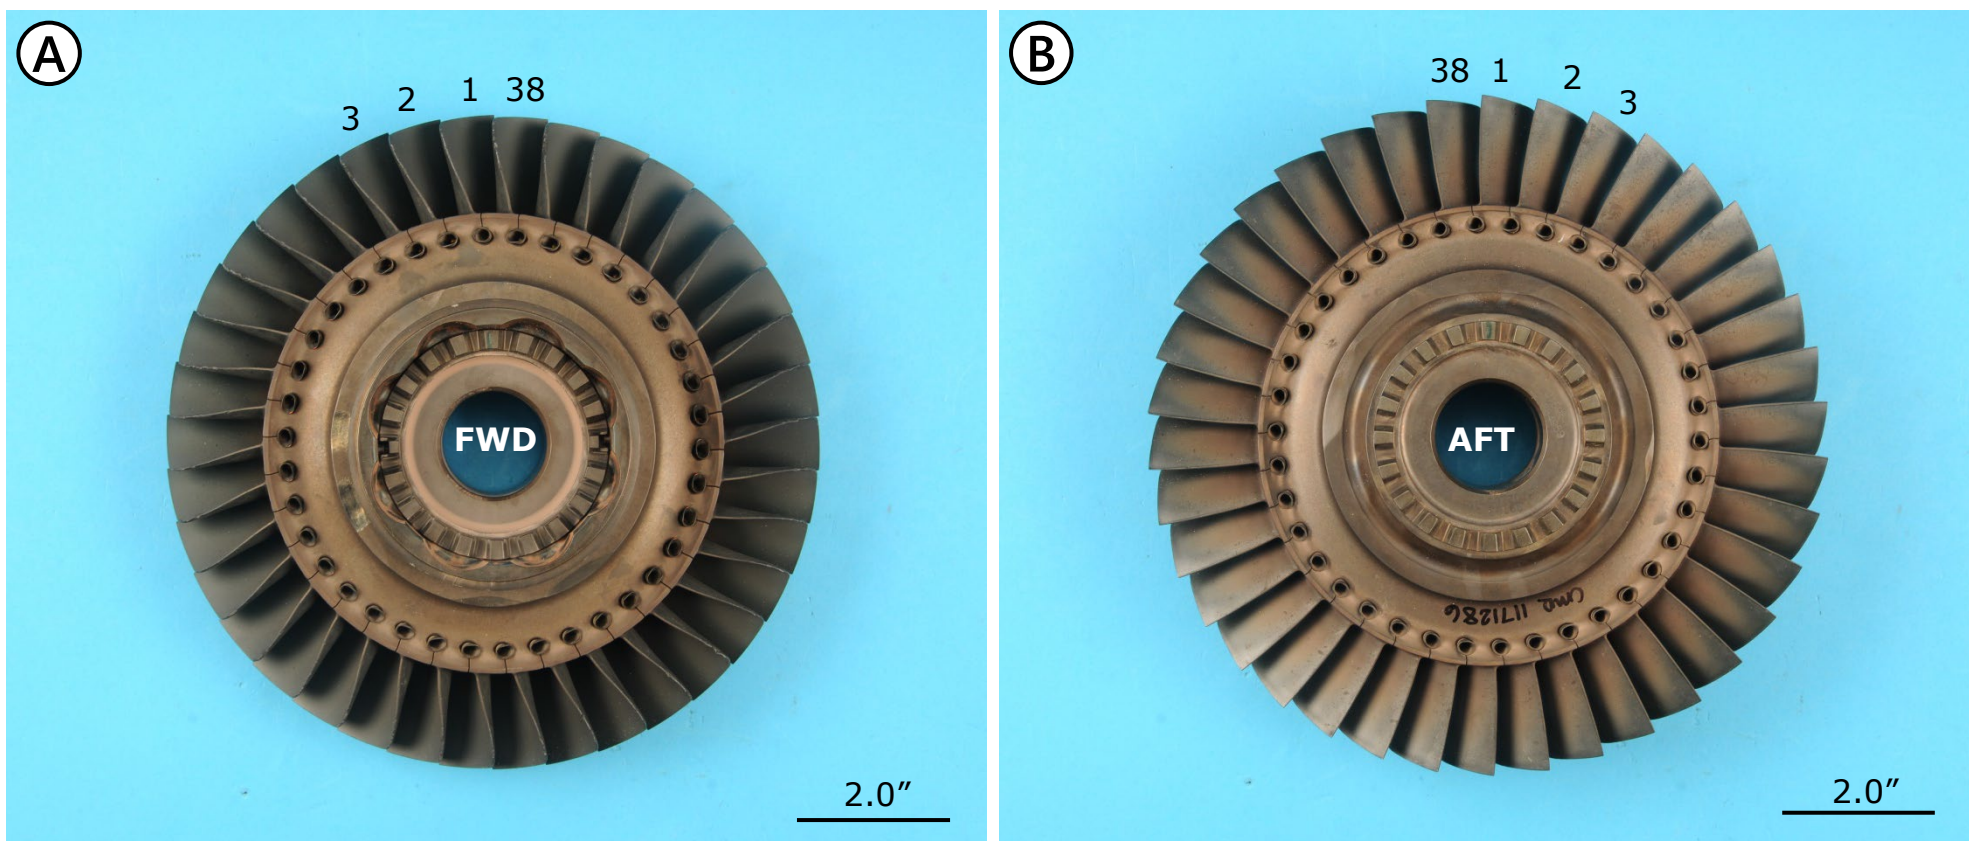
**Figure 15.**

Images showing the (A) forward and (B) aft sides of the 2<sup>nd</sup> stage turbine rotor (P/N 3102106-10) from TPE331-10UA-511G engine S/N P54128, in the as-received condition. For the purposes of this report, the blades were numbered 1-38 in the clockwise direction aft looking forward with Blade 1 aligned with the high curvic. Close-up images of the blades are shown in Figure 16. Blades 1 and 19 were removed for analysis and are shown in Figure 17.

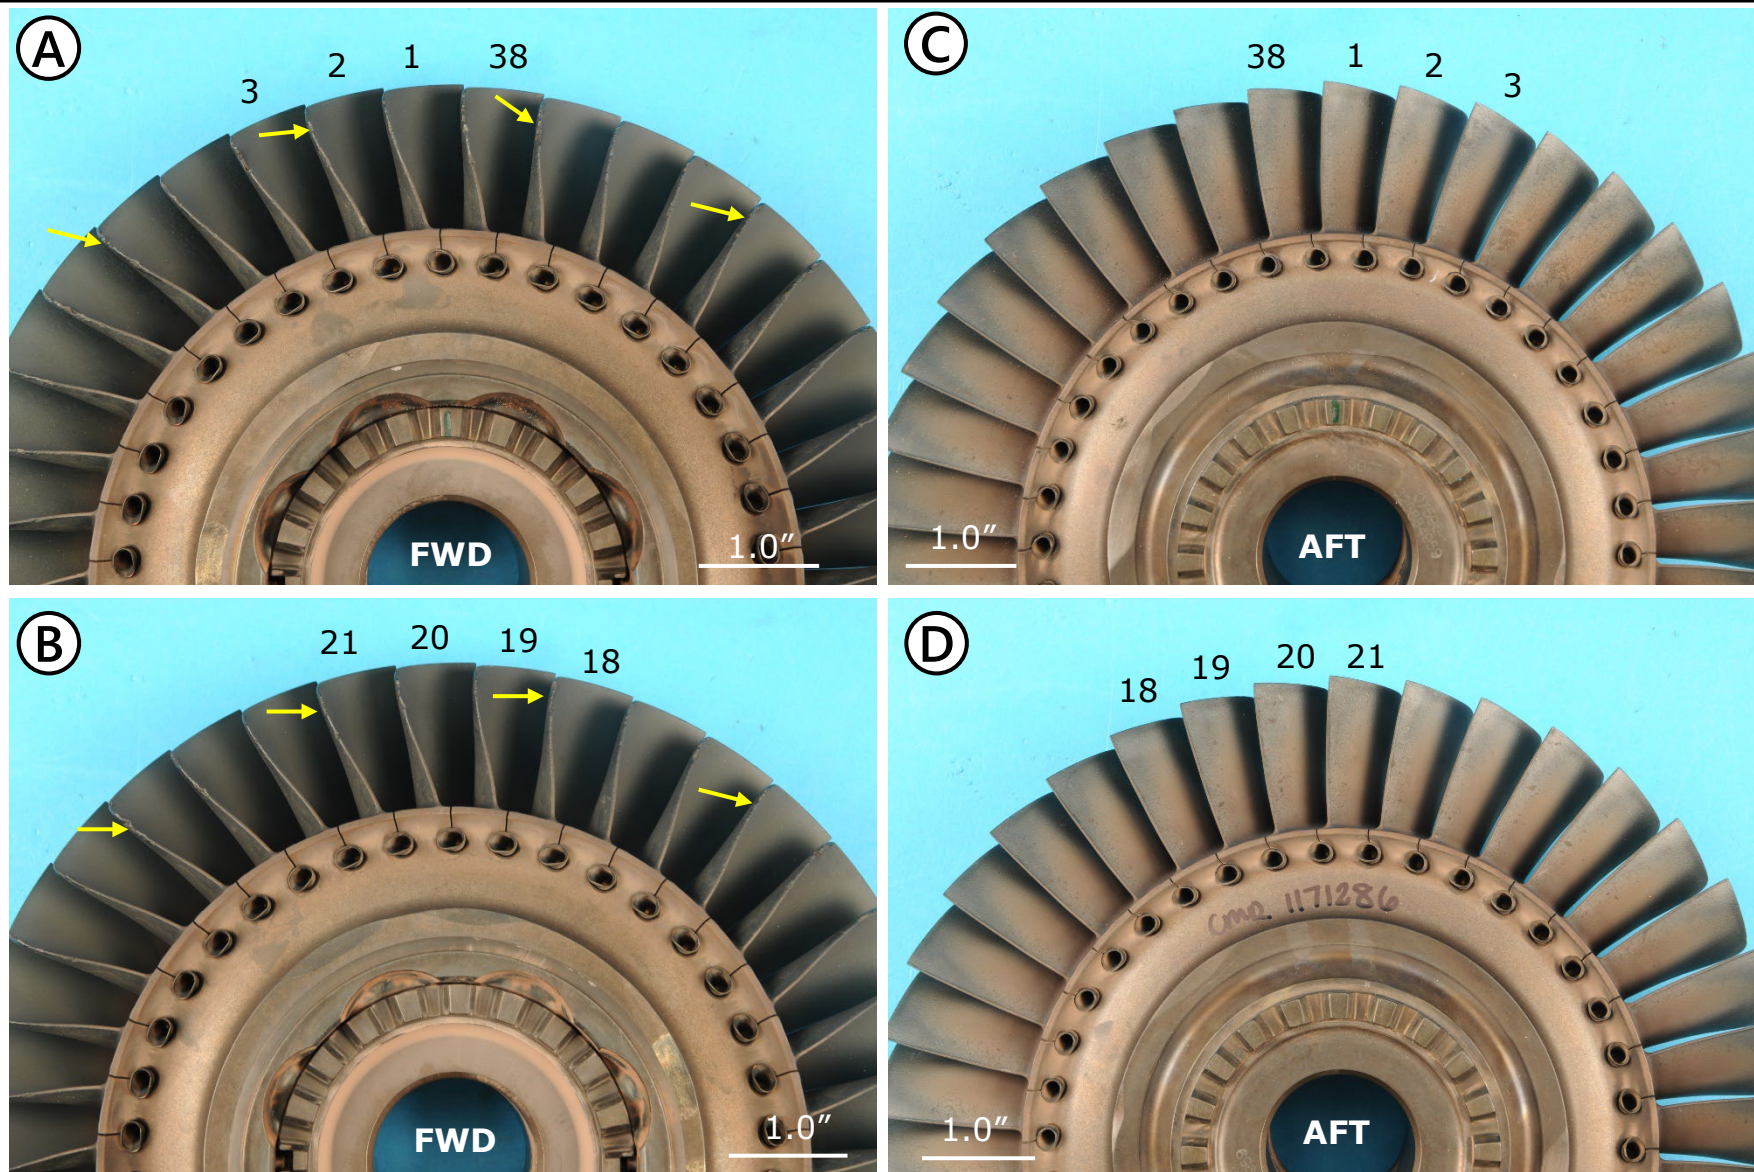
**Figure 16.**

The 2<sup>nd</sup> stage turbine rotor was submitted for comparison purposes (Figures 15-16). Damage was observed on the leading edges of the blades the tips. No blade separations were observed on the 2<sup>nd</sup> stage blades. For the purposes of this report, the blades were numbered 1-38 in the clockwise direction, aft looking forward, with Blade 1 aligned with the high curvic.

Close-up images of the (A-B) forward and (C-D) aft sides of the 2<sup>nd</sup> stage turbine rotor. No blade separations were observed. Damage was observed on the leading edges of the blades near the tips (yellow arrows in (A-B)).

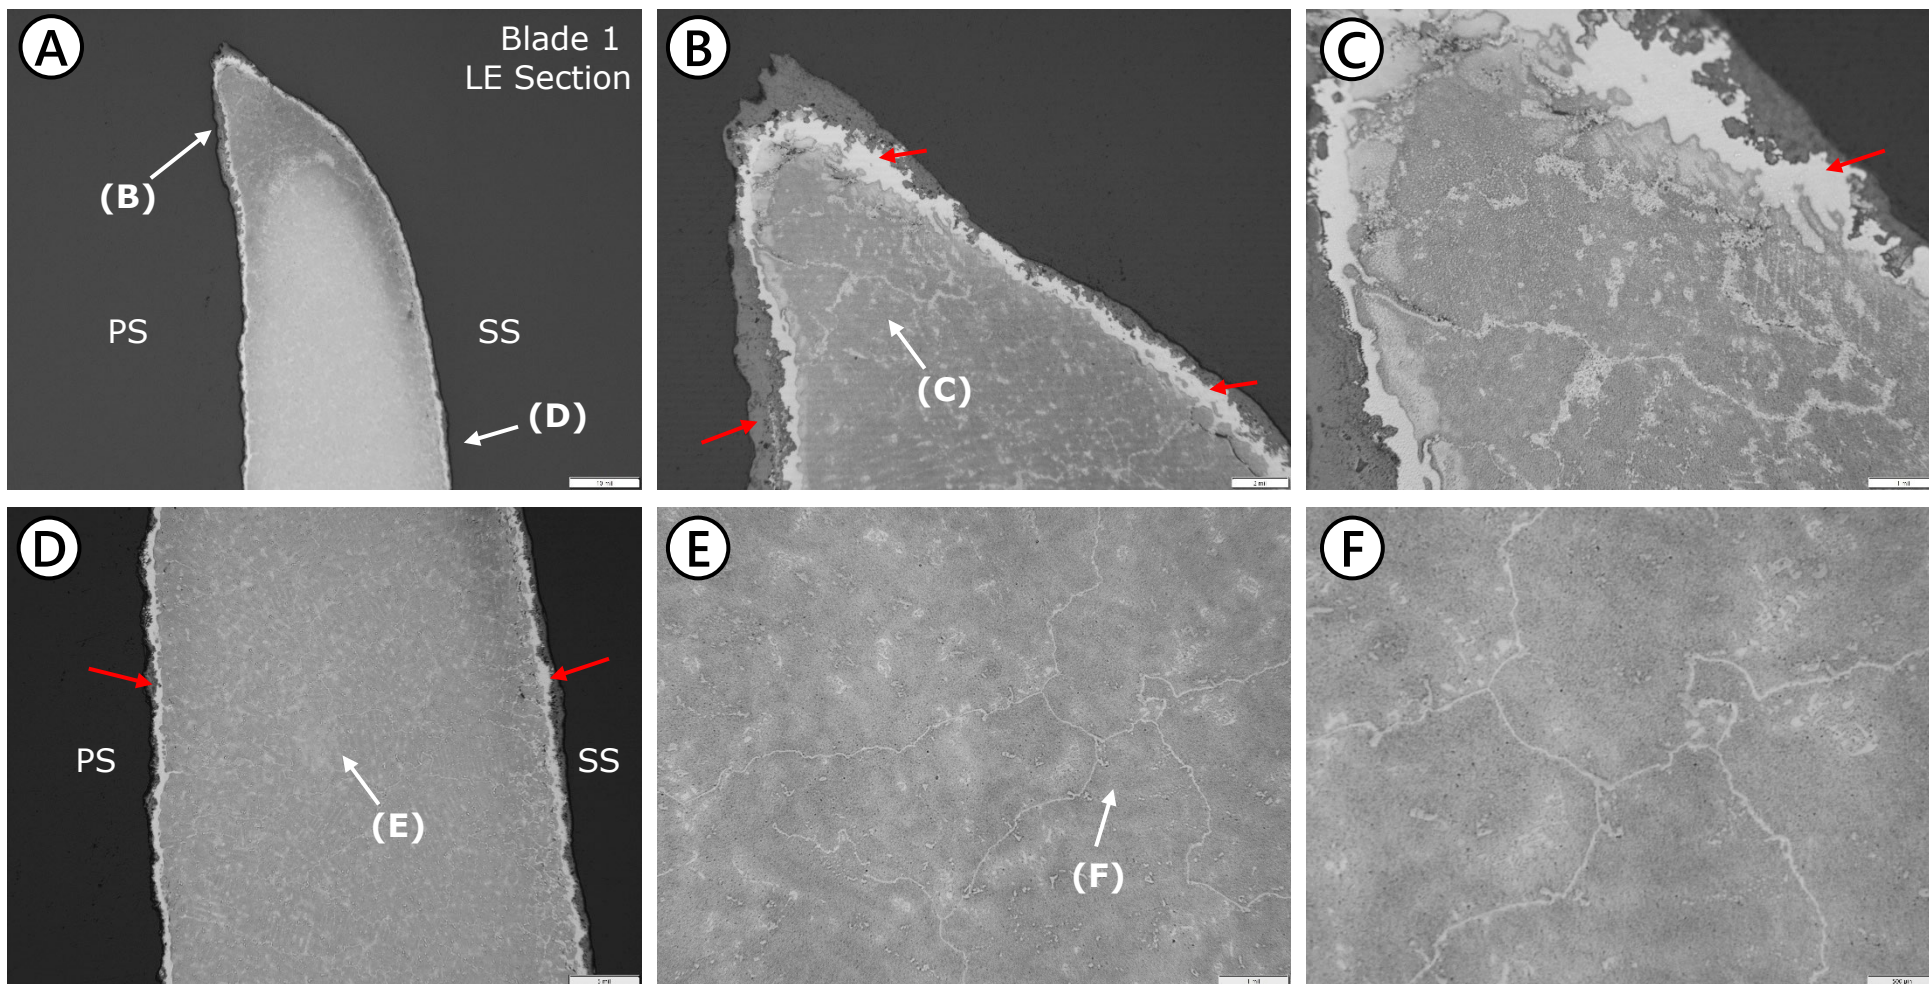
**Figure 18.**

at the blade tips, pressure, and suction sides of the blades. Resolution of the gamma prime phase was observed in the cross sections analyzed. In comparison to heat treat standards for uncoated Mar-M247 at 1, 10, 100, and 1000 hours of exposure, the microstructural features of Blades 1 and 19 suggested exposures to metal temperatures near 2200°F over a period of time between 10 and 100 hours.

(A-F) Cross section prepared through the Blade 1 leading edge of the 2<sup>nd</sup> stage turbine rotor (reference Figure 17A). Oxidation and alloy depletion were observed on the blade tip and pressure and suction sides (red arrows in (B-D)). The resolution of the gamma prime was indicative of exposures to metal temperatures near 2200°F over a period of time between 10 and 100 hours. .  
Etchant: 10% Oxalic acid, electrolytic.

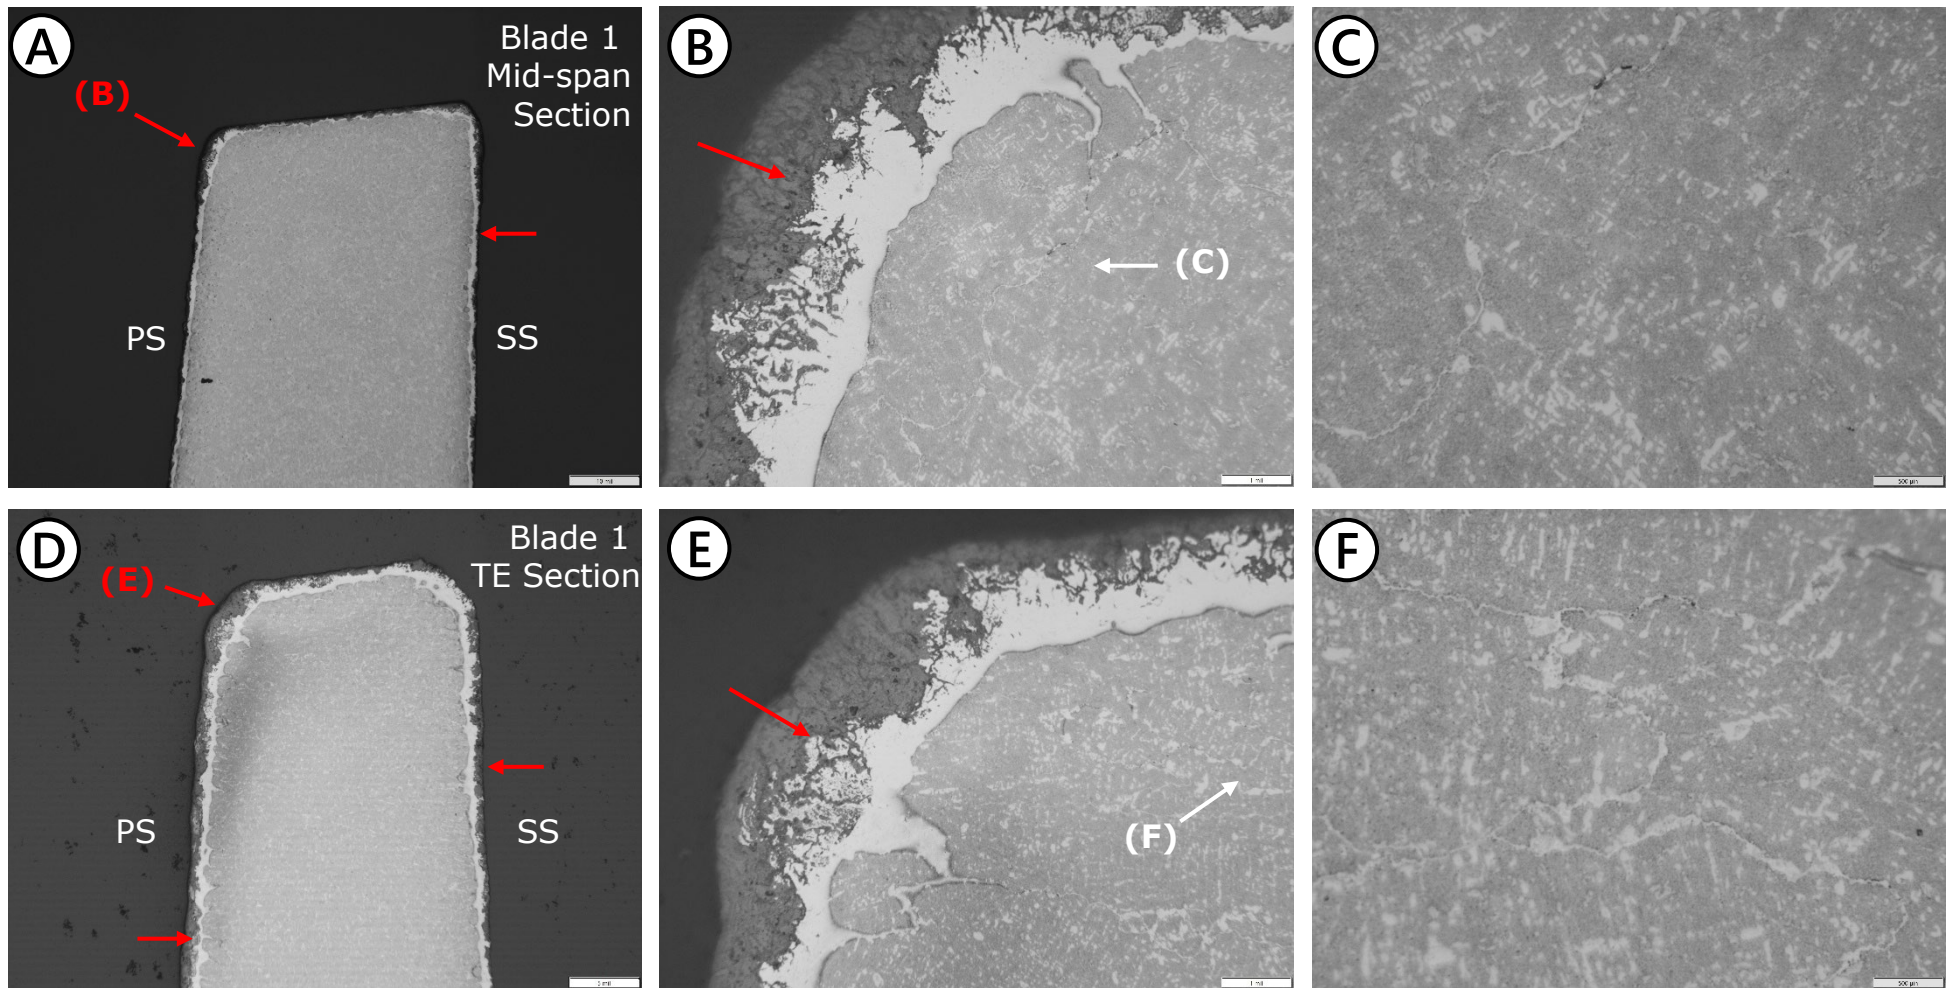
**Figure 19.**

(A-F) Cross sections prepared through the (A-C) midspan and (D-F) trailing edge of Blade 1 from the 2<sup>nd</sup> stage turbine rotor (reference Figure 17A). Oxidation and alloy depletion were observed on the blade tip and pressure and suction sides (red arrows in (A-B) and (D-E)). The resolutioning of the gamma prime was indicative of exposures to metal temperatures near 2200°F over a period of time between 10 and 100 hours. Etchant: 10% Oxalic acid, electrolytic.

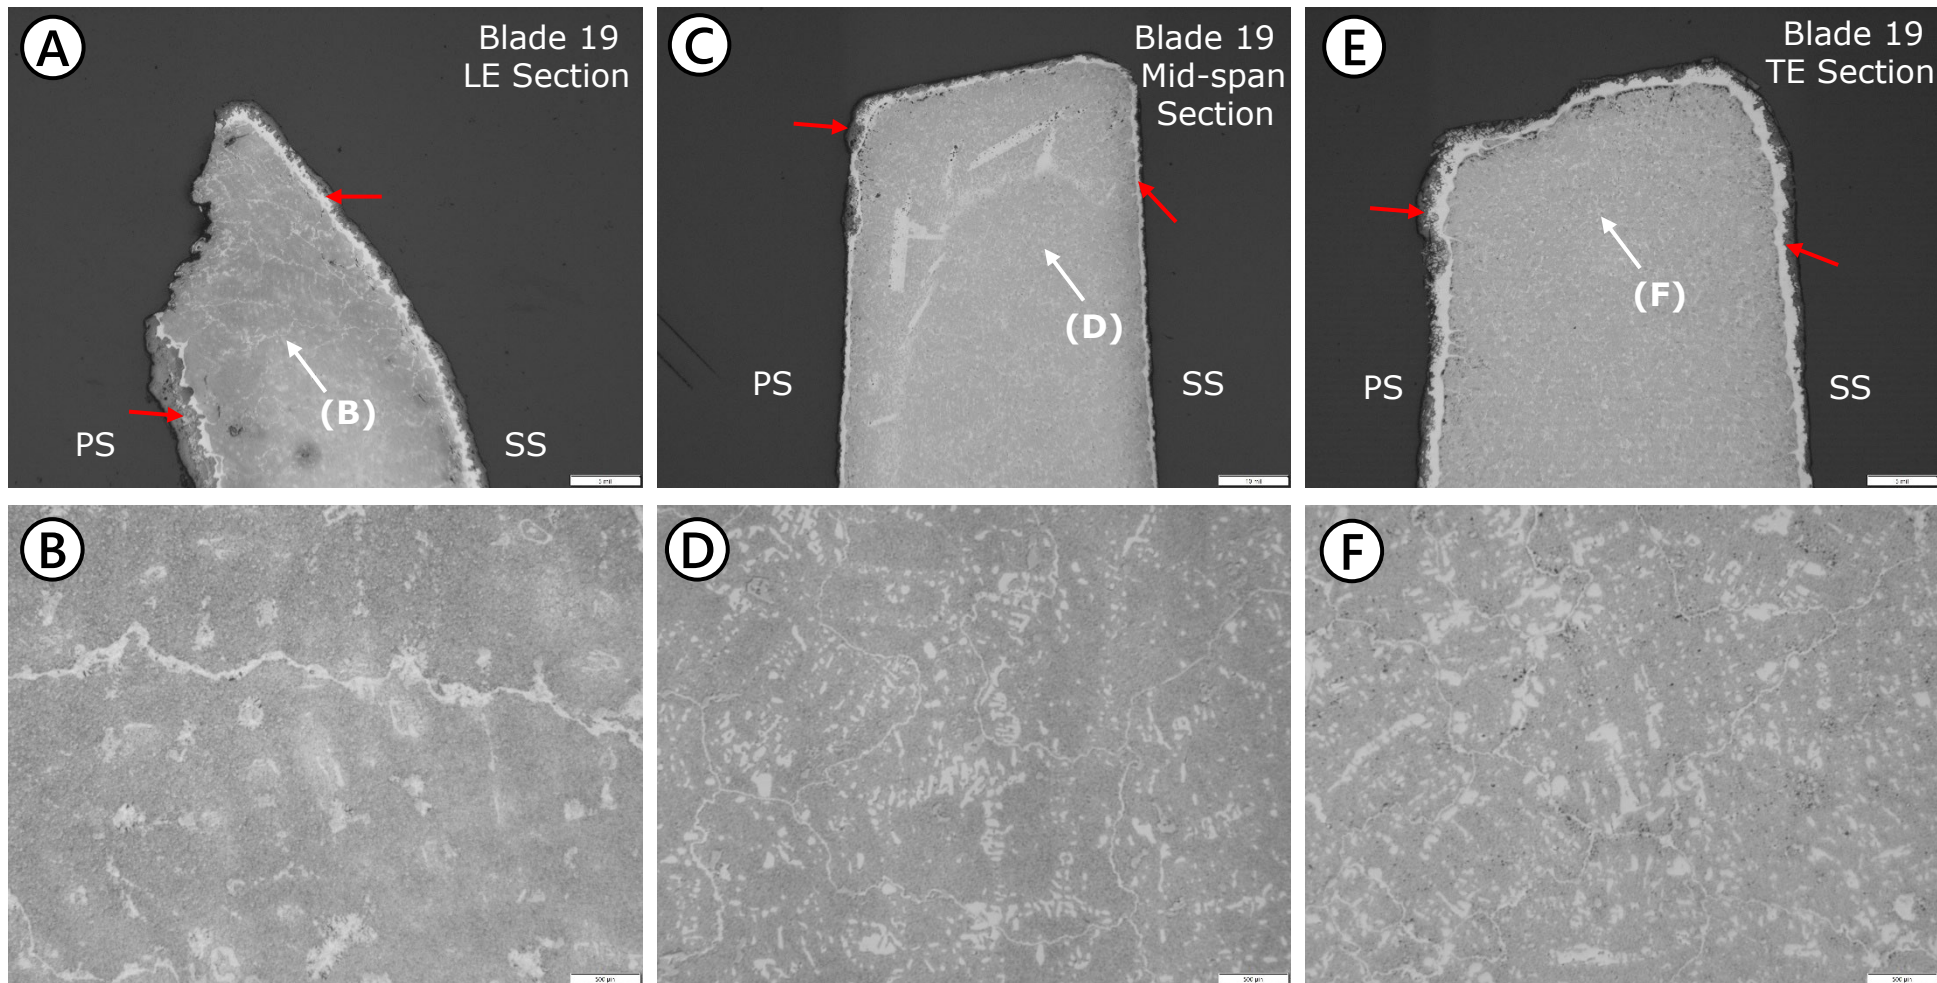
**Figure 20.**

Cross sections prepared through the (A-B) leading edge, (C-D) midspan, and (E-F) trailing edge of Blade 19 from the 2<sup>nd</sup> stage turbine rotor (reference Figure 17C). Oxidation and alloy depletion were observed on the blade tip and pressure and suction sides (red arrows in (A), (C), and (E)). The resolution of the gamma prime was indicative of exposures to metal temperatures near 2200°F over a period of time between 10 and 100 hours.

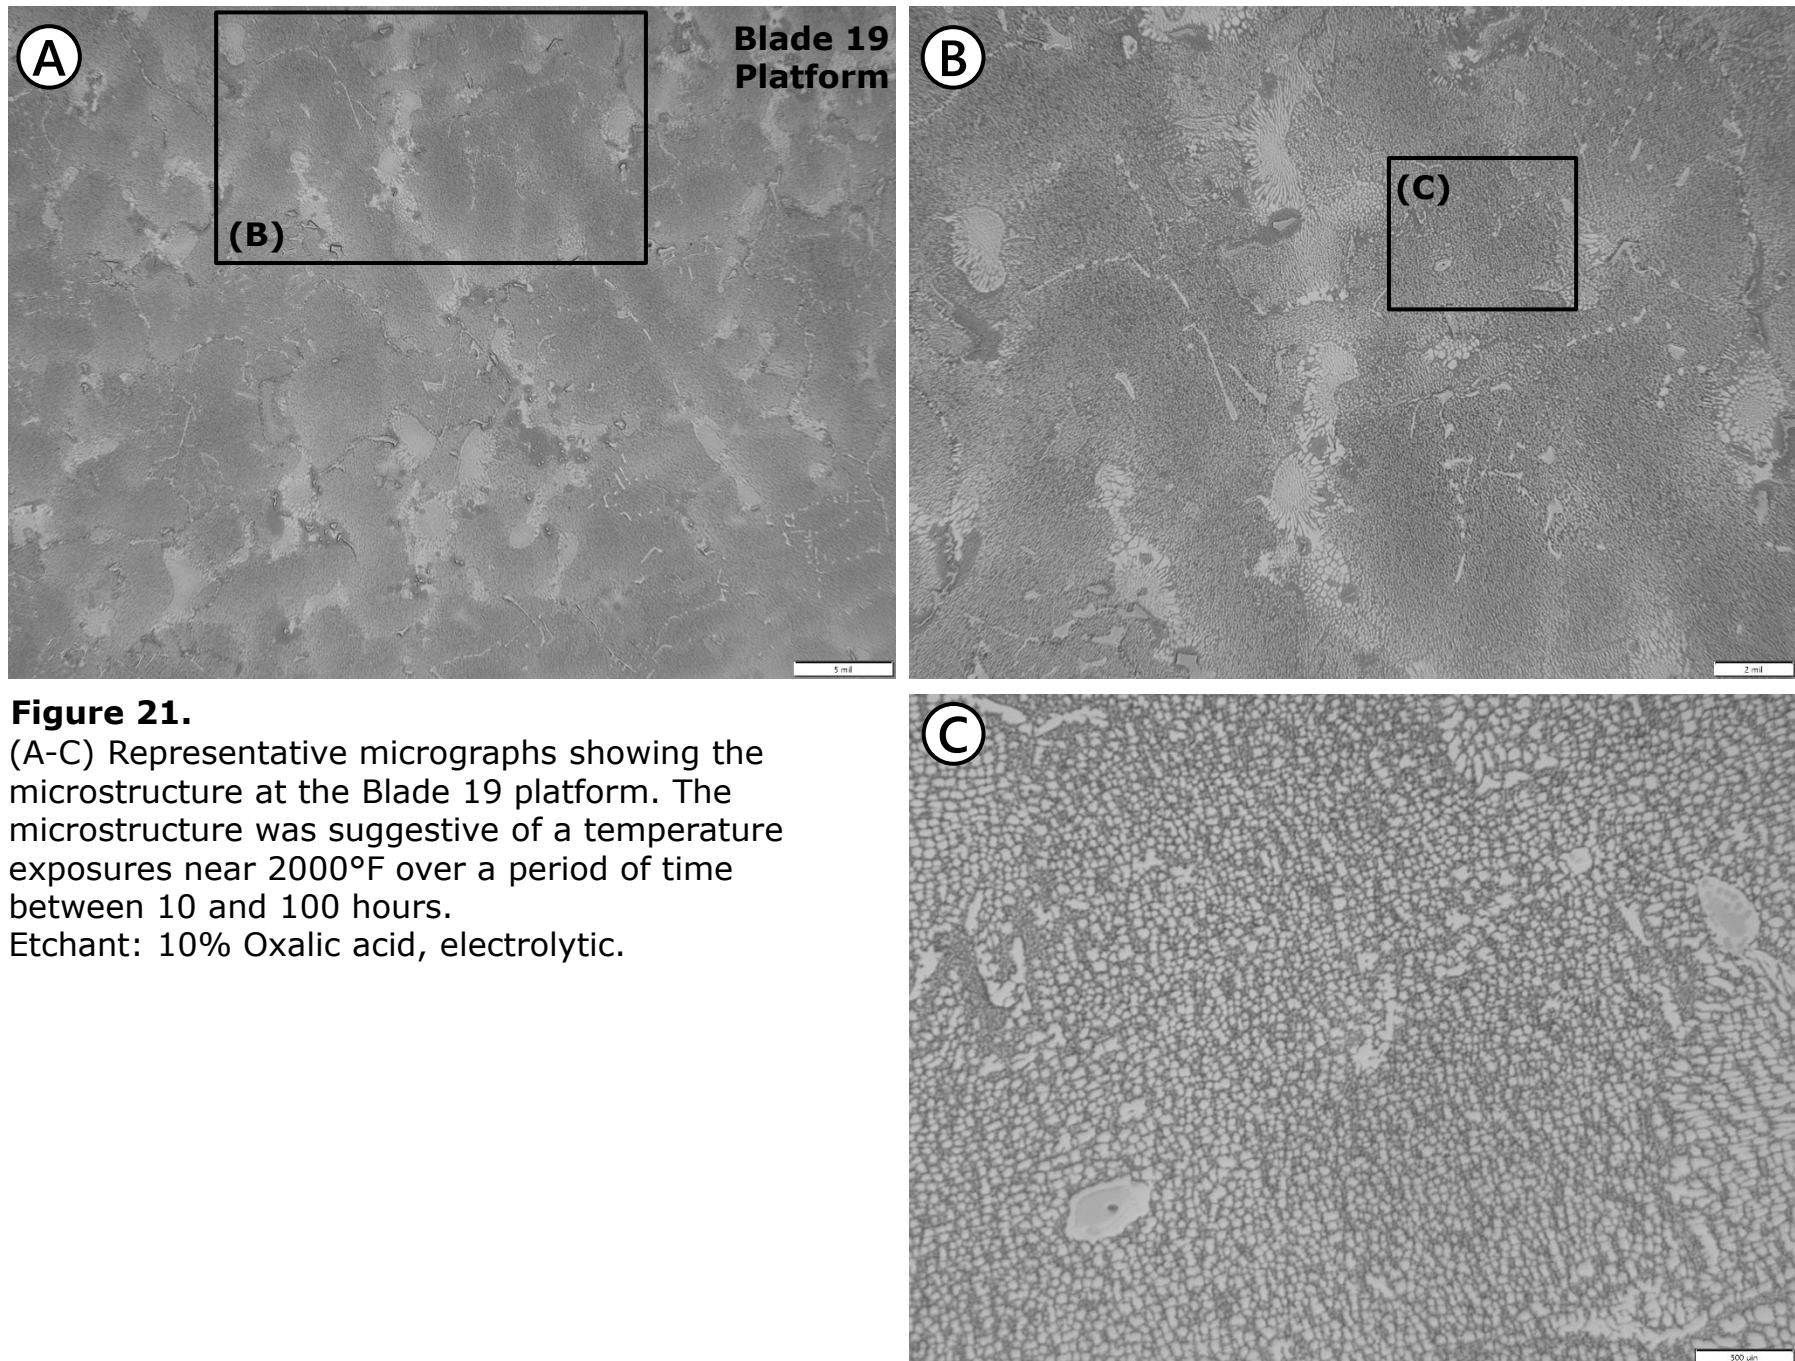
**Figure 21.**

Evaluation of the Blade 19 microstructure near the platform was indicative of a temperature exposure near 2000°F over a period of time between 10 and 100 hours (Figure 21).

(A-C) Representative micrographs showing the microstructure at the Blade 19 platform. The microstructure was suggestive of a temperature exposures near 2000°F over a period of time between 10 and 100 hours.

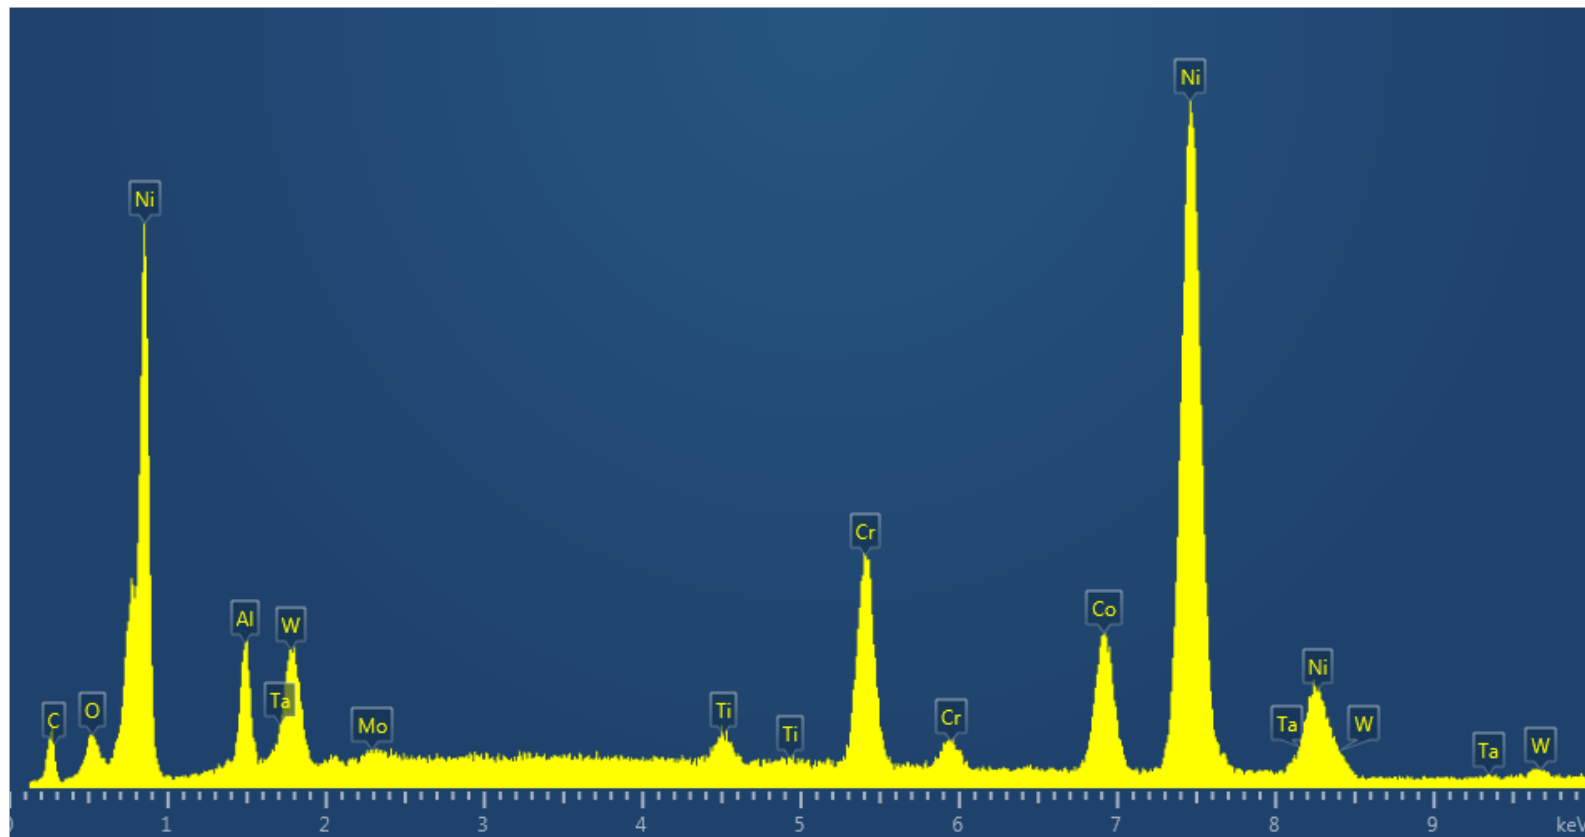
EDX analysis of the base material of the 2<sup>nd</sup> stage turbine rotor blades revealed a nickel alloy similar to the specified Mar-M247 base material (Figure 22).

**Figure 22.**  
Representative EDX spectrum produced from analysis of the 2<sup>nd</sup> stage turbine rotor blades. The spectrum was indicative of a nickel base alloy similar to the specified Mar-M247 base material.
