ERA22FA086

Group Chair's Factual Report - Attachment # 3

Honeywell Materials Laboratory Report, Engine Serial Number, P54128

Conduct investigation of the separated turbine blade, Blade 1, from the 1<sup>st</sup> stage rotor assembly P/N 3107080-1, S/N 3-03501-1120.

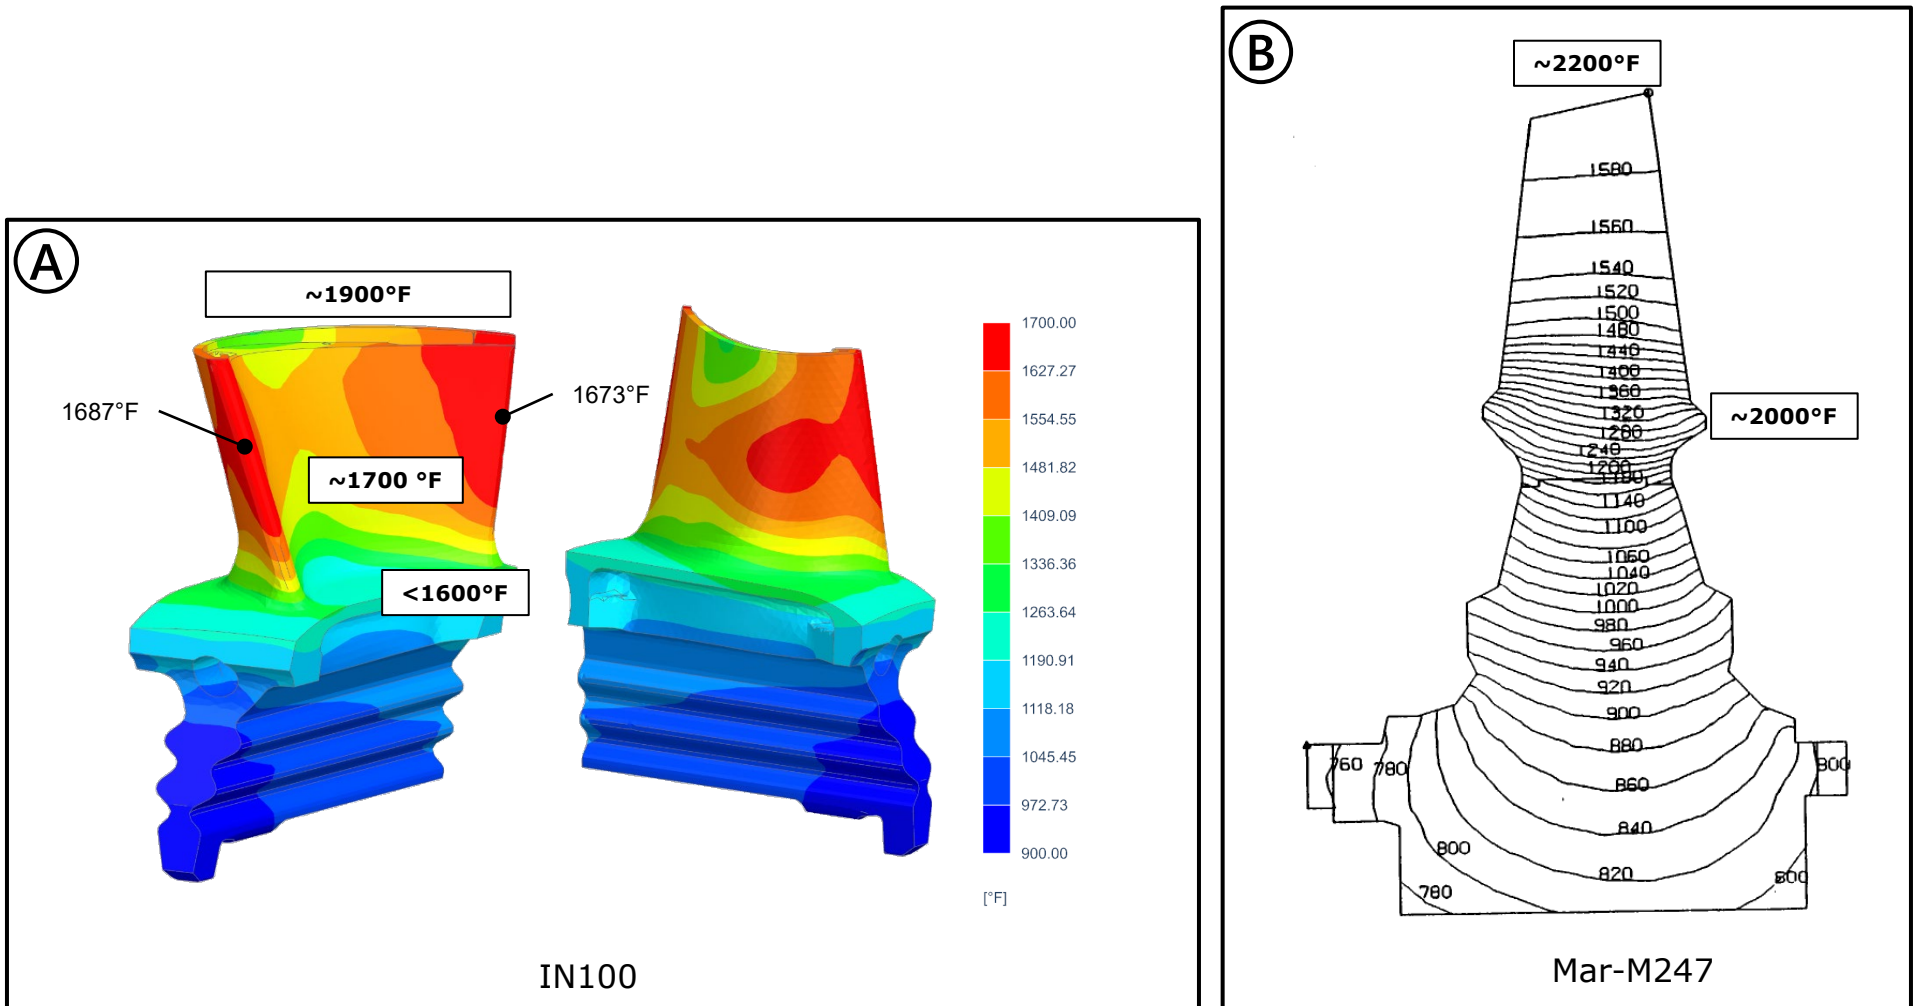
**Figure 23.**

Diagrams showing the thermal models for the 1<sup>st</sup> stage blade and 2<sup>nd</sup> stage rotor at steady state conditions are shown in Figure 23. The 1<sup>st</sup> stage blade exhibited ~200°F difference in the measured airfoil temperatures compared to the thermal model. The 2<sup>nd</sup> stage blade exhibited ~600°F difference in the measured airfoil temperatures compared to the thermal model.

Diagrams showing the thermal models for the (A) 1<sup>st</sup> stage blade and (B) 2<sup>nd</sup> stage rotor at steady state conditions. The white boxes outlined the temperature estimates performed on the approximate locations of the blades analyzed (e.g. platform, mid-span, and tips). The 1<sup>st</sup> stage blade exhibited ~200°F difference in the measured airfoil temperatures compared to the thermal model. The 2<sup>nd</sup> stage blade exhibited ~600°F difference in the measured airfoil temperatures compared to the thermal model.
