ERA22FA086

Group Chair's Factual Report - Attachment # 6

Honeywell Materials Laboratory Report, Engine Serial Number P54133

Determine the fracture mode of the submitted coupling shaft (P/N 894119-1) from TPE331 engine S/N P54133.

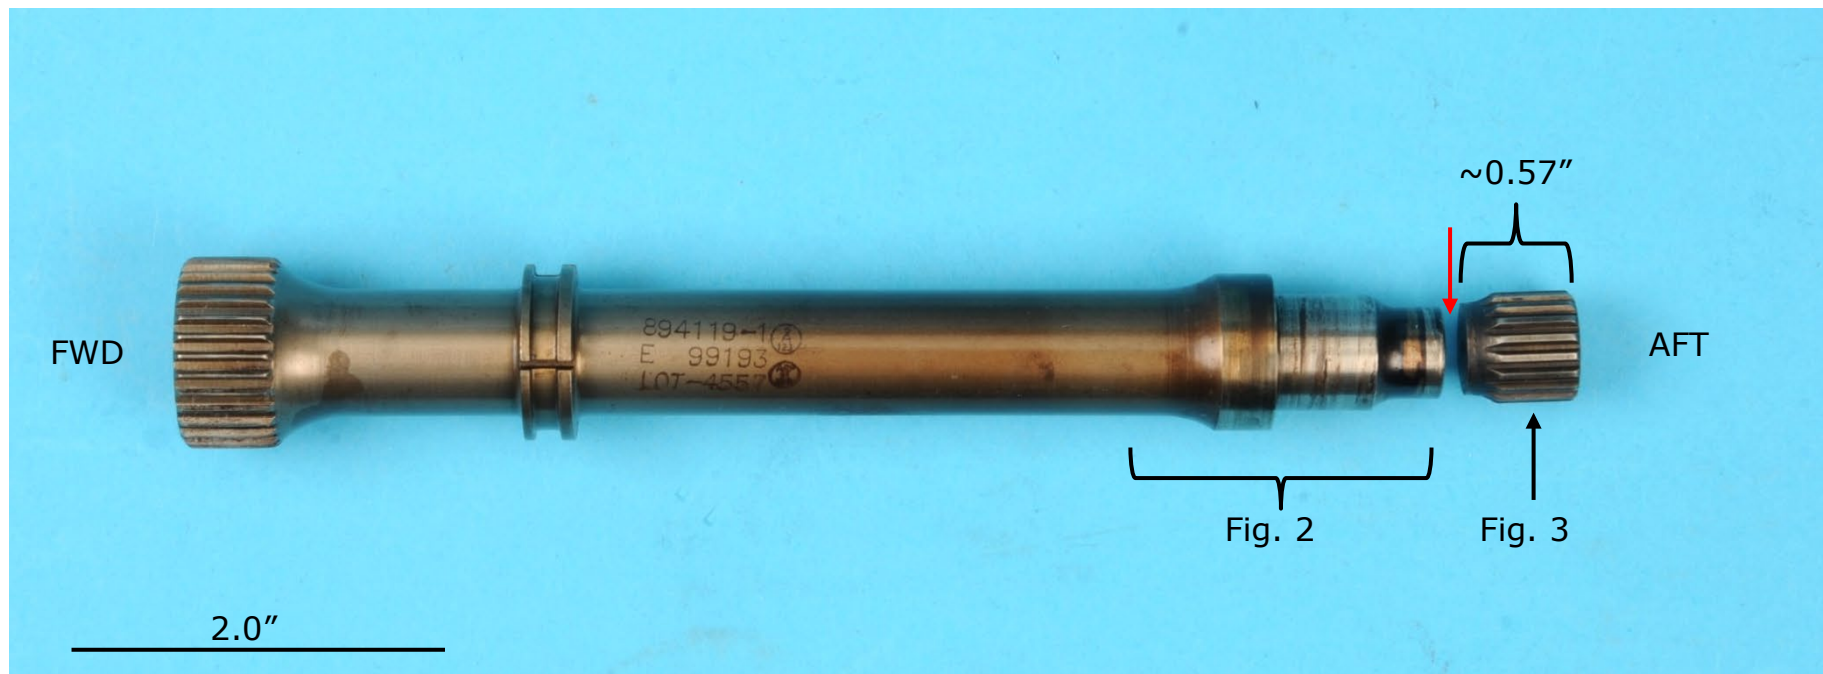
**Figure 1.**

The coupling shaft (Lot Number 4557) from TPE331 engine S/N P54133 had separated approximately 0.57" from the aft end (Figure 1). The fracture surface of the separation was oriented normal to the shaft axis and was flat in appearance.

Overall image showing the as-received condition of the separated coupling shaft (P/N 894119-1, Lot Number 4557) from TPE331-10UA-511G engine S/N P54133. The coupling shaft had separated approximately 0.57" from the aft end (red arrow). Close-up images of the areas identified are shown in Figures 2-3.

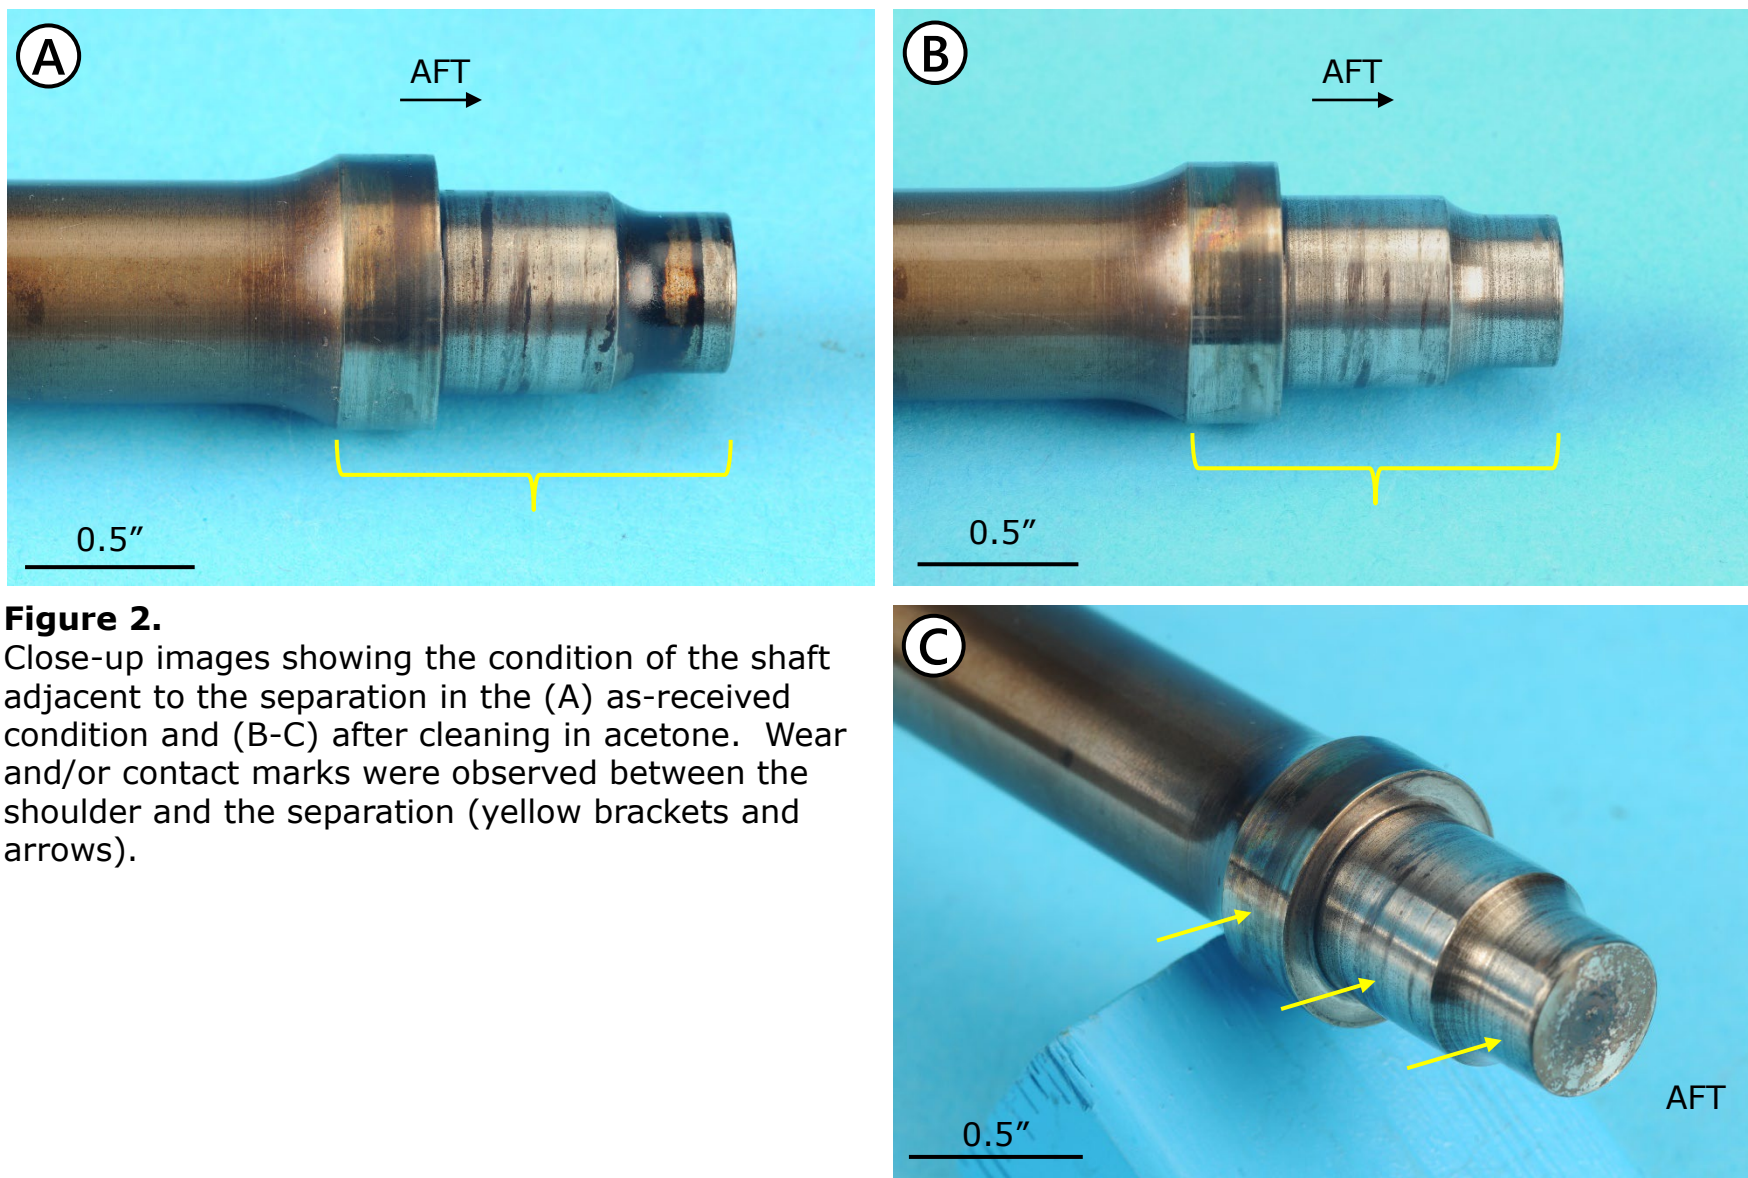
**Figure 2.**

Close-up images showing the condition of the shaft adjacent to the separation in the (A) as-received condition and (B-C) after cleaning in acetone. Wear and/or contact marks were observed between the shoulder and the separation (yellow brackets and arrows).

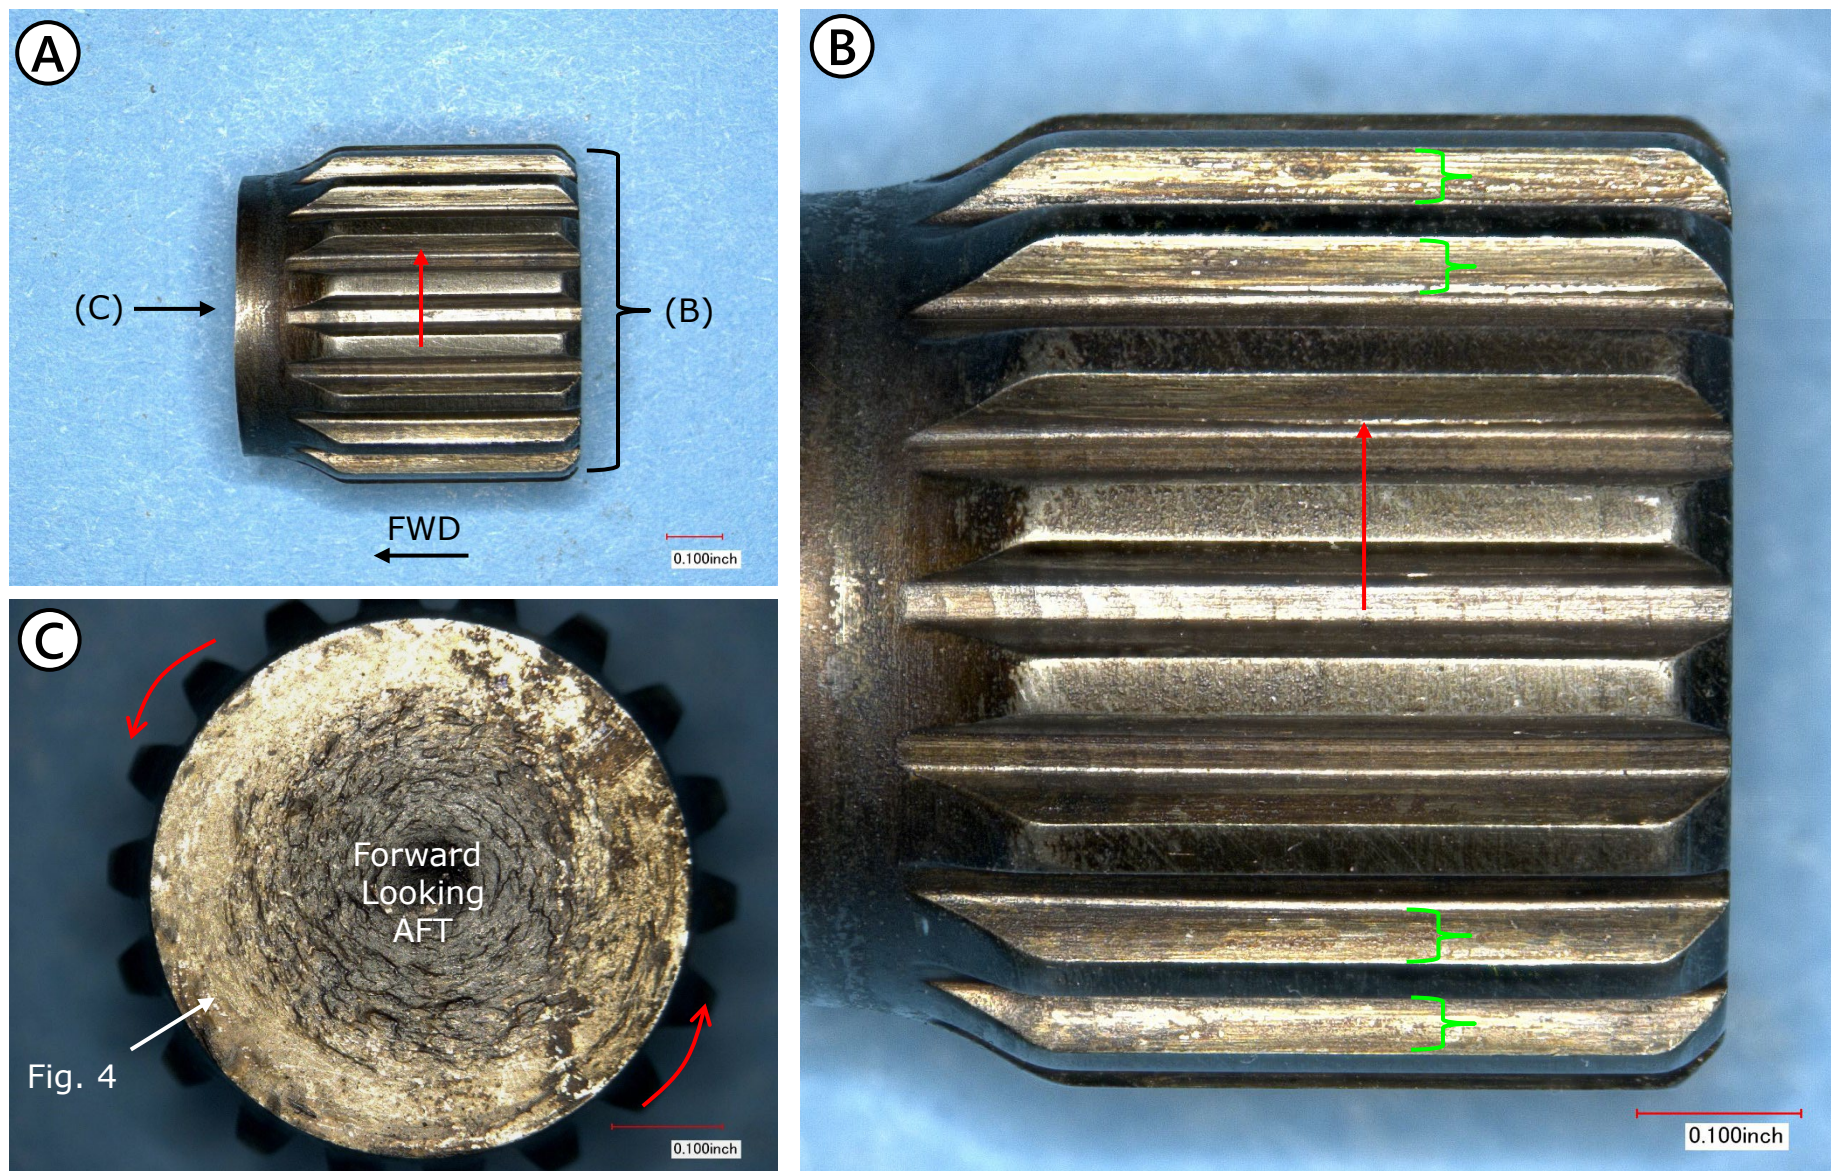
**Figure 3.**

Wear was observed between the shoulder and the separated aft end of the shaft (Figure 2). Contact/wear patterns were observed on both sides of the gear teeth from the aft end of the coupling shaft (green brackets in Figure 3B).

(A-C) Digital microscope images of the separated coupling shaft (reference Figure 1). The red arrows indicate the specified direction of shaft rotation within the engine (counterclockwise, forward looking aft (FLA)). Wear was observed on both sides of the gear teeth (green brackets in (B)). Scanning electron microscope (SEM) images of the coupling shaft fracture surface are shown in Figure 4.

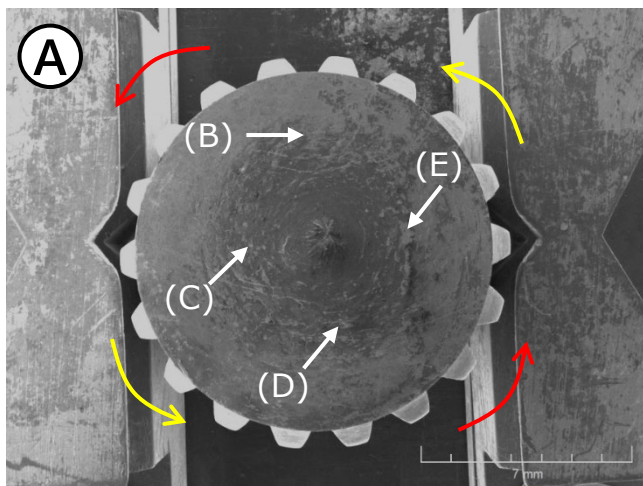
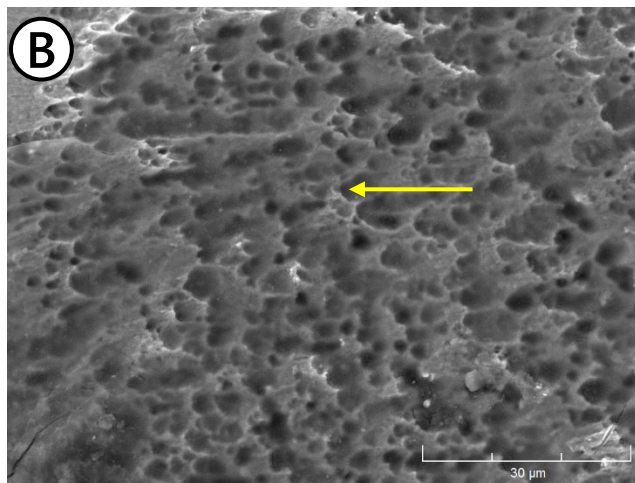
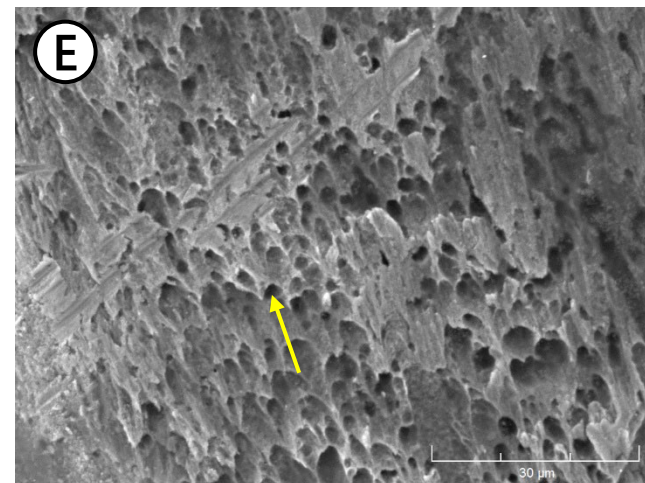
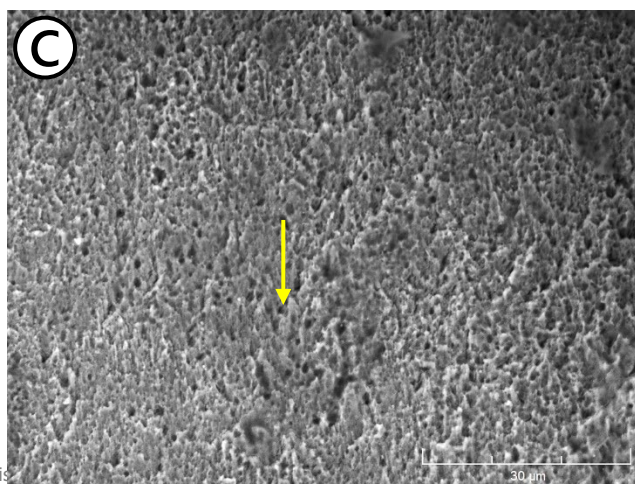
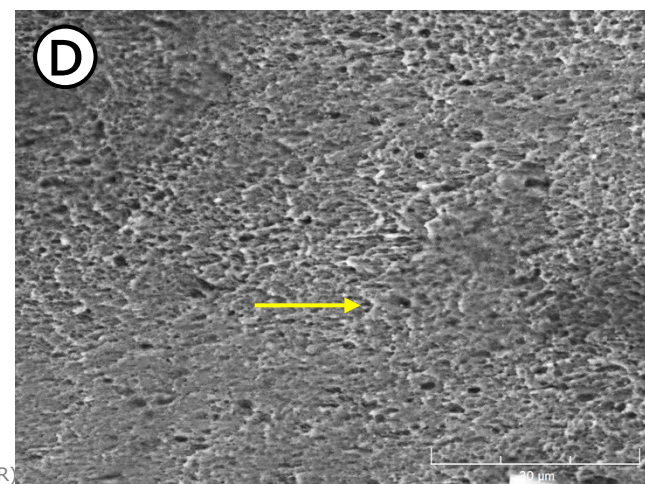
**Figure 4.**

- The separation of the coupling shaft was the result of torsional overload. Overload dimples were observed to be elongated in the counterclockwise direction (forward looking aft (FLA)), which indicated that the aft section separated as a result of torsional loading in the clockwise direction relative to the forward section.
- The base material of the coupling shaft was indicative of the specified H11 tool steel, as determined by energy dispersive X-ray (EDX) analysis.
- No further work was performed per customer request.
- See Findings.

The fracture surface of the coupling shaft was examined in the SEM and is shown in Figure 4. Most of the fracture features were obscured by smearing and secondary damage. In areas with less damage, overload dimples elongated in the counterclockwise direction (forward looking aft (FLA)) were observed, which indicated that the aft section of the coupling shaft had separated as a result of torsional loading in the clockwise direction relative to the forward section (aft looking forward (ALF)). The specified direction of rotation of the shaft was counterclockwise FLA.

(A-E) Secondary electron (SE) SEM images showing the fracture surface of the aft section of the separated coupling shaft (reference Figure 3C). Most of the fracture features were obscured by smearing and secondary damage. Fracture features indicative of torsional overload were observed in some locations, as indicated by the elongated dimples in the counterclockwise direction in (B-E). The yellow arrows indicate the direction of the rotation with respect to the mating fracture surface. The red arrows in (A) indicate the specified direction of the shaft rotation within the engine (counterclockwise FLA).

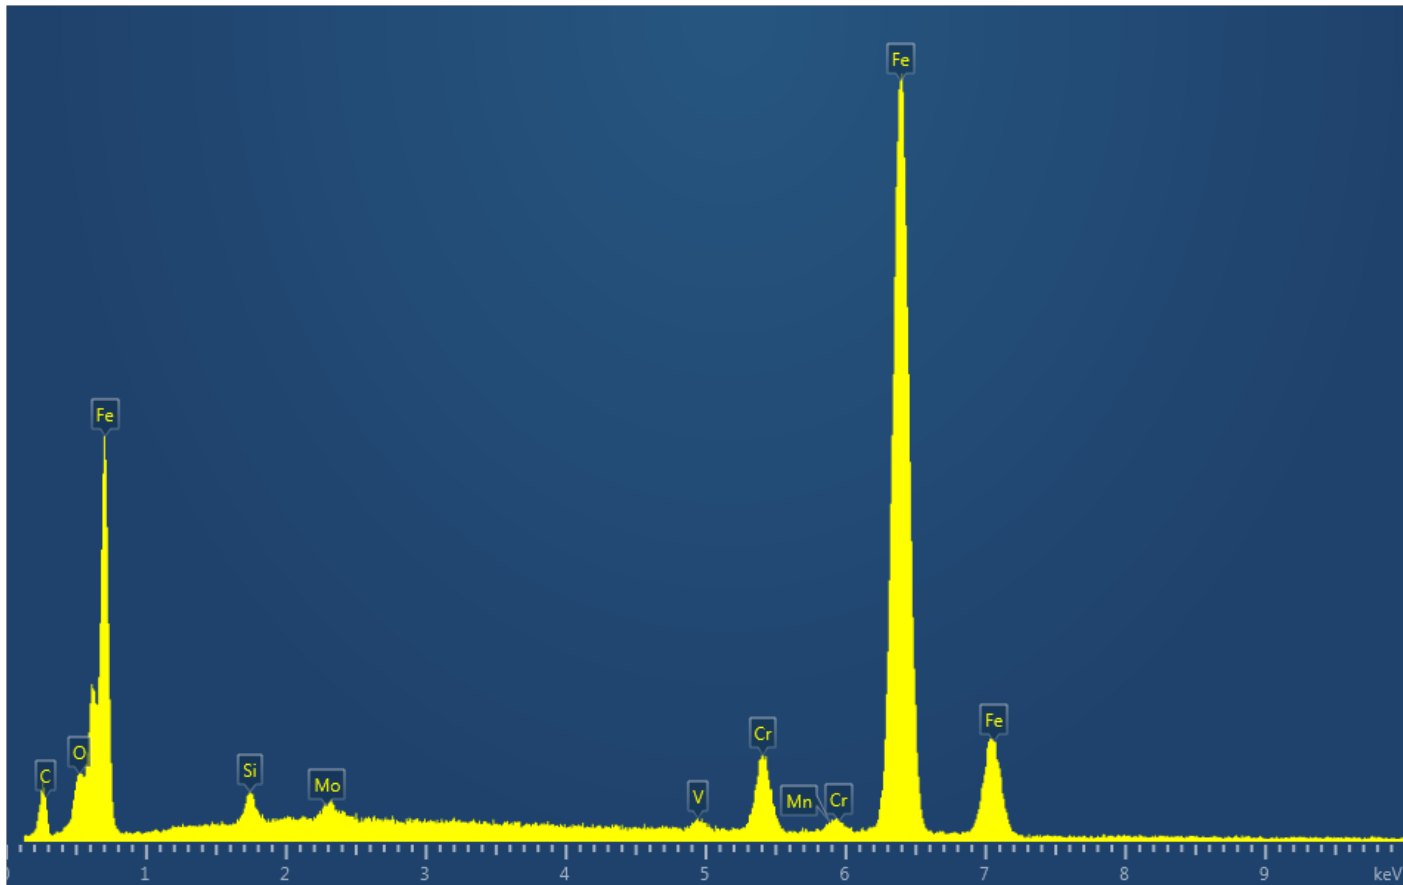
**Figure 5.**

EDX analysis of the coupling shaft produced a spectrum indicative of the specified H11 tool steel material (Figure 5).

Representative energy dispersive X-ray (EDX) spectrum produced from analysis of the coupling shaft base material. The spectrum was indicative of the specified H11 material.
