# National Transportation Safety Board

ERA22FA095

## **WRECKAGE EXAM**

Airplane: Mooney M20J, N3707H

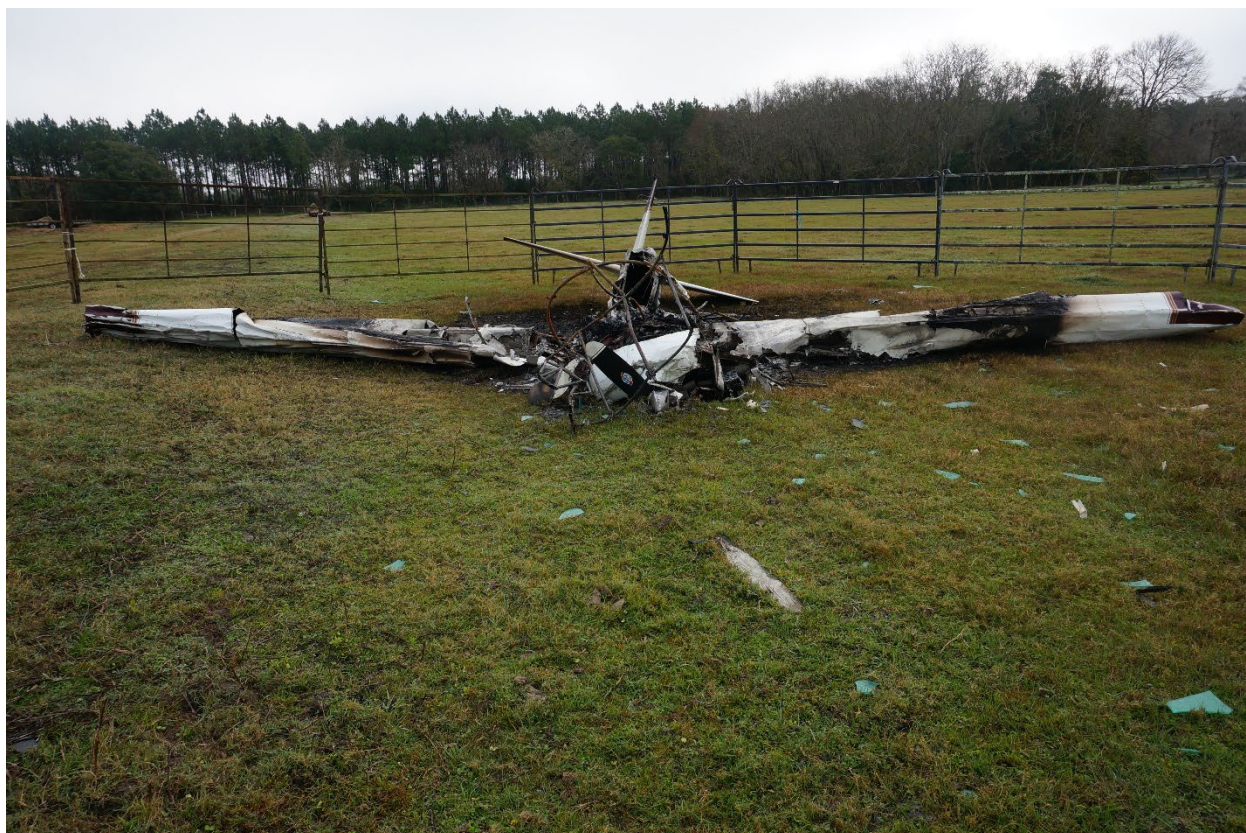
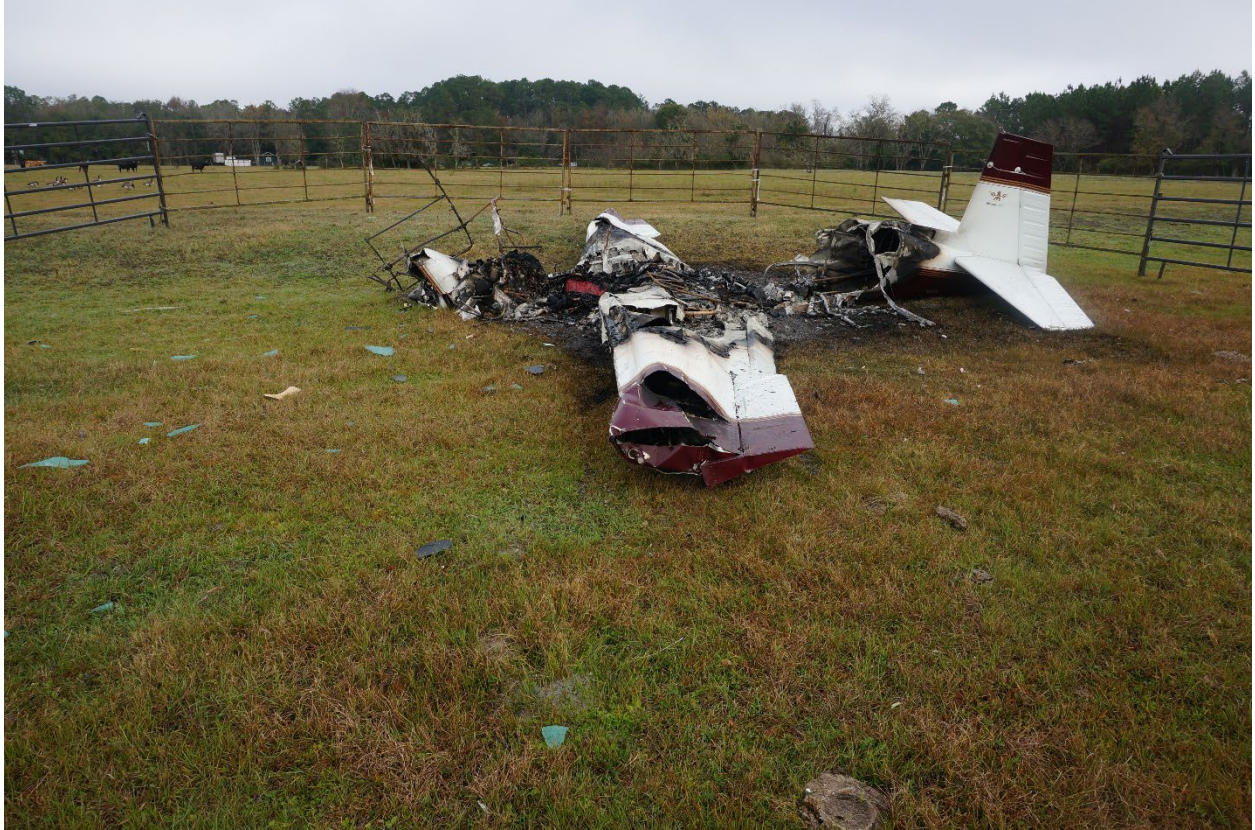
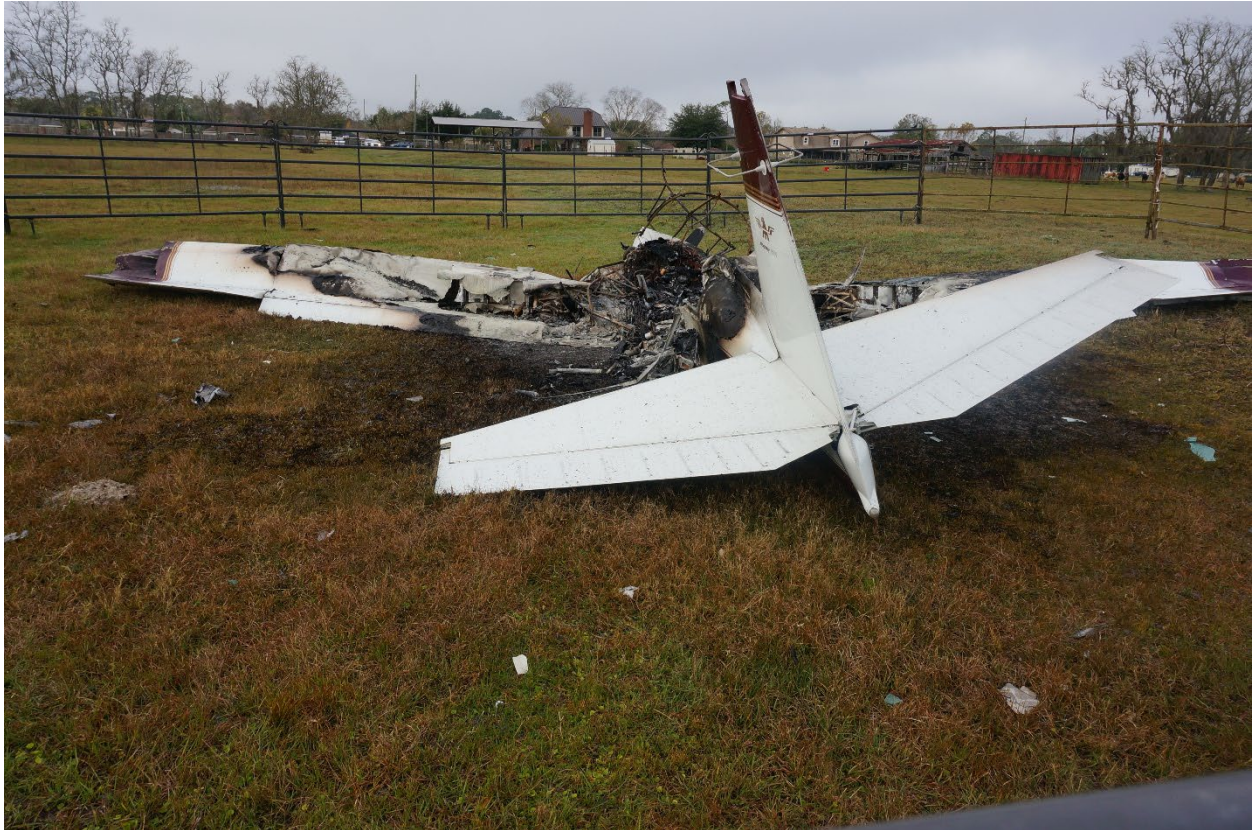
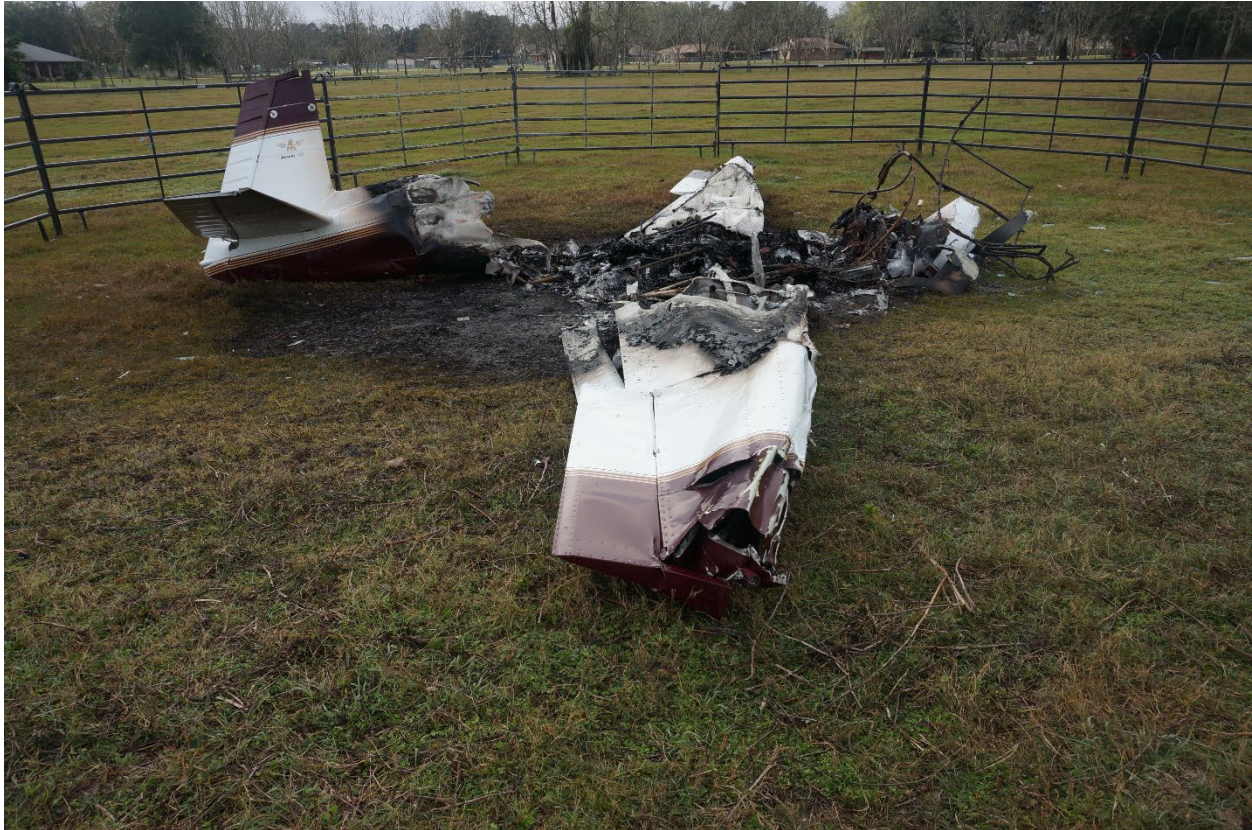
The fuselage section from just forward of the horizontal stabilizer to the engine cowling was largely consumed by fire. Both wings remained largely intact, although both sustained leading edge crush damage and significant fire damage from the root area to about the outboard edge of the flaps.

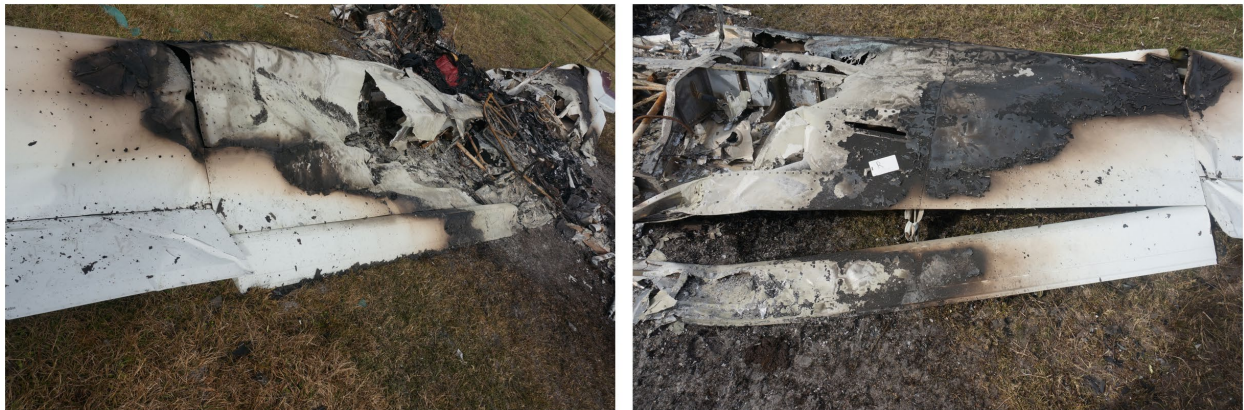
**Figure 5 - Flaps (Left) and (Right)**

Both flaps were partially separated from their hinge points, and the inboard ends of both flaps were partially melted.

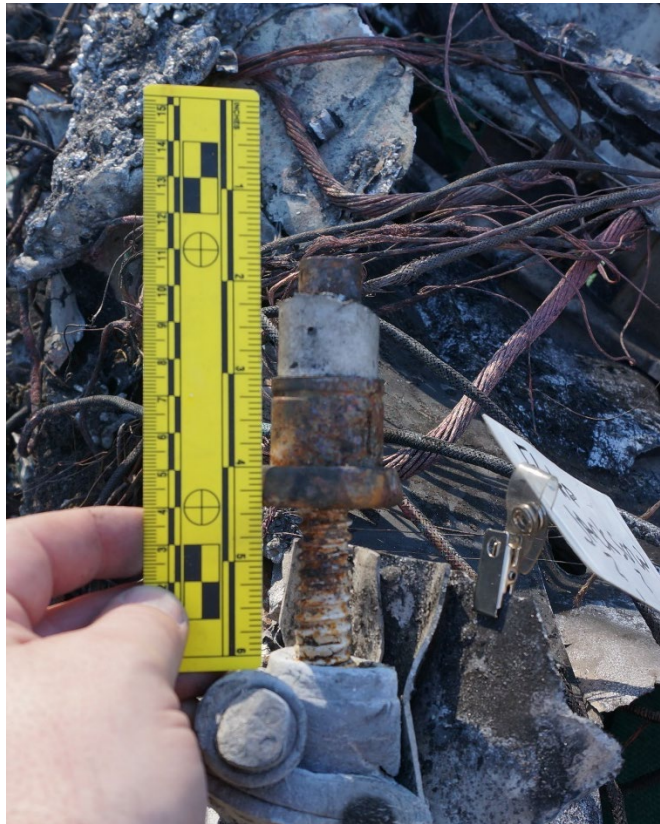
**Figure 6 - Flap Actuator Jackscrew**

The flap actuator jackscrew was extended  $1 \frac{9}{16}$  inches, with 9-10 exposed threads. According to the airplane manufacturer, this is consistent with the flaps at or near the takeoff setting of  $15^\circ$ .

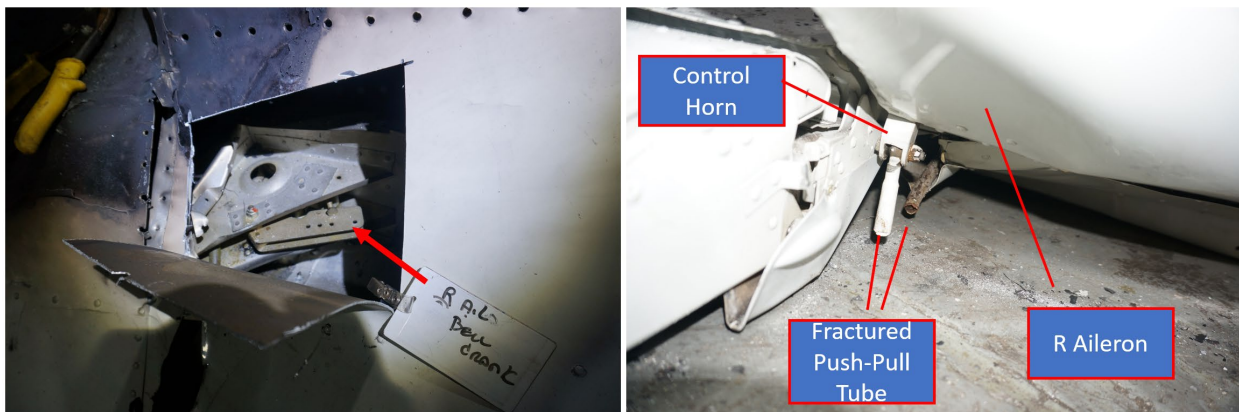
**Figure 7 - Right Aileron Bell Crank (Left) and Fractured Push-Pull Tube (Right)**

Both ailerons remained attached, and flight control continuity was confirmed from the left aileron to the left wing root area. The right aileron bellcrank was impact-damaged and impinged against the wing spar. The push-pull tube between the bell crank and the aileron horn was fractured near the control horn.

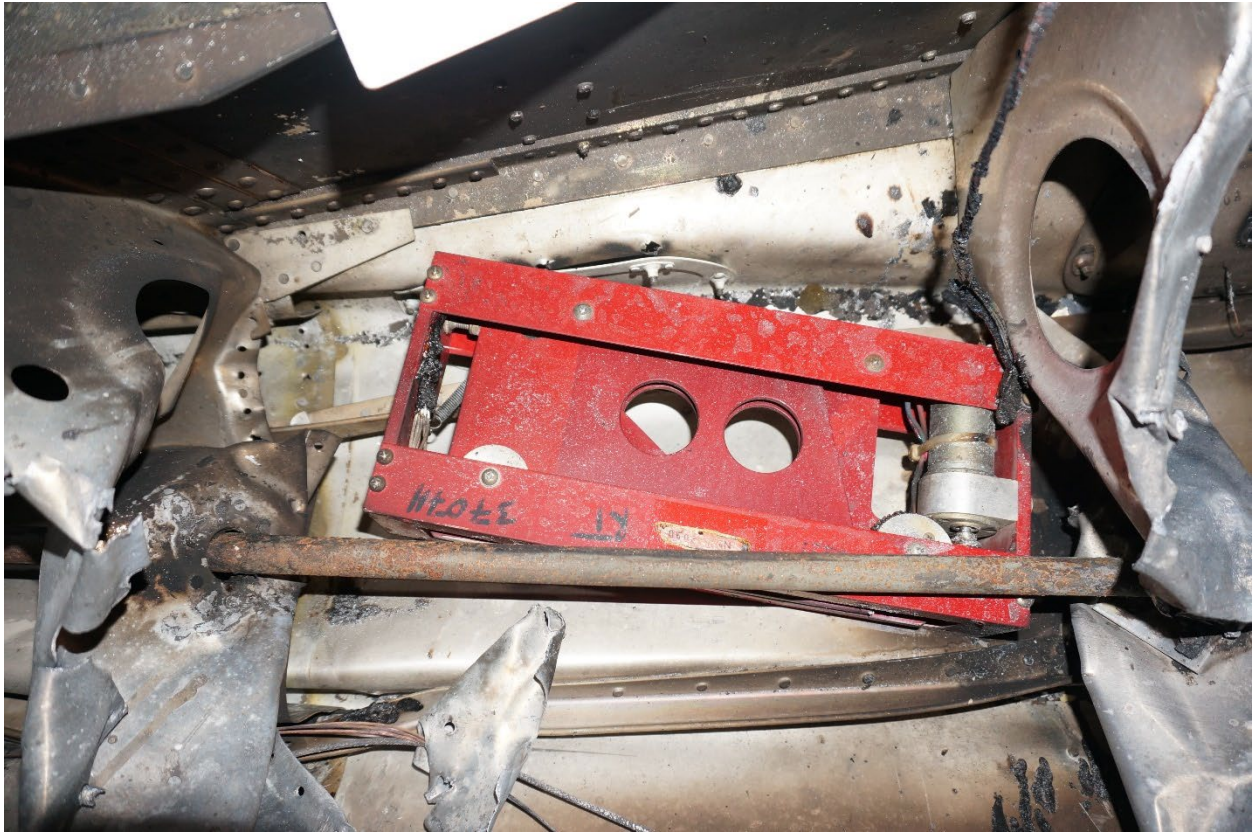
**Figure 8 - Right Speedbrake Assembly**

The right speedbrake assembly was found loose inside the right wing.

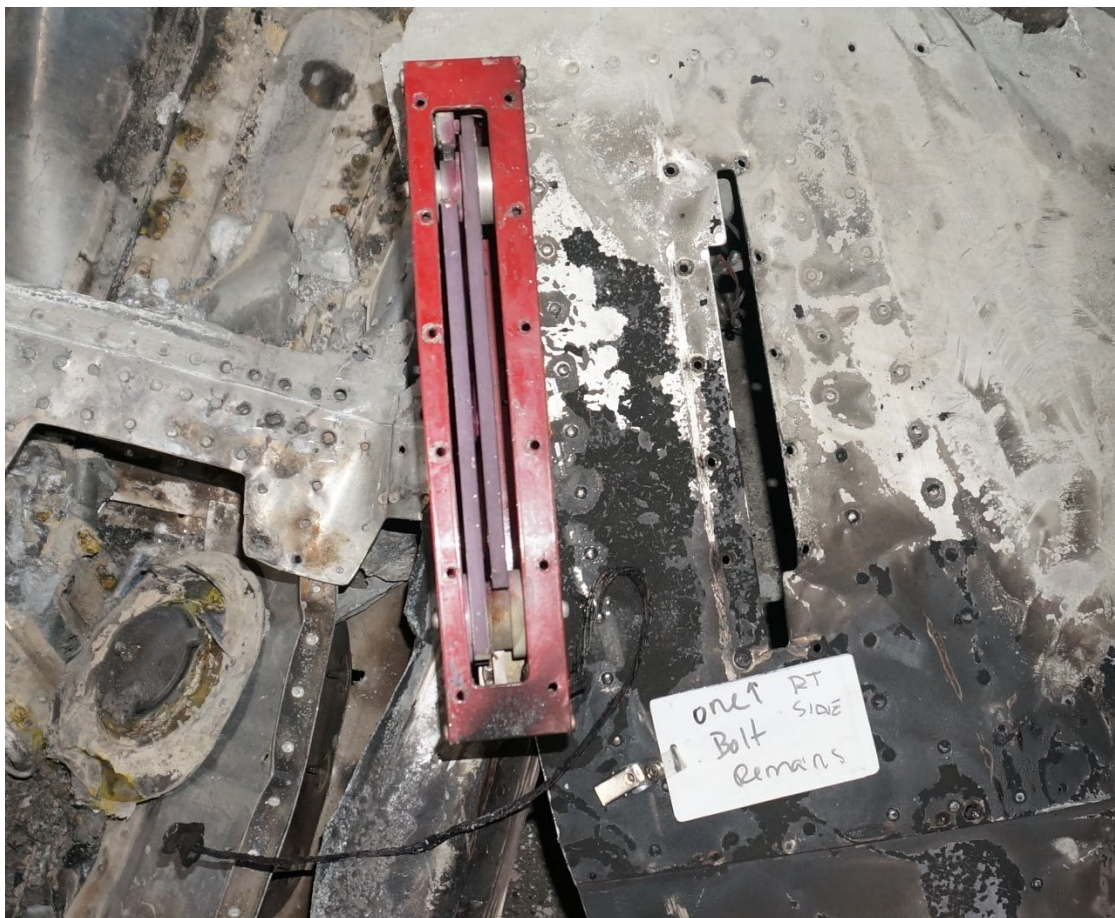
**Figure 9 - Right Speedbrake Mounting Bolt**

One of the 12 bolts upper mounting bolts remained in its hole. The lower mounting bracket remained in place in the wing, the two rivets that attach the bottom of the speedbrake to the lower bracket were fractured.

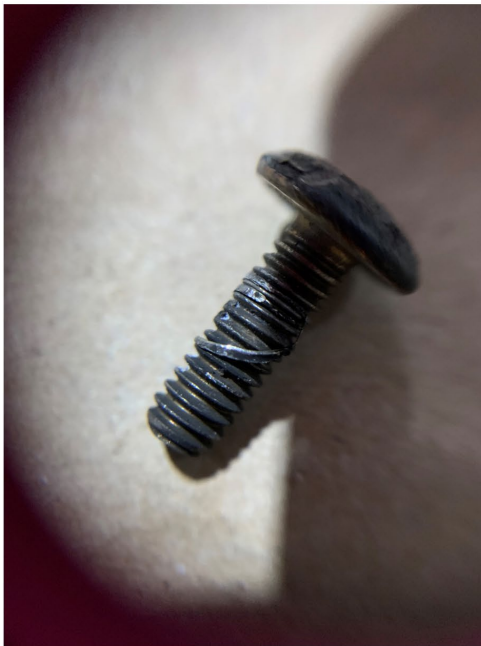
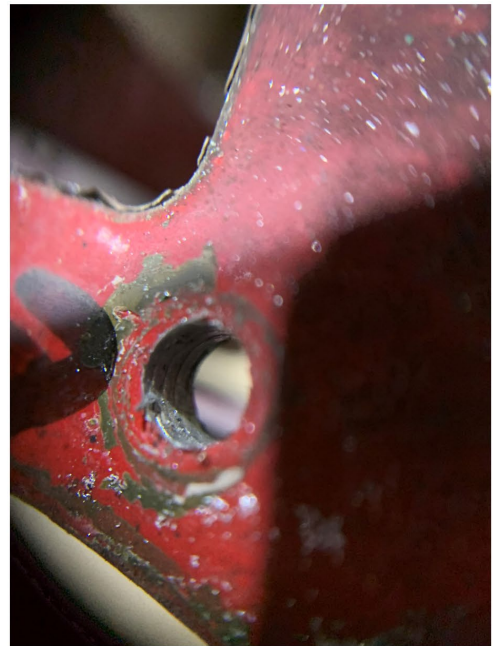
**Figure 10 Right Speedbrake Mounting Bolt (Left) and Corresponding Hole in Speedbrake Assembly (Right)**

Some metal remnants were found in the mounting bolt threads, and the threads in the corresponding hole in the speedbrake assembly were damaged.

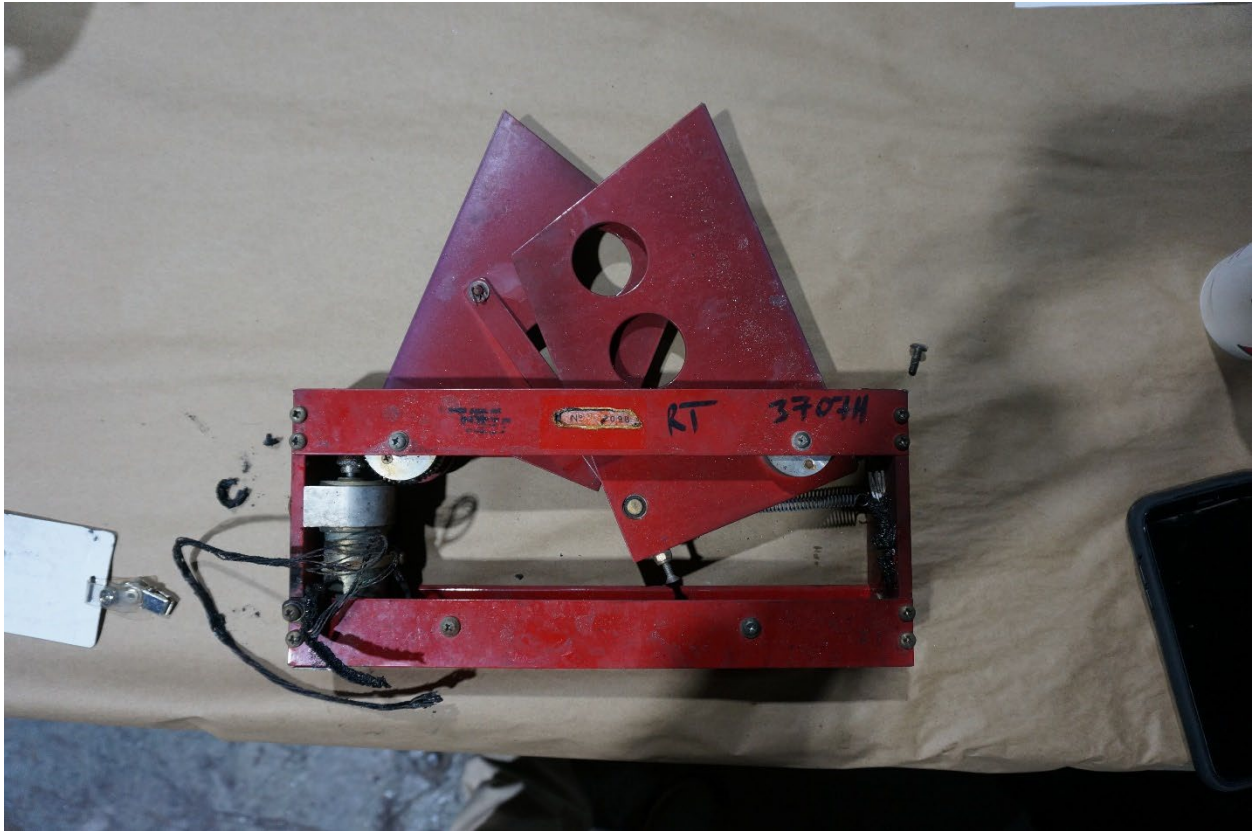
**Figure 11 - Right Speedbrake Positioned Where Panels Rubbed Each Other, When Manually Extended**

When manually opened, the right speedbrake panels rubbed together slightly, in the position shown. When fully extended and released, the spring mechanism fully retracted the panels.

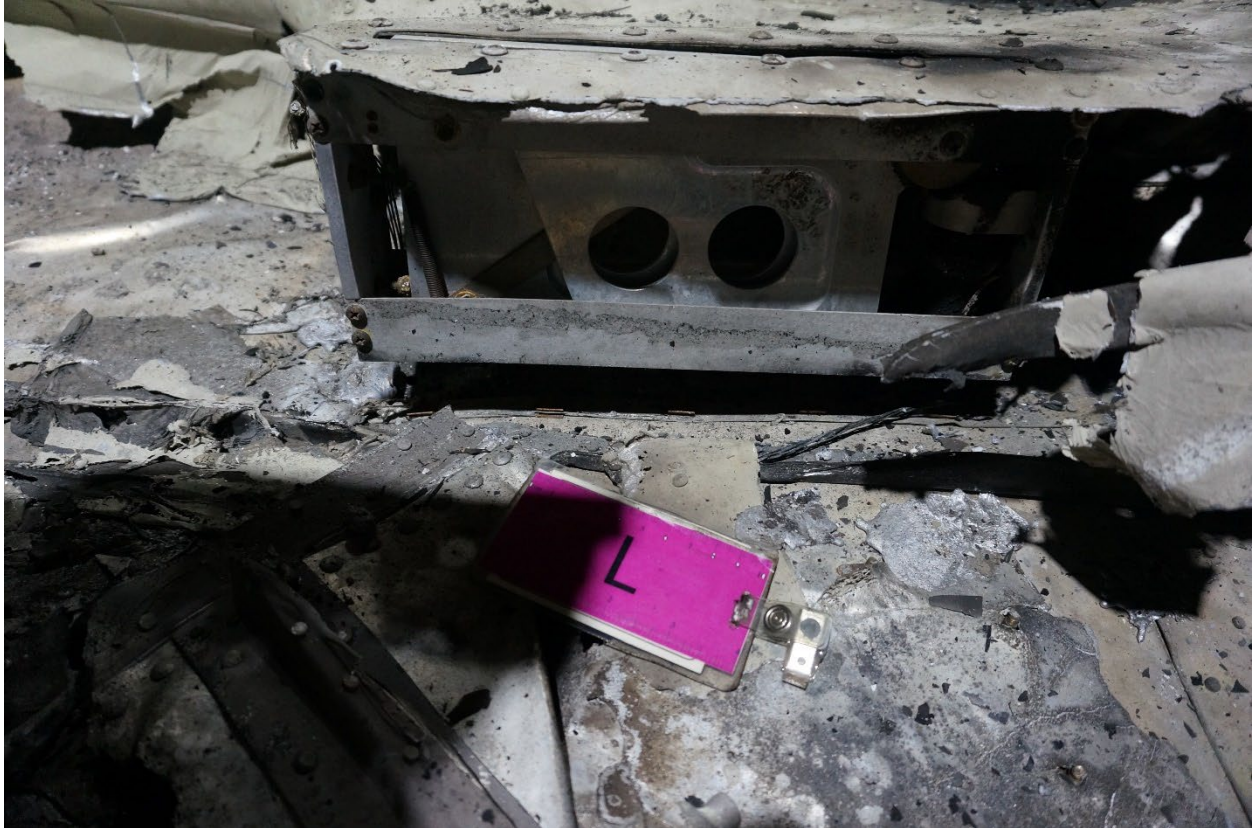
**Figure 12 - Left Speedbrake**

The left speedbrake remained in place, with all 12 upper mounting bolts in place. The lower mounting bracket remained in place in the wing, the two rivets that attach the bottom of the speedbrake to the lower bracket were fractured.

When manually opened, the left speedbrake panels opened smoothly. When fully extended and released, the spring mechanism fully retracted the panels.

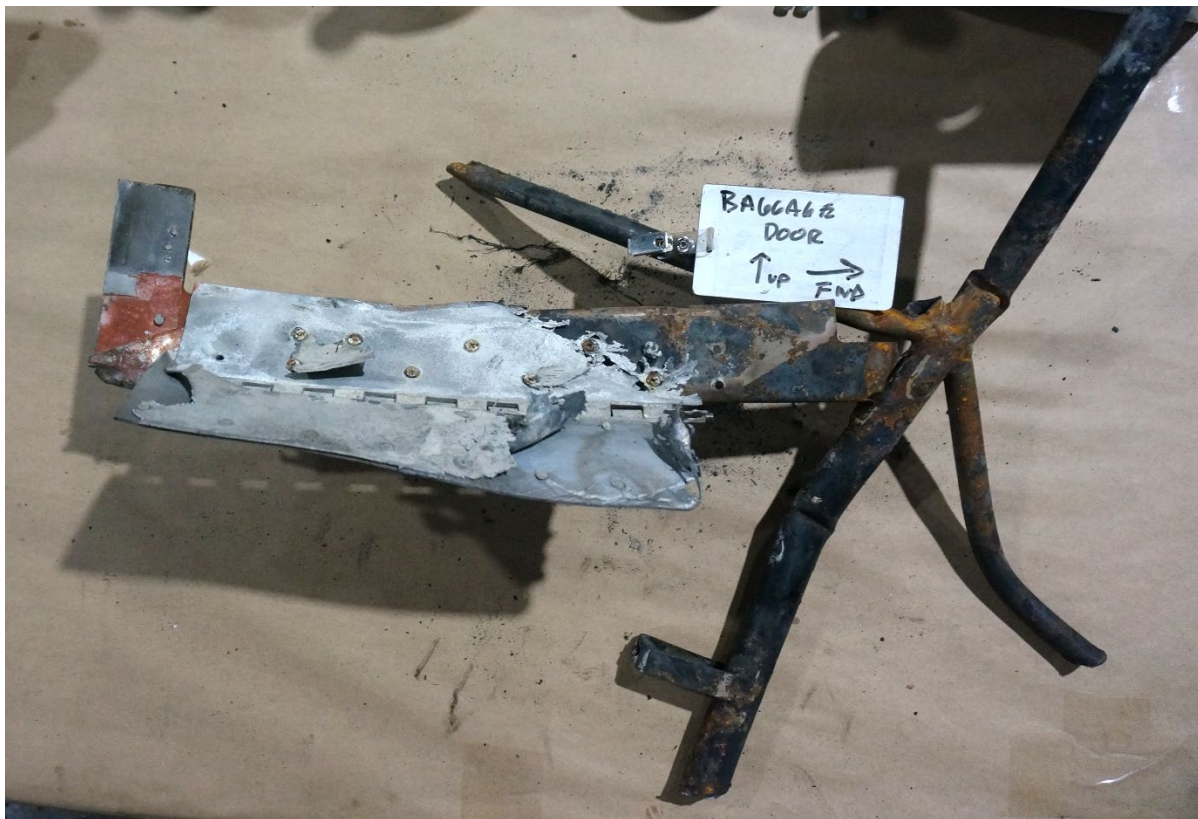
**Figure 13 - Baggage Door Hinge**

The baggage door piano hinge remained mostly intact and remained partially attached to its mount. About 2" of aluminum structure remained on either side of the hinge along most of its length. The forward ends of the aluminum sections were partially melted. The remainder of the door structure was not located in the wreckage, and may have been consumed by the post accident fire.

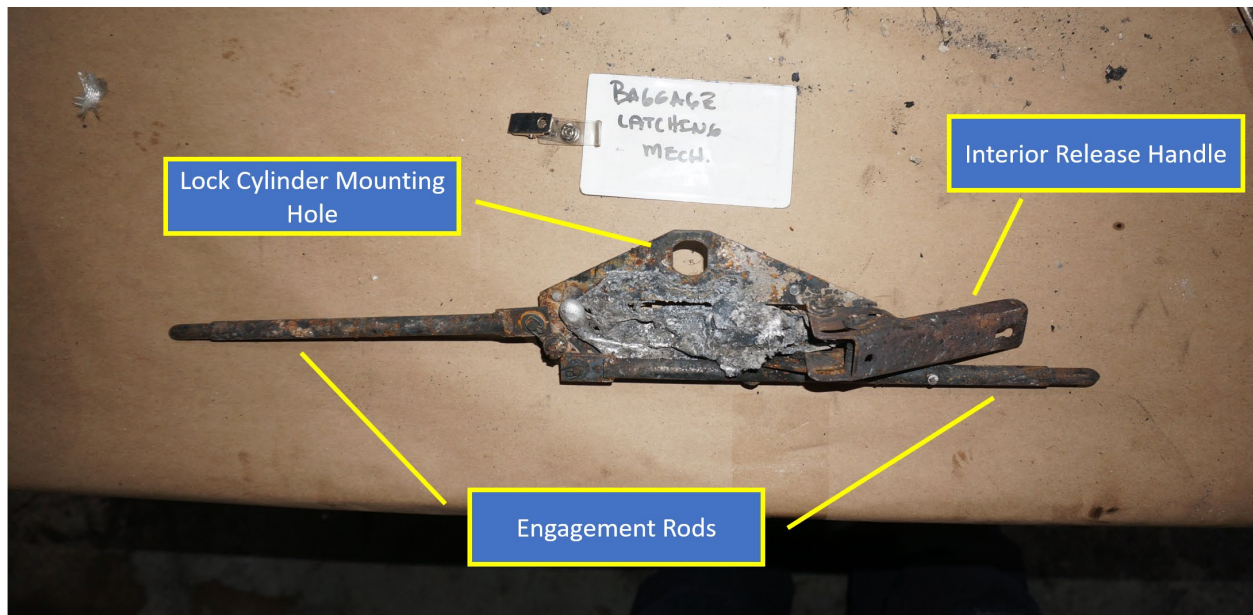
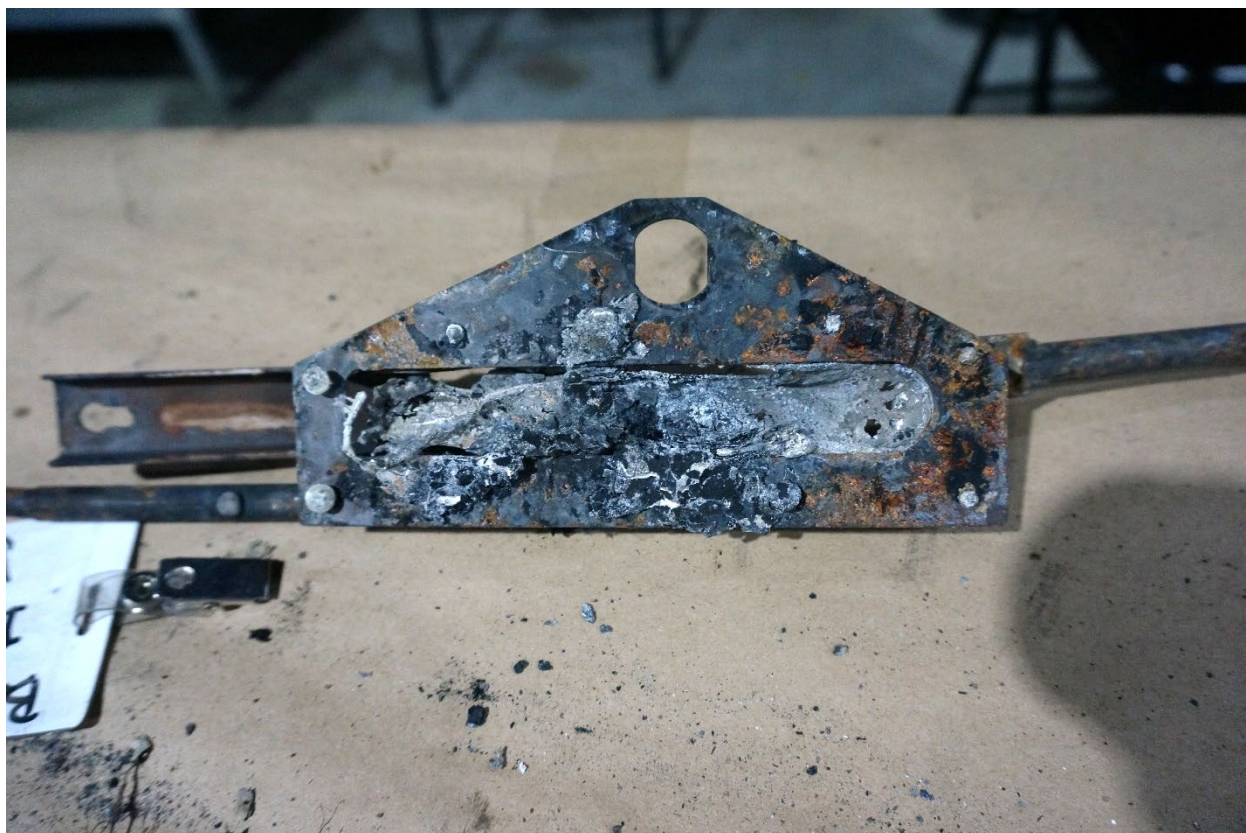
The baggage door latching mechanism was found largely intact, fire damaged, with none of the door structure attached. The lock cylinder and exterior latch handle were not found, however silver/grey molten metal remained on the center section of the assembly. Both engagement rods remained intact and attached to the assembly.

**Figure 14 - Baggage Door Latching Mechanism - Interior Side**

**Figure 15 - Baggage Door Latching Mechanism - Exterior Side**

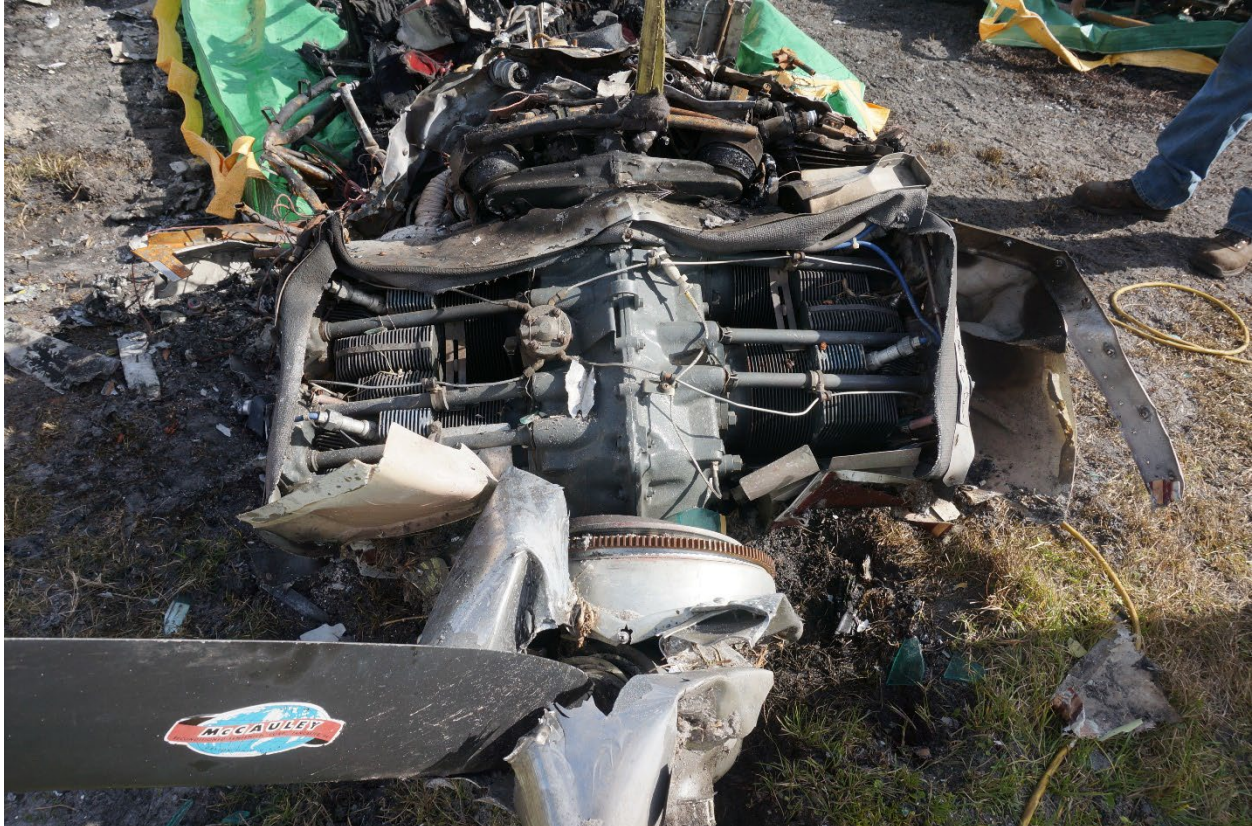
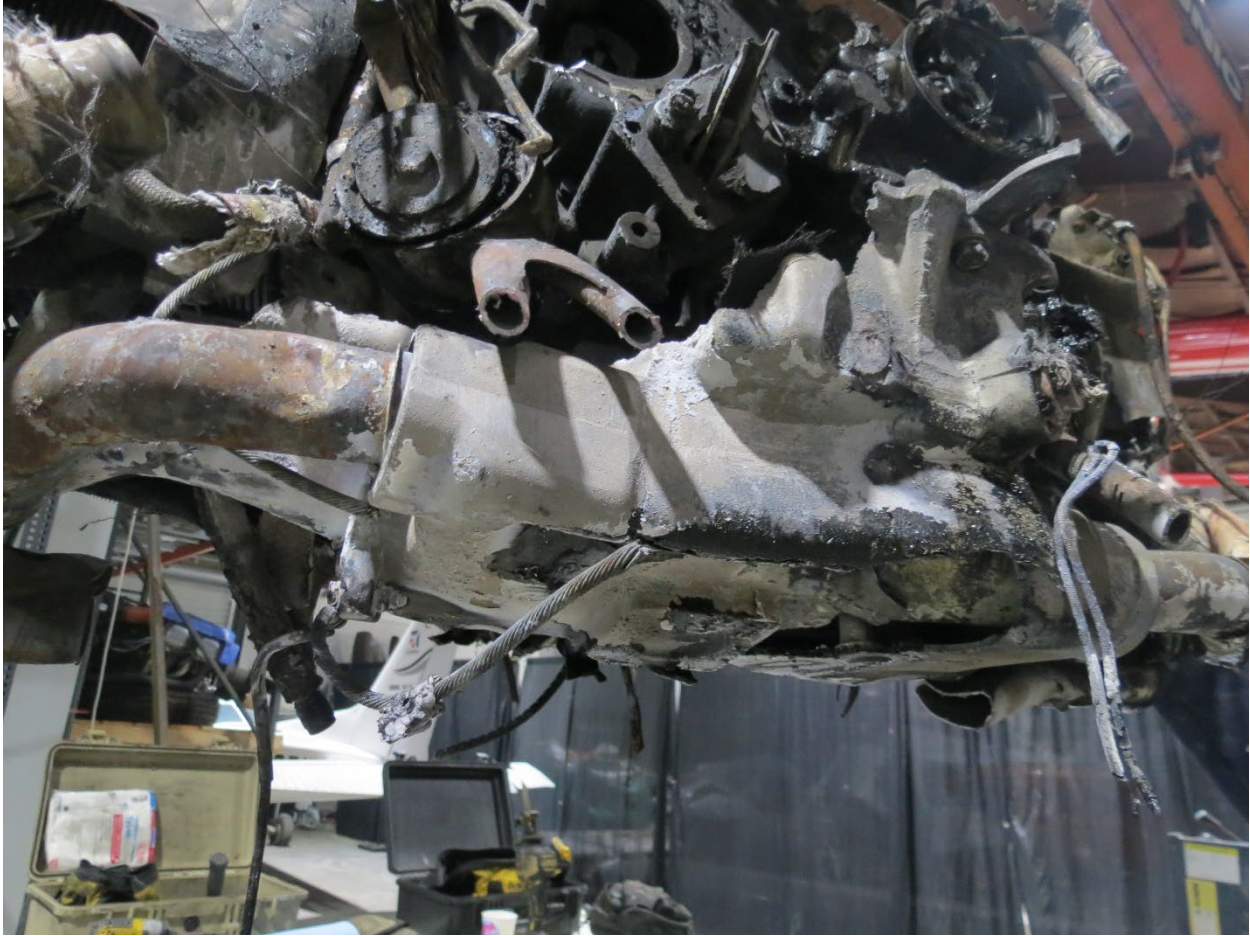
The engine was an Avco Lycoming model IO-360-A3B6D, s/n L-20711-51A. The exhaust and intake tubing sections were partially crushed. The oil sump was fractured and partially burned.

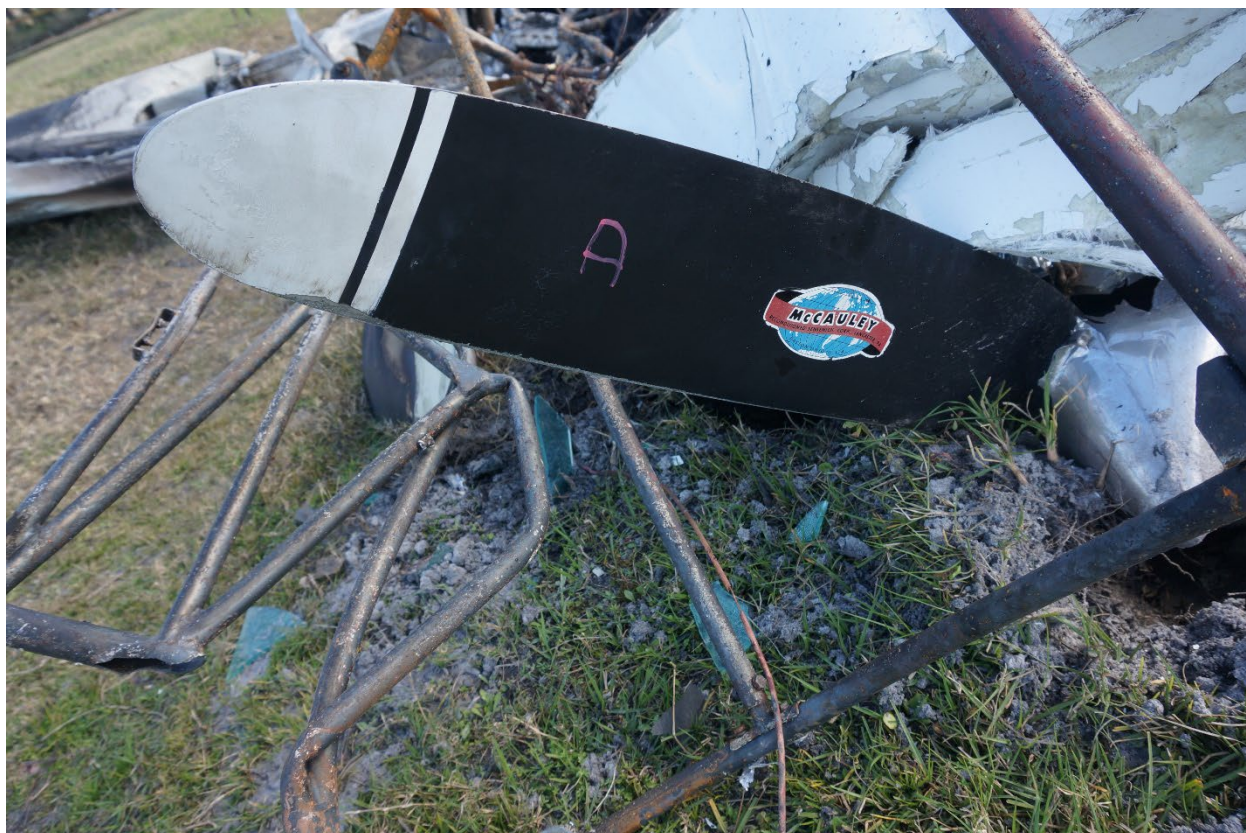
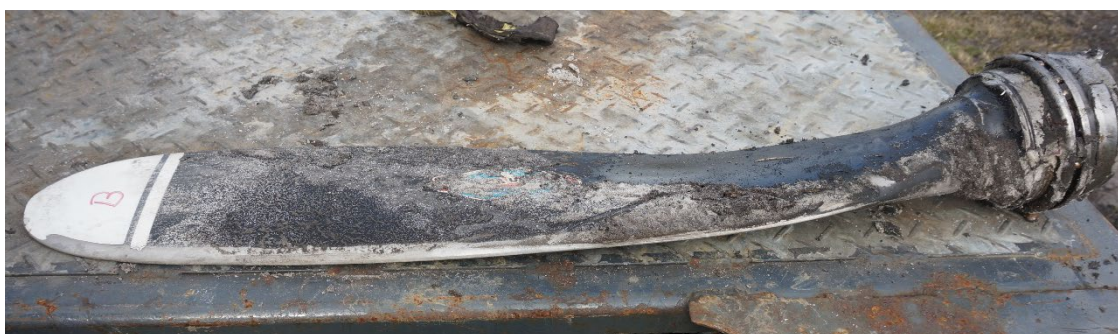
The propeller hub remained attached to the engine crankshaft flange with the hub and spinner partially buried in soft, sandy soil. One propeller blade, labeled "A", remained attached to the hub, above ground and undamaged, except for loose snap rings and shims in the hub. The other blade was separated from the hub and buried in the impact crater. It was bent slightly forward and exhibited abrasion of the paint along the length of the leading edge.

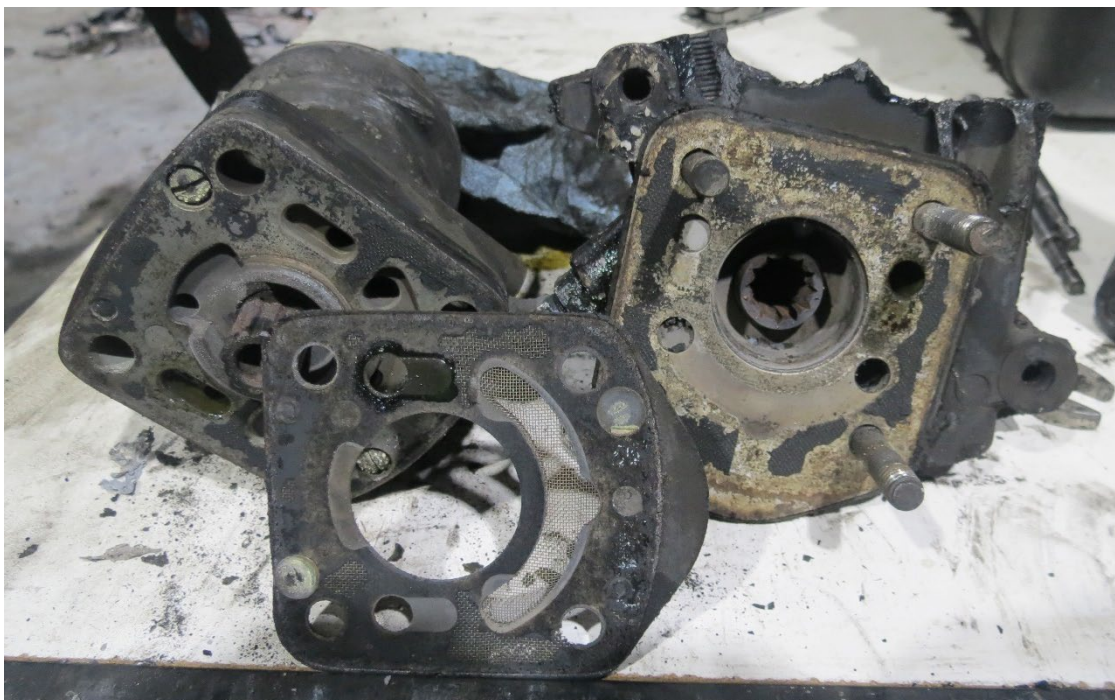
**Figure 20 - Propeller Governor**

The propeller governor was separated from engine and fire damaged. The control arm assembly was separated from the governor and not found. The oil filter screen was absent of debris.

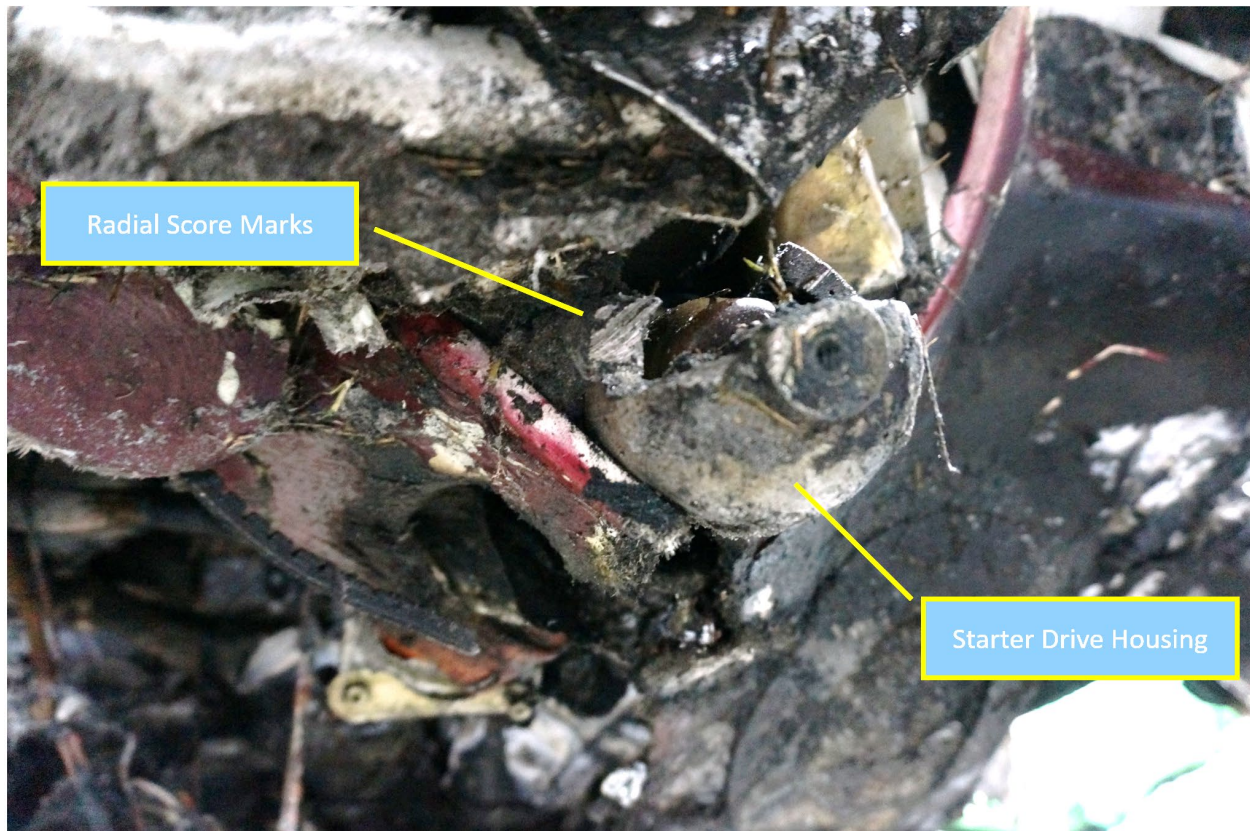
Radial score marks consistent with starter ring gear rotation, were present on the forward section of starter drive housing.

**Figure 21 - Starter Drive Housing with Radial Score Marks**

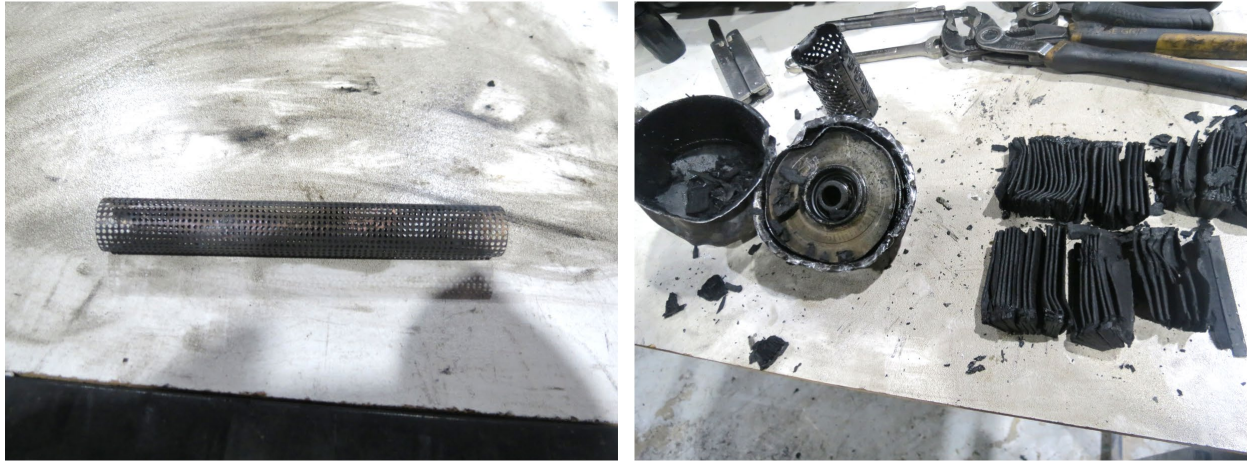
**Figure 22 - Oil Suction Screen (Left) and Oil Filter (Right)**

The oil suction screen was absent of debris. The oil filter was fire damaged, the internal filter element was charred, with no metallic debris present.

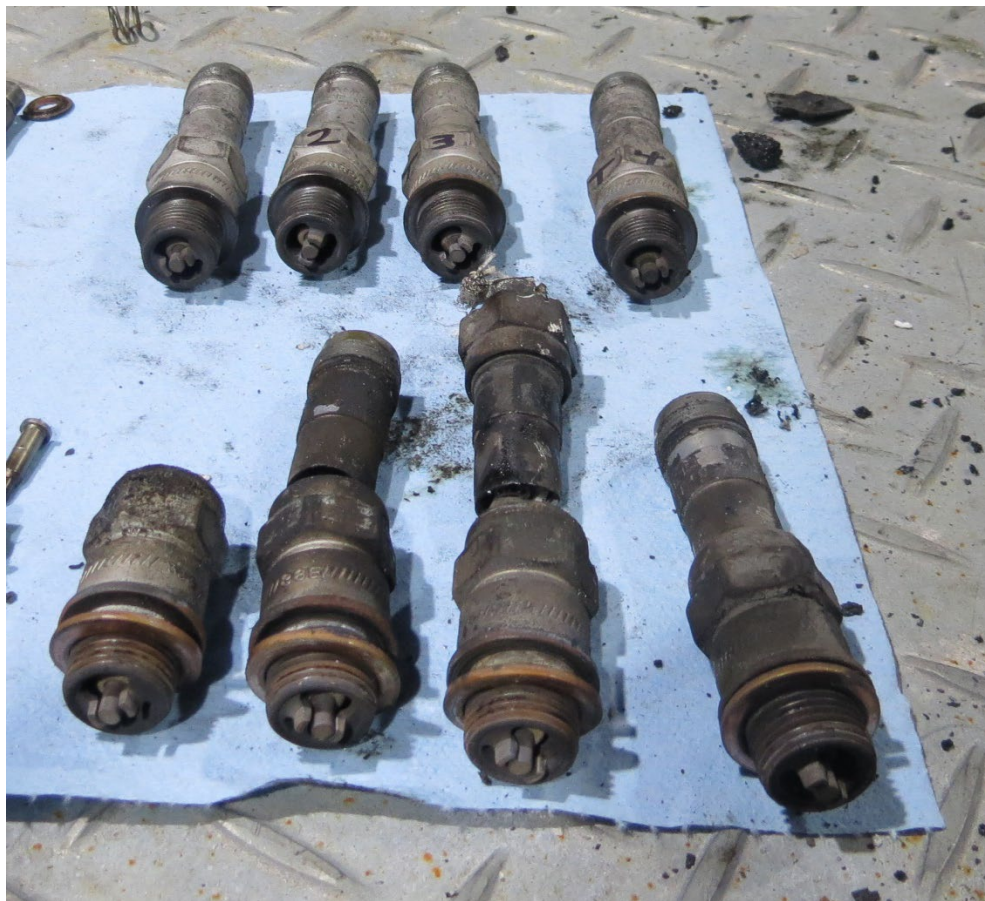
**Figure 23 - Spark Plugs**

The Nos. 1 2 3 bottom spark plugs were fractured/impact damaged. All electrodes on all plugs were light grey in color and appeared worn normal when compared to a Champion check-a-plug chart.

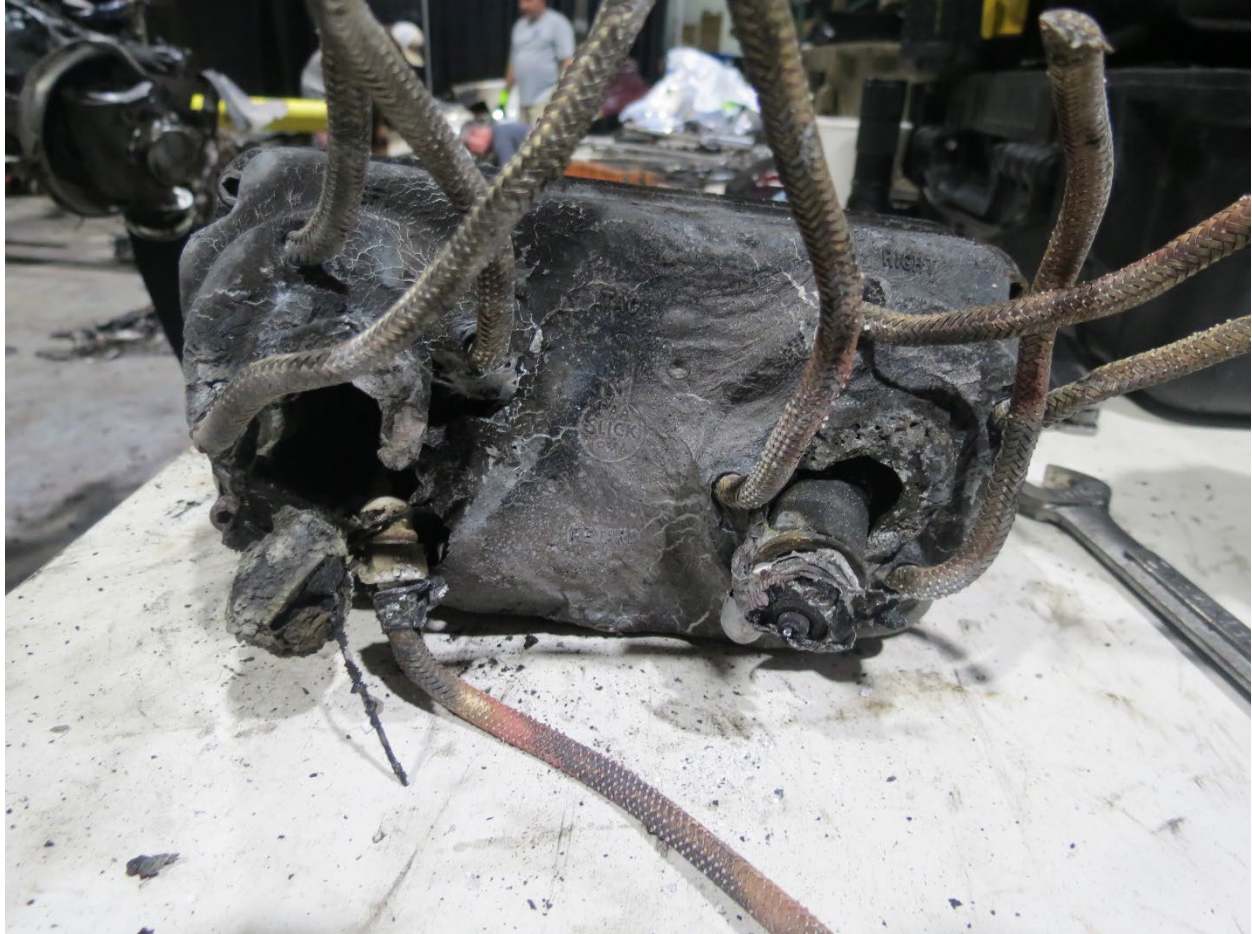
**Figure 24 - Dual Magneto**

The single drive dual magneto found separated from the engine and fire damaged, which precluded testing.
