# National Transportation Safety Board

ERA22FA095

## **WRECKAGE EXAM**

Airplane: Mooney M20J, N3707H

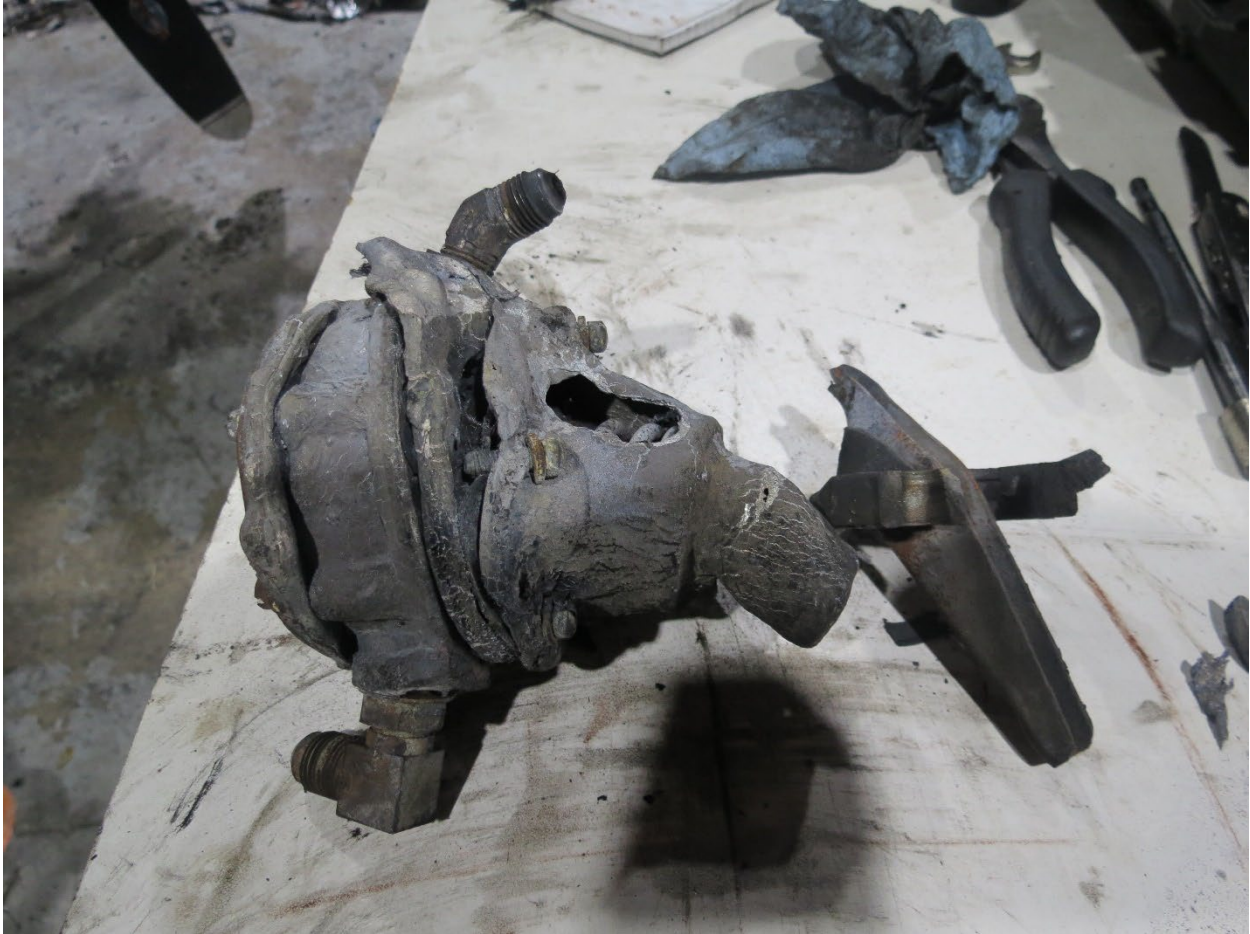
**Figure 25 Engine Driven Fuel Pump**

The engine driven fuel pump was separated from the engine and partially melted, precluding testing. The eccentric inside the engine moved the pump's actuator rod when the crankshaft was rotated.

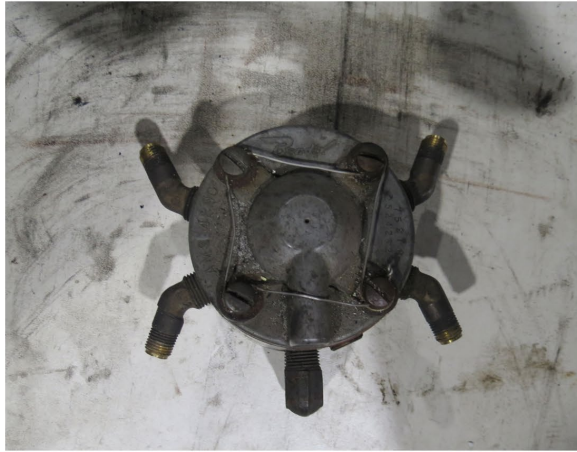
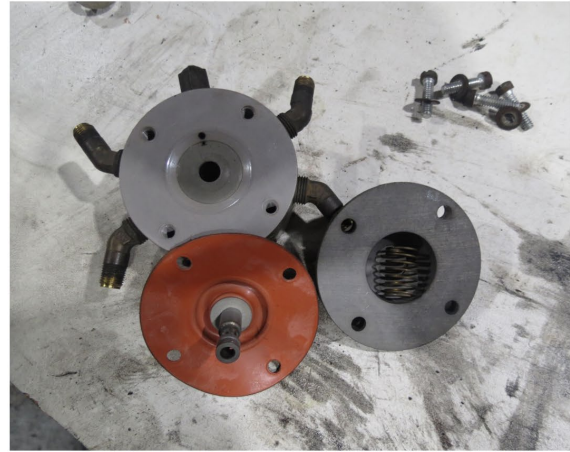
The fuel flow divider was undamaged, the diaphragm was intact, damp and smelled of aviation fuel.

**Figure 26 - Fuel Flow Divider - Intact (Left) Partially Disassembled (Right)**

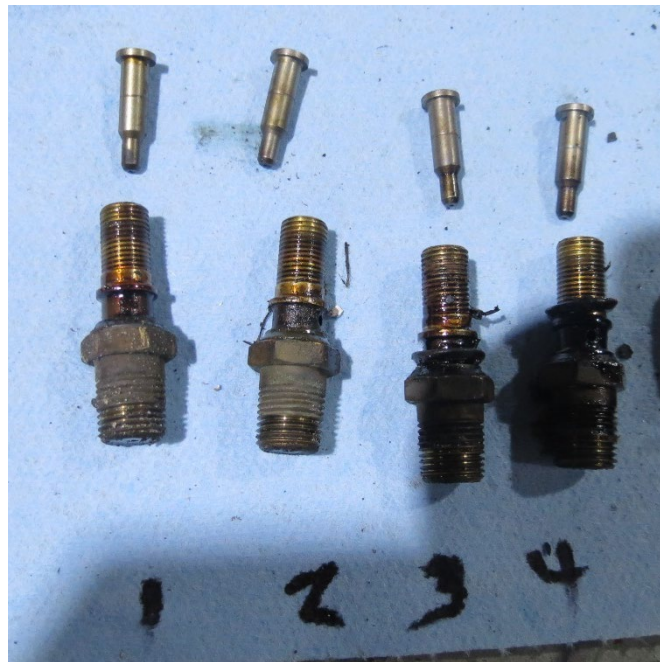
**Figure 27 - Fuel Injector Nozzles**

All four fuel injector nozzles were removed and found unobstructed. The nuts that secure the fuel injector upper deck pressure shrouds were found installed backward (the flange was up instead of down) on all four cylinders.

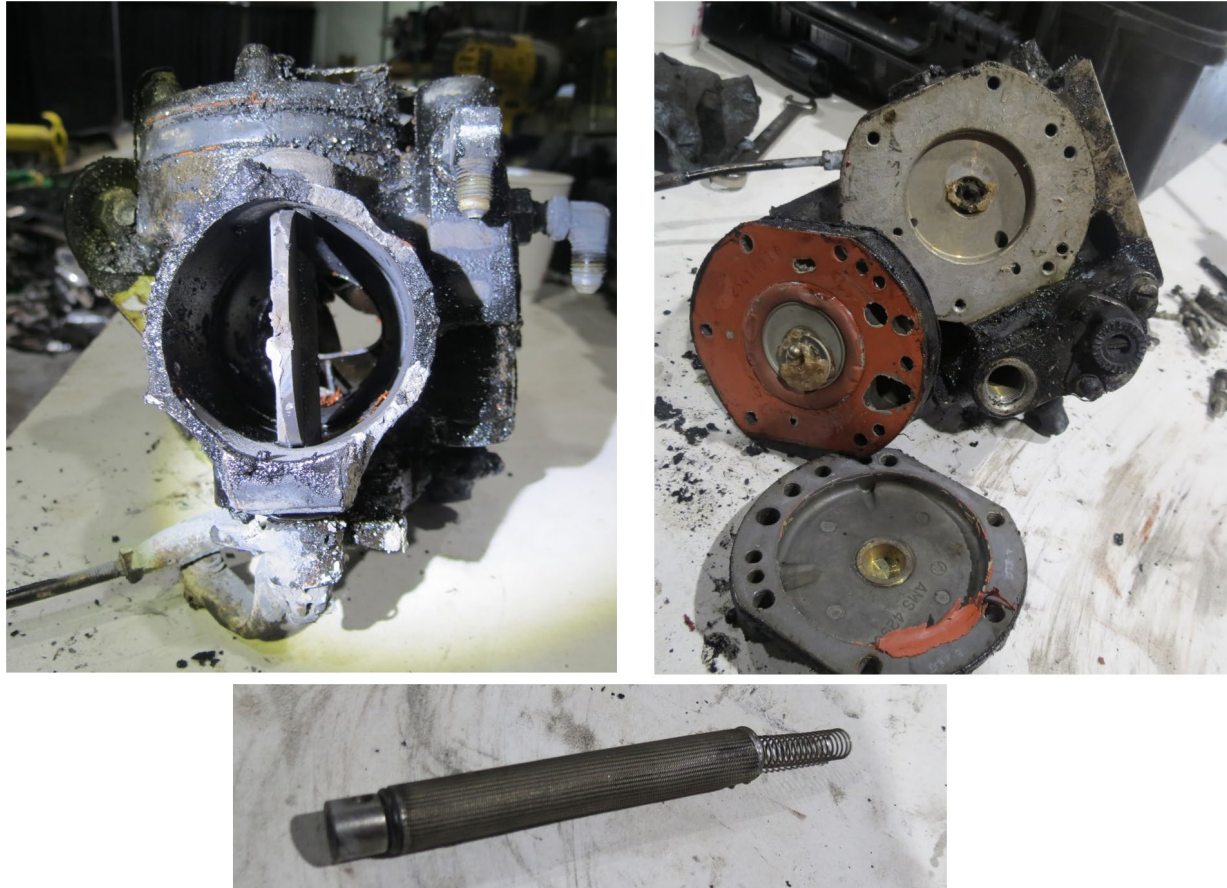
Fuel injection servo was separated from the engine, fire and impact damaged, and fractured across the throttle bore. Throttle cable remained attached to the servo throttle arm which was about 3/16 inch from the throttle stop (about 1/8 to 1/4 of throttle travel from full idle).

The mixture cable remained attached to the servo mixture arm, the arm was separated from the servo. The fuel inlet screen removed and was absent of debris. The servo regulator section partially disassembled, the diaphragms were fire/heat damaged.

**Figure 28 - Fuel Servo - Intact (Top Left) Partially Disassembled (Top Right) Fuel Inlet Screen (Bottom)**

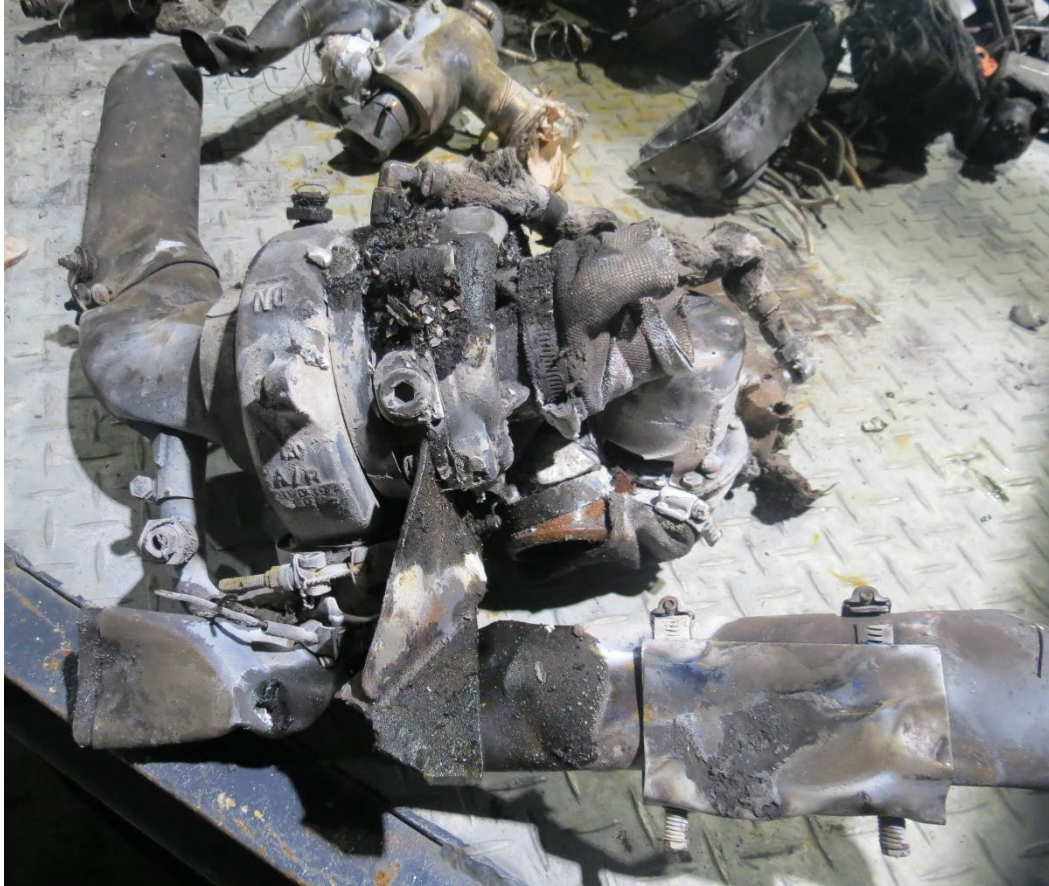
**Figure 29 -Turbocharger Assembly**

The turbocharger inlet and exhaust tubing and the fixed exhaust bypass were impact damaged and partially crushed. The inlet and exhaust tubing was removed, and the compressor shaft rotated freely by hand, no damage noted to compressor wheel blades or the exhaust/turbine wheel blades.
