## Robinson Helicopter Company Accident Report

| AIRCRAFT MODEL: | <u>R44 Raven II</u> |
| REGISTRATION: | <u>N544SC</u> |
| NTSB IDENTIFICATION: | <u>ERA22FA096</u> |

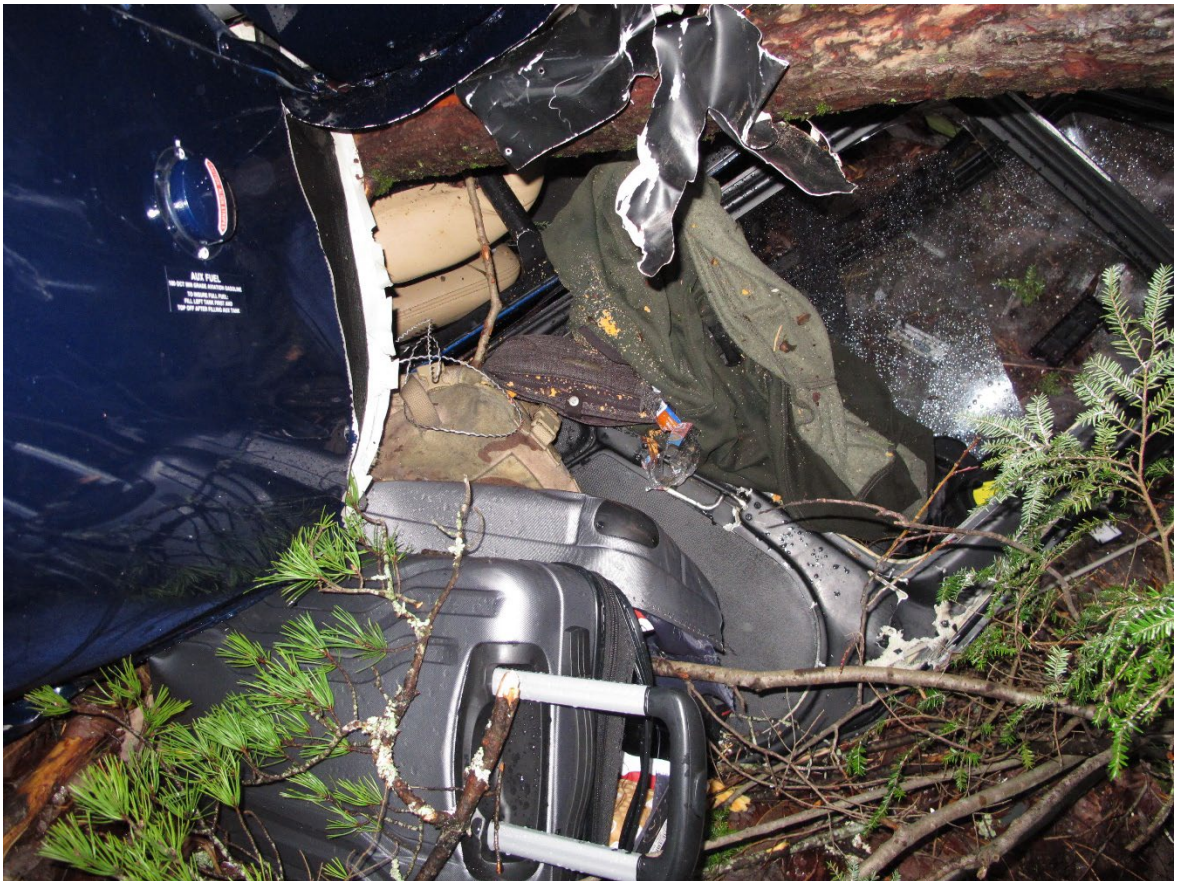
The floor of the cabin structure was deformed upward, more severely at the nose. A tree trunk pierced thru the belly, up between the aft seats and protruded out the aft right door.

Above and below: Right side of cabin prior to recovery.

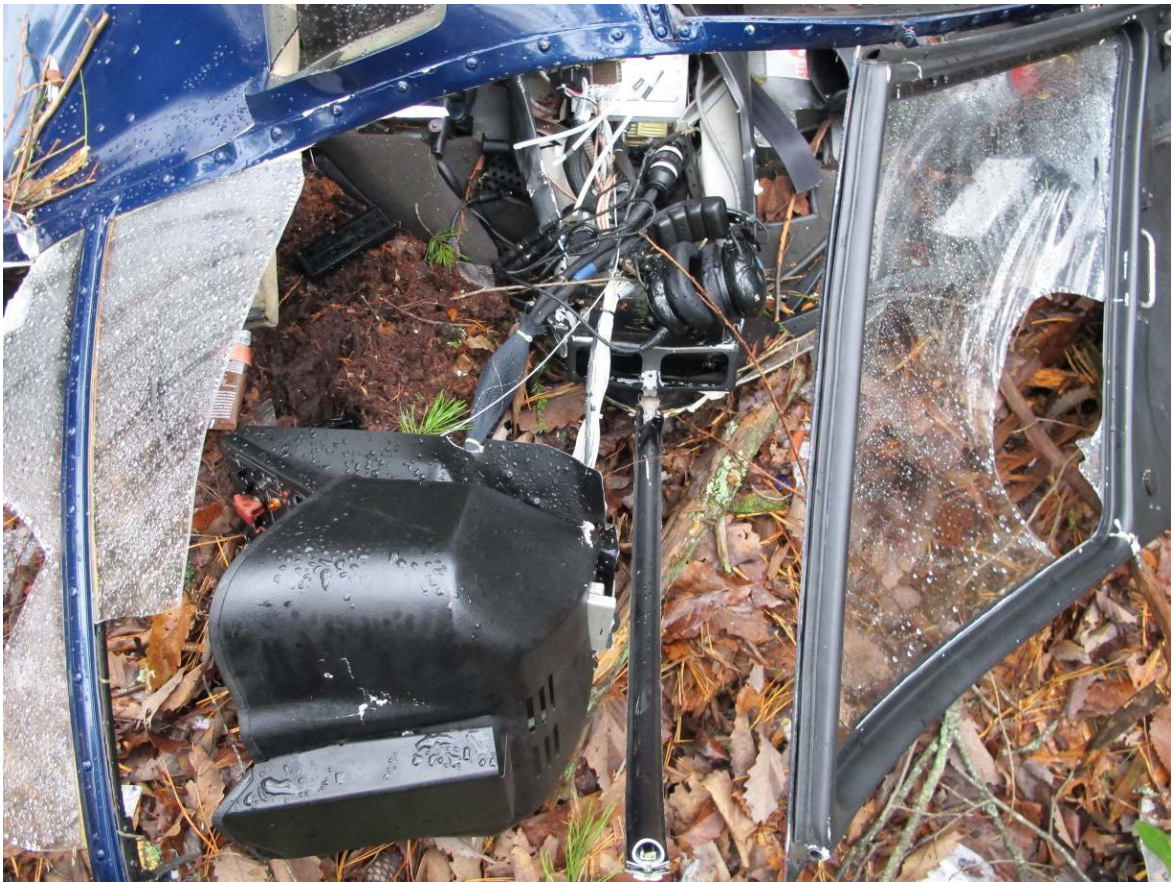
Nose of the cabin prior to recovery.

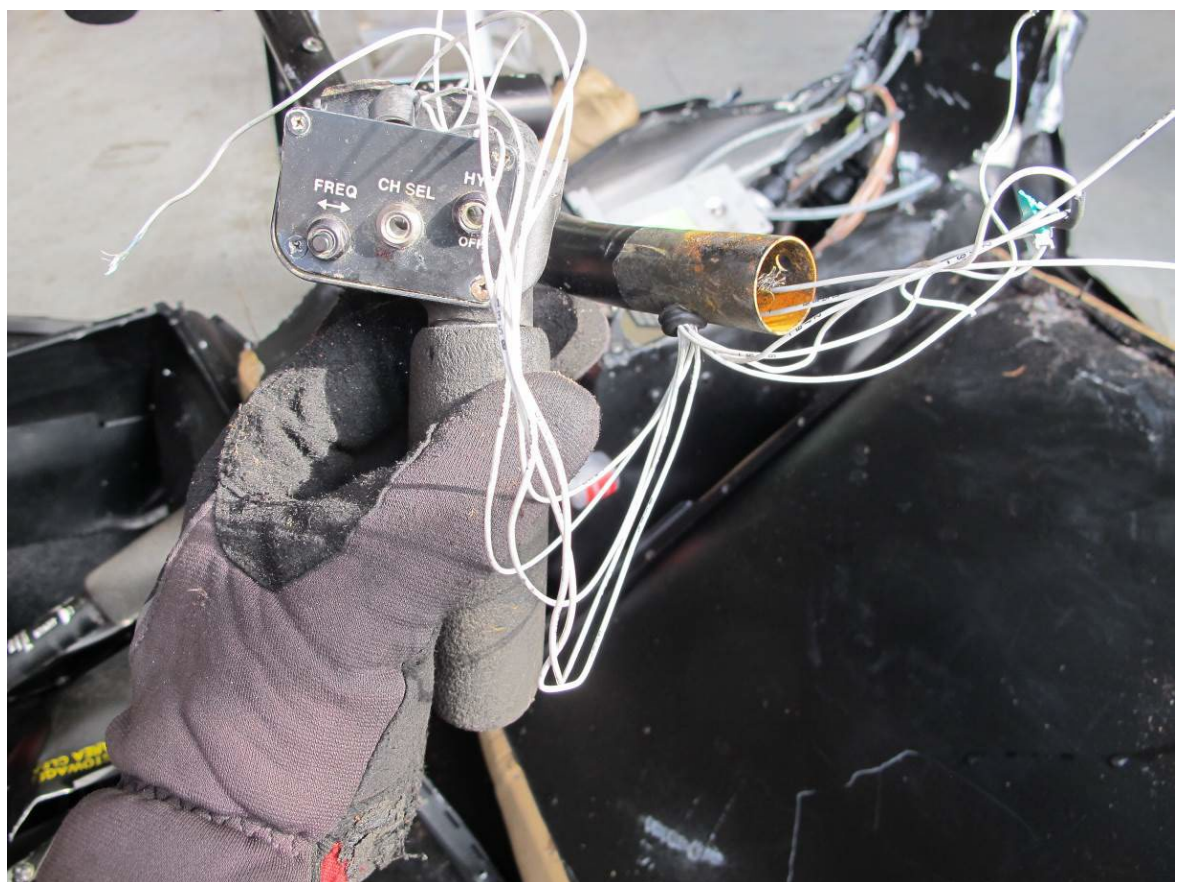
The pilot's cyclic grip was disconnected from the crossbar. The surface of the disconnect was angular and jagged. The left side cyclic control was installed. The collective was positioned approximately mid-travel. The removable collective and tail rotor pedals were recovered on the aft left floor. The pilot's tail rotor pedals were positioned with the left pedal forward.

Pilot's cyclic grip and crossbar.

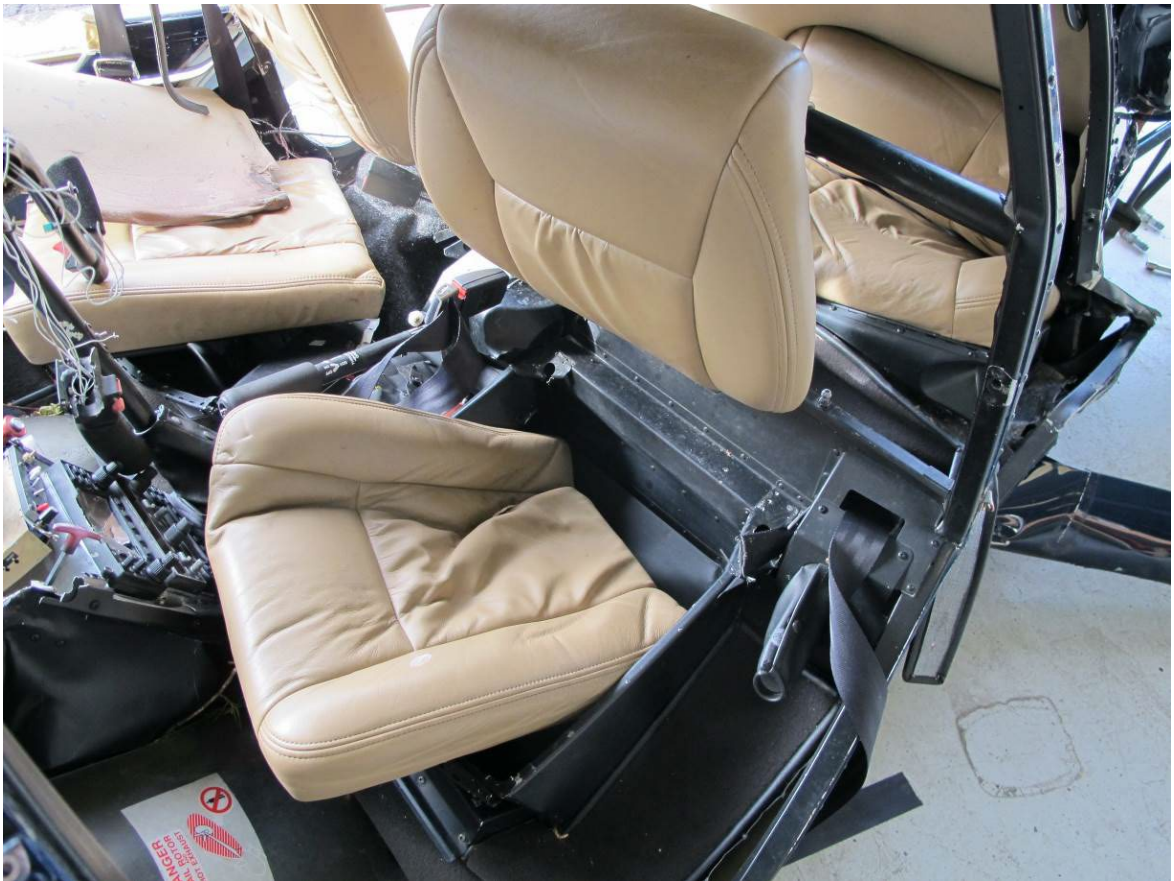
The front right seat structure was severely deformed. The front left seat structure was moderately deformed. Both aft seat structures were severely deformed and the seat backs/bulkhead was folded over the seat bottoms.

Front left seat.

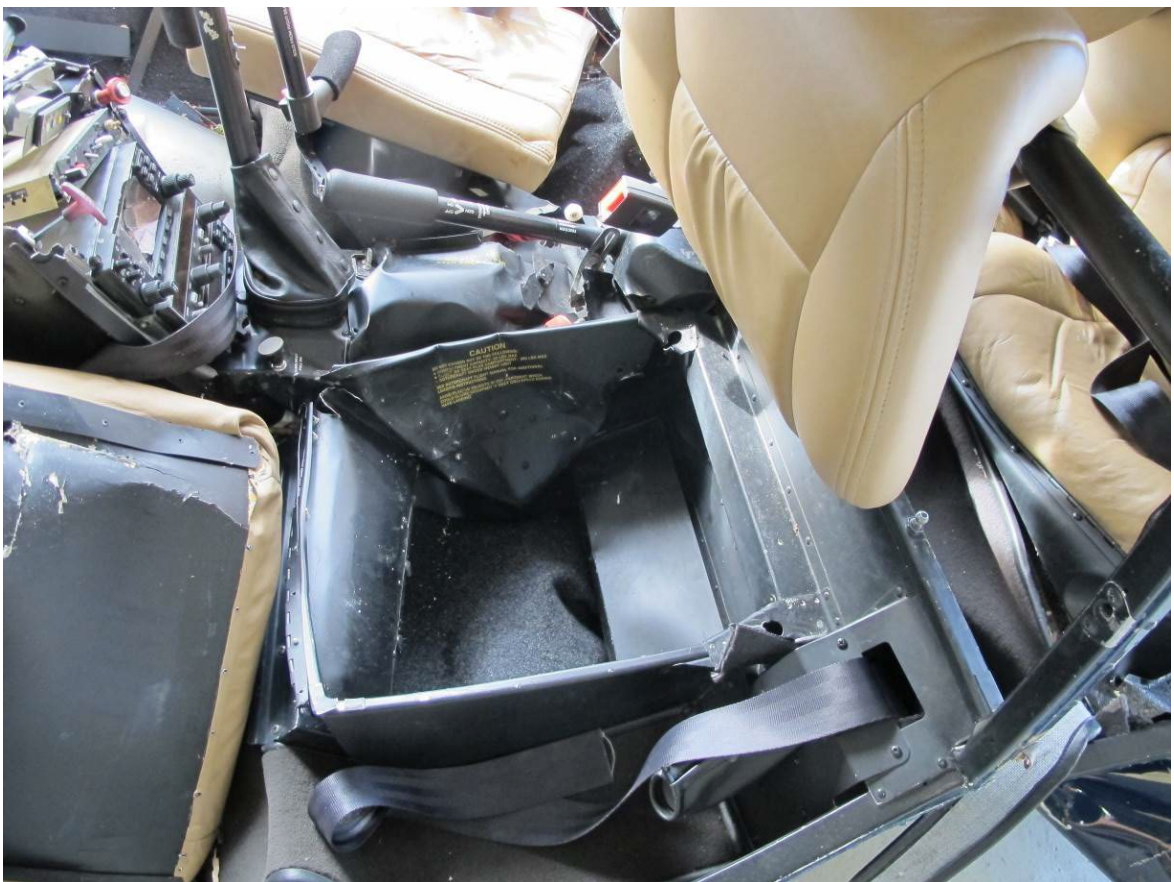
Front left seat structure.

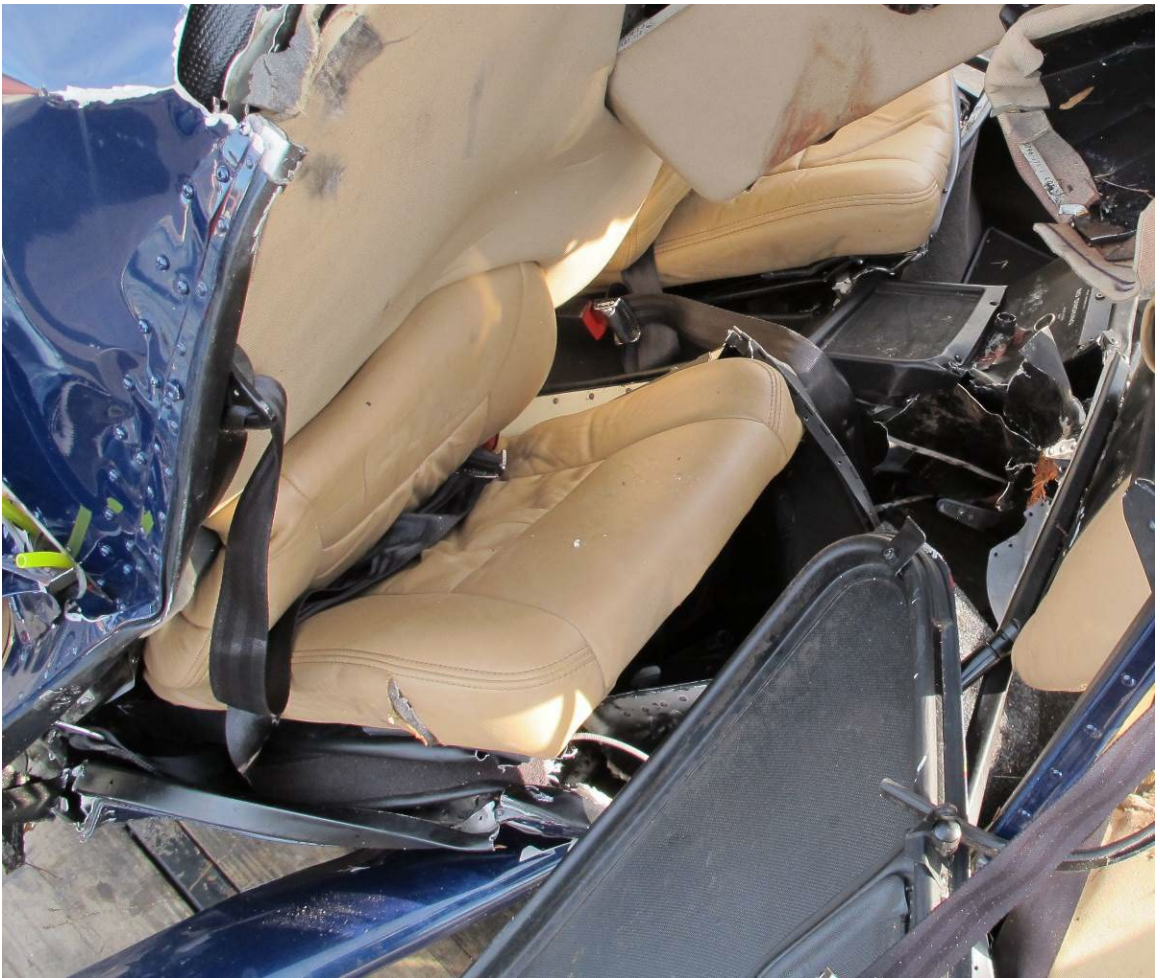
Aft right seat.

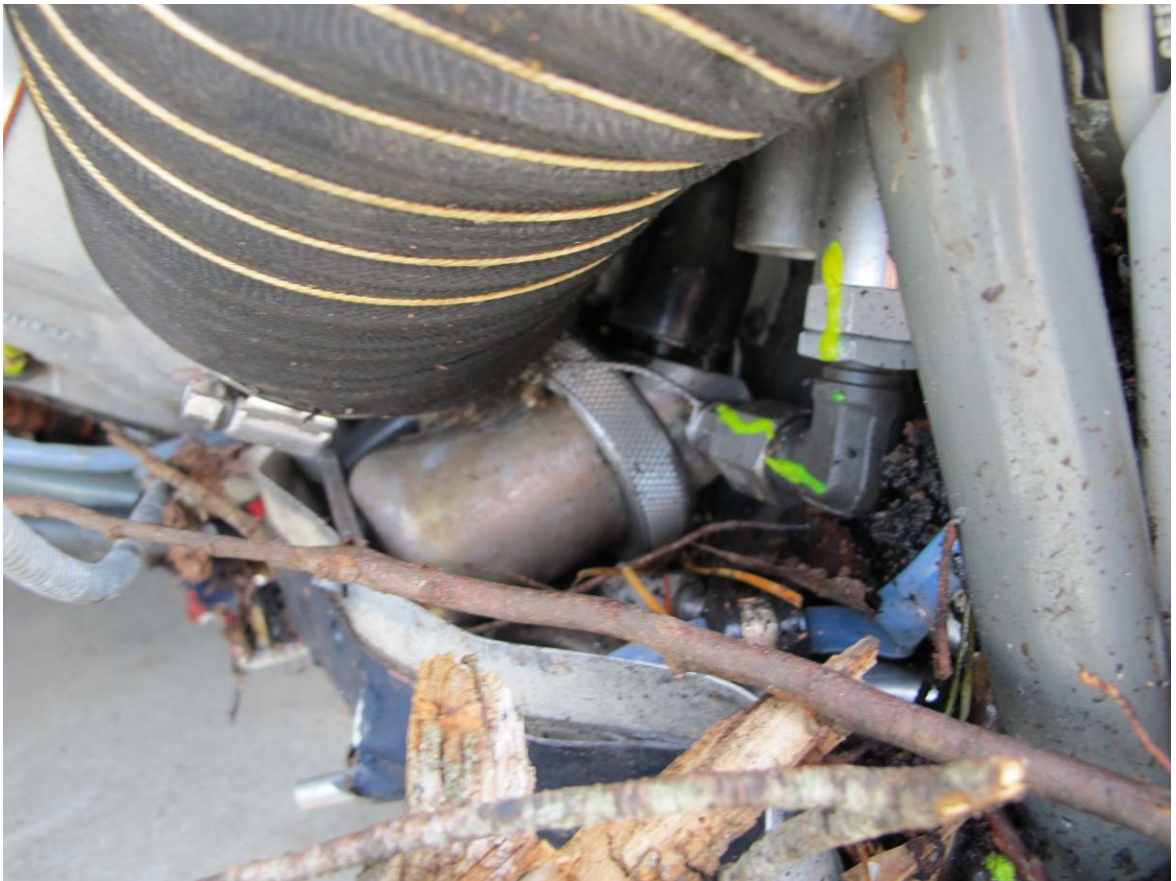
The gascolator sustained impact damage. The bowl contained no fuel. The screen was clean.

Gascolator assembly.

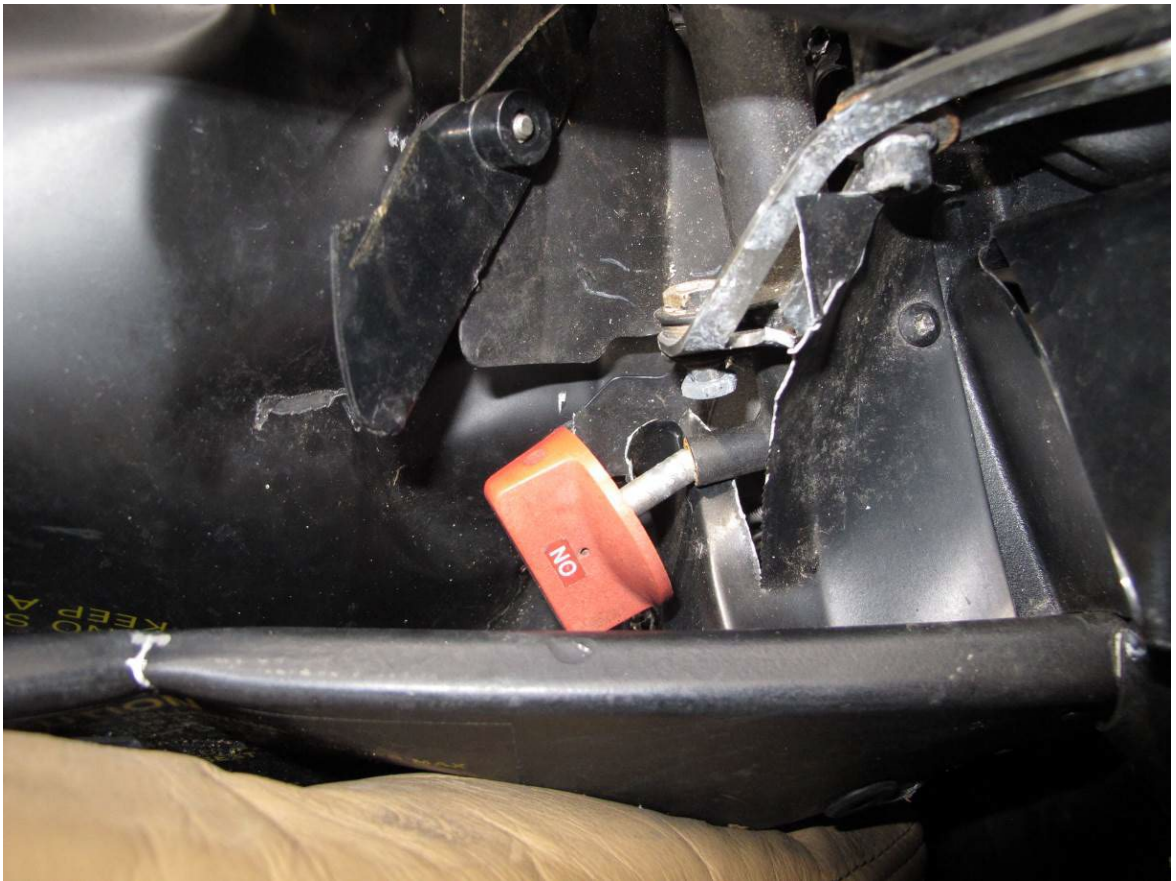
The fuel shutoff knob was mostly in the on position. The connecting rod was damaged.

Fuel knob position.

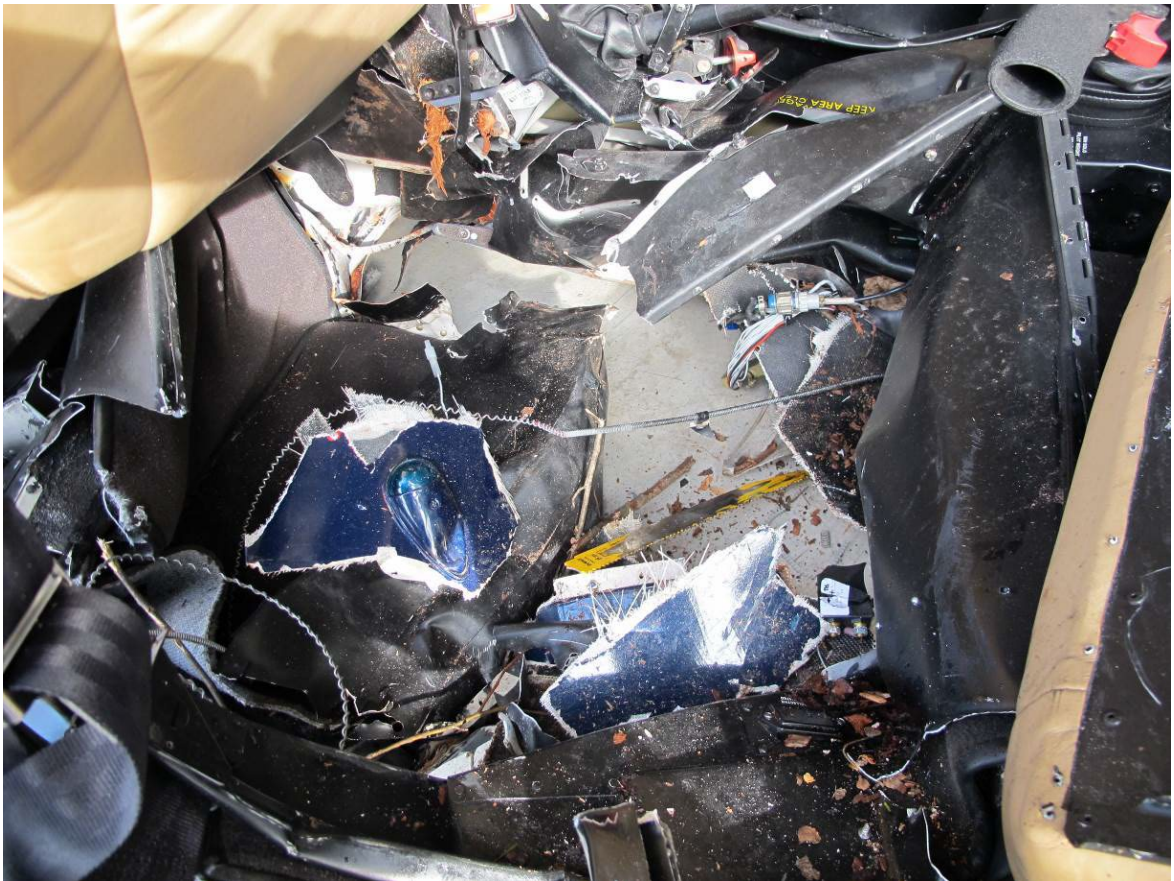
The fuel mixture control knob was in the full rich position. The fuel mixture guard was hanging on the console. The fuel mixture arm on the fuel control unit was in the cutoff position. The control wire sheathing was secure in the mounting clamps. The control wire sheathing was stretched due to impact damage.

Fuel mixture control wire sheathing stretched.

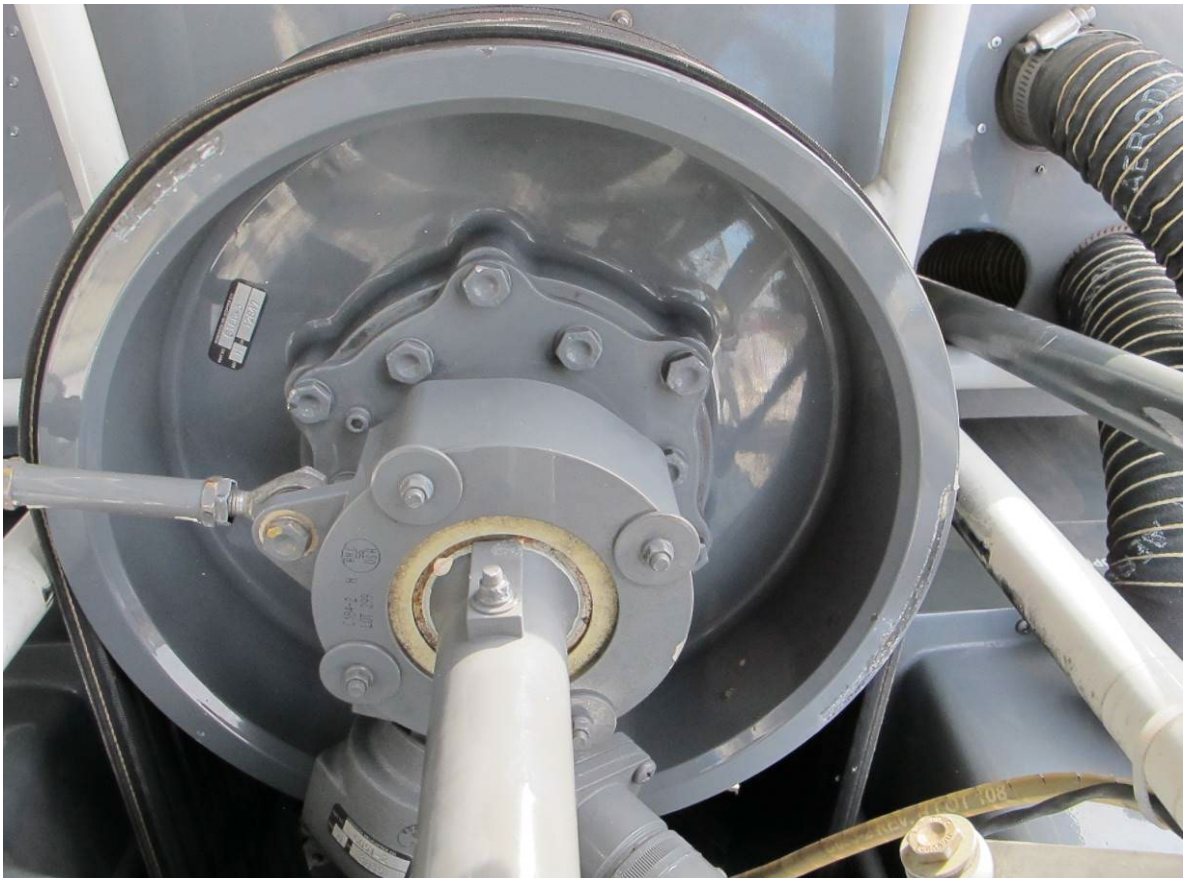
Score marks on aft face of upper sheave.

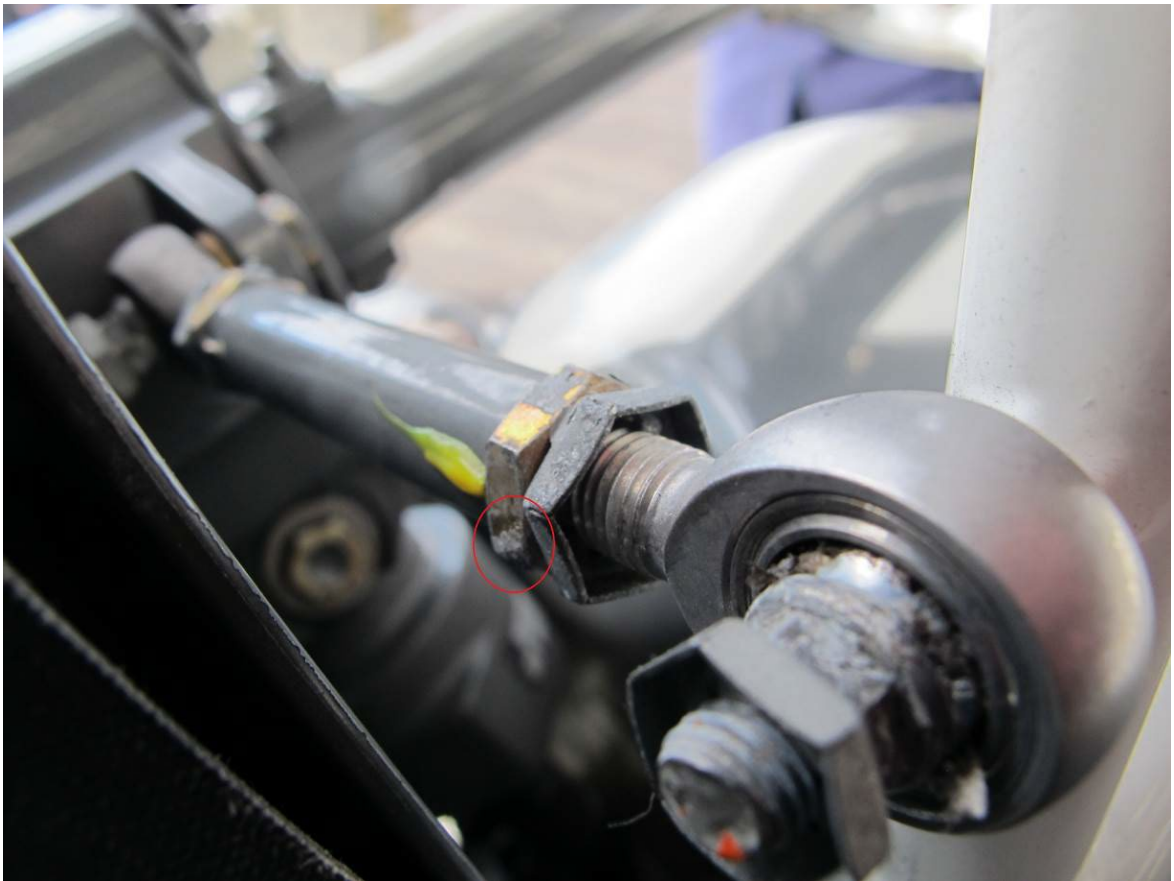
Paint transfer on jam nut of clutch centering strut.

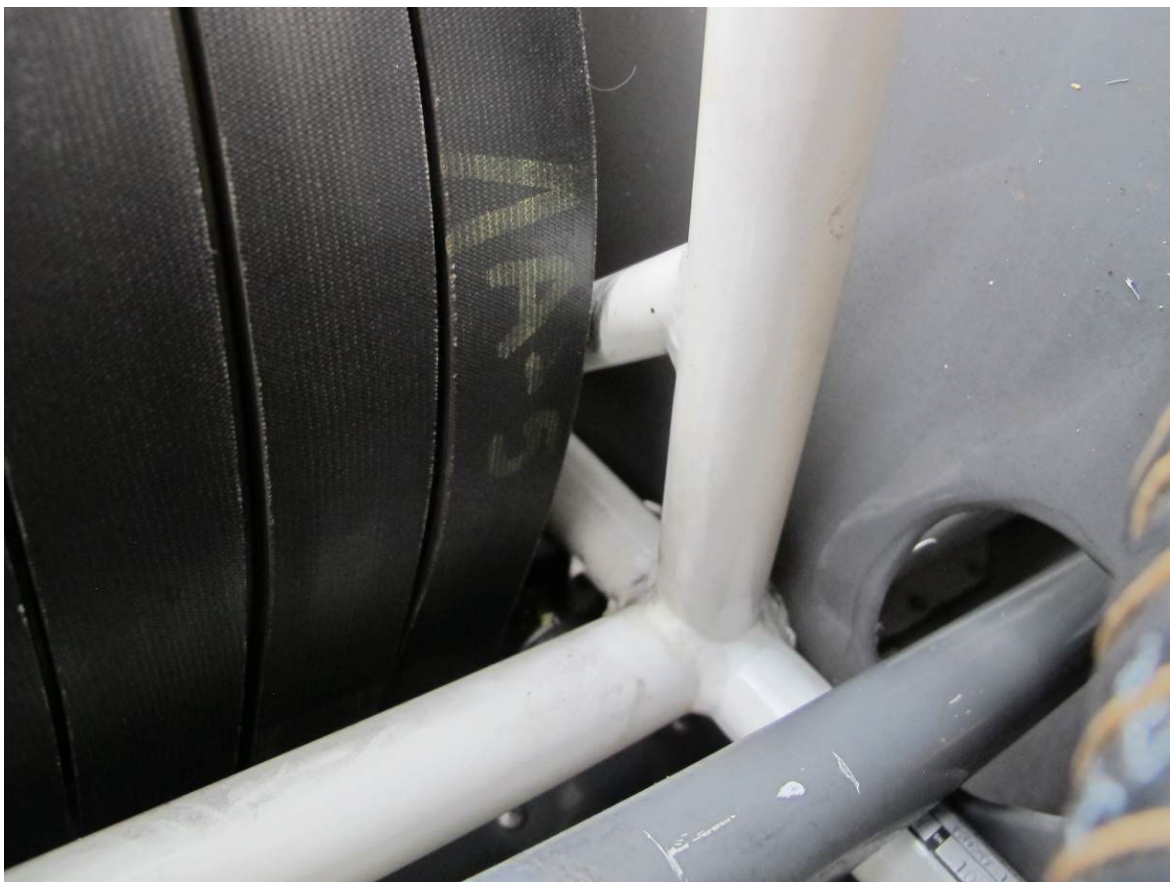
Rubber transfer on right side of upper frame.

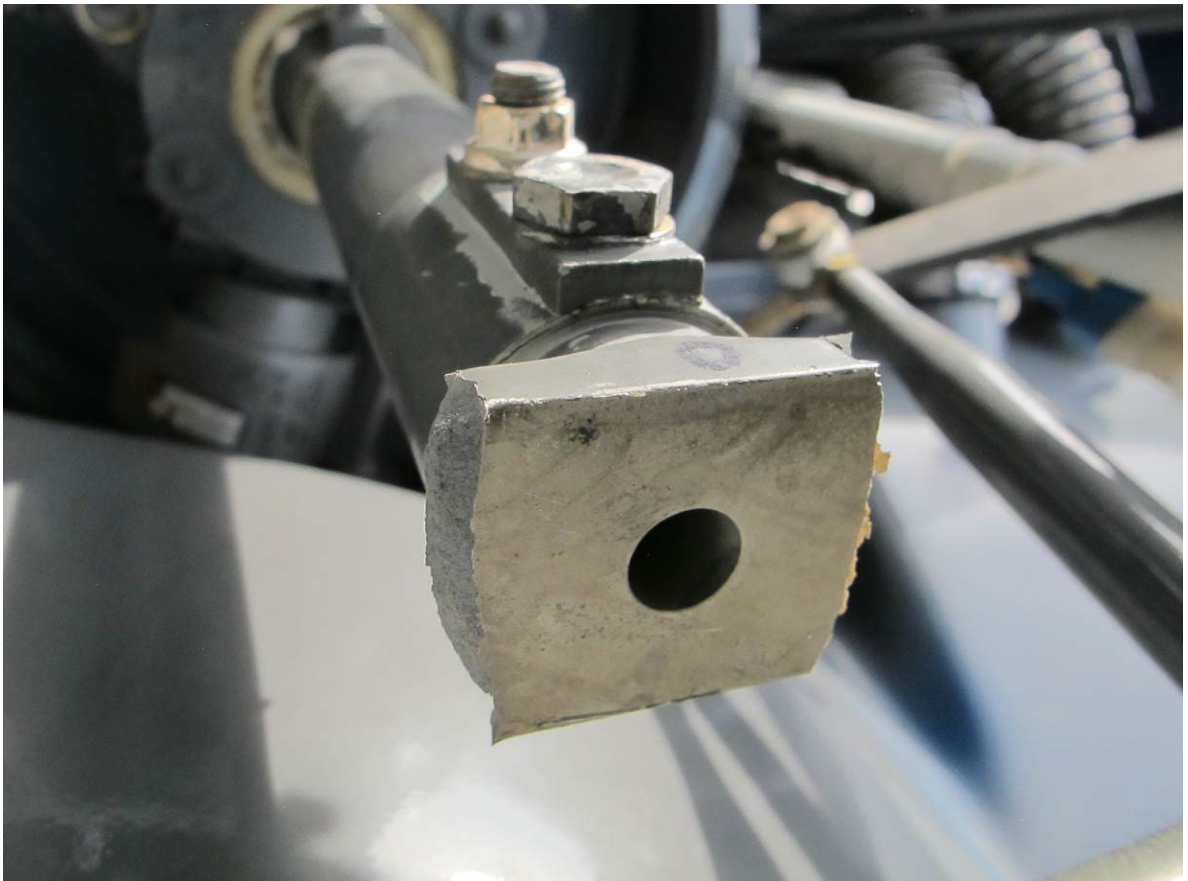
Both ears of the clutch shaft yoke of the intermediate flex coupling were bent and disconnected. The surface of the disconnect was angular and jagged. The flex plate was also bent.

Above and below: Disconnect in intermediate flex coupling.

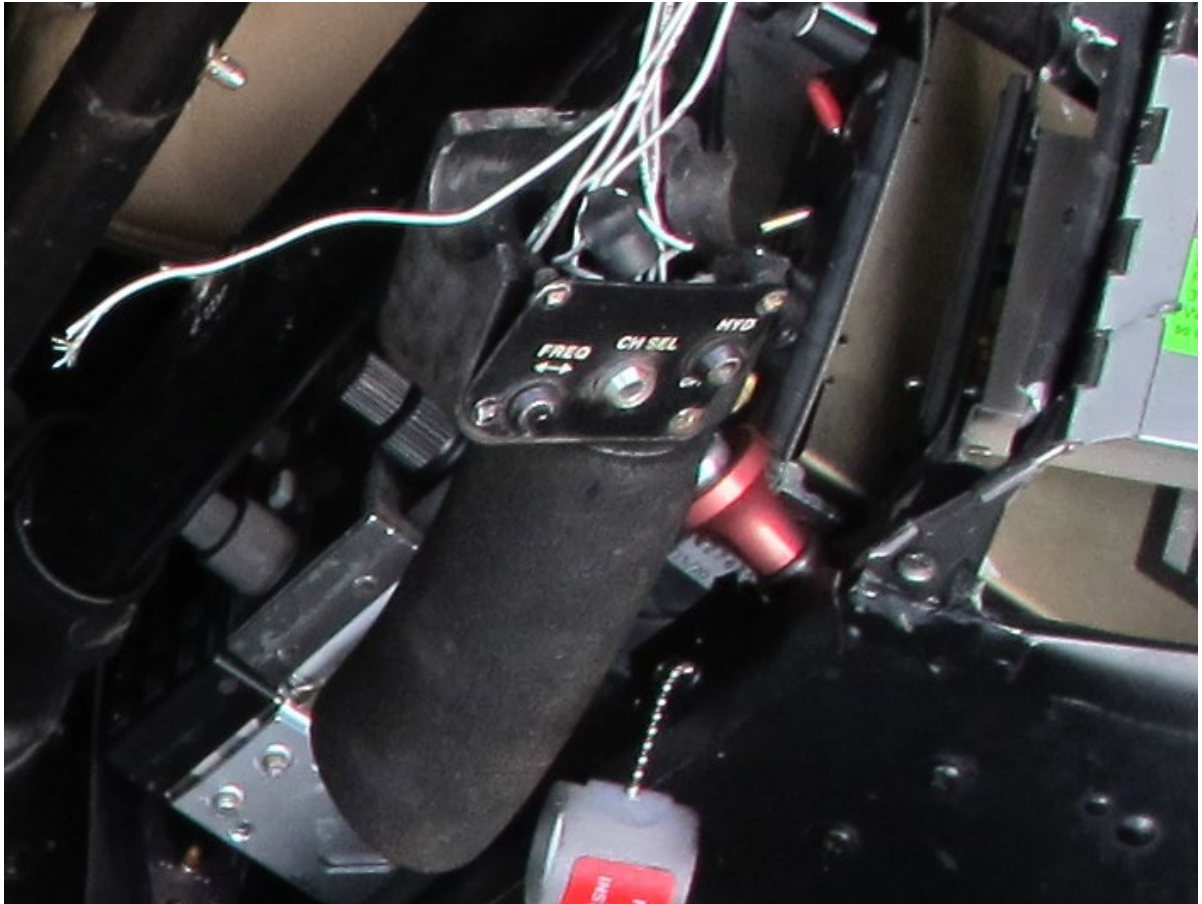
The flight control system had discontinuities at the locations indicated on the diagrams on pages 12.2 and 12.8. The disconnects are shown individually in the photographs that follow. No evidence of pre-impact failures of the flight control system was found. The center section of pitch link between disconnects C and D was not recovered.

Disconnect B at aft end of C121-19 push pull tube.

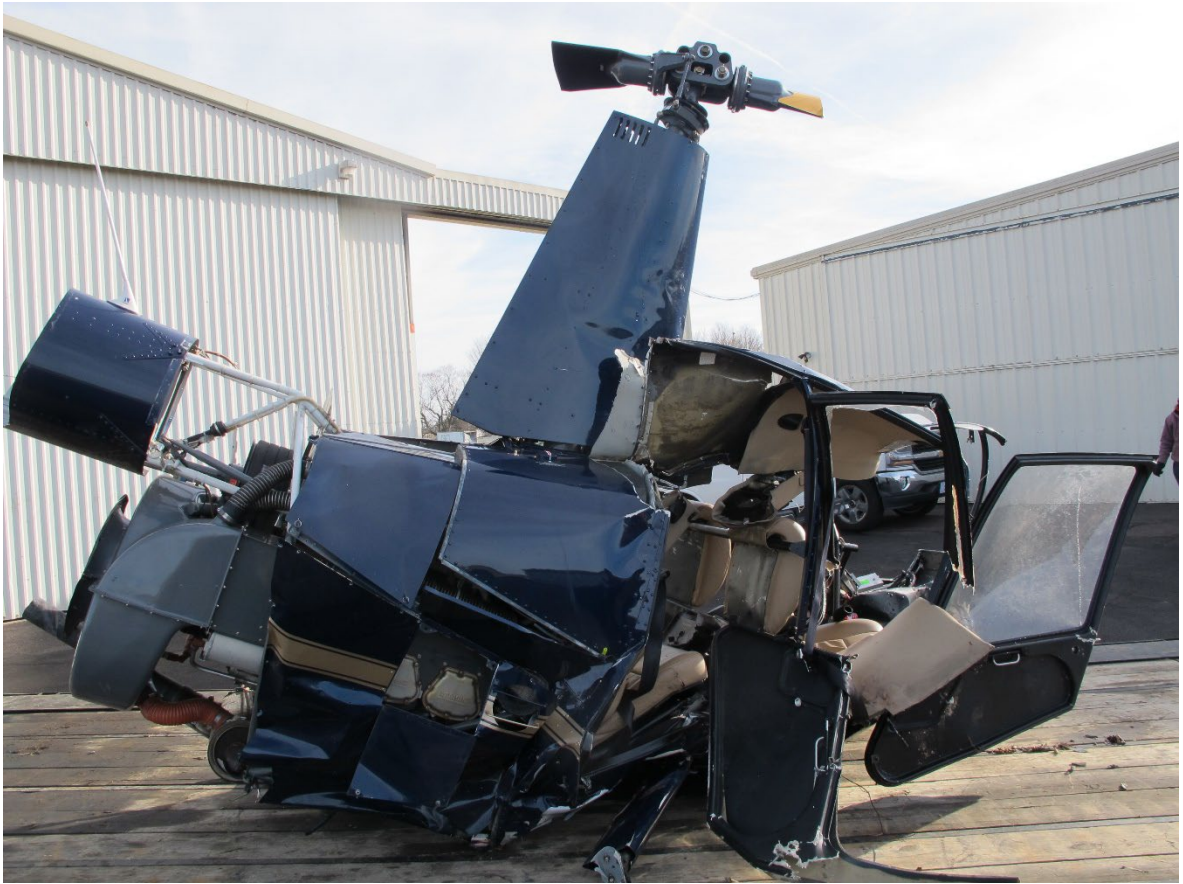
The fuselage and cowlings sustained impact damage with the belly and chin being deformed upward and aft. The door frames were distorted. Three doors remained attached to the cabin, the aft left door was separated. The windshields were shattered.

Right side of fuselage.

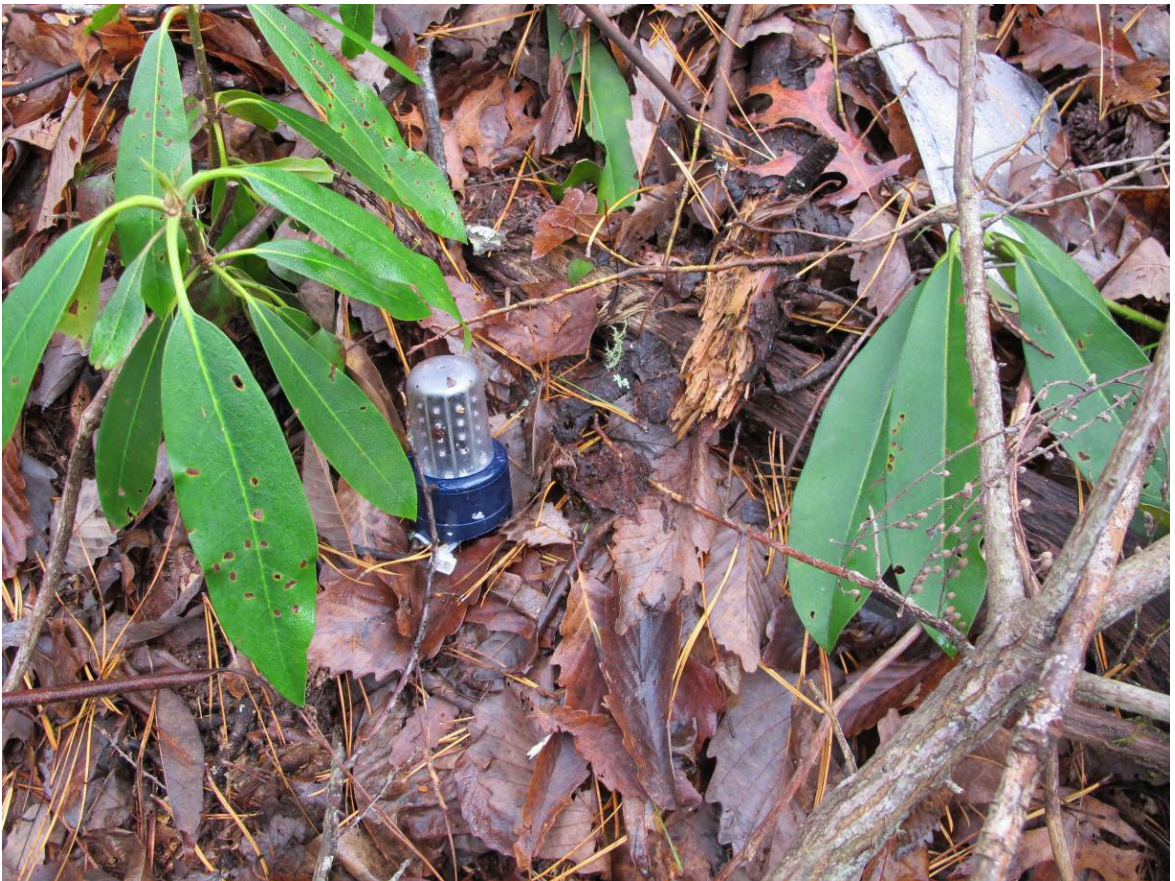
The forward end of the tailcone remained attached to the upper frame. Most of tailcone bay 6 was not located in the debris field although the strobe light and sections of the tail rotor guard were recovered in the immediate area. Tailcone bay 7 was separated from bay 6 at the bulkhead leaving the rivets sheared.

Strobe light.

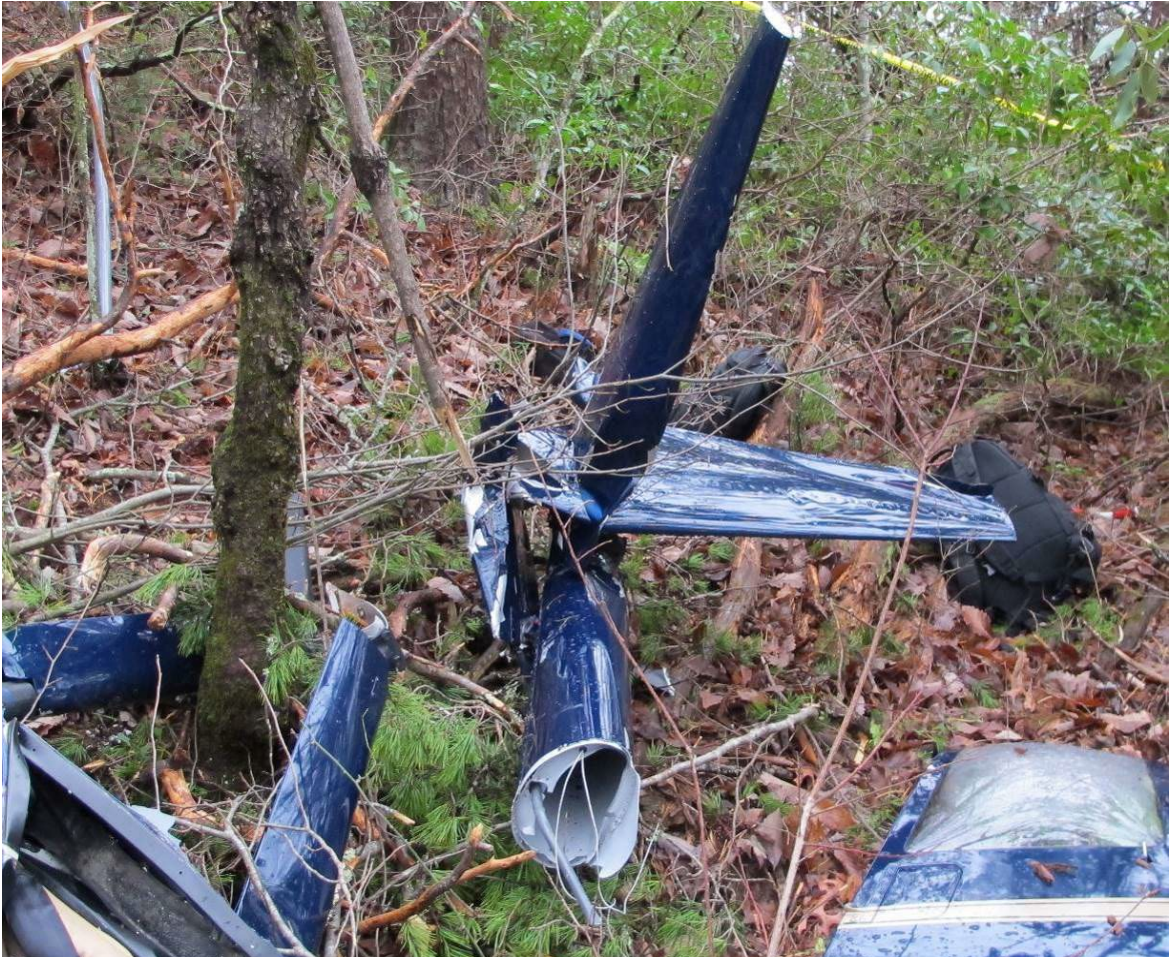
The empennage remained attached to the aft bulkhead. The bulkhead was partially disconnected across the center. The surface of the disconnect was rough and matte gray in color. The lower portion of the disconnected bulkhead was partially separated from bay 7. The lower vertical stabilizer was bent and folded up to the left with multiple dents and creases on the leading and trailing edges. The upper vertical and horizontal stabilizers had minor dents to their leading and trailing edges.

Separation between tailcone bay 7 and aft bulkhead casting.
