# National Transportation Safety Board

ERA22FA096

## **WRECKAGE EXAMINATION SUMMARY**

Location: Cosby, Tennessee  
Date: December 29, 2021  
Time: 1425 EST  
1925 UTC  
Helicopter: N544SC, Robinson Helicopter Company R-44 II

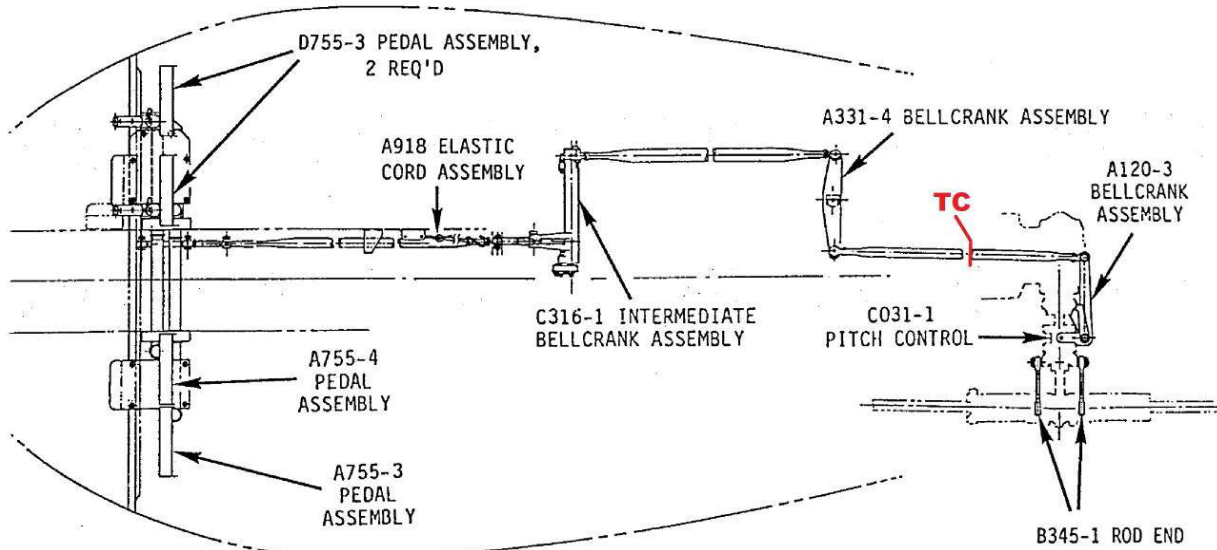
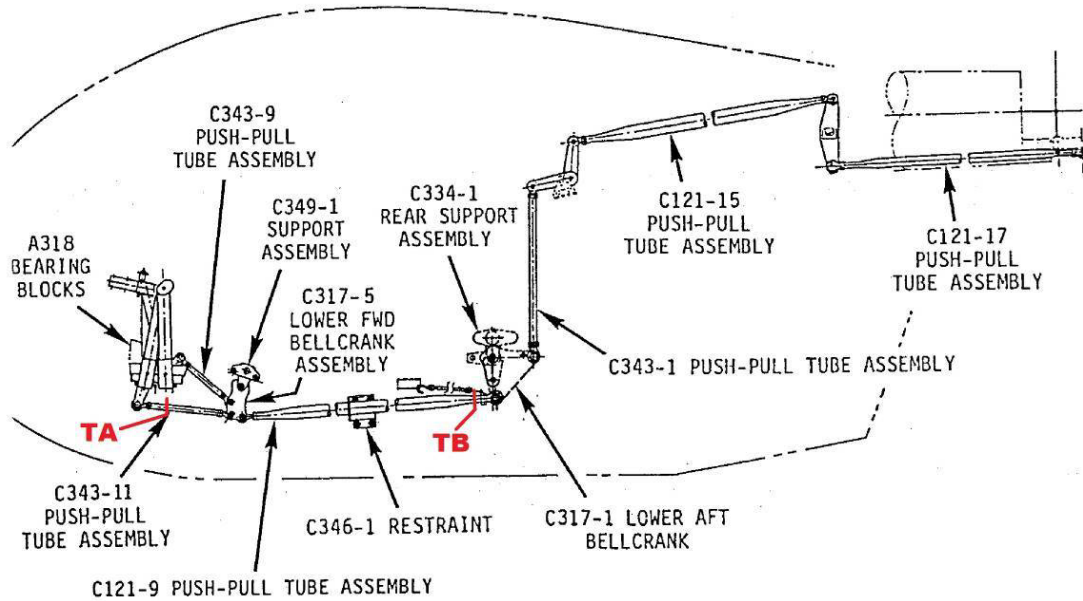
# TAIL ROTOR CONTROL SYSTEM

The flight control system had discontinuities at the locations indicated on the diagrams on pages 10 and 11. The disconnects are shown individually in the photographs that follow. No evidence of pre-impact failures of the flight control system was found. The center section of pitch link between disconnects C and D was not recovered.
