# NATIONAL TRANSPORTATION SAFETY BOARD

## Onboard Image Recorder

### Specialist's Factual Report By Sean Payne

Location: Crosby, TN  
Date: December 29, 2021  
Helicopter: Robinson R-44 II, N544SC  
Operator: Private  
NTSB Number: ERA22FA096

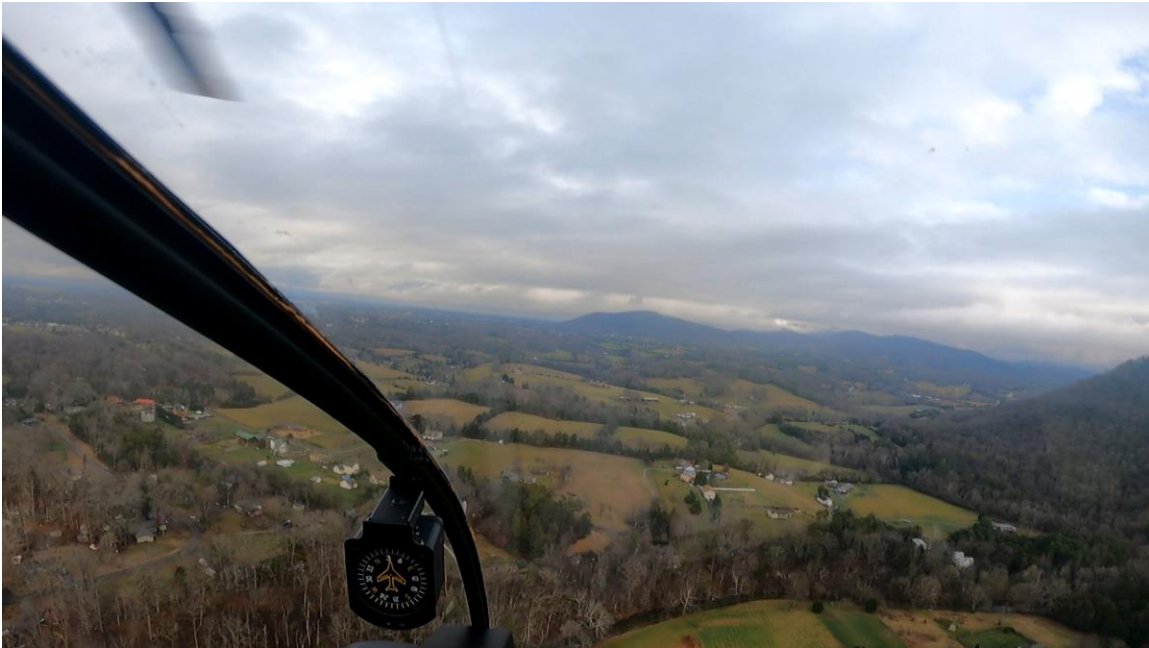
**Figure 1.** A screenshot of the GoPro recording at 02:14:54.

The video started at 2:14:54 EST. The helicopter was already in flight. Figure 1 is a screenshot at the start of the recording. Recorded audio revealed sounds of the helicopter, engine and rotor system consistent with normal operation. The helicopter was on a magnetic heading of roughly 030 degrees. GoPro GPS Metadata showed the helicopter's groundspeed was 92 knots and GPS altitude was 1470 feet.

The helicopter was at position 1 marked in the KML (figure 21 presented at the last page of this report). Ahead of the helicopter was rising terrain, portions of which contained mountain top obscuration. The cloud layer appeared broken at the helicopter's current position, and thickening ahead of the helicopter and up along the horizon.

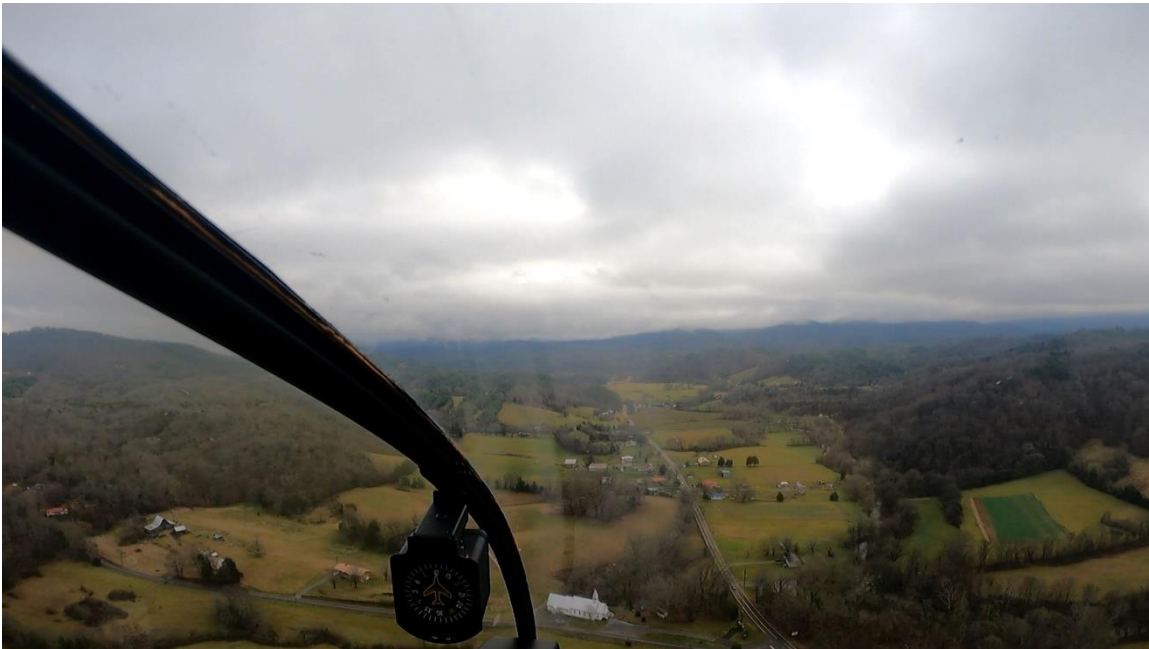
**Figure 2.** A screenshot of the GoPro recording at 2:16:02.

By 2:15:54, the helicopter had changed heading to the east. The helicopter appeared to be following State Road 339 in Sevier County, TN. The magnetic compass was showing roughly 120 degrees. The metadata showed the helicopter was at 90 knots and 1470 feet. Figure 2 is a screenshot of this time.

In figure 2, the helicopter was flying in a shallow valley. Ahead of the helicopter was rising terrain, portions of which contained mountain top obscuration. The area in the immediate vicinity of the helicopter appeared overcast and no longer broken.

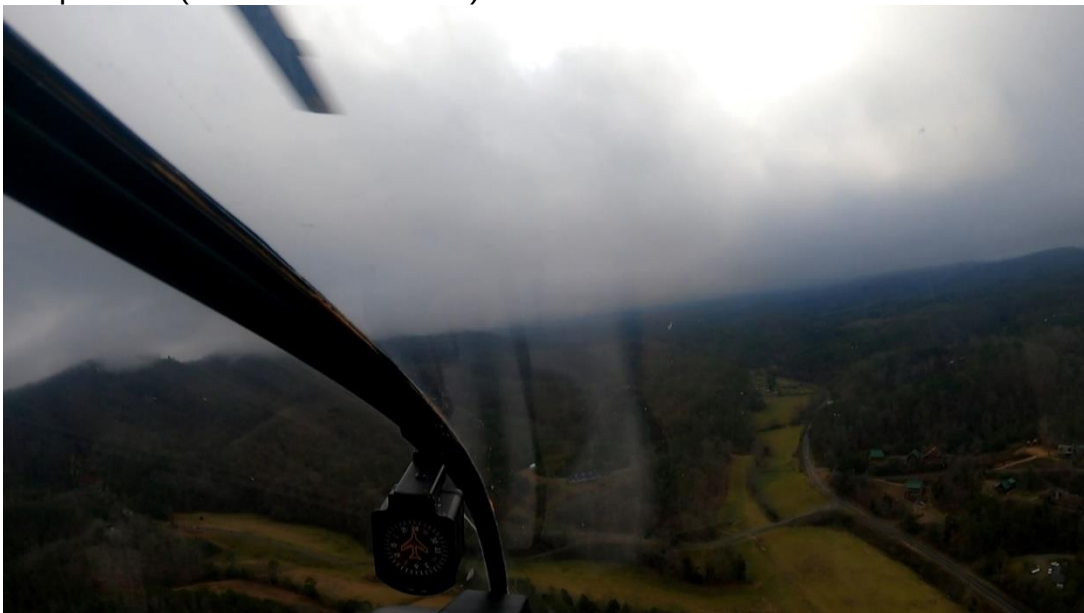
**Figure 3.** A screenshot of the GoPro recording at 2:17:13.

By 2:17:13, the helicopter had changed heading to the southwest. The helicopter appeared to be following Dixon Branch Road in Sevier County, TN. The magnetic compass was showing roughly 240 degrees. The metadata show the helicopter was at 91 knots and 1620 feet. Figure 3 is a screenshot of this time.

The helicopter continued to follow Dixon Branch Road in a shallow valley. The clouds ahead of the helicopter appeared thicker and solid overcast. There was obvious mountain top obscuration to the left of the helicopter's track. As noted by the metadata discussed above, the helicopter had descended slightly from the last noted position (from 1620 feet MSL).

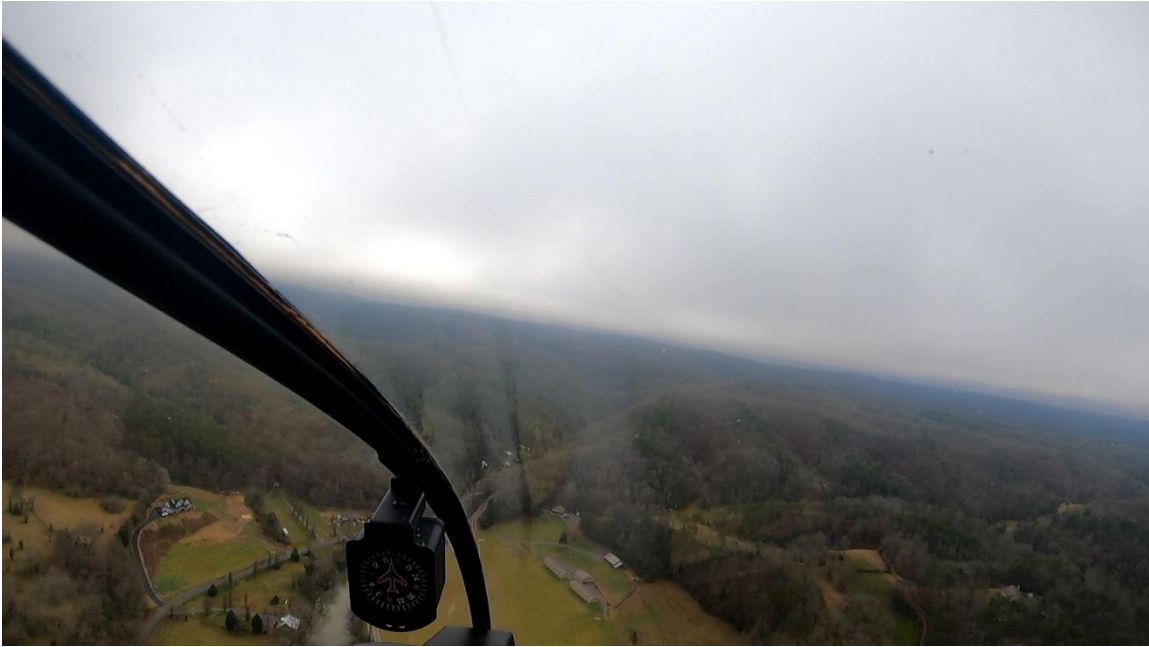
**Figure 4.** A screenshot of the GoPro recording at 2:18:20.

At 2:18:20, the helicopter had taken a track consistent with following State Road 416 in Sevier County, TN. Metadata show the helicopter was at 90 knots and 1688 feet. Figure 4 is a screenshot of this time.

Figure 4 showed the terrain ahead appeared to be rising. There was a solid overcast layer ahead. There appeared to be a horizon available, however, it was difficult to determine if there was mountain top obscuration ahead.

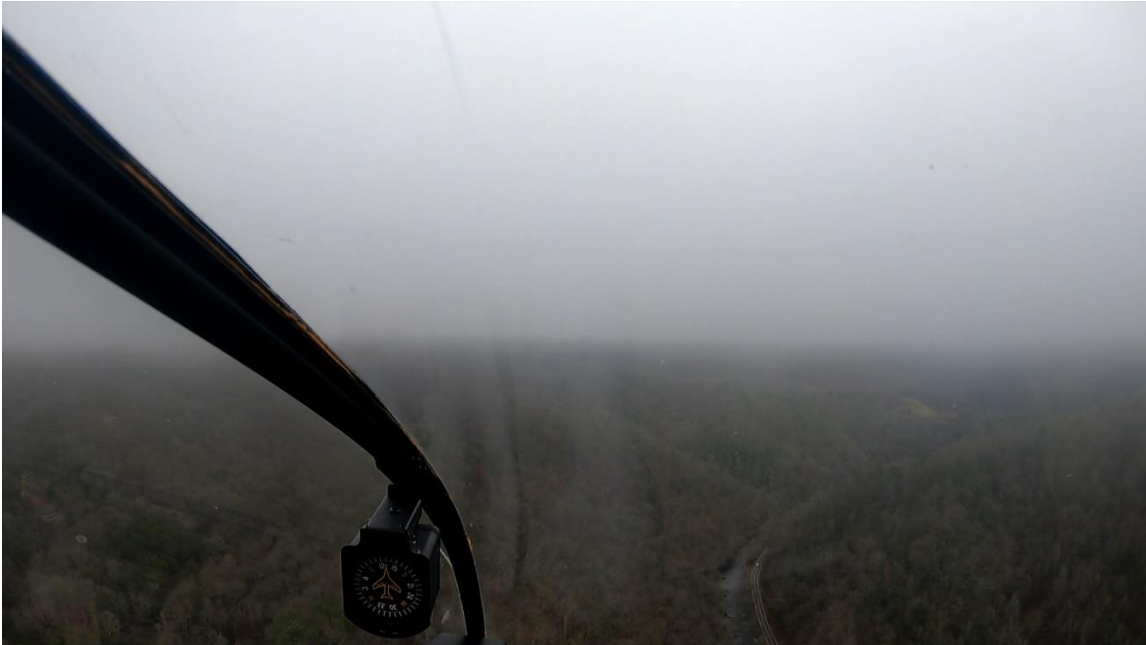
**Figure 5.** A screenshot of the GoPro recording at 2:19:35.

At 2:19:35, the helicopter had entered visible moisture. The helicopter flew in and out of the base of the overcast layer. Visibility ahead of the helicopter appeared significantly reduced. The metadata show the helicopter was at 85 knots and 1865 feet. The helicopter had descended slightly from the altitude noted previously. Figure 5 is a screenshot at this time.

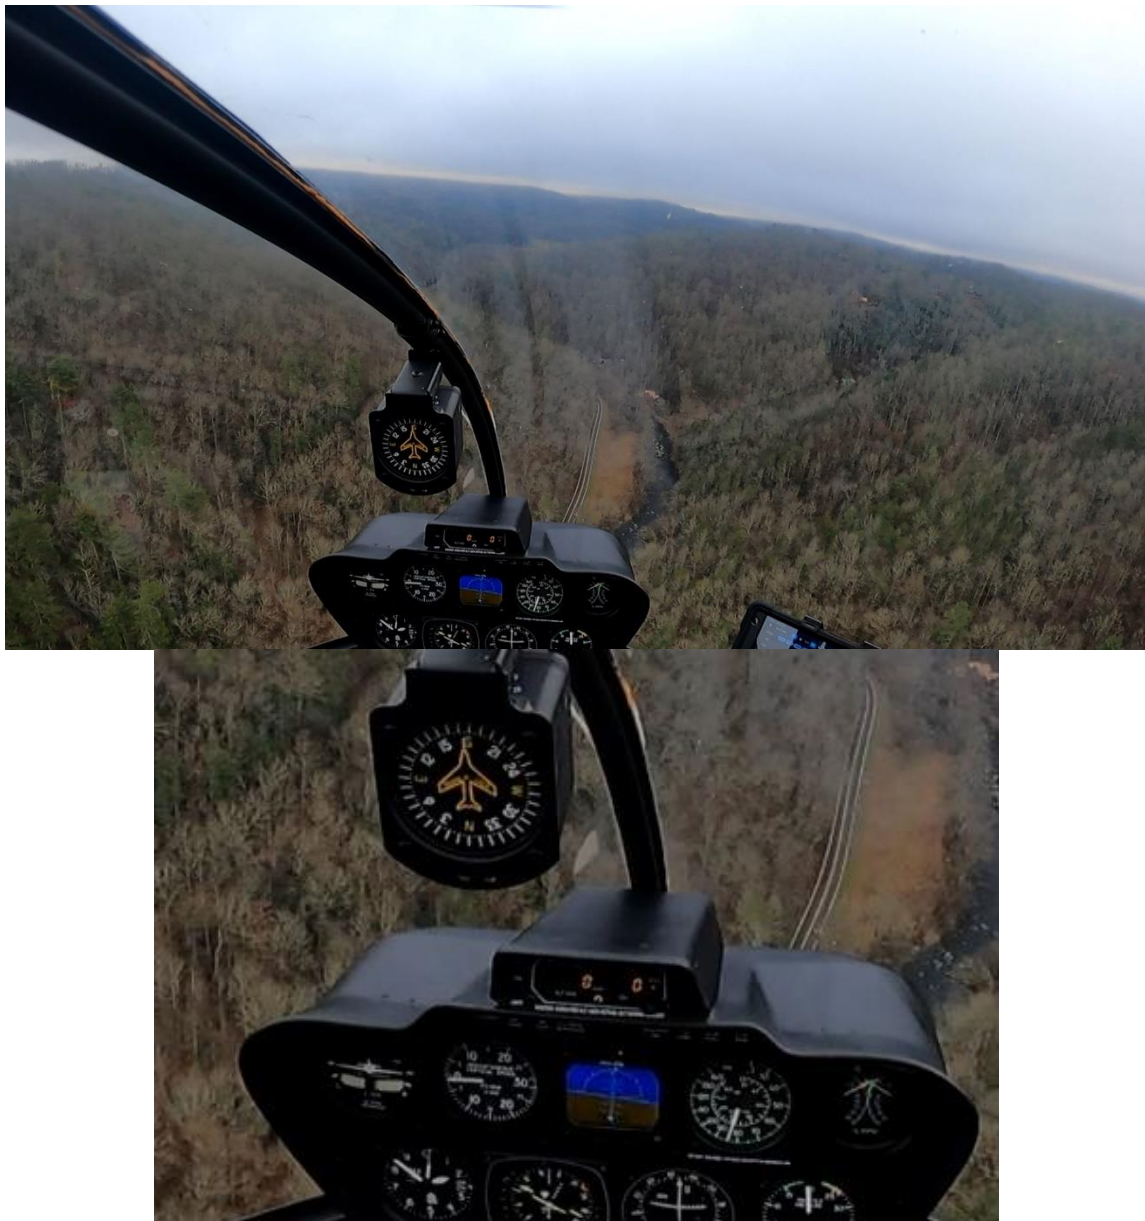
**Figure 6.** A screenshot of the GoPro recording at 2:20:26.

Around 2:20:26, the helicopter had entered an area of increased visibility. The helicopter was over State Road 416. Figure 6 is a screenshot at this time. The metadata show the altitude was 1847 feet and 93 knots.

At this time (figure 6, 2:20:26), the left seat passenger had changed the view of the GoPro to more of a downward angle and the upper instrument panel was captured. The change in camera view was not related to the increase in visibility that was present ahead of the helicopter. An addition subfigure for each figure that captured the helicopter's instrument panel depicts a zoomed and cropped screenshot of the instrument panel at the same moment.

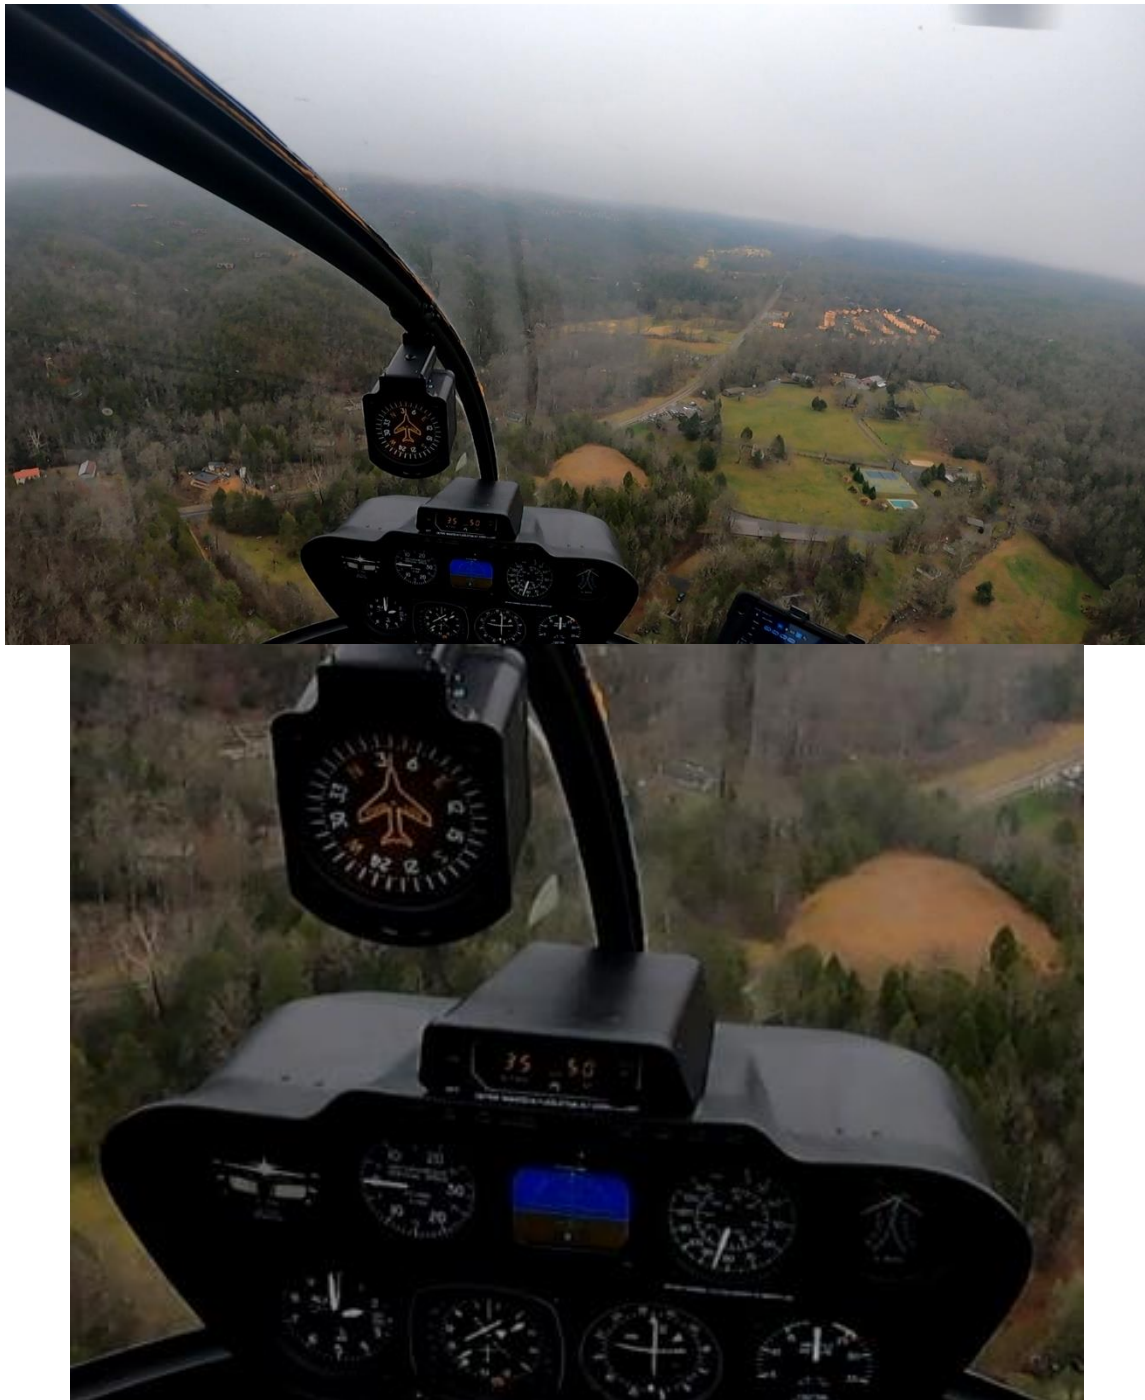
**Figure 7.** A screenshot of the GoPro recording at 2:22:02

By 2:22:02, the helicopter had emerged from flying over the hilltop and picked up a track line that followed State Road 321. Figure 7 is a screenshot at this time. Metadata showed the helicopter was at 94 knots and 1986 feet.

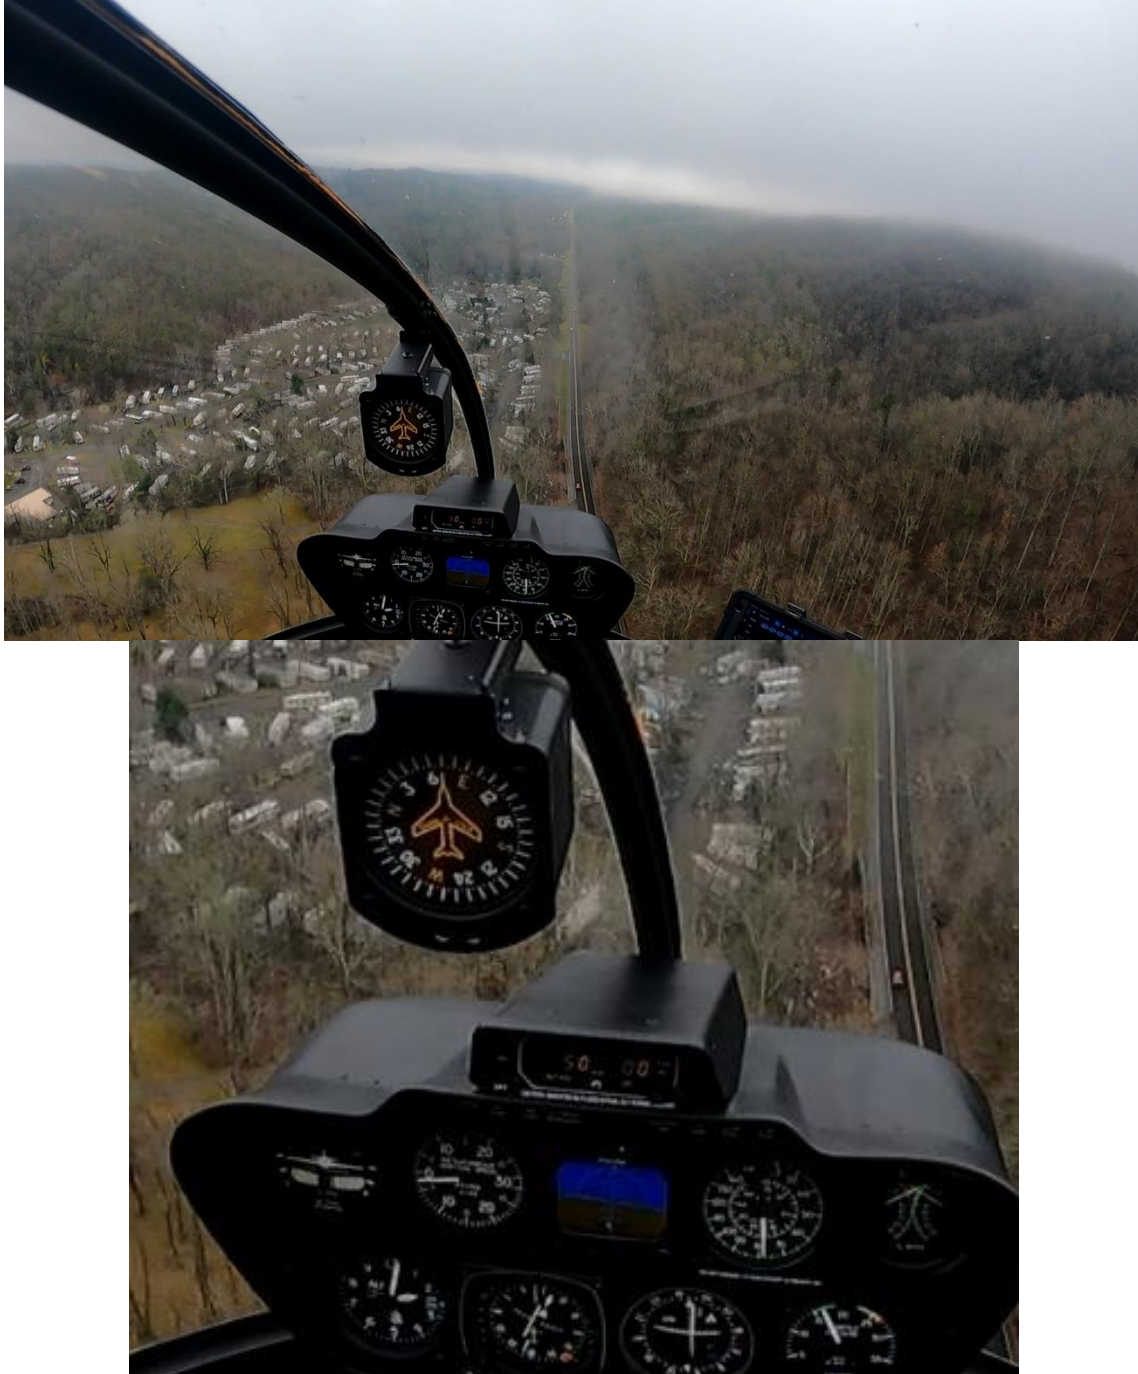
**Figure 8.** A screenshot of the GoPro recording at 2:23:00

The helicopter continued to track east on State Road 321. At times, the helicopter entered visible moisture at the base of the overcast cloud layer. By 02:23:00, the helicopter was directly over State Road 321 near an RV Park (*Outdoor Resorts at Gatlinburg*). The metadata show the helicopter's altitude was 86 knots and 2020 feet. There was rising terrain and mountain top obscuration ahead of the helicopter.

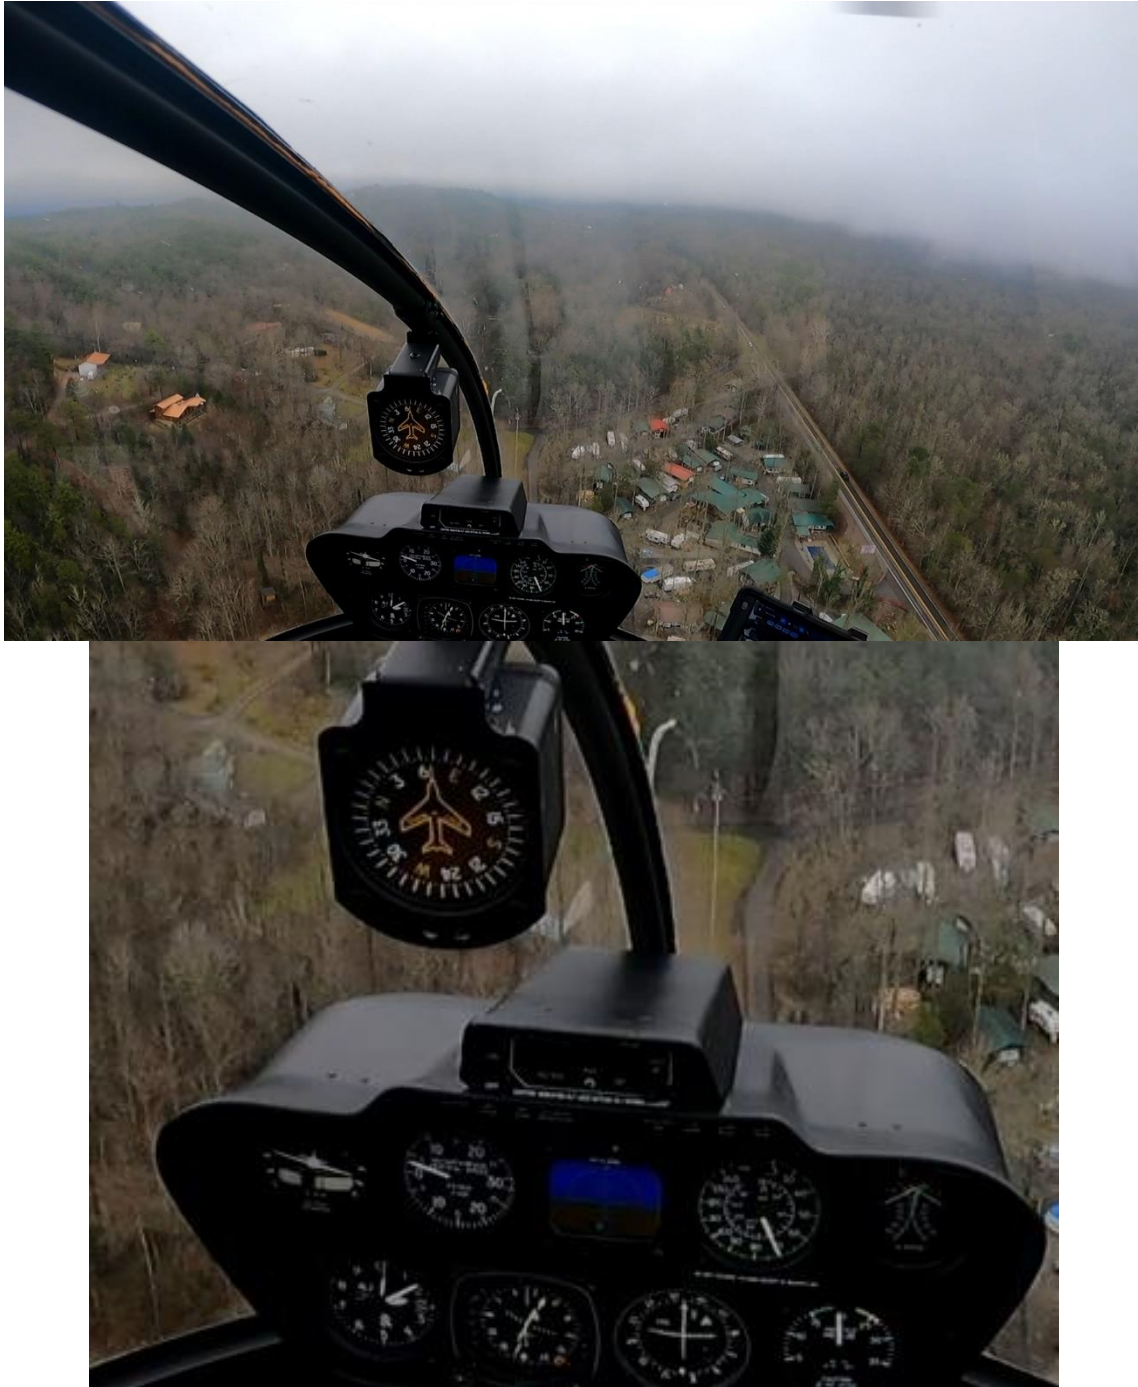
**Figure 9.** A screenshot of the GoPro recording at 2:23:56

By 2:23:56, metadata show the helicopter continued to climb as it approached rising terrain. The metadata showed the helicopter was at 77 knots and 2150 feet. The helicopter was over *Arrow Creek Campground* (State Road 321). There was rising terrain and mountain top obscuration ahead of the helicopter. Figure 9 is a screenshot at this time.

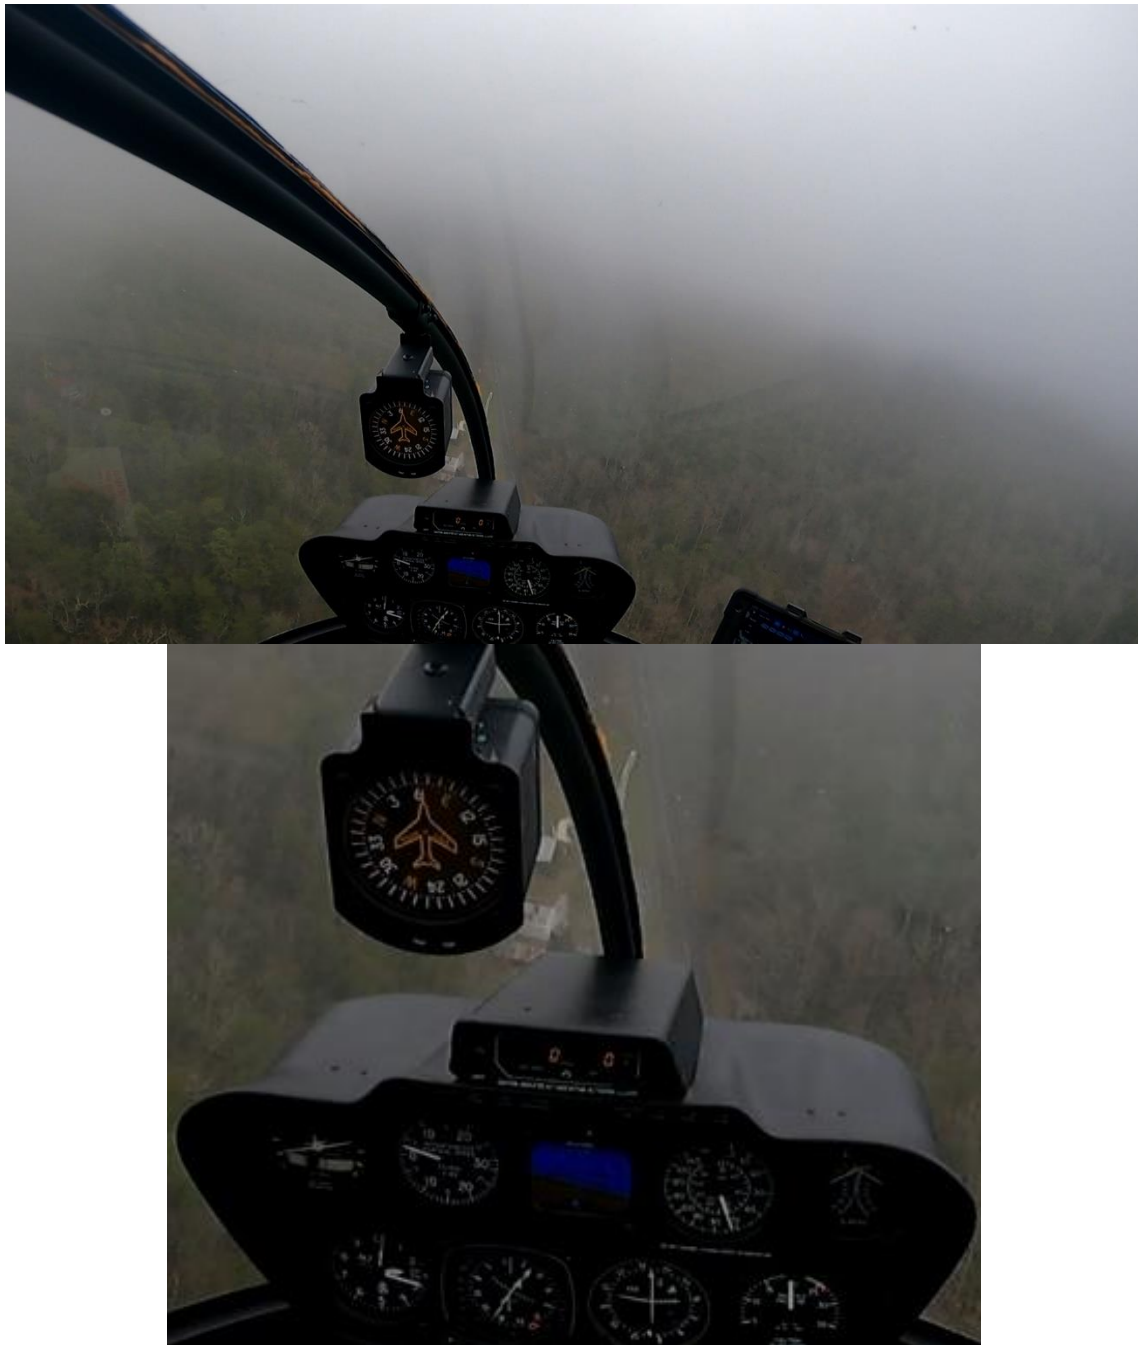
**Figure 10.** A screenshot of the GoPro recording at 2:24:22.

By 2:24:22, the helicopter had climbed and continued ahead on State Road 321. Metadata show the helicopter groundspeed was 82 knots and altitude was 2287 feet. The helicopter had entered the base of the overcast layer. Objects on the ground appeared as if they were closer to the helicopter (terrain had risen). The helicopter was in a slight left bank. Note that the camera's point of view is angled downward and may not be representative of the helicopter pilot's field of view. Figure 10 is a screenshot at this time.

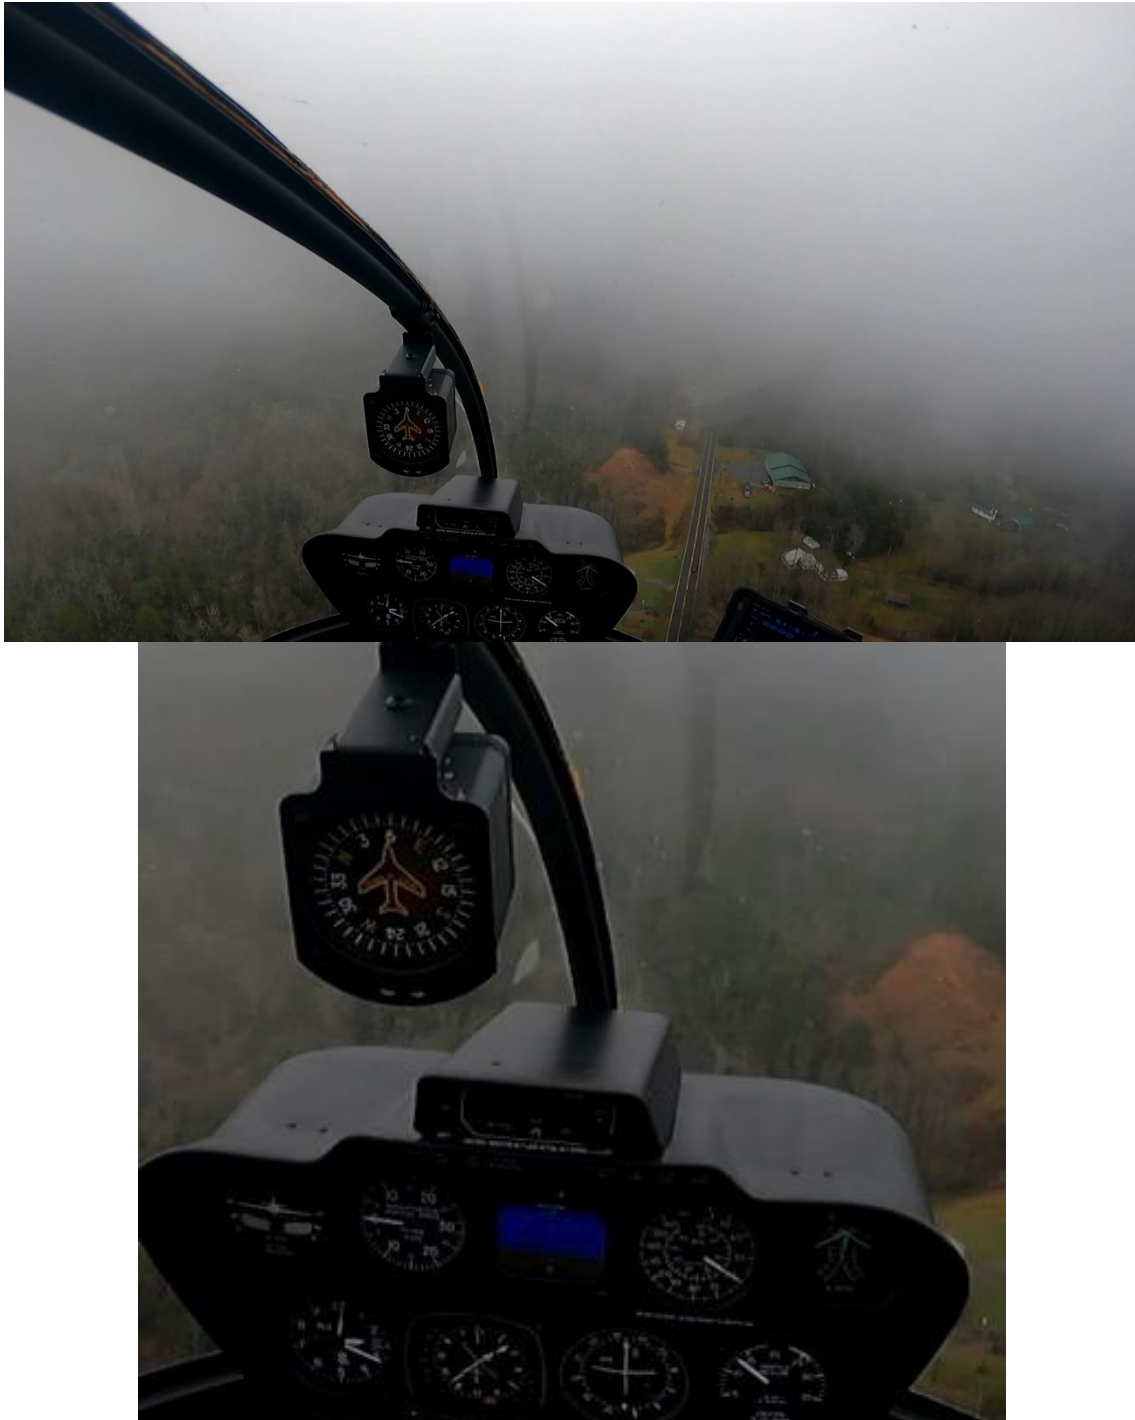
**Figure 11.** A screenshot of the GoPro recording at 2:24:34.

At 2:24:34, there was a decreasing trend beginning in the helicopter's airspeed and groundspeed metadata. The metadata show the groundspeed was 64 knots and the altitude was 2320 feet. At this time, the manifold pressure indicator was reduced and displayed about 13 inHg. The helicopter appeared to be in the base of the overcast cloud layer. The helicopter was approaching Pittman Volunteer Fire Department on State Road 321. Figure 11 is a screenshot at this time.

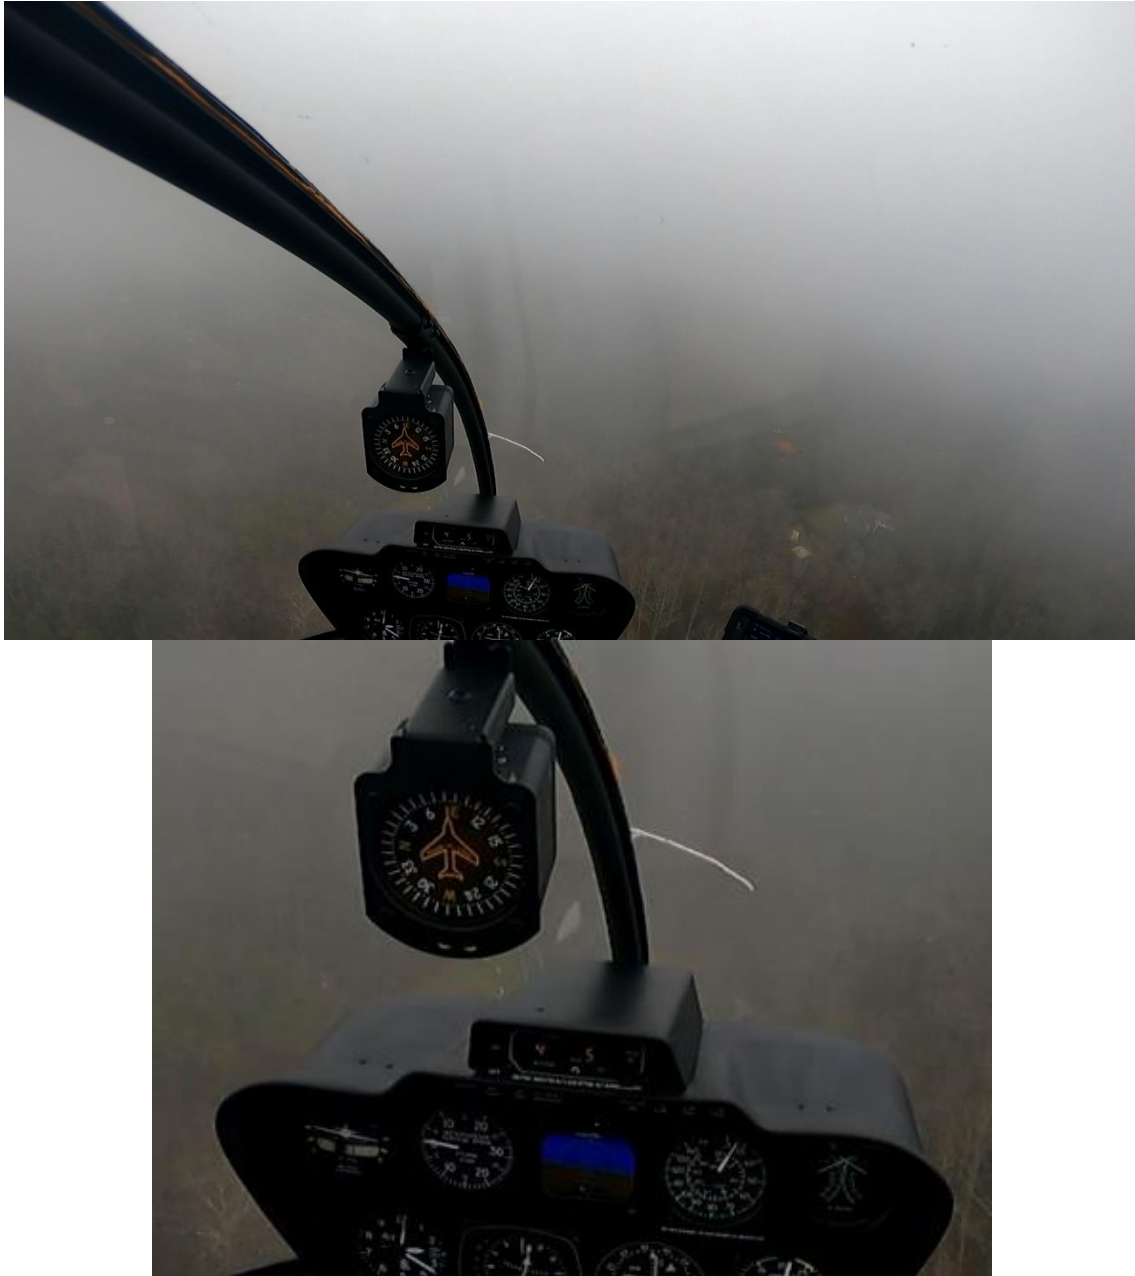
**Figure 12.** A screenshot of the GoPro recording at 2:24:48.

At 2:24:48, power was increased to 19 inHg, indicated airspeed had slowed to less than 20 knots and altitude appeared to have been maintained (around 2320 MSL). GoPro GPS Metadata show 25 knots of groundspeed and 2347 feet. The helicopter was solidly in the base of the overcast layer. As the indicated airspeed decreased to less than 20 knots, the attitude indicator at first showed the helicopter was rotors level but in a slight nose up pitch, indicating the helicopter was in a slowing attitude but maintaining altitude. Manifold pressure began holding about 19 inHg. The yaw string on the windscreen was pointing hard right (indicated a left yaw trend). Figure 12 is a screenshot at this time.

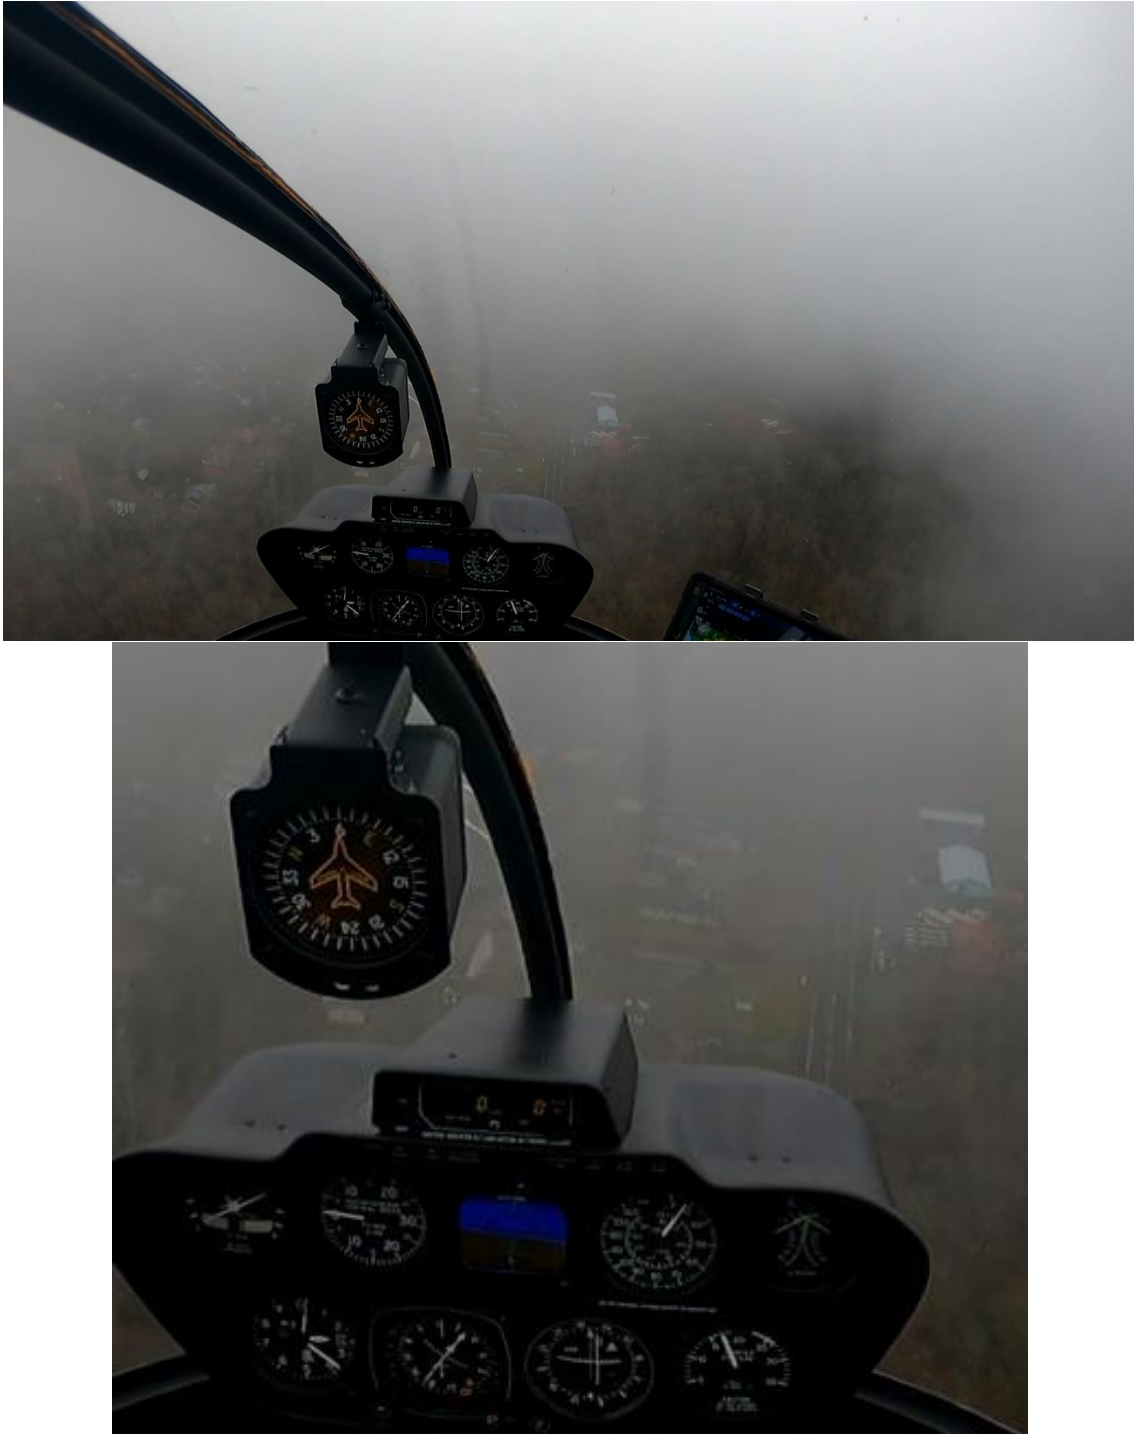
**Figure 13.** A screenshot of the GoPro recording at 2:25:00.

Figure 13 is a screenshot taken at 2:25:00 local time. Manifold pressure decreased to 17 inHg. indicated airspeed had a decreasing trend, and the altimeter showed altitude remained around 2350 MSL. The helicopter was in a slight left bank. The helicopter was enveloped in the base of the overcast layer. Note that the camera's point of view is angled downward and may not be representative of the helicopter pilot's field of view.

Around this time, the pilot's iPad was visible. The pilot's iPad was running ForeFlight. There appeared to be a flight plan entered that consisted of four airport identifier waypoints. The airport waypoints were unable to be determined. The ForeFlight app also appeared to display a NEXRAD radar overlay. The overlay showed areas of green and yellow precipitation.

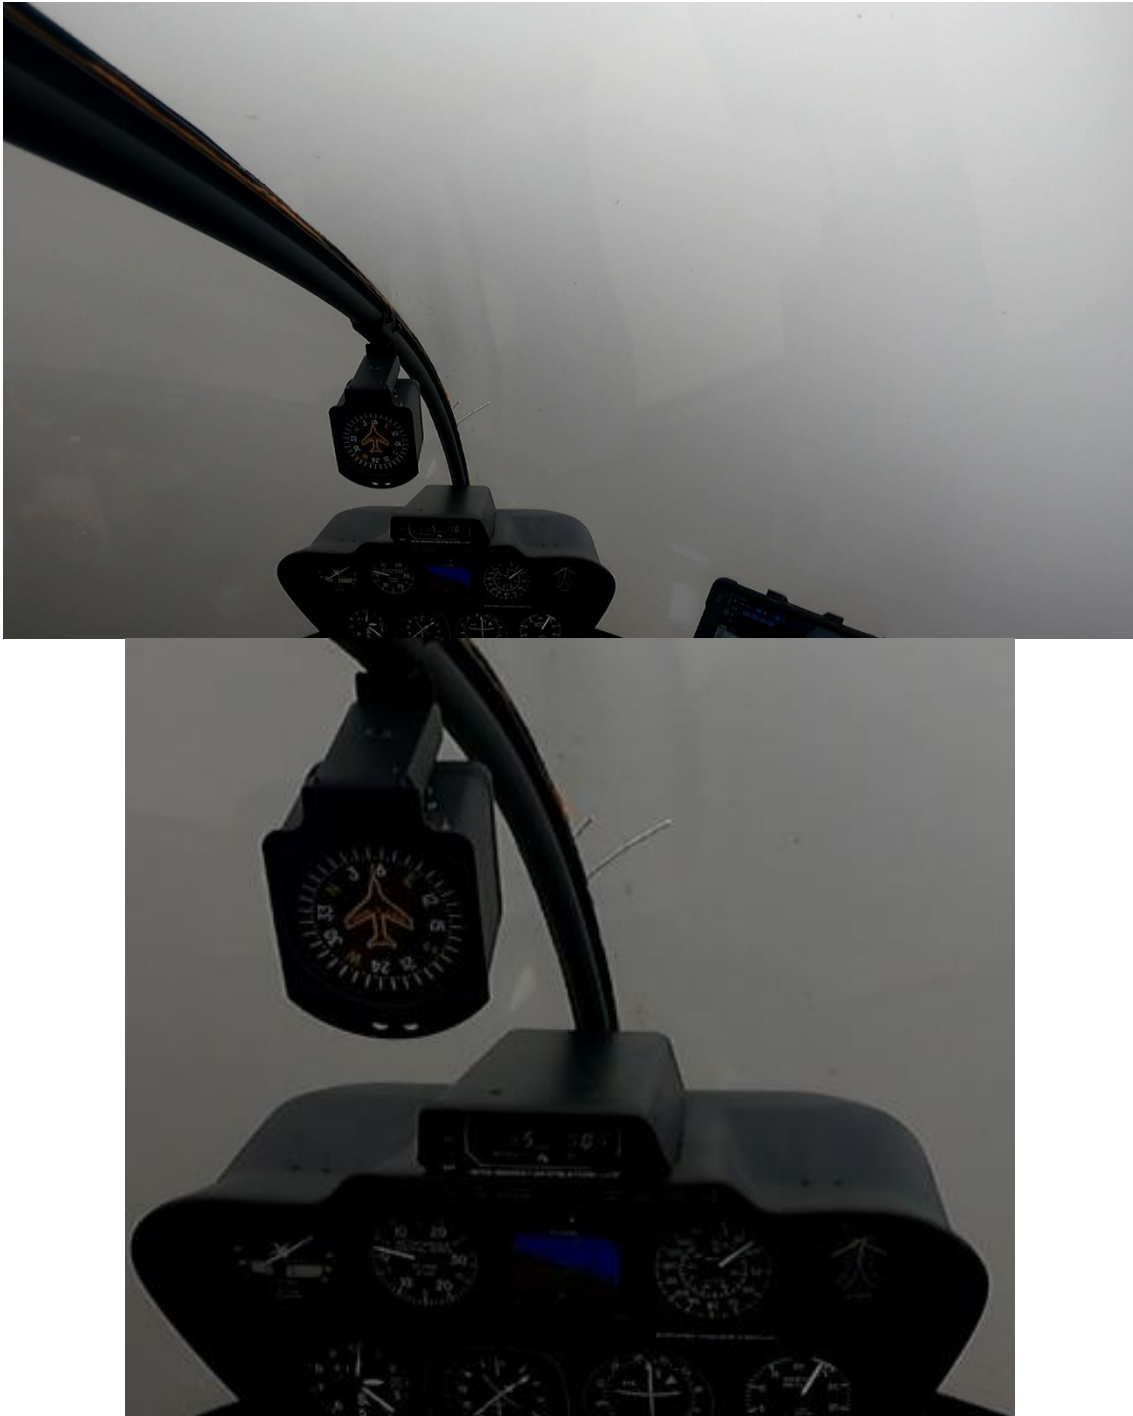
**Figure 14.** A screenshot of the GoPro recording at 2:25:07.

Figure 14 is a screenshot taken at 2:25:07. The manifold pressure gauge showed an increased power setting to 28 inHg (beyond the red arc), the attitude indicator showed an increasing left bank trend and a nose down attitude. Airspeed increased slightly to about 35 knots indicated. The yaw string was pointing slightly right. The group characterized the outward and forward visibility based on the camera's point of view as "zero visibility."

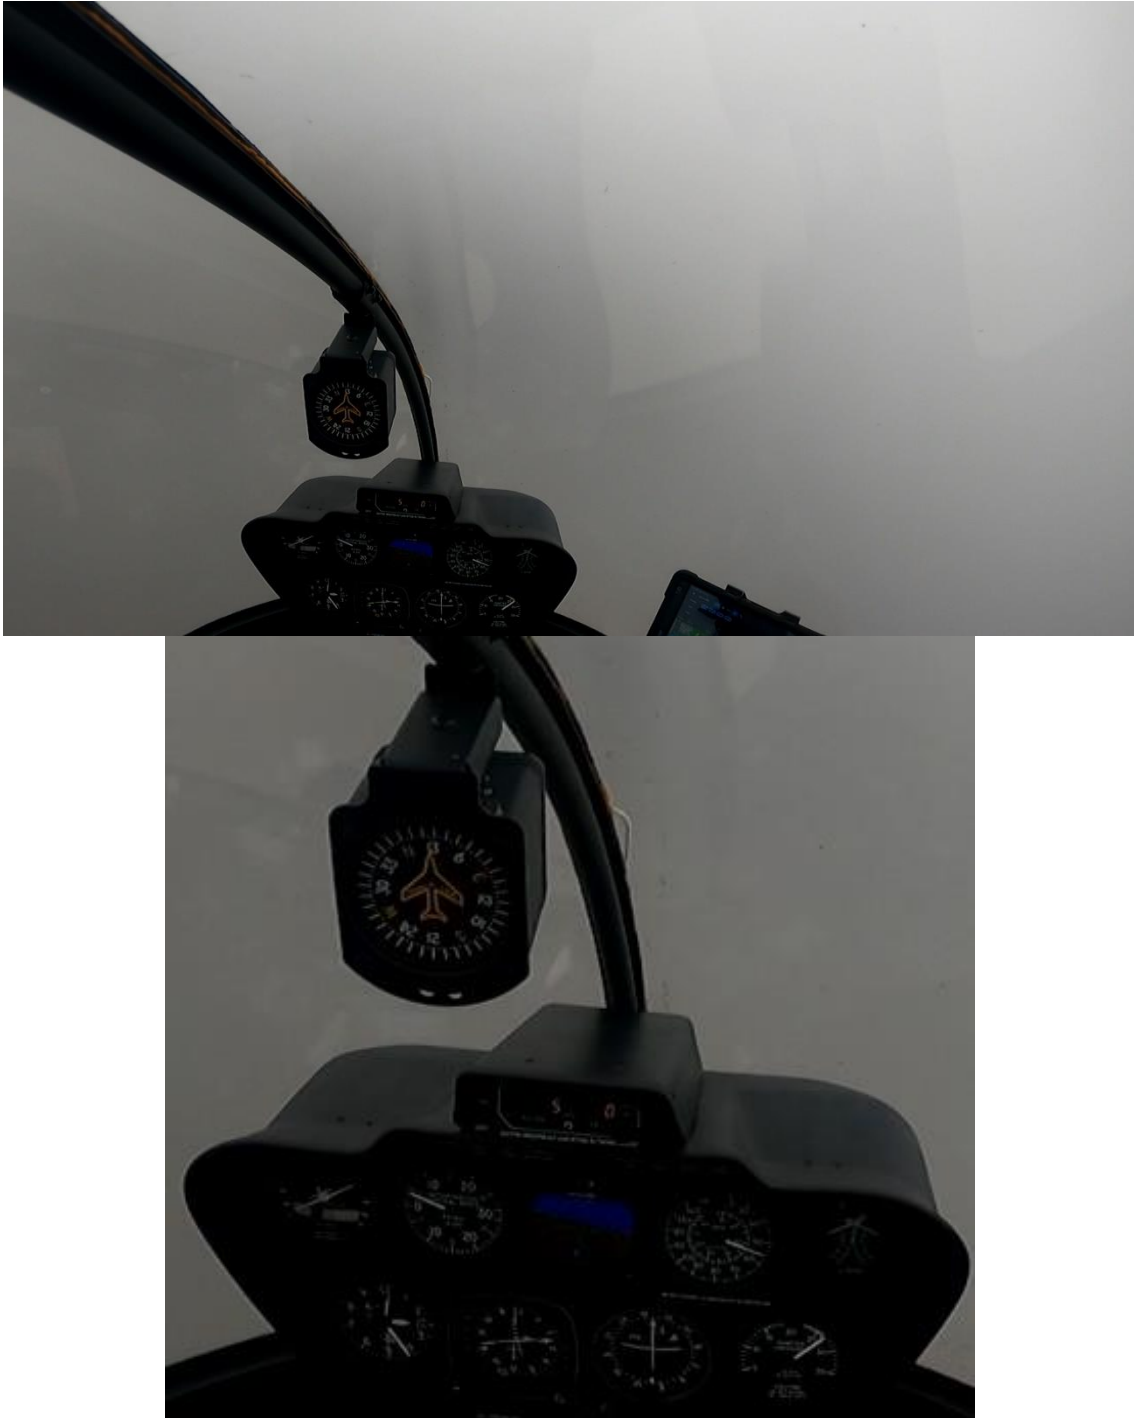
**Figure 15.** A screenshot of the GoPro recording at 2:25:11.

Figure 15 is taken 4 seconds later at 2:25:11. Indicated airspeed had increased (57 knots indicated), altitude had increased slightly, manifold pressure had increased beyond 27 inHg (beyond red arc zone). The helicopter had a significant left bank angle and a nose down pitch attitude (referencing the attitude indicator).
