# NATIONAL TRANSPORTATION SAFETY BOARD

## Onboard Image Recorder

### Specialist's Factual Report By Sean Payne

Location: Crosby, TN  
Date: December 29, 2021  
Helicopter: Robinson R-44 II, N544SC  
Operator: Private  
NTSB Number: ERA22FA096

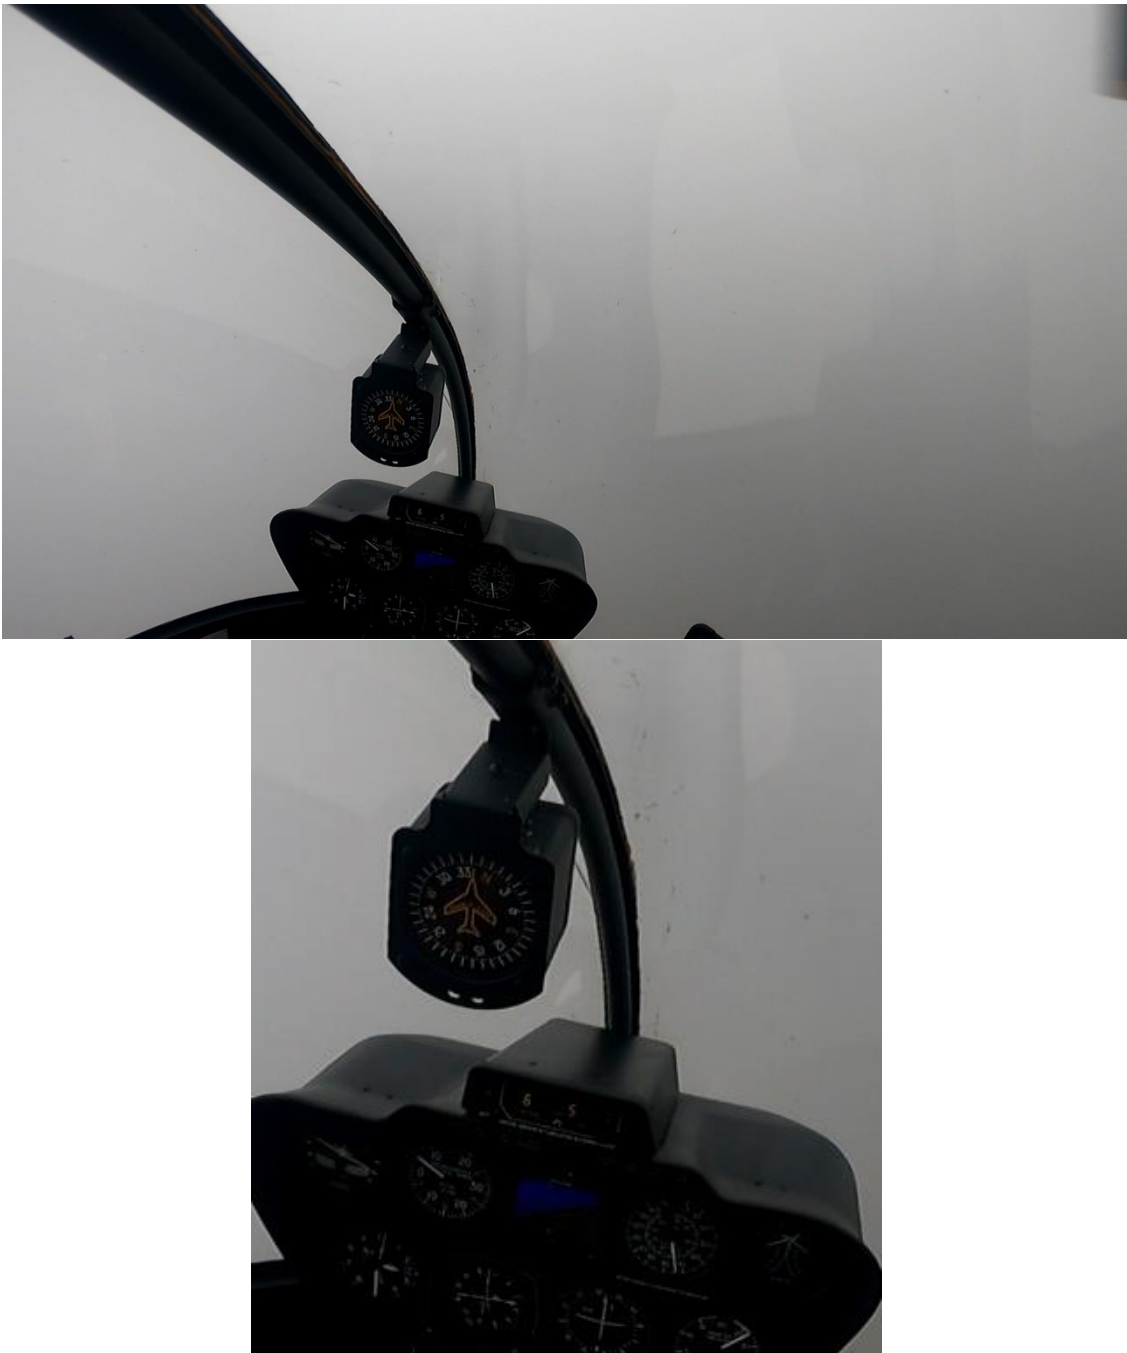
**Figure 16.** A screenshot of the GoPro recording at 2:25:18.

For the next approximately 11 seconds, the manifold pressure indicator stayed at about 27 inHg (beyond the red arc). Airspeed during this time, increased to about 74 knots indicated, altitude had showed a climb to about 2500 feet MSL. The helicopter was now in a right bank, slightly nose down (referenced to the attitude indicator). There appeared to be no visual references available outside the windscreen (based on the camera's field of view). Figure 16 is presented below at time 2:25:18.

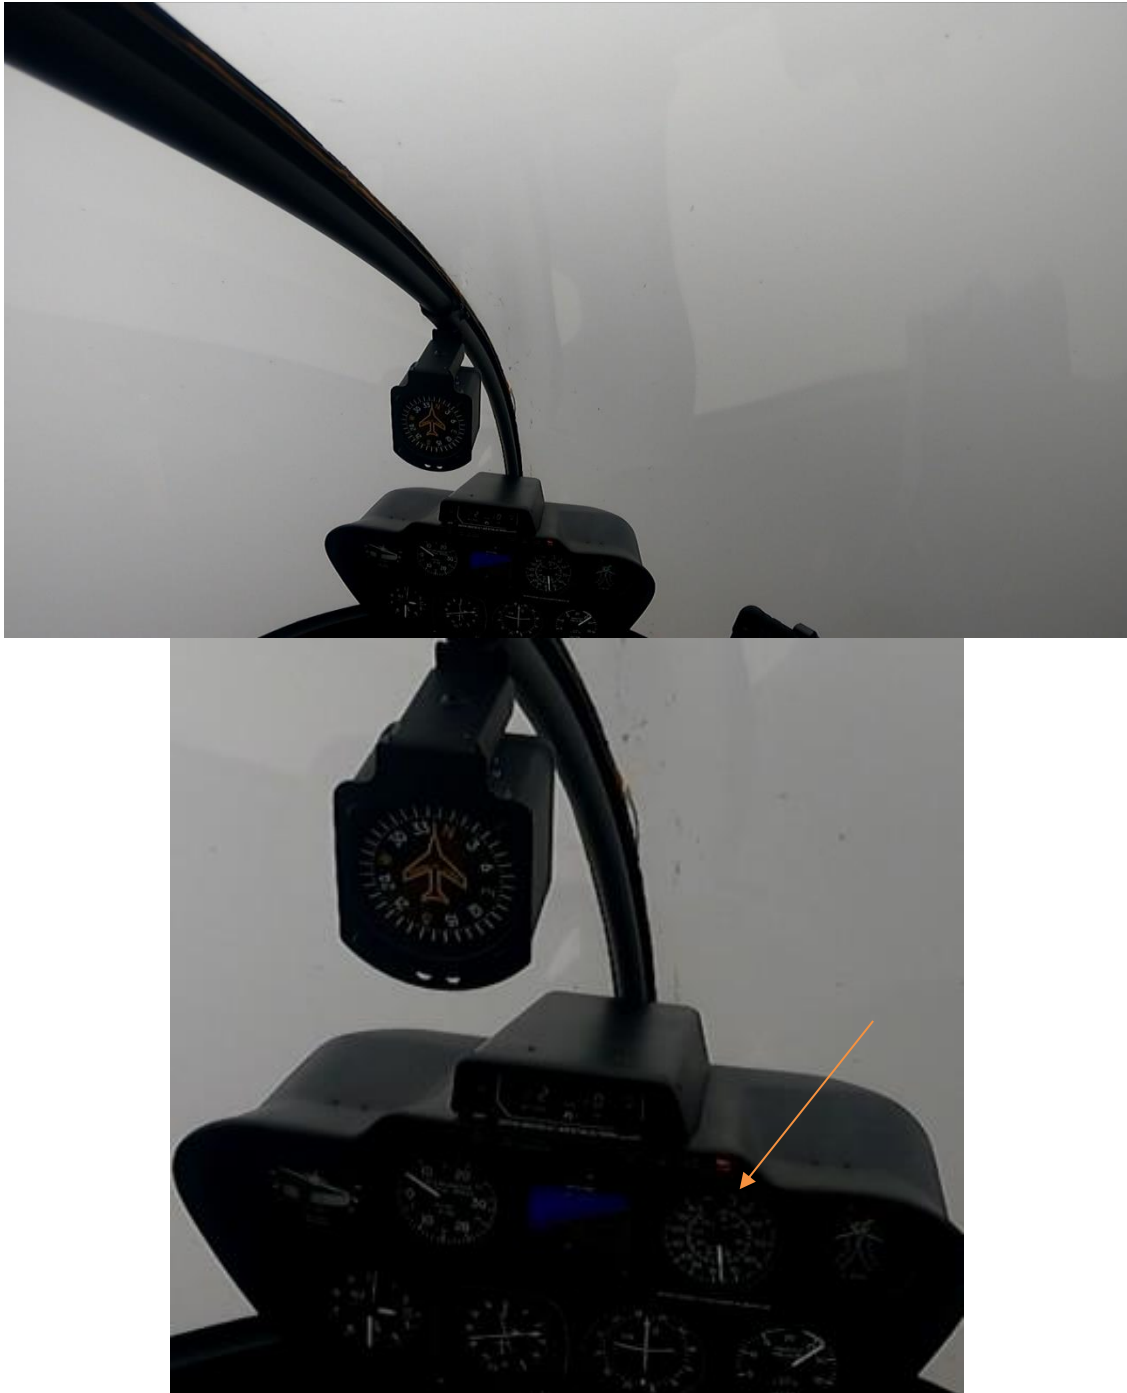
At 2:25:20, airspeed continued to increase to almost 80 knots indicated, altitude stayed around 2500 feet MSL and manifold pressure was still maintained around 27 inHg (beyond the red arc). The low rotor RPM warning light illuminated and the low rotor RPM horn was audible on the audio track. The engine and rotor rpm tach needles indicated around 90%. Figure 17 is a screenshot at this time, an arrow points to the low rotor RPM warning light.

**Figure 17.** A screenshot of the GoPro recording at 2:25:20. An arrow points to the low rotor RPM warning light.

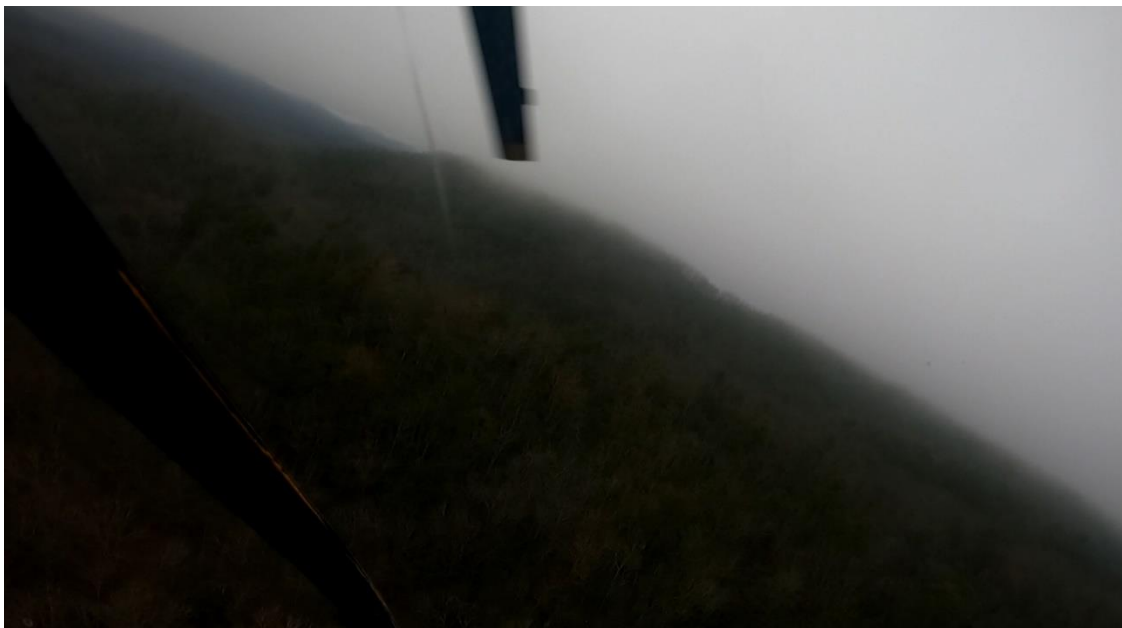
**Figure 18.** A screenshot of the GoPro recording at 2:25:30.

Figure 18 is a screen capture taken at 2:25:30. As the helicopter continued to break out of the overcast layer, terrain suggested the helicopter was yawing rapidly to the left (yaw and roll had just reversed from the right).

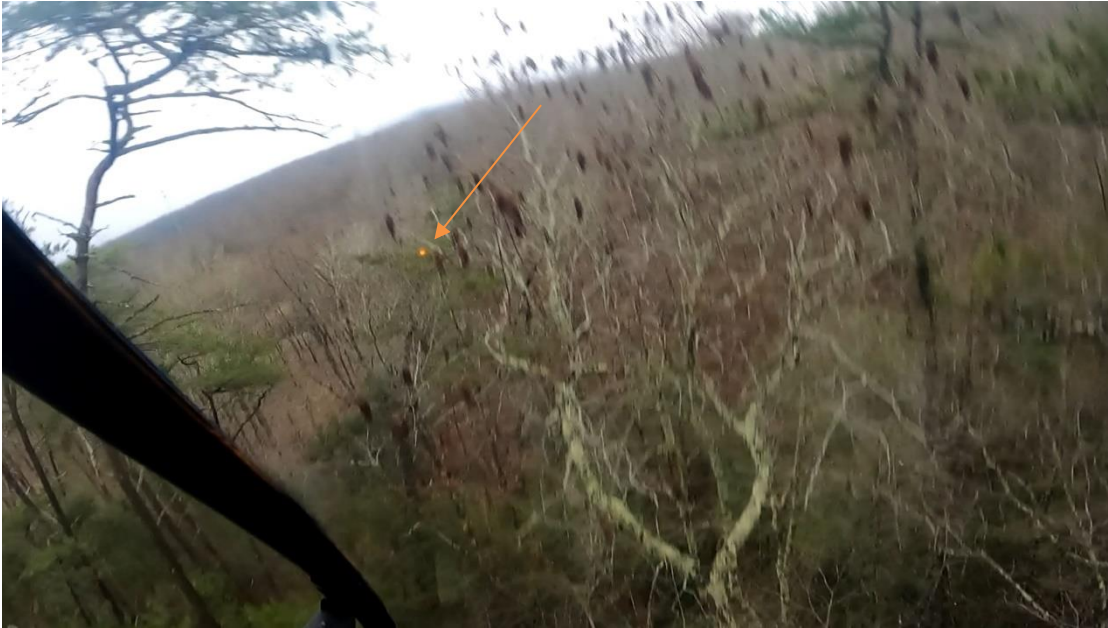
Figure 19 is a screenshot taken at 2:25:32. The helicopter's fuselage had appeared to impact the tree line. There was an amber light present in the reflection of the windshield. An arrow has been added to show the location of the light in the screenshot.

**Figure 19.** A screenshot of the GoPro recording at 2:25:33. An arrow has been added to show the location of the light in the screenshot.

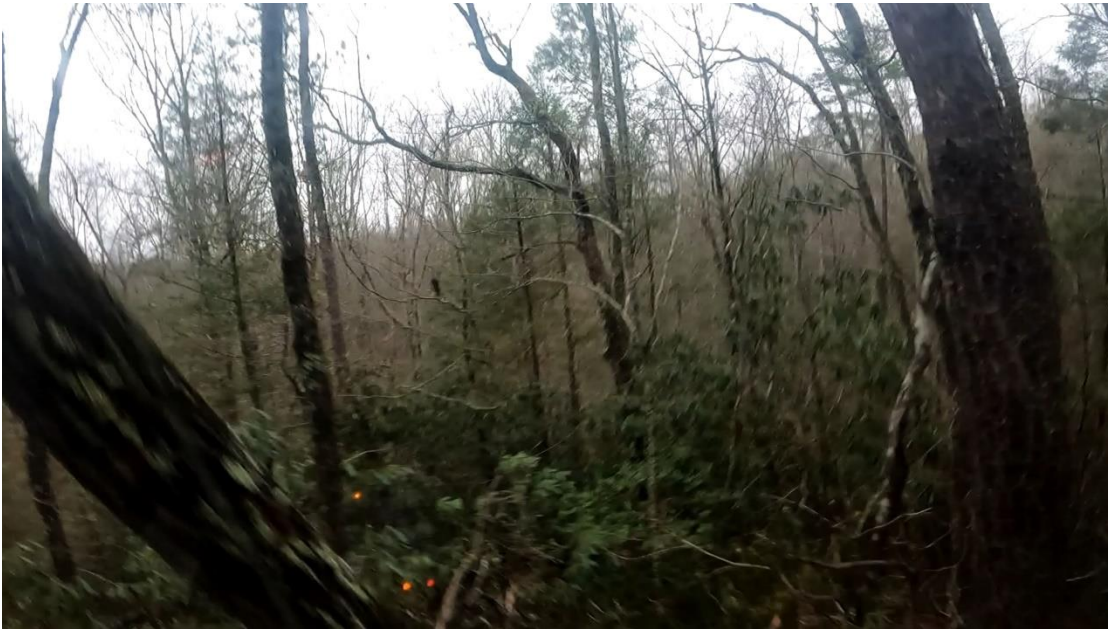
**Figure 20.** A screenshot of the GoPro recording at 2:25:33.

Figure 20 is a screenshot taken at 2:25:32 (a few frames after figure 19). The impact sequence continued, at times the helicopter's main rotor blades were impacting tree trunks and branches. There were two amber lights and one red light present in the reflection from the windshield. The upper amber light in the reflection, in conjunction with configuration of the other lights in the reflection (lower amber and lower red), suggested that these lights are the low rotor rpm light (amber), alternator light (amber) and oil pressure light (red).
