# **NATIONAL TRANSPORTATION SAFETY BOARD**

## **COMPONENT EXAMINATION REPORT**

Place : Robinson Helicopter Company, Torrance, CA  
Date : April 29, 2022  
Vehicle : Robinson R-44 II / N442VB  
NTSB No. : ERA22FA098  
Investigator: D. Boggs

Main Gear Box, part number (PN) C006-7 Rev AL, serial number (SN) 10151

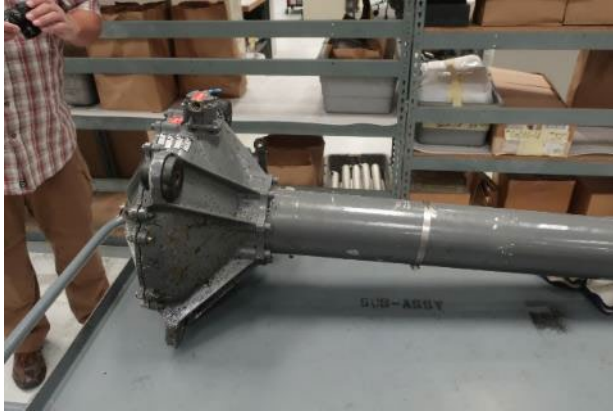
The main gear box and mast assembly was intact (Photo 1) with the mast tube extending from the top (Photo 2). The mast tube exhibited paint scrapes but appeared straight. The drive shaft was contained within the mast tube and appeared straight. No major damage was evident on the hub attachment area. The sump pan had a 1.5 inch long hole towards the bottom of the sump at the base of a rib; it appeared to be impact damage. The rotor brake exhibited slight impact damage, pushing it into the gear box housing. The right-side isolation mounts were in place, the left side isolation mounts were not present. The hydraulic pump was in place, forward tube fitting had been removed, aft tube elbow in place.

Photo 1 - Main gear box with mast tube attached.

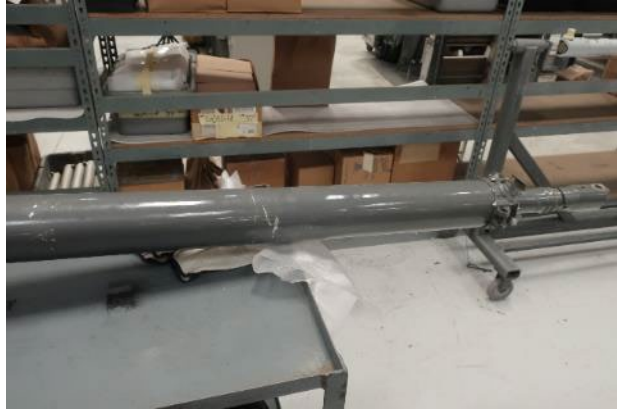
Photo 2- Mast tube with drive shaft extended out the top.

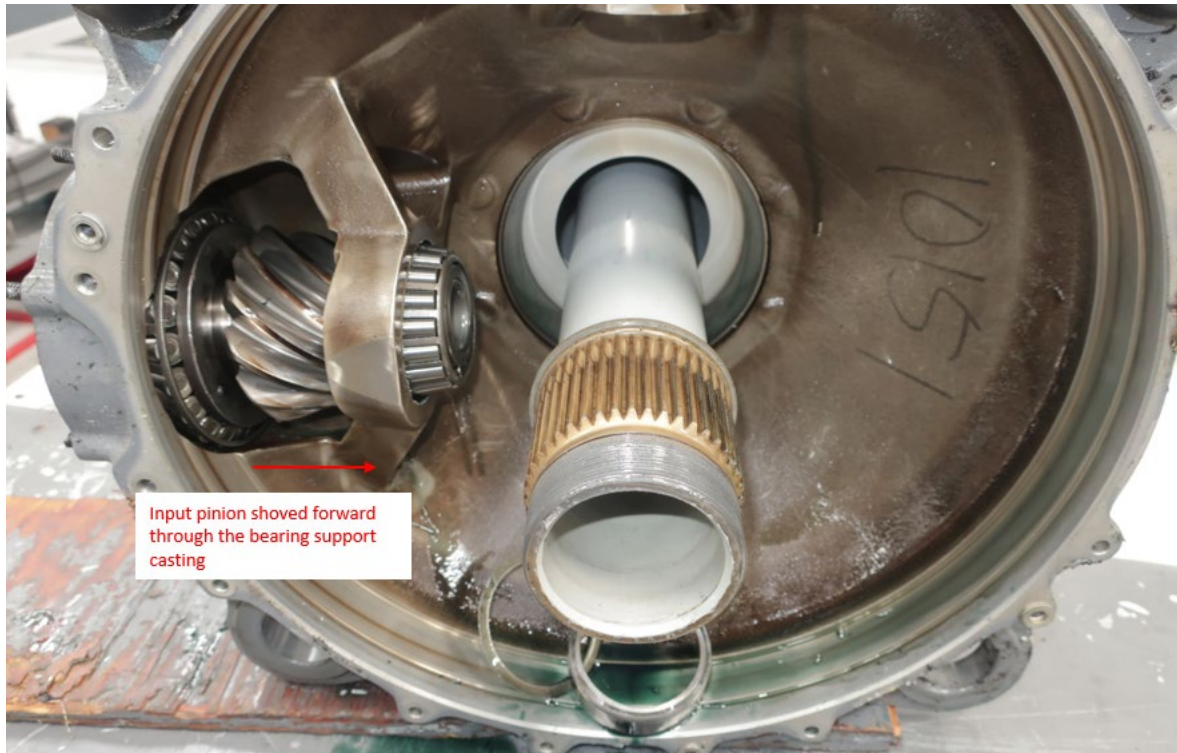
Photo 3 - Input pinion, support casting, and main rotor drive shaft.

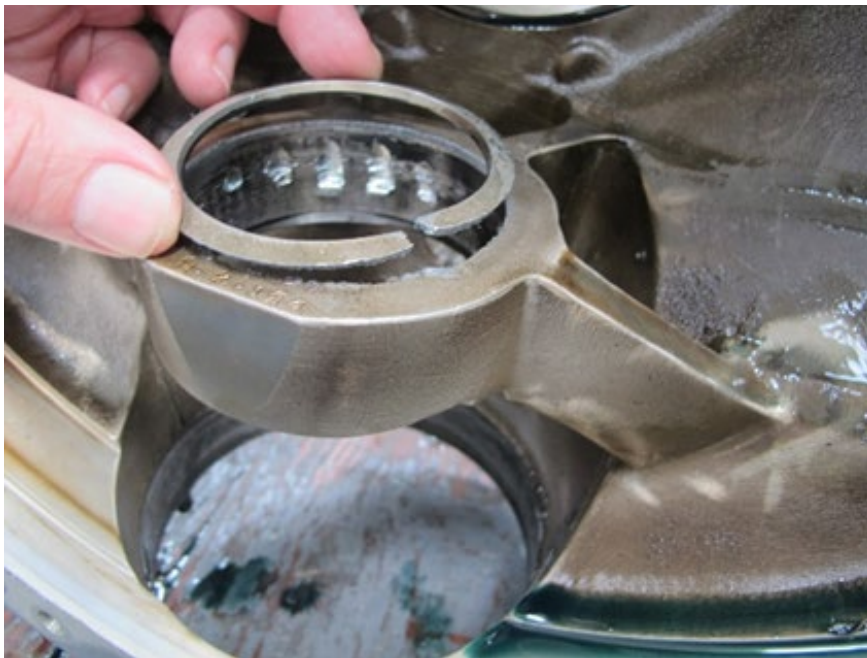
Photo 4 - Input pinion support casting showing cast retaining flange separation.

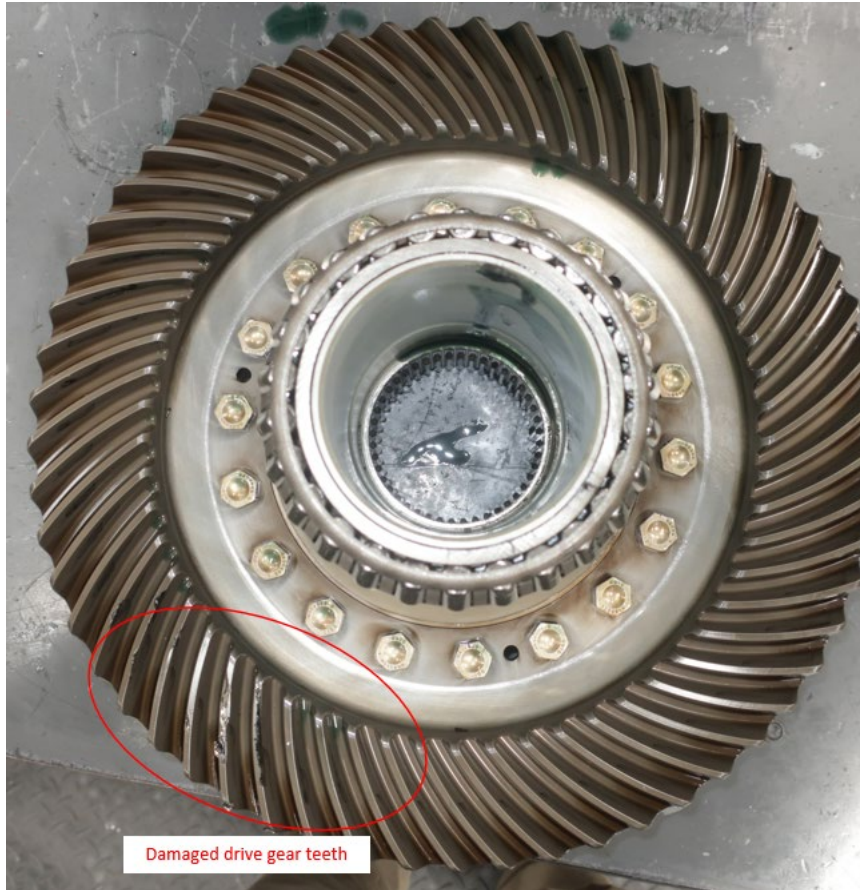
Photo 5 - Area of damaged ring gear teeth.

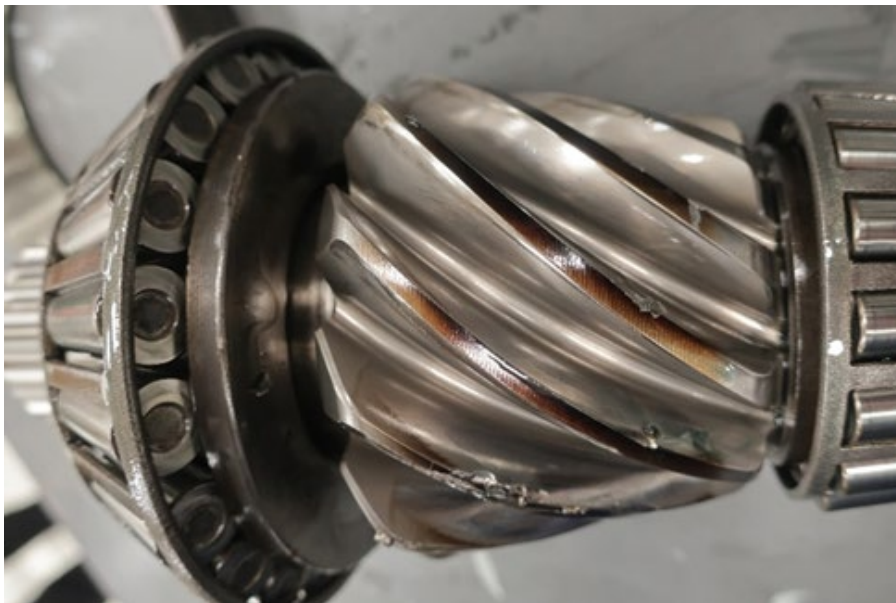
The input yoke and driveshaft could not be rotated by hand. The oil drain plug/chip detector was removed. The chip detector had black 'sludge' with metal chips observed. The oil fill cap was removed, and the ring gear teeth were visible thru the oil filler port. The rotor brake assembly & bearing seal were removed. The sump pan was removed. There were 3 silver flakes found in oil residue on bottom of drive gear. There was a slight drive gear movement experienced when applying torque to the input pinion by hand. The ring gear and carrier were pulled out of the gearbox case. The power input pinion had been shoved forward, damaging the bearing support flange, and pushed out the support bearing (Photos 3 and 4). There were 7 sequential teeth that exhibited damage on the ring gear (Photo 5). There were numerous pinion teeth that exhibited damage (Photo 6). Metal chips were observed along the interior base of the MGB housing.

Photo 6 - Damaged input pinion teeth.

The drive shaft was pulled out of the mast tube, it did not have any visible damage. When rolled on a table it did not exhibit any eccentricity or bowing. The power input pinion was pulled out. Damage to 3 teeth were observed. There was no visible rotational damage or discoloration in any of the bearings or their races.
