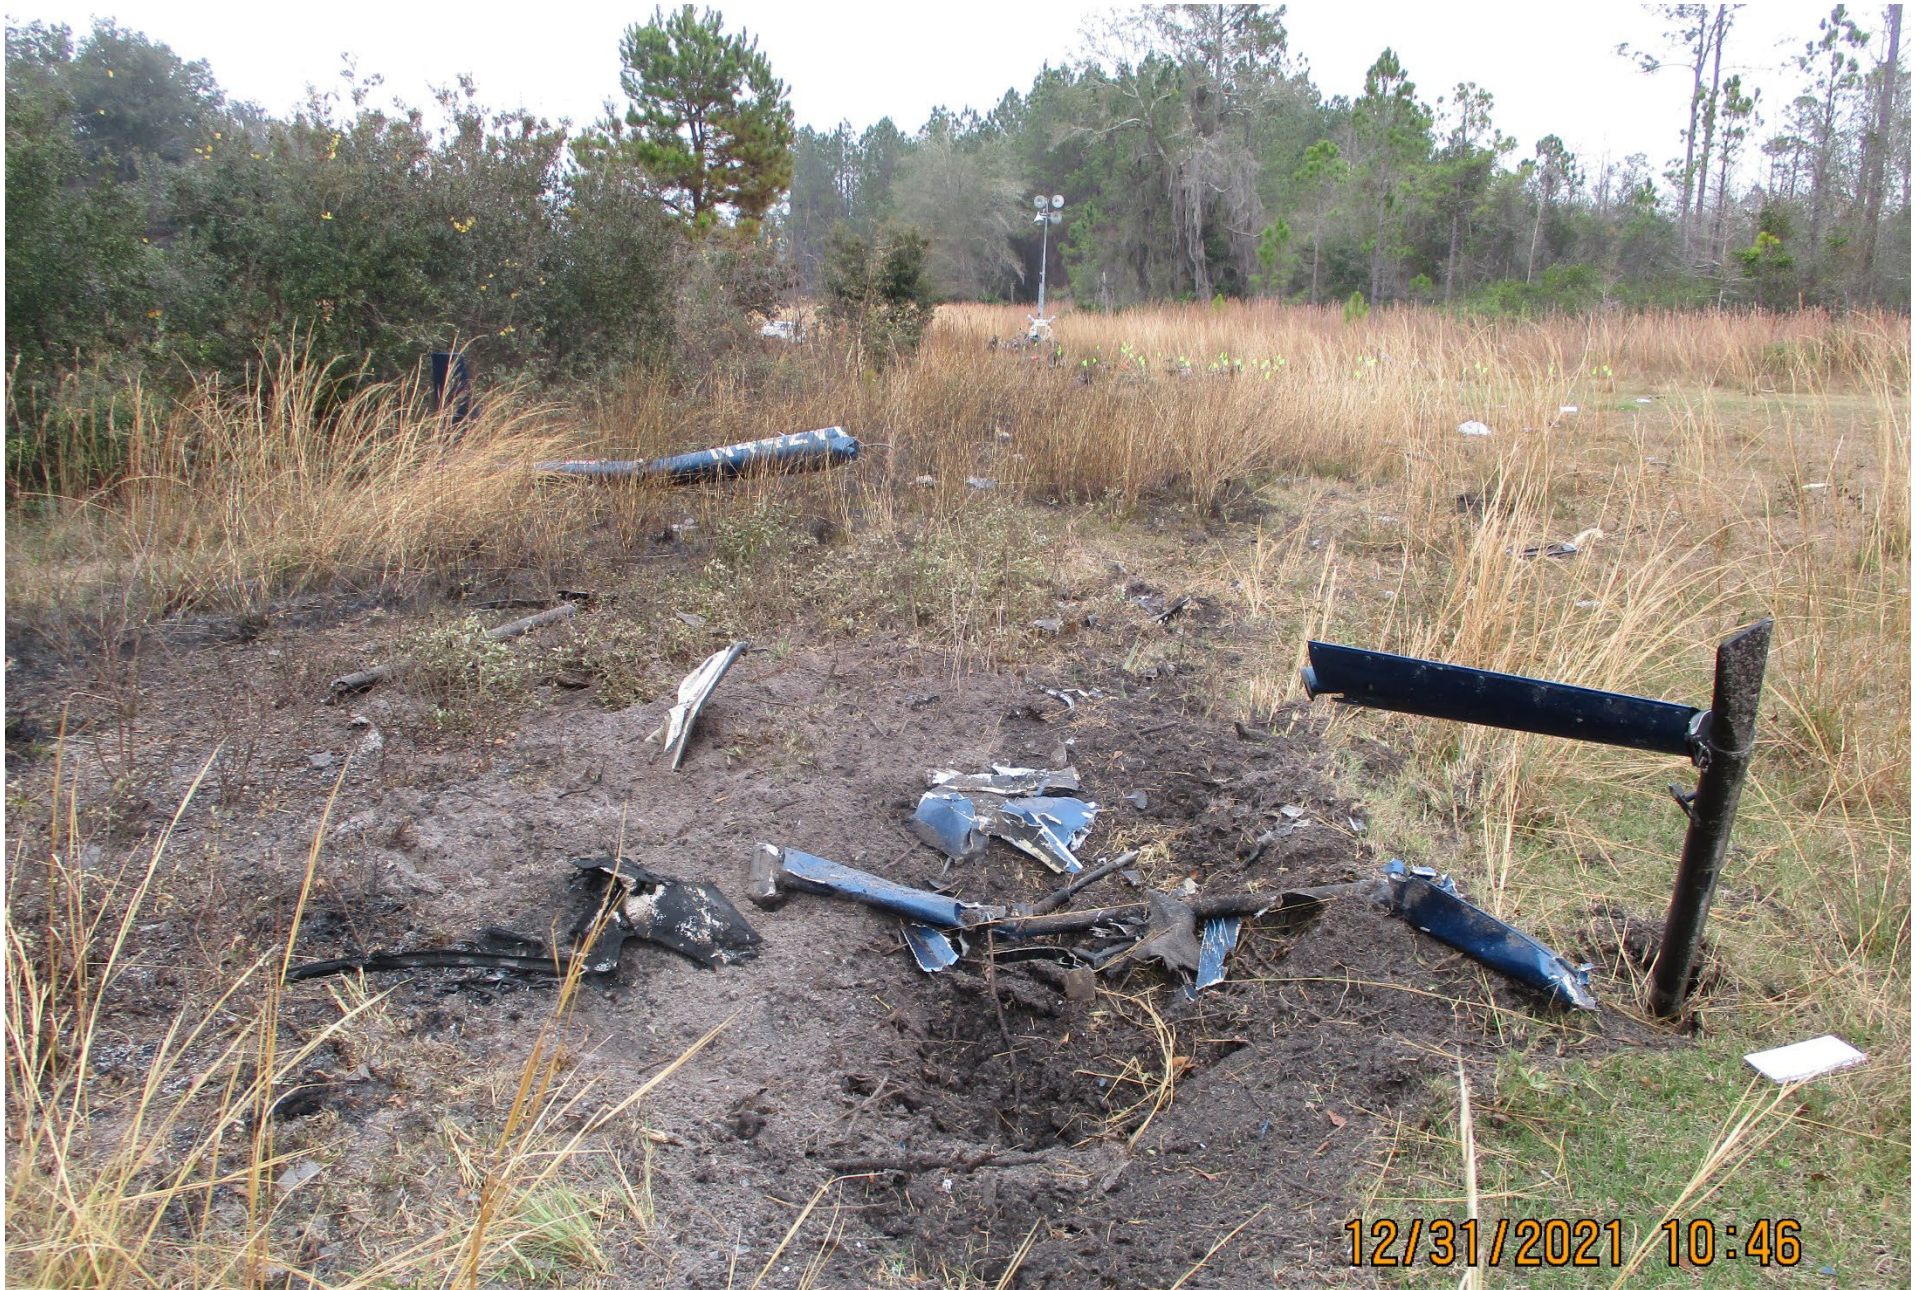
**Photo 1 – initial impact point**

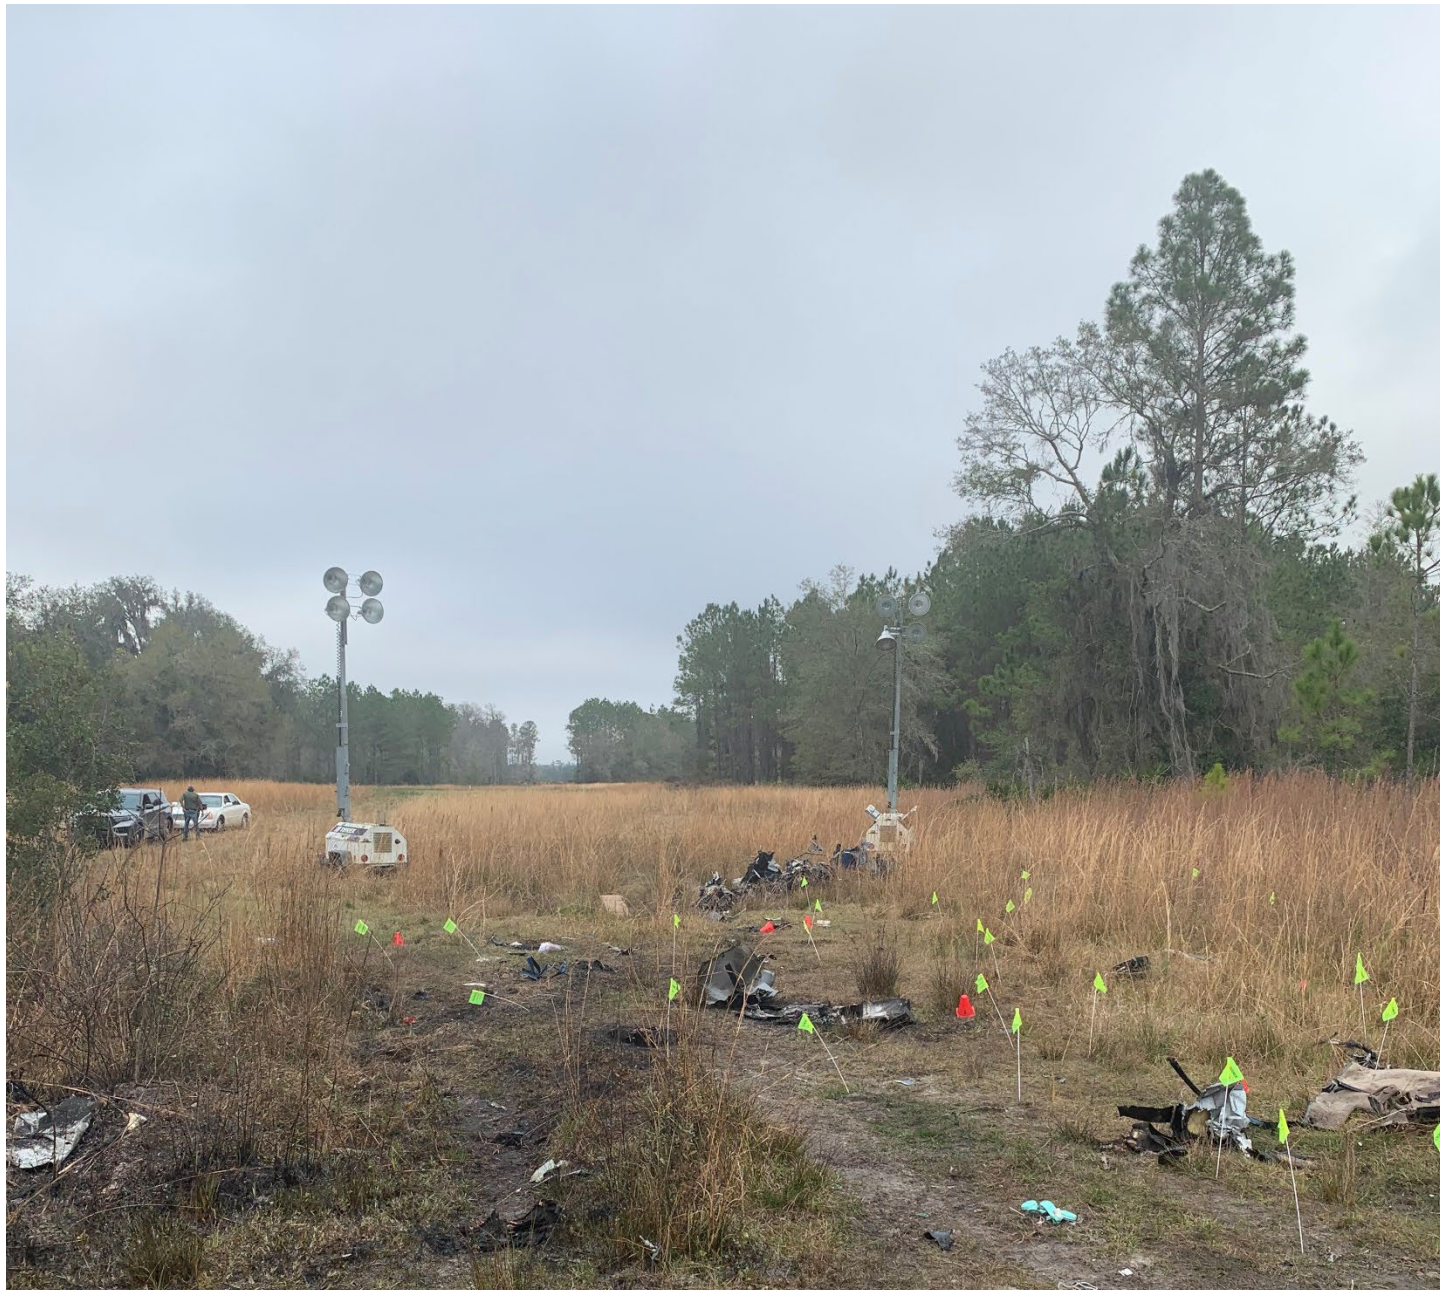
**Photo 2 – wreckage path with scattered parts**
