# NATIONAL TRANSPORTATION SAFETY BOARD

## MATERIALS LABORATORY FACTUAL REPORT

Report No. 22-063

Place : Danville, VA  
Date : 2/1/2022  
Vehicle : Cessna 310R, N622QT  
NTSB No. : ERA22FA114  
Investigator : Lynn Spencer

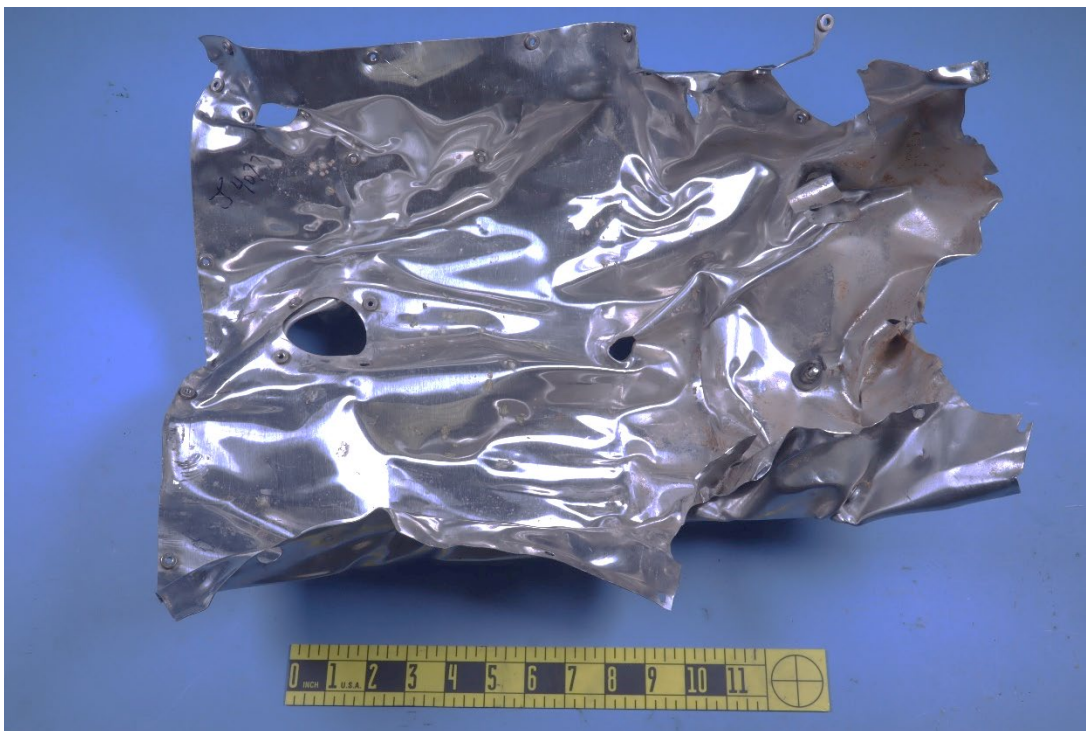
The outer casing of the heater was unfastened and pried apart to remove the heat exchanger and combustor assembly. Ventilation air to the cabin would pass between the outer hot section of the heat exchanger and the interior surface of the outer casing. The interior surface of the outer casing (Figure 2) did not exhibit any signs of soot to indicate a leak of combustion products from the outer hot section of the heat exchanger. The exterior surface of the outer hot section of the heat exchanger (Figures 3, 4) did not exhibit any defects or failure of the materials that would allow combustion products to intermix with the ventilation air. All the weld seams were intact and there were no areas of rusted or eroded material.

Figure 2: Interior surface of outer casing.

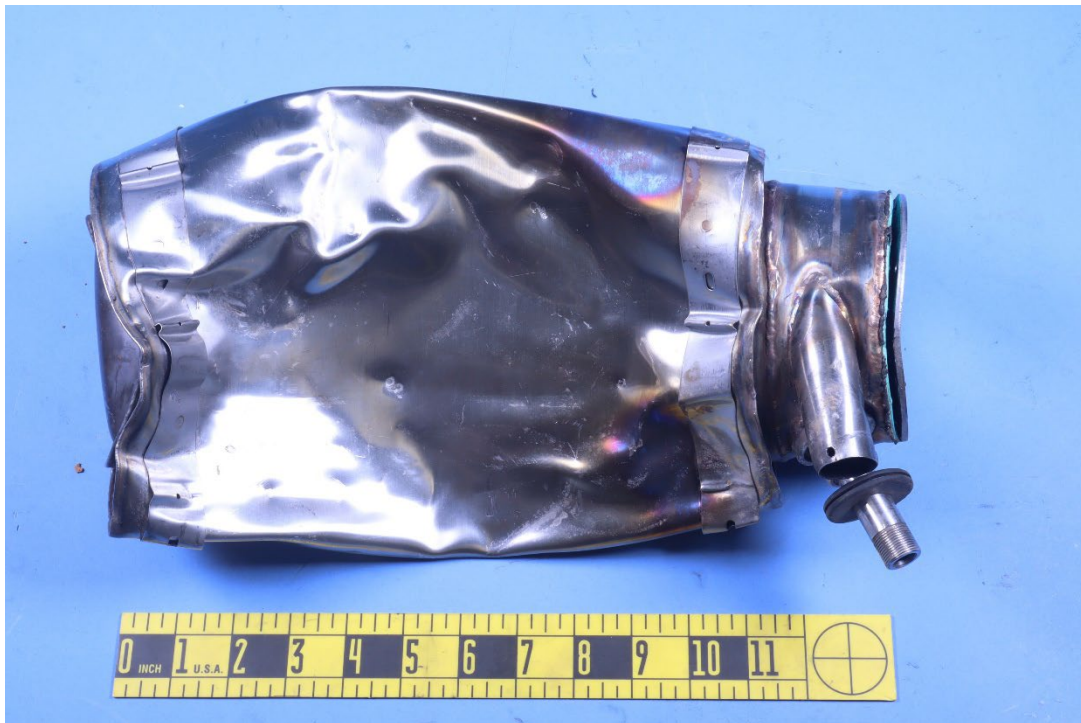
Figure 3: Exterior surface of outer hot section.

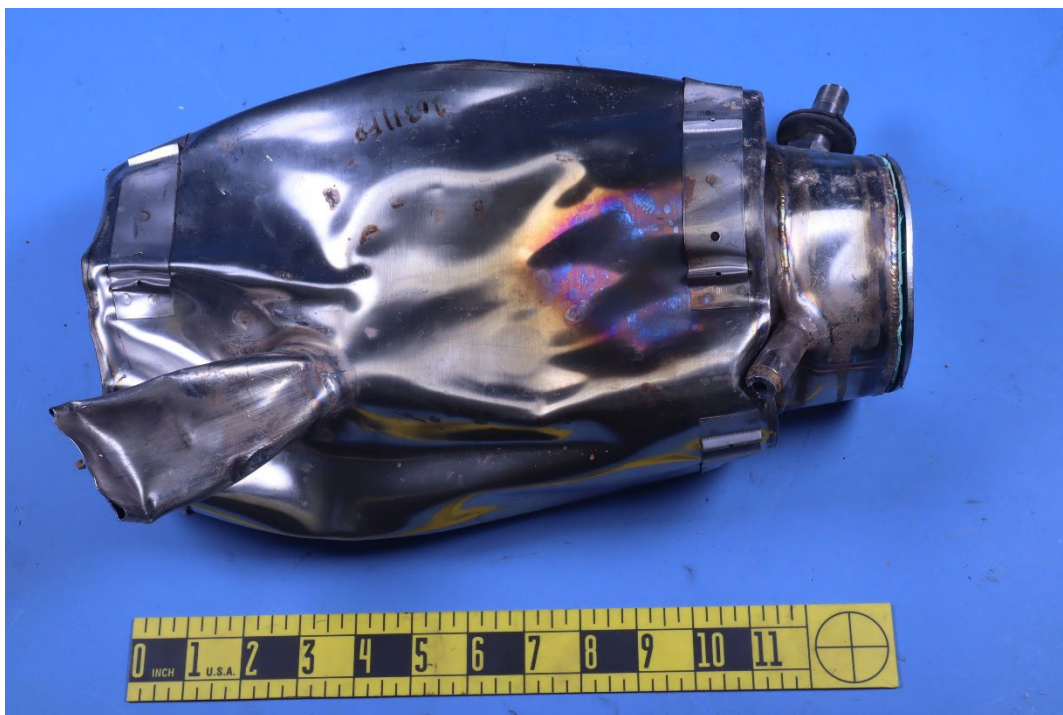
Figure 4: Exterior surface of outer hot section.

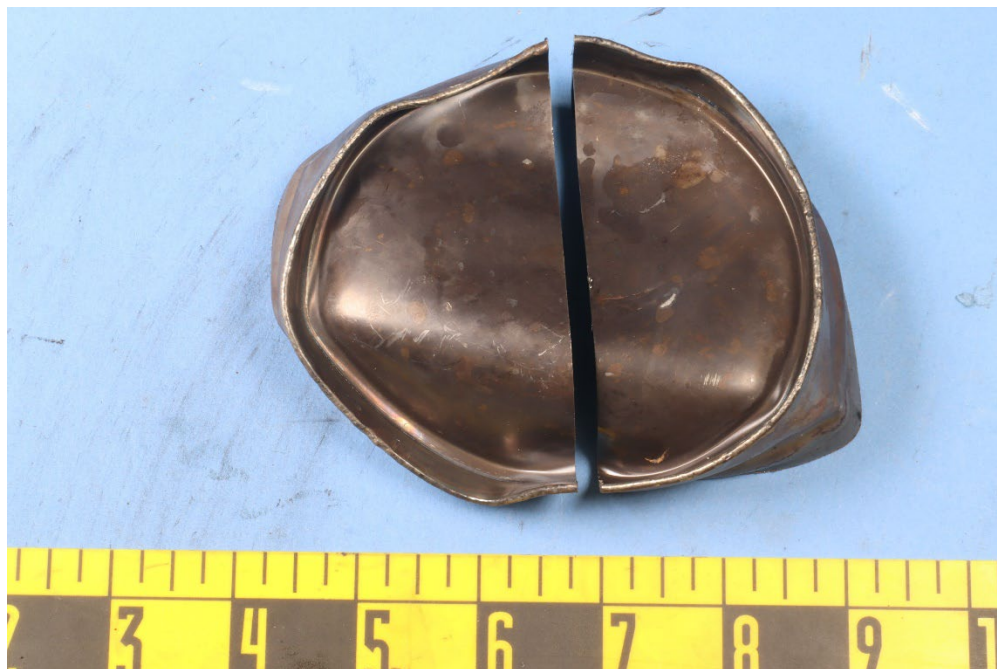
the combustor portion of the heater. The heat exchanger and combustor assembly was sectioned to facilitate examination of the interior surfaces and crossover ports between the interior hot section and the outer hot section. First a longitudinal section was made splitting the heat exchanger and combustor assembly in half (Figure 5). Additional, perpendicular sections were made at the ends of both halves of the heat exchanger and combustor assembly to allow the individual layers of the assembly to be examined (Figures 6, 7). Examination of the layers of the heat exchanger did not reveal any defects or failure of the materials that would allow combustion products to intermix with the ventilation air. The weld seam of the end cap of the interior hot section was intact with no evidence of any cracking (Figure 8). The weld seam of the outer hot section layers was intact with no evidence of any cracking (Figure 9).

Figure 8: Weld seam on the end cap of the interior hot section.

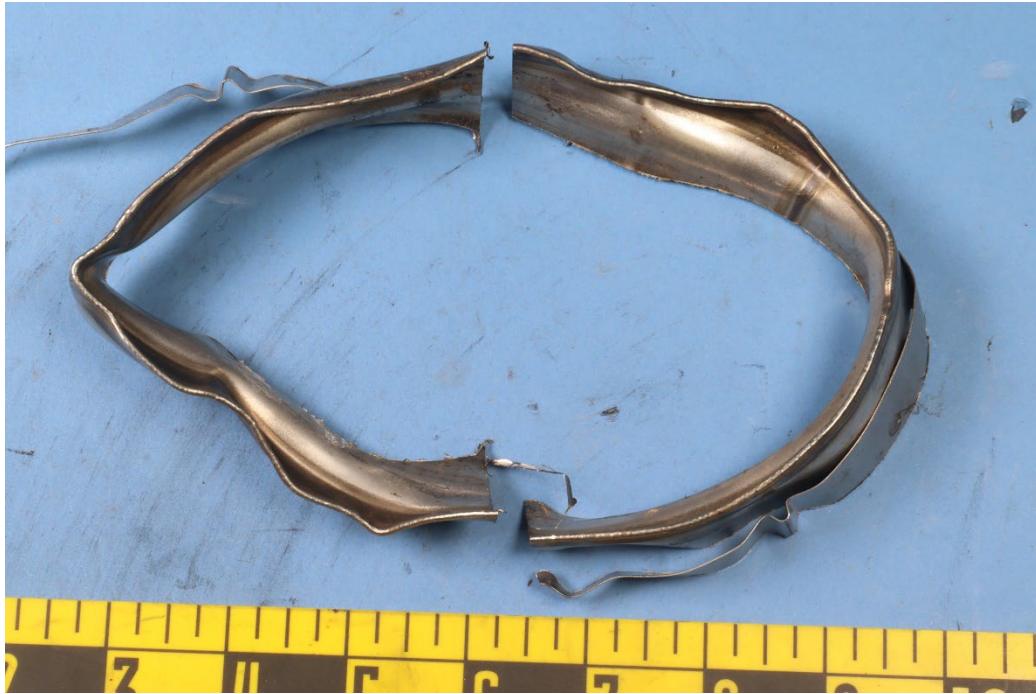
Figure 9: Weld seam of the outer hot section layers.

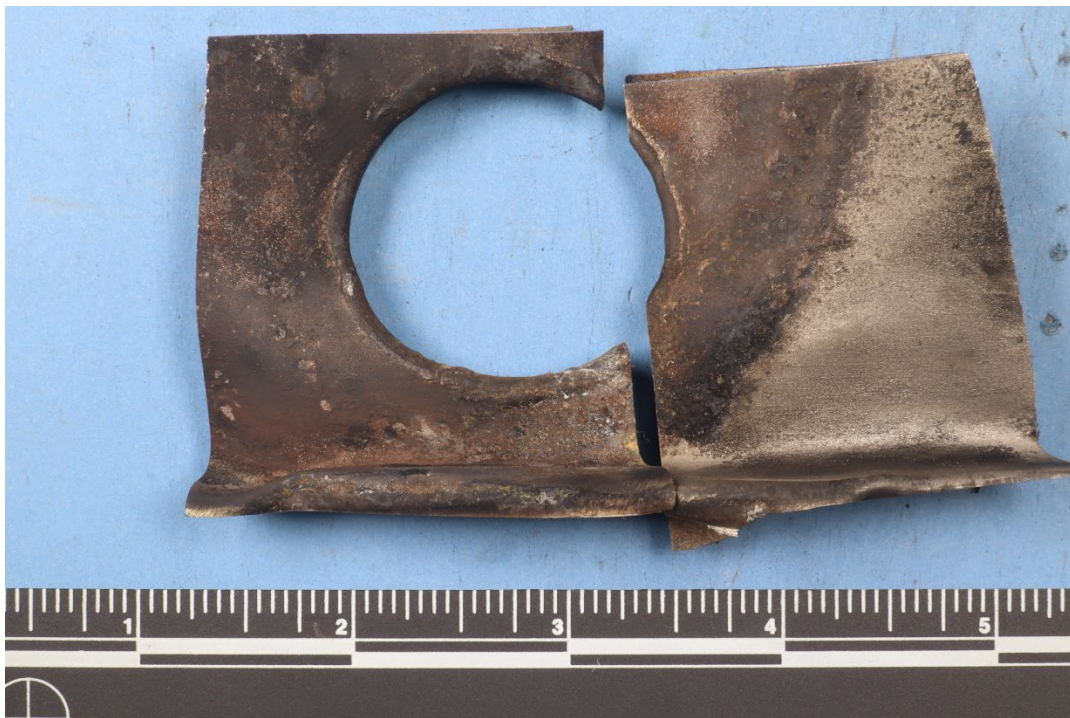
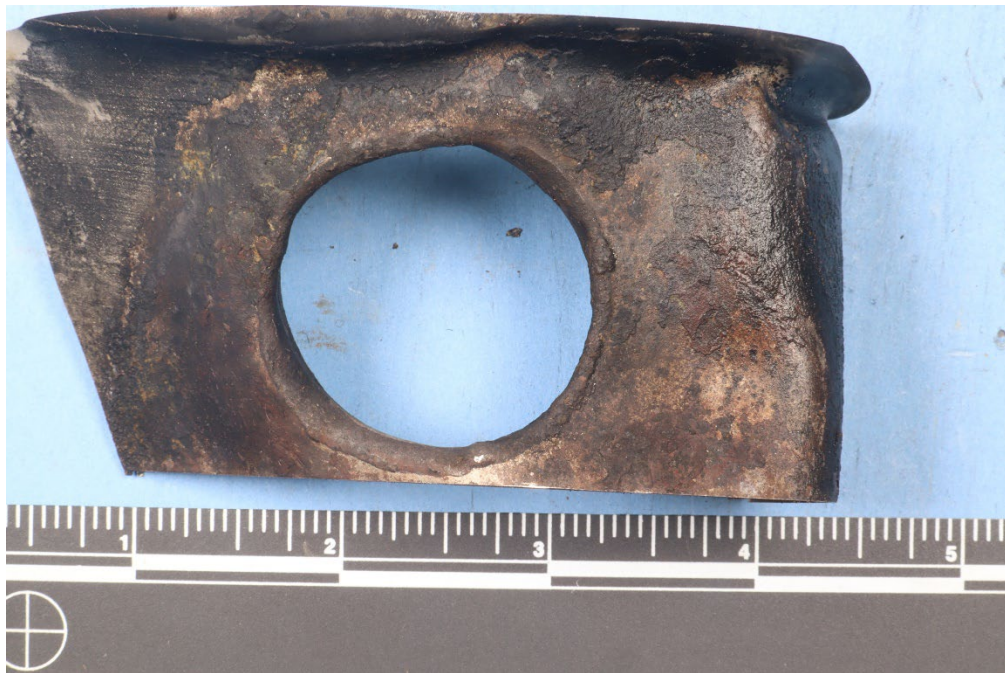
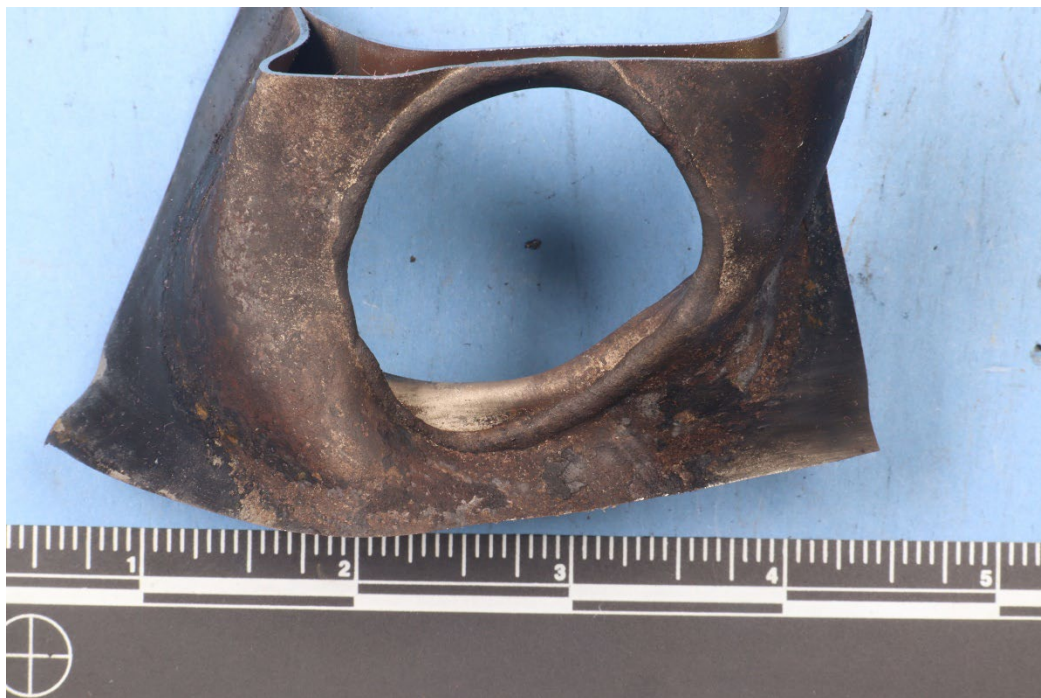
The section containing the combustor of the heater was further sectioned to reveal the crossover ports. All three crossover ports were examined, and no cracks or other defects were identified (Figures 10, 11, 12).
