# National Transportation Safety Board

ERA22FA114

## **AIRPLANE PERFORMANCE STUDY**

Location: Danville, Virginia  
Date: February 1, 2022  
Time: 1006 EST  
1506 GMT  
Airplane: Cessna 310R, N622QT

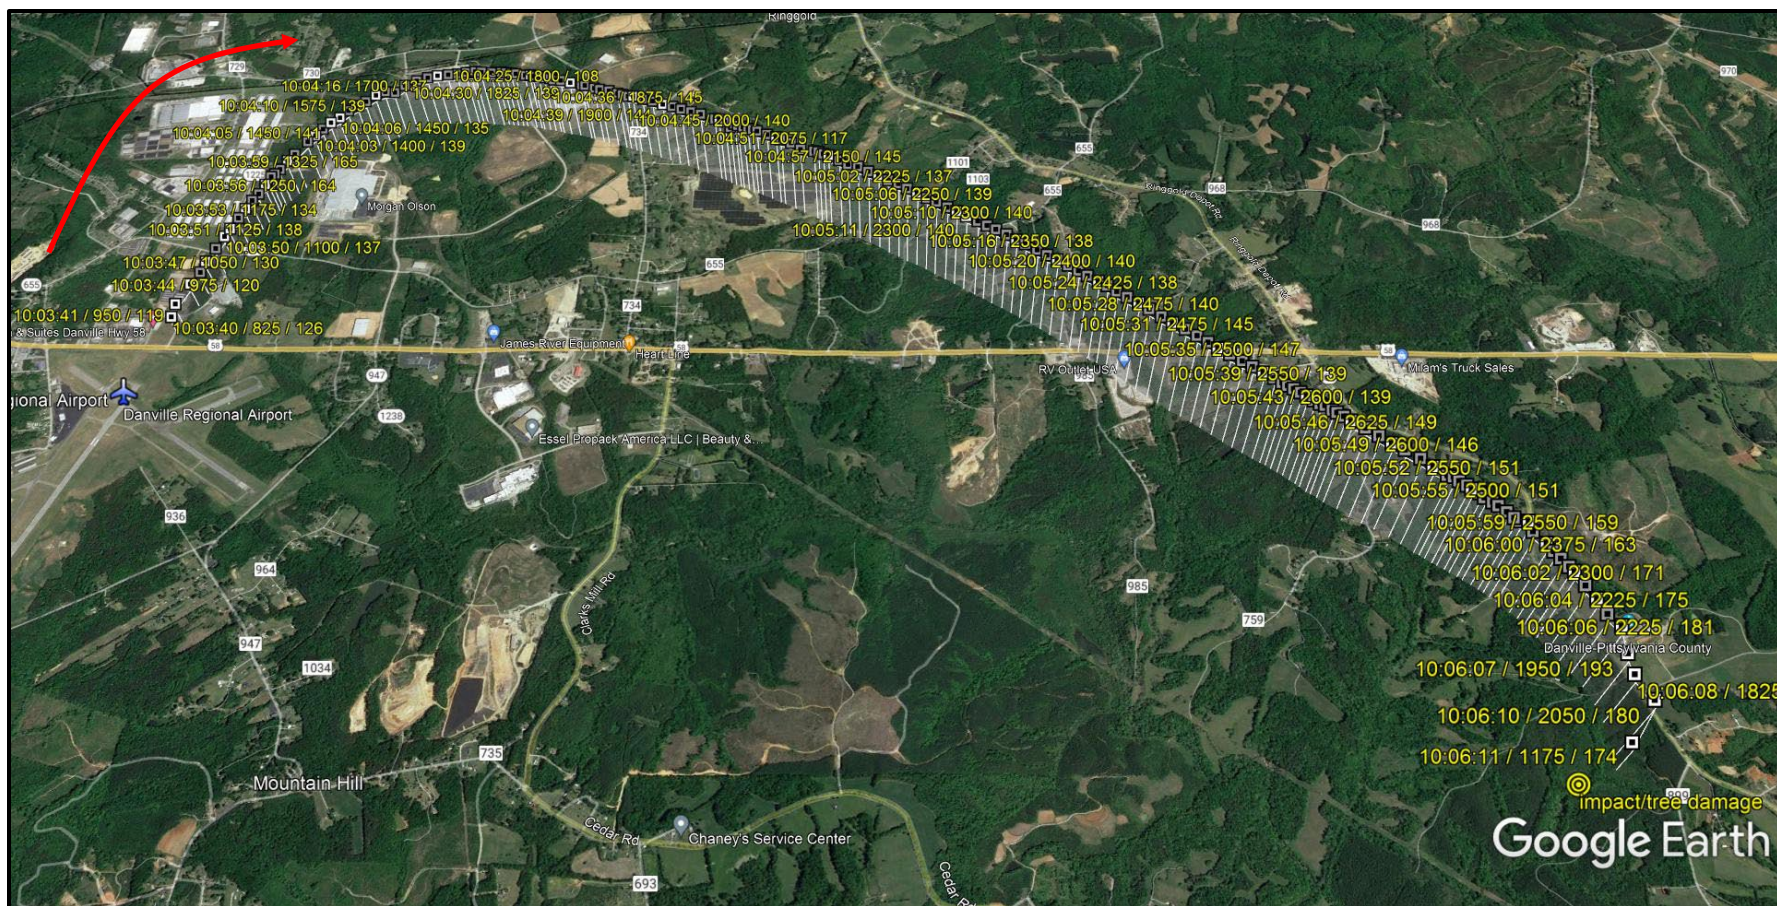
Figures 2 and 3 show the ADS-B ground track for the three-minute flight. In addition, Figure 2 includes the ADS-B altitude and estimated airspeed in yellow. Figure 4 is a time history of the ADS-B altitude and ground speed.

**Figure 2: ADS-B Ground Track for Accident Flight with Time (EST), Altitude (ft, msl), and Estimated Airspeed (kt)**

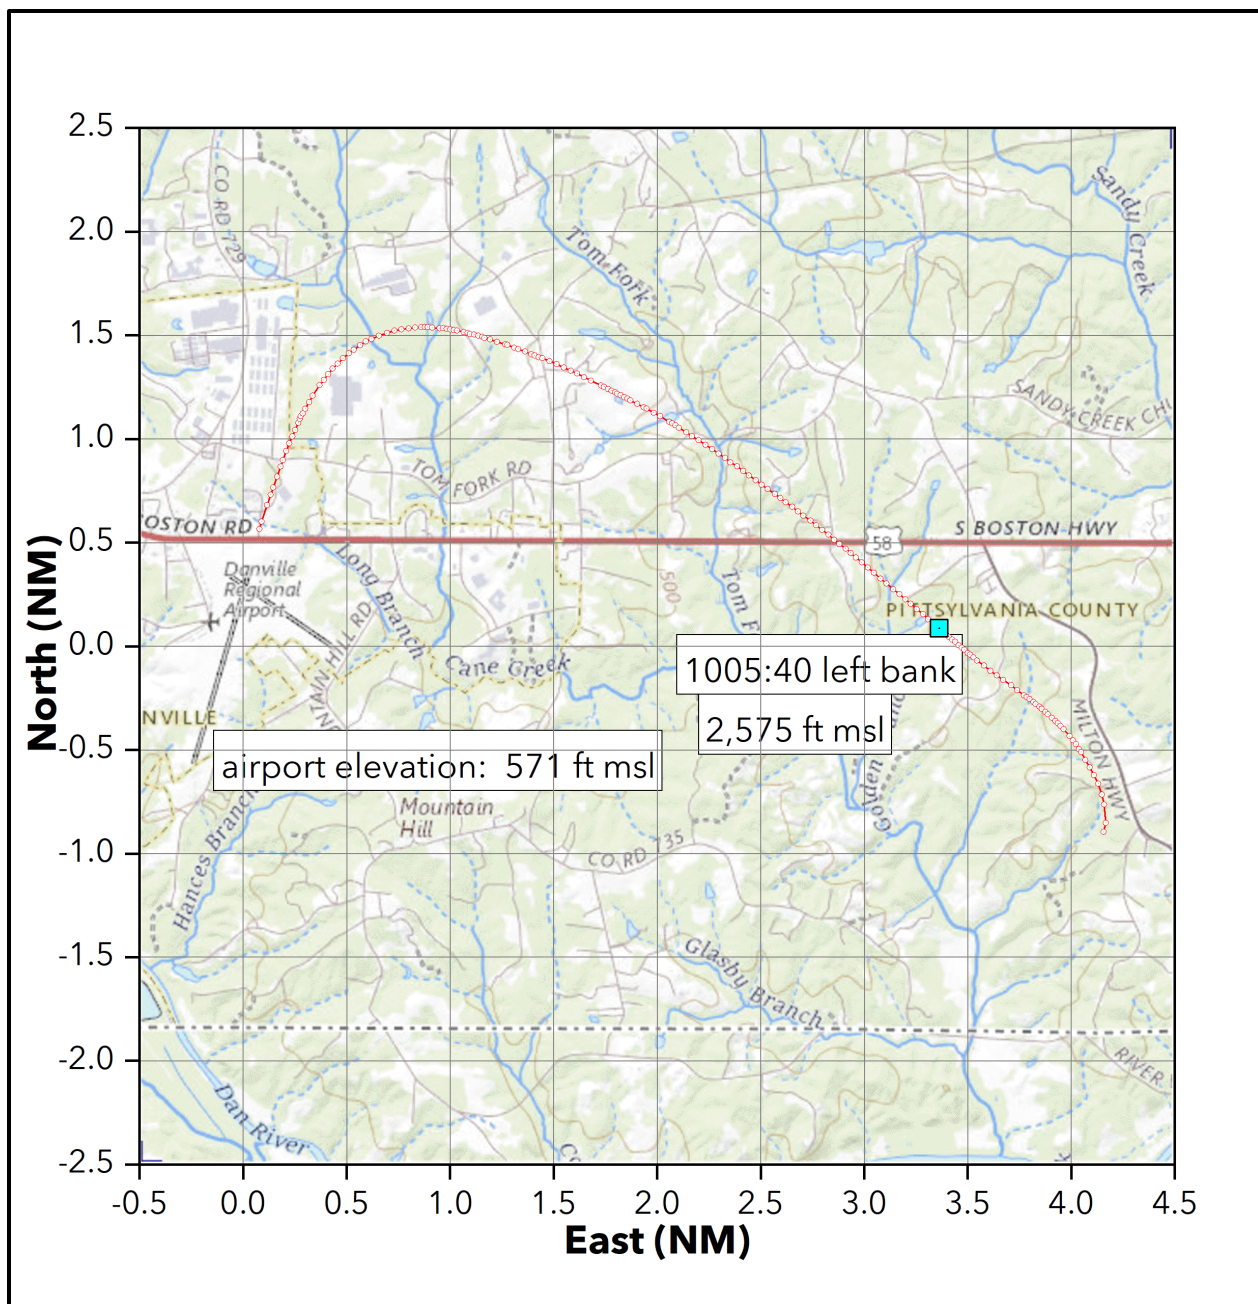
Assuming the left engine was not operating, the accident airplane banked into the inoperative engine at approximately 1005:40 and 2,575 ft msl as highlighted in Figure 3 and then subsequently rolled right until the end of the ADS-B data at 1006:11.

**Figure 3: ADS-B Ground Track with Left Bank Angle Denoted**

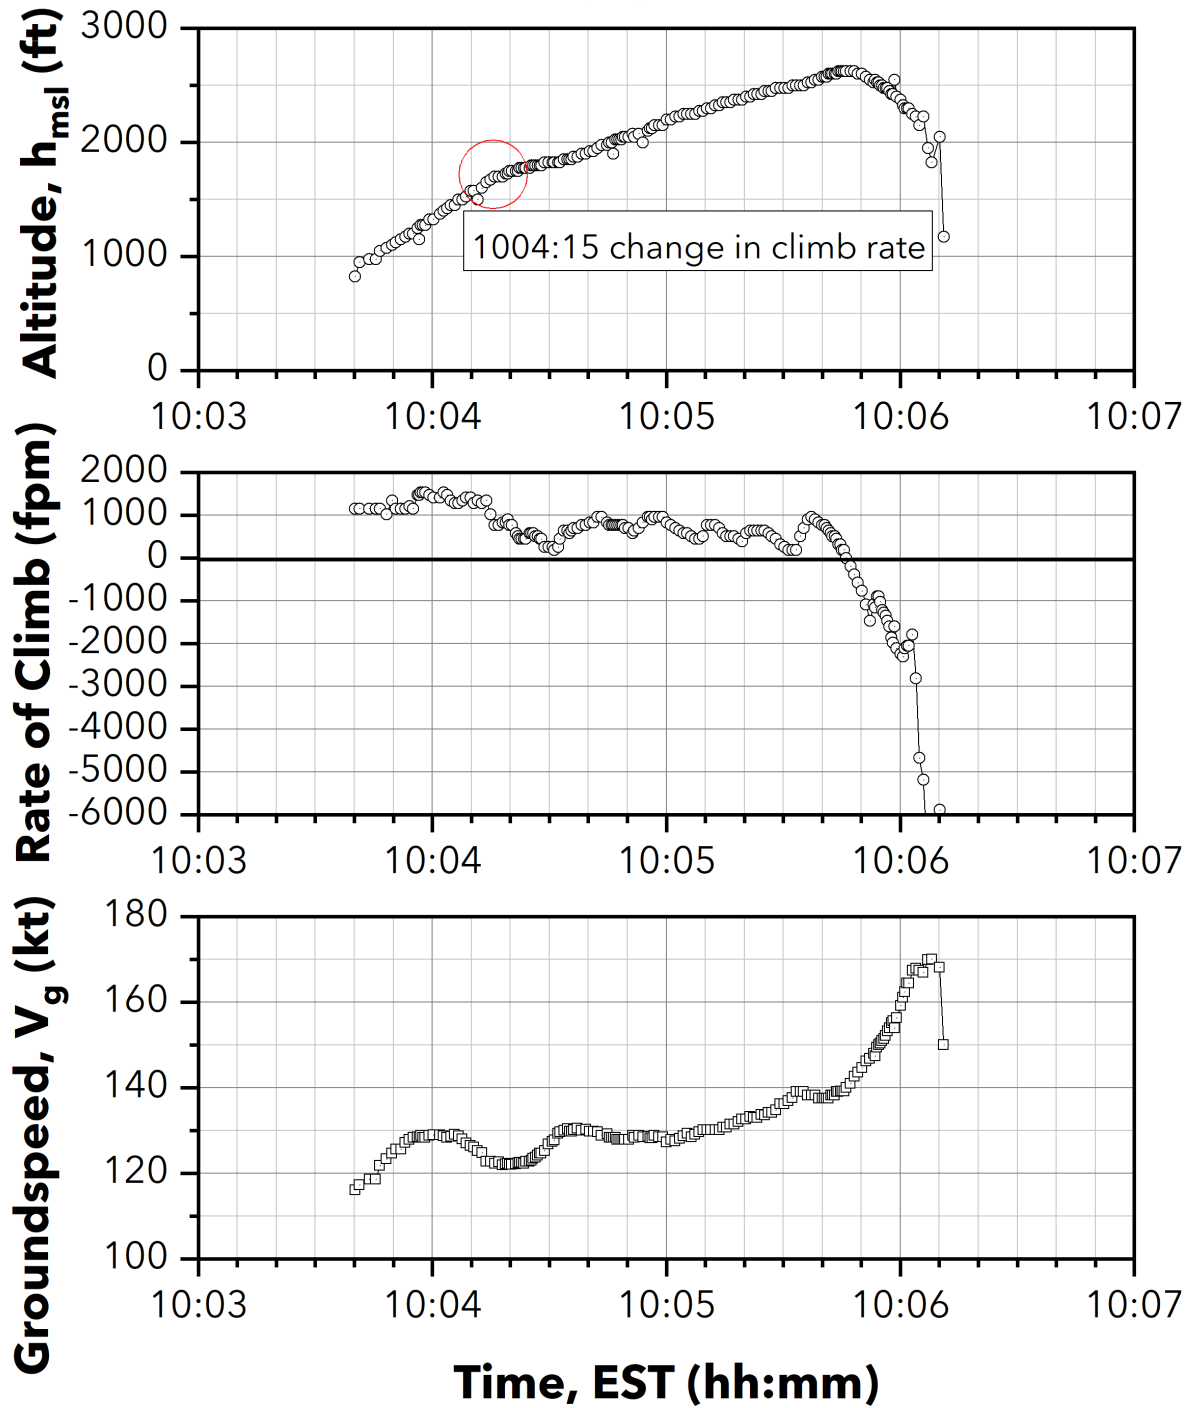
Figure 4 indicates that at approximately 1004:15, the airplane climb rate subsequently decreased from 1,200 ft/min to about 500 ft/min, and the acceleration stopped<sup>1</sup> with the ground speed remaining relatively constant at around 130 kt. The airplane ultimately reached a maximum recorded altitude of about 2,625 ft msl at 1005:44, four seconds after the airplane began a 10°-bank-angle left turn. Estimated bank angle is shown in Figure 5.

**Figure 4: ADS-B Altitude and Ground Speed**

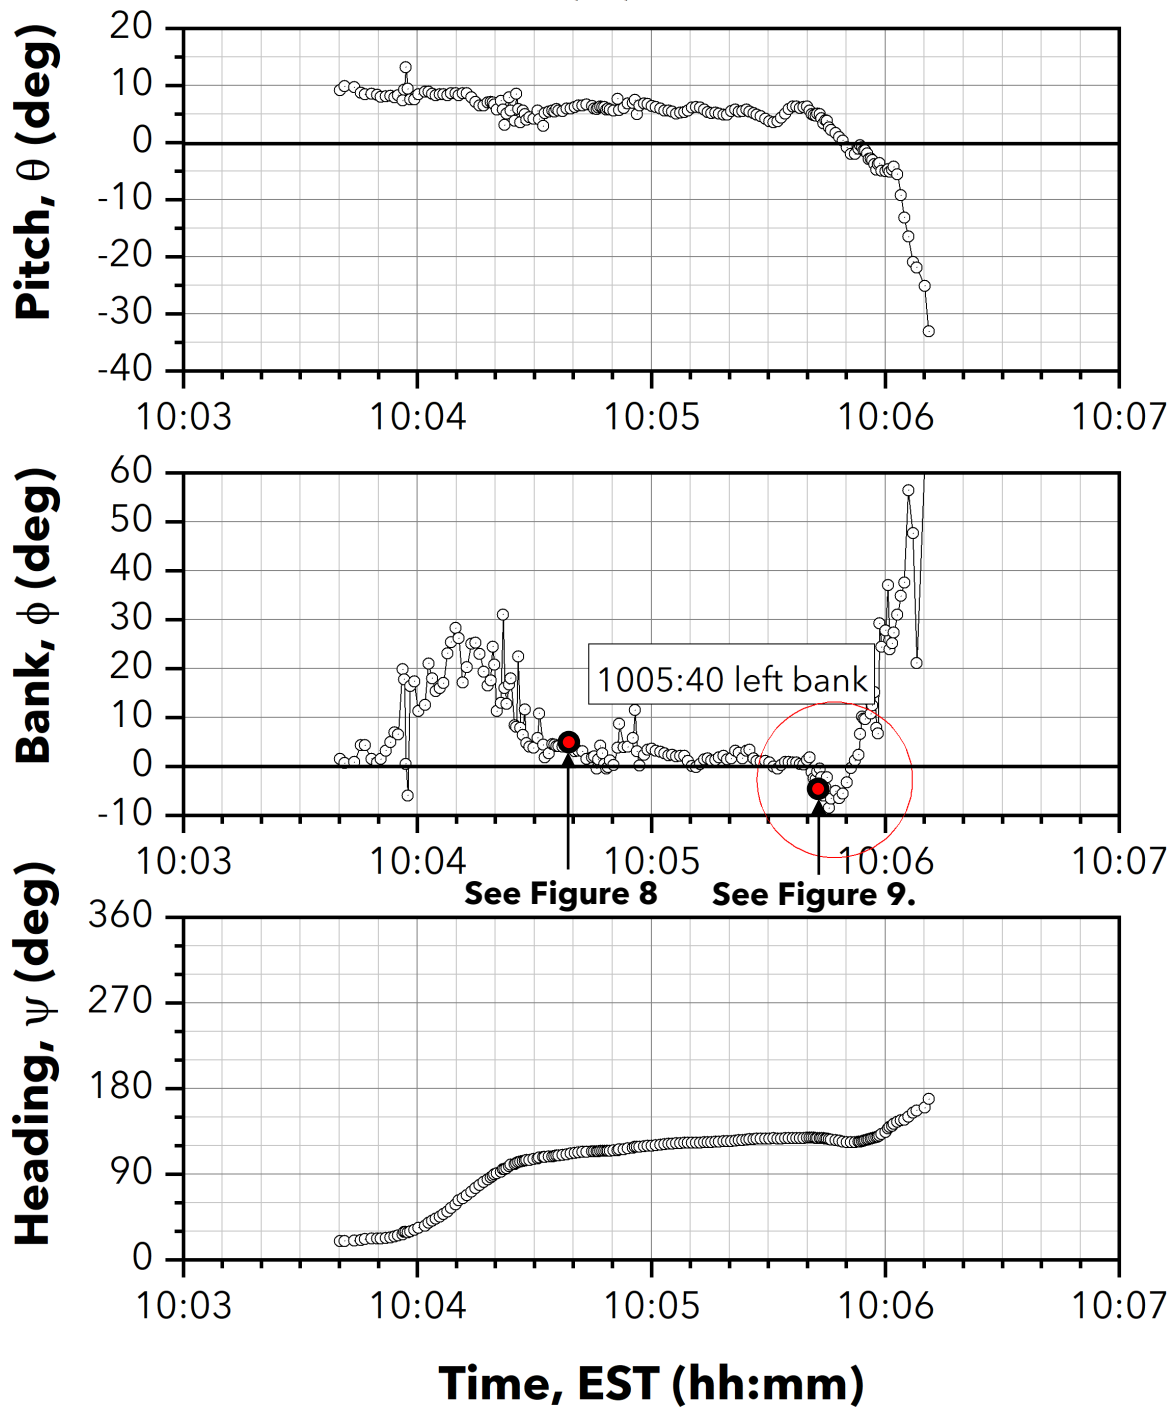
Ten seconds after turning left, the airplane returned to wings-level and then rolled right at about 3 deg/sec while descending at more than 1,000 ft/min. The last estimated bank angle was over 60° to the right at an altitude of 1,175 ft msl.

**Figure 5: Estimated Pitch, Bank, and Heading Angles**

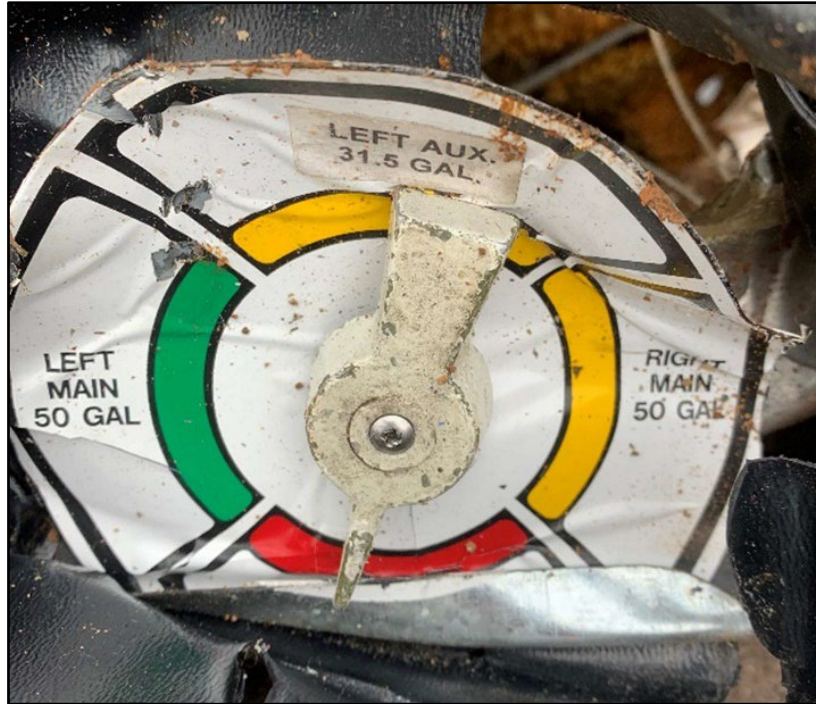
Figures 6 and 7 show the positions of the left and right fuel selectors, respectively, found in the wreckage. The left engine was set to "LEFT ENGINE OFF" while the right was found set to "LEFT MAIN 50 GAL". It could not be determined when the left fuel selector was turned off.

The fuel selector for the left engine on N622QT was found in the "LEFT ENGINE OFF" position, the left throttle was near idle, and the left propeller was near feather. In the case of an engine failure during take-off, the airplane manufacturer's POH specifies that 5° bank angle into the operative engine be established at a speed greater than 92 kt.

**Figure 6: Left Engine Fuel Selector set to "LEFT ENGINE OFF"**

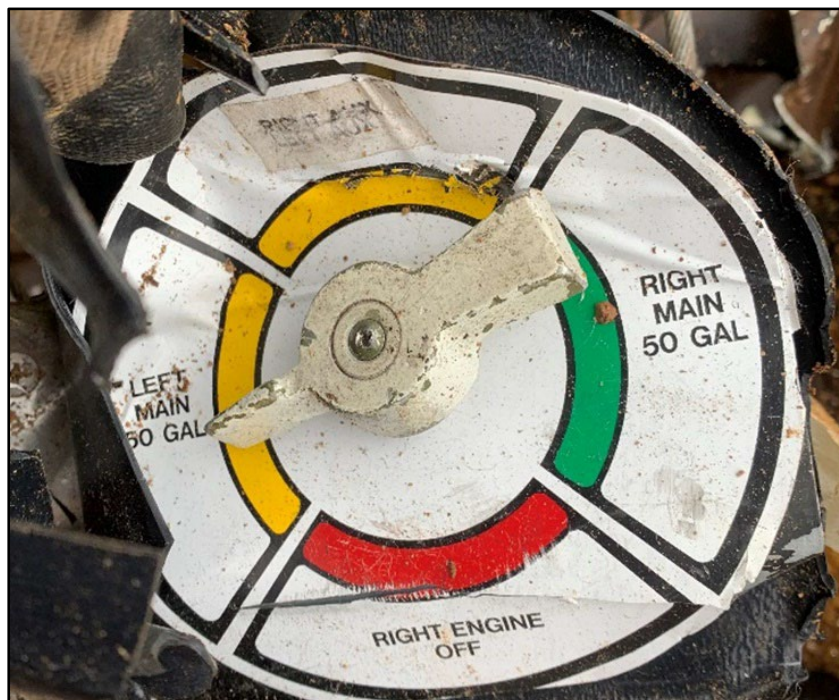
**Figure 7: Right Engine Fuel Selector set to "LEFT MAIN 50 GAL"**

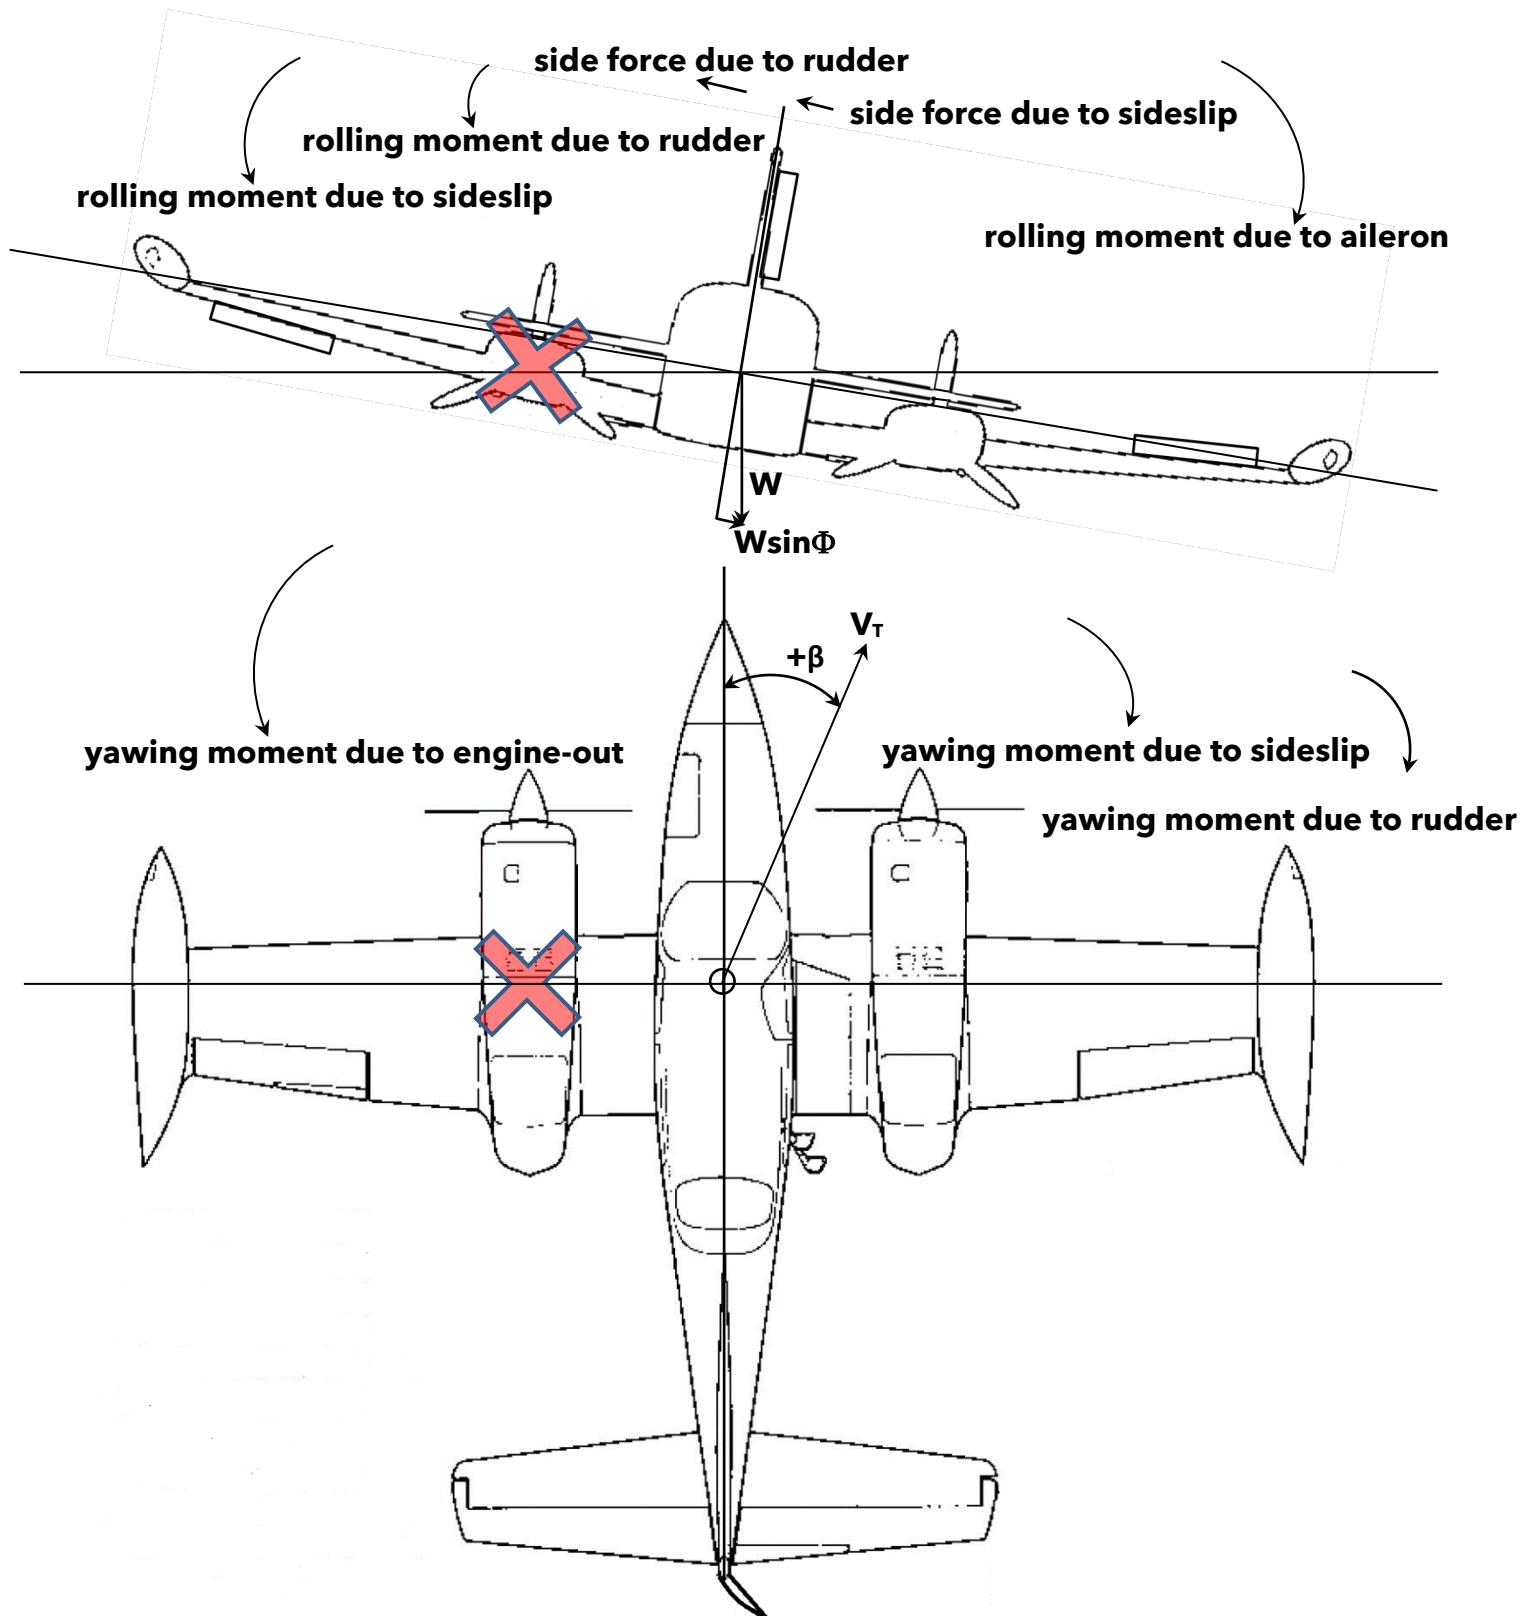
However, the airplane POH assumes that full opposite rudder is used to counter the yawing moment that results from the engine failure, that the inoperative propeller is feathered, and that 5° of bank into the operating engine is used to balance the side force generated by the full rudder input. Figure 8 shows the balance of forces and moments for  $V_{mc}$  with the left engine inoperative. If these conditions do not exist, the airplane can quickly become uncontrollable at airspeeds much higher than  $V_{mc}$ .

**Figure 8:  $V_{mc}$  Defined with 5° Bank into the Operating (Right) Engine  
(As Viewed from Rear and Top, Respectively)**

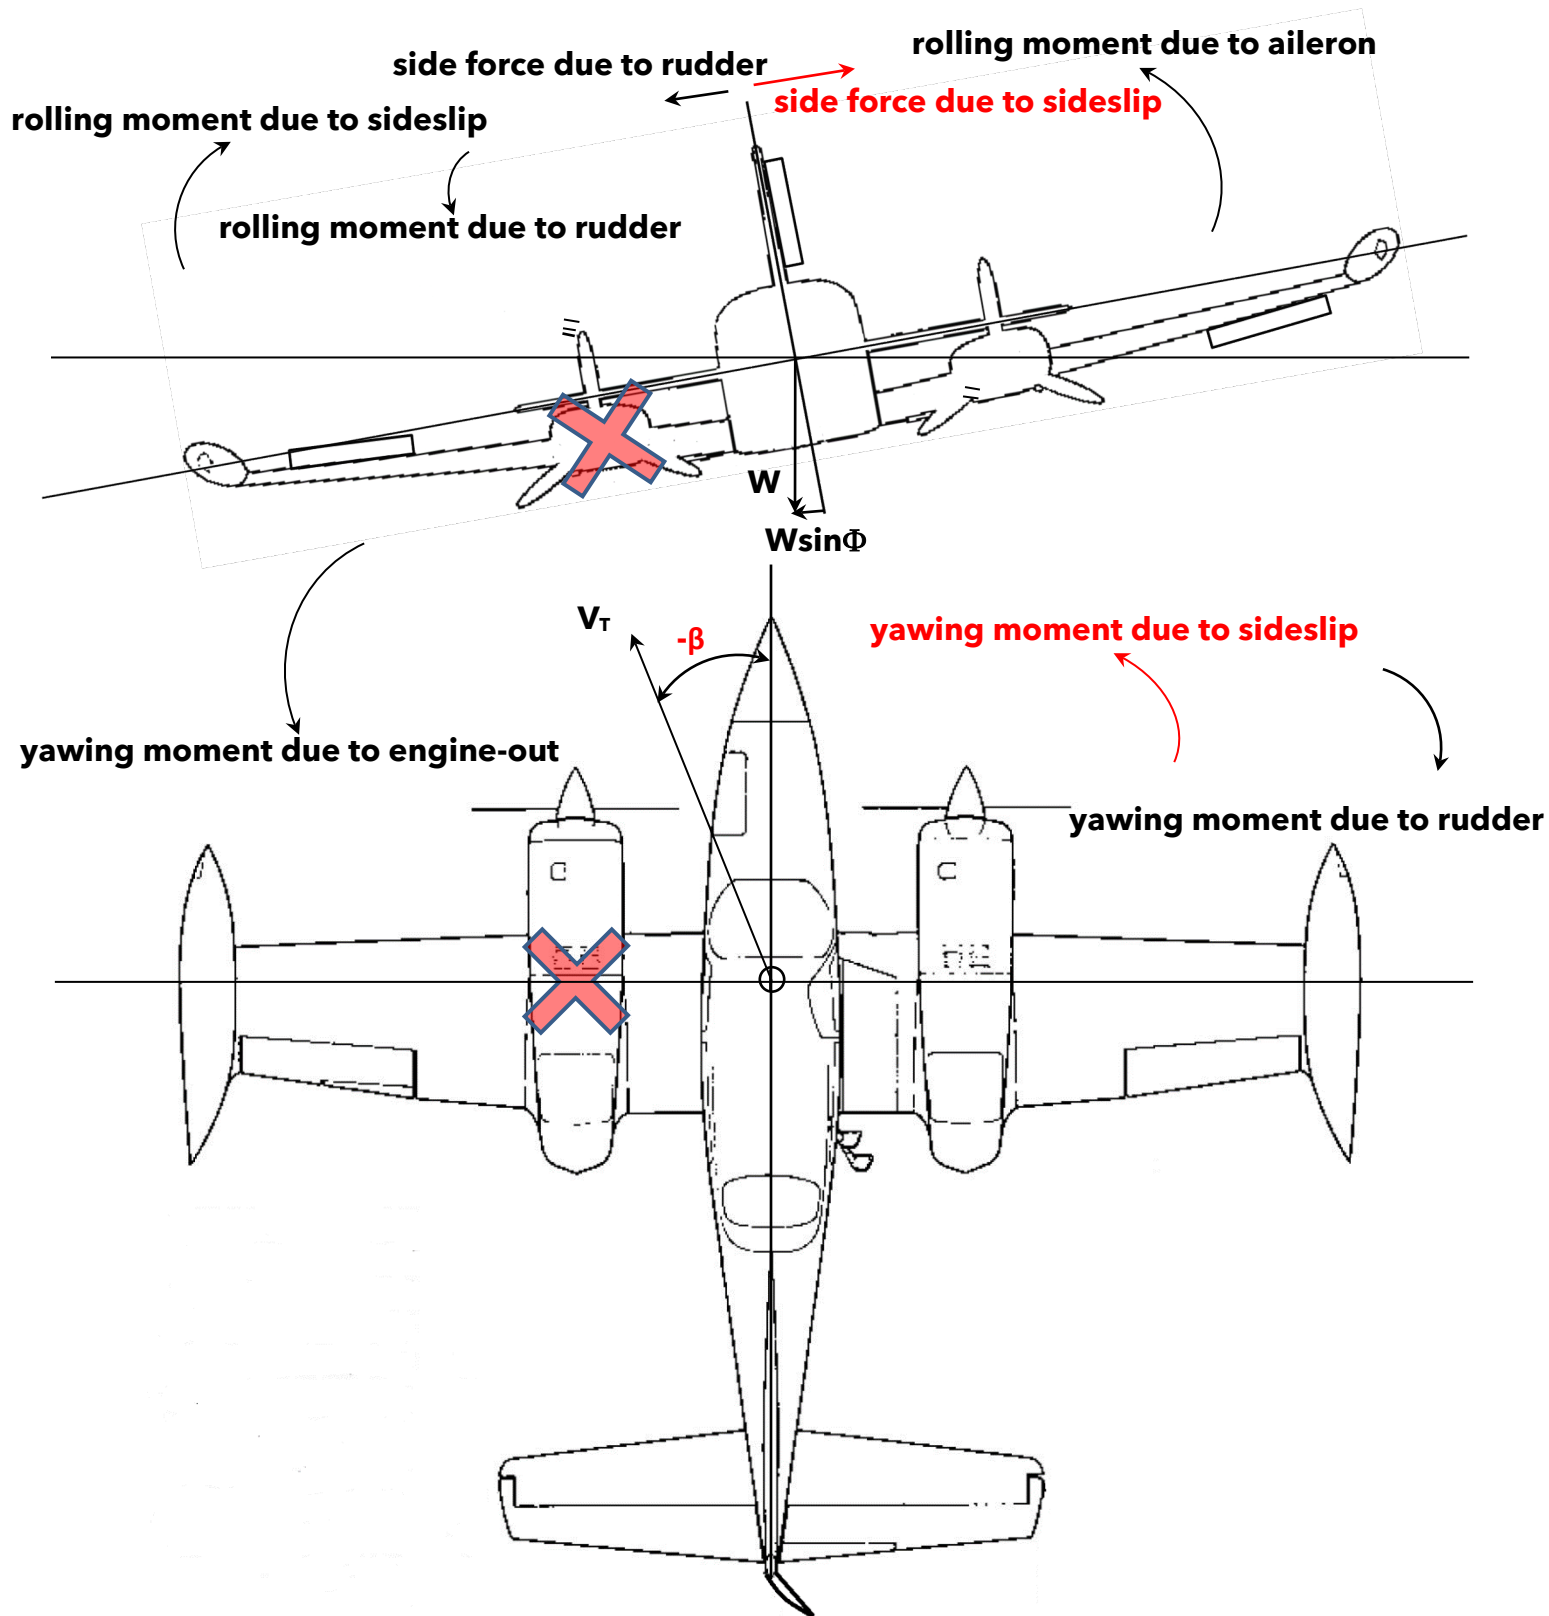
Figure 9 shows the balance of forces and moments for the case where the airplane is (improperly) banked 5° into the inoperative engine. When the airplane is banked into the inoperative engine, sideslip is the only means to balance the lateral component of weight. The negative sideslip that is required then compounds the engine-out asymmetry and effectively reduces the yawing moment generated by the rudder for directional control.

**Figure 9: Improper Left Bank with Left Engine Inoperative  
(As Viewed from Rear and Top, Respectively)**
