## **NATIONAL TRANSPORTATION SAFETY BOARD**

Office of Aviation Safety  
Eastern Region

**Photo Array**

**ERA22FA114**

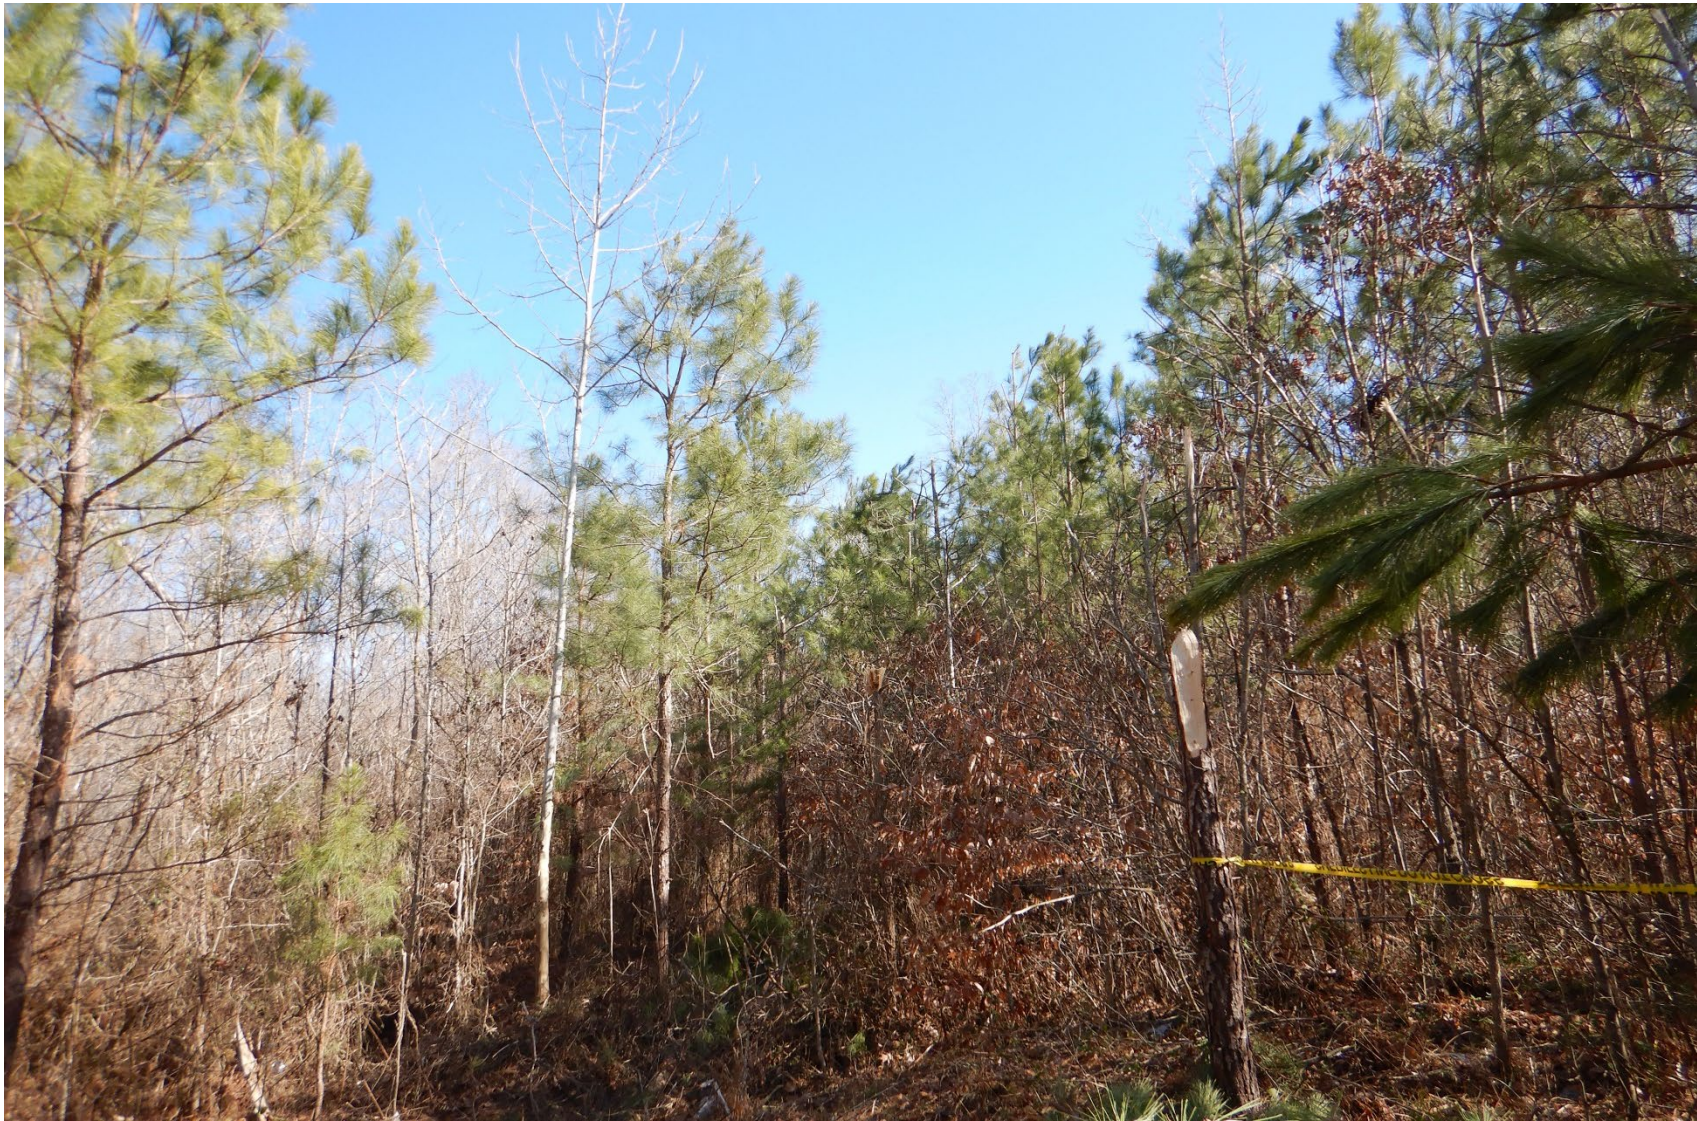
**Photo 1 – View of tree damage from accident airplane**

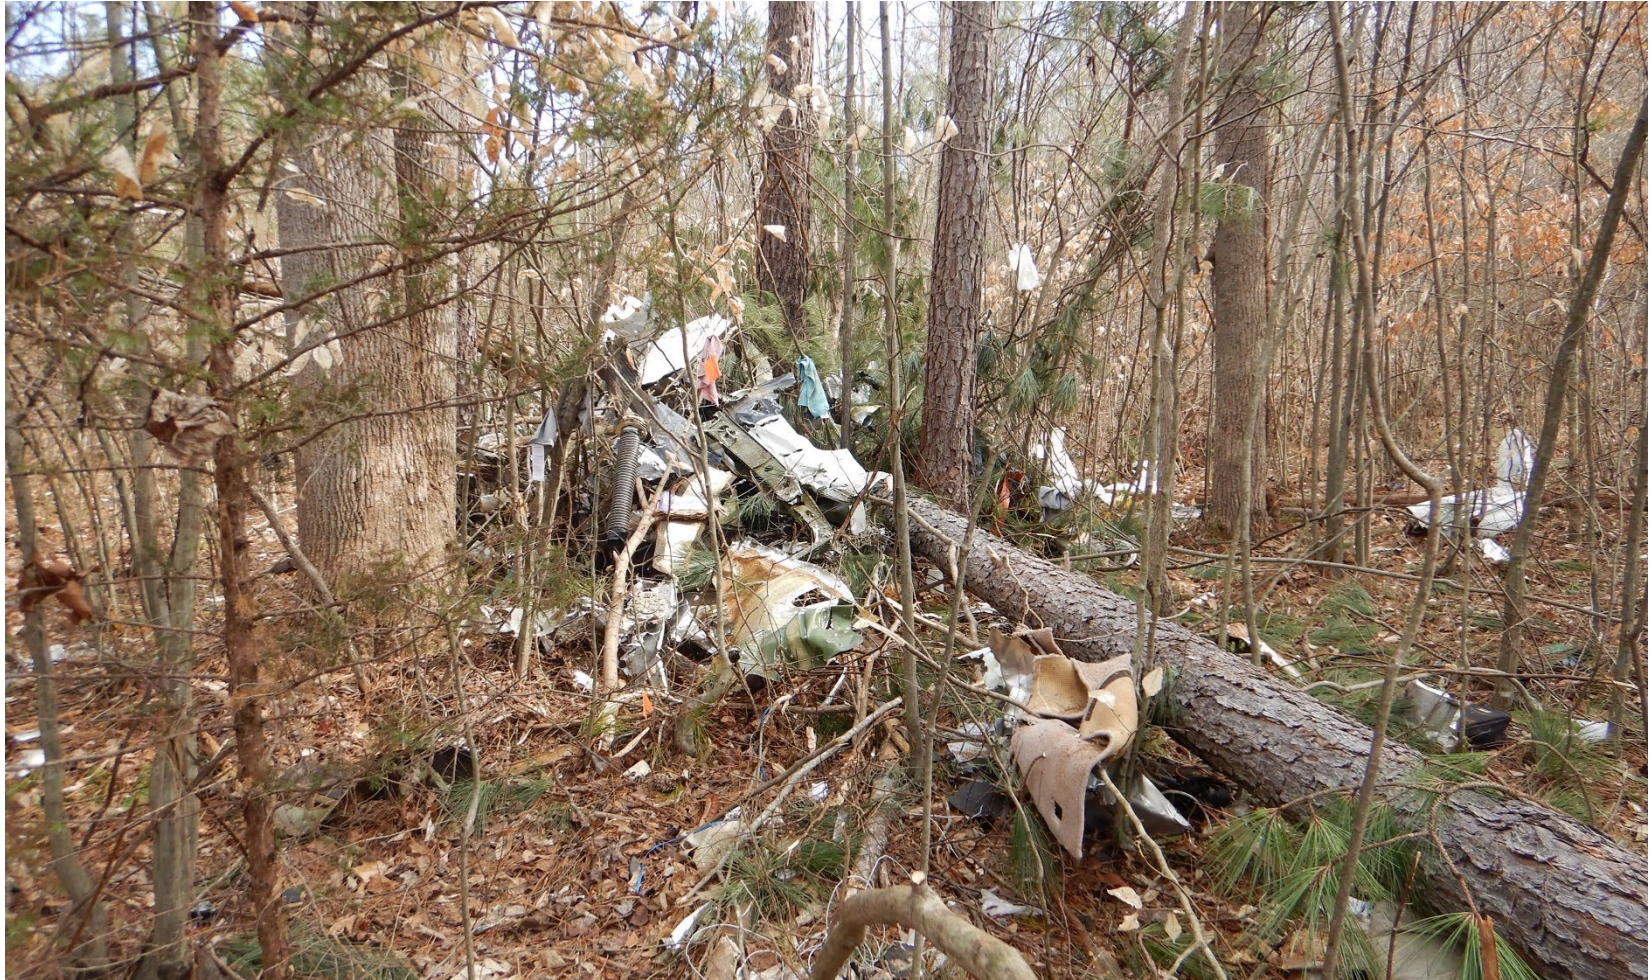
**Photo 2 – View of highly fragmented wreckage**

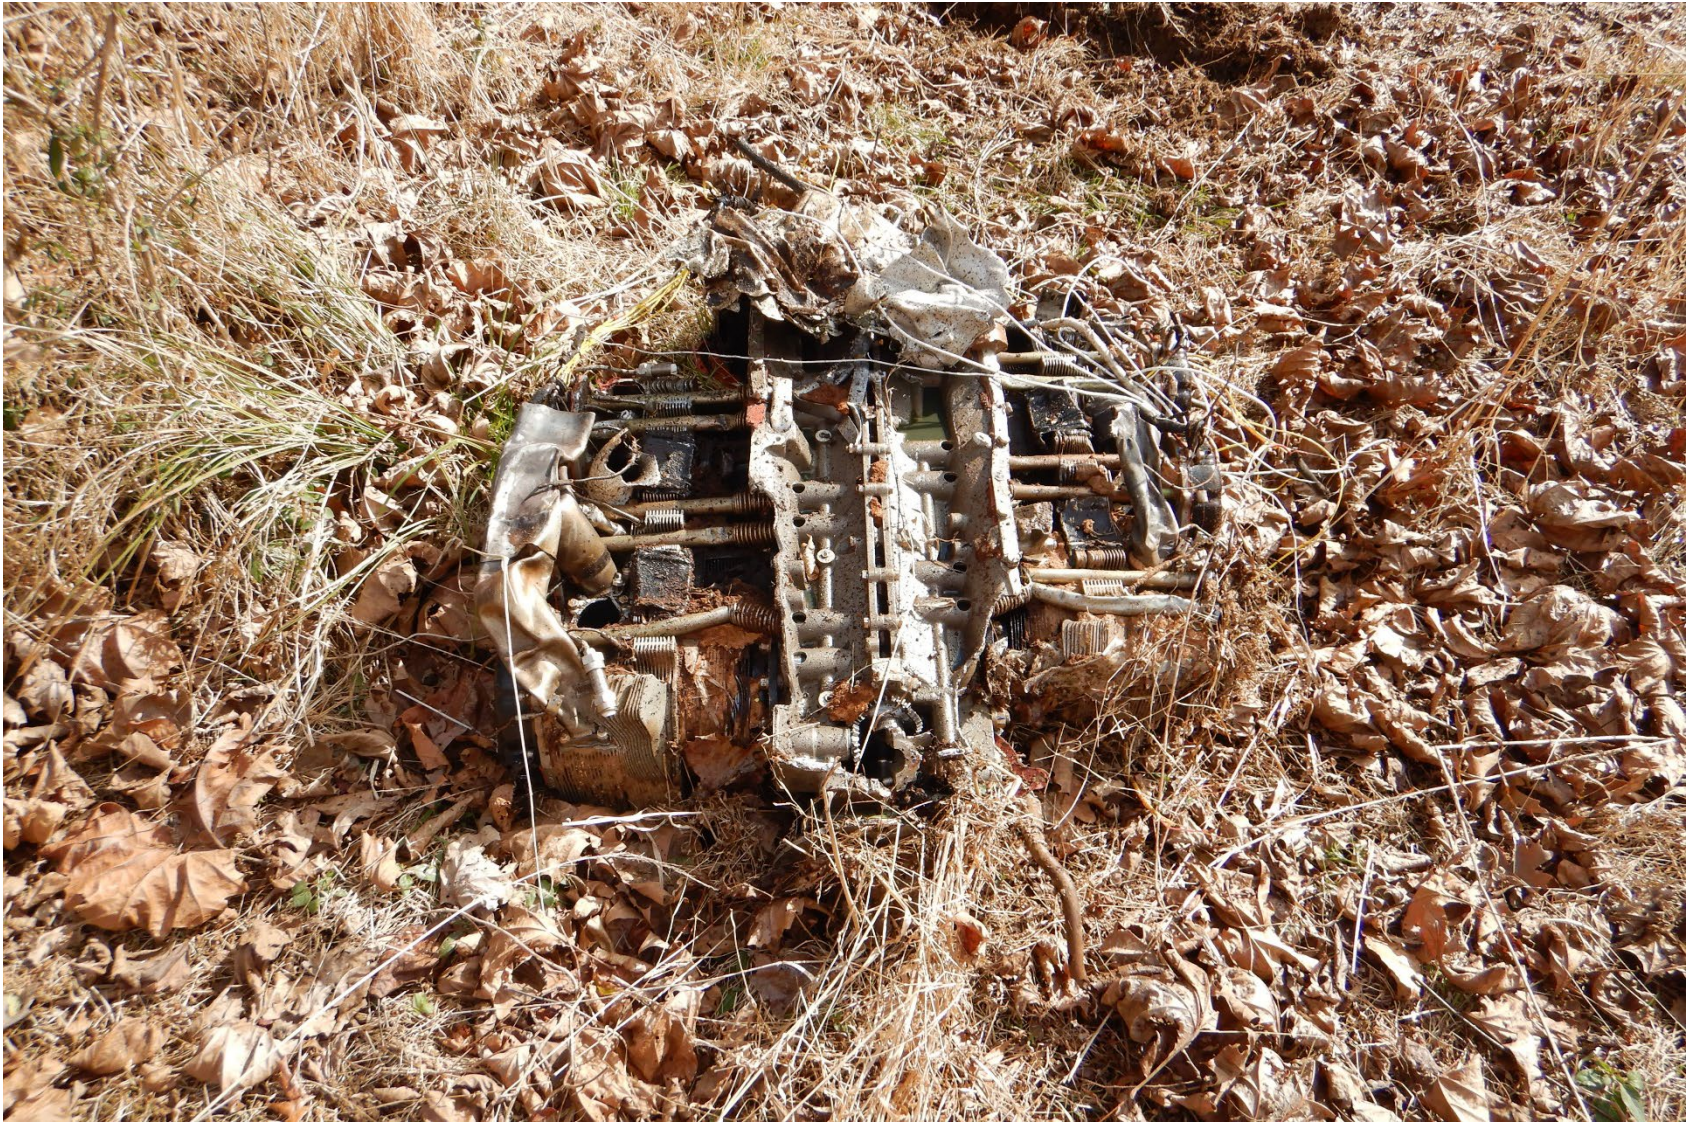
**Photo 3 – View of engine separated from airplane during impact sequence**

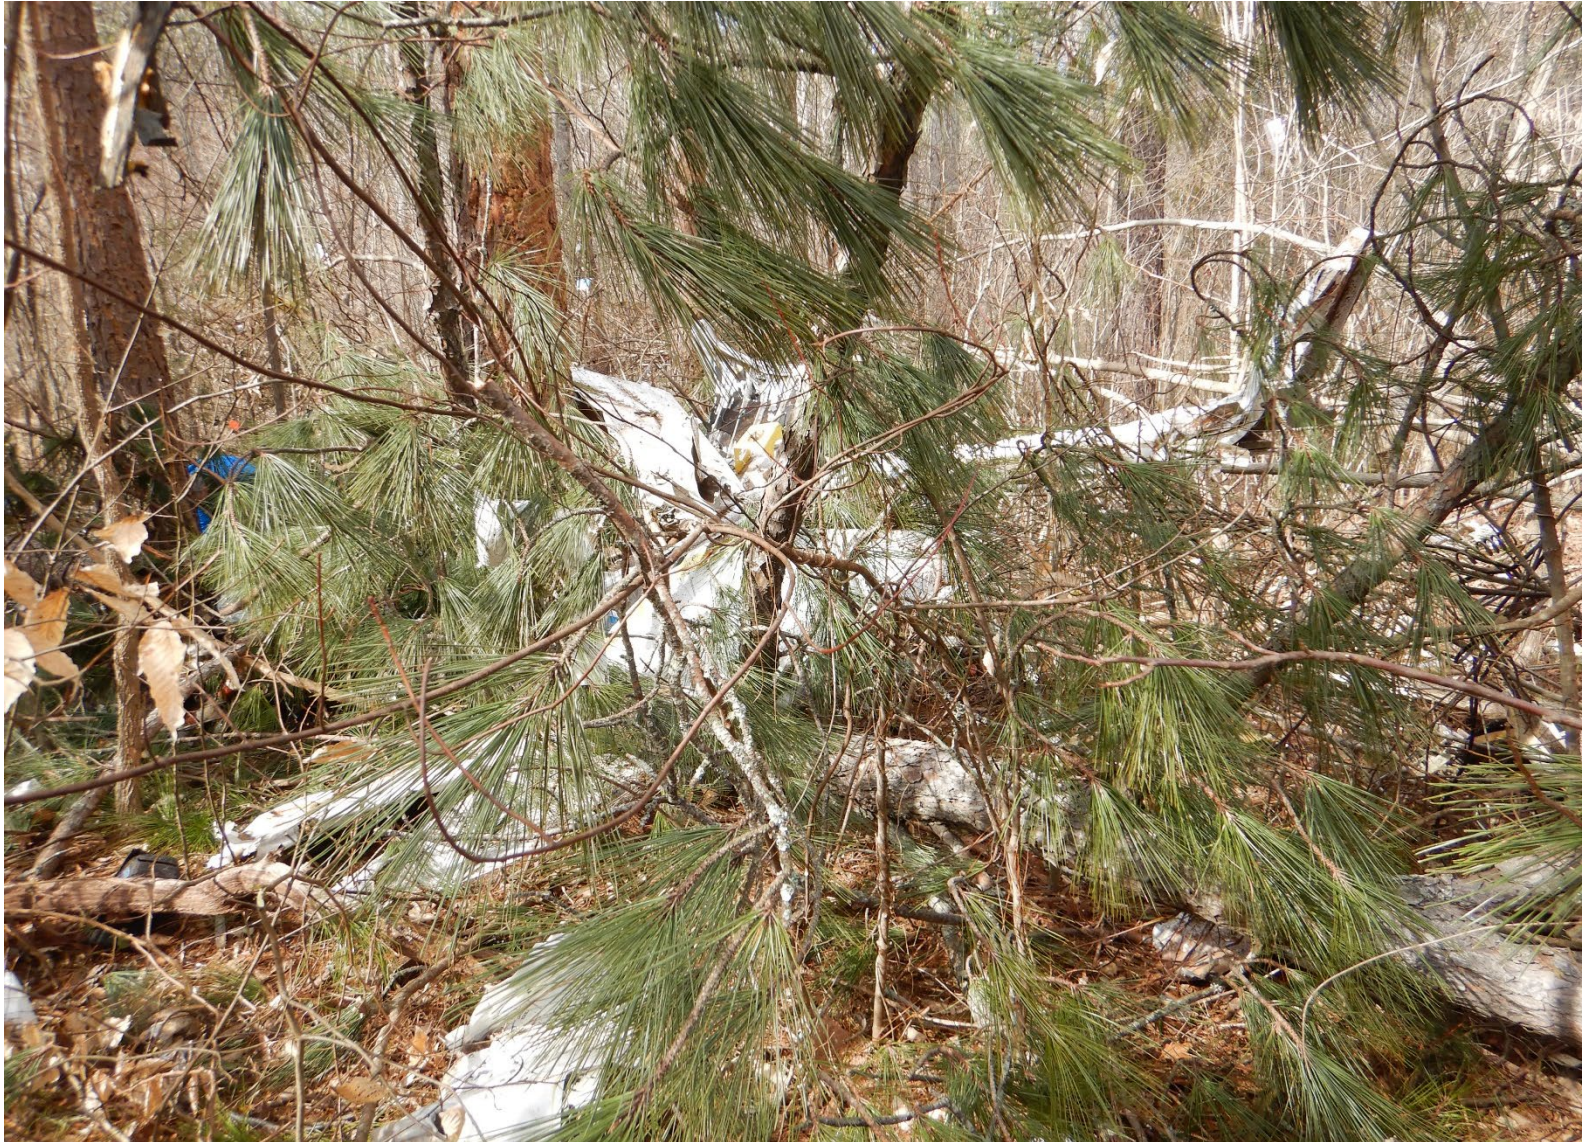
**Photo 4 – View of impact fragmented fuselage and empennage**

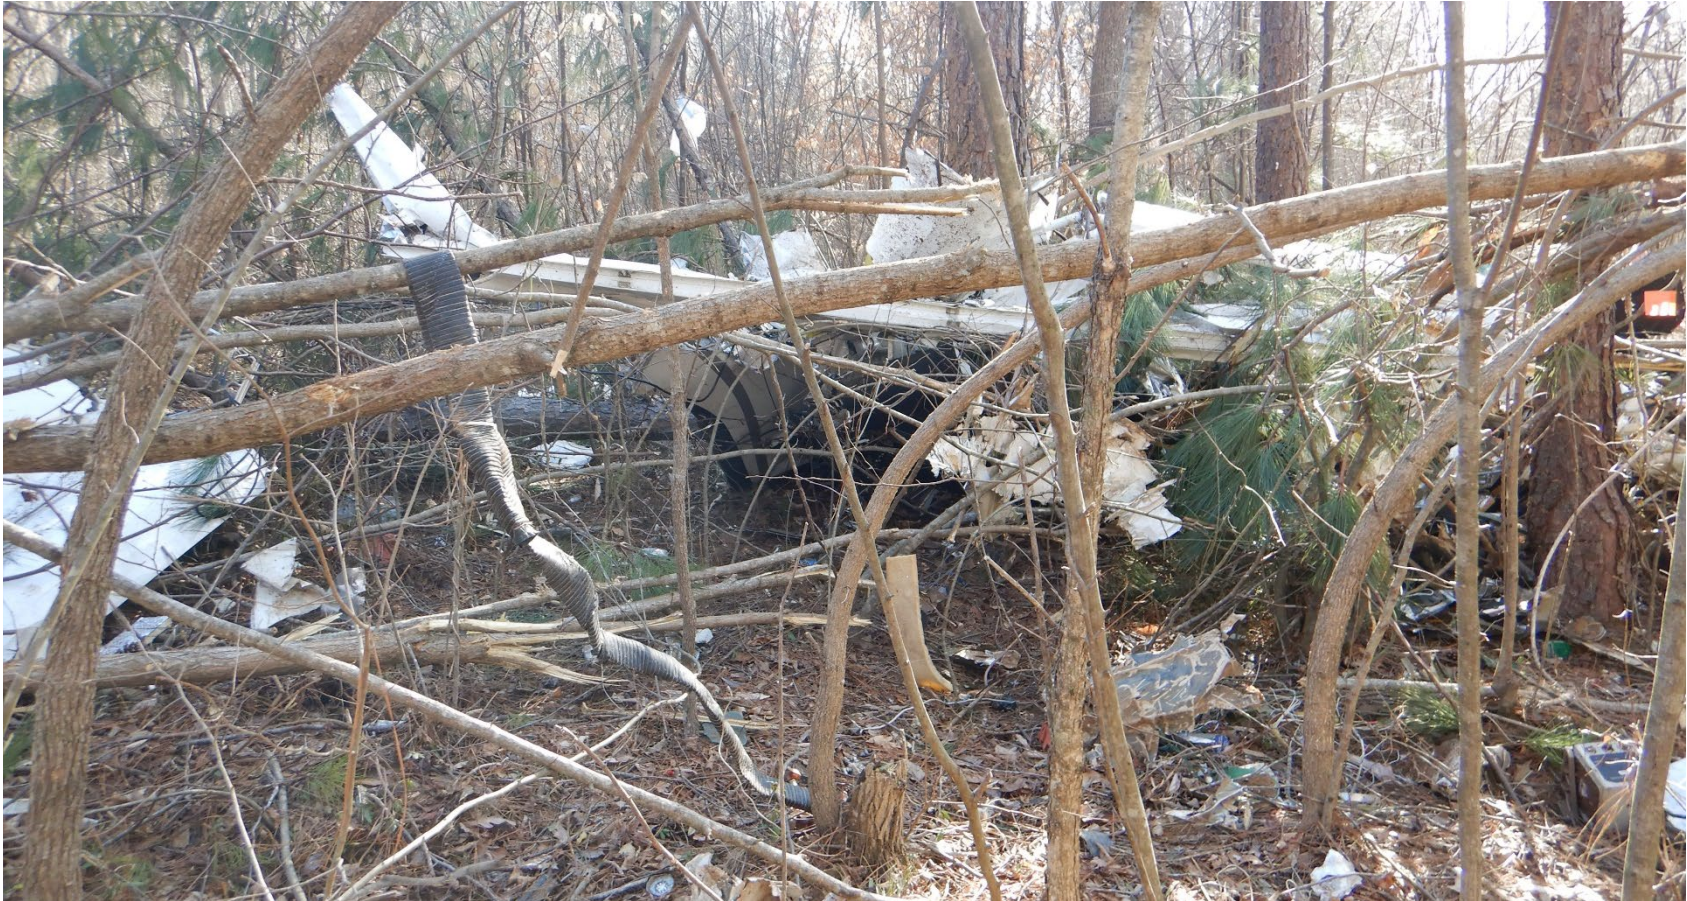
**Photo 5 – View of impact fragmented fuselage and empennage from opposite direction**

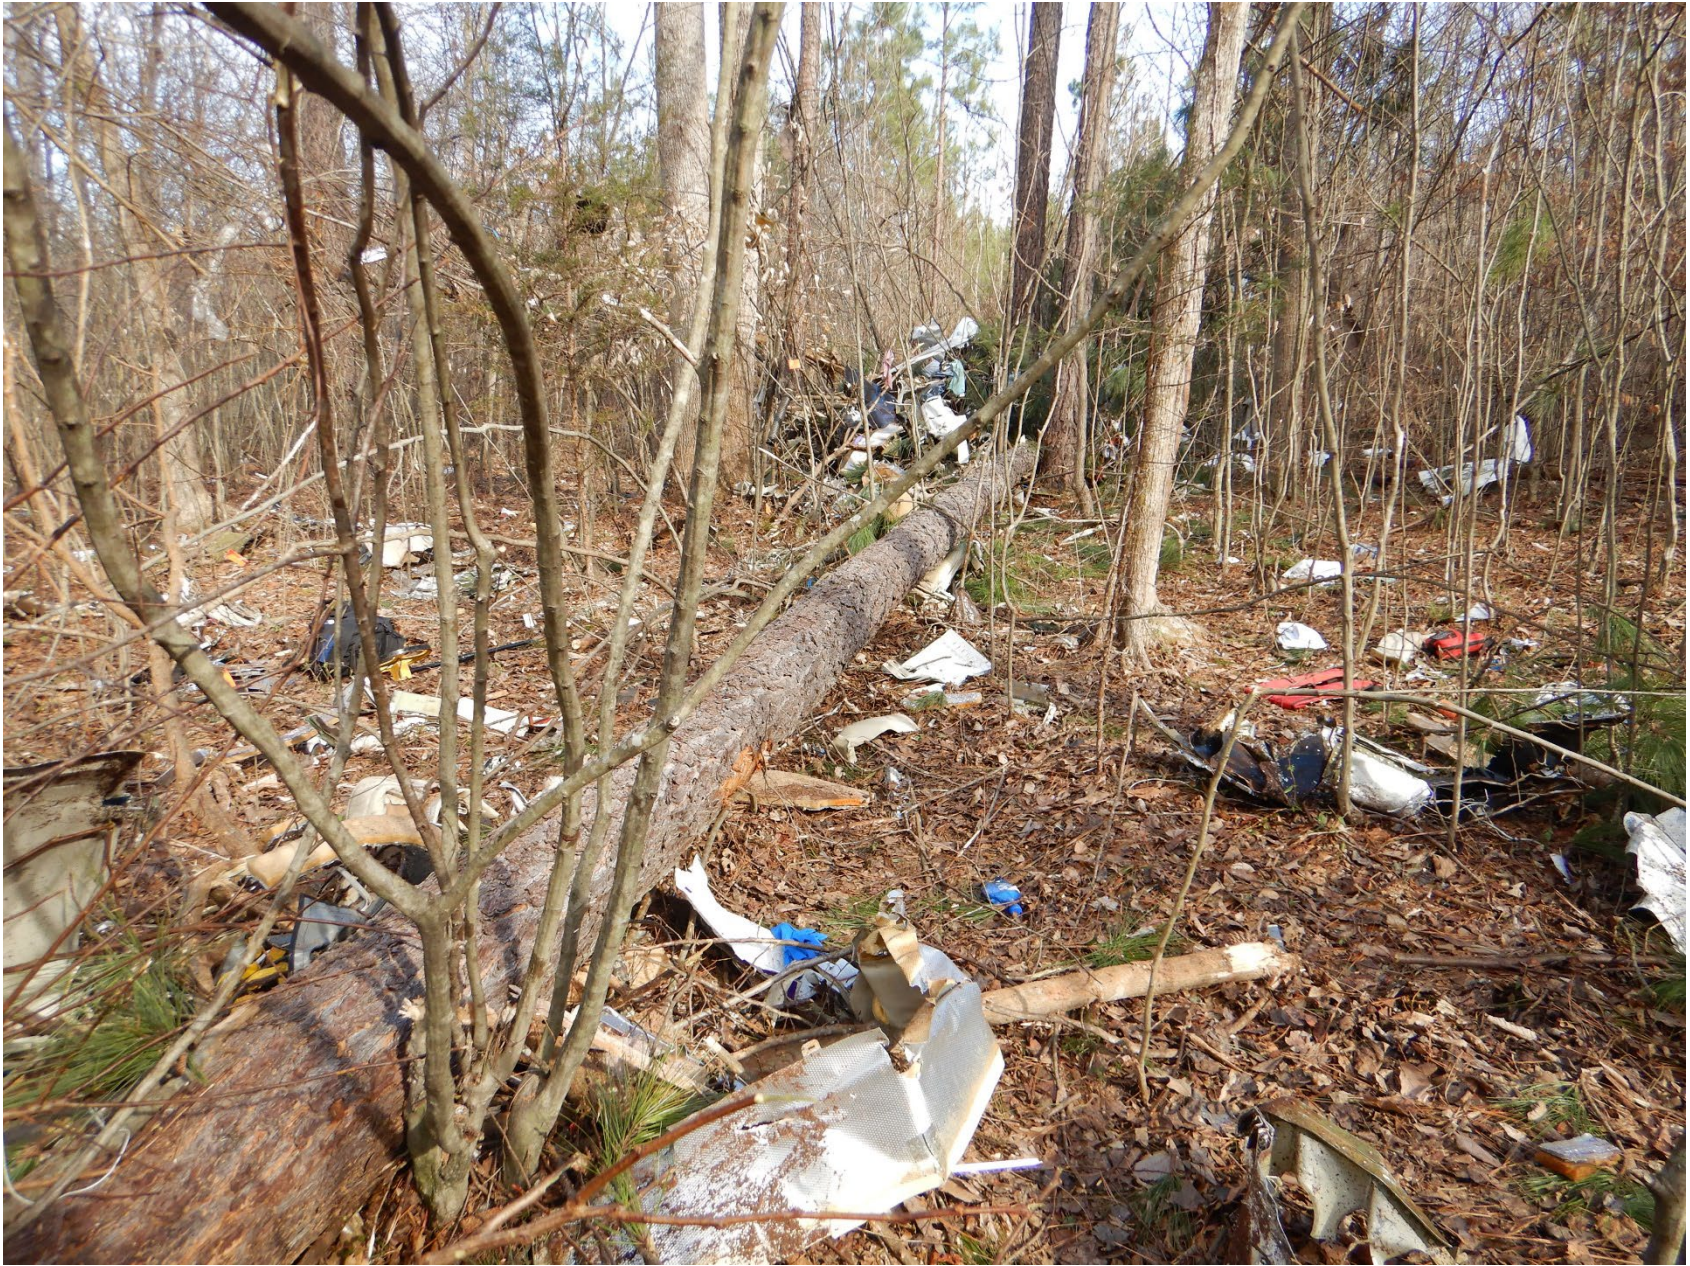
**Photo 6 – View of impact fractured tree resting on wreckage**

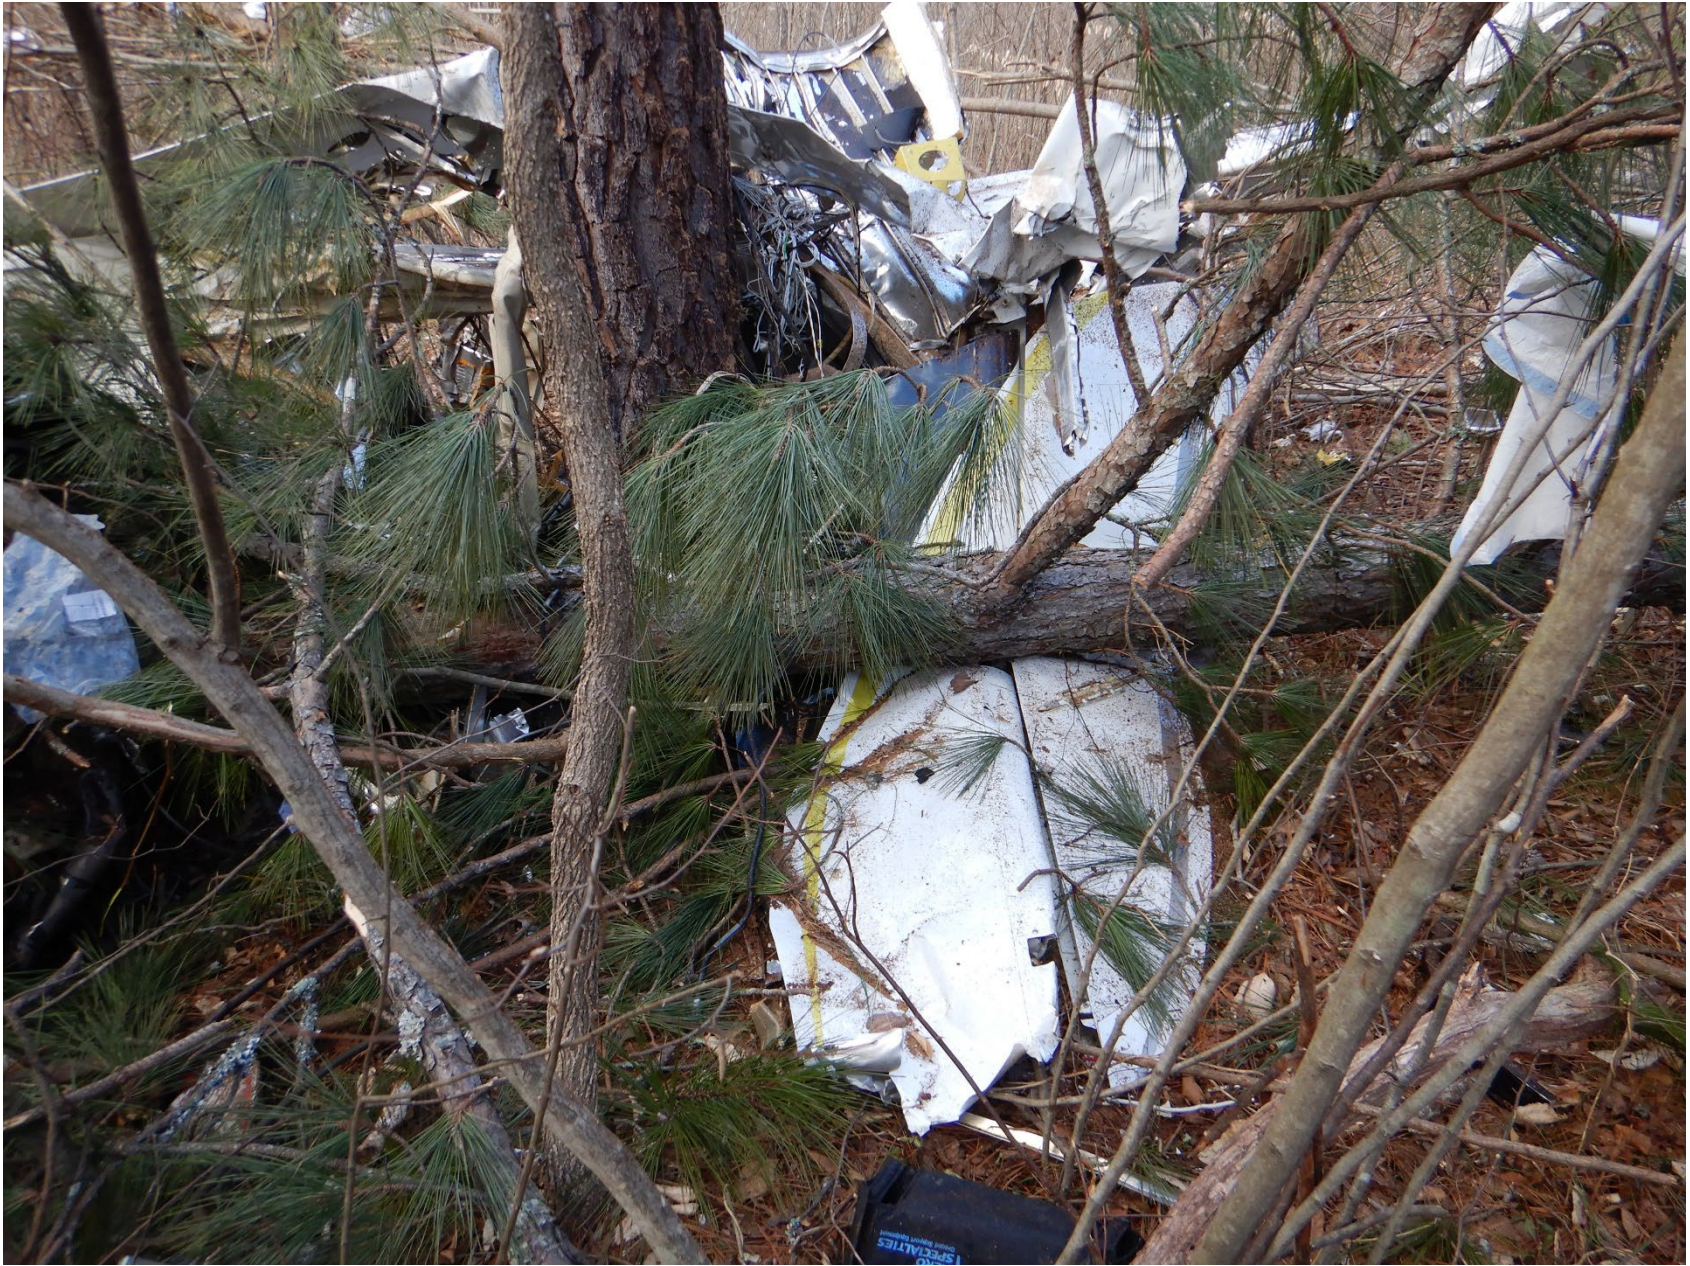
**Photo 7 – Closer view of main wreckage**

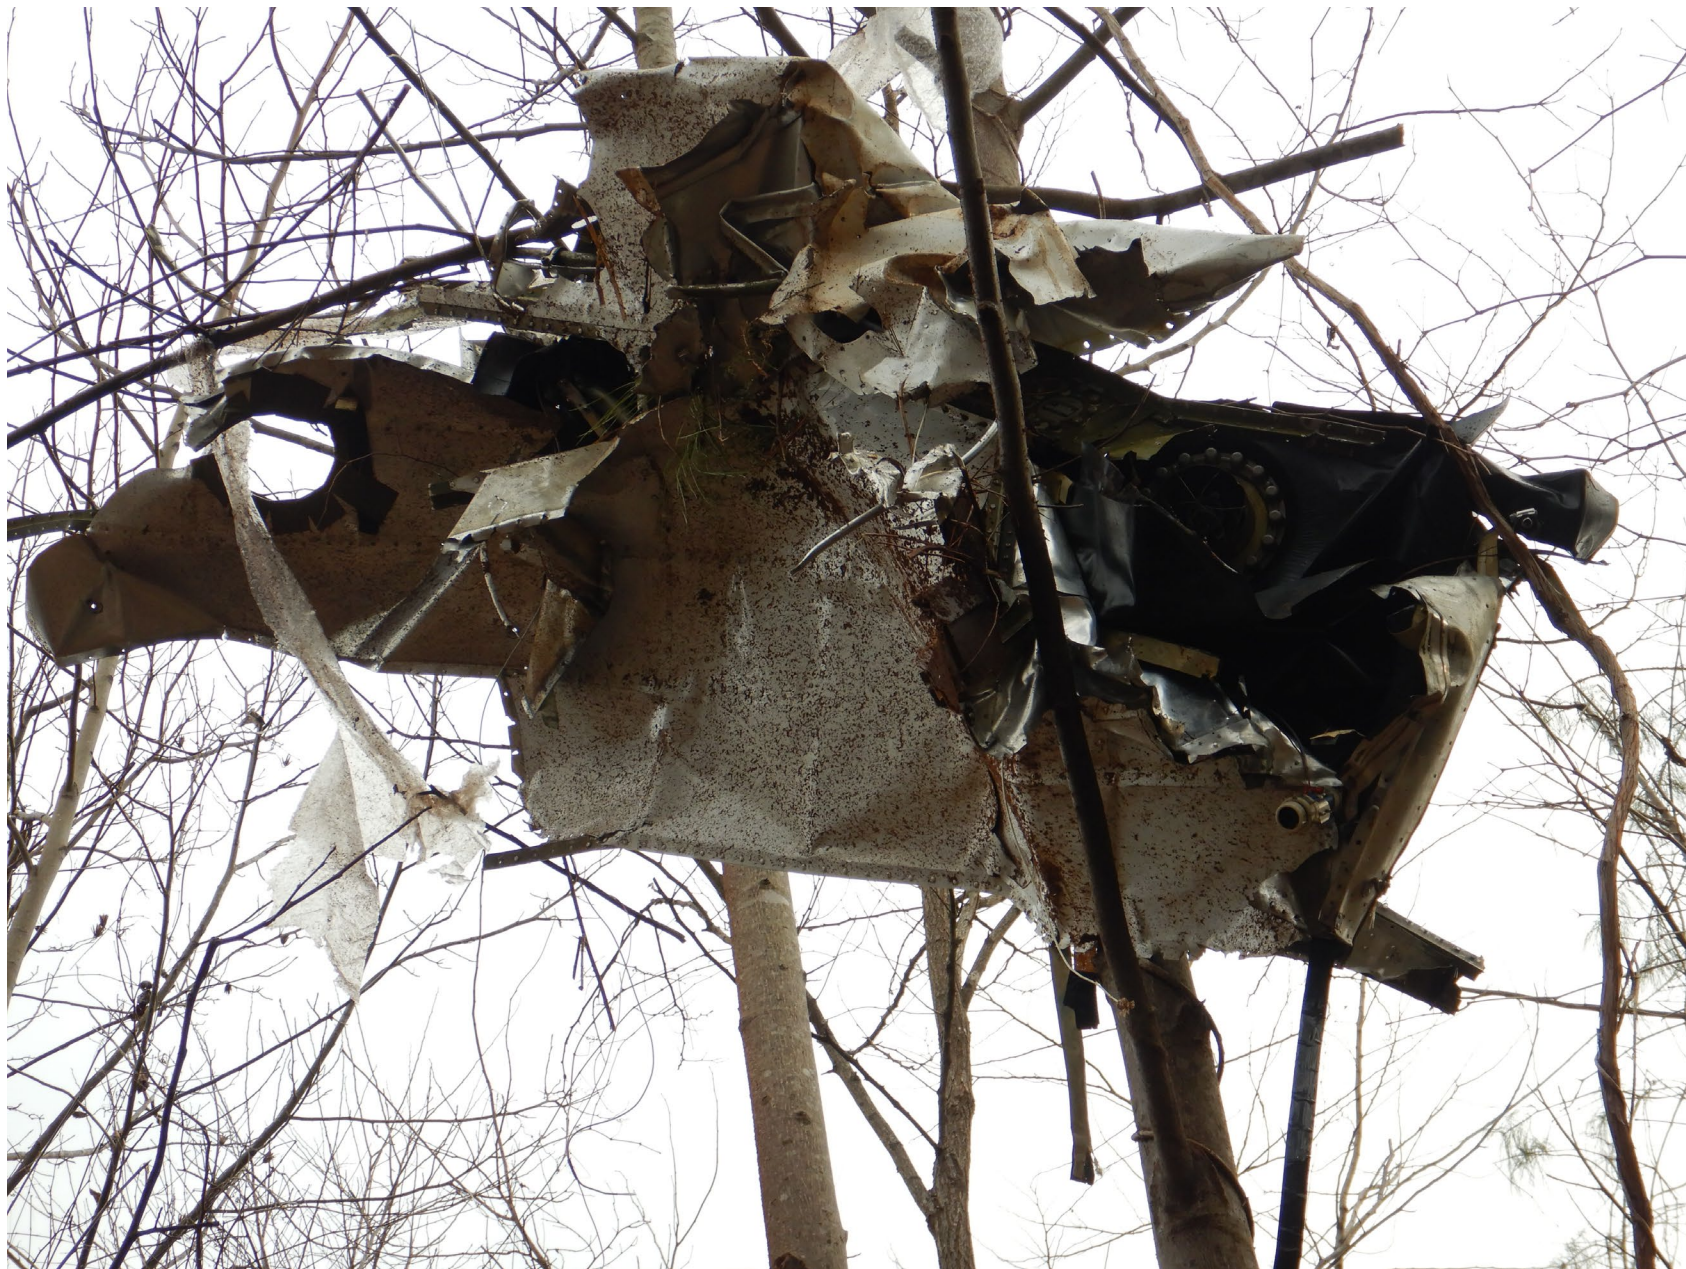
**Photo 8 – View of wreckage in a tree along the debris path**

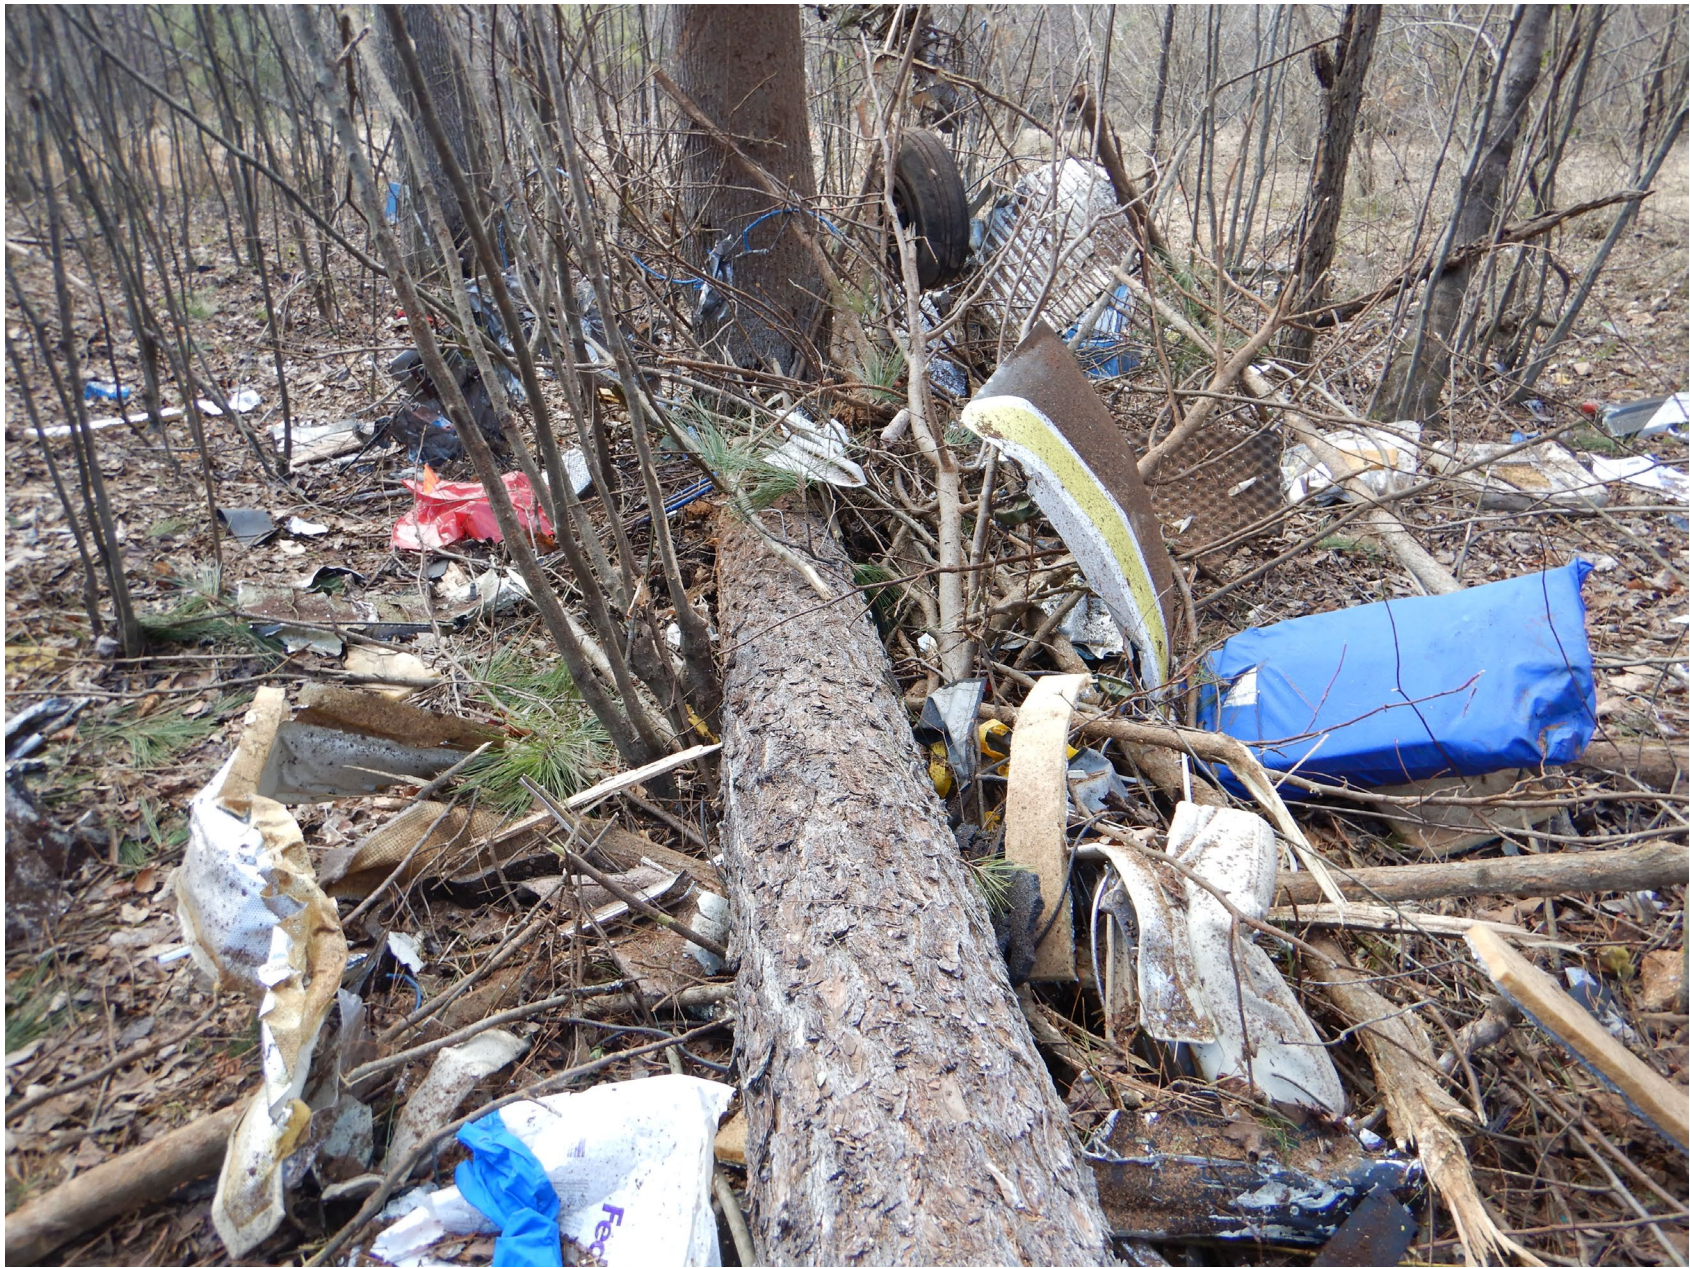
**Photo 9 – View of scattered wreckage around and under fractured tree trunk**

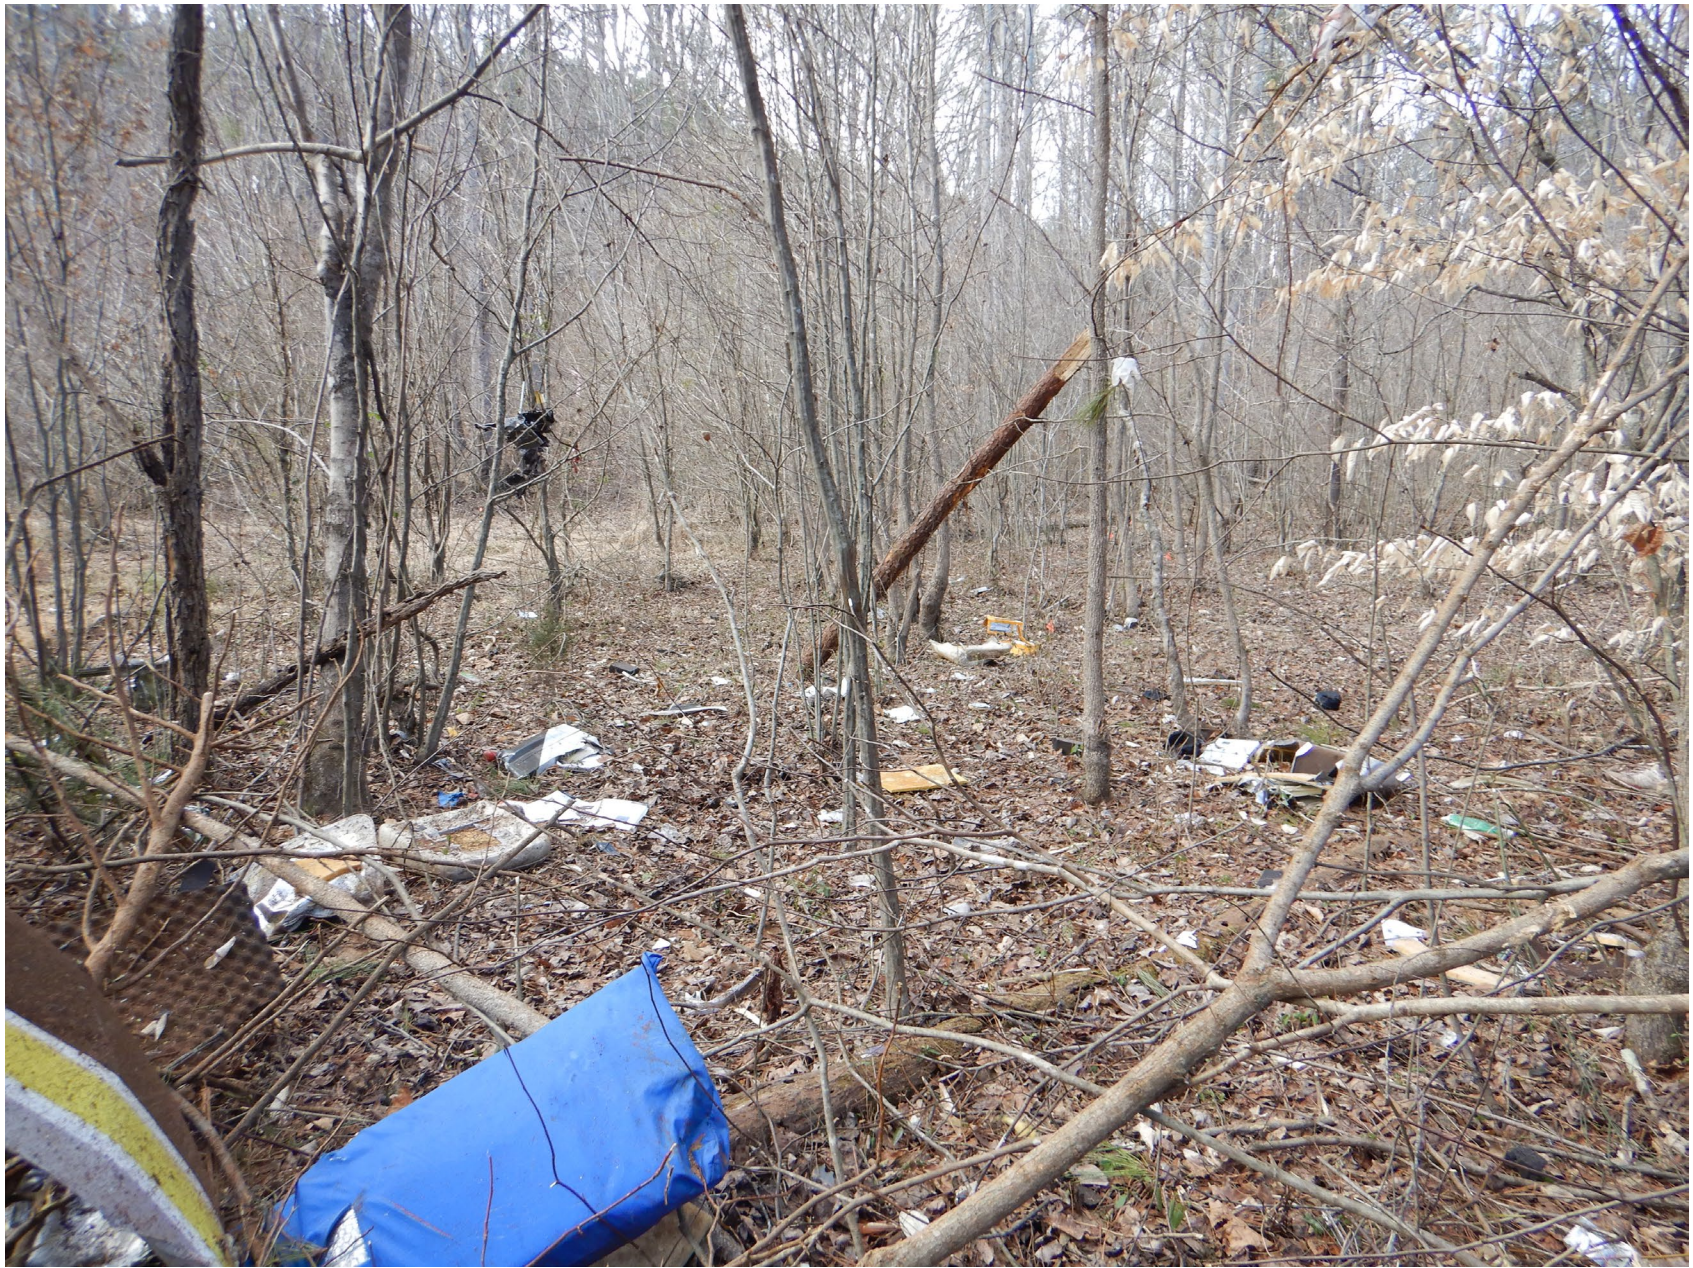
**Photo 10 – Wreckage debris in wooded area**

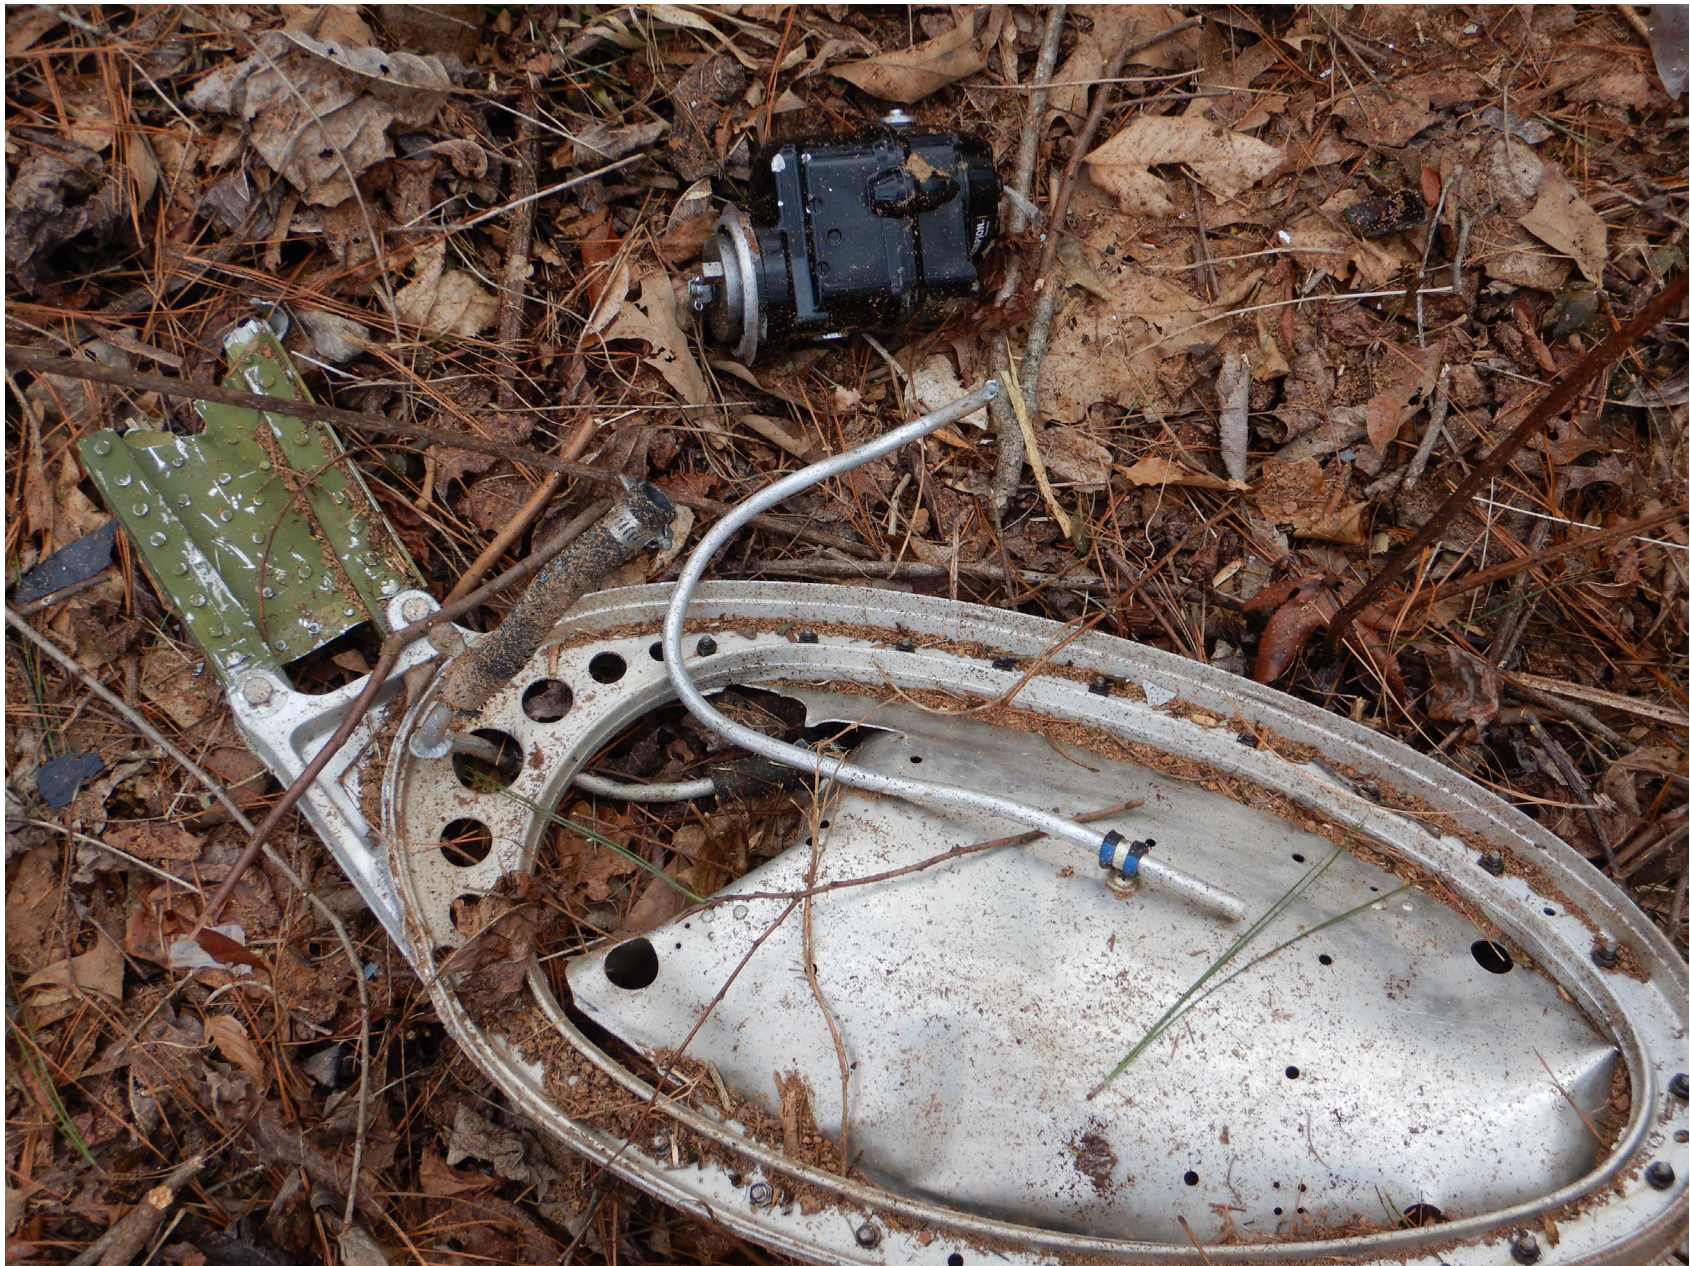
**Photo 11 – View of fractured magneto and wreckage**
