## **NATIONAL TRANSPORTATION SAFETY BOARD**

Office of Aviation Safety  
Eastern Region

**Photo Array**

**ERA22FA114**

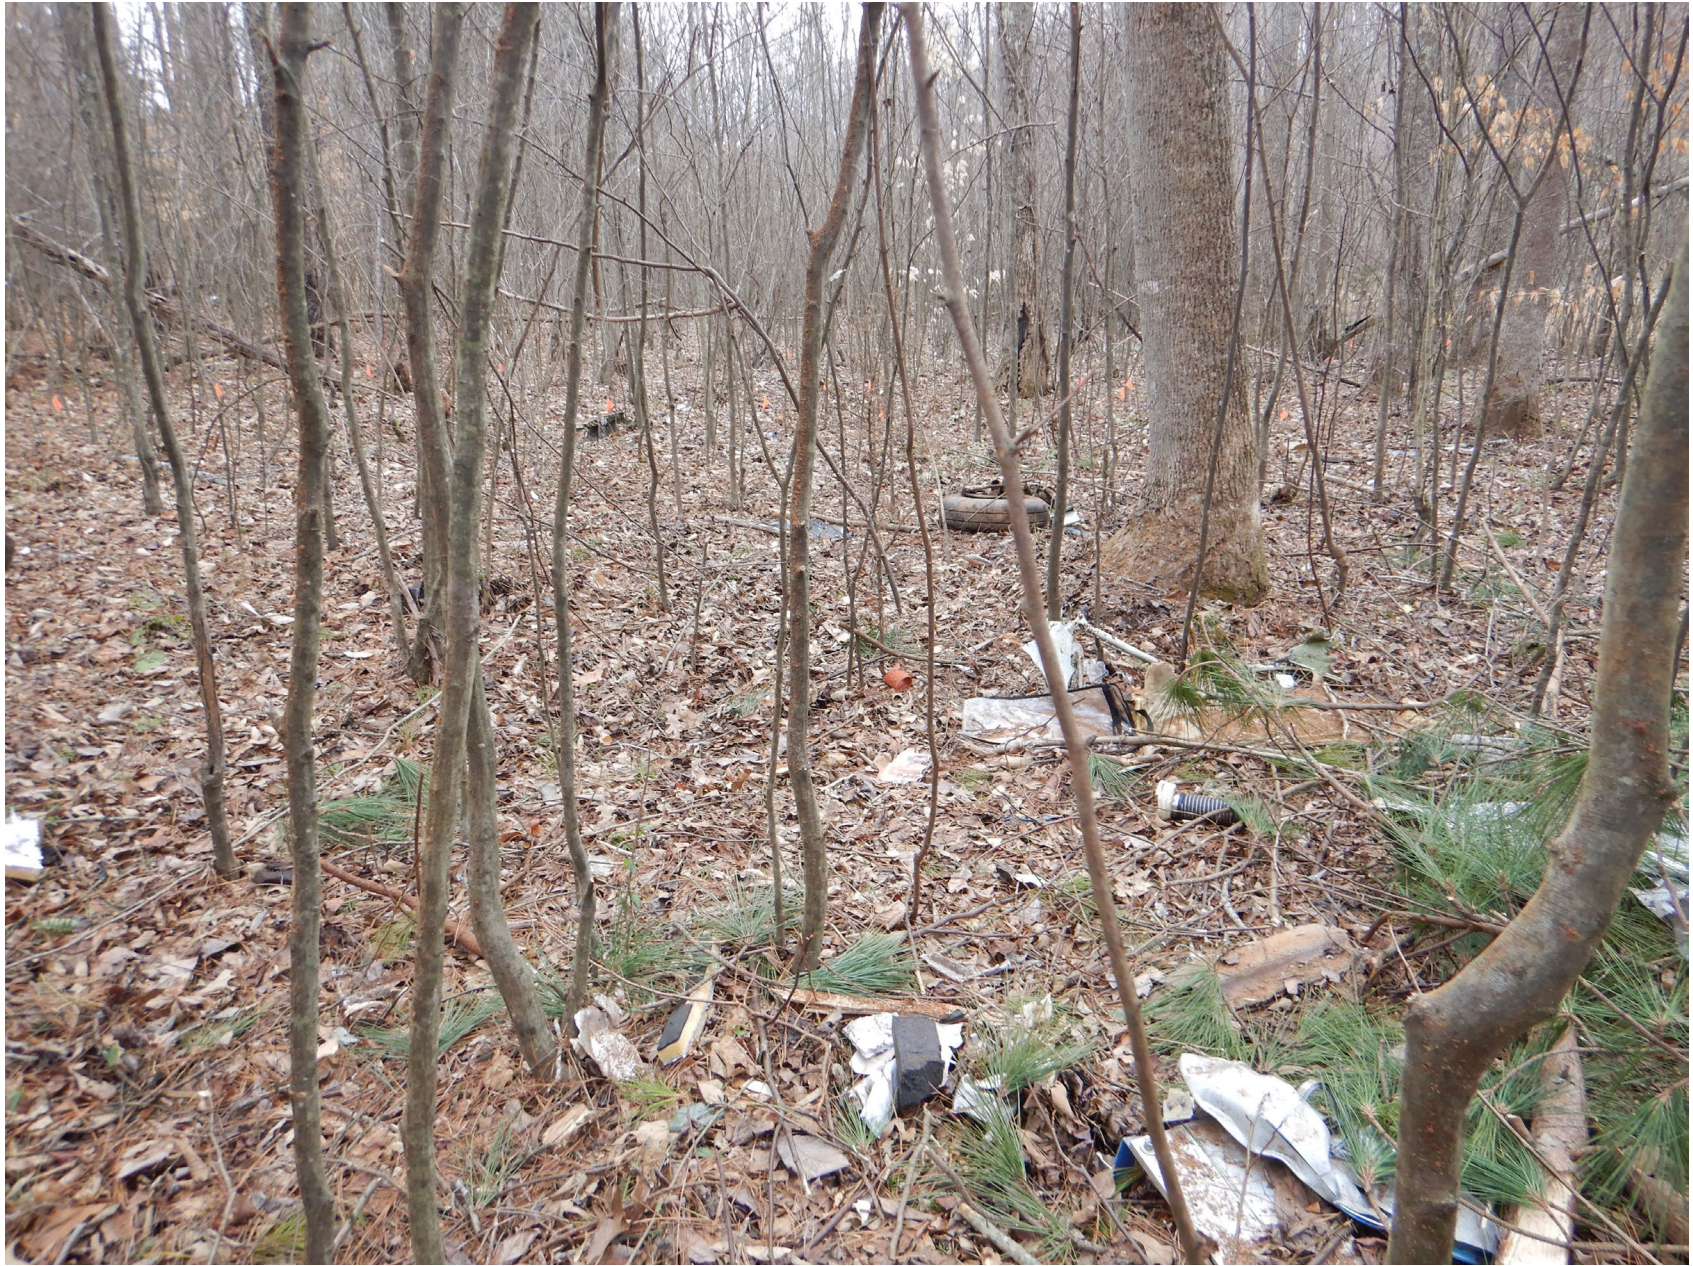
**Photo 12 – View of debris and fractured landing gear**

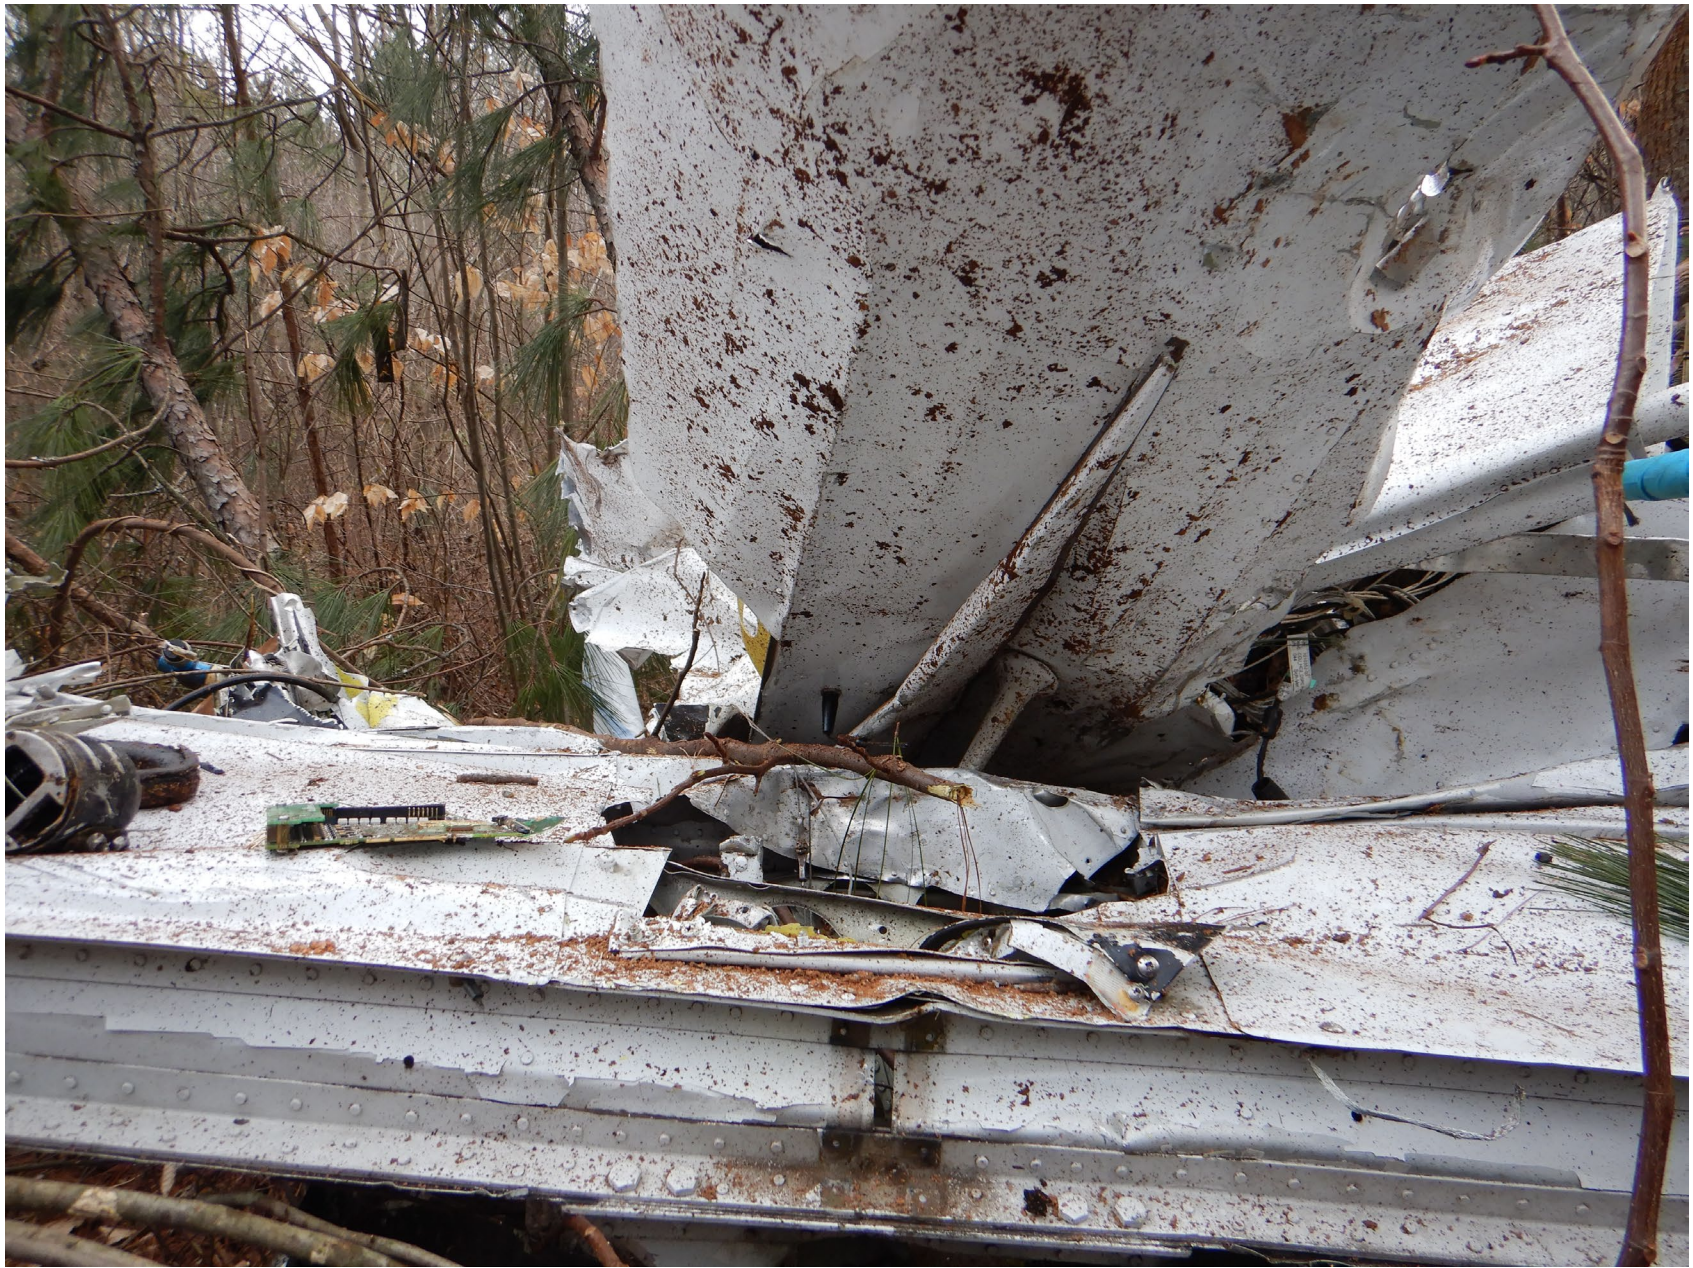
**Photo 13 – Close-up view of main wreckage**

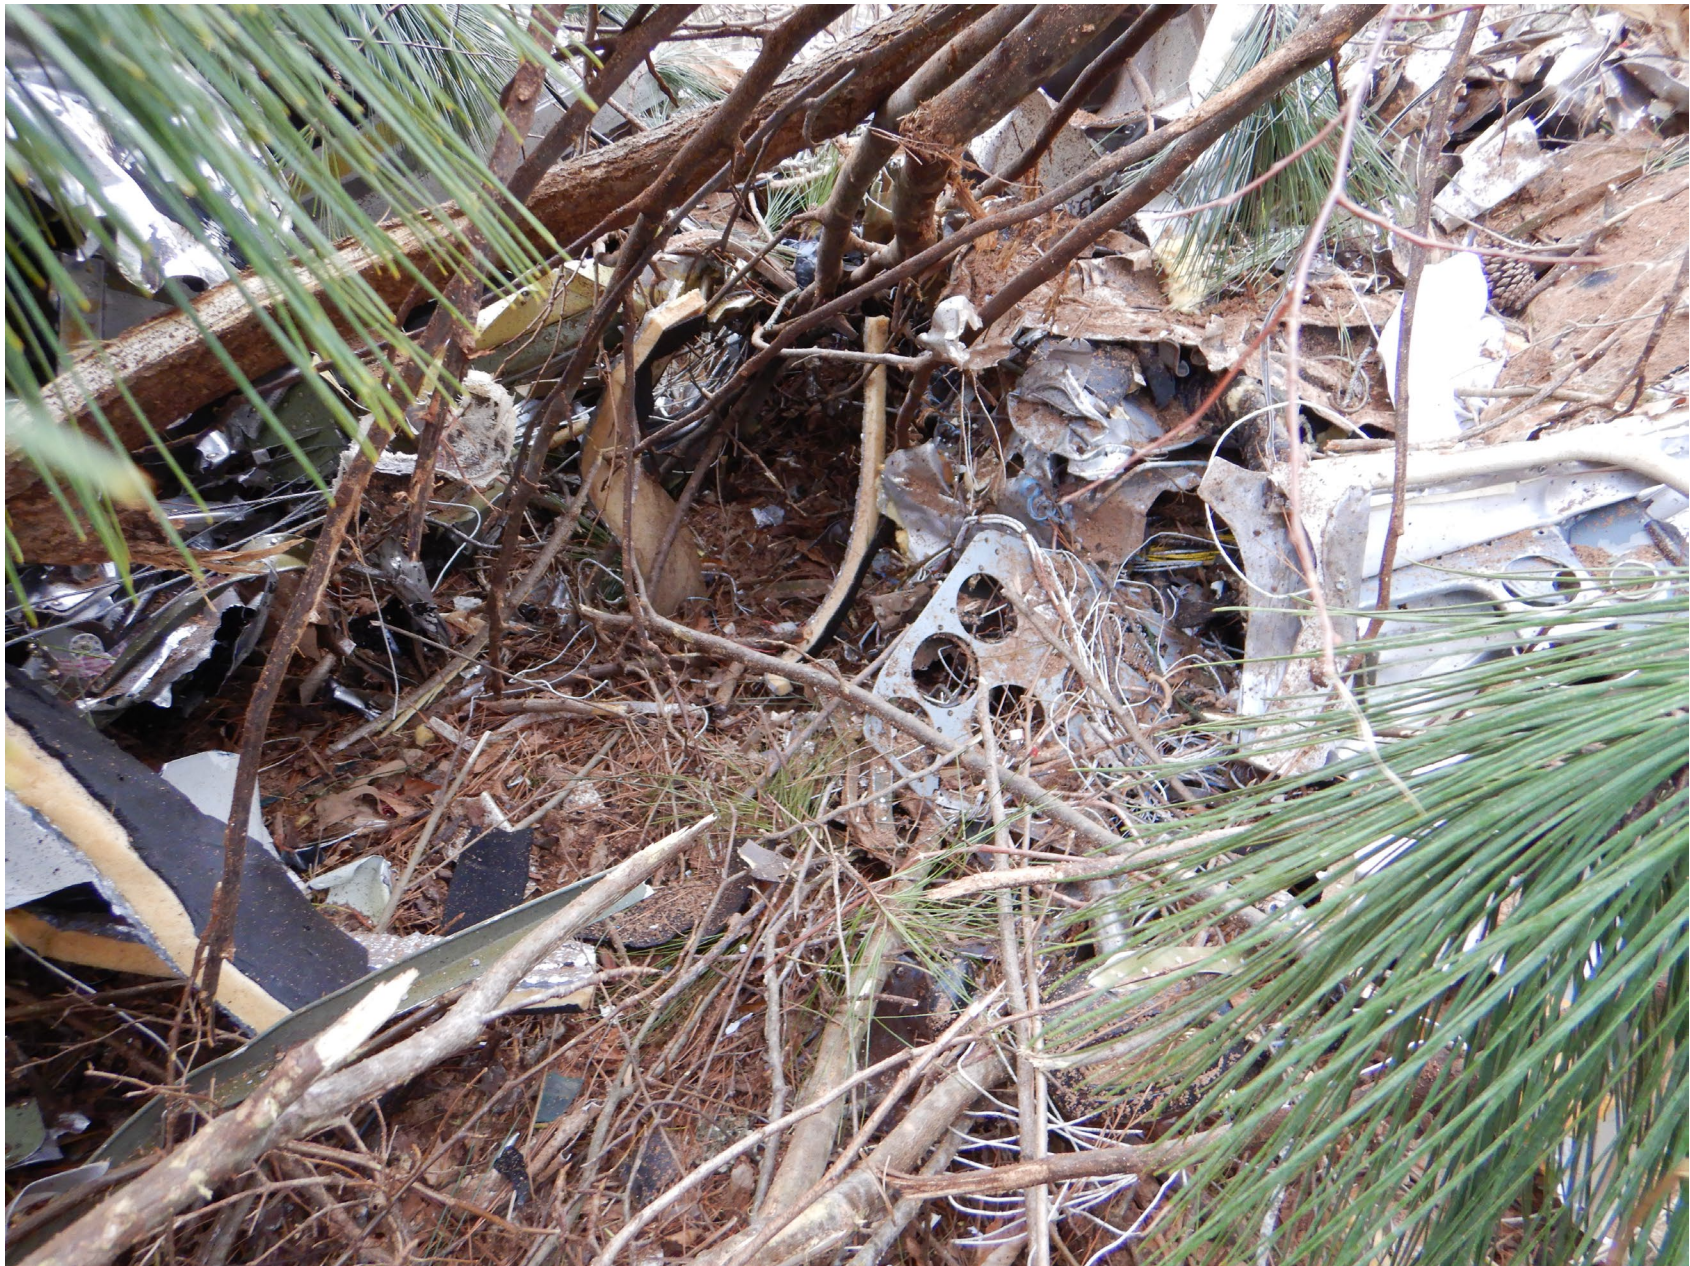
**Photo 14 – View of highly fragmented cockpit area**

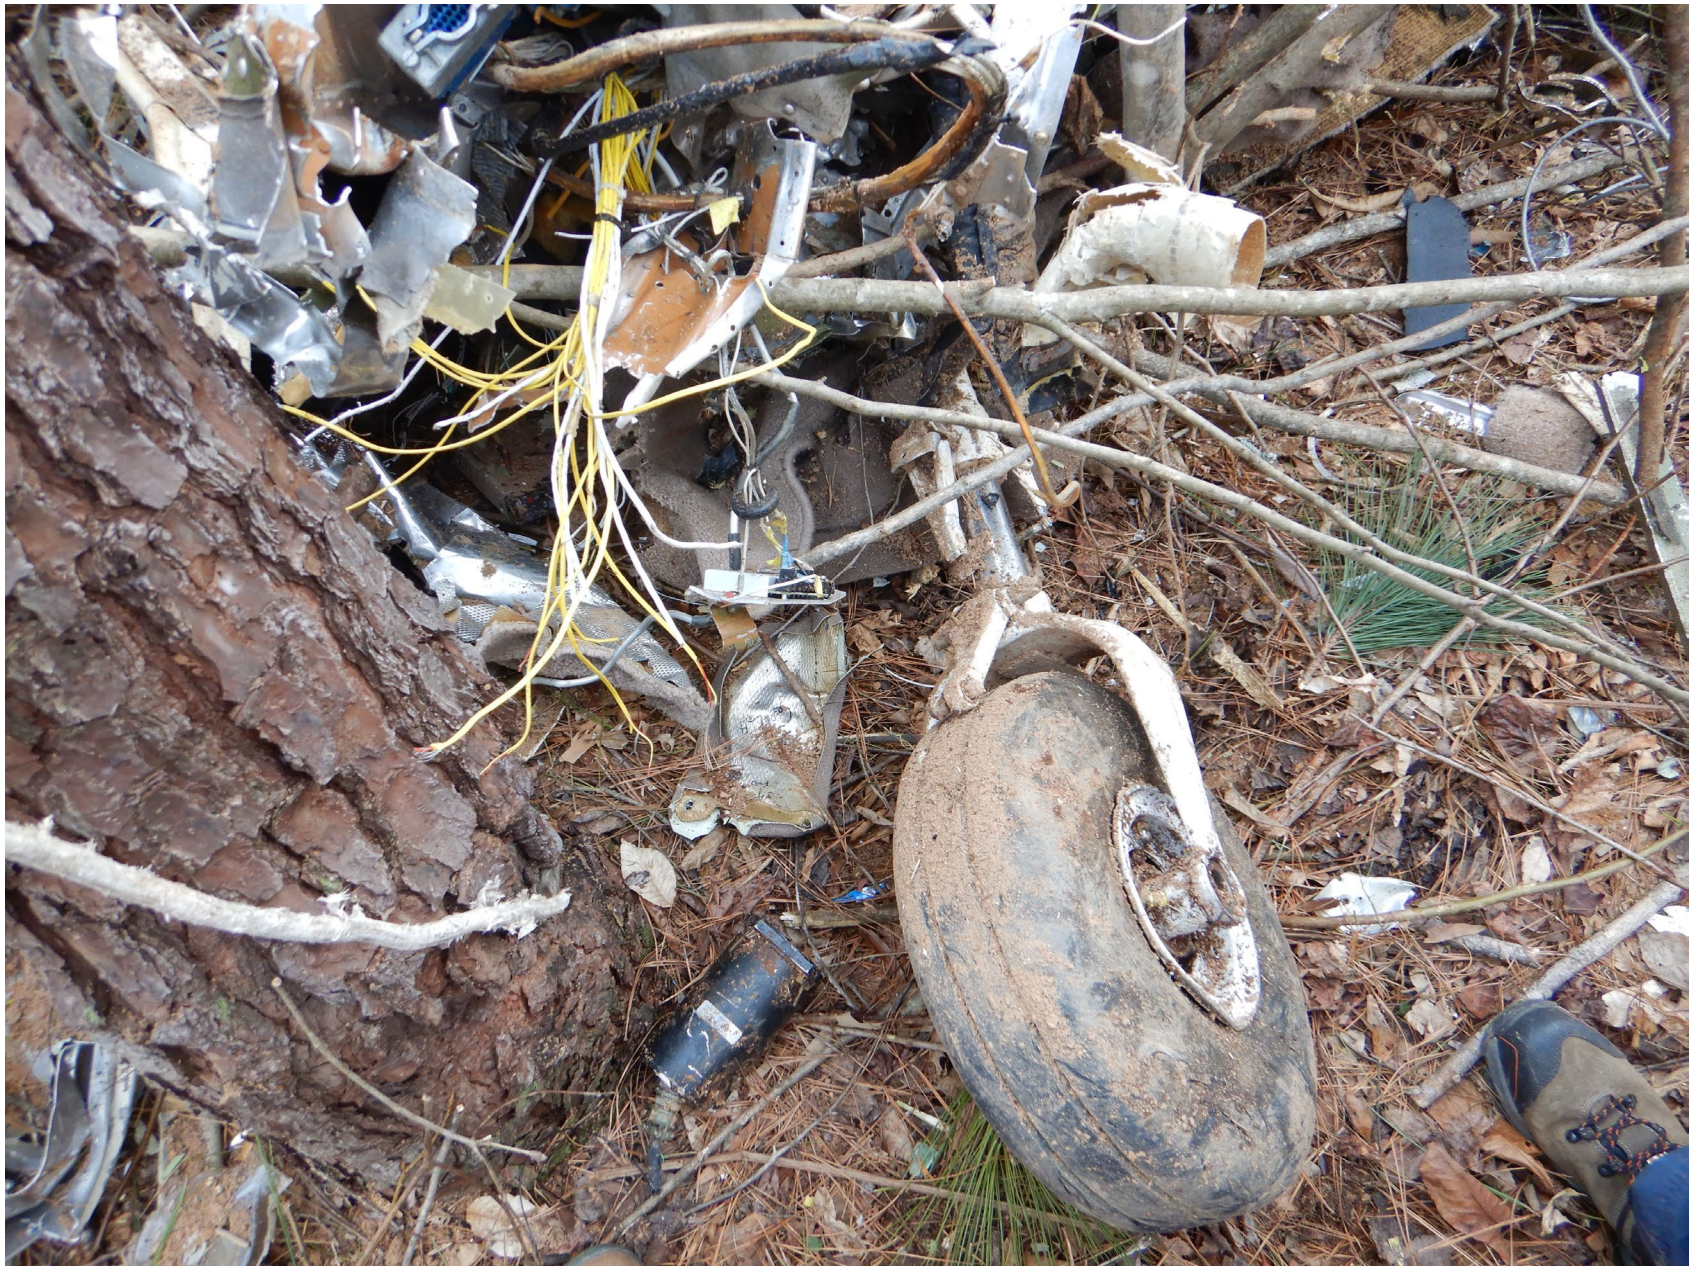
**Photo 15 – View of nose landing gear near remnants of cockpit**

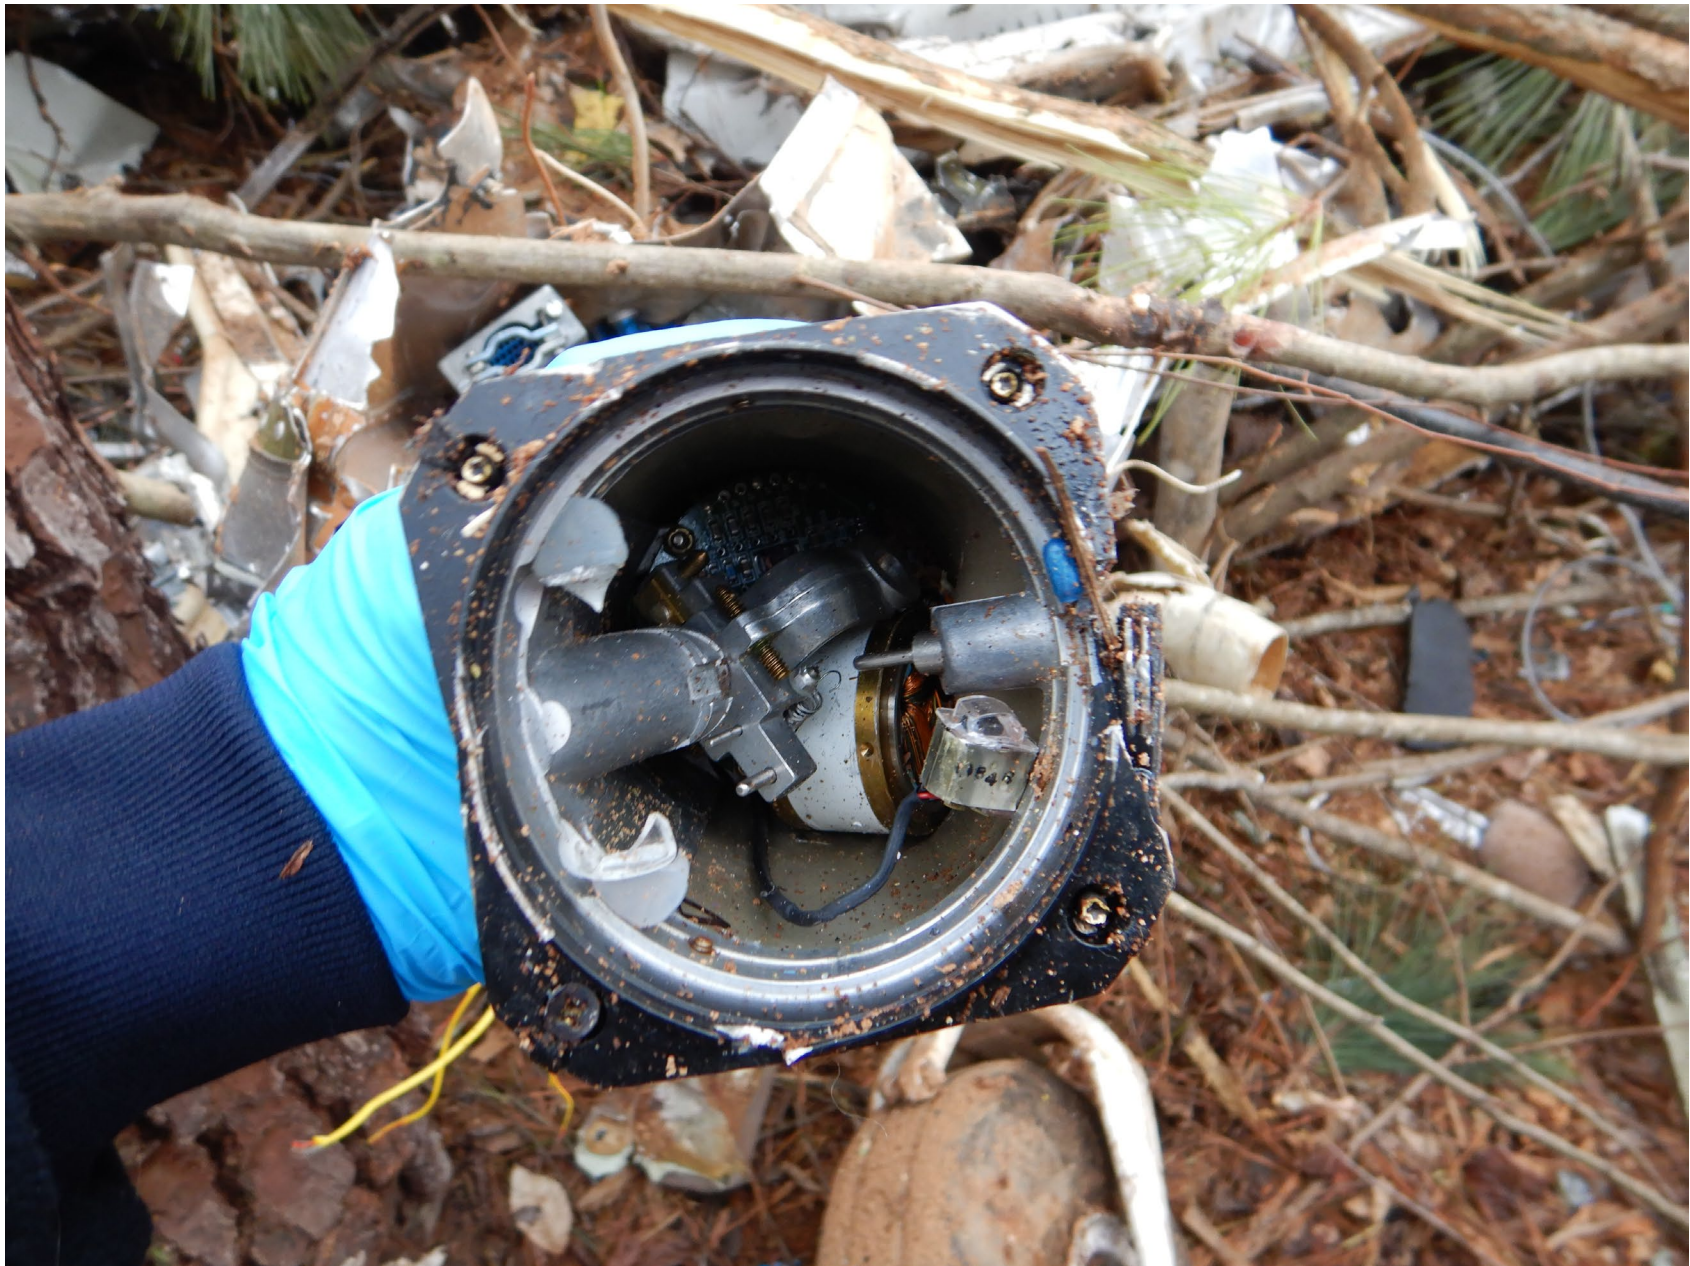
**Photo 16 – Housing of gyroscopic instrument separated from cockpit control panel**

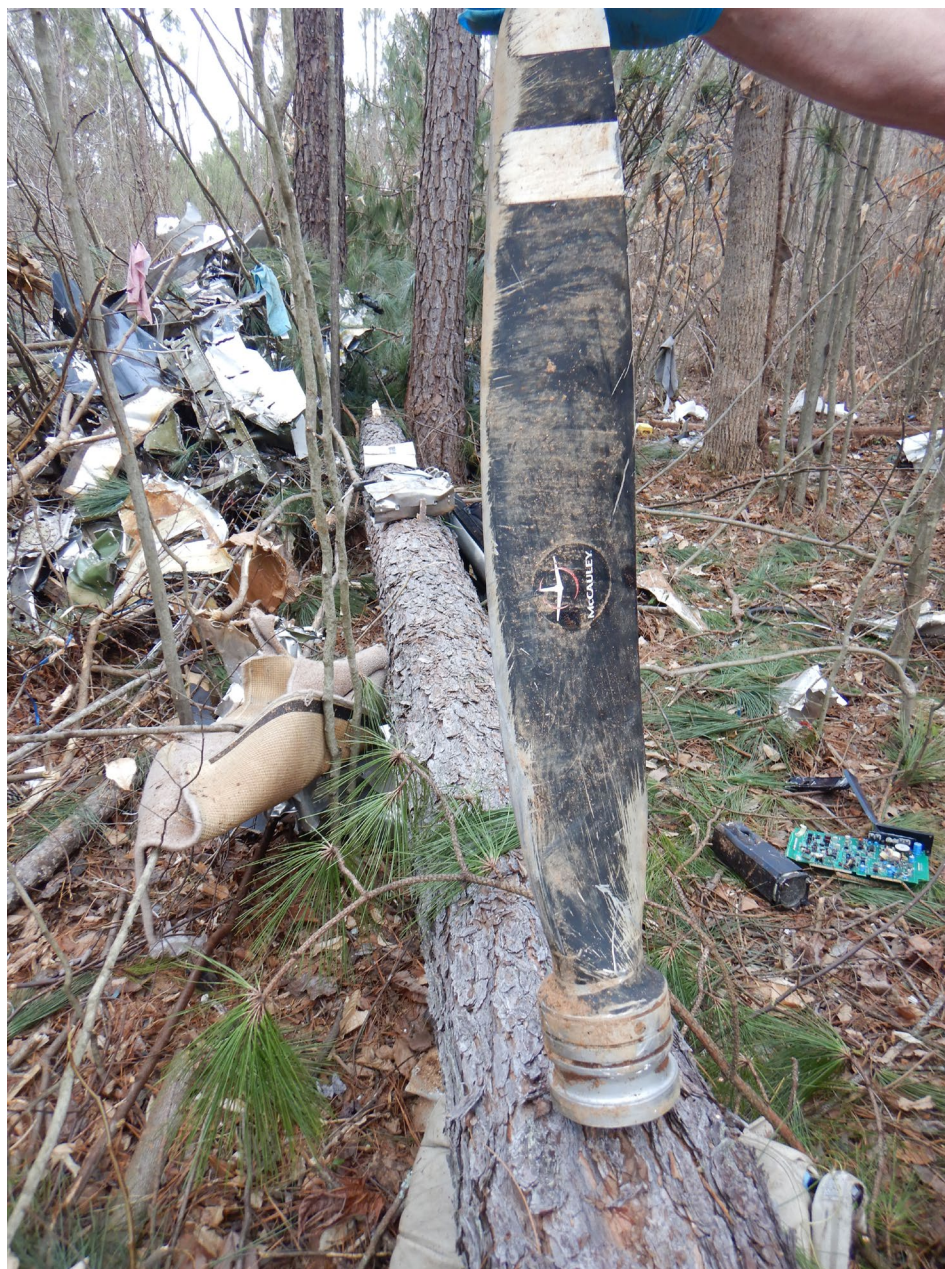
**Photo 17 – View of propeller blade separated from hub with chordwise abrasion on face**

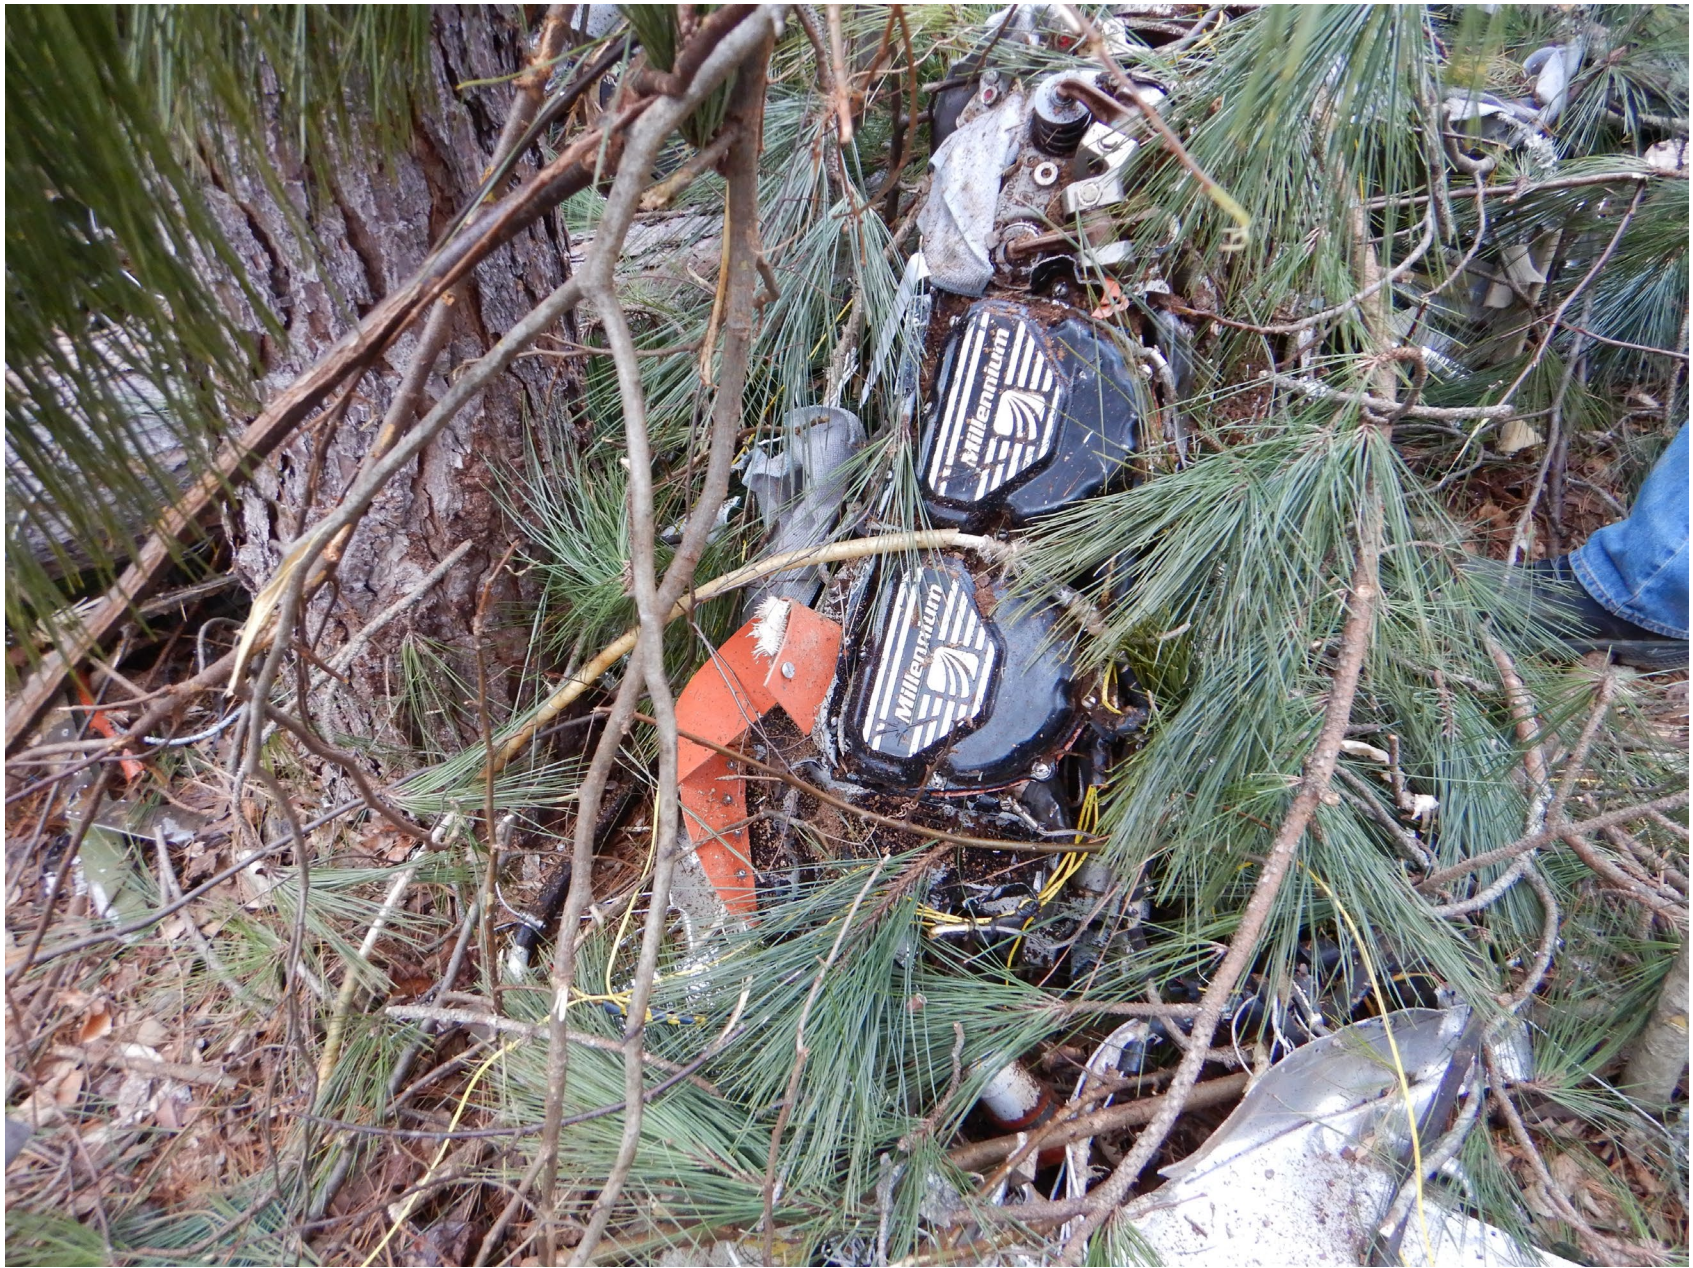
**Photo 18 – View of engine #2 near main wreckage**
