## MEMORANDUM OF RECORD

Exhaust CO Exposure Research

NTSB Accident Number: ERA22FA114

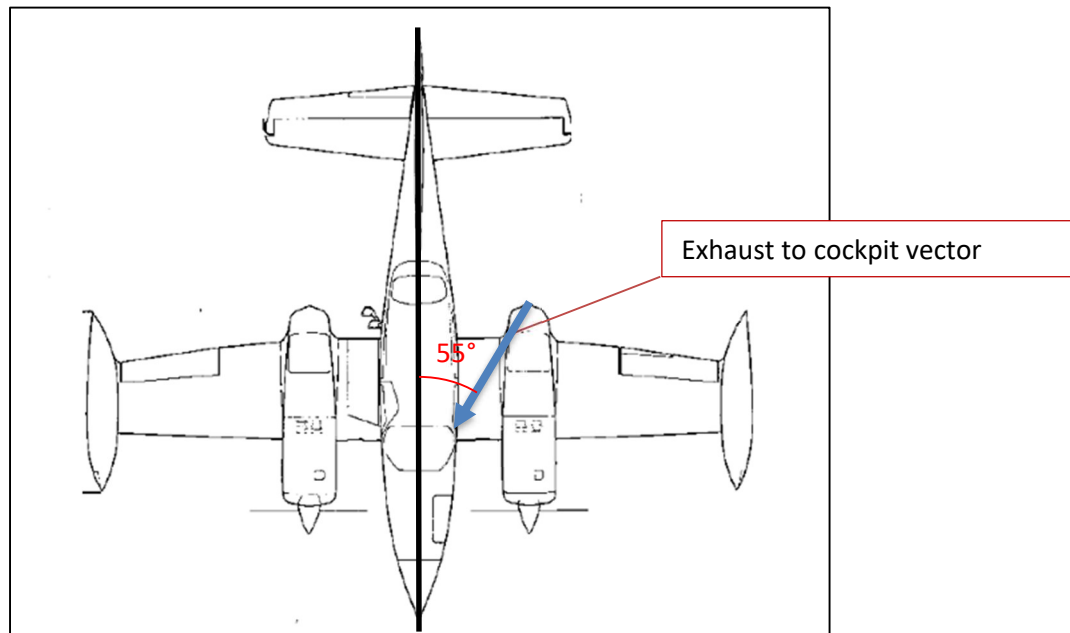
The following is a summary of research conducted by Sol Aerial Surveys at my request. The goal of the research was to use the accident make/model airplane and simulate the wind direction and speed from the day of the accident so that, the wind velocity was directly aligned with engine exhaust to cockpit vector, as seen in Figure 1.

*Figure 1 - View of airplane with exhaust to cockpit vector*

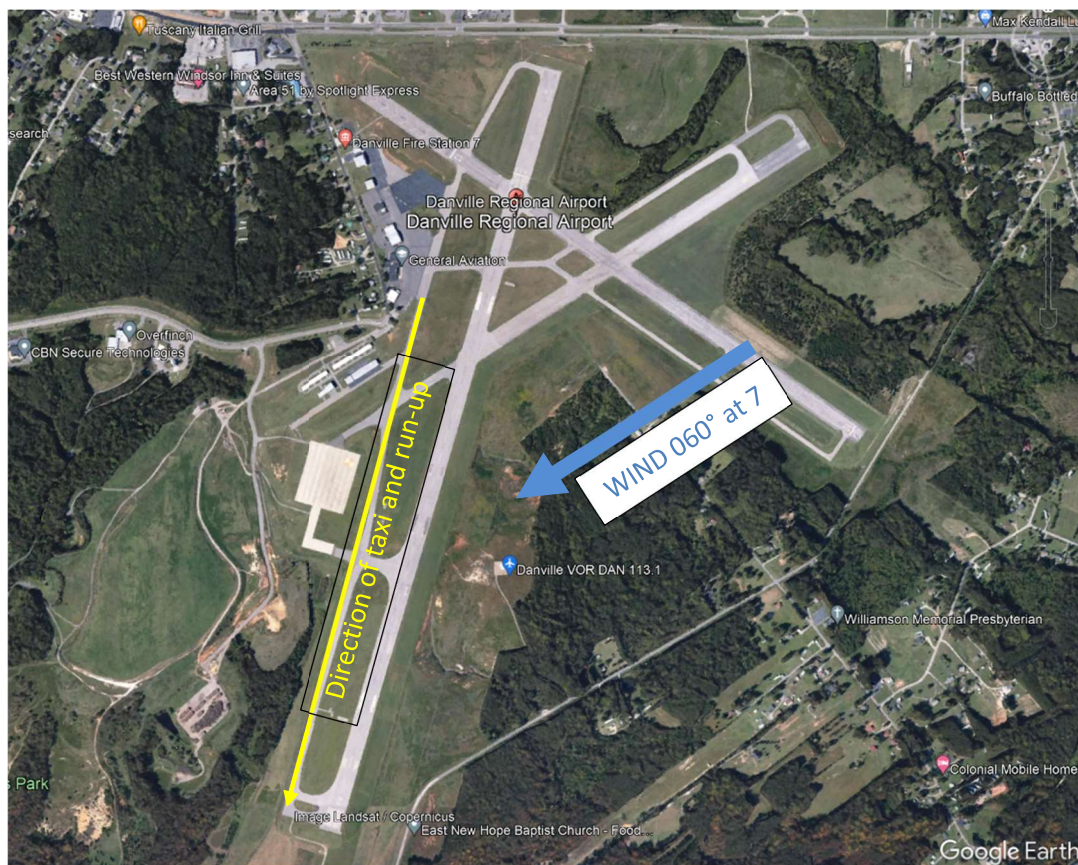
On the day of the of the accident, winds were from 060° true at 7 kts, and the airplane's engines were started on the ramp, where the airplane then taxied to the run-up area of runway 2 for run-up and surveying computer start-

up. During this taxi and subsequent run-up, the accident airplane was heading 196° true (205° magnetic), with the relative wind to the airplane being a 44° left quartering tailwind, which would have blown the exhaust from the left engine toward the cockpit and heater air intake at the nose of the airplane. The airplane was on this heading for about 8-10 minutes per the statement of another company pilot who taxied out in front of the accident airplane and conducted the run-up at the approach end of runway 2 while turned into the wind.

Figure 2 - Danville Regional Airport with wind velocity
