## **NATIONAL TRANSPORTATION SAFETY BOARD**

# **EXAMINATION SUMMARY**

**ERA22FA114**

Location: Danville, Virginia  
Date: February 1, 2022  
Time: 1006 EST  
Airplane: Cessna 310R, N622QT

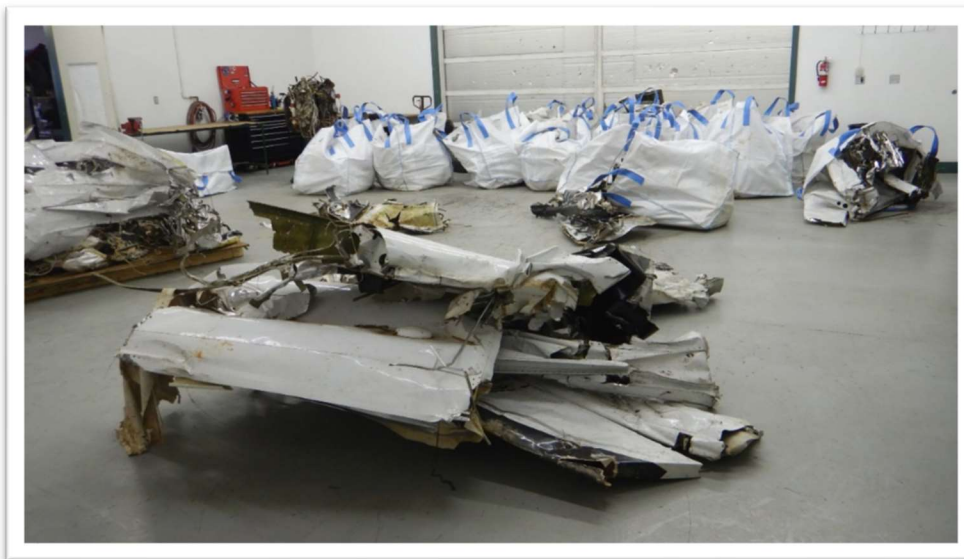
The airplane impacted a wooded area about 4 nautical miles southeast (104°) of DAN. Severed treetops indicated that the airplane entered the wooded area banked to the right about 30°. The wreckage was highly fragmented along the 382-foot debris path oriented on a true heading of 246°. There was a strong fuel odor but no evidence of fire.

*Photo 1 - Wreckage before layout*

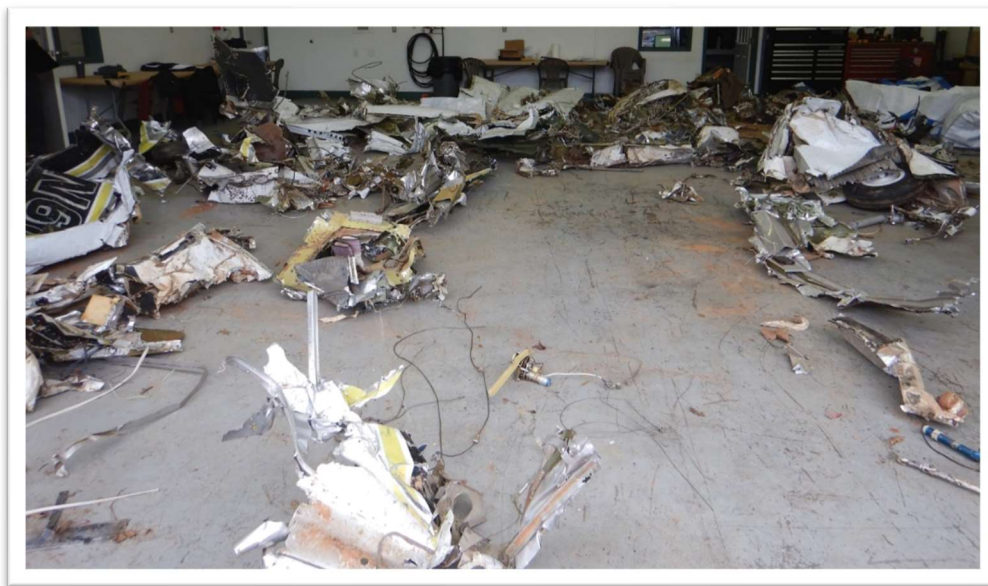
*Photo 2 - Wreckage after layout (scrap pieces not shown)*

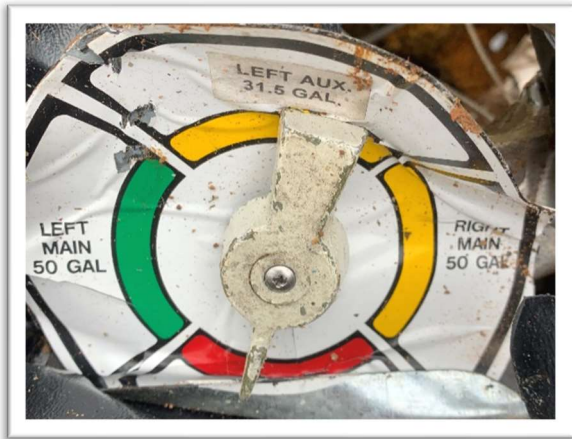
Debris was observed in the left and right fuel strainer screens. Left and right fuel strainer bowls were clean. The left fuel selector handle was found in the off position. The right fuel selector handle was found in the left main position. The left and right fuel selector valves were impact separated and had tumbled through the trees. The left fuel selector valve displayed a witness mark indicating it had been forced from the off position toward the auxiliary tank position. The right fuel selector valve lever was bent up at both ends and the position could not be determined. The left and right fuel strainers were examined. Minor debris was observed on the screens. The fuel strainer bowls were clean.

*Photo 1 - Left engine fuel selector*

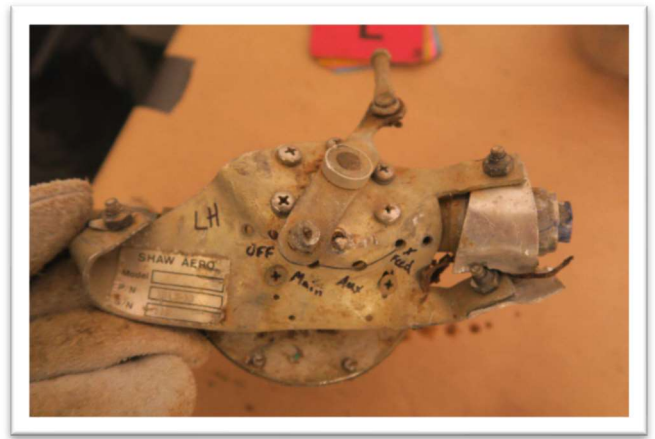
*Photo 2 - Left fuel selector valve*

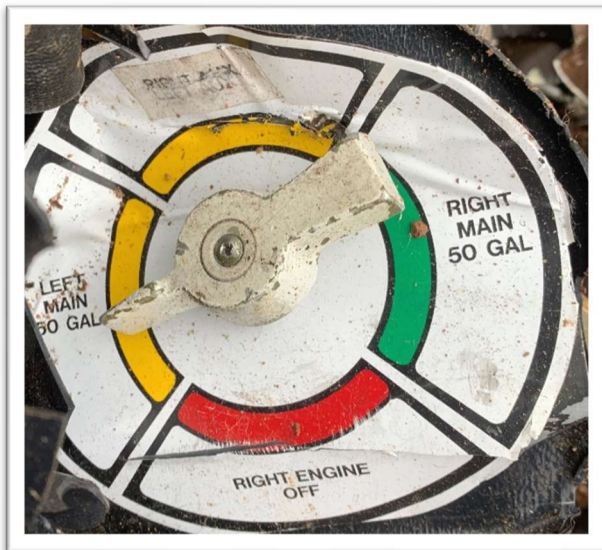
*Photo 3 - Right engine fuel selector*

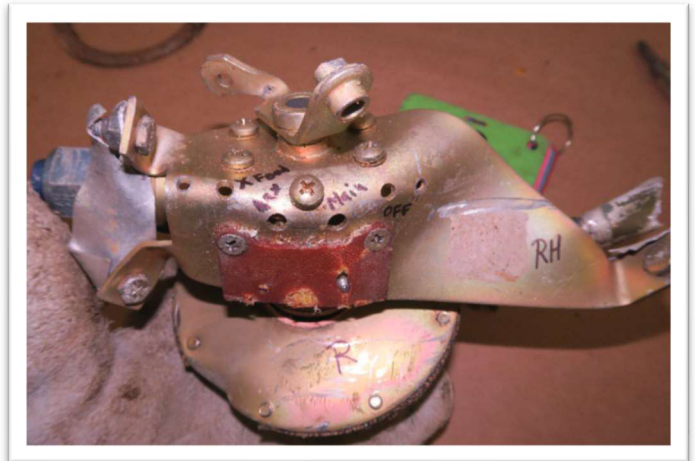
*Photo 4 - Right fuel selector valve*

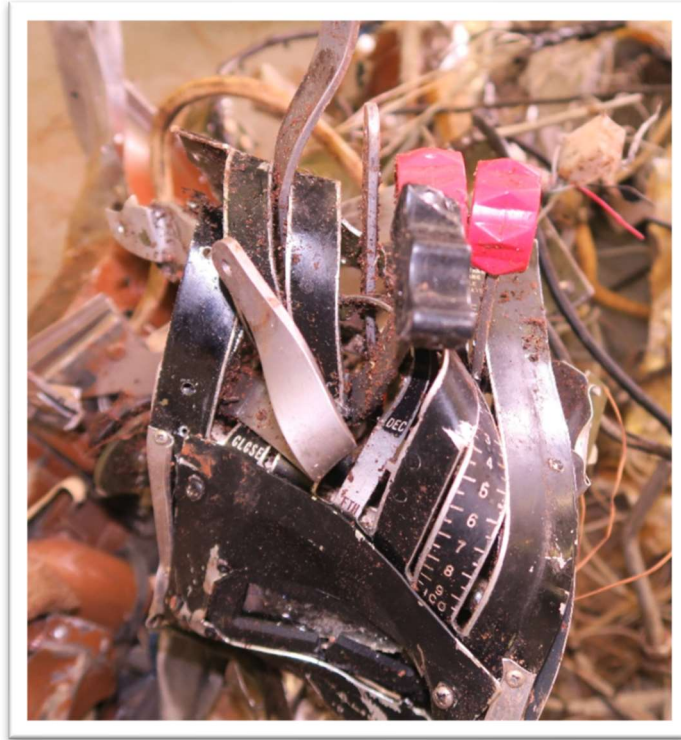
The control quadrant was impact crushed left to right. Left engine control levers indicated: Throttle, near idle; propeller, near feather; mixture, full rich. Right engine control levers indicated: Throttle, full forward; propeller, low pitch, mixture, full rich.

*Photo 5 - Throttle control quadrant*

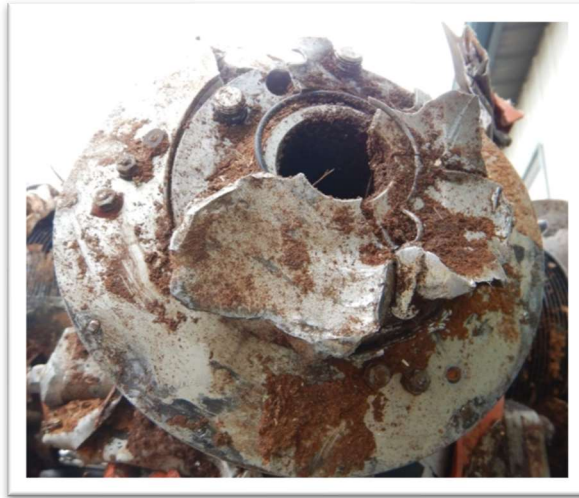
*Photo 8- Left engine propeller crankshaft mounting flange*

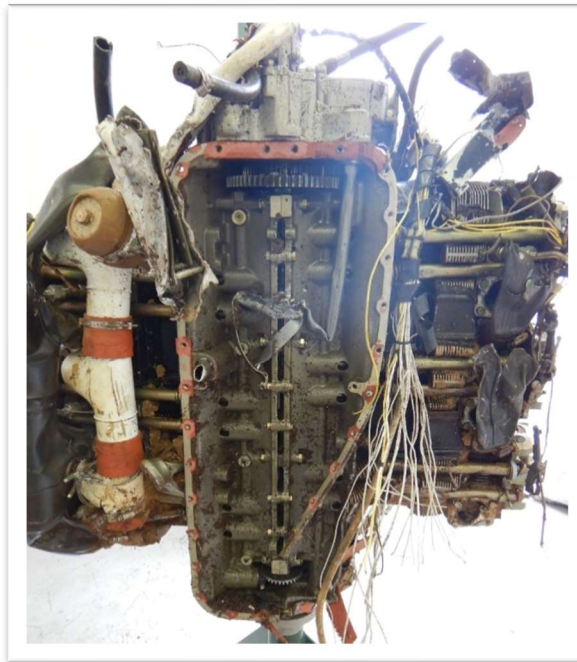
*Photo 9 - Left engine on stand*

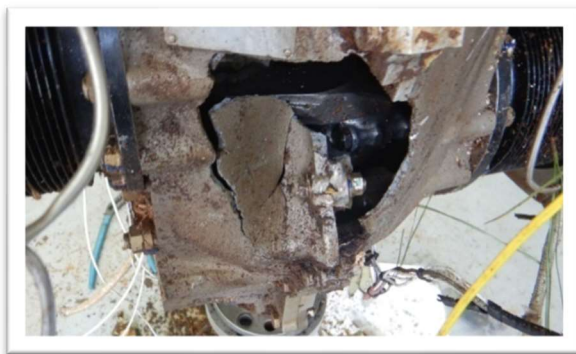
*Photo 10 - Damage of forward crankcase*

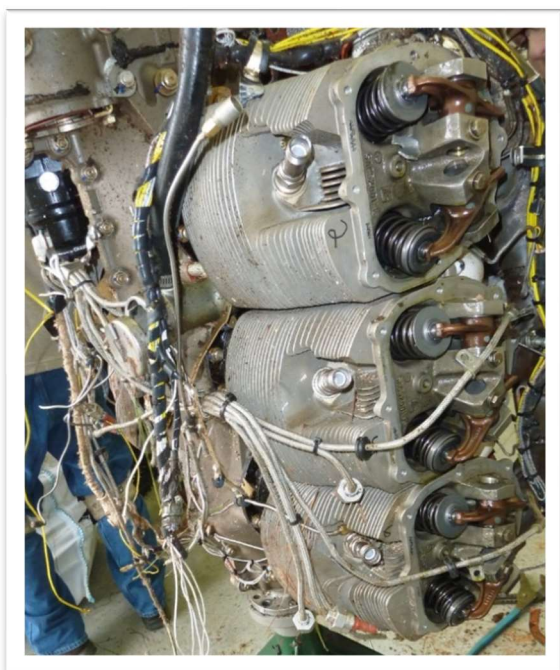
*Photo 11 - Cylinder Nos. 2,4,6; rocker covers removed*

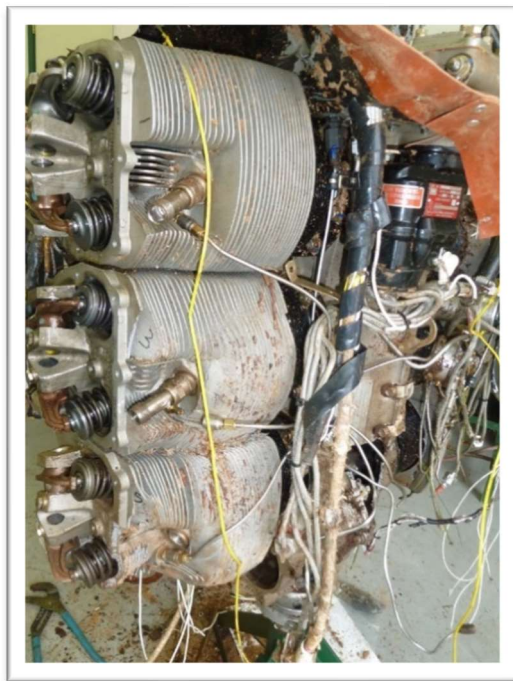
- Cylinder Nos. 3,5 and 6 were impact damaged and pushrod/tubes were impact damaged on both the intake and exhaust for cylinder No.5 and for the exhaust on cylinder No. 6
- The right air intake assembly was fractured off.
- The left air intake was fractured off cylinder No. 2
- Left magneto was fractured off; right magneto screw had fractured and was hanging out and partially under the rubber boot covering the magneto capacitor.

*Photo 12 - Cylinder Nos.1,3,5; rocker covers removed*

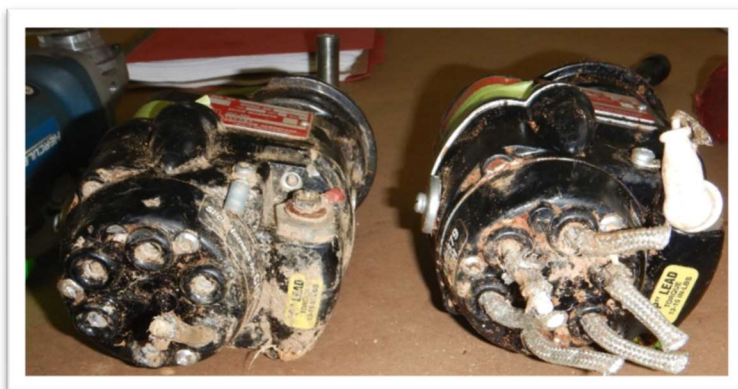
- Right magneto: Spark produced on all leads when magneto rotated by hand
- Left magneto: Magneto impact separated from engine; all but one ignition lead impact separated from magneto; harness caps removed; partially disassembled; paperclip inserted into magneto cap posts; spark observed from paperclip to the cap housing on each post.

*Photo 13 - Left engine magnetos before testing*

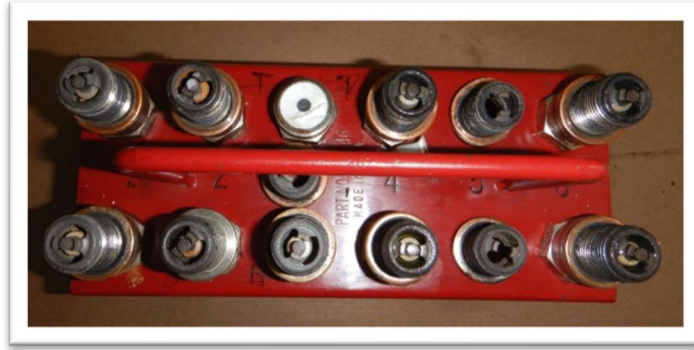
- Spark plugs, top – normal; Nos. 3 and 5 fractured and missing electrodes; No. 2 with carbon deposits
- Spark plugs, bottom – Nos. 1, 2, 4 and 6 normal; no electrode gap on No. 3; No. 5 fractured/missing electrode.

*Photo 14 - Left engine sparkplugs*

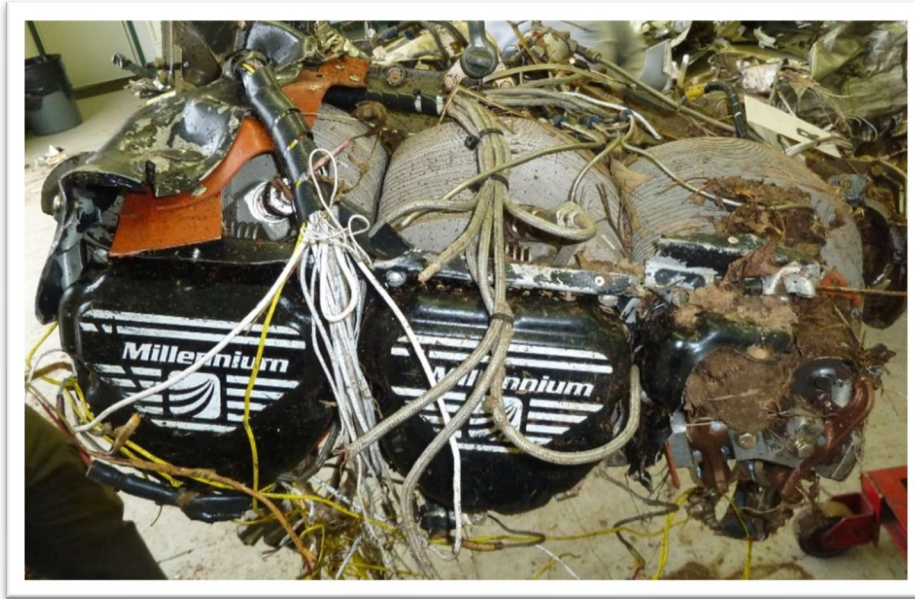
*Photo 15 - Right engine (Cylinder Nos. 1, 3, 5) prior to examination*

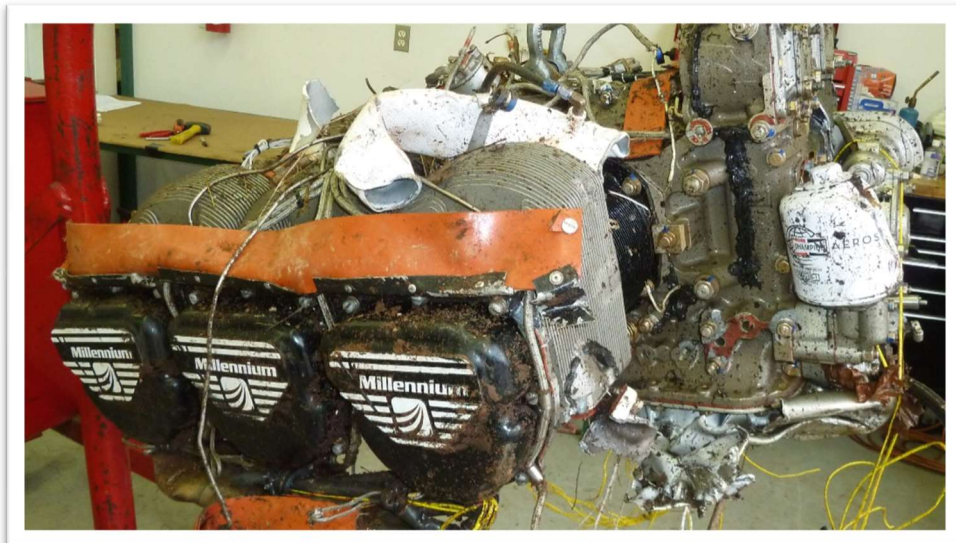
*Photo 16 - Right engine (Cylinder Nos. 2, 4, 6) prior to examination*

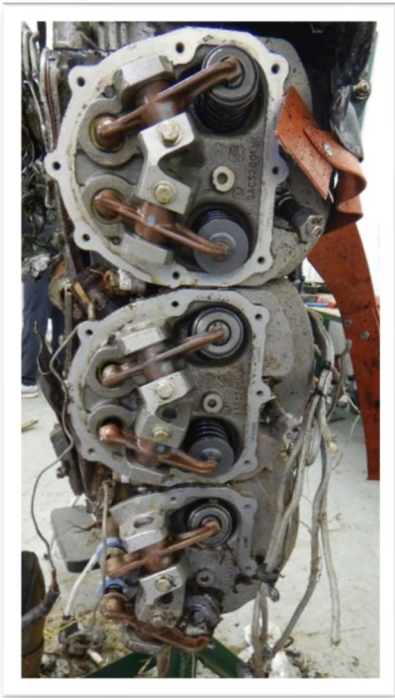
- Cylinder Nos. 1, 2 and 3 exhaust tubes impact separated/fractured
- Starter/starter adapter drive impact separated
- Rocker covers removed; rocker arm on cylinder No. 5 fractured

*Photo 17 - Cylinder Nos. 1,3,5; rocker covers removed*

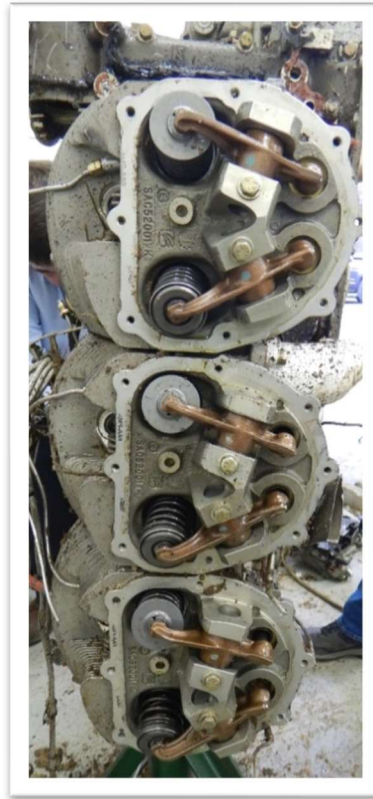
*Photo 18 - Cylinder Nos. 2,4,6; rocker covers removed*

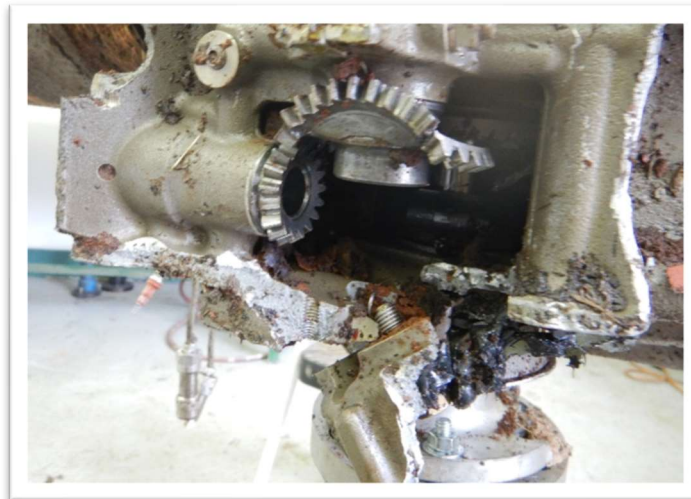
- Crankcase fractured in multiple places/oil pickup tube impact crushed
- Small, front camshaft drive gear fractured
- All cylinder air induction tubes impact separated

*Photo 19 - Front camshaft drive gear impact damage*

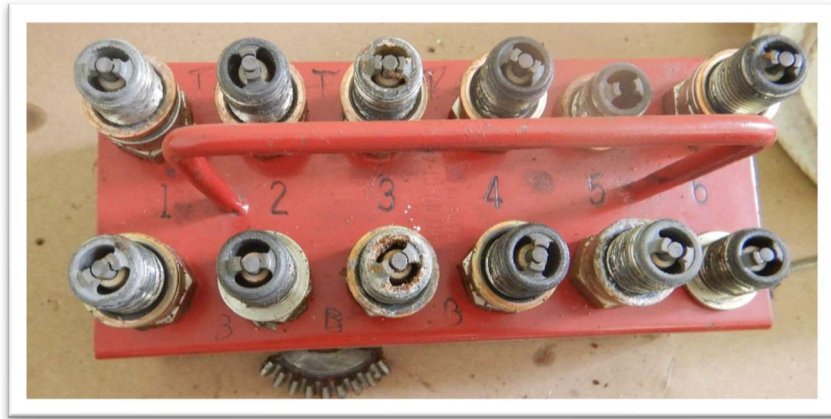
- Spark plugs look normal with the following exceptions: No. 5 bottom spark plug has no gap, and the top of the plug is missing; Top of No. 2 bottom spark plug is missing, and the gap is small; No. 3 bottom spark plug has broken porcelain and the gap is small.

*Photo 20 - Spark Plugs*

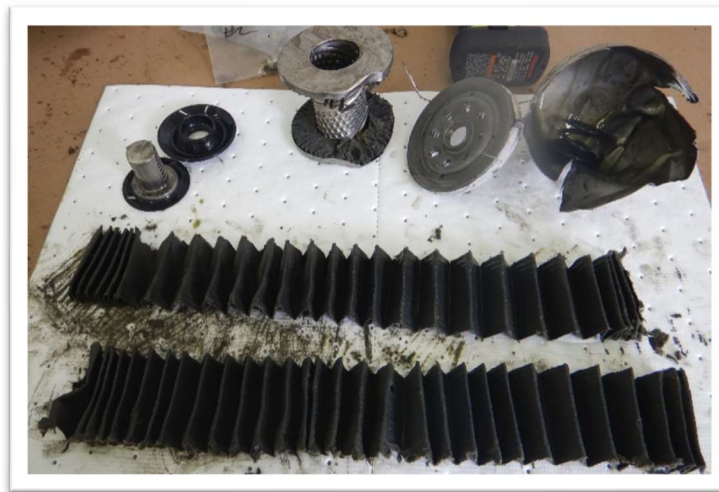
- Oil filter cut open, no debris or metal noted

*Photo 21 - Disassembled oil filter*

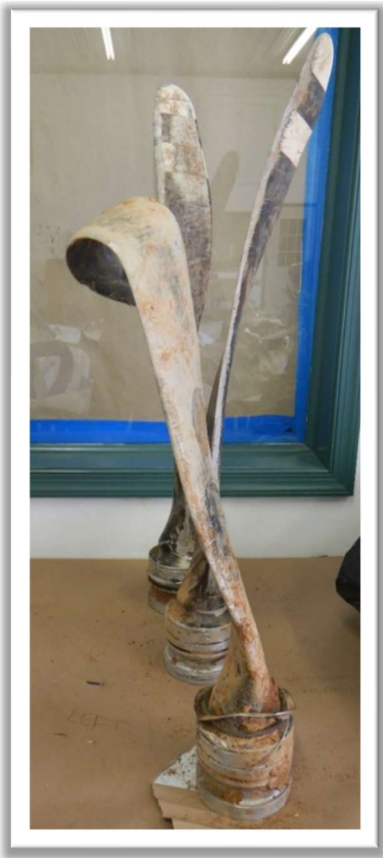
- Blade 1 – Forward bend; leading edge polishing and chordwise abrasion
- Blade 2 – Leading edge gouging; span and chordwise abrasion; outer 9 inches of blade curled
- Blade 3 – Leading edge gouging and polishing; chordwise abrasion; blade twisted

*Photo 22 - Left engine propeller blades*

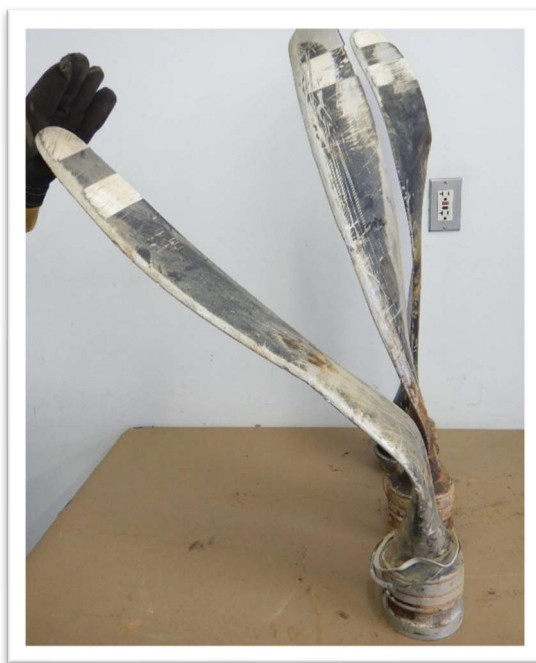
- Blade 1 – bent aft about 70° aft near root; leading edge gouging/chordwise abrasion
- Blade 2 – Tip curled; spanwise and chordwise abrasion; leading edge polishing and gouging.
- Blade 3 – Chordwise abrasion; leading edge polishing; blade twisting

*Photo 23 - Right engine propeller blades*

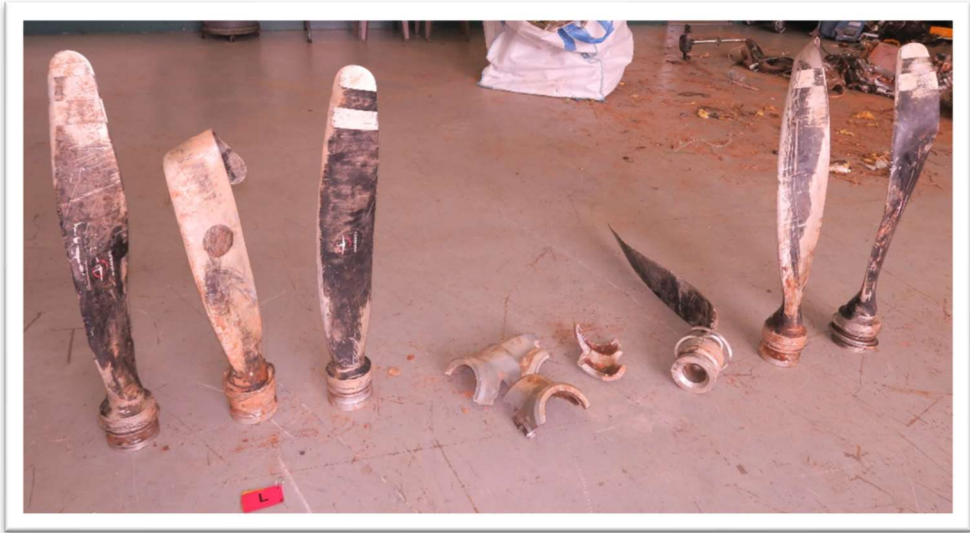
*Photo 24 - Propeller blades*
