# National Transportation Safety Board

## **MATERIALS LABORATORY**

Factual Report 23-063

Place : Lexington, North Carolina  
Date : February 16, 2022  
Vehicle : Beech 58, N58LF  
NTSB No. : ERA22FA126  
Investigator : Timothy Monville

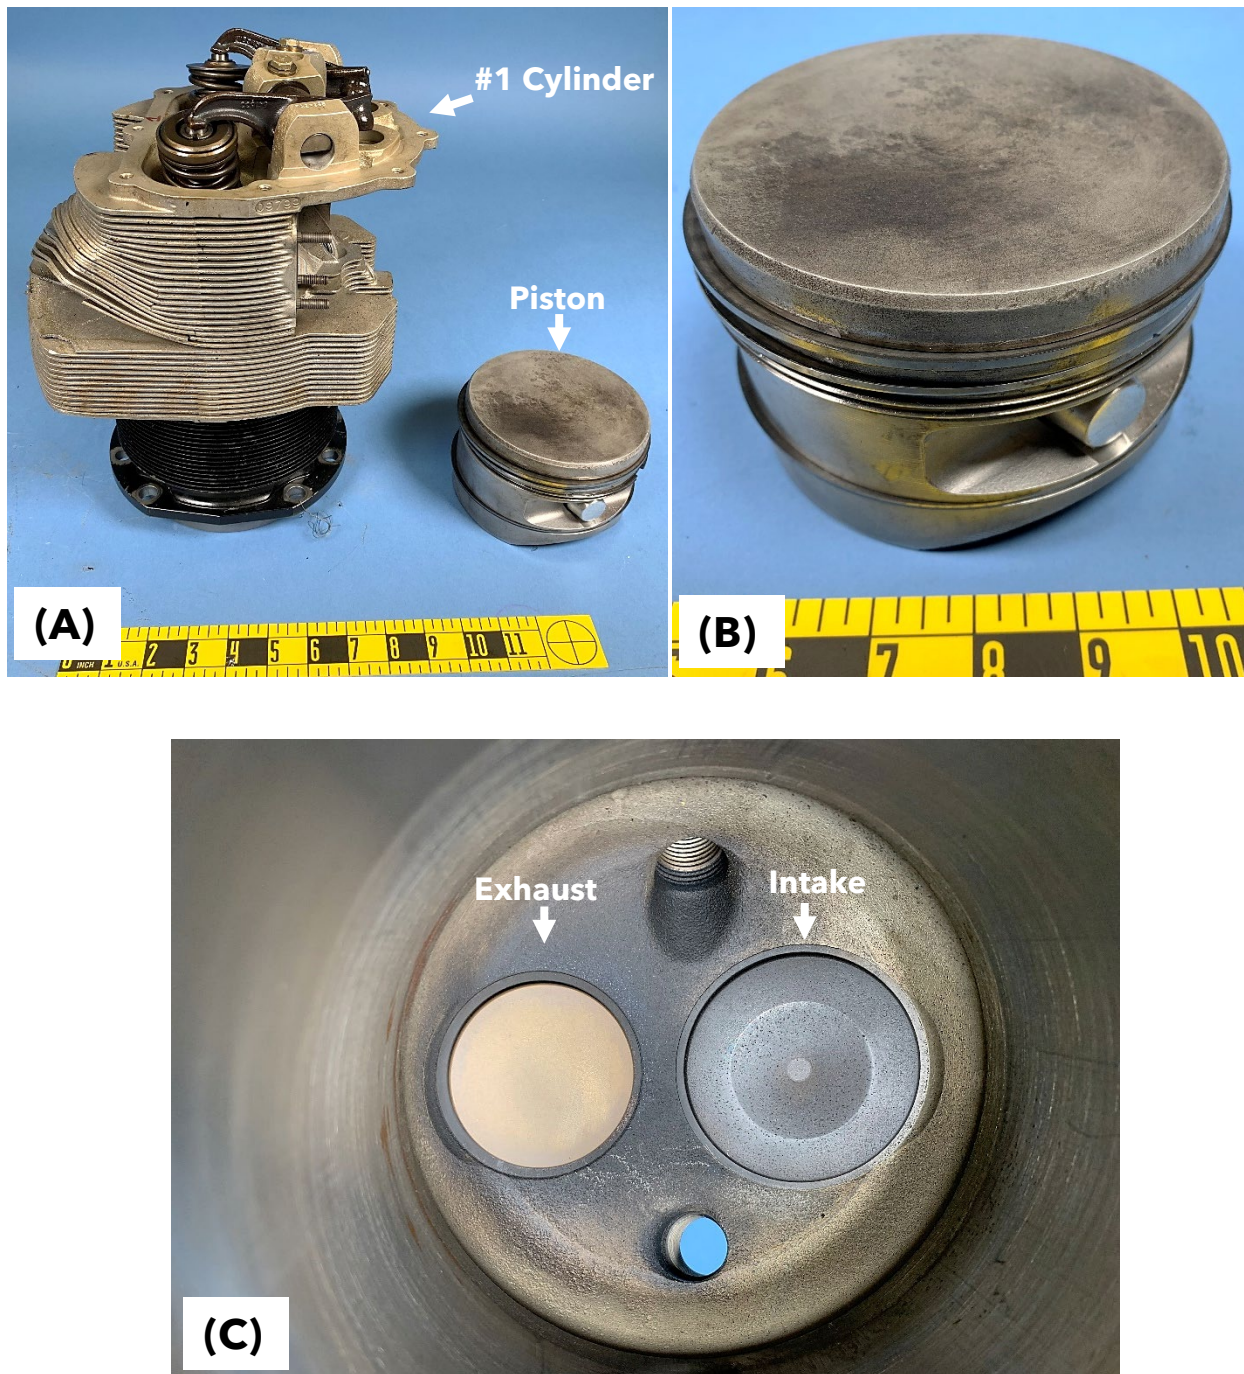
Figure 1 show photographs of the as-received #1 cylinder, piston, and piston pin from the right engine. The piston was intact and the outer surface contained minor amounts of black combustion deposit. The head portion of the piston at the bevel edges showed evidence of minor erosion features; and the skirt portion showed evidence of minor longitudinal scoring marks (see figures 2 and 3).<sup>2</sup> The piston rings were intact. The surface of the wrist pin and the bore for the wrist pin showed no evidence of wear.

The inner surface of the combustion chamber for the #1 cylinder in the areas of the barrel portion contained evidence of circumferential scoring marks consistent with a machine polished surface with no evidence of longitudinal scoring or gouging<sup>3</sup>

marks. The head portion of the intake and exhaust valves were intact and showed no evidence of deformation. The exposed head portion of the intake valve (larger diameter) exhibited a dark film consistent with combustion deposit. The exhaust valve (smaller diameter) exhibited a lighter tint, minor grit blast-like, surface appearance compared to the intake valve. The inner top surface of the combustion chamber in many areas exhibited minor grit blast-like appearance.

**Figure 1.** Overall view of (A) the #1 cylinder and piston with piston pin from the right engine; (B) oblique view of the piston; and (C) internal view of the cylinder combustion chamber showing the head portion of the intake and exhaust valves.

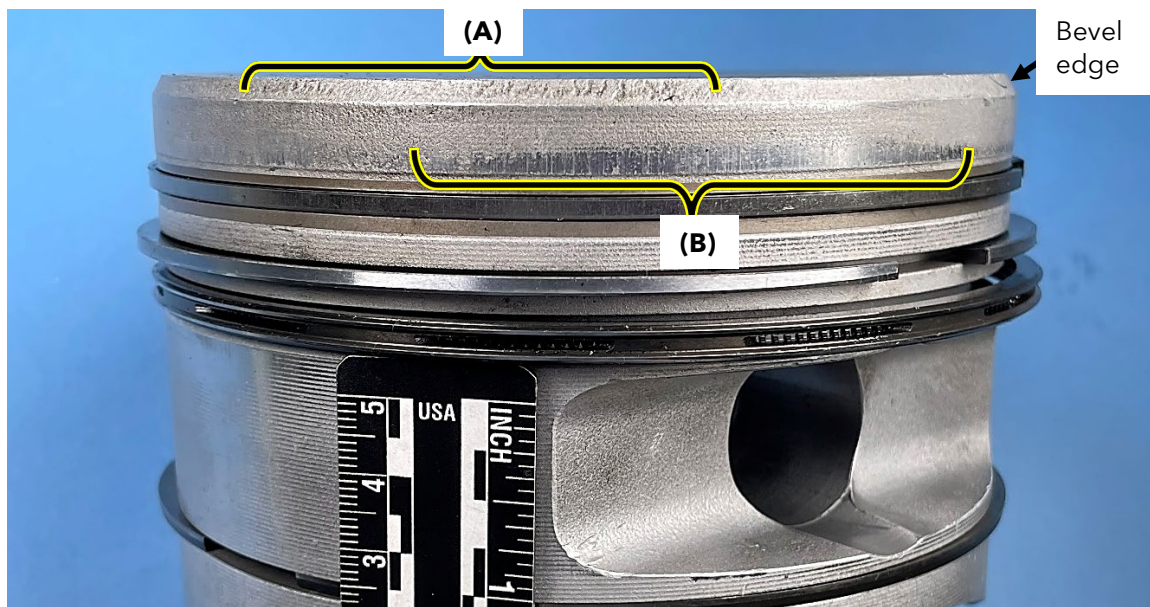
**Figure 2.** Side view of the piston from the right engine's #1 cylinder showing mechanical damage at the bevel edge of the head, such as (A) minor erosion features, and (B) minor axial scrape marks.

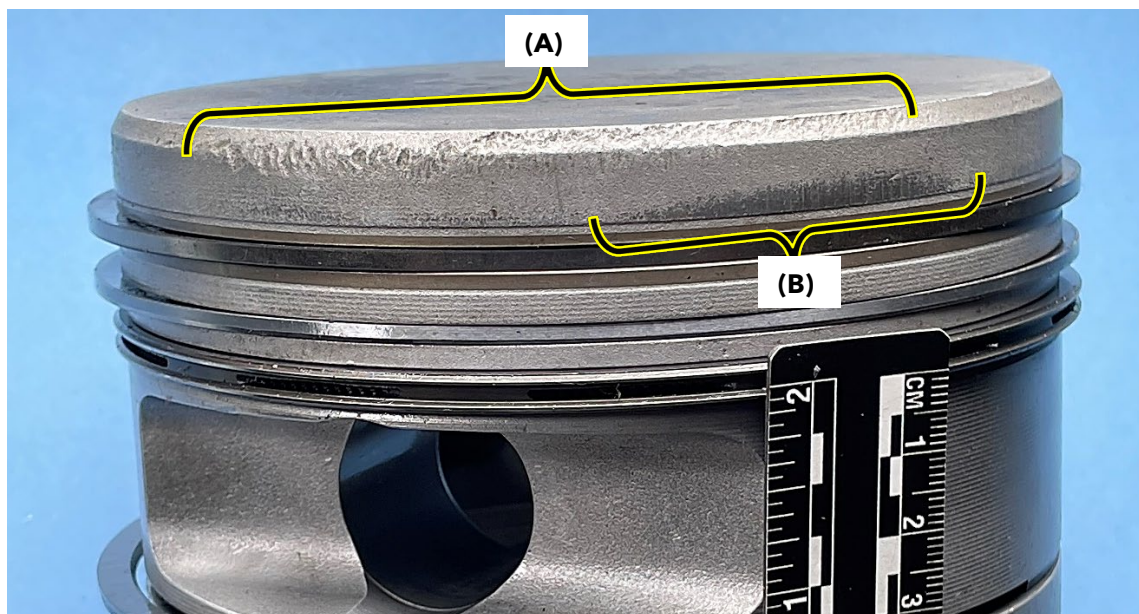
**Figure 3.** Side view of the piston from the right engine's #1 cylinder showing mechanical damage at the bevel edge of the head, such as (A) minor erosion features, and (B) minor axial scrape marks; from an area located nearly diametrically opposite shown in figure 2.

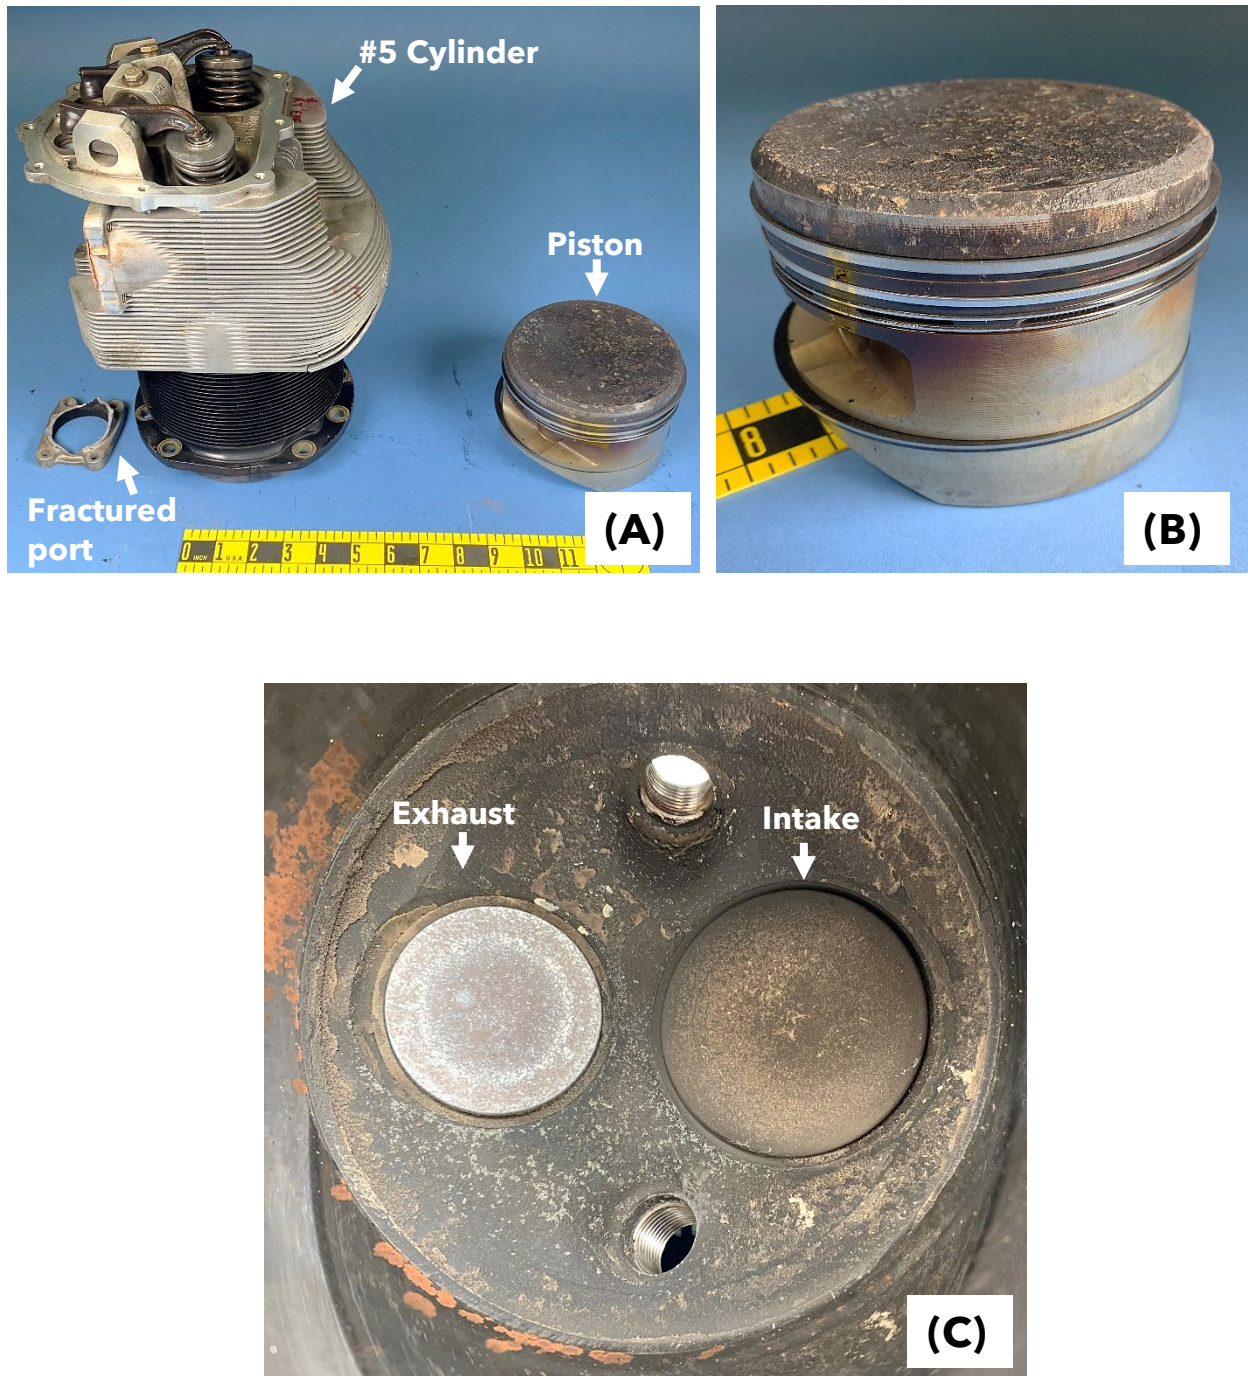
Figures 4 and 5 show photographs of the as-received #5 cylinder and piston from right engine. The piston was intact and the head portion contained heavy black combustion deposit. The piston rings were intact and the skirt portion of the piston showed evidence of minor longitudinal scoring marks. The surface of the wrist pin and the bore for the wrist pin showed no evidence of wear.

The combustion chamber of the cylinder for the piston exhibited a mirror-like polished finish and the barrel portion of the combustion chamber showed no evidence of longitudinal scoring or gouge marks. The head portion of the intake and exhaust valves were intact and showed no evidence of deformation. The exposed head portion of the intake valve (larger diameter) exhibited a dark black-brown tint whereas the exhaust valve exhibited a light grey-blue tint.

**Figure 4.** Overall view of (A) the #5 cylinder, fractured port from the exhaust/intake port, and piston without piston pin from the right engine; (B) oblique view of the piston; and (C) internal view of the cylinder combustion chamber showing the head portion of the intake and exhaust valves.

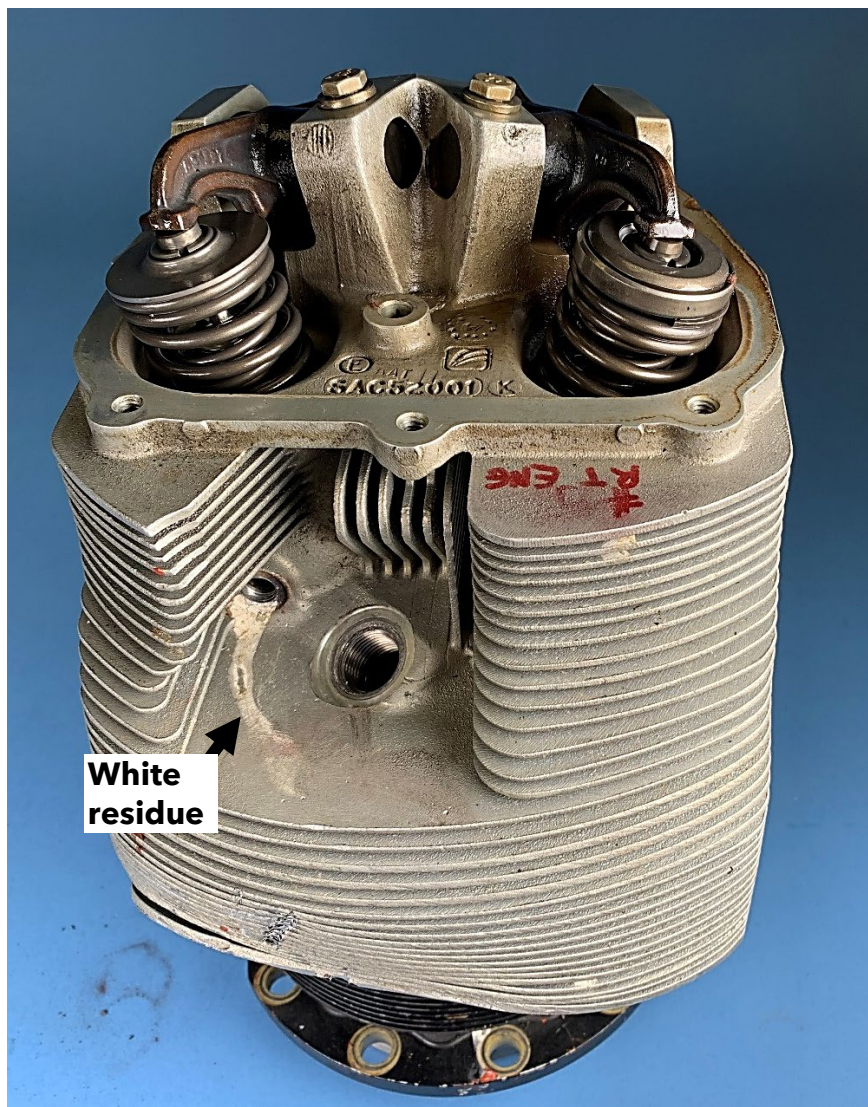
The entry port for the injector nozzle contained a white and dry residue, see figure 5. A cotton tipped applicator at the end of a wood handle was dosed with acetone and then the cotton end was rubbed against the white residue. The residue at the end of the cotton swab was analyzed by Fourier transform infrared (FTIR) spectroscopy analysis. The result of the analysis is reported in Appendix 1.

**Figure 5.** View of the #5 cylinder showing white residue at the entry port for the injector nozzle.

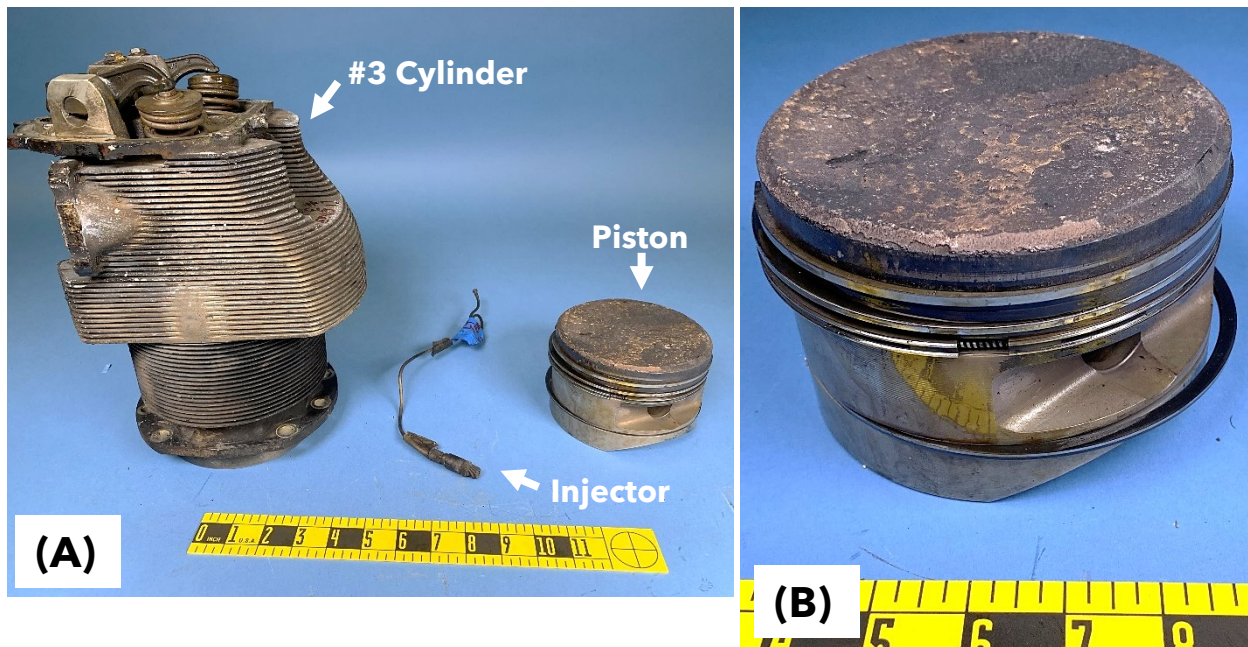
Figures 6 and 7 show photographs of the as-received #3 cylinder, piston, fuel tube and injector nozzle from the left engine. The piston was intact and the outer surface of the piston and inner surface of the cylinder (combustion chamber) exhibited appearance similar to those of the #5 piston and cylinder for the right engine.

**Figure 6.** Overall view of (A) the #3 cylinder, piston without piston pin, and fuel injection nozzle with tube, from the left engine; (B) oblique view of the piston; and (C) internal view of the cylinder combustion chamber showing the head portion of the intake and exhaust valves.

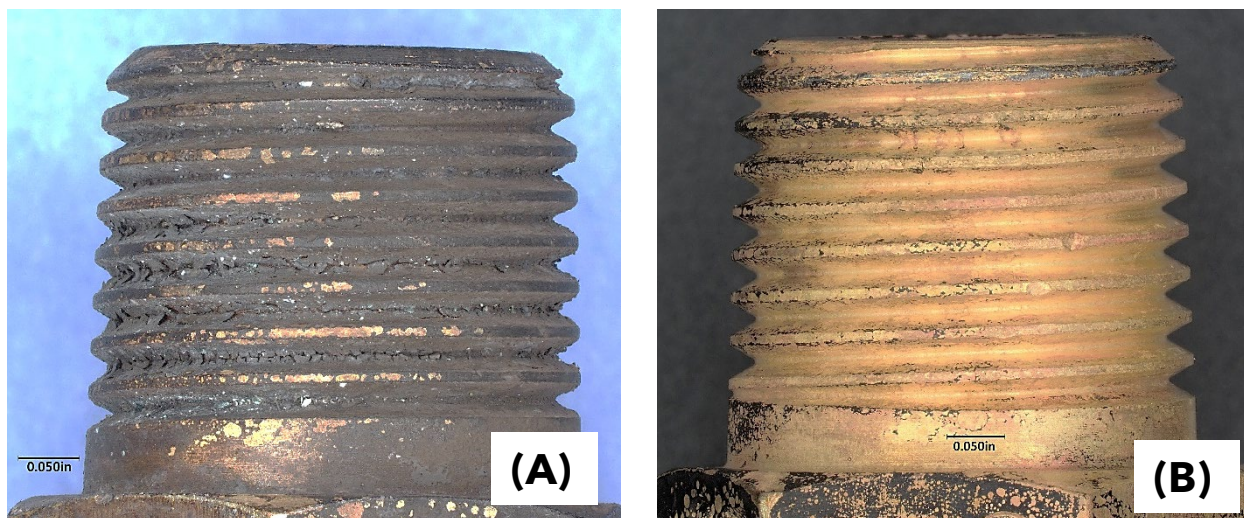
Bench binocular microscope of the fuel injection nozzle revealed the outer threads and exposed port of the injection nozzle were covered with a black deposit. The fuel injector nozzle was disassembled. Light was illuminated through one end of the nozzle while the other end was inspected with a bench binocular microscope. Light passed through the nozzle and there was no evidence of foreign matter blocking the nozzle. The fuel injector nozzle was ultrasonically cleaned with Alconox, a commercial detergent. Post-cleaning binocular microscope examination of the fuel

injector nozzle revealed the crown portions of the outer threads were intact and showed no evidence of shearing (thread stripping).

**Figure 7.** Side view of the fuel injection nozzle from the #3 cylinder of left engine in the (A) as-received condition and (B) after cleaning.

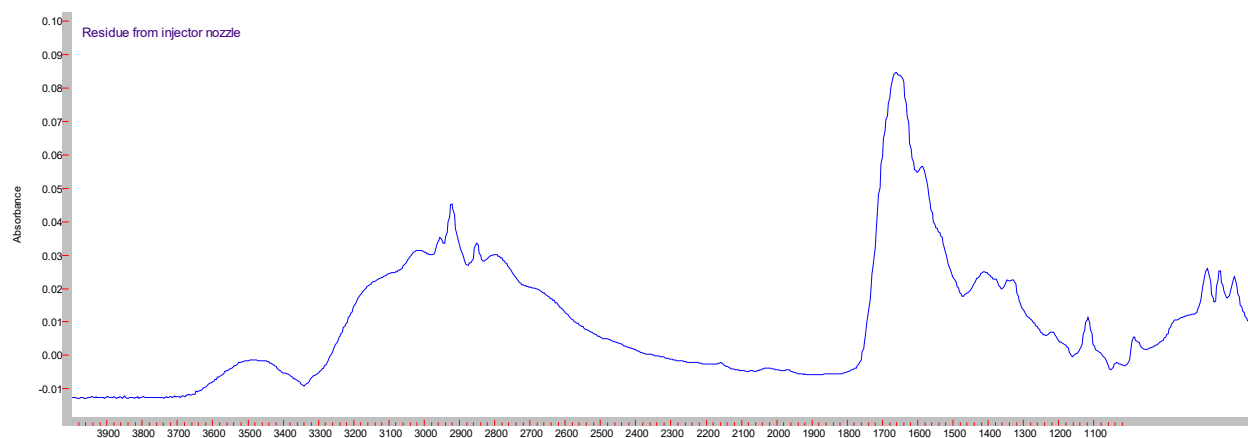
The surface outside of the fuel injector nozzle was swabbed using a white cotton swab. This sample was examined using a Fourier Transform Infrared (FTIR) spectrometer with a diamond attenuated total reflectance (ATR) accessory in accordance with ASTM E1252-98 (American Society for Testing Materials E1252-98: *Standard Practice for General Techniques for Obtaining Infrared Spectra for Qualitative Analysis*). The spectrometer was used to collect and process infrared wavelength absorbance spectra of the unknown material(s). The FTIR spectrum from the sample is shown below.

The spectrum for the material contained the following combination of spectral peaks corresponding to particular functional groups found within molecular structure of the material. The presence of a broad peak at  $\sim 3480\text{ cm}^{-1}$  is indicative of an oxygen-hydrogen (O-H) stretching bond. Another broad peak  $\sim 3000\text{ cm}^{-1}$  is indicative of a nitrogen-hydrogen (N-H) stretching bond. The presence of a triplet peak at  $\sim 2920\text{ cm}^{-1}$   $\sim 2850\text{ cm}^{-1}$  and  $\sim 2800\text{ cm}^{-1}$  is indicative of a carbon-hydrogen (C-H) single stretching bond. A peak at  $\sim 1660\text{ cm}^{-1}$  is indicative of a carbon-oxygen (C=O) stretching double bond. A broad medium peak at  $\sim 1580\text{ cm}^{-1}$  is indicative of a nitrogen-hydrogen (N-H) bending bond. A single peak at  $\sim 1415\text{ cm}^{-1}$  is indicative of a carbon-hydrogen<sub>2</sub> group bending bond. A single peak at  $\sim 1330\text{ cm}^{-1}$  is indicative of a carbon-oxygen (C-O) bending bond. A weak peak  $\sim 1200\text{ cm}^{-1}$  is indicative of a carbon-nitrogen (C-N) stretching bond. A peak at  $\sim 1100\text{ cm}^{-1}$  is indicative of a carbon-oxygen-carbon (C-O-C) bond. A peak at  $\sim 620\text{ cm}^{-1}$  is indicative of a nitrogen-hydrogen (N-H) out-of-plane bending bond. The spectrum was consistent with a carboxyamine or a mixture of materials containing amines and carboxylic acids. A spectral library search was performed on the swab sample spectrum. No matches were found, however, there were similarities to several surfactants (which often contain amines) as well as other amines and carboxylic acids. Common additives to aviation gasoline used for deposit control, antioxidants and anti-corrosion control often contain these types of materials. The material on the surface of the cylinder was likely the residue left when the fuel evaporated.
