## RECORD OF CONVERSATION

**Date: February 25, 2022**  
**Person Contacted: Benjamin Jones**  
**NTSB Accident Number: ERA22FA126**

**Subject:** ERA22FA126, Record of Conversation/Interview

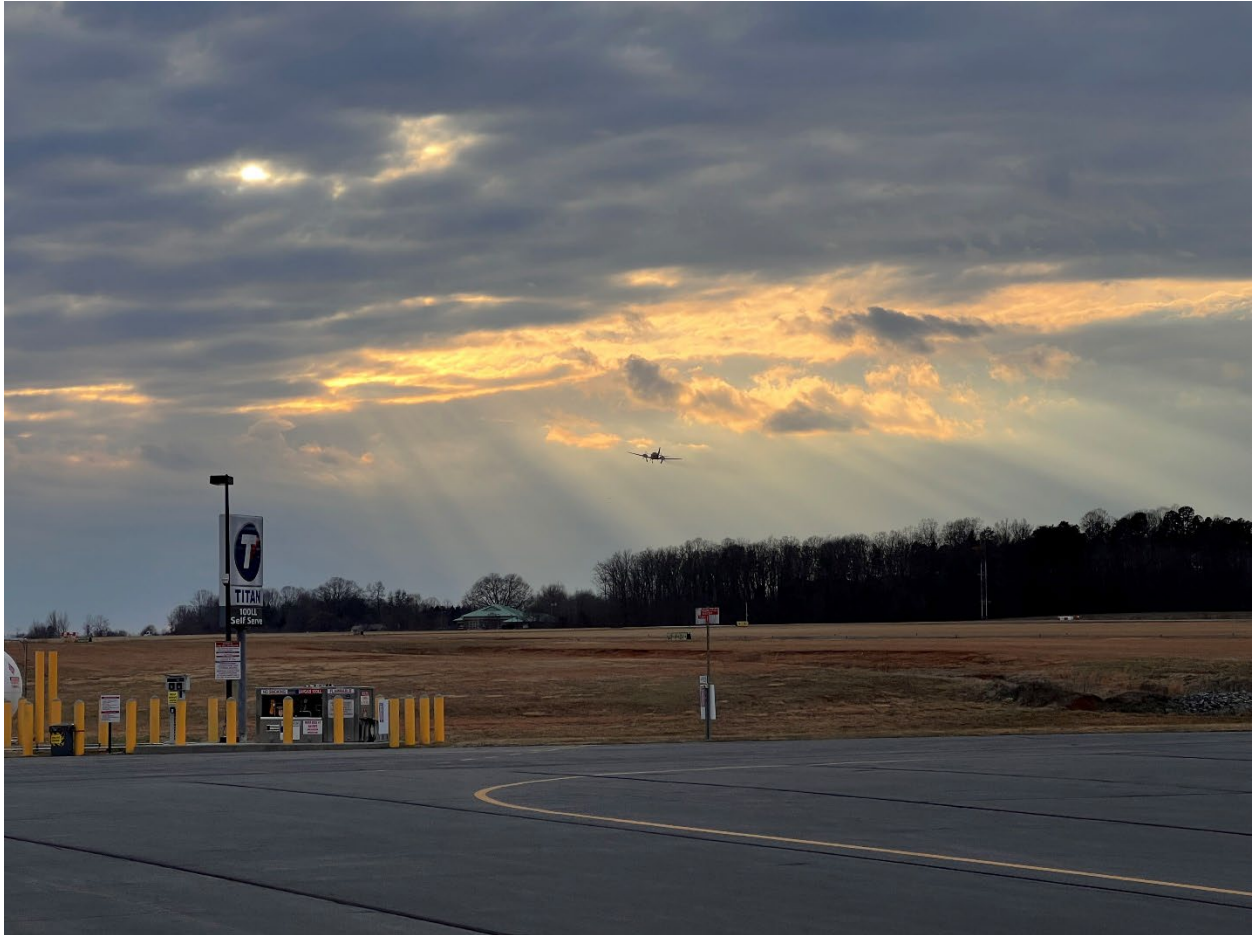
*Right engine*, continuous full blown white smoke from take-off until it was shut-down/failed.

Figure 1: Digital Photograph Provided by Shawn DeForest. View Depicting Airplane During Takeoff with Landing Gear Extended and Smoke Trailing Right Engine.
