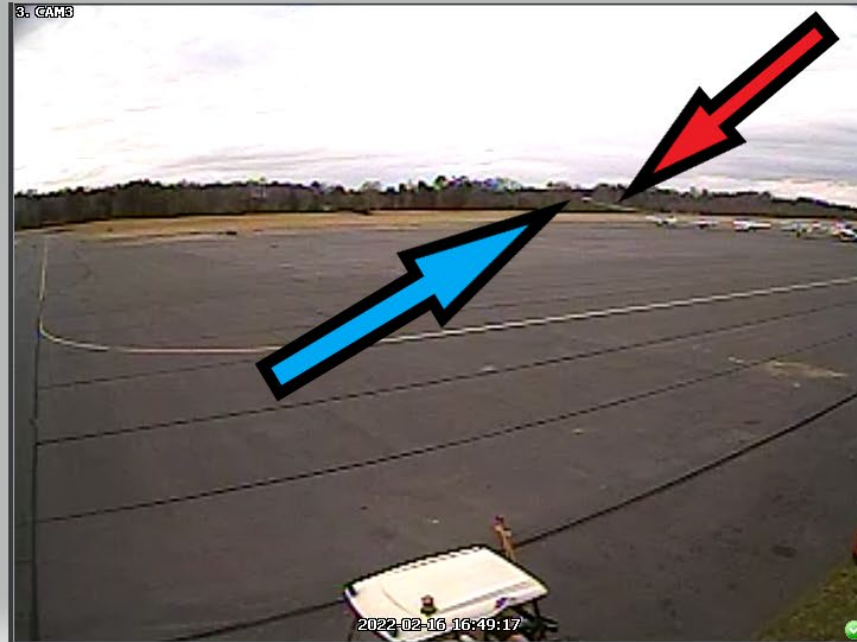
**Photo 1 – Annotated Screen Image From Airport Security Video. Blue Arrow Points to Airplane During Early Portion of Takeoff While Red Arrow Points to Smoke Trailing the Right Engine.**

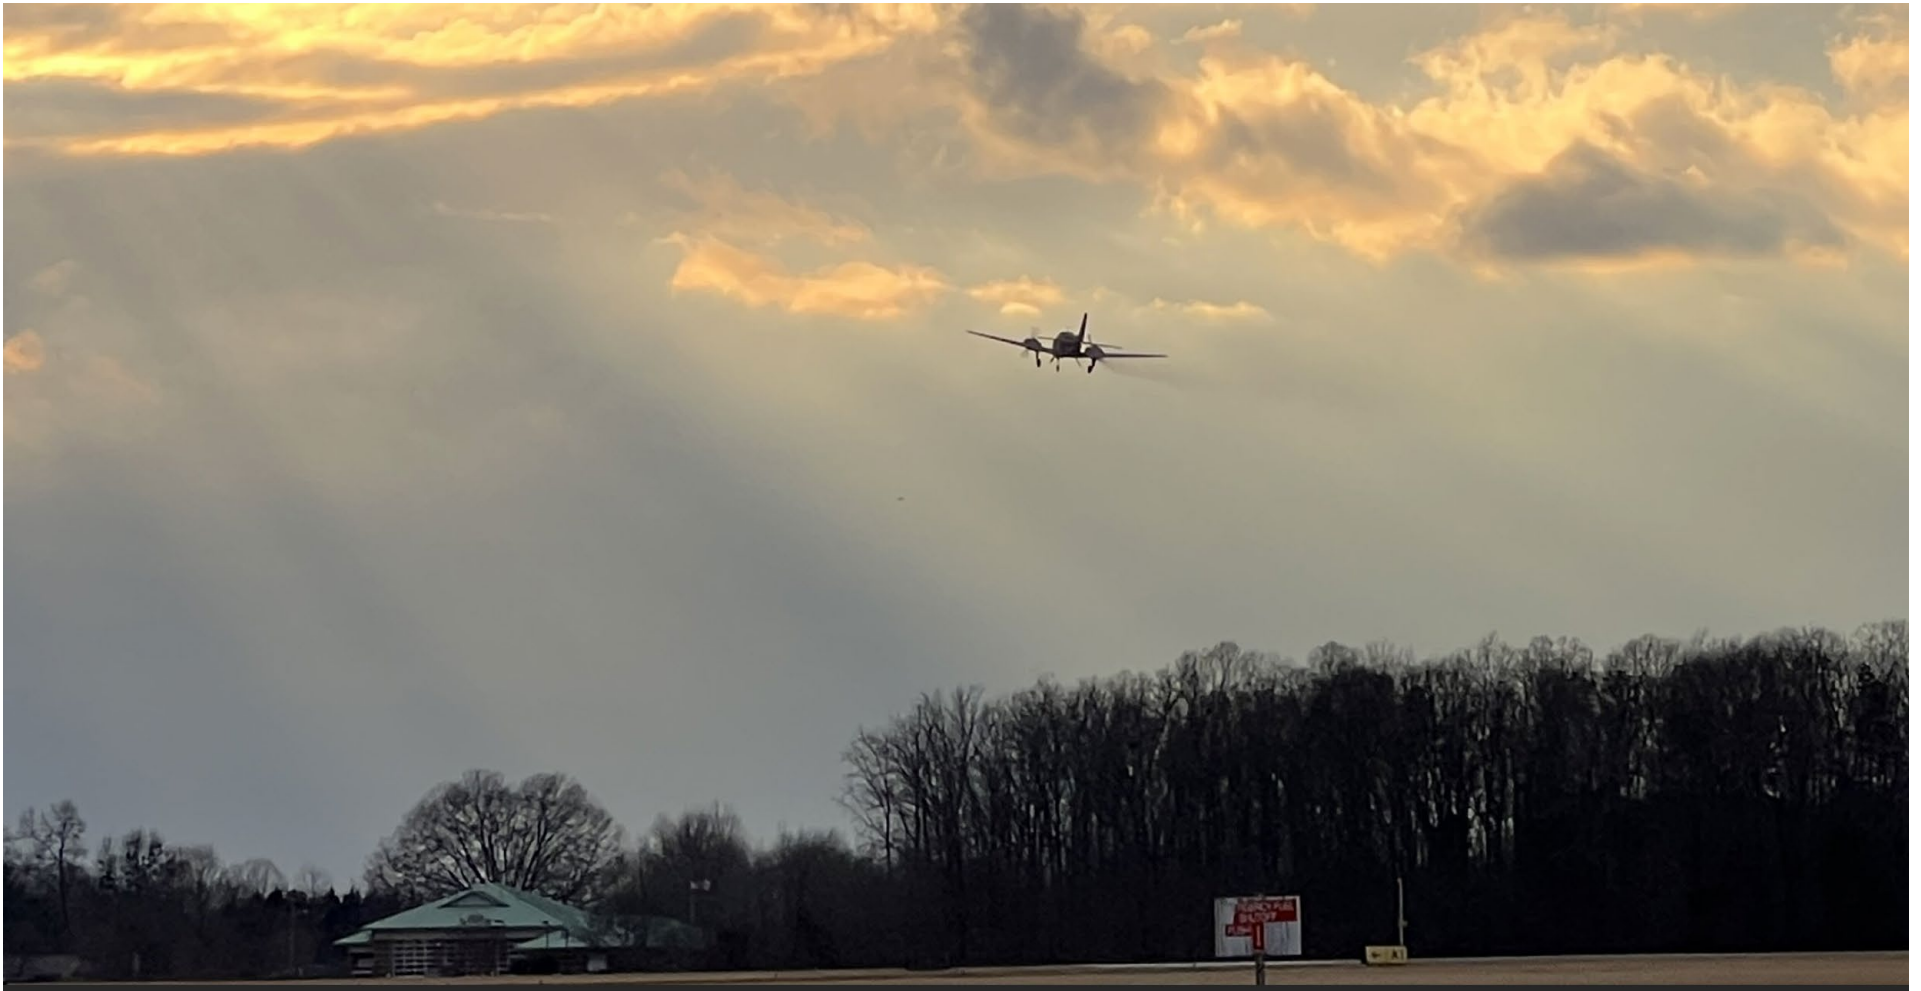
**Photo 2 - Enlarged Photograph Provided By Witness Shawn DeForest. View of the Accident Airplane In-Flight Showing the Landing Gear Extended and Smoke Training the Right Engine.**

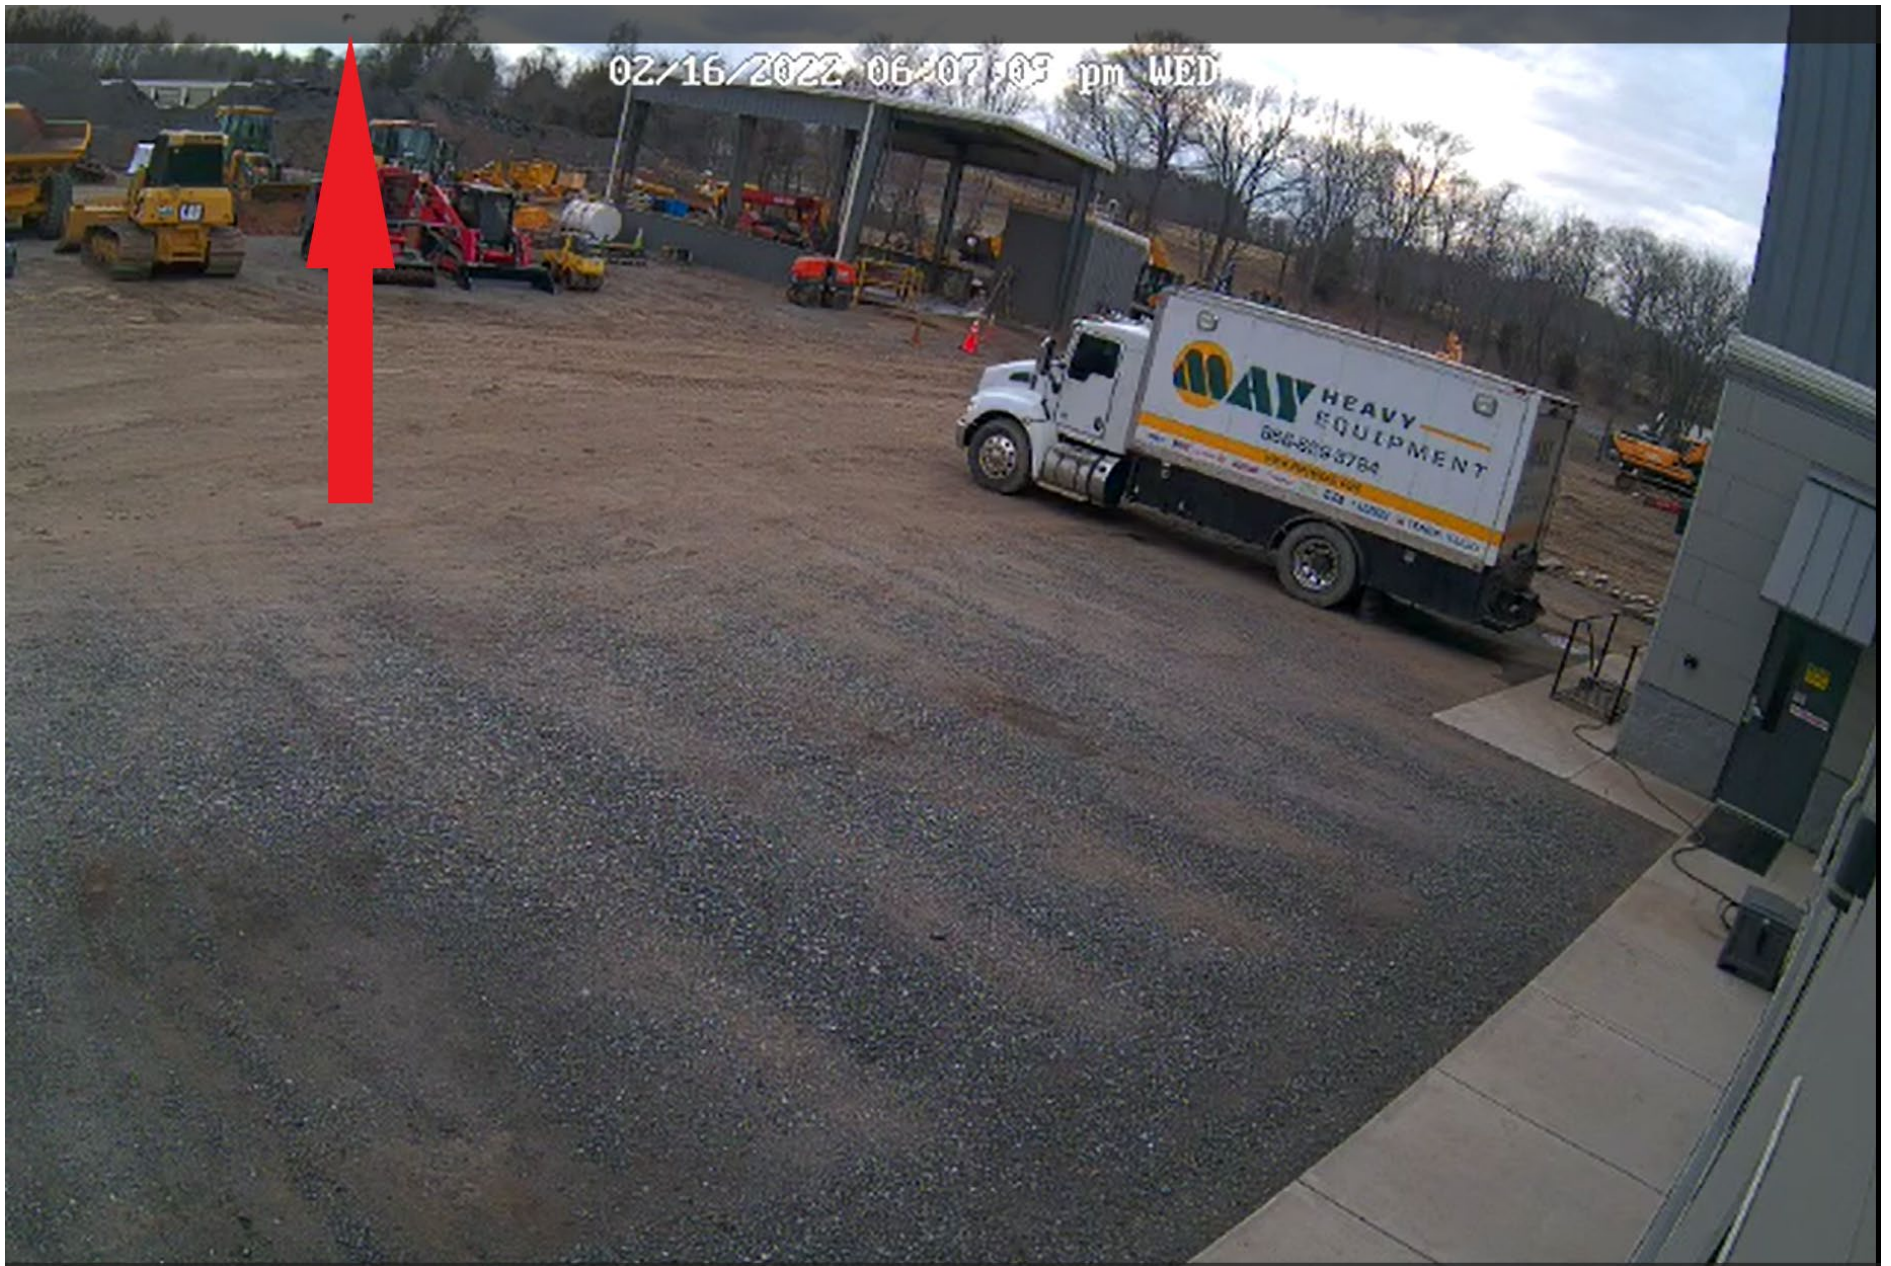
**Photo 3 – Annotated Image From Video From May Heavy Equipment. Red Arrow Points to Airplane In-Flight.**

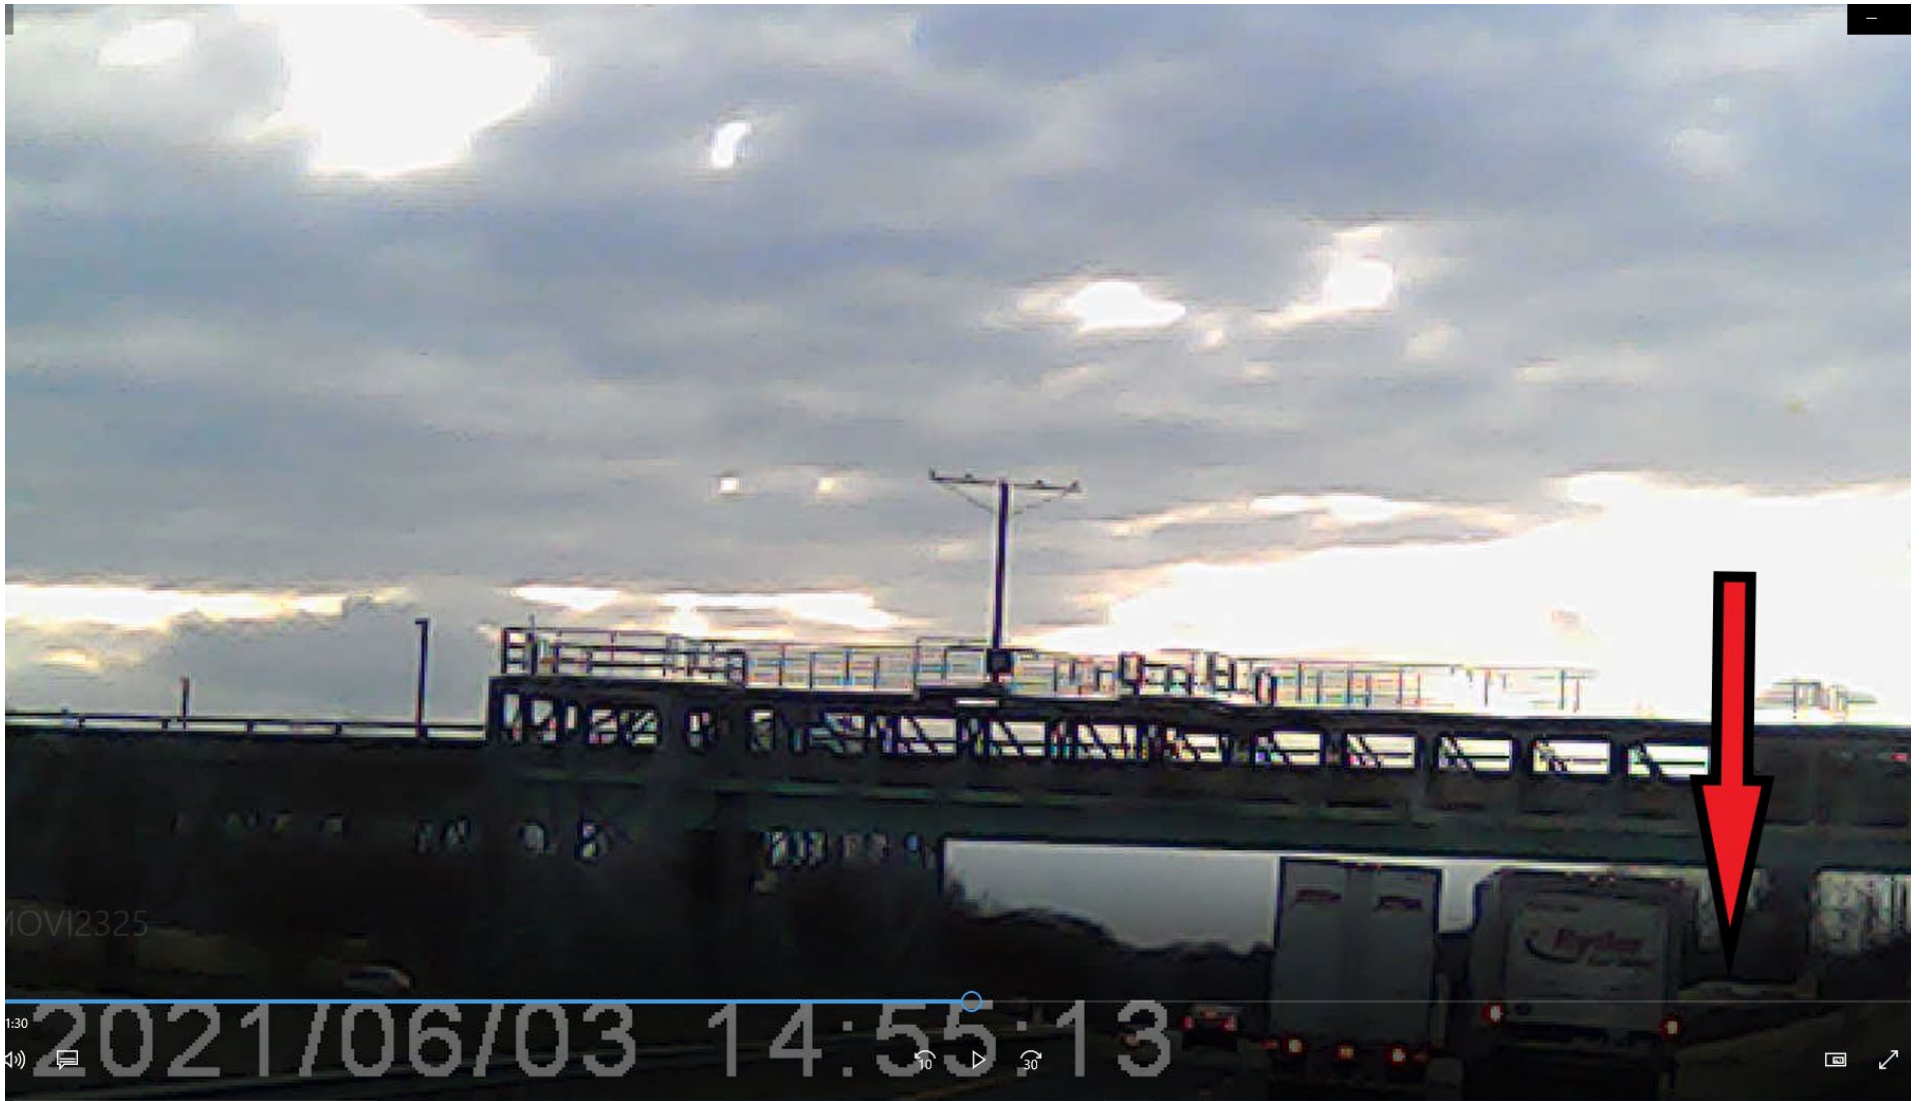
**Photo 4 – Annotated Image From Video of Vehicle on Highway. Red Arrow Points to Airplane Before Impact with the Truck.**

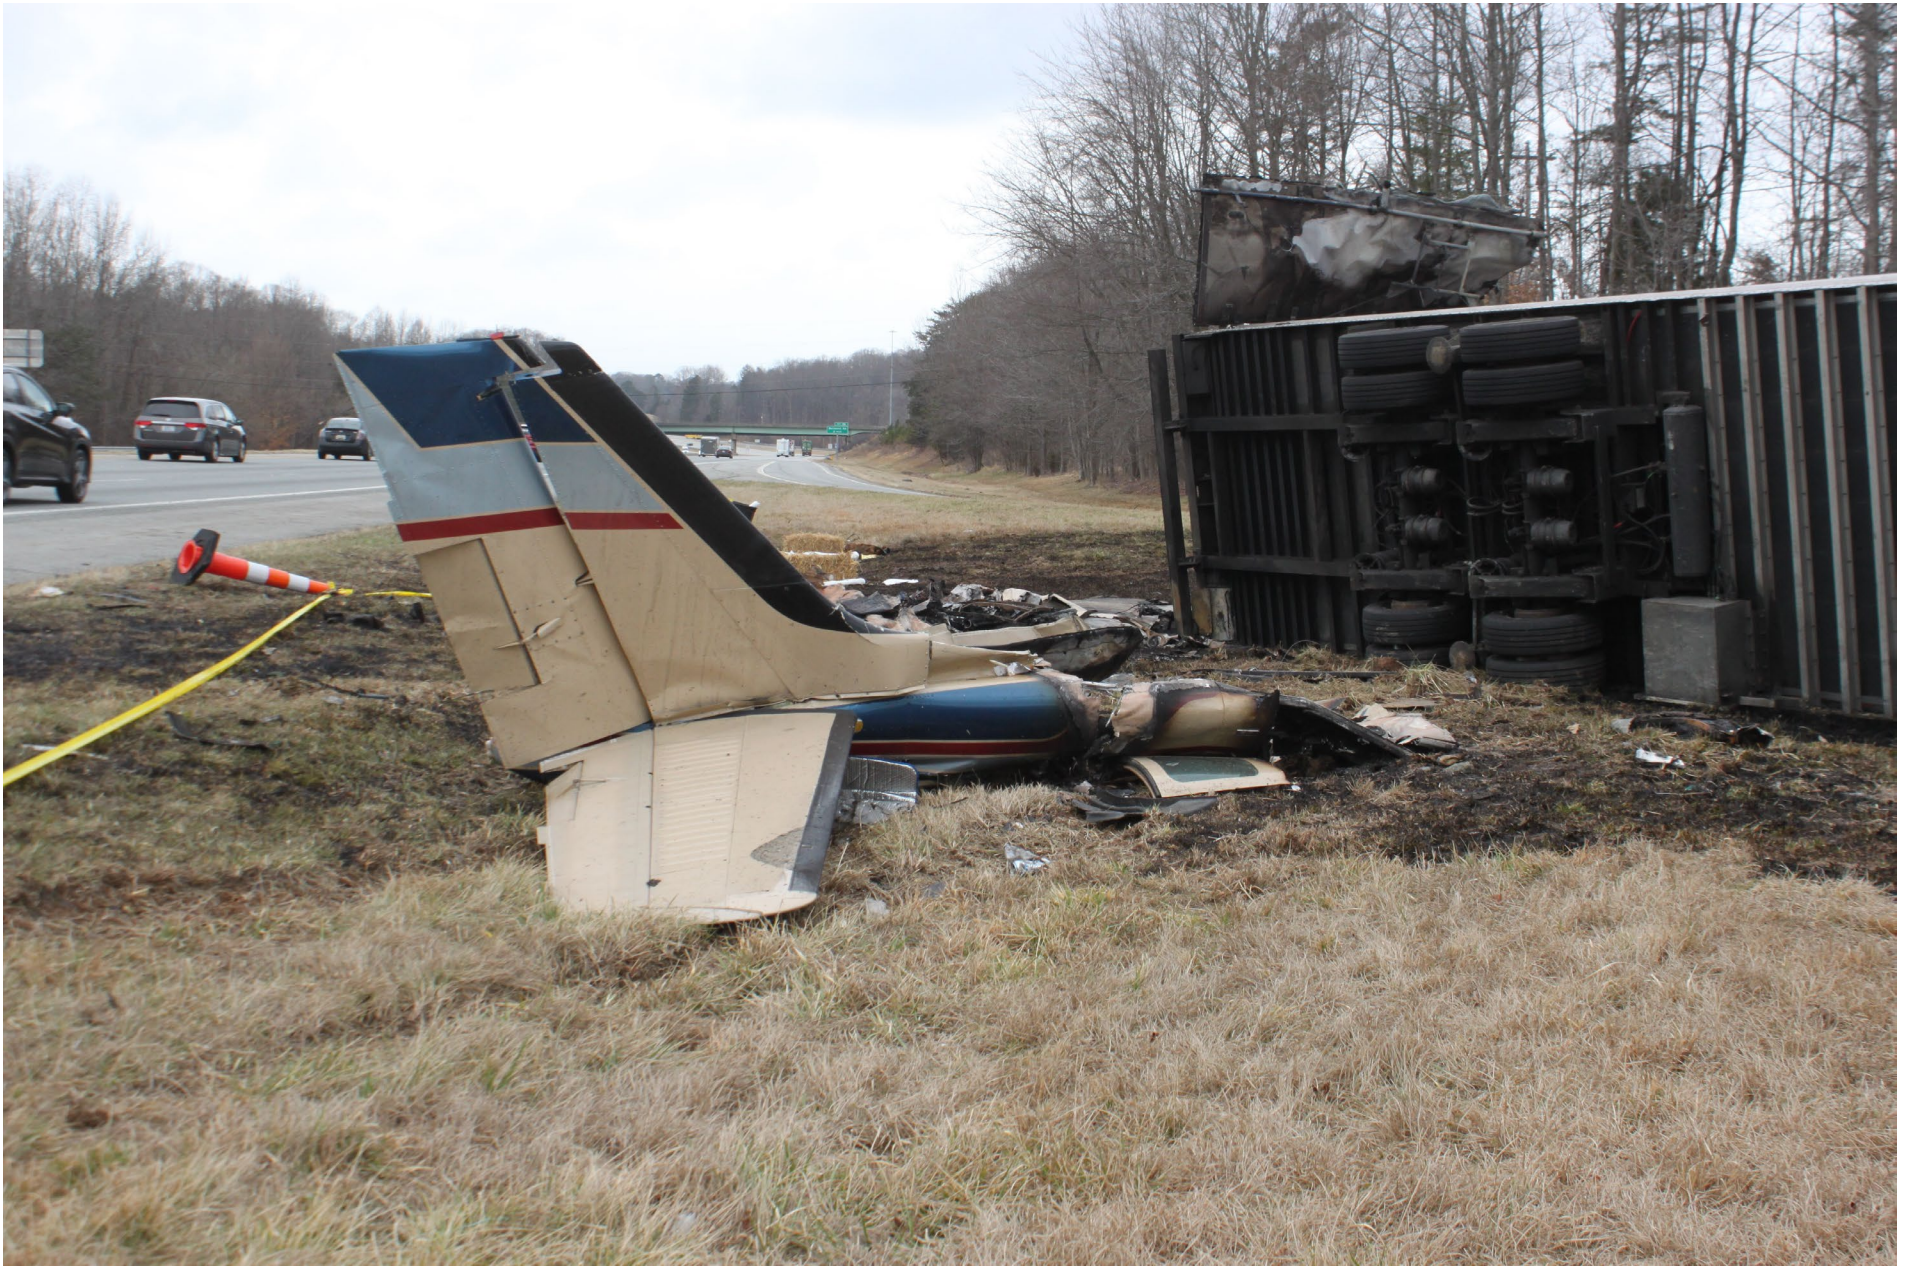
**Photo 5 – NTSB Digital Photograph. View of the Aft Empennage, and Impacted Tractor Trailer.**

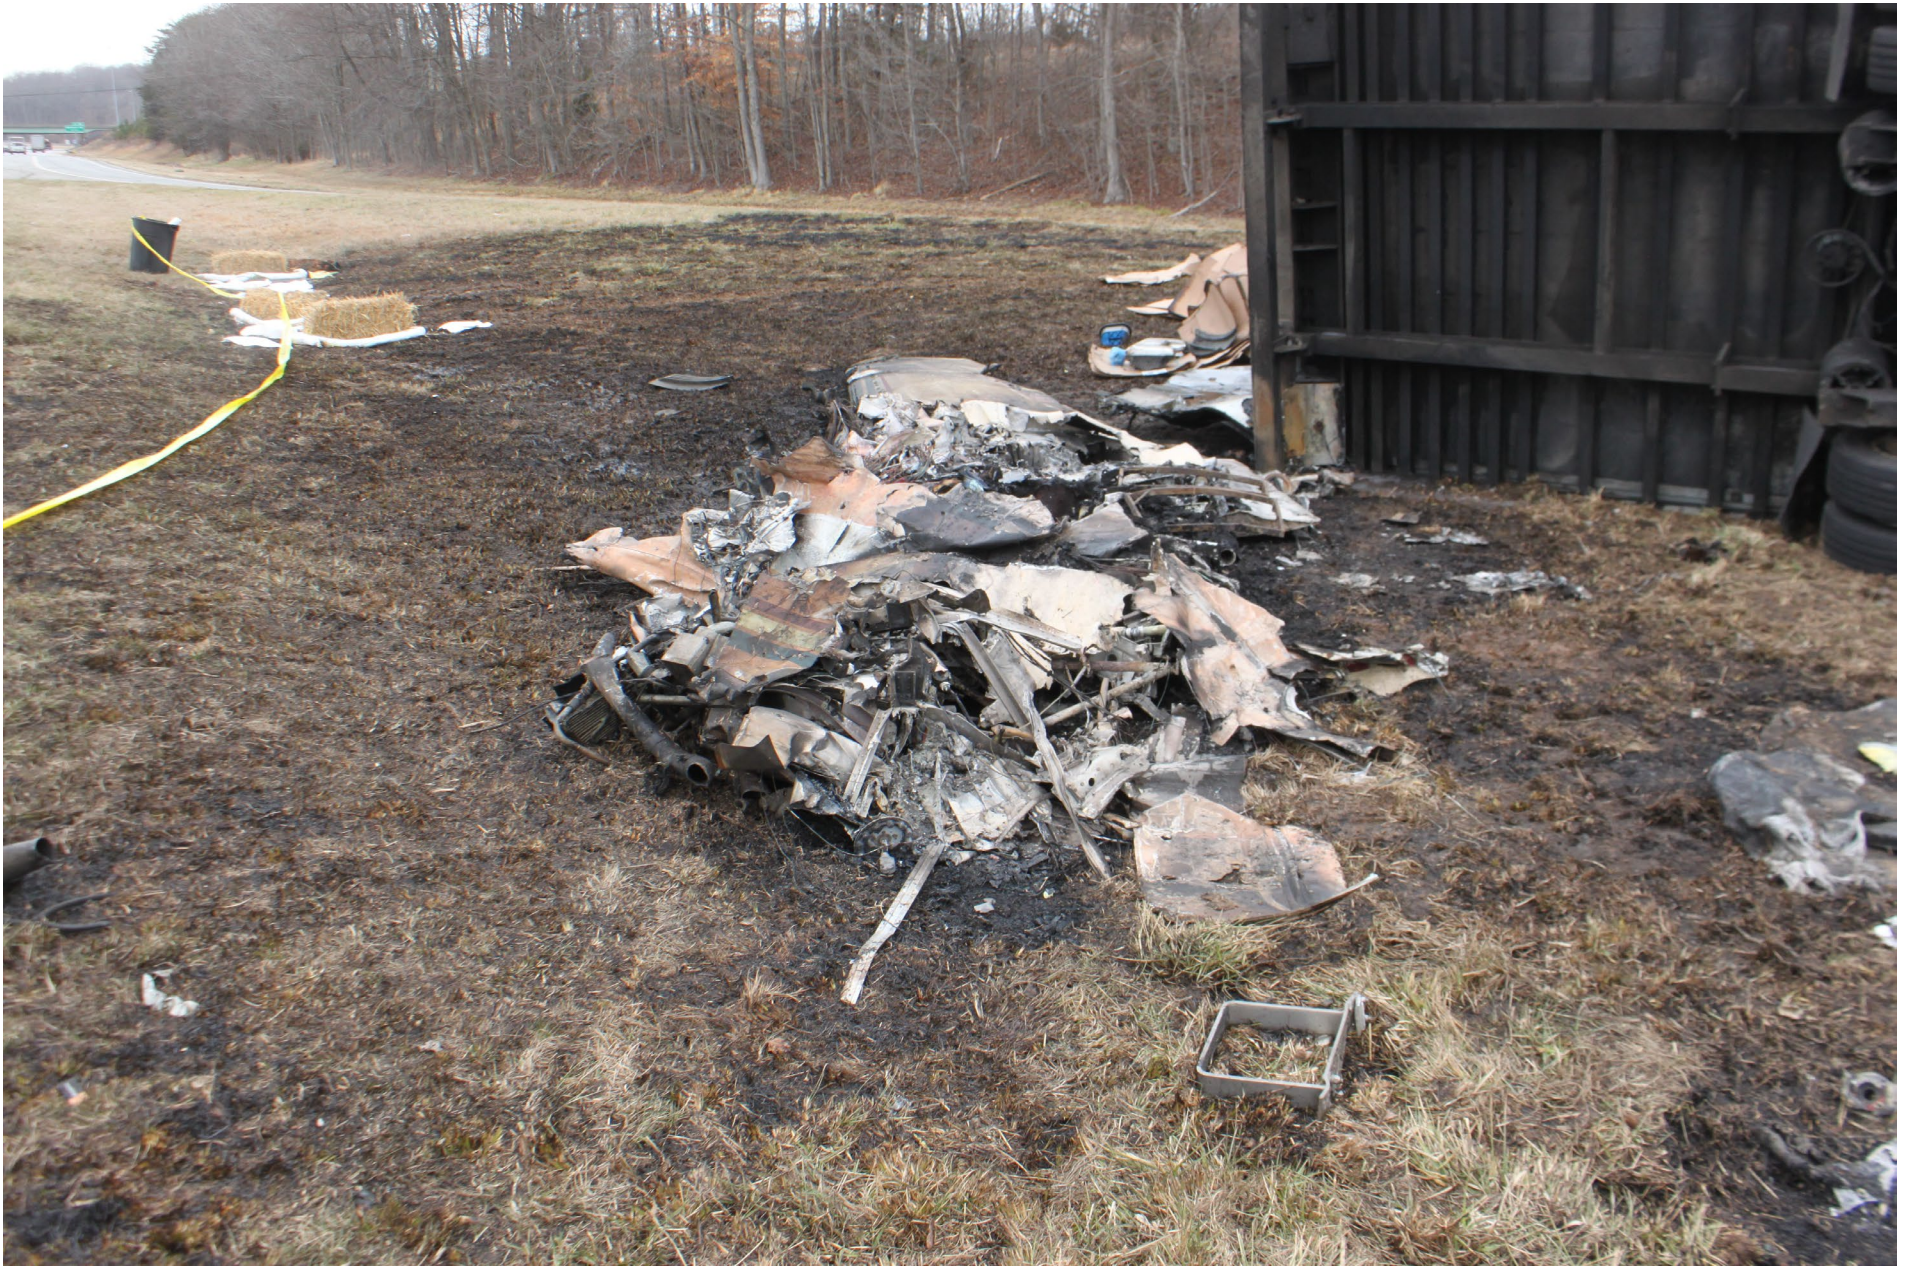
**Photo 6 – NTSB Digital Photograph. View of a Portion of the Left Wing in the Foreground, Cockpit, and Right Wing in the Background.**

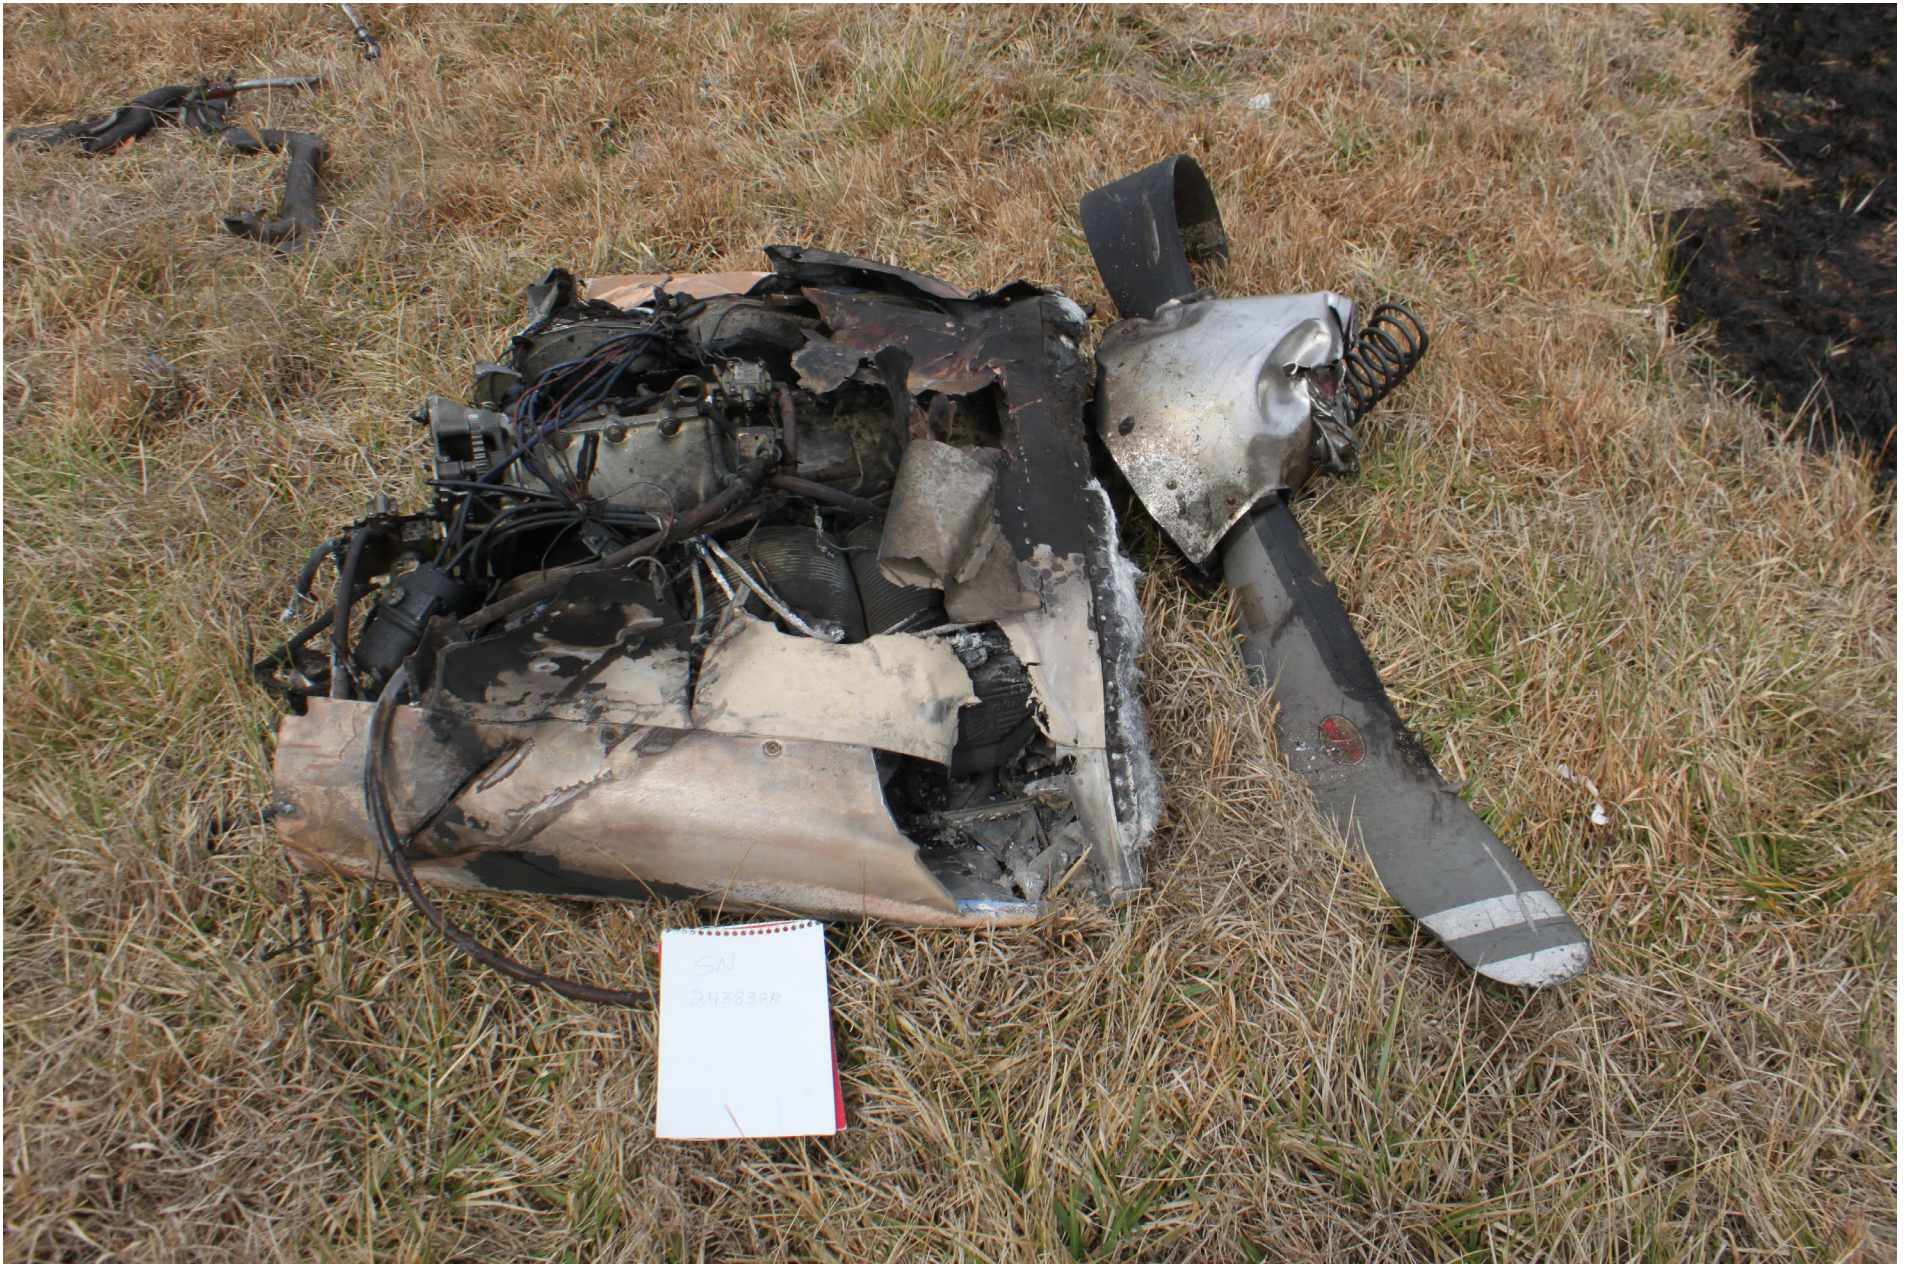
**Photo 7 – NTSB Digital Photograph. View of the Left Engine Assembly with Attached Propeller.**

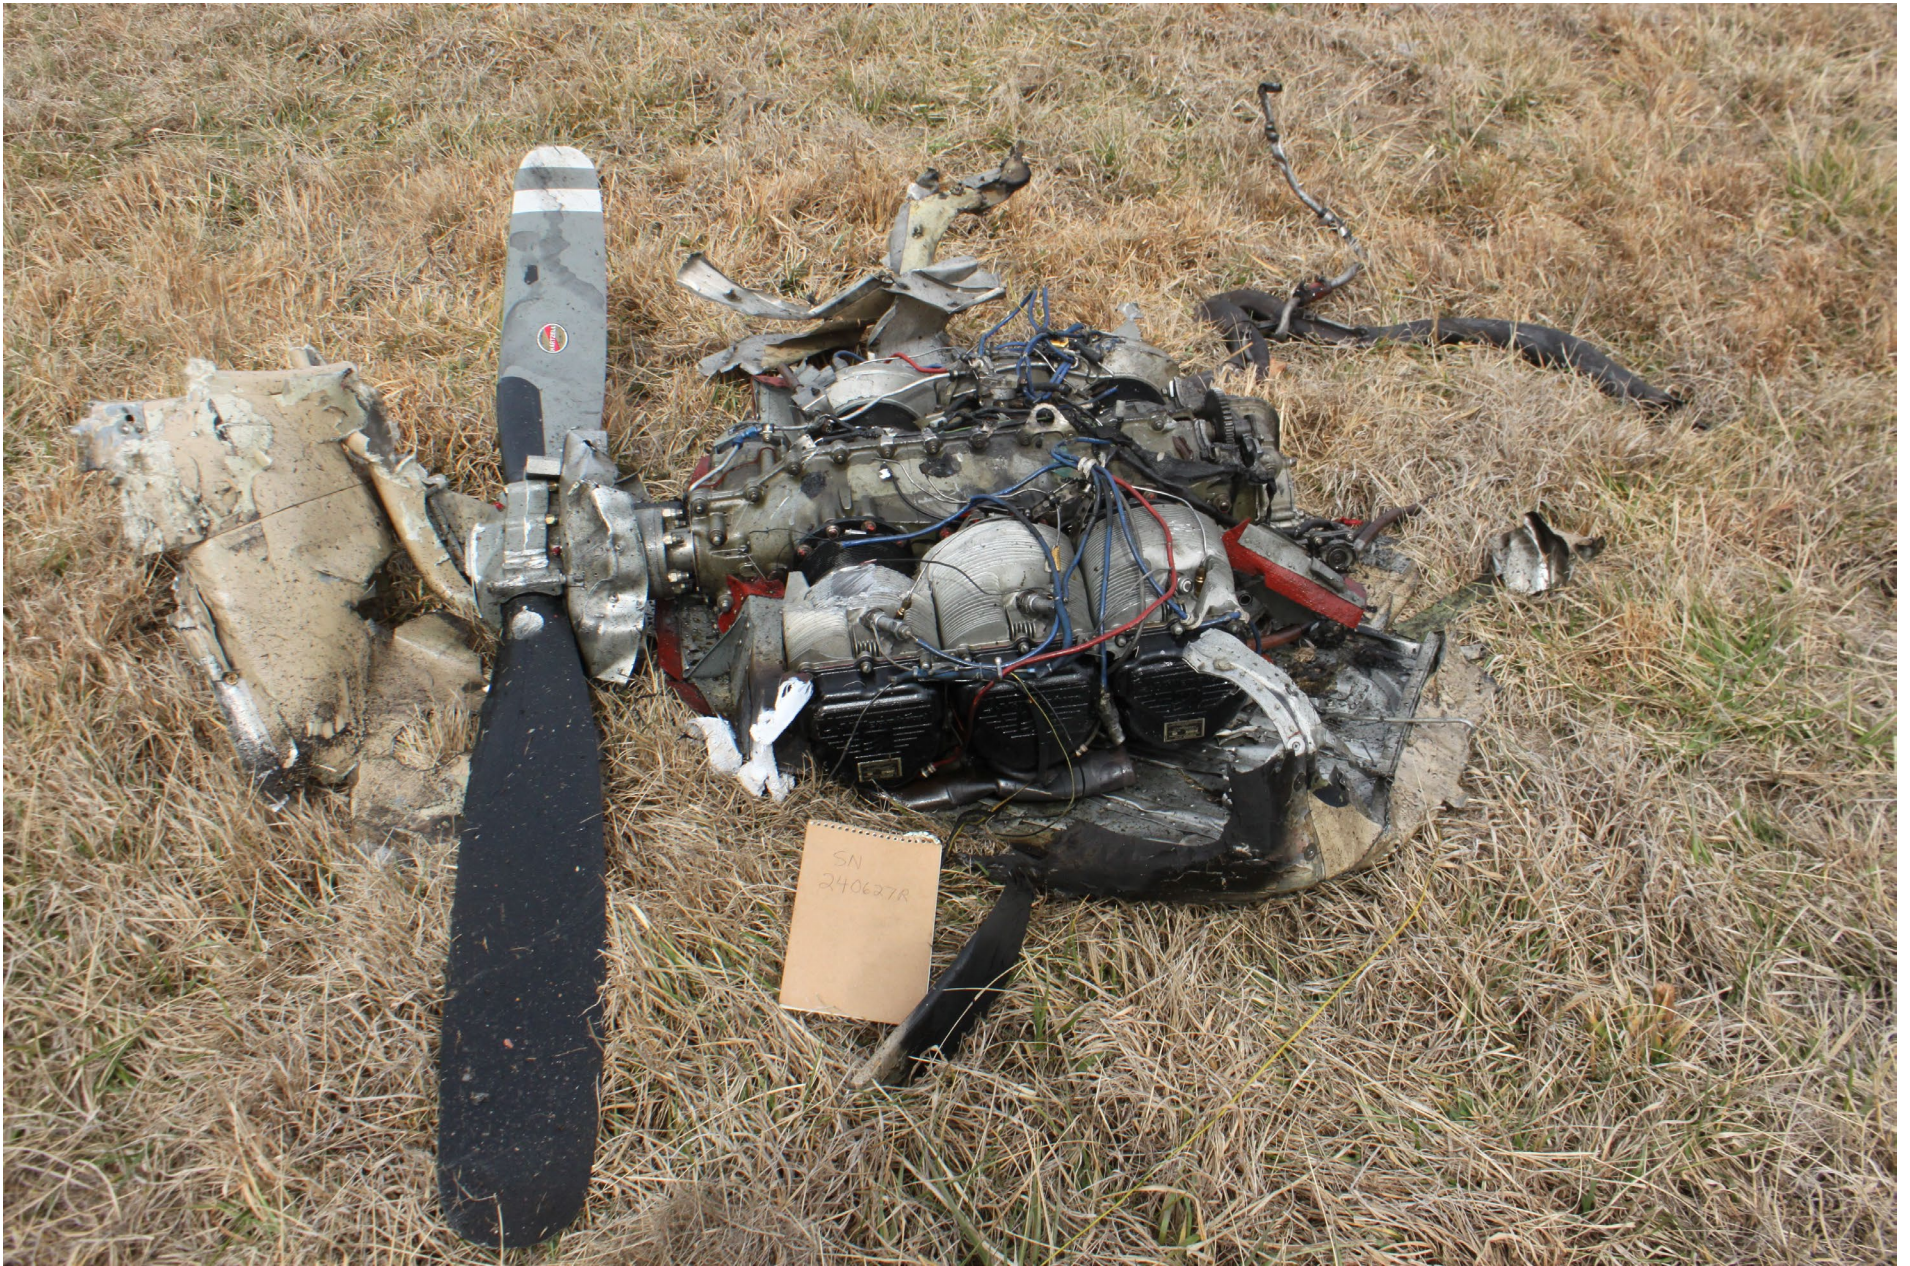
**Photo 8 - NTSB Digital Photograph. View of the Right Engine Assembly with Attached Propeller.**

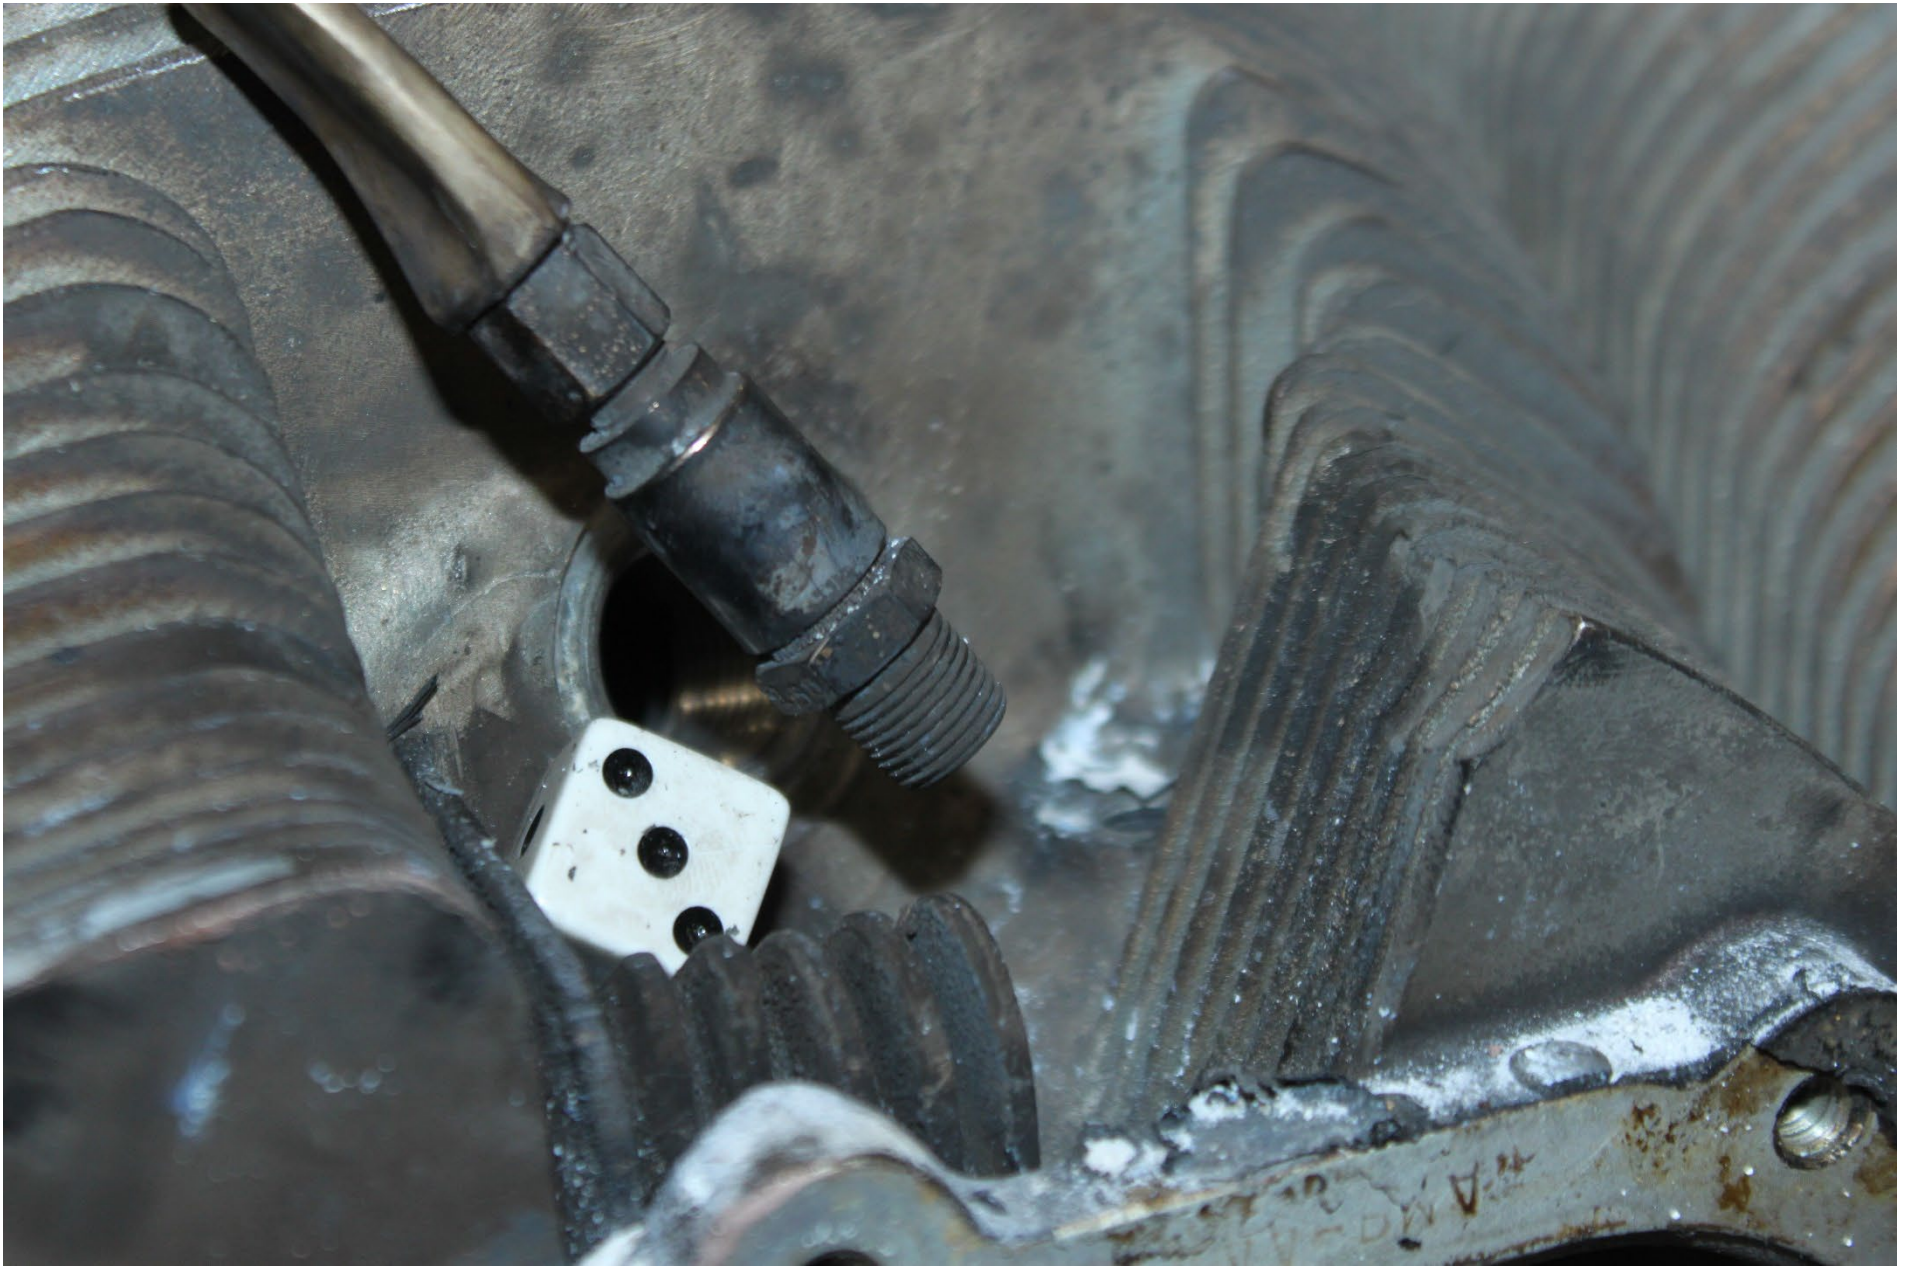
**Photo 9 – NTSB Digital Photograph. View of the No. 3 Cylinder Fuel Injector Nozzle of the Left Engine As Found Not Installed in the Cylinder. Note the soot Along the Length of the Threads.**

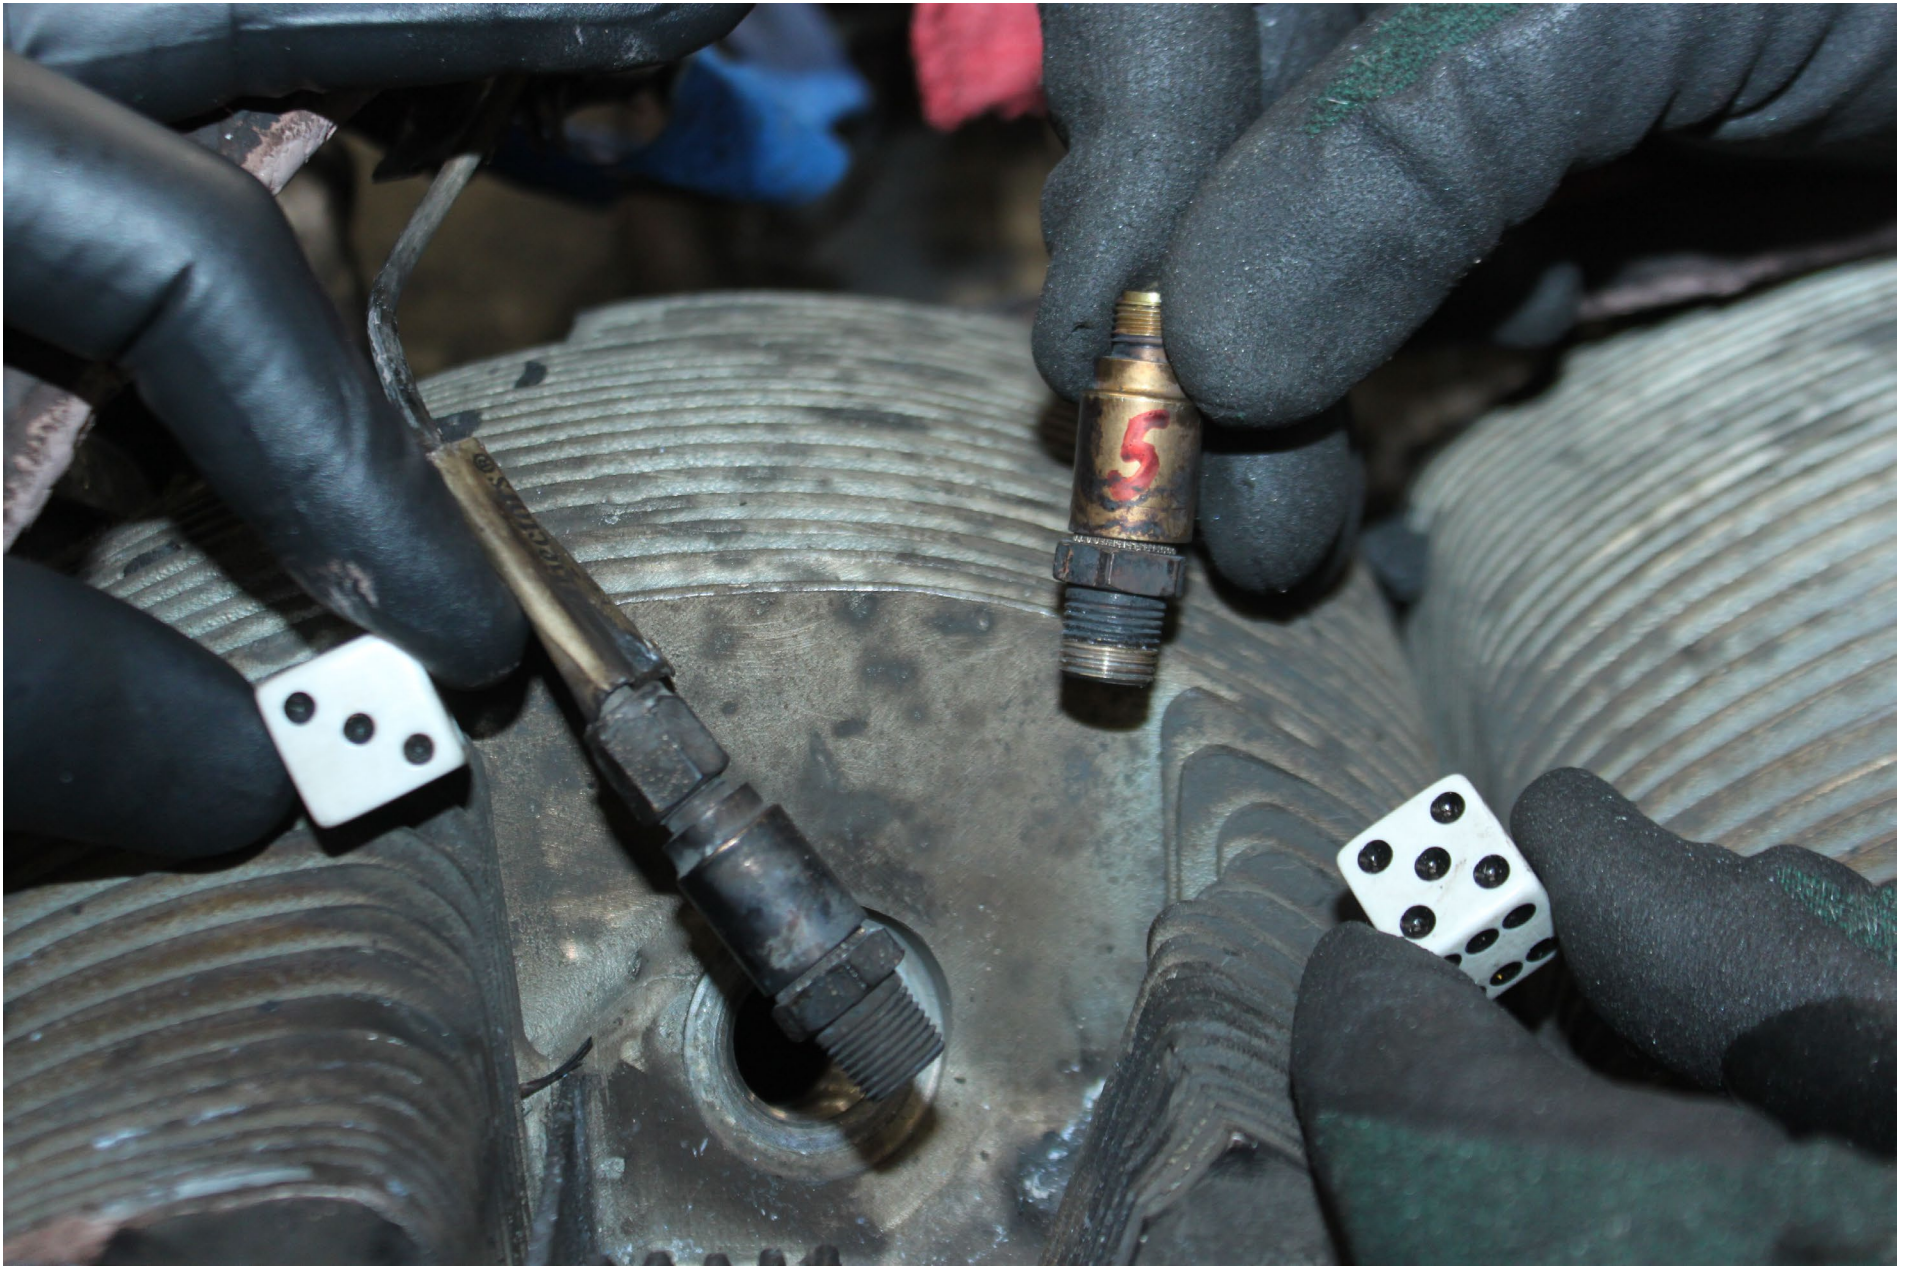
**Photo 10 – NTSB Digital Photograph. View Showing the Nos. 3 and 5 Fuel Injector Nozzles of the Left Engine. Note the Completely Sooted Threads of the No. 3 Nozzle and the Clean and Sooted Line of the Threads of the No. 5 Nozzle.**
