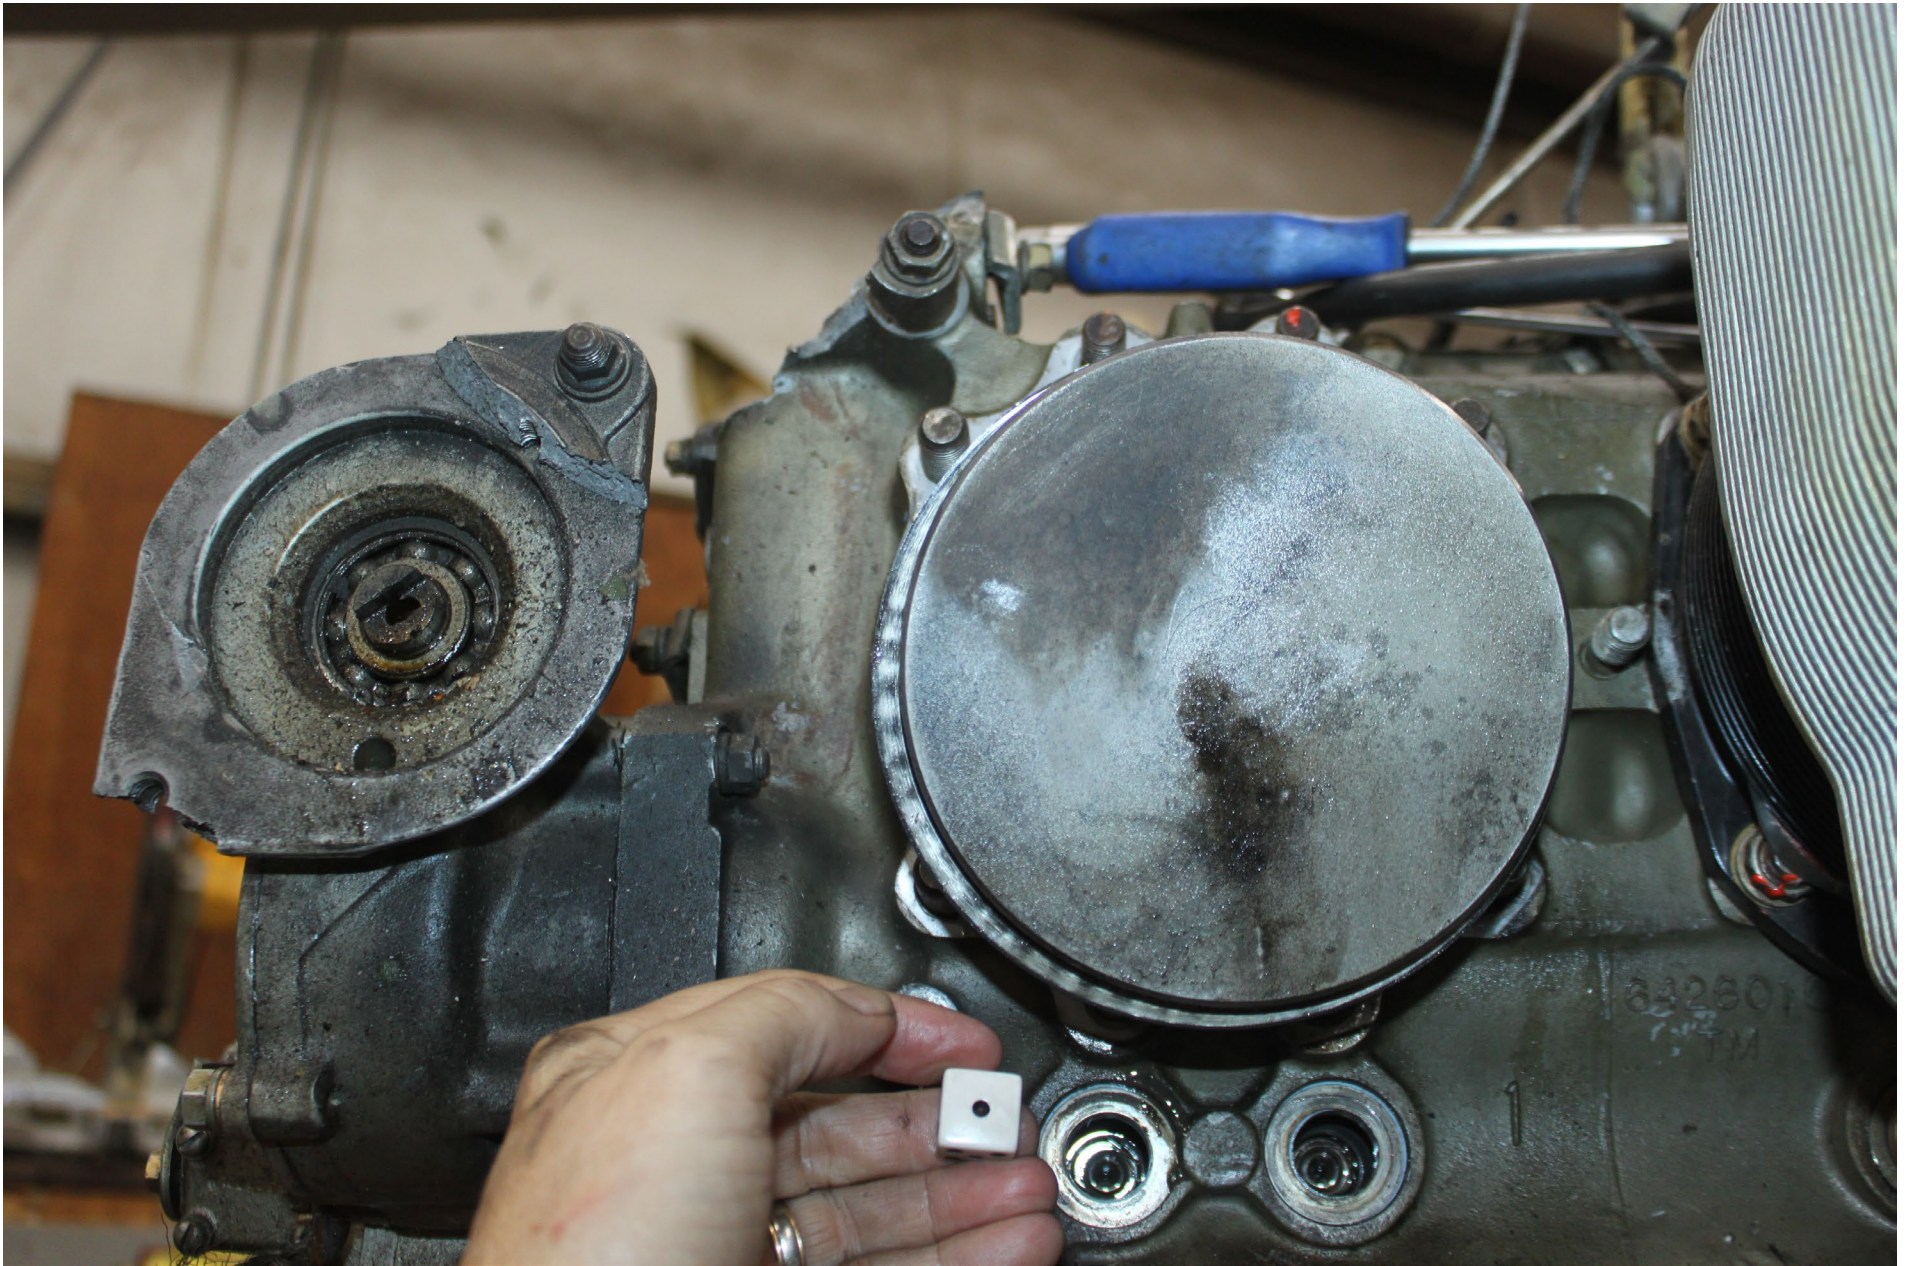
**Photo 11 – NTSB Digital Photograph. View of the No. 1 Piston of the Right Engine. Note the Appearance on the Crown of the Piston.**

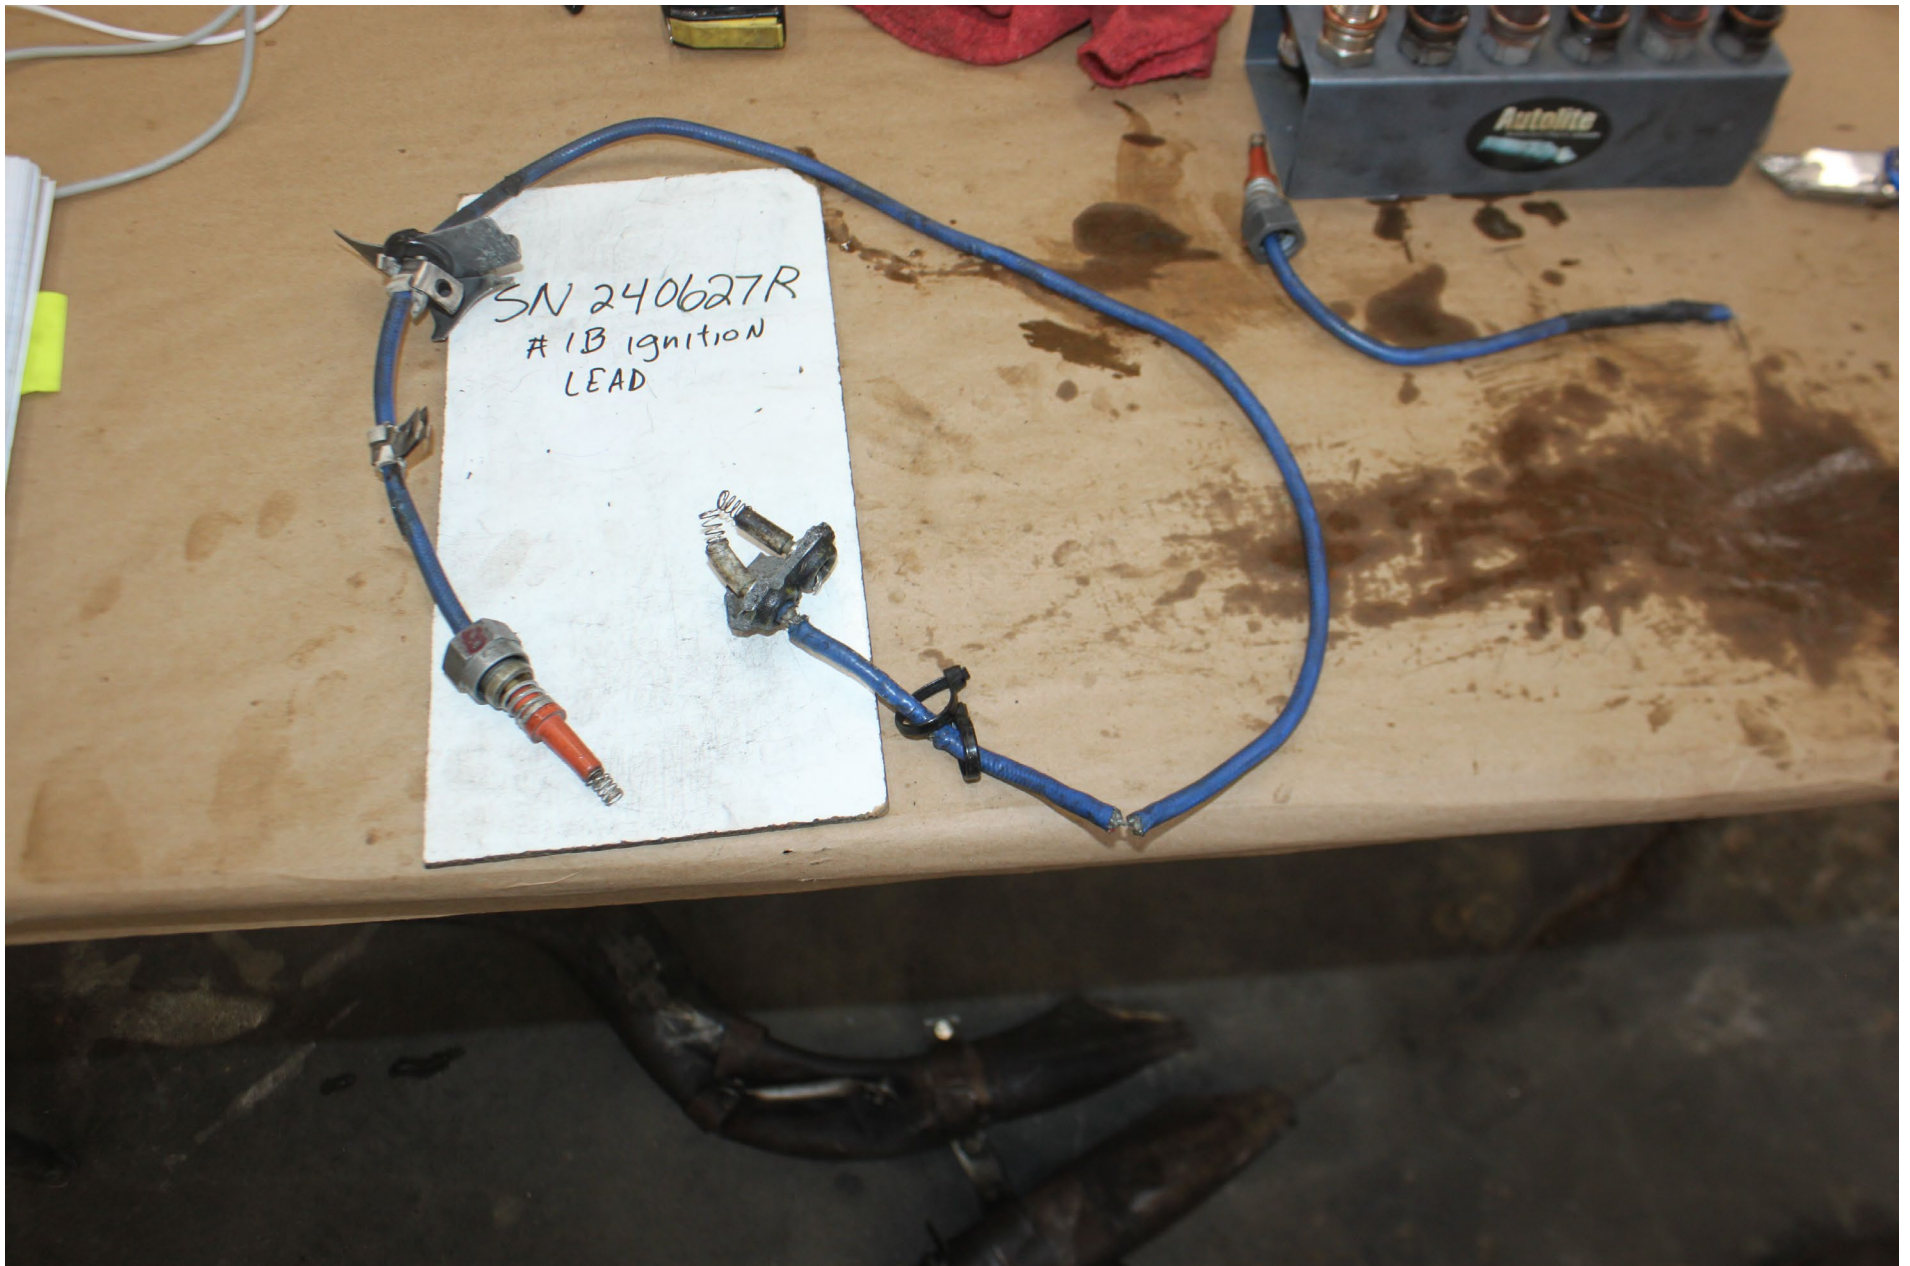
**Photo 12 – NTSB Digital Photograph. View of the No. 1 Cylinder Bottom Ignition Lead of the Right Engine.**

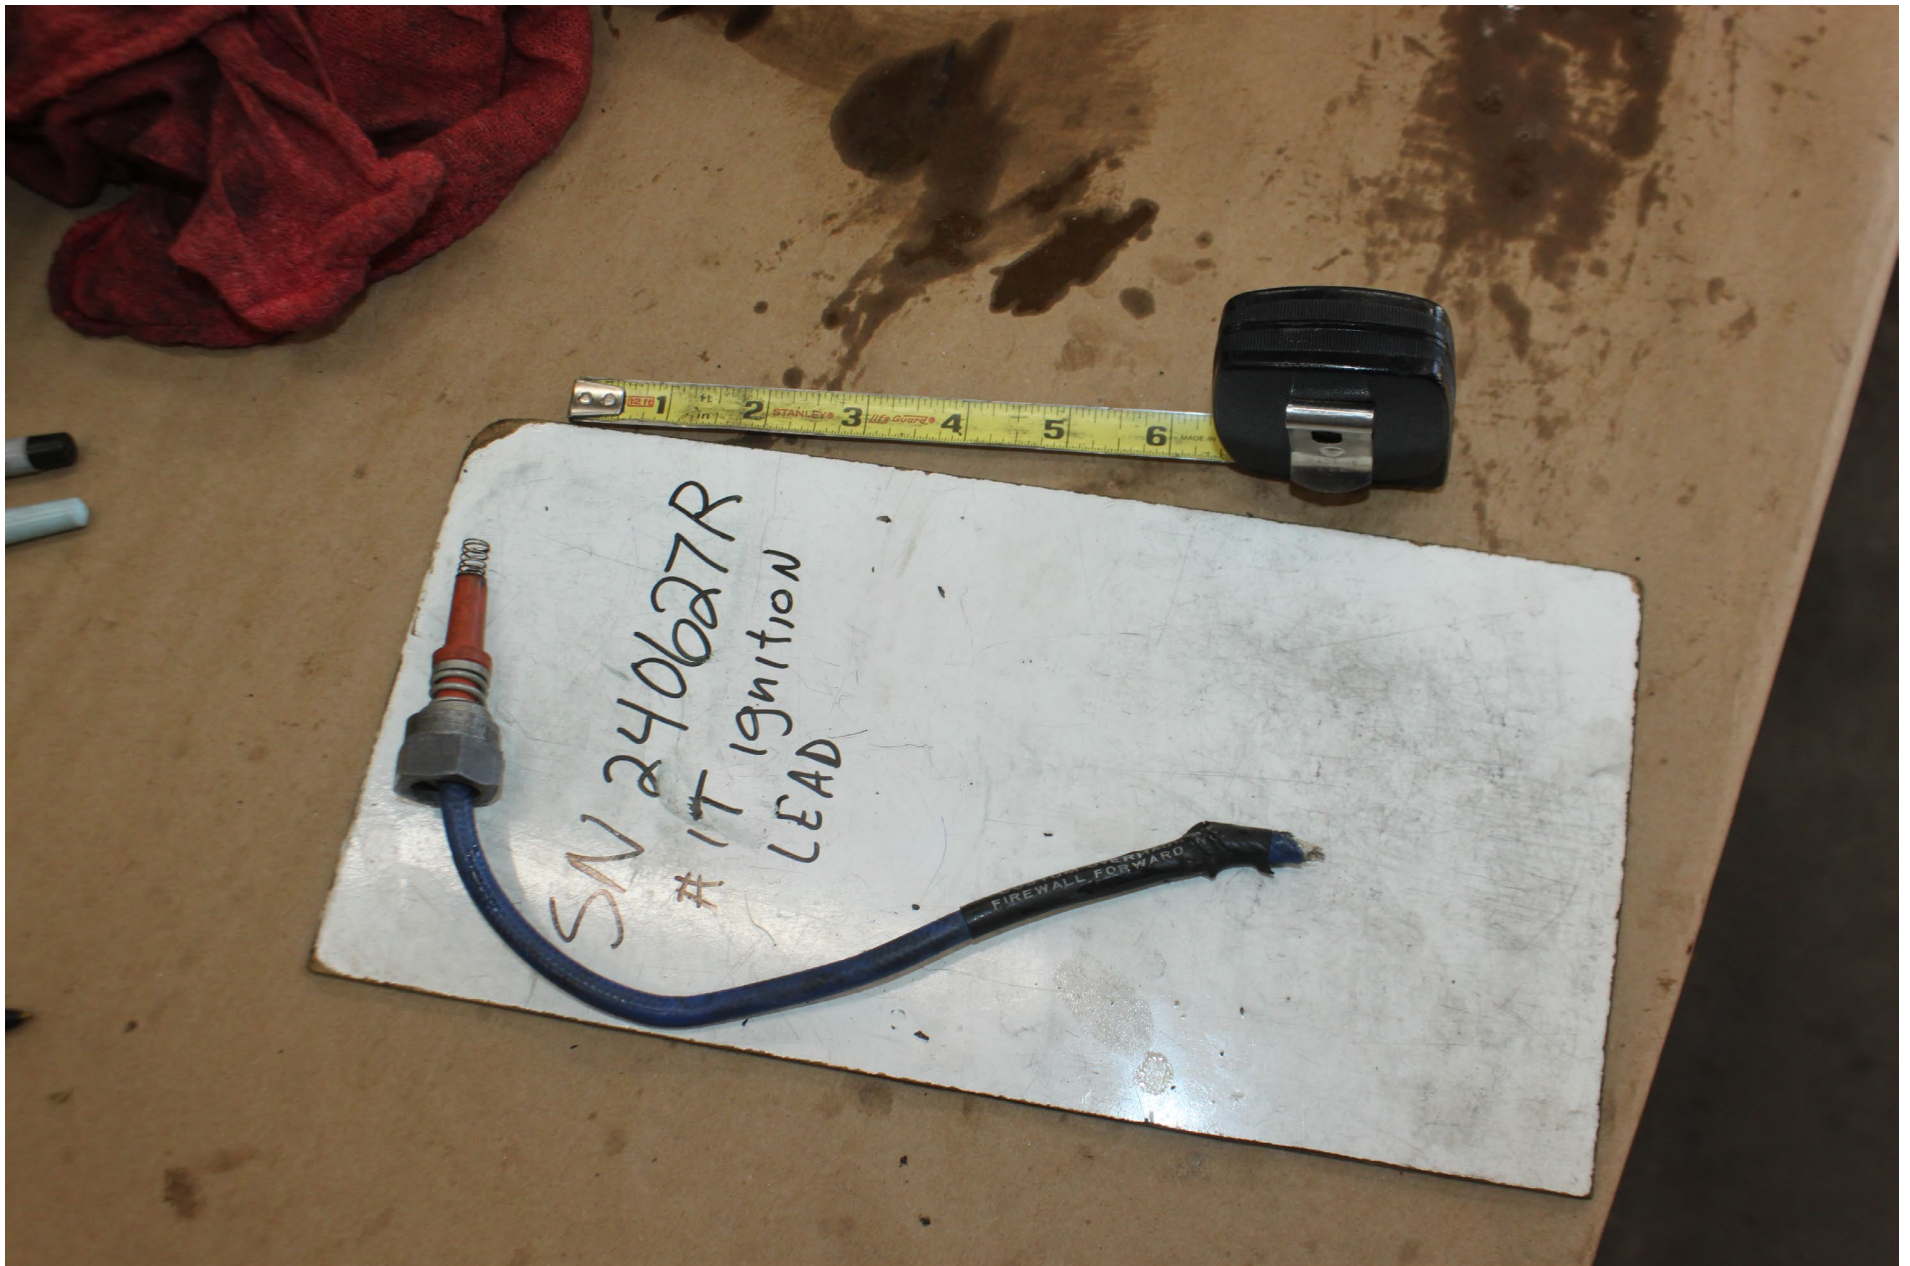
Photo 13 – NTSB Digital Photograph. View of the No. 1 Top Ignition Lead of the Right Engine.

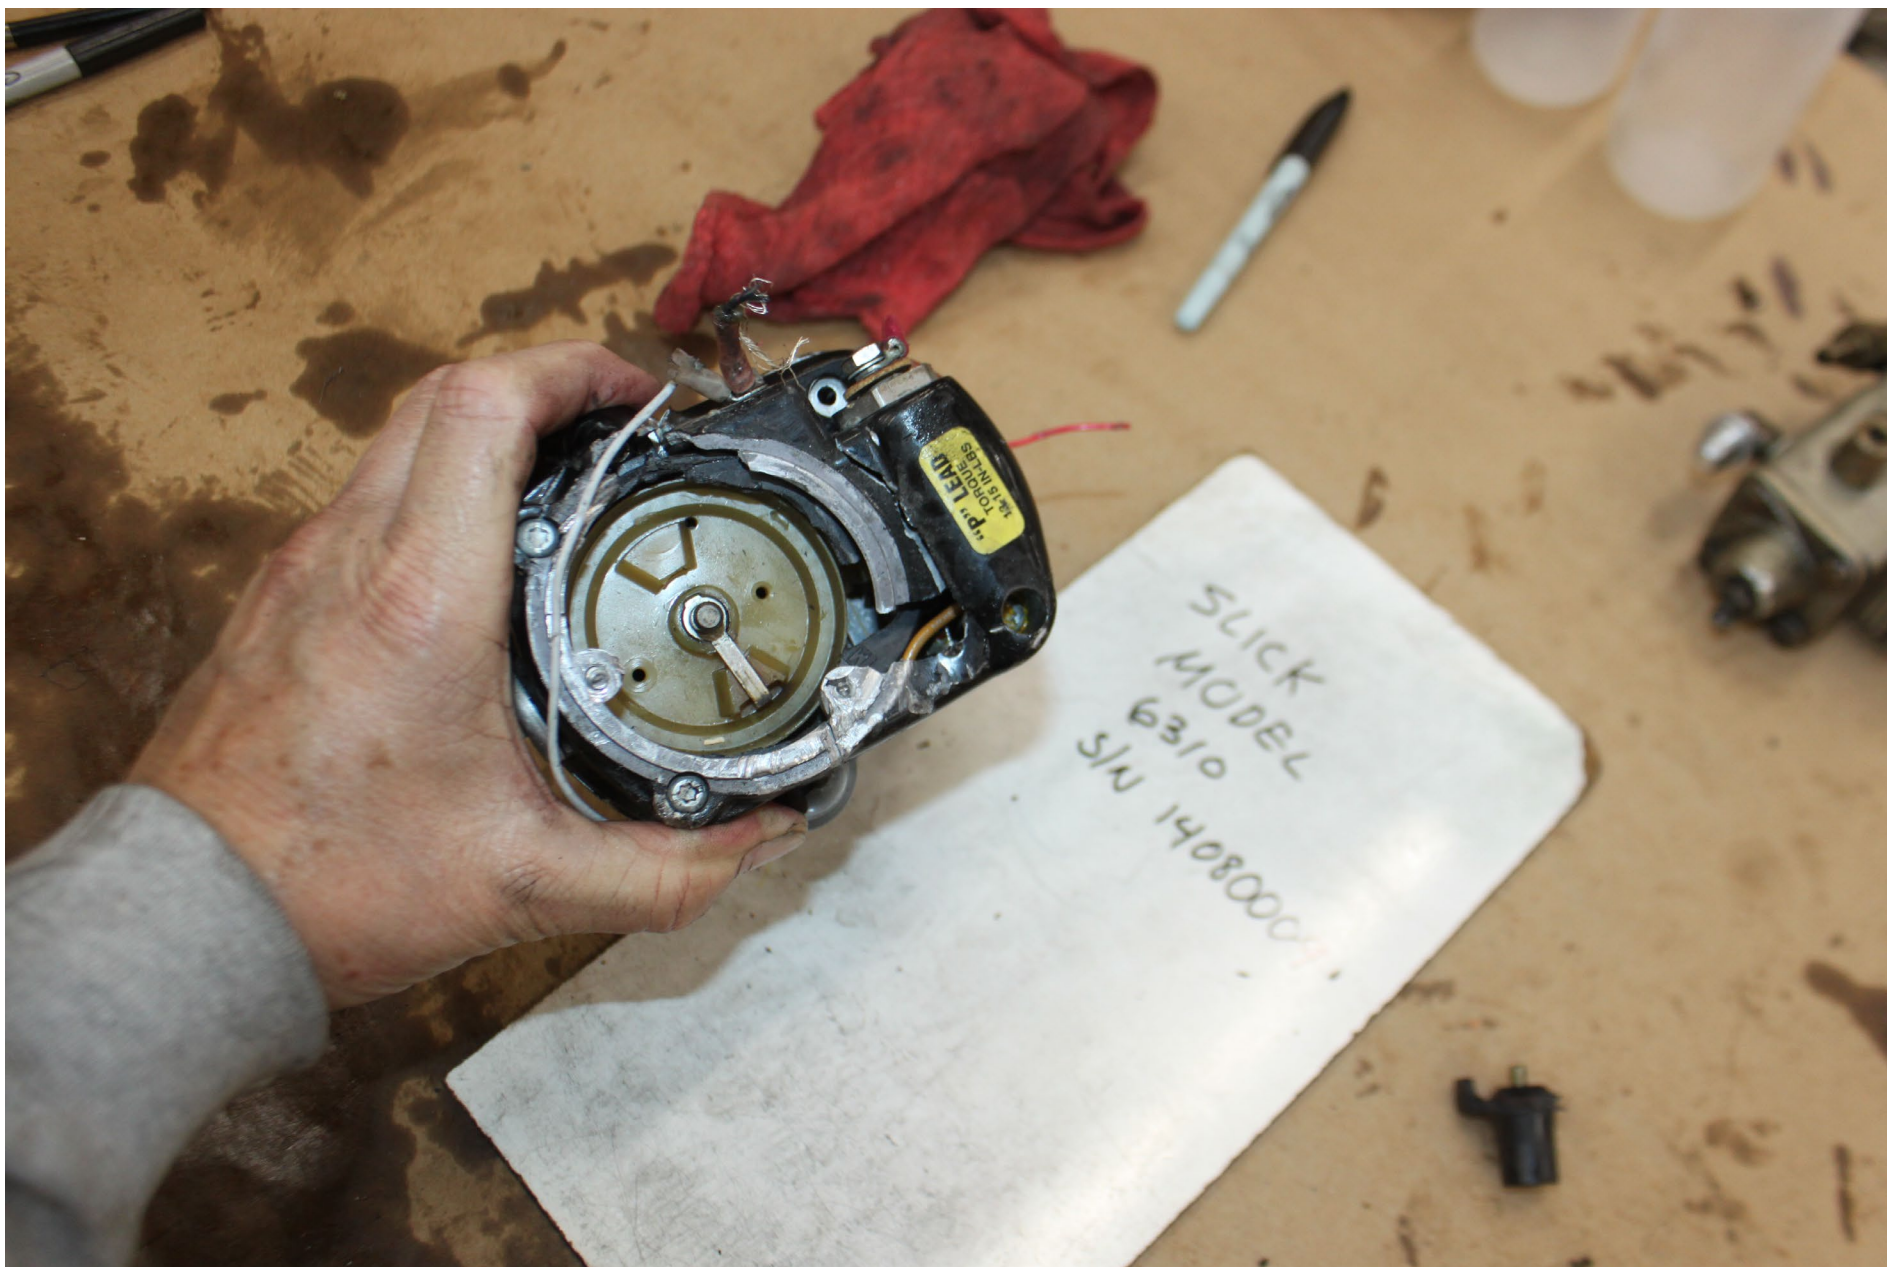
**Photo 14 – NTSB Digital Photograph. View up the Aft Portion of the Impact Separated Right Magneto of the Right Engine Showing the Impact Separated Distributor Block and Cover.**

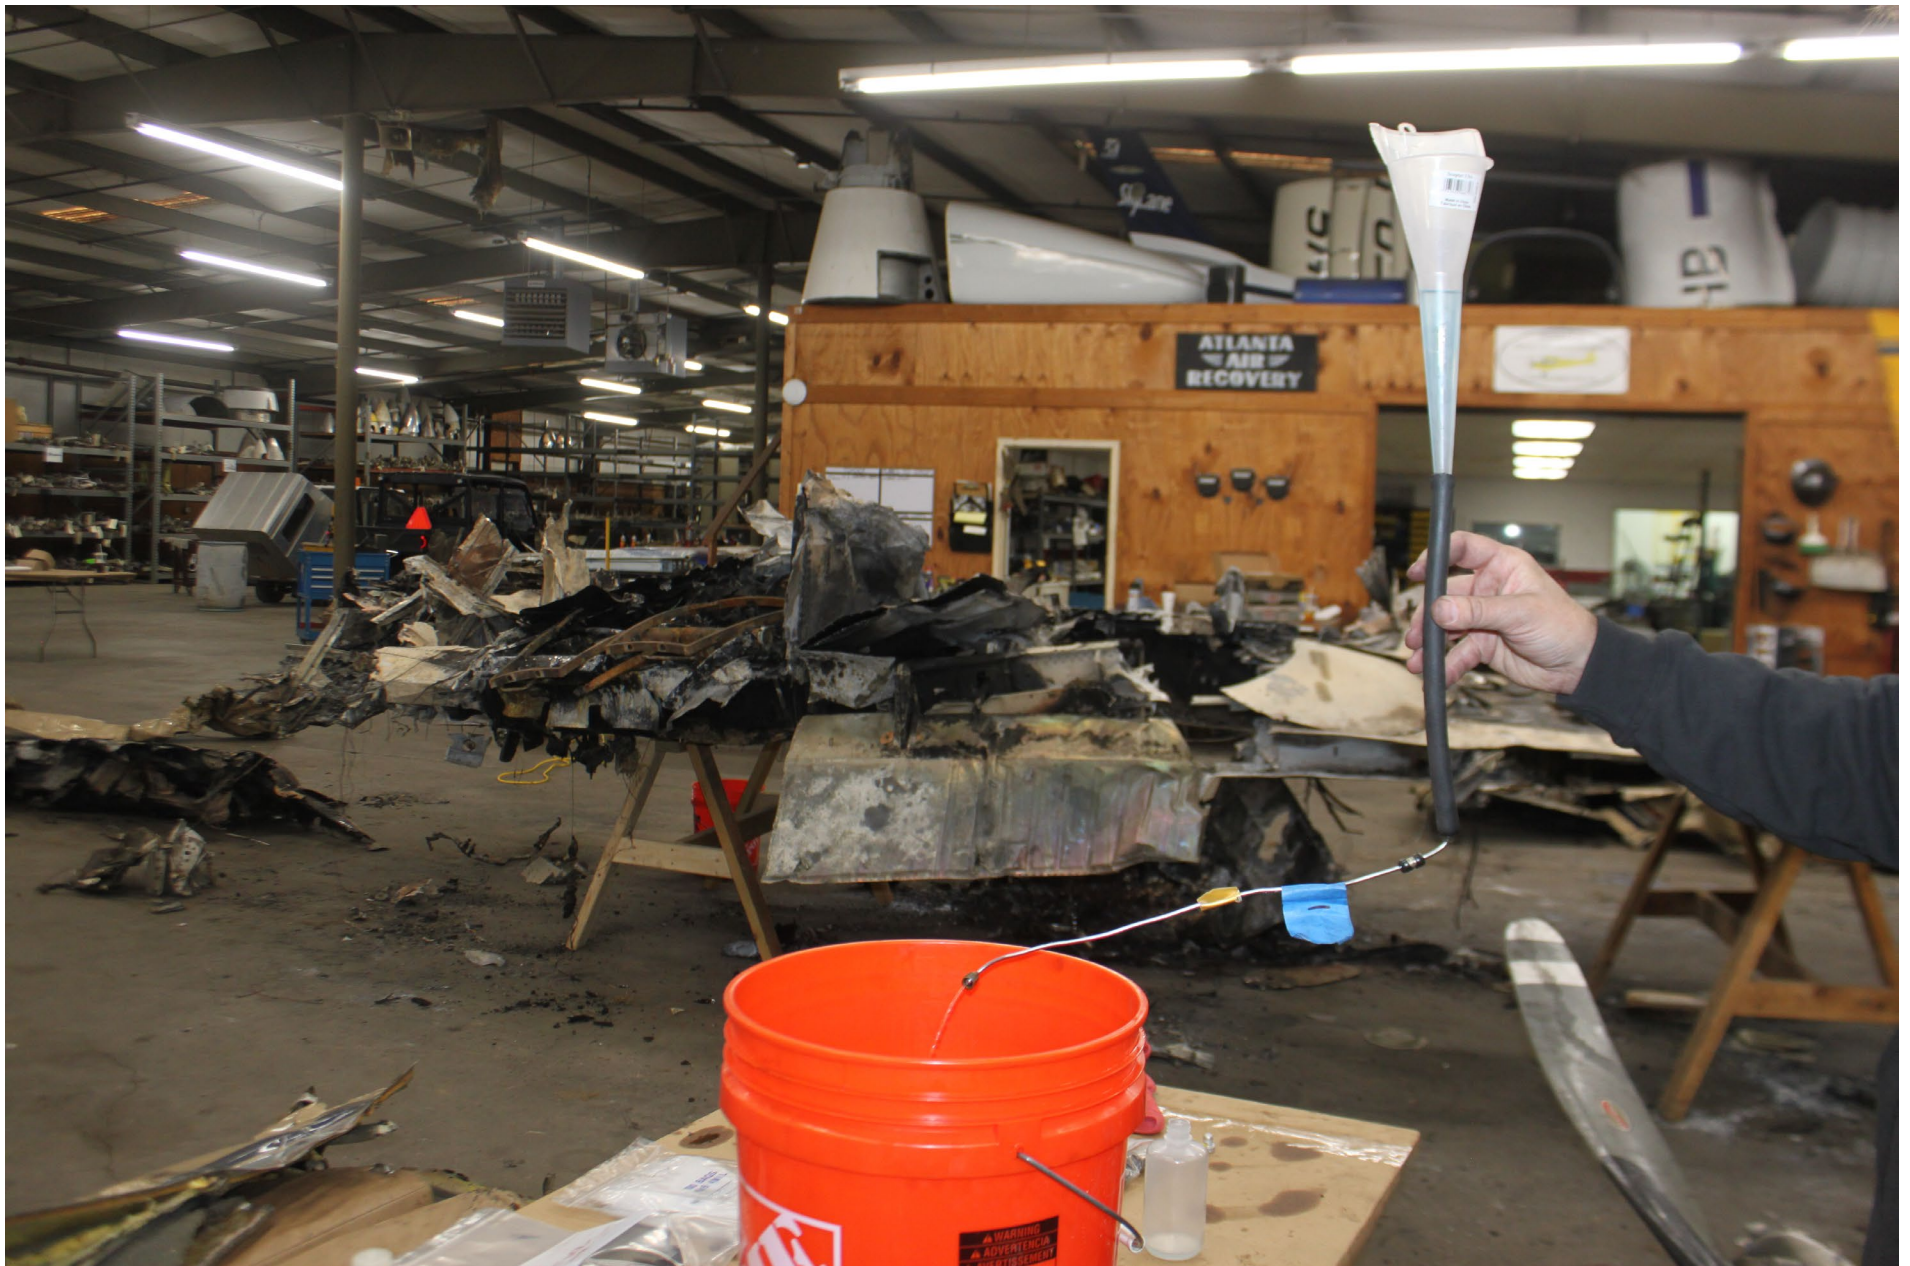
**Photo 15 – NTSB Digital Photograph. View Showing the Flow Testing of the No. 1 Cylinder Fuel Injector Line of the Right Engine.**

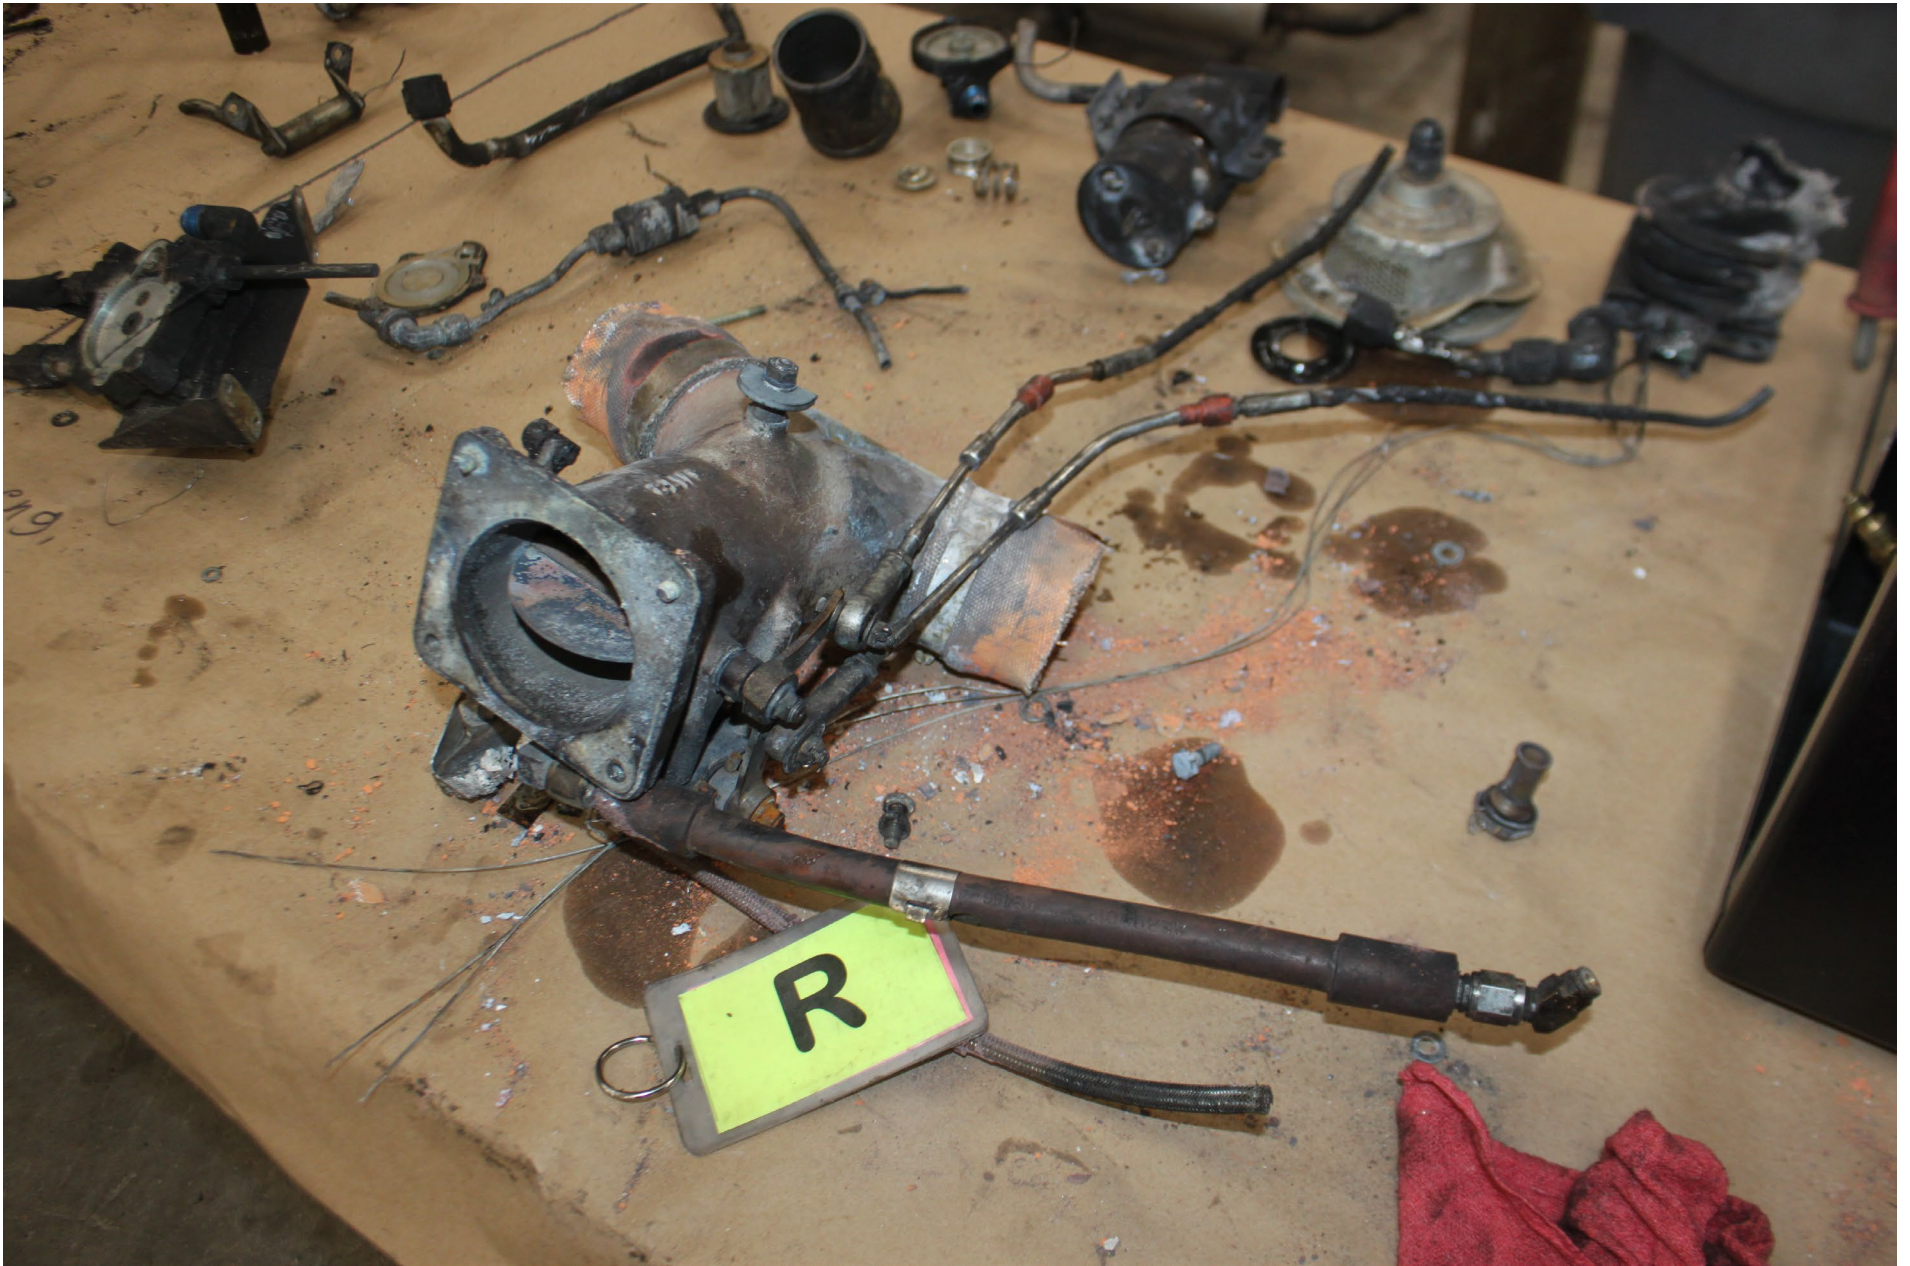
**Photo 16 – NTSB Digital Photograph. View of the Right Throttle Body and Metering Valve. Note the Extensive Heat Damage.**

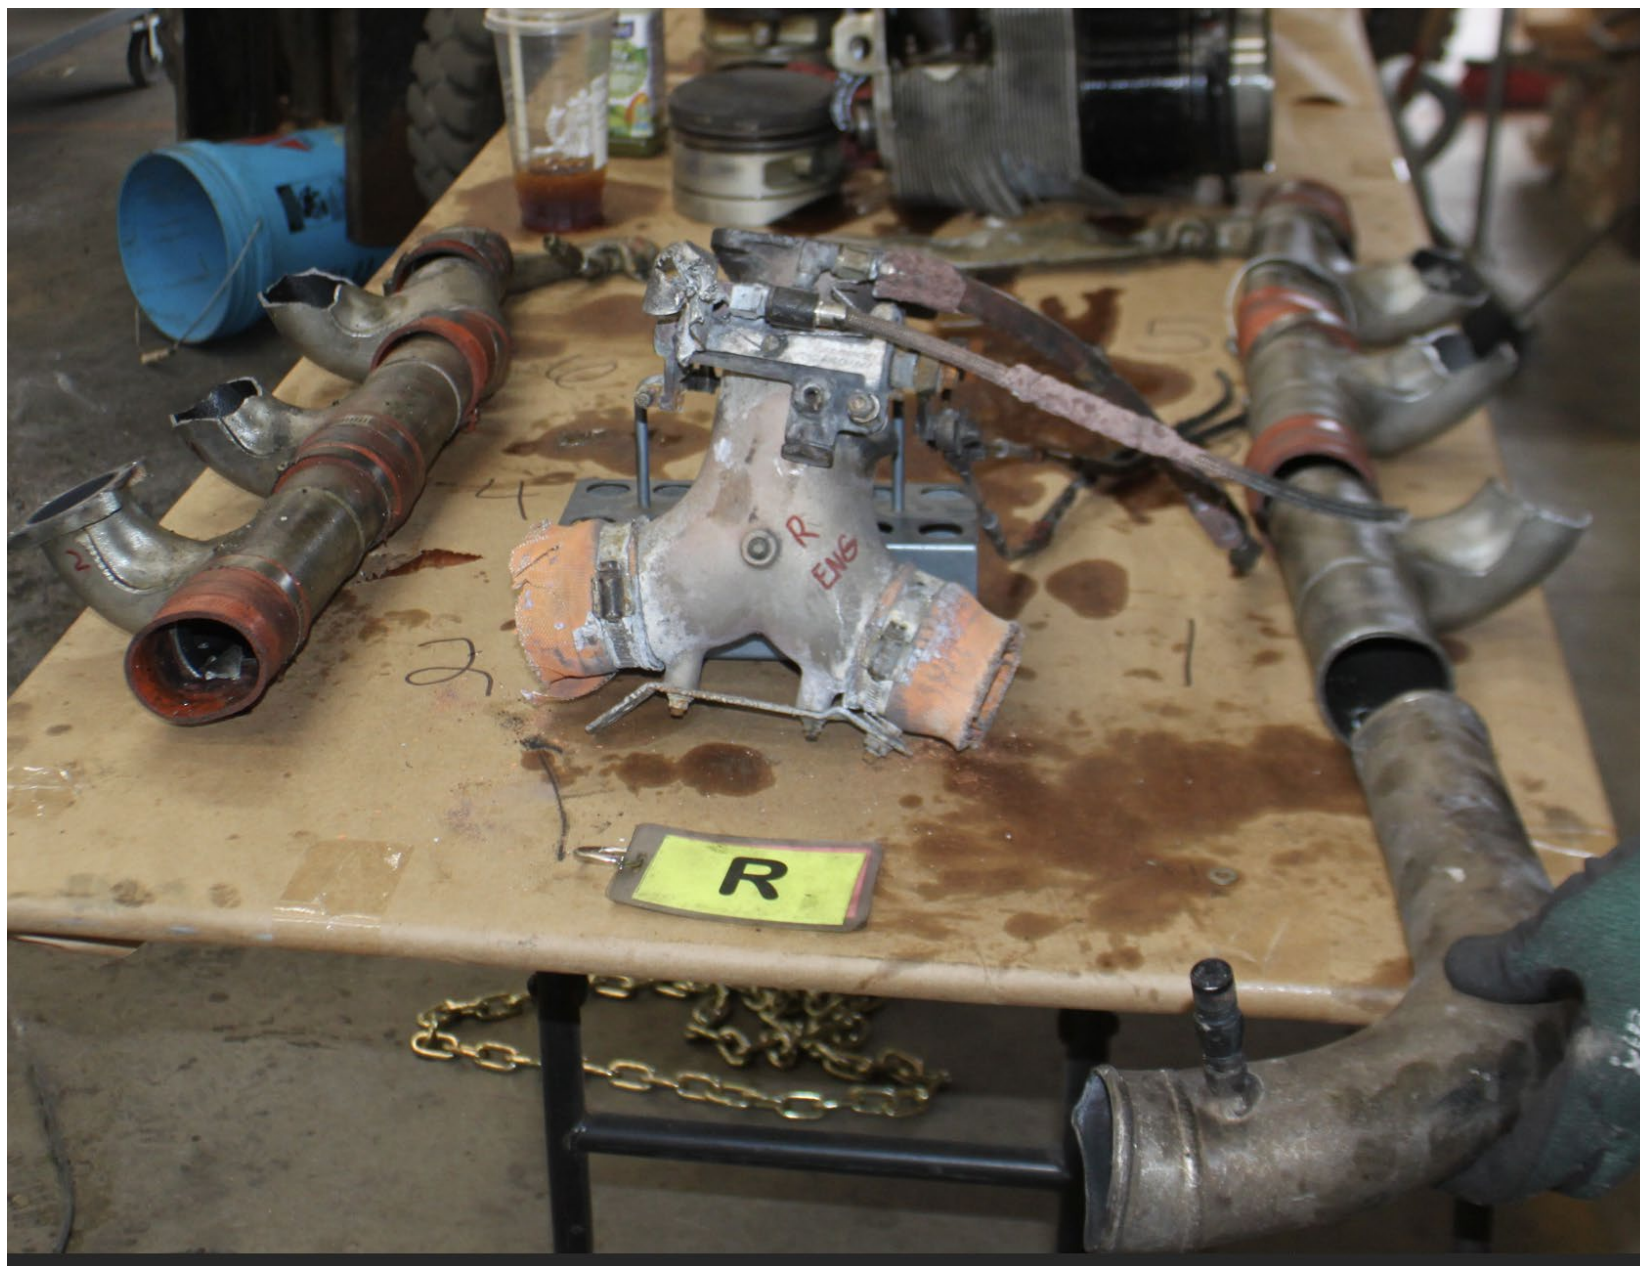
**Photo 17 – NTSB Cropped Digital Photograph. View of the Layout of the Right Engine Air Induction and Throttle Body and Fuel Metering Valve. The No. 1 Cylinder Is On the Lower Right Portion of the Photograph.**

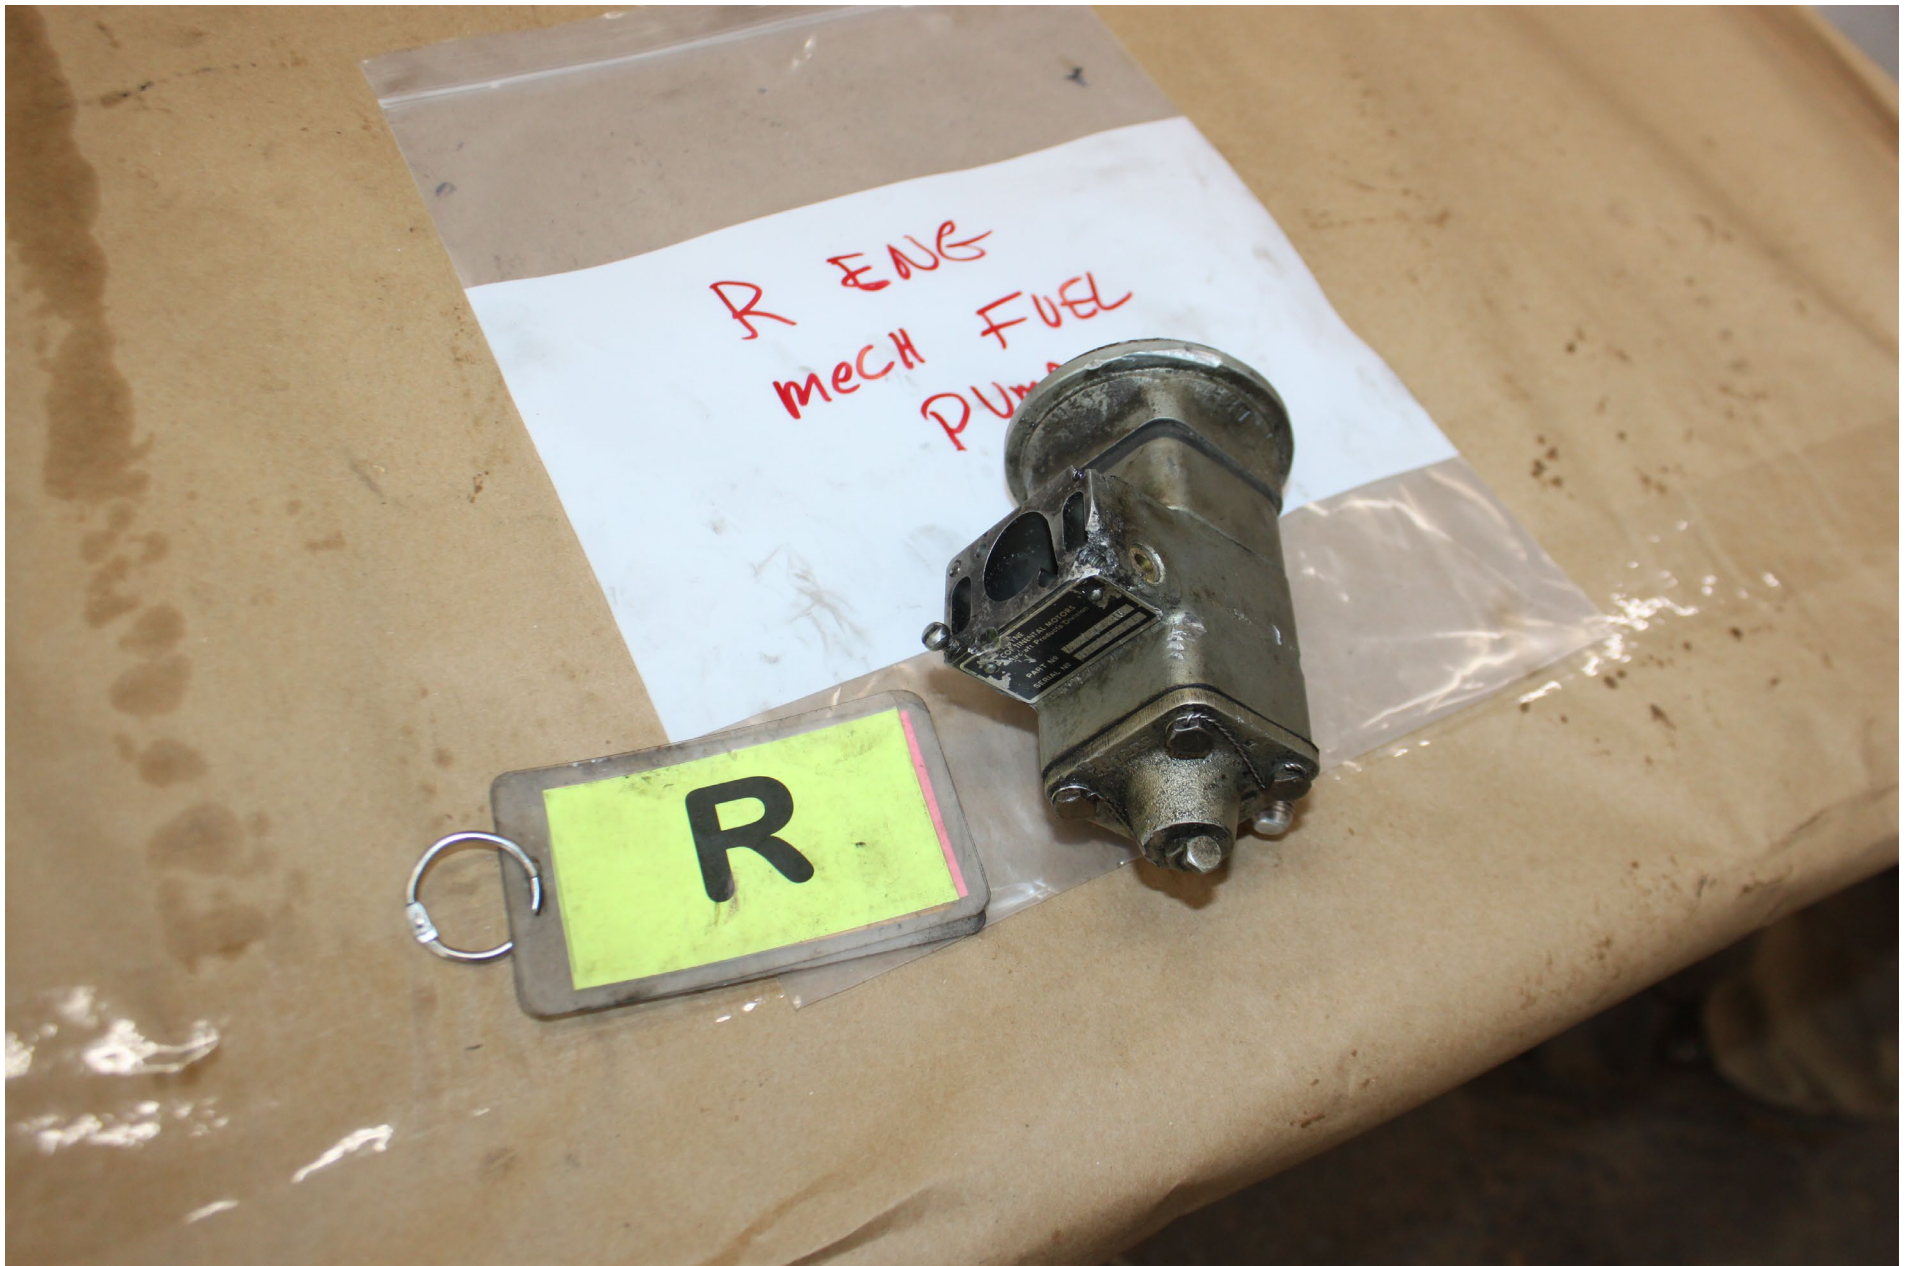
**Photo 18 – NTSB Digital Photograph. View of the Impact Separated Right Engine-Driven Fuel Pump.**

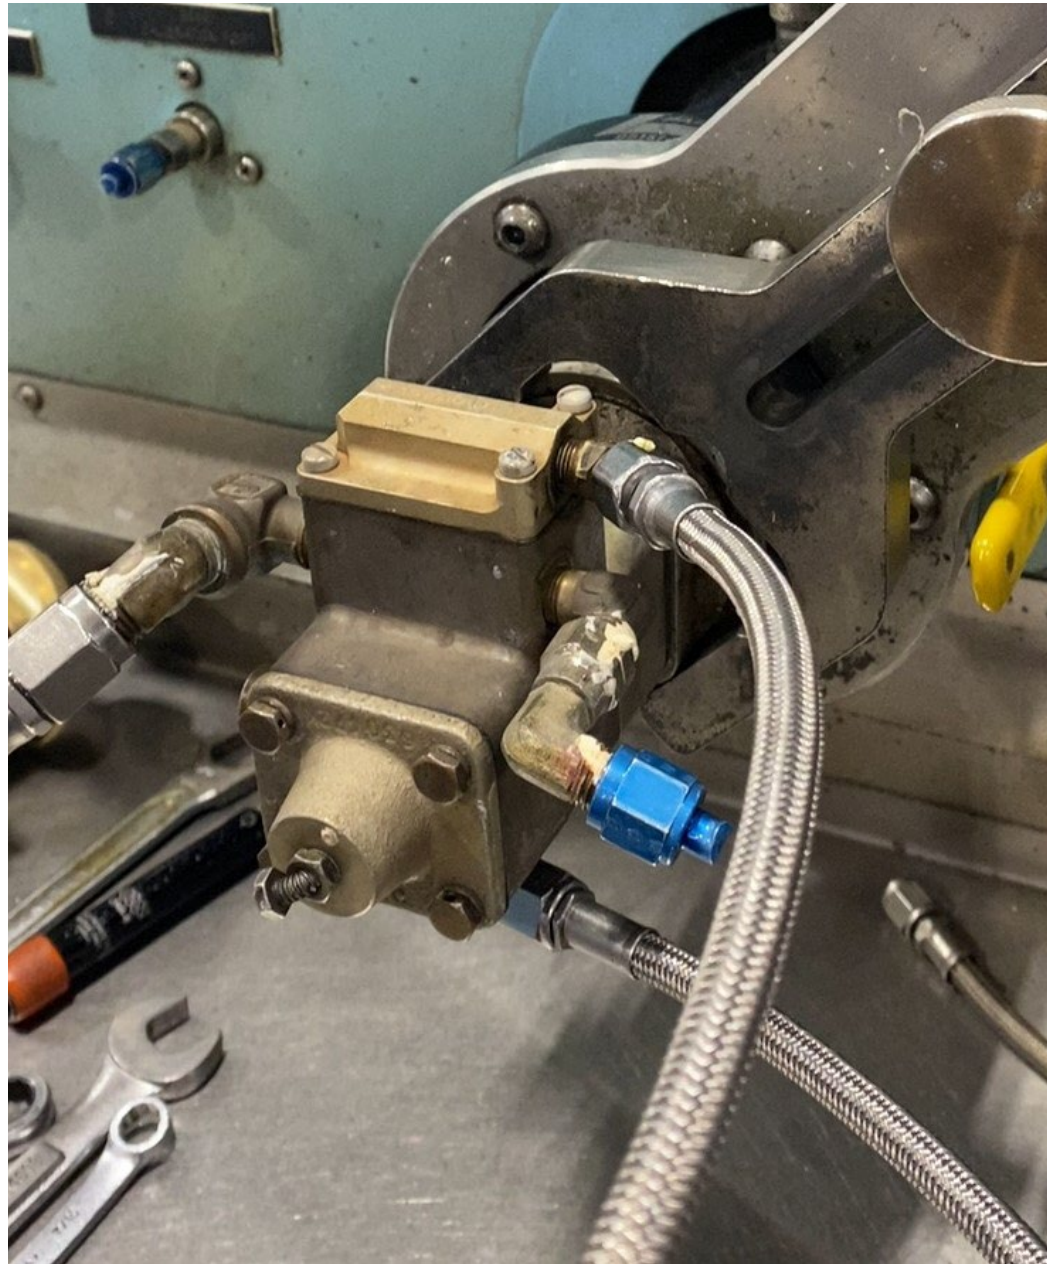
**Photo 19 – NTSB Digital Photograph. View of the Right Engine-Driven Fuel Pump on Production Test Bench Before Bench Testing.**
